Diamond drilling at the Stanhope colliery

by V. M. Threader

[6 July 1972]

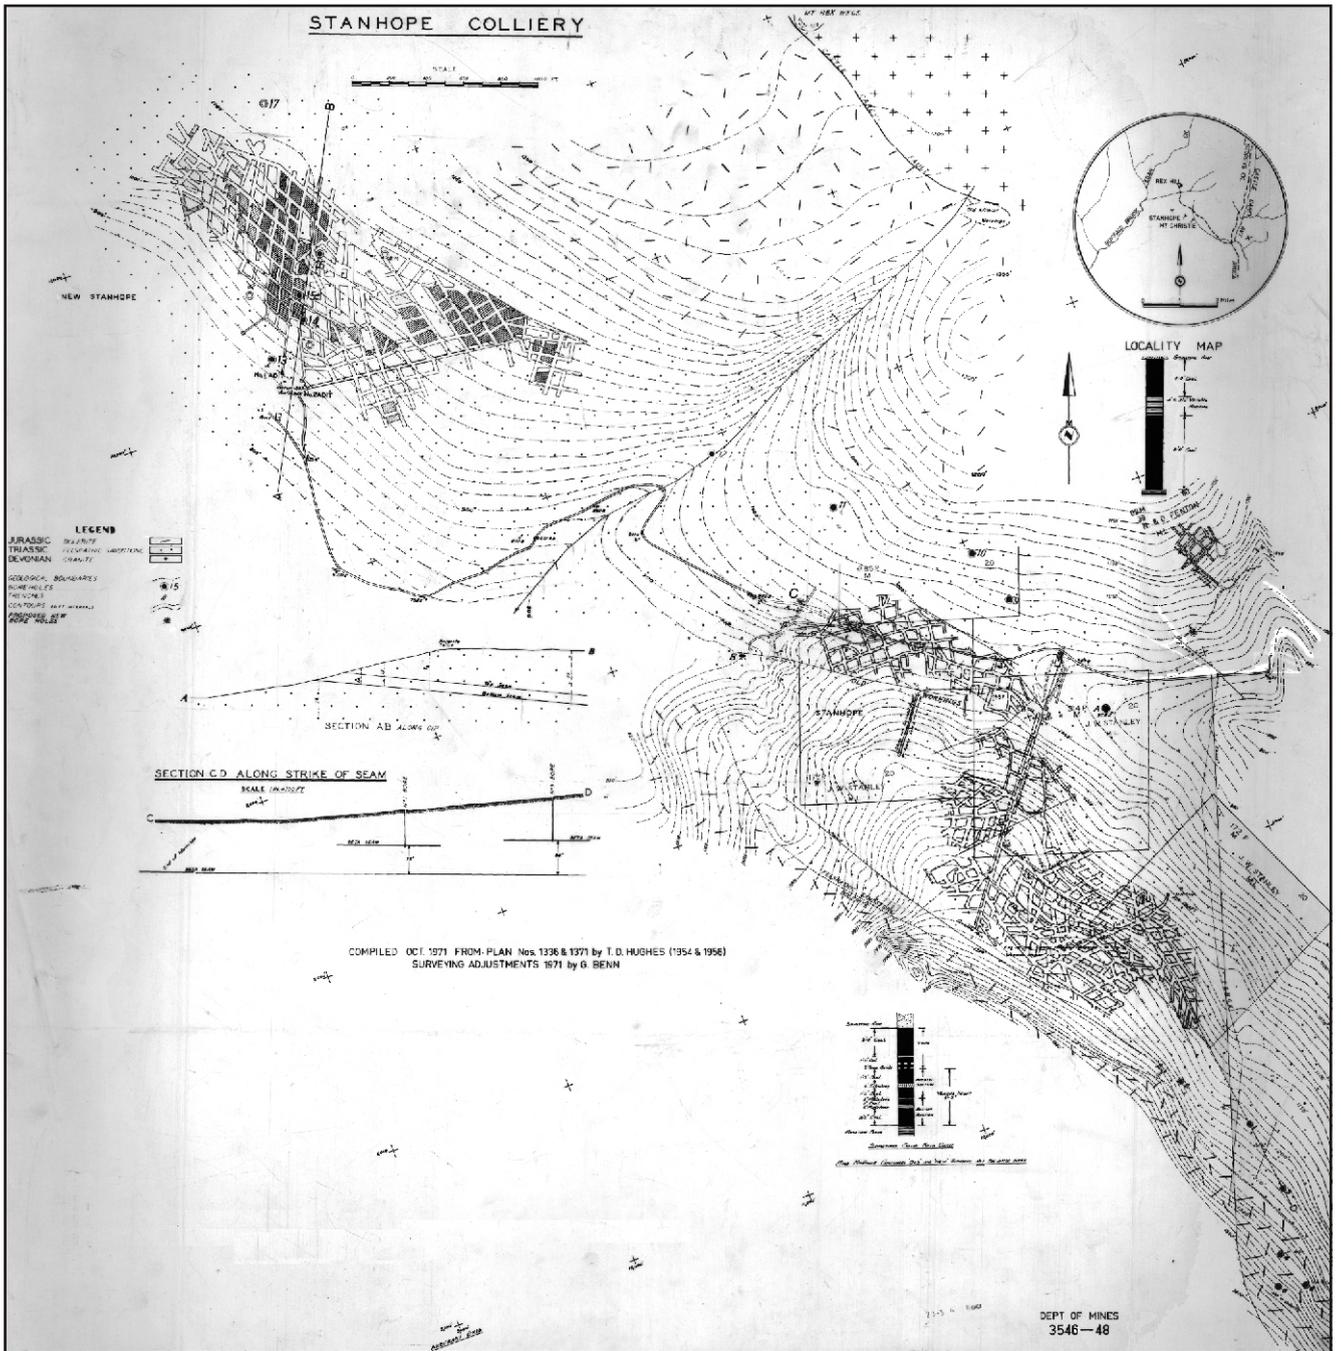
Figure 1
Mine plan, New Stanhope Colliery

The present owner has suggested that the Stanhope colliery (easterly workings) mined a seam lying 50 feet above that mined at the New Stanhope colliery (westerly workings).

Departmental surveyor G. Benn has conducted a tie survey in order to construct the attached composite map (fig. 1) from the two mine plans 1336 and 1371 produced by T. D. Hughes in 1954 and 1956.

It is suggested that a hole sited at C would be better placed to test the theory. It should intersect the Stanhope seam at approximately 40 ft and, if it is present, the New Stanhope seam at 90 feet. The poor quality of the upper coal intersections in holes 15, 16 and 17, and the absence of significant coal seams in Hole A, suggest that the two mines worked the same seam.

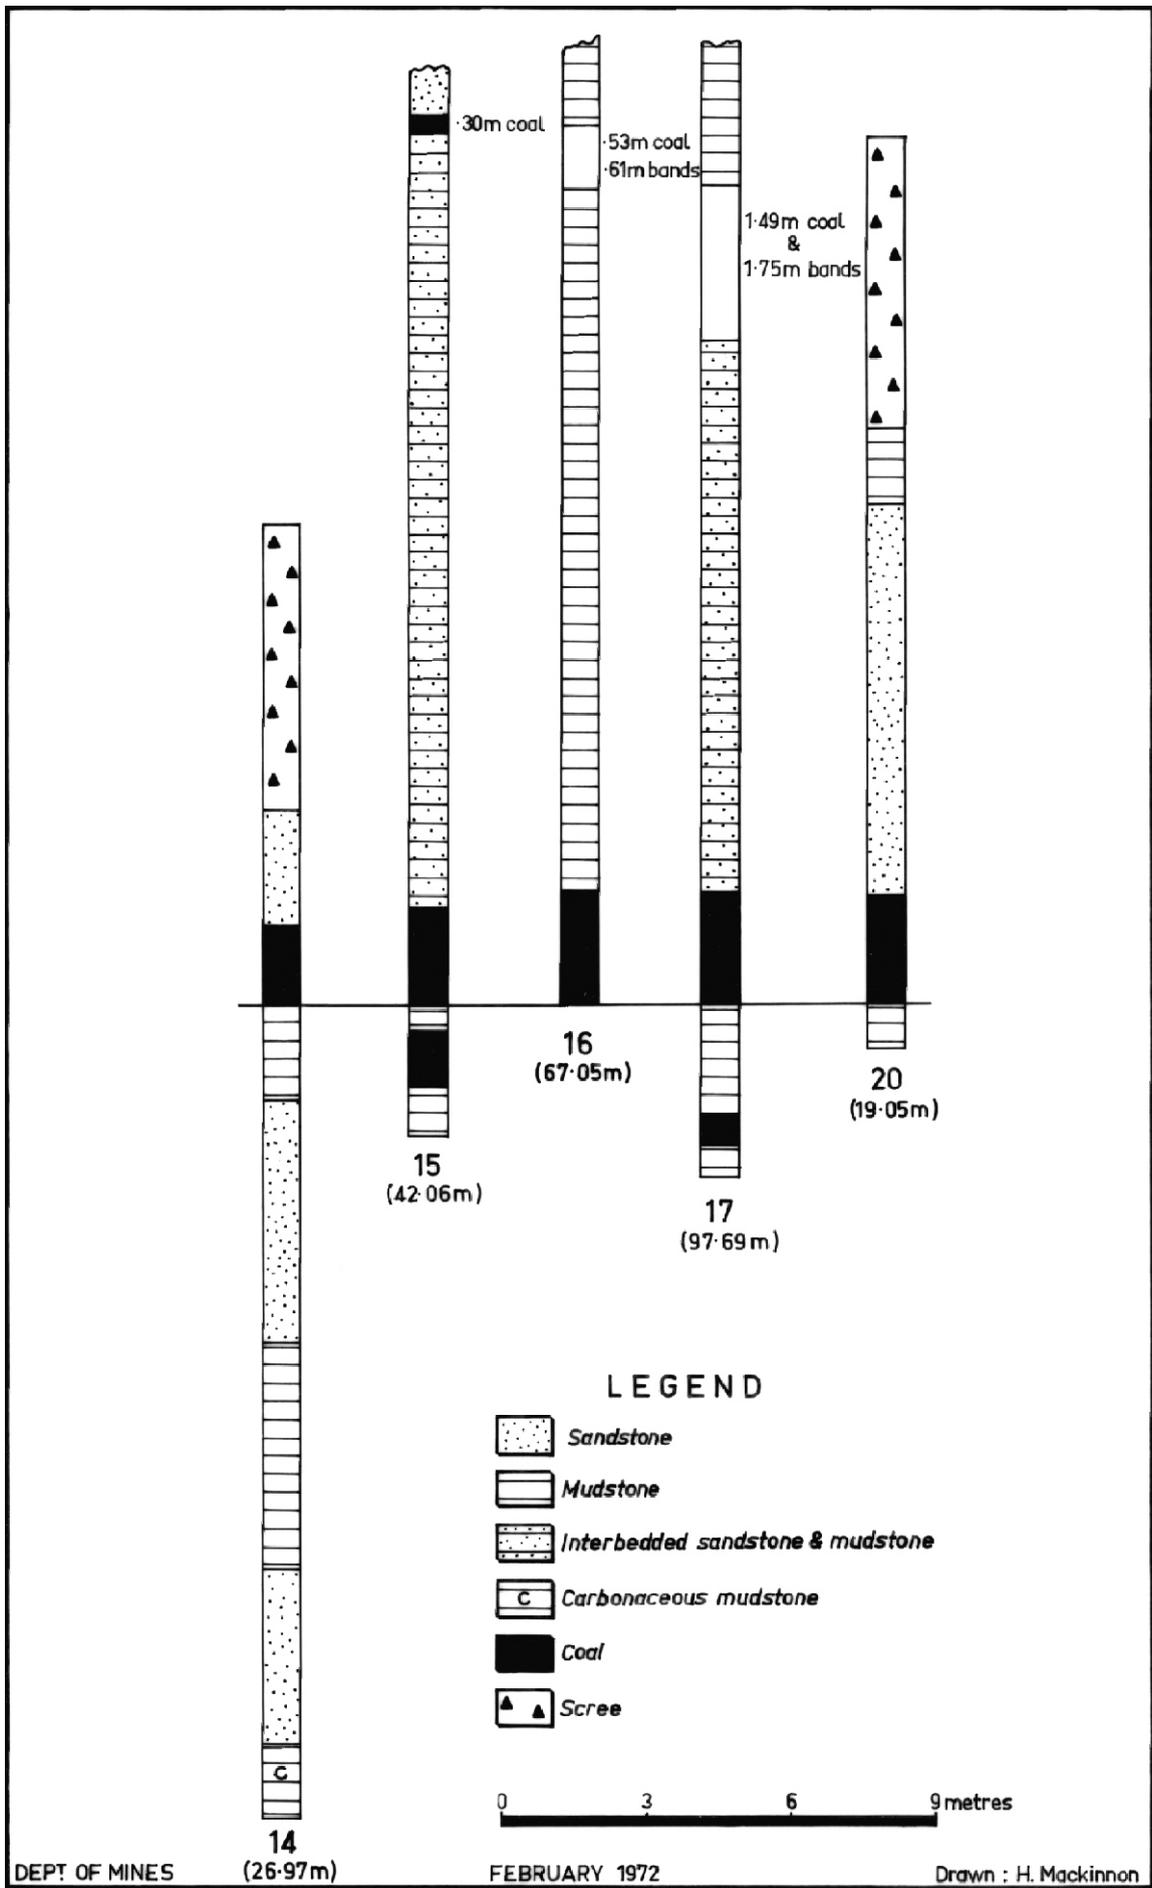
Figure 2
Bore logs of some drilling, New Stanhope Colliery

A tabulated summary of the drilling results is given. A more detailed account is not warranted due to the poor state of the records. A portion of this drilling is also shown on the accompanying sketch section (fig. 2). The elevations of the holes are given relative to the bottom of the New Stanhope seam. The coal intersections 40–50 feet above the seam in this section presumably represent the upper coal seam which Mr Stanley correlates with the Stanhope seam. Mr Stanley sited two new holes, A and B, to test the theory. Hole A was drilled to 105 ft and did not intersect a workable seam (see attached log). Hole B has not been drilled.

The drilling to date has tended to be unsystematic and wasteful and the benefit obtained from the 3,000 ft of drilling already carried out has not been sufficient to warrant the expense.

It is suggested that future drilling be carried out by an experienced operator using heavier machines capable of producing larger diameter core.
