Unpublished Report 1975/51

Further observations, Department of Mines site, Mornington.

D. E. Leaman

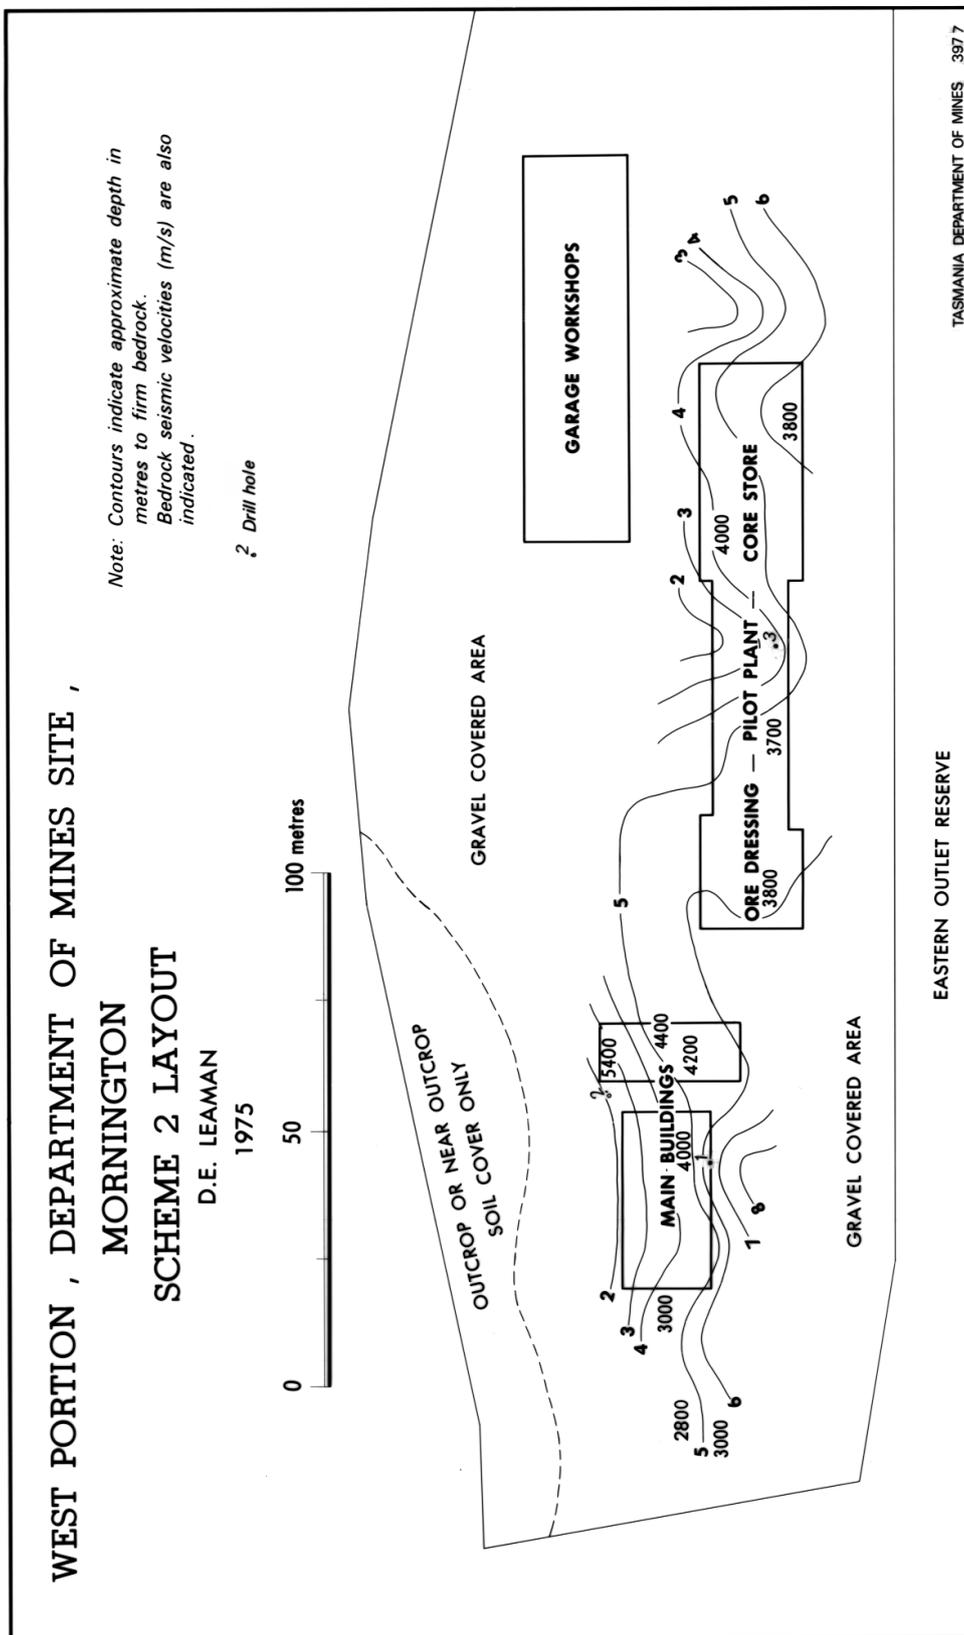
The results of a primary geological survey and seismic survey were presented by Leaman (1975). The interpretation of the seismic survey was not regarded as wholly reliable without some control due to the range of properties possessed by the gravel-talus overburden. Four drill holes were subsequently placed to evaluate the reliability of the survey (fig. 1).

Placed in the region of the main building where the seismic results suggested a substantial bedrock depression. The particular region is also marked by a small swamp and it was suspected that the velocity presumed overall was too high for the material in this zone. This would be especially so if piping had occurred.

A depth of about 6 m to rock was expected but only 3.7 m was recorded. It appears likely that the values in excess of 5 m as shown in the original plan reflect low velocity, texturally disturbed material. It is significant that a similar swampy zone occurs near the eastern end of the core store building where interpreted depths were also high.

Placed in the region of the main building. Expected depth to rock 2 m; observed depth ~3 m.

Placed in the region of the pilot plant. Expected depth to rock 3.5 m; observed depth ~3.5 m.

Placed adjacent to the drain just south of the property boundary and aligned with the southern wall of the main building this hole was used to give an indication of the maximum depth of talus materials. Expected depth to rock >8 m; observed depth ~7.7 m.

In each case the talus/gravel overburden was easily drilled and was self supporting but core recovery was often poor. There were zones where no core was obtained. The bedrock was in good condition and showed only minor weathering effects.

The interface between overburden and rock was found to be abrupt in each case.

At the time of the original surveys (late summer) the property was very dry although it was apparent that two regions were generally swampy with a high water table. The presence of piping features was also noted in all cuts and in collapse zones across the surface. All these features were confirmed at the time of drilling (mid-winter). The property is subject to sheet inundation from the steep slopes to the north and much of this runoff stays on the surface. The remainder appears to pass into the rock/talus junction near the northern boundary and in passing through the variable overburden causes considerable piping. As a result the property is very wet, in places very boggy and the overburden is subject to collapse and compaction under load.

Great care will be necessary to ensure adequate drainage, and drains along the northern side of the property are suggested. As a result of the partial destruction of the overburden all pier footings should be properly founded on bedrock which is never more than 4 m deep in the area marked for development.
