1977/18. Investigation of possible highway routes between Latrobe and Devonport.

W.L. Matthews

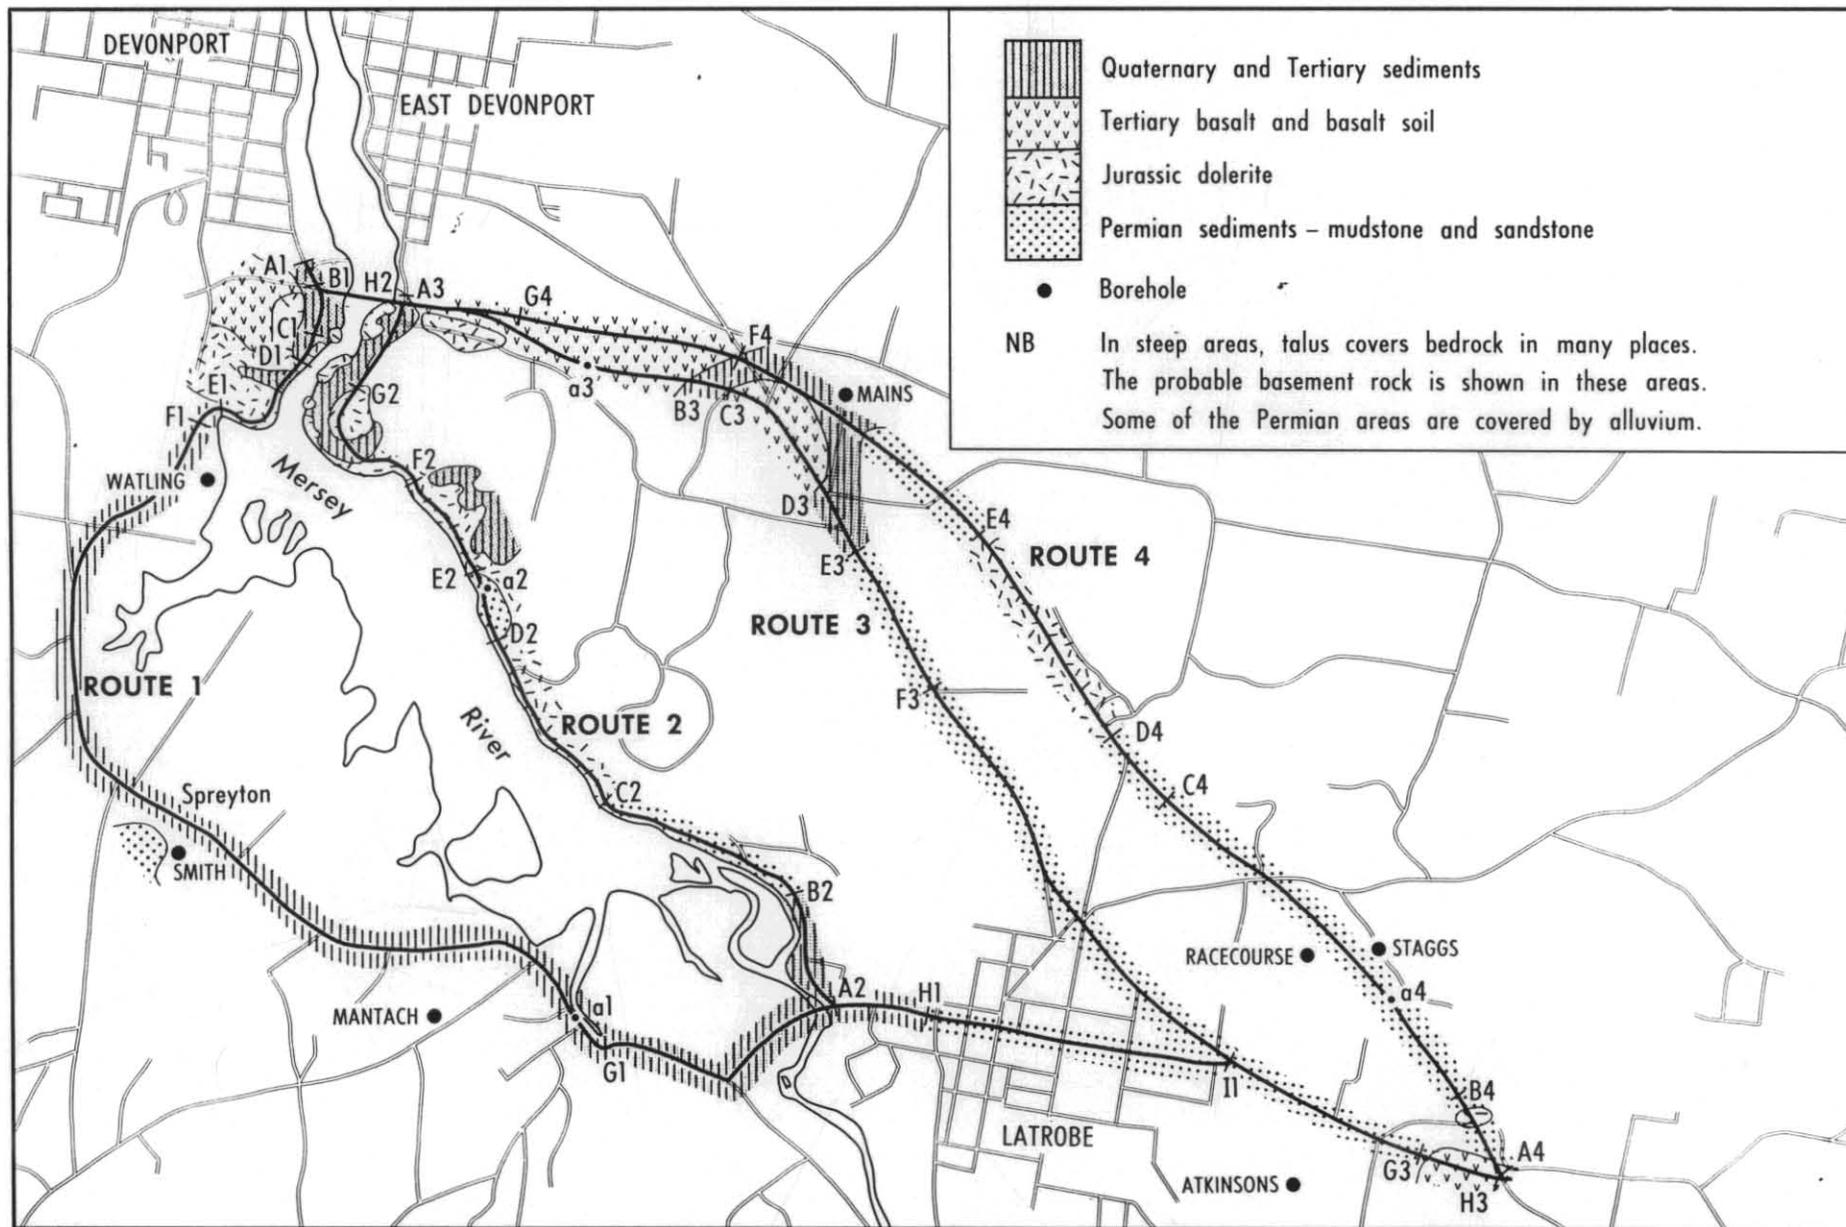
Figure 1.

Gutteridge, Haskins and Davey, consulting engineers, requested information on four possible road routes between Latrobe and Devonport. Three possible alignments are along existing roads while the other would be a new route (fig. 1). Comments were requested on soil stability and on the geology of the soil and rock, with particular attention to their suitability for road construction. The projected road is a dual carriageway with a 55 m wide road reserve. The survey undertaken along each route was only of a reconnaissance nature.
