UR 1978-43

## Groundwater investigations at Lime Bay and Plunkett Point, Tasman Peninsula.

W.C. Cromer

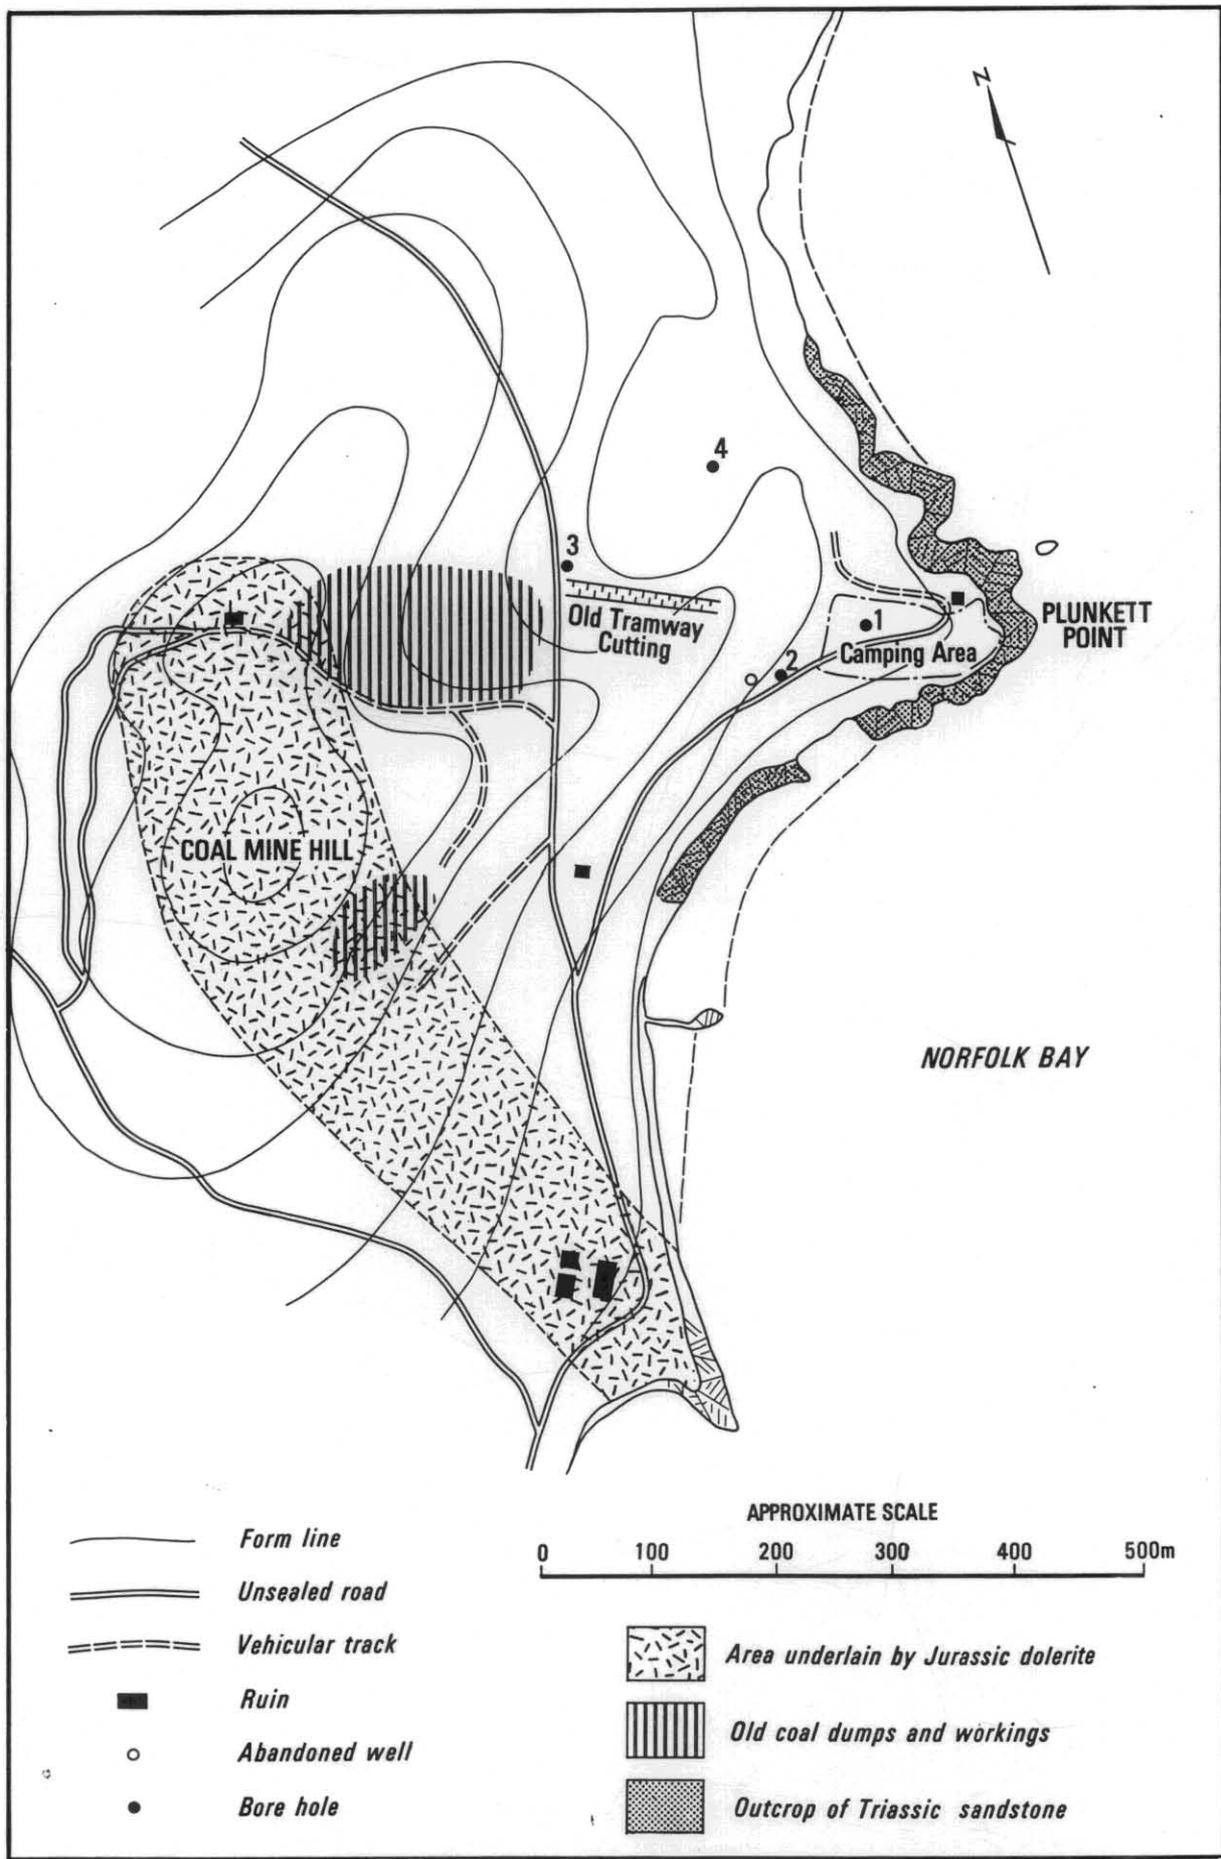
Figure 1. Sketch map of the Plunkett Point area, Tasman Peninsula.

The camping area and surrounds (fig. 1) are in the Saltwater River Reserve. Triassic sandstone and Jurassic dolerite form the bedrock in the district, and in the Coal Mine Hill area both are covered by a variable thickness of sand and clayey sand. It was these unconsolidated sediments which were investigated as a possible source of groundwater. Four mechanically augered holes were drilled in and near the camp site (fig. 1). The logs (depths in metres) are:

All holes were either dry or damp, suggesting that despite the nature and thickness of the sediments, no permanent water table exists. An explanation for this may be that the relief of the sandstone basement is

sufficiently high to enable groundwater to drain rapidly coastwards (many seepages occur at sea level), and that the dense bushy vegetation does not permit much infiltration of water or rapidly evapotranspires that which does infiltrate.

The chances of finding useful amounts of groundwater in the sediments are poor. There may be local pockets of groundwater in small depressions (the old convict well, which is now filled in, may have tapped one of these) but even then the supply is unlikely to be permanent. The underlying Triassic sandstone probably contains water, but a drilling rig would be needed to explore its potential.

It is suggested instead that surface water supplies (for example, the swampy area drained by creeks north of the site) be investigated to provide water to the camping area.

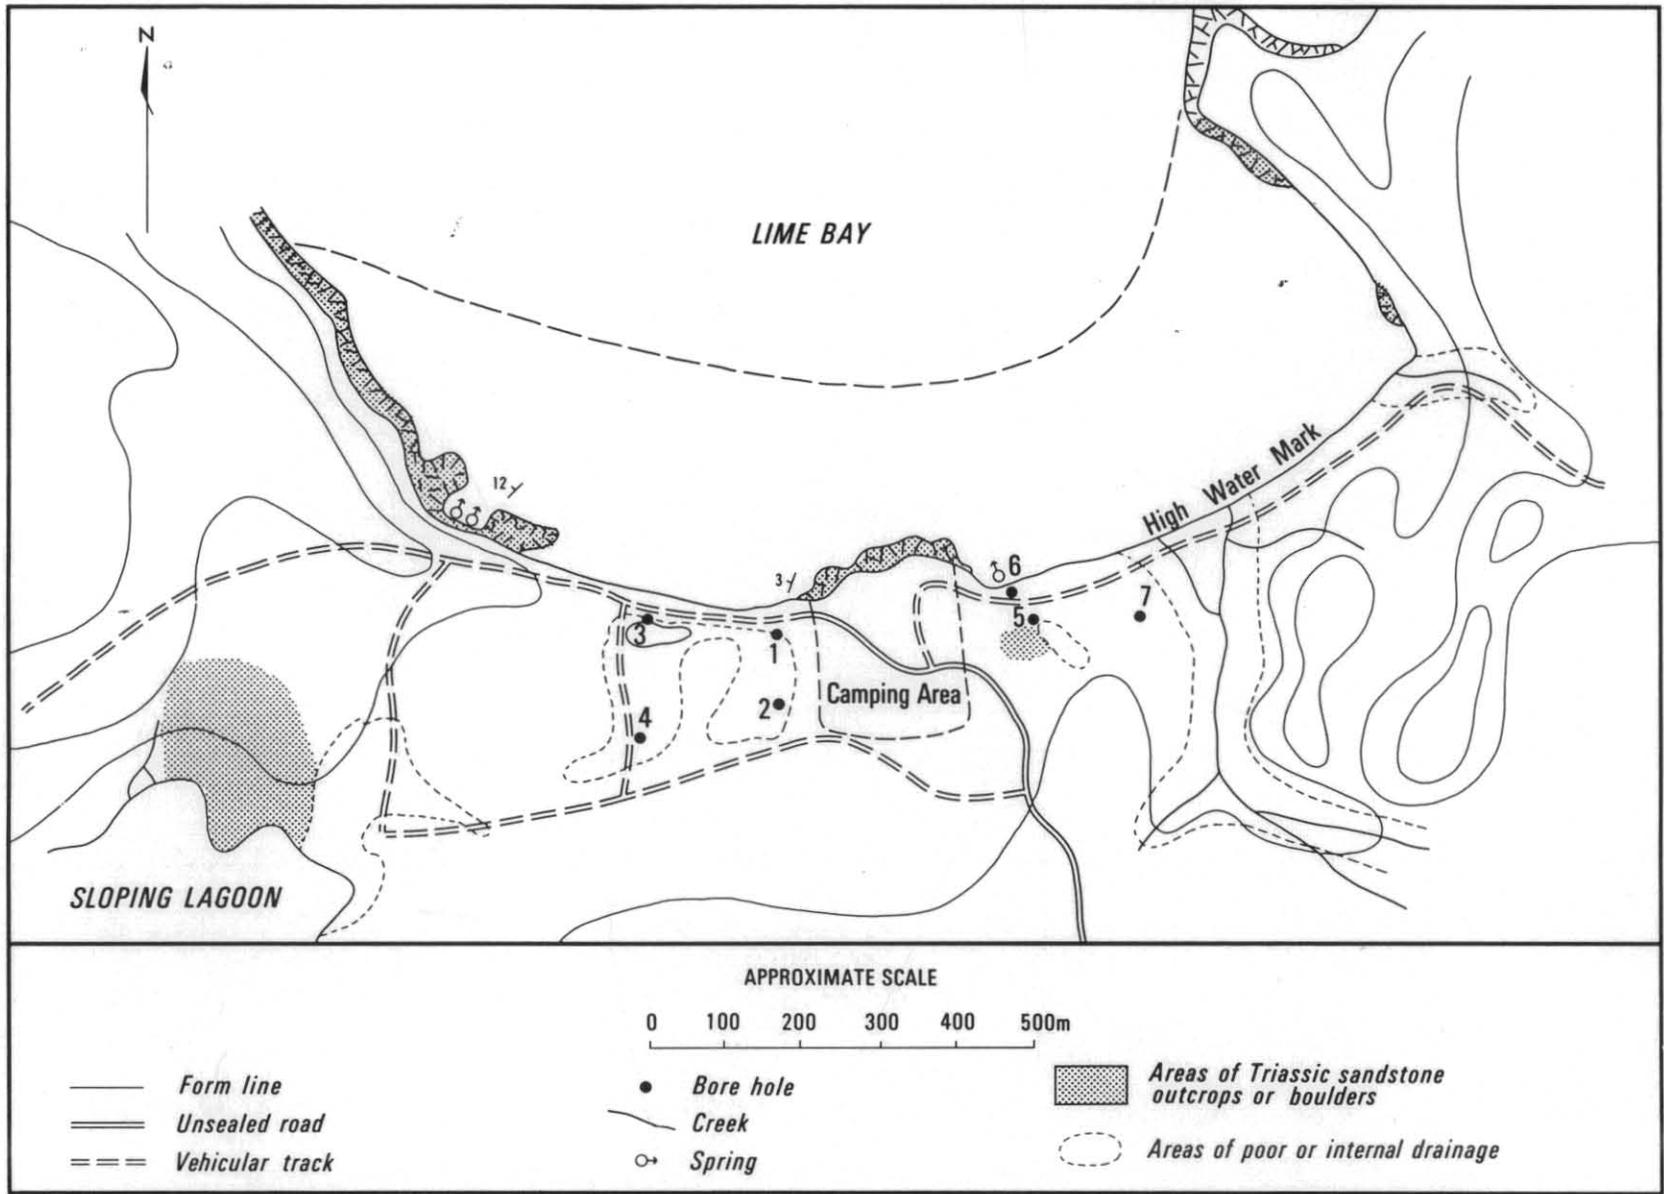
Figure 2. Sketch map of the Lime Bay area, Tasman Peninsula.

This camping area is on a small headland of Triassic sandstone in the middle of Lime Bay Beach (fig. 2). The geology of the surrounding area is similar to Plunkett Point in that Triassic sandstone and mudstone is overlain in places by a variable thickness of windblown sand, and sand and clay derived from weathered bedrock material. Seven augered holes were drilled at or near the site. Their logs (depths in metres) are:

All the holes were dry, indicating the absence of permanent groundwater (especially as during late winter and spring water levels are generally at their highest). Over much of the area the cover sand is very thin

and there is no chance of obtaining groundwater from it. Drilling the underlying sandstone is not recommended because of the low elevation of the site.

The unconsolidated sediments at both sites are not favourable aquifers. All holes drilled were dry. In each case, water will need to be trucked to the camping ground if existing surface water cannot be used. It is probably not economic to investigate the groundwater prospects of the Triassic sediments.
