1979/10. Site investigations for a proposed water main and reservoir at Rocherlea.

W.R. Moore

PROPOSED RISING MAIN AND RESERVOIR SITES - ROCHERLEA

SEISMIC AND MAGNETOMETER TRAVERSE AND AUGER DRILLING

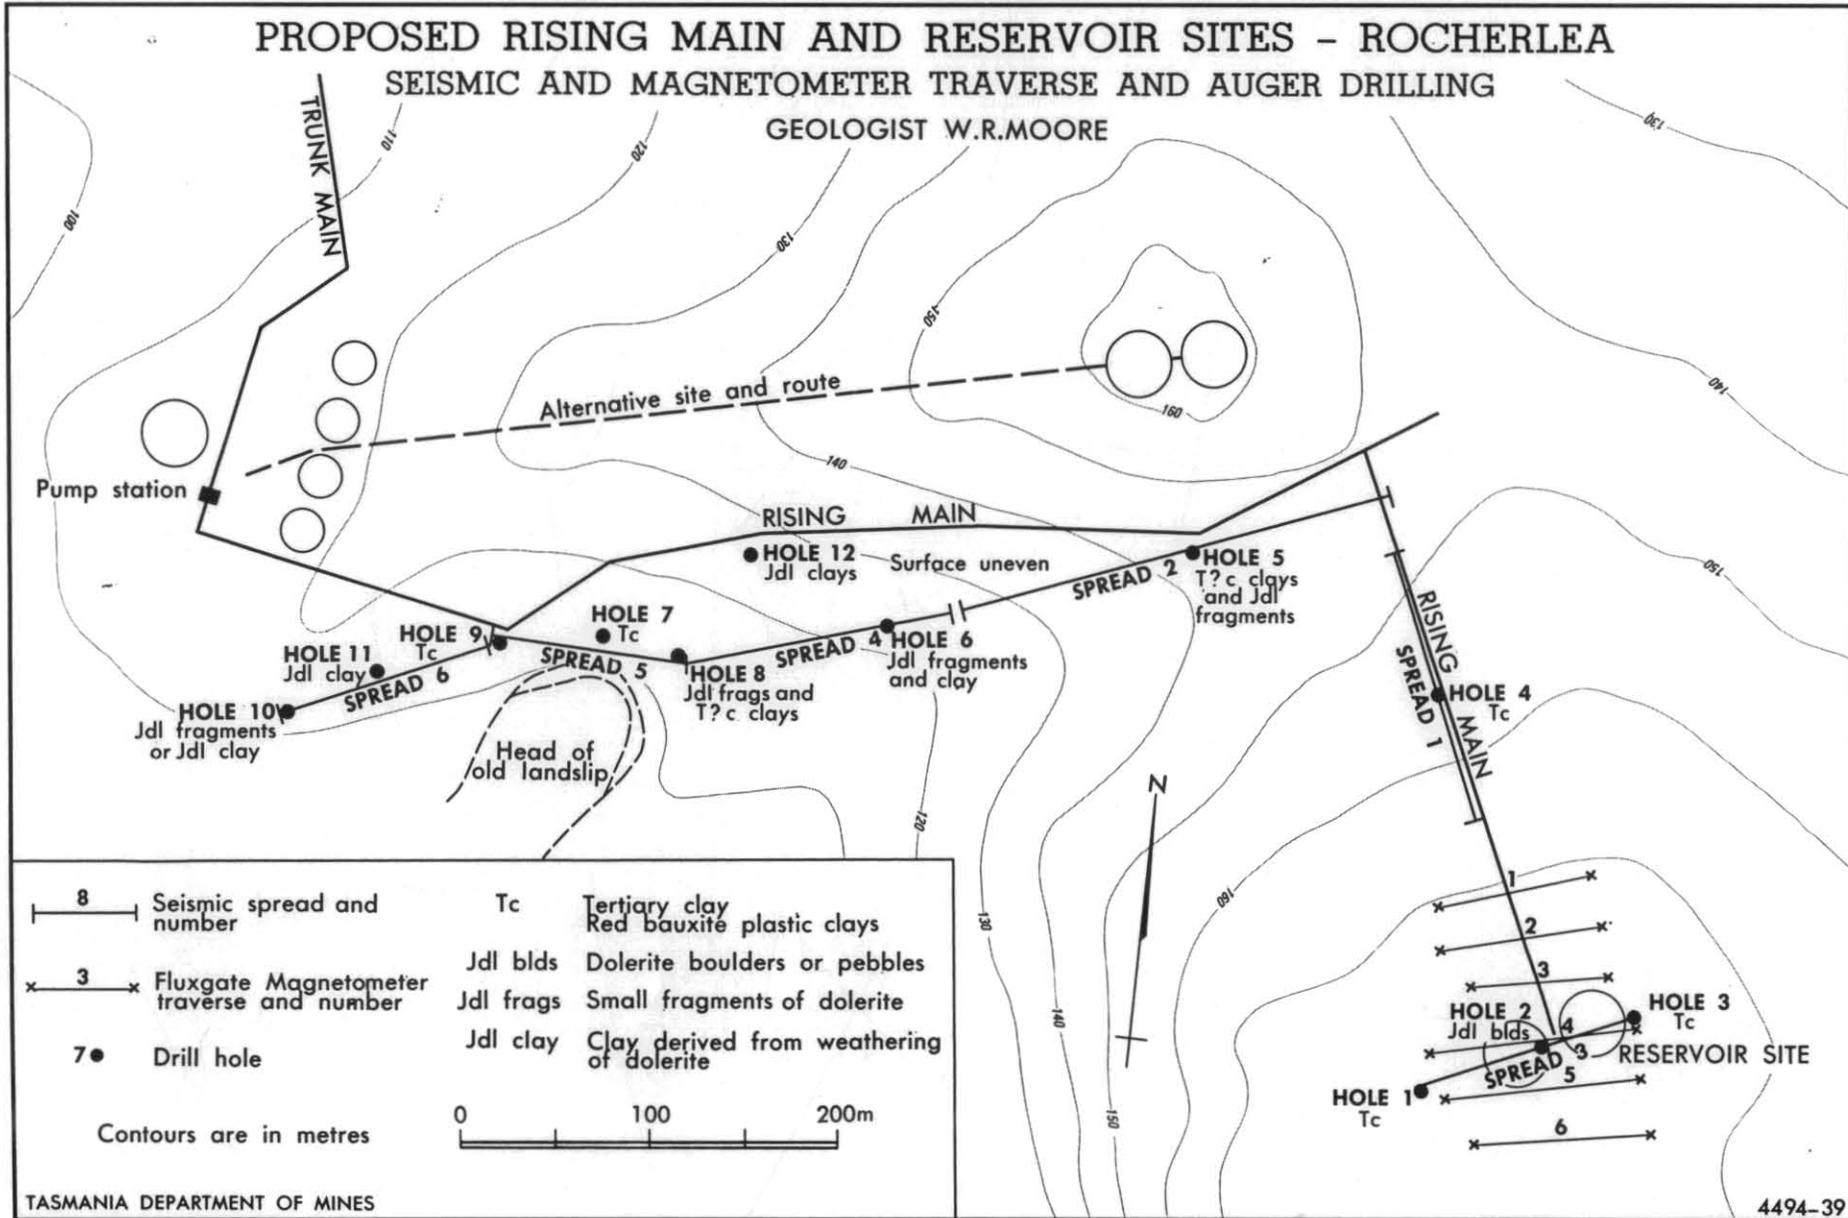
Figure 1

side, in the saddle, and on the eastern slopes down to Russells Plains. The soil is clayey with abundant ironstone pebbles and boulders and is thought to be underlain by Tertiary sediments of the Launceston Group (Longman *et al.*, 1964; Longman, 1966). These sediments extend westward into the head of the valley area below the northern dolerite ridge. The only outcrop of these Tertiary sediments occurs at a small farm dam approximately 200 m south-east of the proposed reservoir site. Here, light-grey and white clay and mottled bauxitic stained clay with ironstone boulders and nodules form the wall and side of the dam. Red and grey clay of the Tertiary Launceston Group have been found in many of the holes drilled in conjunction with the seismic investigation. These sediments are overlain by talus deposits along the pipe-line route and abut closely against and possibly overlie the dolerite at the reservoir site (fig. 1).

Gully headward erosion has been recently active as indicated by the old landslip, the heel of which is close to the proposed pipe-line route (fig. 1). Auger hole 7 drilled near this landslip penetrated 8.2 m of red plastic clay indicating that Tertiary sediments underlie the unstable area.

Five seismic spreads were fired near the proposed pipe-line route (fig. 1). A mechanical defect on the tractor mounted drill prevented the firing of spreads on the actual route. The spreads extend from the foot of the east-west dolerite ridge to the saddle and cover an area with no outcrop.

A fluxgate magnetometer traverse was undertaken along the pipe-line route across the saddle, to the proposed reservoir site. This was followed by an east-west seismic spread (spread 3, fig. 1) where the dolerite/Tertiary contact was thought to be located. Six closely spaced east-west magnetometer traverses were undertaken across this hill. The geophysical investigation was followed by shallow auger drilling using a tractor mounted 'Proline' drill.

An east-west seismic spread (spread 3, fig. 1) in the vicinity of this boundary ignored these dolerite outcrops even though the shots were located as close as it was feasible to drill a shot hole. Both ends of the Spread 3 indicated the presence of a thick slow surface layer with depths to dolerite or unknown bedrock at the west end of 6 - 8 m and 17 m at the east end (table 1). Unfortunately all attempts to fire a suitable mid-shot on this spread had to be abandoned because of the danger of flyrock.

- (a) Two or three back-hoe pits be dug between auger holes 7, 9 and 12 in an attempt to establish the Tertiary/dolerite boundary.
- (b) That the pipe-line route be resurveyed and pegged closely so that the pegs cannot be confused with the other sub-division pegs. This appears to have caused a discrepancy between the map supplied by the engineer and a preliminary survey of the seismic lines by this Department.
- (c) A series of trial pits be dug with a back-hoe close to this pegged route to site the line into the Tertiary sediments as much as possible within design and stability limitations.

- (a) On the higher section of this hill a grid of an adequate size for the reservoirs be pegged and then checked with a hammer seismograph.
- (b) This grid then be drilled using a combined auger and diamond drill. Some of these combined auger and diamond holes will be required to go to the bedrock seismic refractors.
