1979/30. Report on pre-feasibility geological site investigation, Metropolitan Water Board Dunns Creek Project.

A.T. Moon

The proposed Dunns Creek Project involves a 15 to 20 m high dam on Dunns Creek, a tributary of Browns River, close to Kingston. Pre-feasibility geological studies have been carried out in the period March to May 1979.

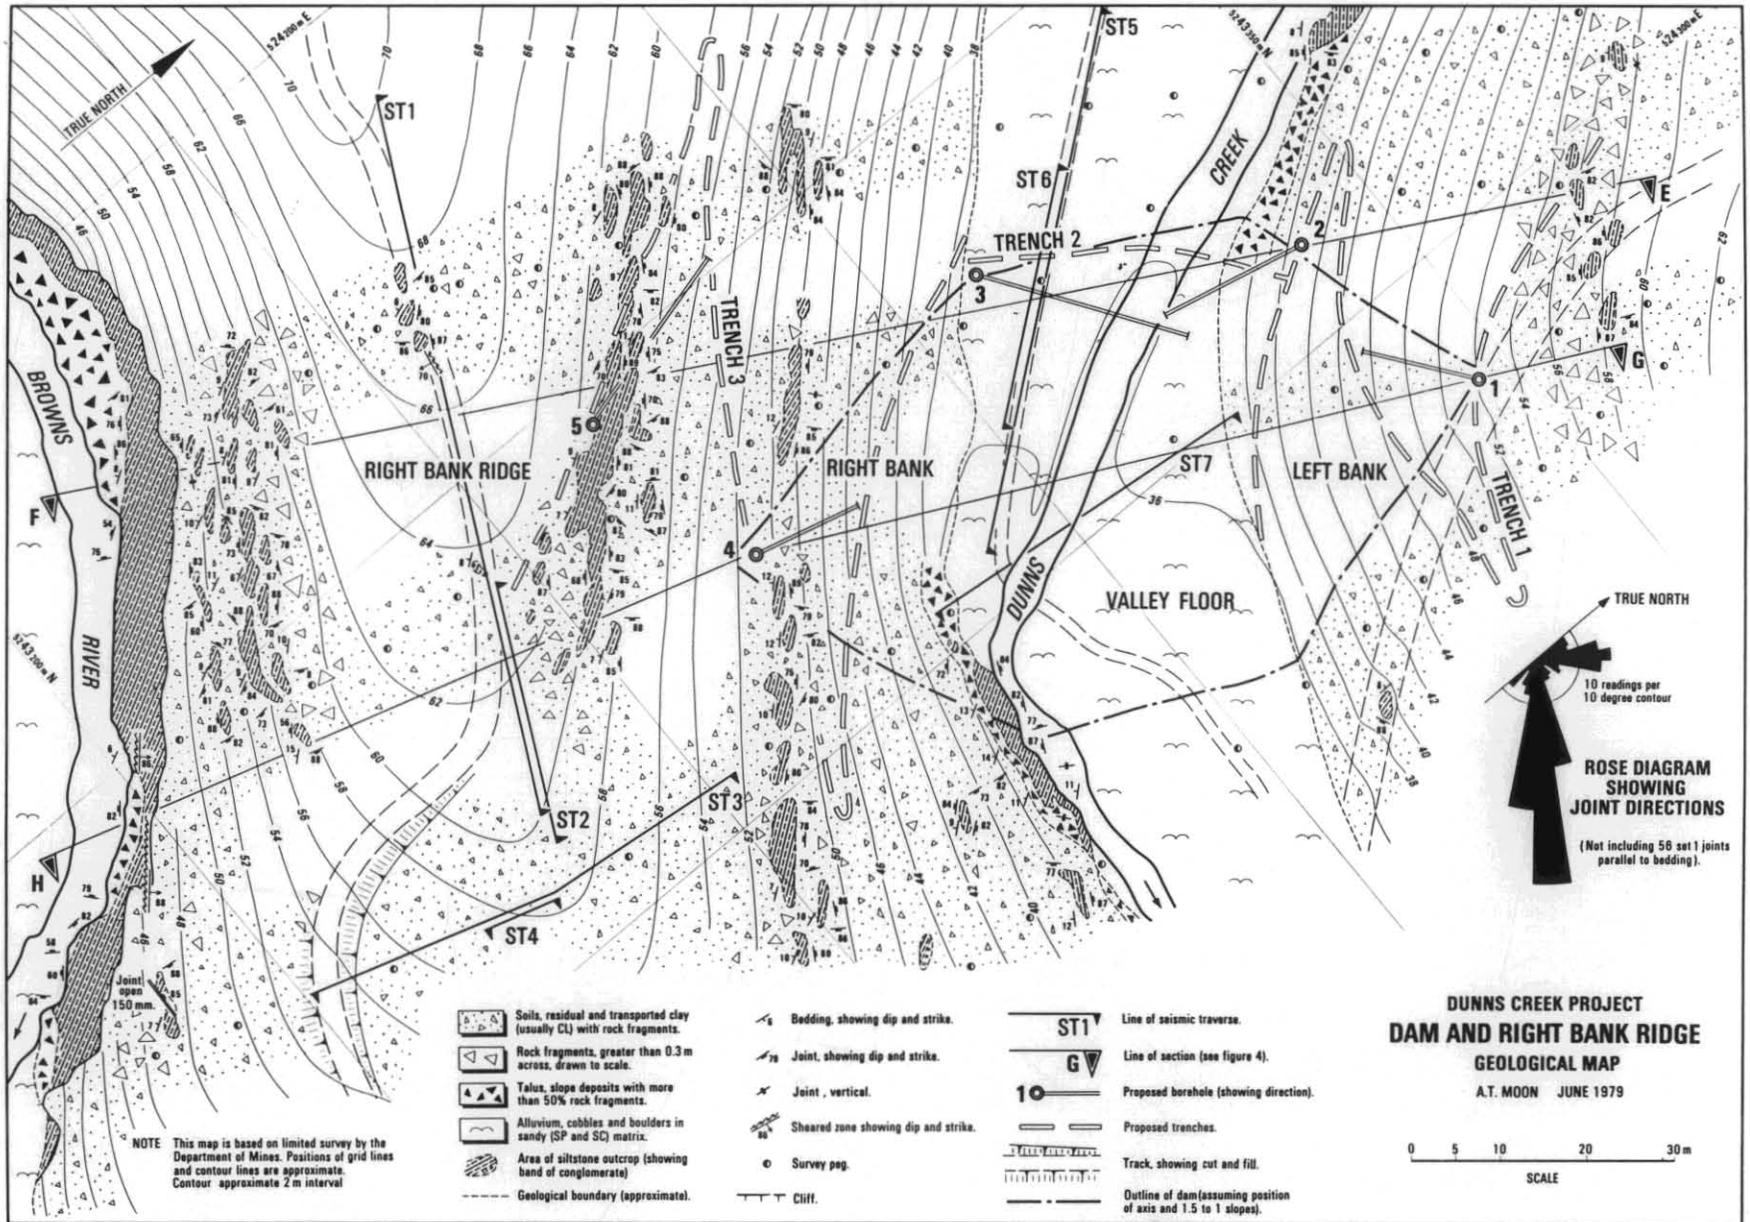
Figure 3.

In outcrop, joints are open or filled with soil, but most may be expected to be closed below the surface. One very prominent open joint has been mapped in an outcrop above the cliff overlooking Browns River (fig. 3). In this locality the whole rock mass is probably loosened and open joints may extend down to river level. This is caused by movement of the rock mass towards the river along Set 1 defects.

The most prominent sheared zone (fault) observed was adjacent to Browns River (fig. 3 and section GH, fig. 4). It consisted of a zone of closely spaced fractures about 500 mm wide. There is no apparent displacement across the fault.

There is potential for leakage of the reservoir through the Right Bank Ridge (fig. 3) close to the dam. The remainder of the reservoir is likely to be watertight.

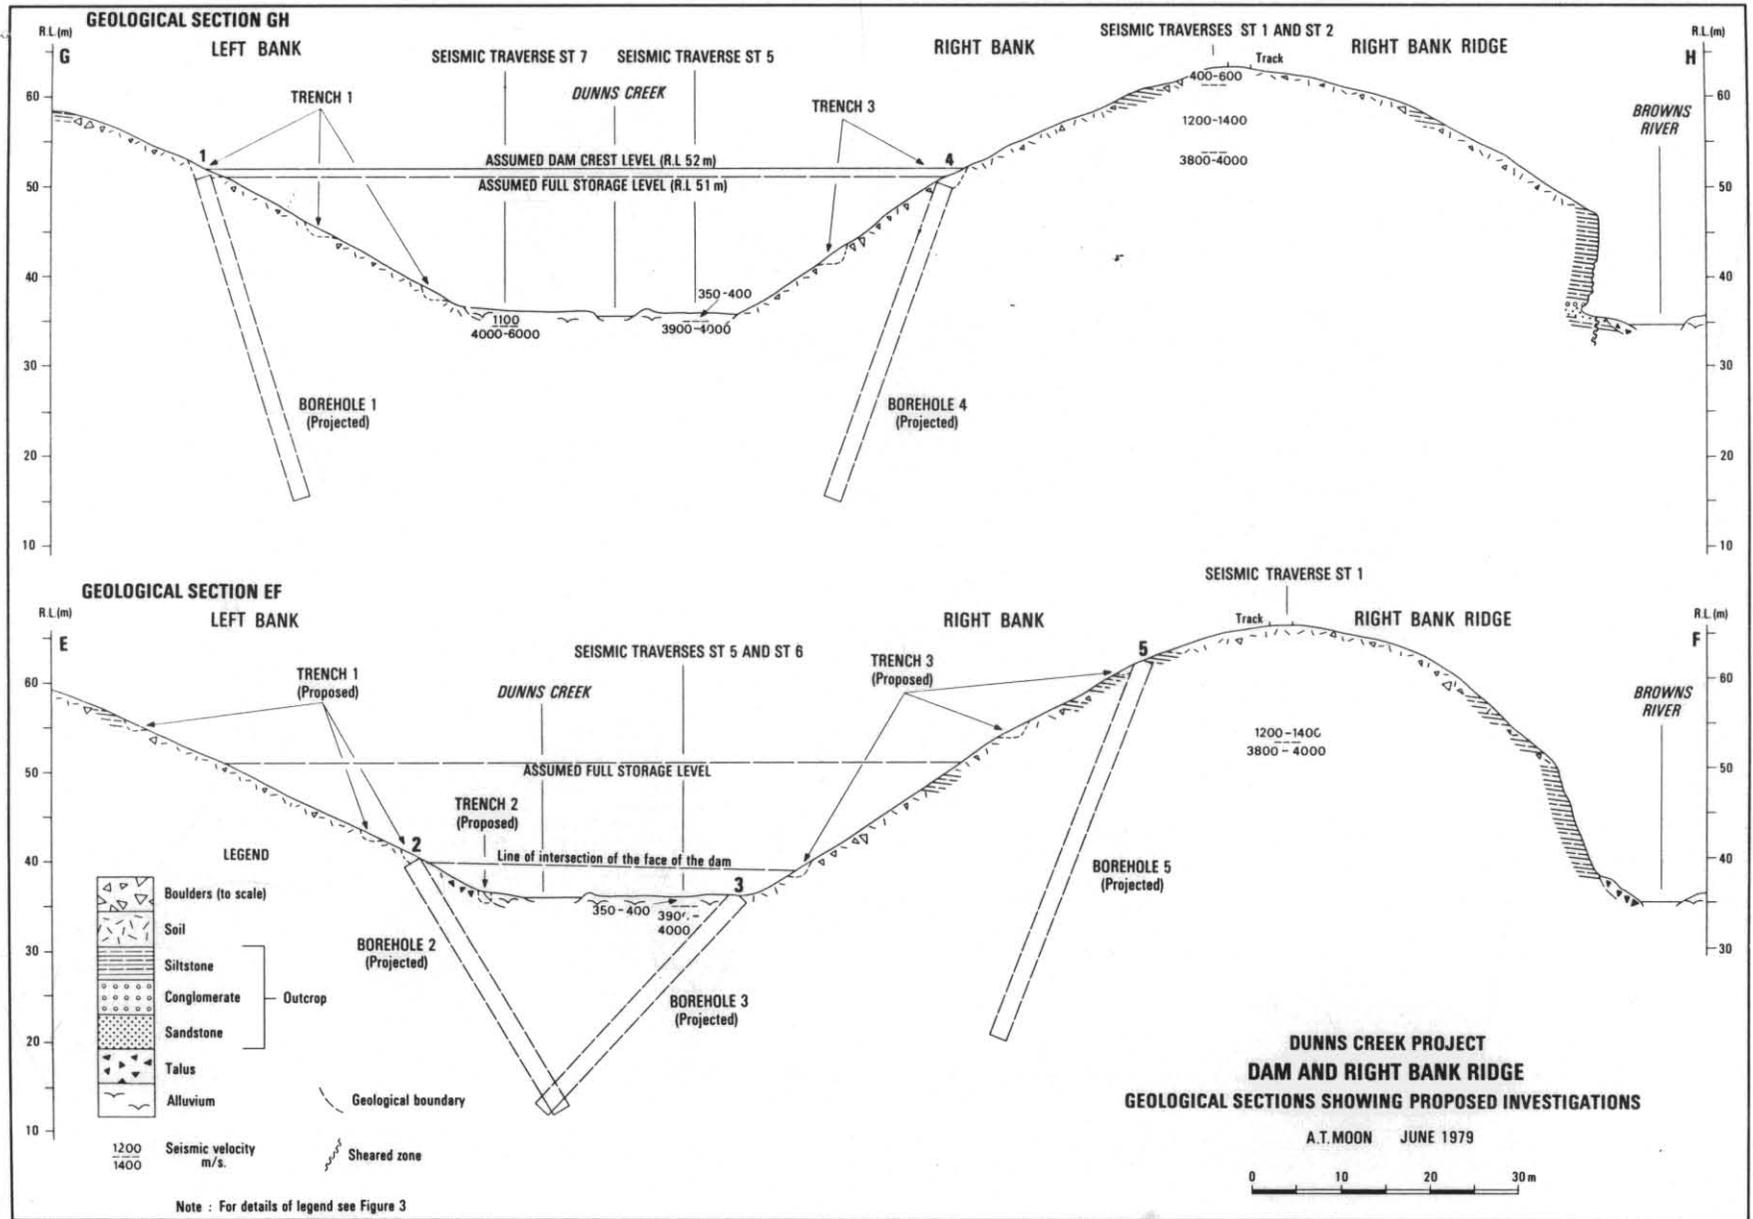
Figure 4.

The sandstone is yellow-brown when highly weathered, slightly friable and of medium strength. It is medium- to coarse-grained. A two metre thick bed of sandstone crops out close to Browns River (see section GH, fig. 4) and sandstone was observed cropping out on the right bank. In this preliminary investigation, no attempt was made to distinguish between the sandstone and coarse siltstone in the weathered outcrops. The sandstone beds will be mapped in detail during the feasibility studies after trenching and drilling has exposed the complete succession.

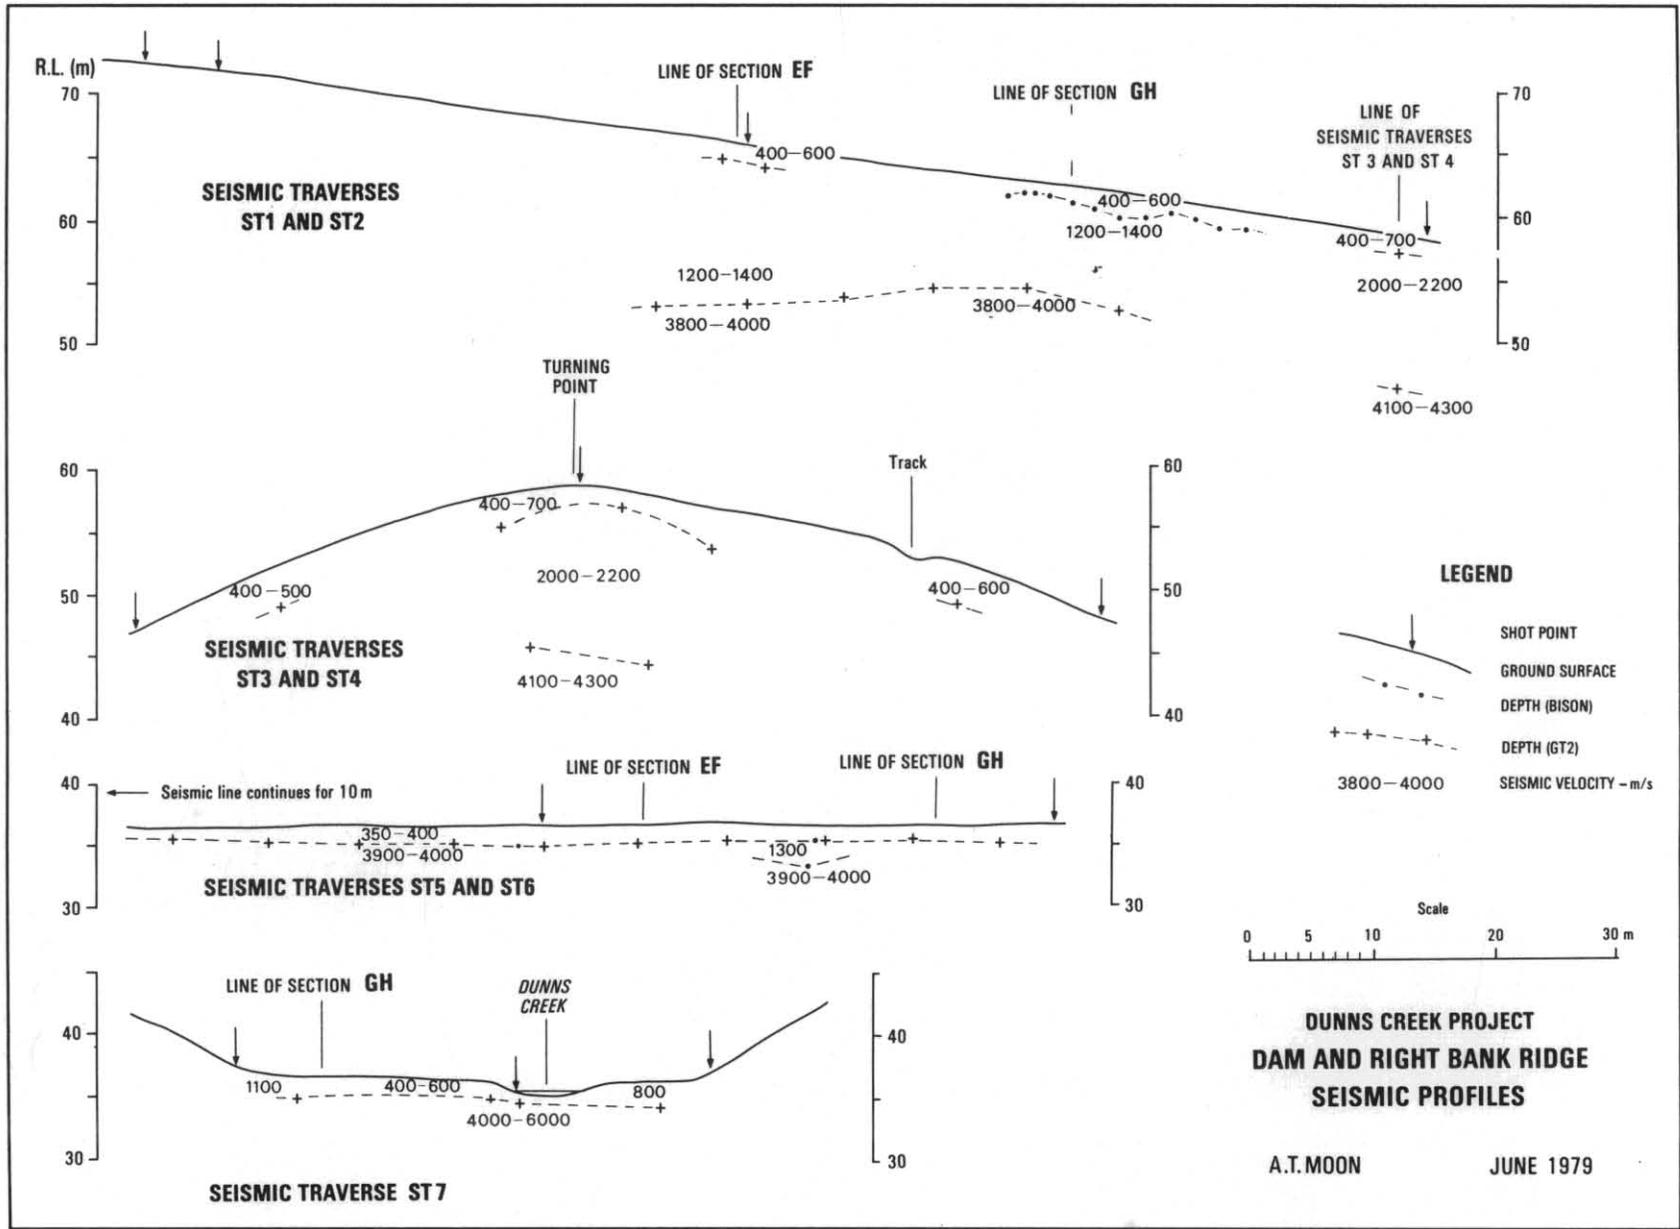
Figure 7.

Part of one of the seismic traverses (ST6, fig. 7) showed an intermediate velocity layer ( $V = 1300$  m/s) to a depth of three metres. This may be due to the presence of an old buried creek channel or it may represent weathered or loosened bedrock.

An intermediate velocity of 1300 m/s located on seismic traverse ST6 may be due to an old buried creek channel or weathered and/or loosened siltstone.
