1983/51. Groundwater prospects at Keenan's property, South Arm

D.J. Sloane

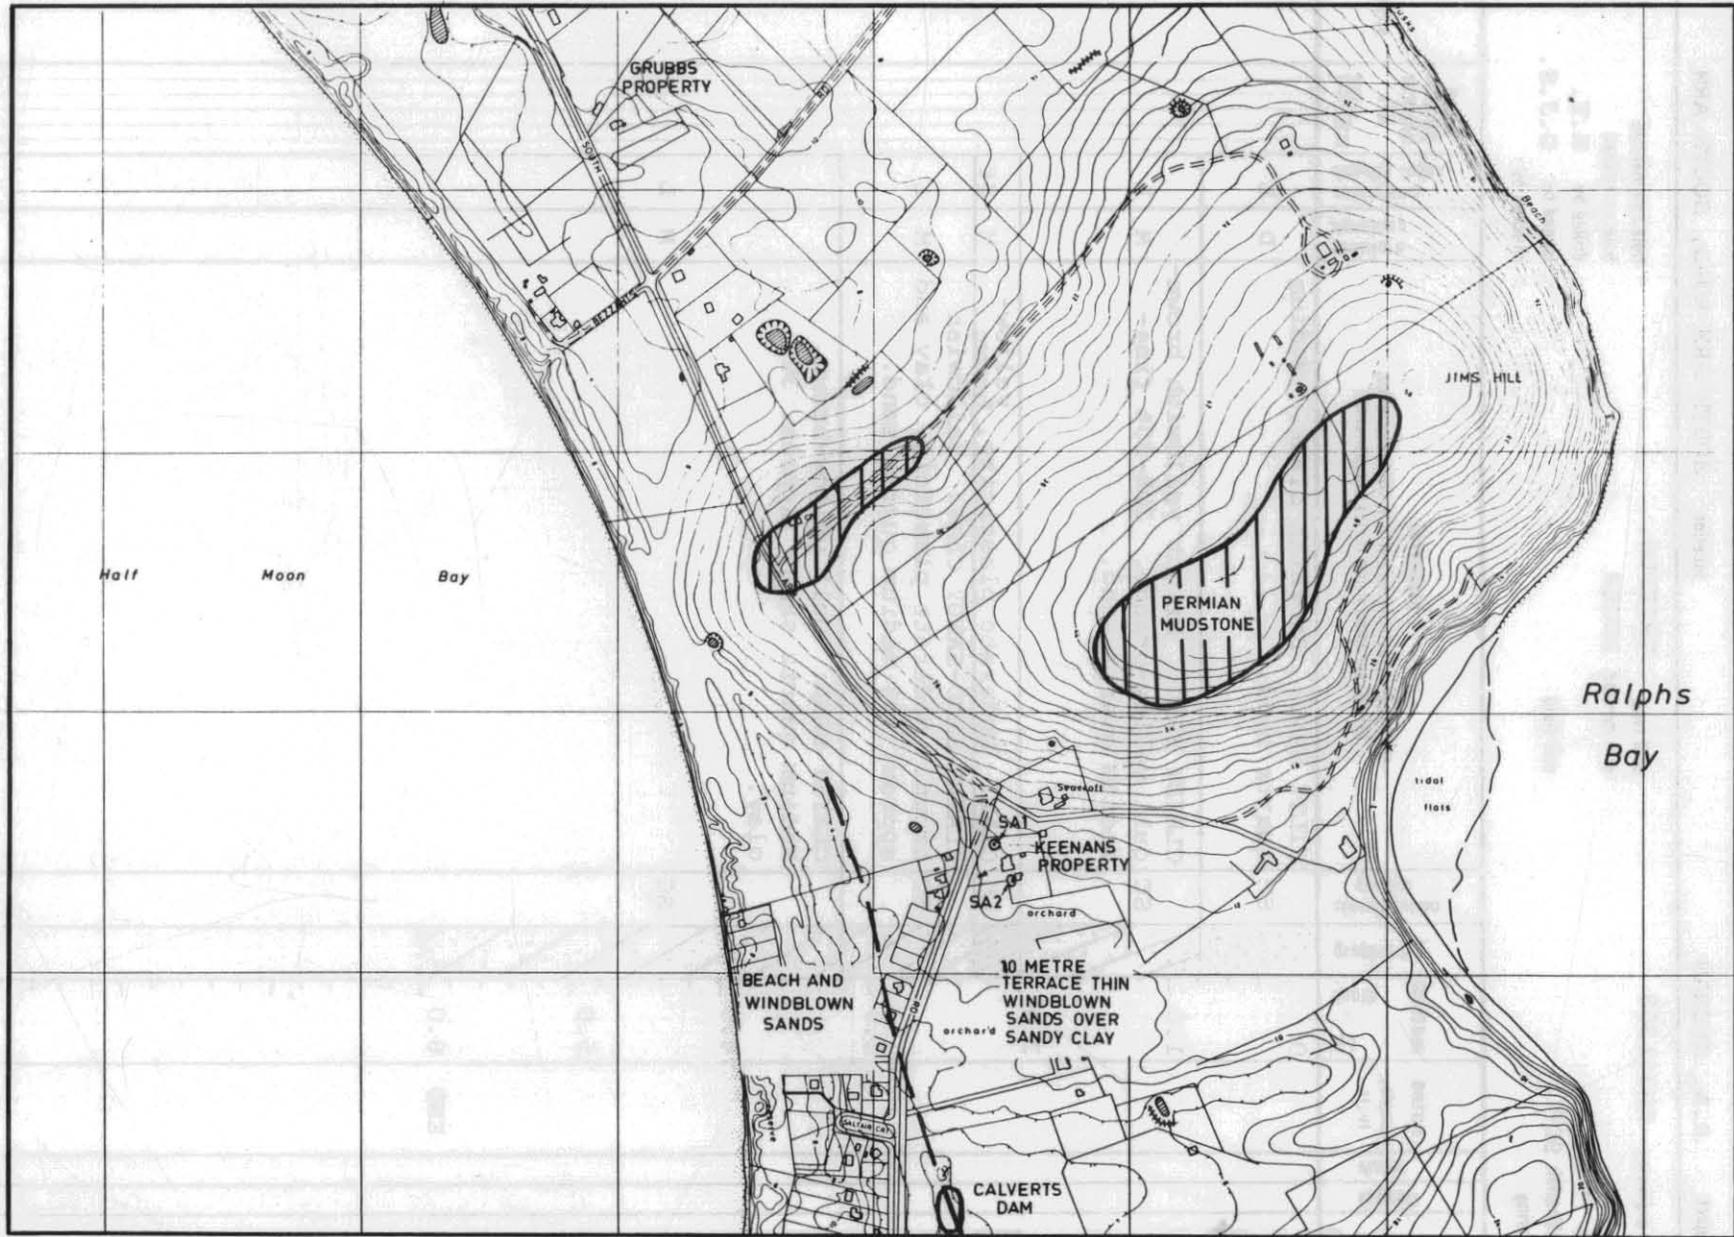
The property is located to the rear of the narrow coastal dunes, on the southern base of Jims Hill. The area to the east of South Arm Road is part of a distinct terrace level about 10 m above sea level. Keenan's property is located at the northern end of this terrace. The approximate boundary between the terrace and the more recently formed dunes and beach sand area is shown in Figure 1.

The Saltair Crescent area to the south has proved to be a more reliable area, as several residences have spear bores which provide reasonable quantities of good quality groundwater. This area has high permeability marine and windblown sands of suitable thickness to enable water extraction by spears. The approximate landward boundary of this area has been shown on Figure 1 and is evident on the ground as a fairly distinct break of slope.
