Slope stability and engineering geology of the Blackstone Heights area

by W. R. Moore

Abstract

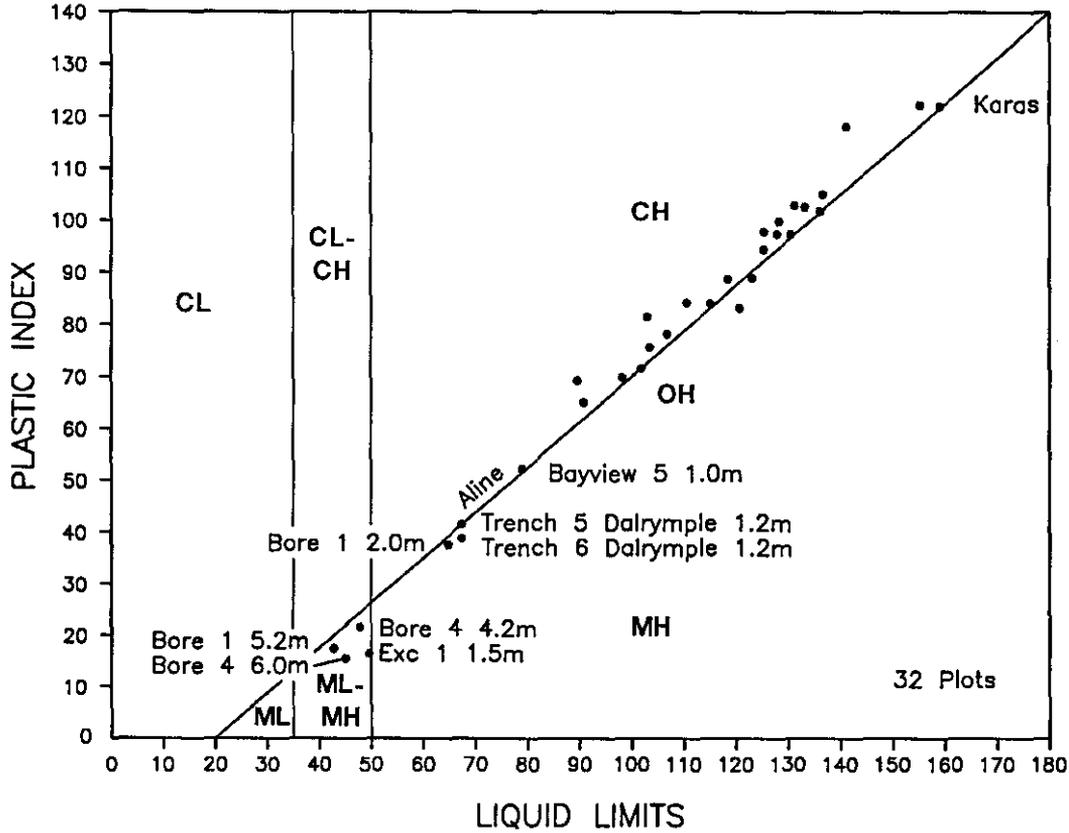
Figure 8. Plasticity chart, Blackstone Heights clays

As noted in drilling, a general decline in plasticity occurs with depth in the auger holes, with the plastic index in BH1 declining from 75 to 17 at 5.1 m depth and in BH2 declining from 122 to 17 at 6.0 m depth. A similar decline is noted in many of the trenches.

When the clays are moist the plastic index is generally high, and the three samples with plasticity indexes of 38–41 were of dry clay. The remainder of the samples have a PI range from 69–123, and liquid limits as high as 154.

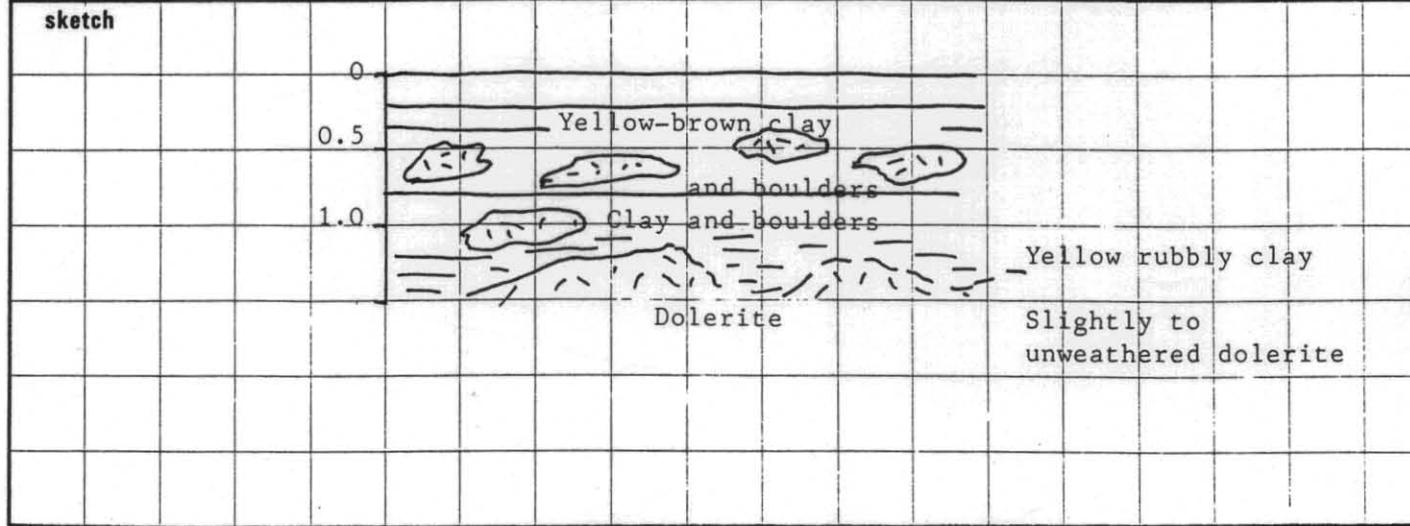
excavation no. 6

The greatest thickness of clay exposed above dolerite rock occurred in Trench 6 (Dalrymple Subdivision), with 2.9 m of clay exposed. In this trench a moist, highly plastic zone, occurred at a depth of 1.4–1.7 m below dry, low to medium-plasticity clay. Such a moist zone is a potential failure plane (Plate 9).

2.0		CL CM	CLAY WITH BOULDERS of med. to unweathered Jdl. Ironstone grits 1-2 mm CLAY - orange, low-medium plasticity dolerite texture seen. Extremely weathered dolerite.	D	V St		Extremely to highly weathered dolerite

2.9m			DOLERITE - slightly weathered rock. Traxcavator could not penetrate with bucket. LL PL PI LS S1 Not tested will be removed before building S2 125 27 98 26 S3 67 28 39 16 S4 128 29 99 25	D	H		Slightly weathered dolerite

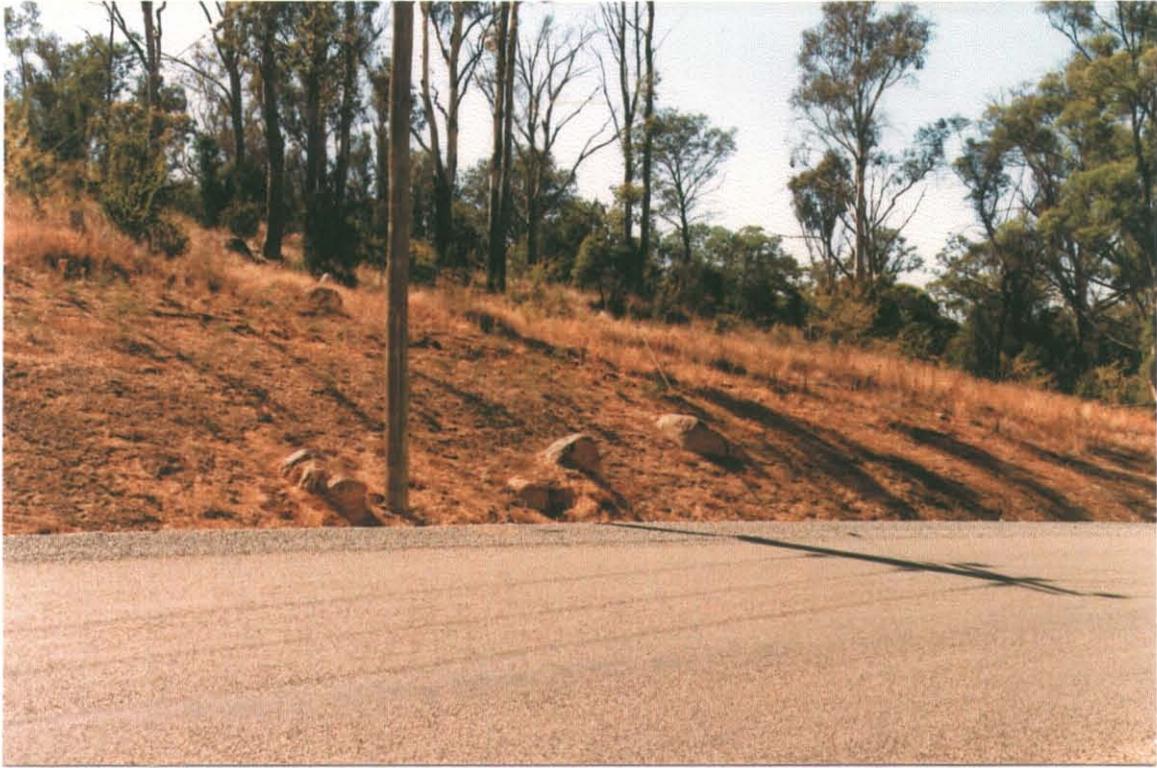
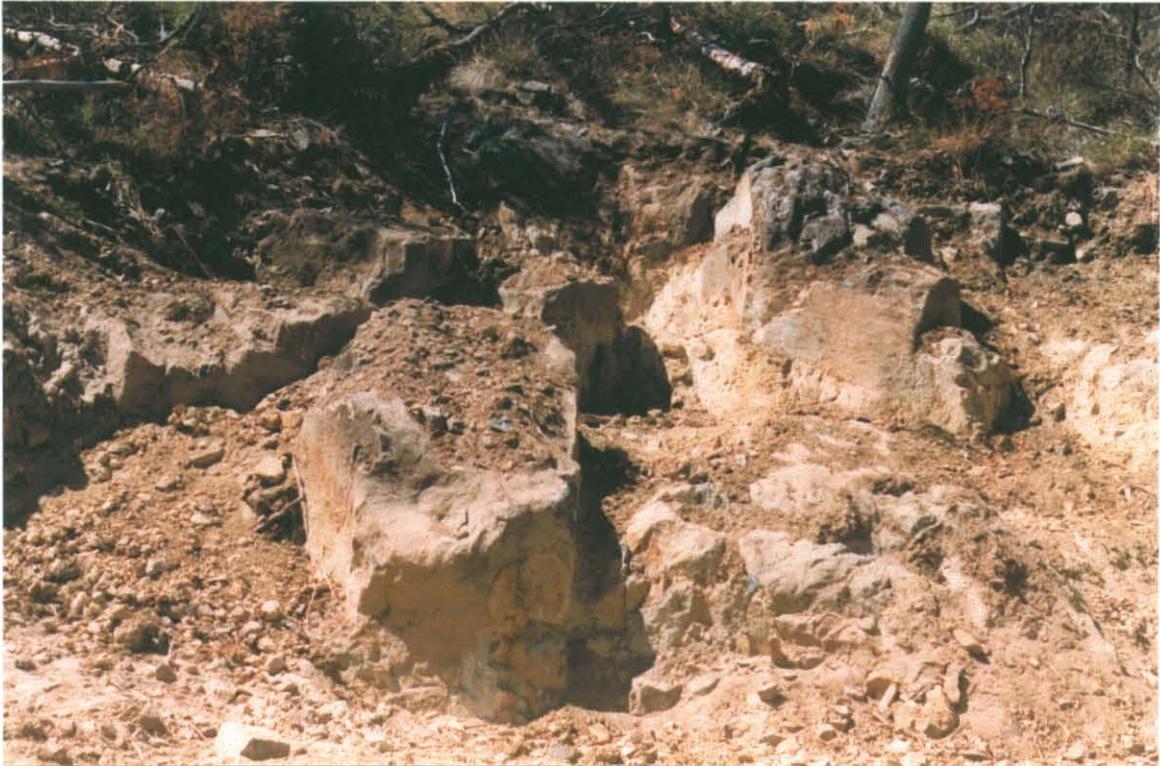
This weathering is different from the mechanical iron-staining of dolerite of the cold Pleistocene age, and is thought to be dominantly chemical and of the warmer Tertiary age. The weathering is frequently concentric, and develops along vertical jointing within the dolerite, forming deep as well as wide zones of clay (Plate 3).

Plate 3. *Kernels of unweathered large dolerite boulders surrounded by clay, Blackstone Heights.*

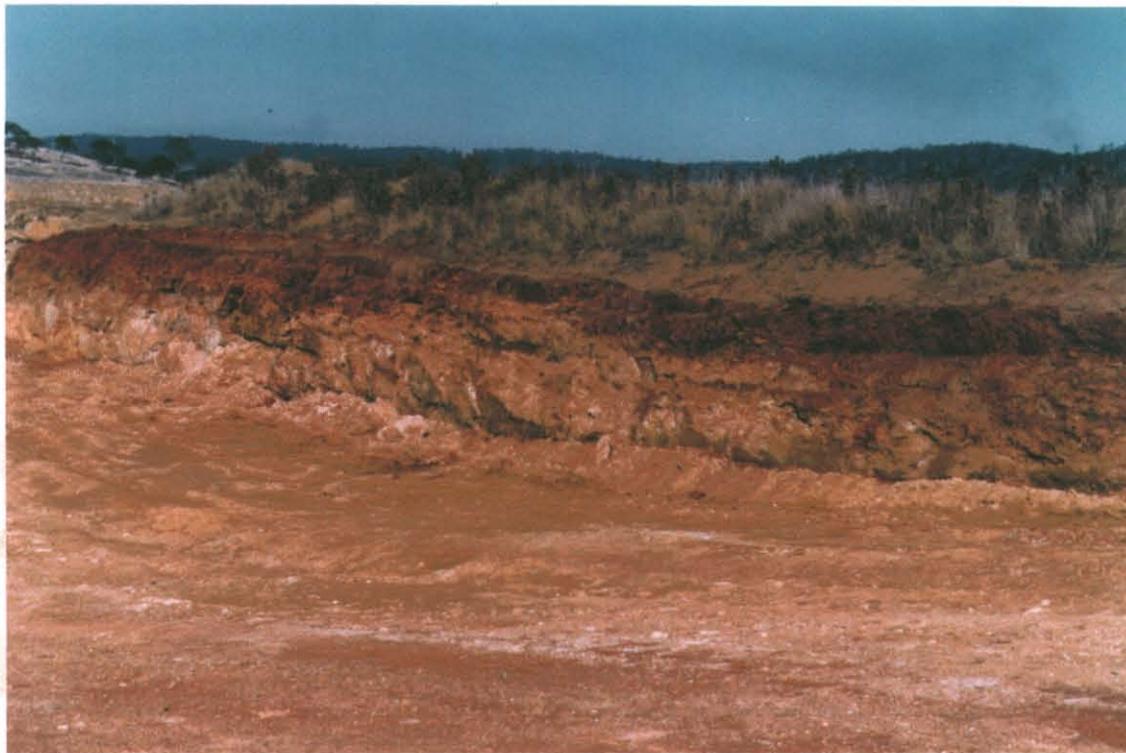
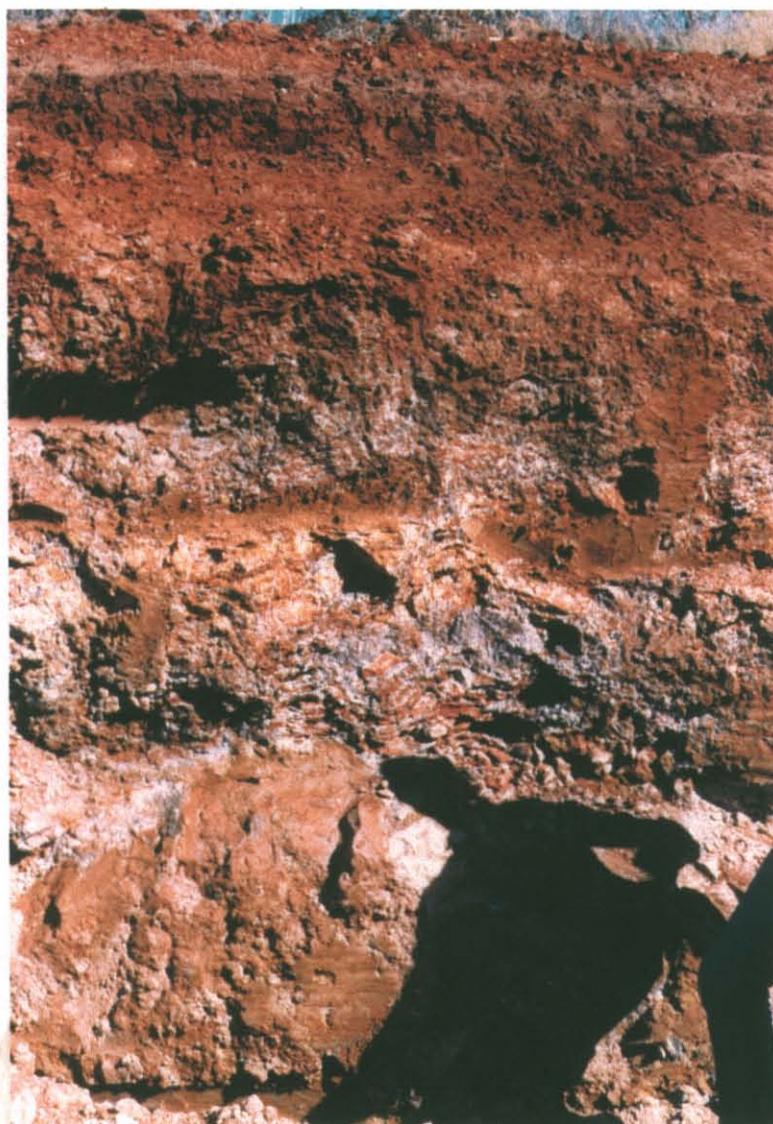
It was the excavations of the first stages of development, and particularly those in the banks of the reservoir, which showed that the Blackstone Heights area had large and thick deposits of clay (Plate 4). Other early exposures showed that clay

Plate 4. *Clay-rock profile in the reservoir bank, Panorama Road, Blackstone Heights.*

(b) White-yellow clay showing igneous texture;

(c) Weathered dolerite.

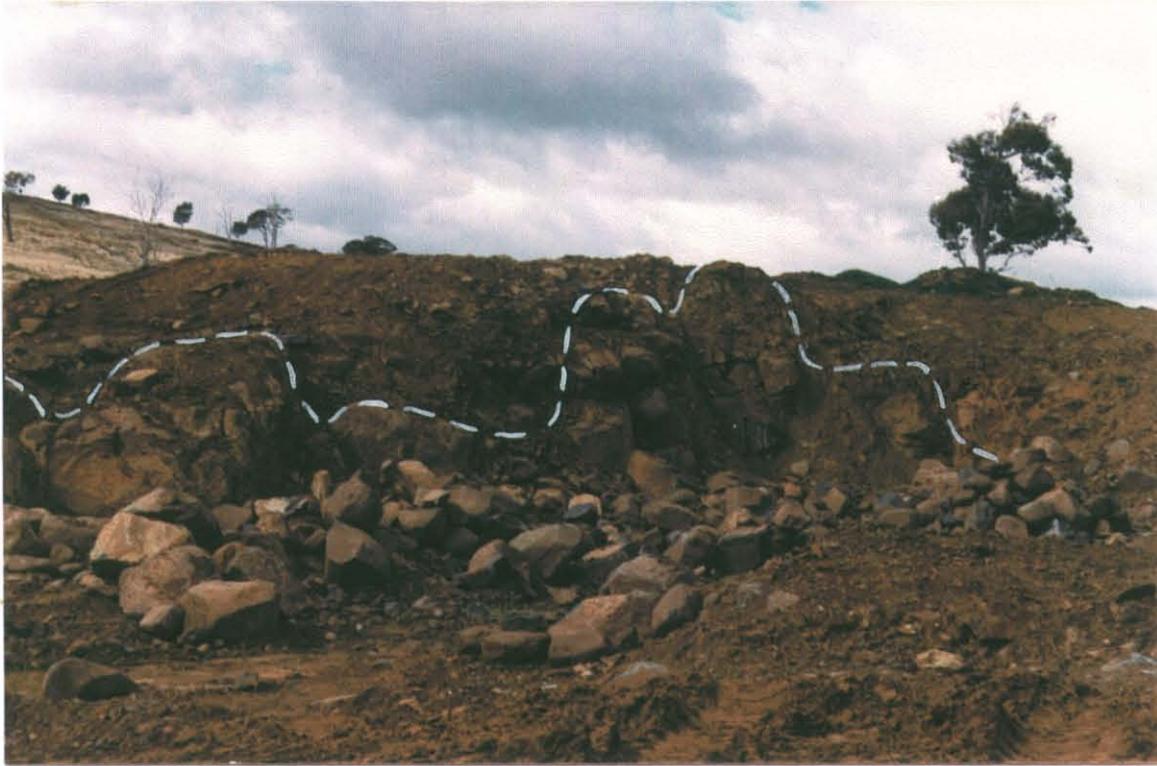
could occur very close to dolerite, and that the profile of the clay and rock could be very irregular (Plates 4 and 7).

Plate 7. *Irregular dolerite profile, Bakers Court quarry.*

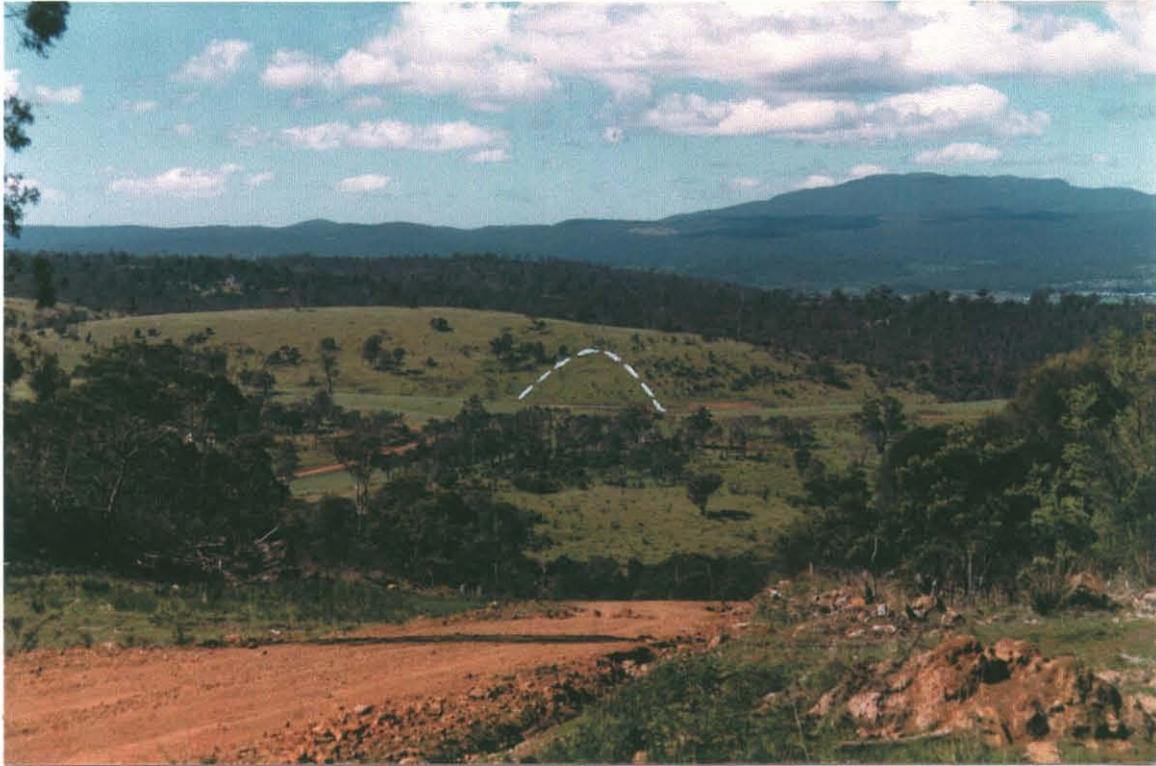
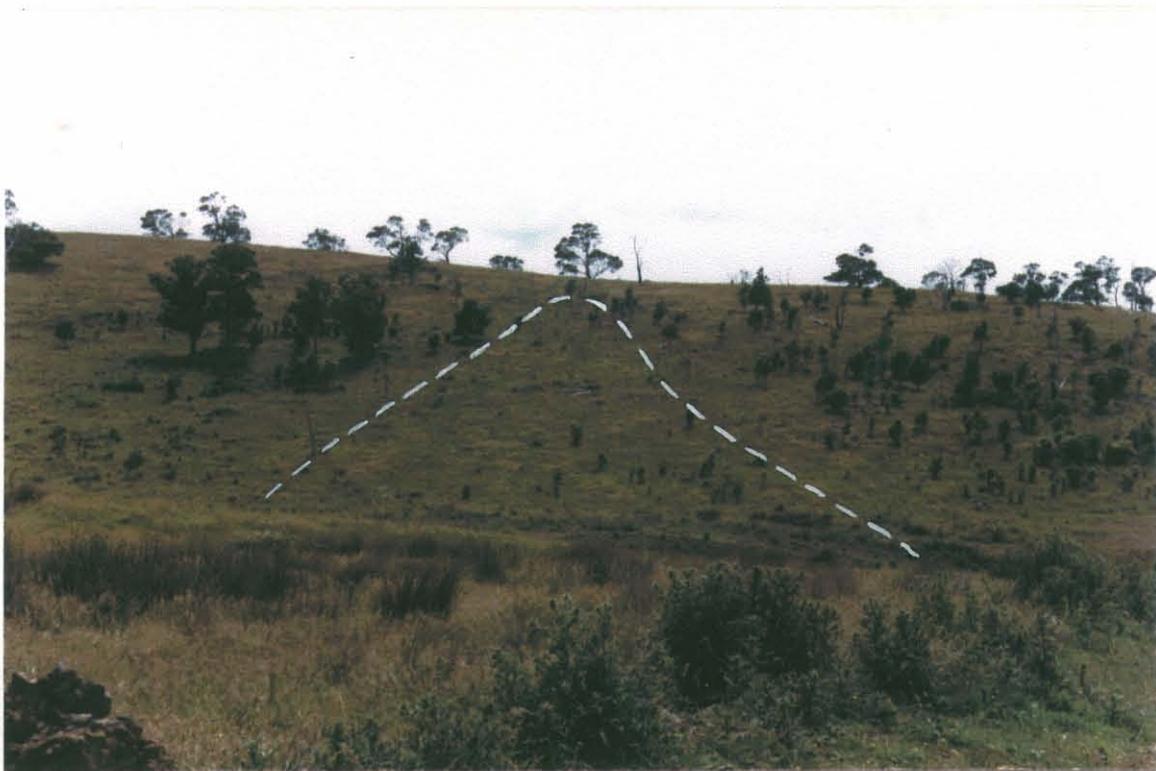
Such an area has already been investigated in the Dalrymple subdivision and an old landslide has been reclassified from Zone 2 to Zone 3, *Building Not Recommended Zone*.

Plate 8. *Old landslide, Central Creek. Top photo from Trulls Saddle, lower photo from Central Creek.*
