## Division of Mines and Mineral Resources — Report 1991/23

# Potential effects of forestry operations on slope stability and springs in the Mt Koonya area

by B. D. Weldon

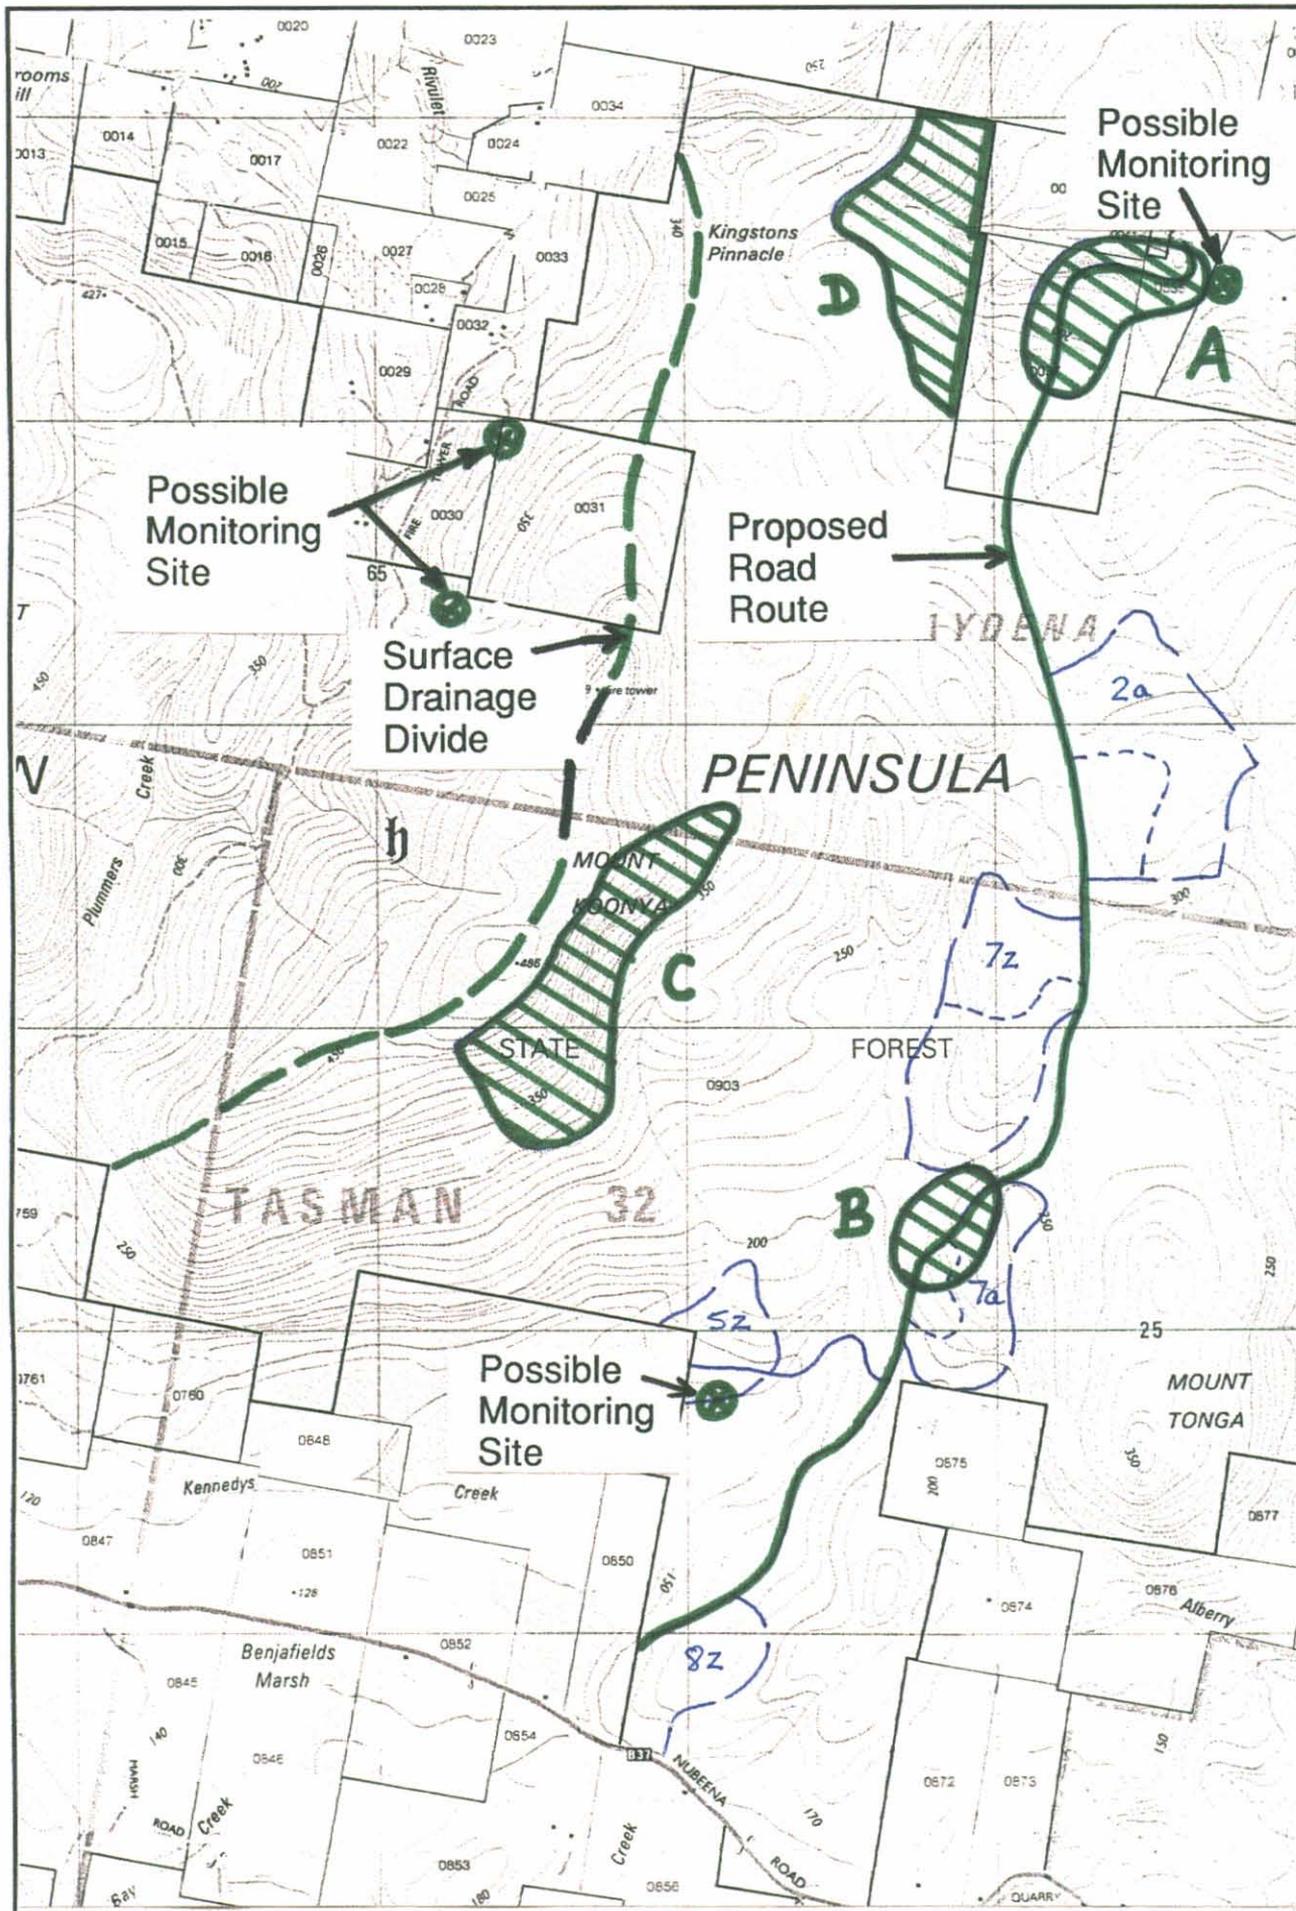
Figure 1

Examination of aerial photographs, and topographical and geological maps, indicated four areas of possible concern regarding slope instability (refer to fig. 1). Two of these areas were viewed during the inspection of the proposed road route.

Access to the proposed road route is via a logging road on private property through area A. The road batters expose dolerite talus and scree apparently overlying dolerite rock (which is exposed in the quarry reserve). Some boulders of dolerite have spalled from the cut road batters, but no landslide failures were observed. Water was not observed seeping from the road batters at the time of the inspection. Forestry operations have already occurred on portions of the private land in area A, with no adverse effects on slope stability being reported. The risk of induced slope instability associated with forestry activities in area A is assessed as low.

During the inspection of the proposed road route, the steep slopes in area B were observed. There was some confusion regarding our position along the proposed road route near area B. It is the authors recollection that boulders of slightly to moderately weathered dolerite in a clayey matrix occurred in this area, along with some outcrop or near-outcrop of dolerite. The slope, as far as could be observed through the forest, was relatively uniform although some minor benches were associated with the areas of dolerite outcrop or near outcrop. On the observations made it is considered unlikely that the area has deep talus or scree deposits. The risk of induced slope instability associated with forestry activities in area B is assessed as low.

Areas C and D were not observed during the November inspection. These areas are not proposed for forestry operations in the Preliminary Logging Advice for the Koonya block but may be considered in the future. The slopes are steep and may be veneered by dolerite talus and scree deposits. For this reason, the areas should be assessed by a field inspection should they be considered in a future forestry program.

Two areas with a possible potential for slope instability (areas A and B, fig. 1) were examined during the inspection of the proposed road route. The evidence available suggests that forestry operations in these areas will not result in slope instability. Should the proposed road be constructed, a re-examination of area B would be desirable.

Two other areas of potential concern with respect to slope instability (areas C and D, fig. 1) have been identified and should be inspected if future forestry operations are planned in or near these areas.

In areas of forestry operations, the road system gives the majority of sediment yield to streams. Stream beds may be potential recharge areas for fractured-rock aquifers. The Commission's suggestion to construct the road and monitor the effects on stream quality before proceeding with operations in designated coupes is fully endorsed. A monitoring program should be in place prior to road construction, and it would be desirable that one winter-spring cycle of observations be made between road construction and the commencement of forestry operations. Possible monitoring sites are indicated on Figure 1.
