Exploration Drilling Grant Initiative – Round 1: Report on Drill Hole LMD5 at Basin Lake Prospect on EL 11/2016 “Lake Margaret”

Executive Summary

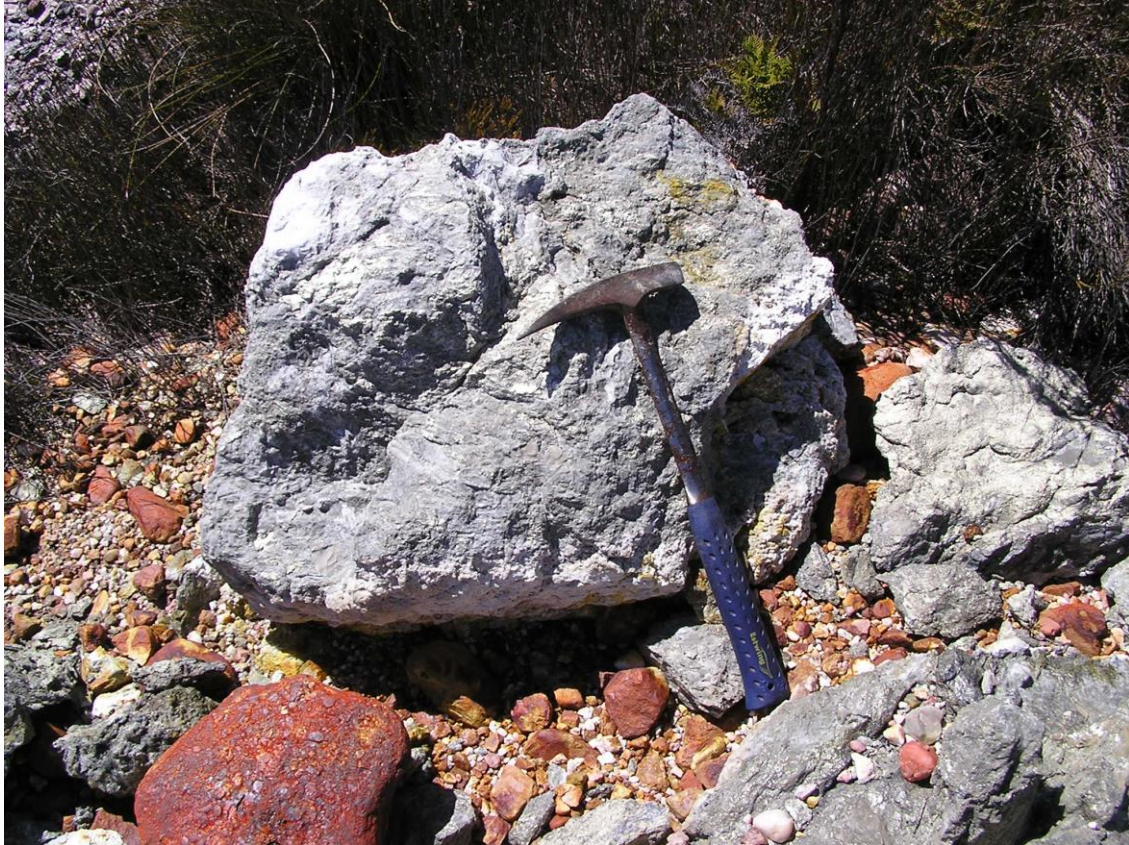
Figure 1.3: Glacial erratic of intensely advanced argillically altered volcanic assaying 5.6% Cu and 0.6g/t Au.

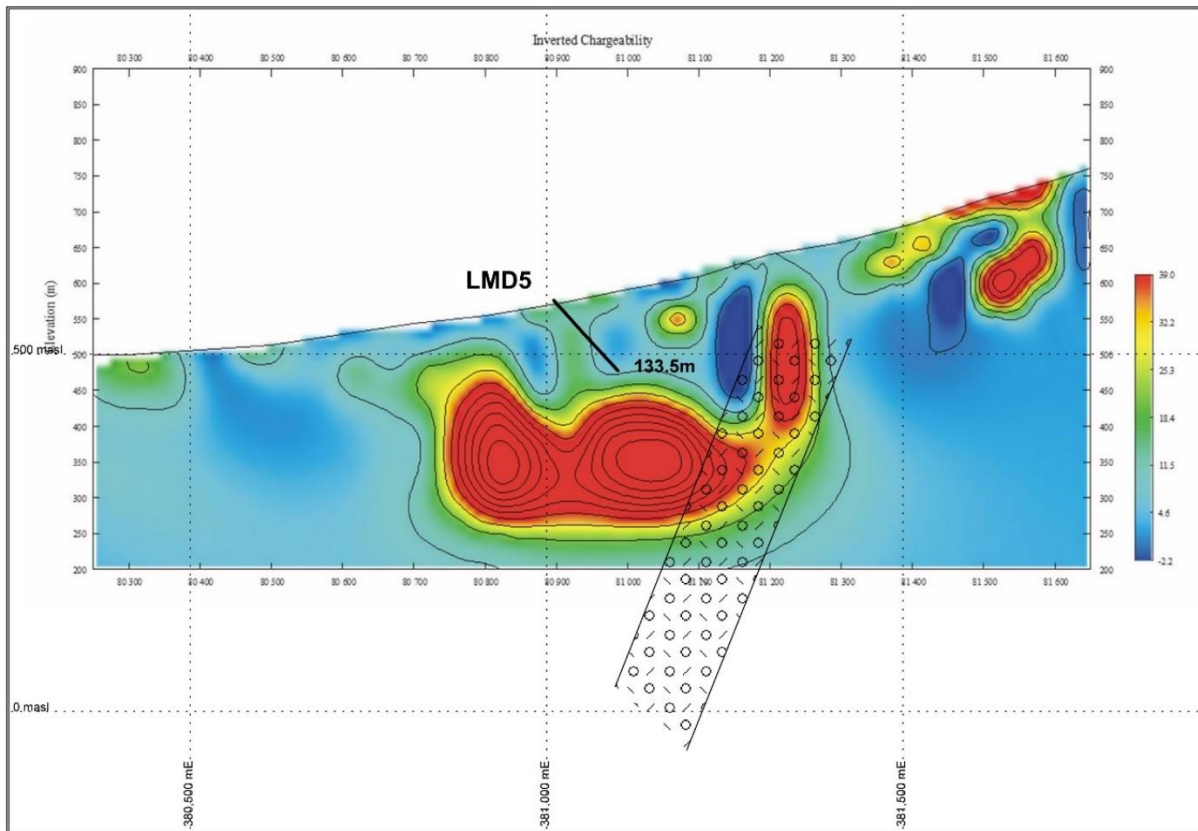
The hole did not penetrate to sufficient depth to test the target and as such there are no significant results to detail.

Figure 4.3: Section 5,353,300mN showing trace of LMD5 with respect to the quartz porphyry unit superimposed on dipole-dipole IP chargeability.

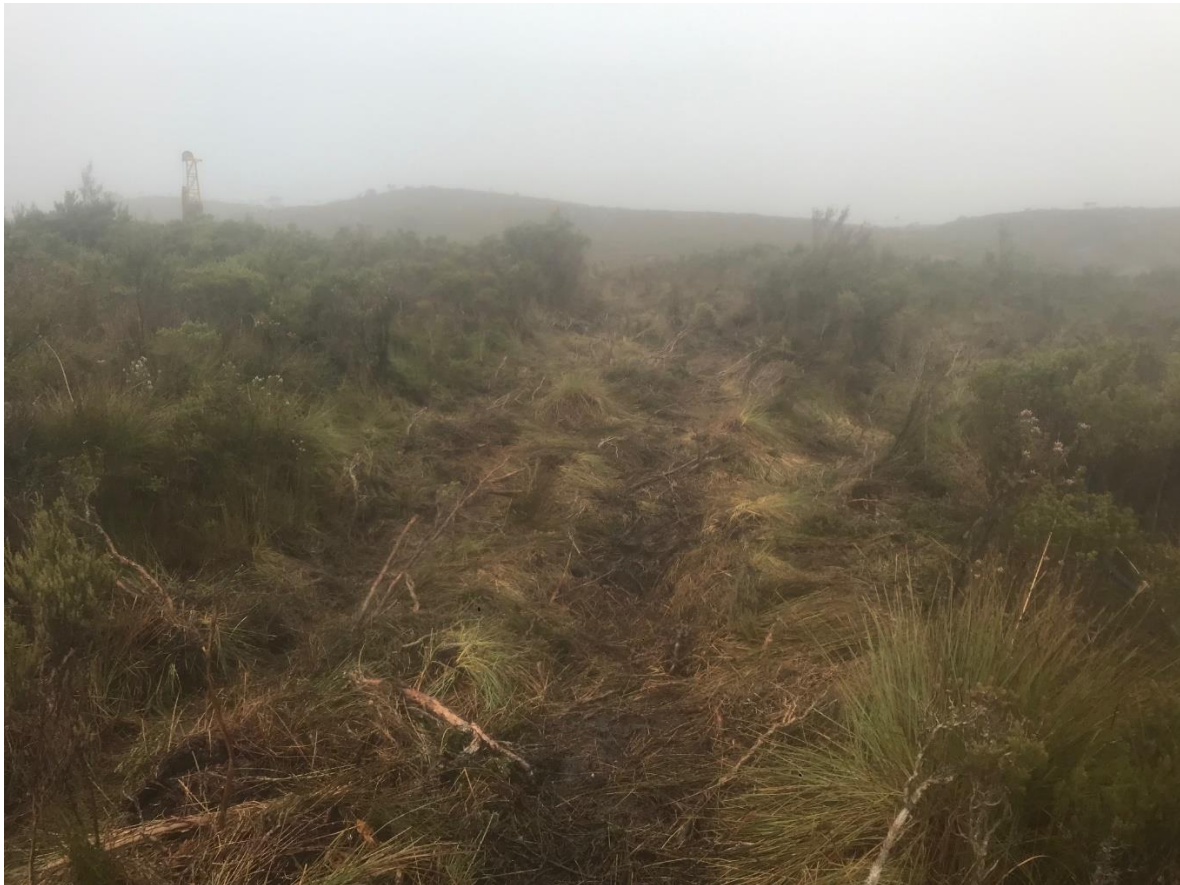
Figure 6.1: *Access track to drill site near completion of hole.*

The tracked vehicles rode over the heath vegetation flattening plants but not removing them. Further the matted heath stopped the tracked vehicles from breaking through into the peat substrate.

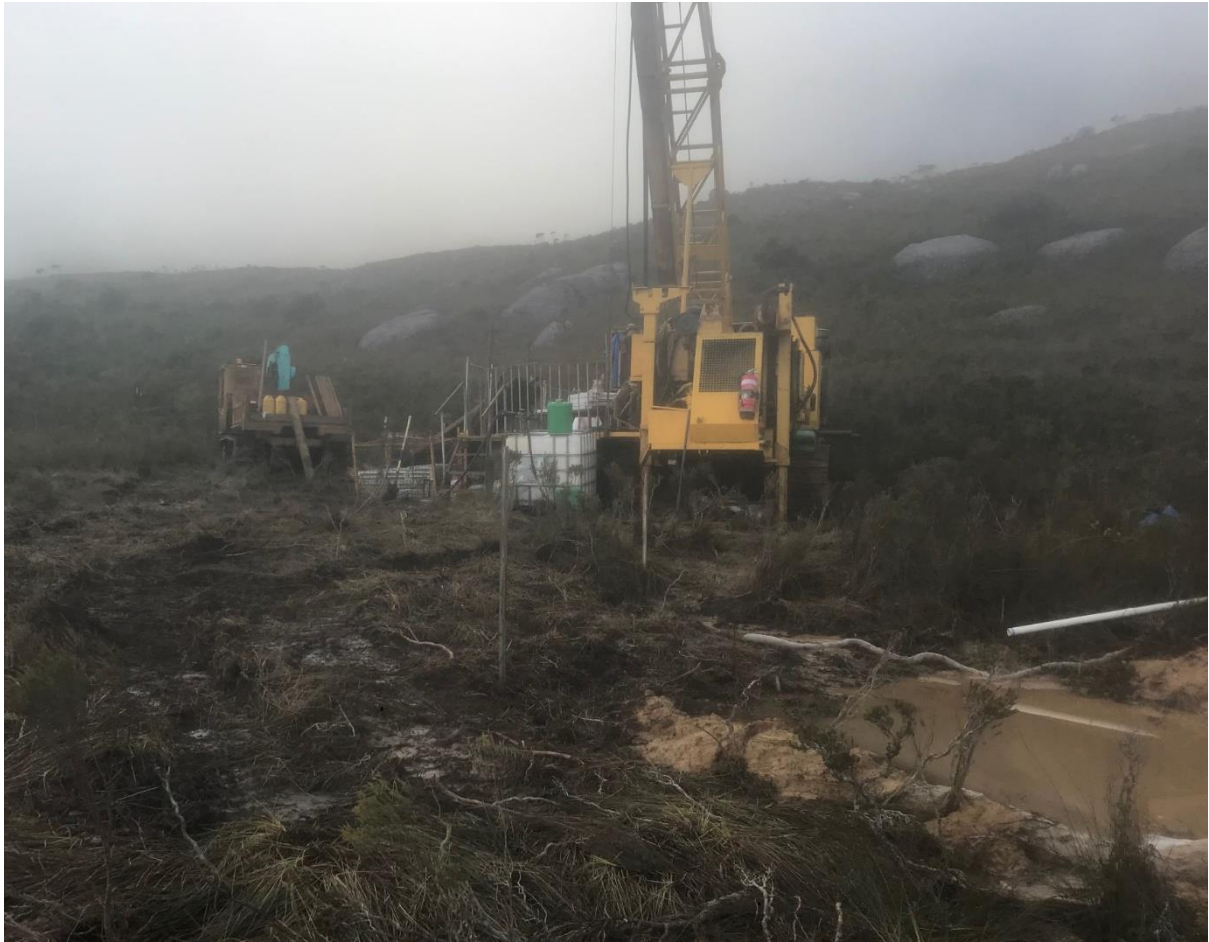
A sump was dug by hand with decanting water passing onto a broad slope and not into distinct watercourses.

Figure 6.2: LMD5 drill site at completion of hole. Hand dug sump in right foreground.
