AUSTMIN RESOURCES NL

ANNUAL REPORT ON EXPLORATION

EL12/88 MOUNT BLACK, TASMANIA

PERIOD SEPTEMBER 1989 TO AUGUST 1990

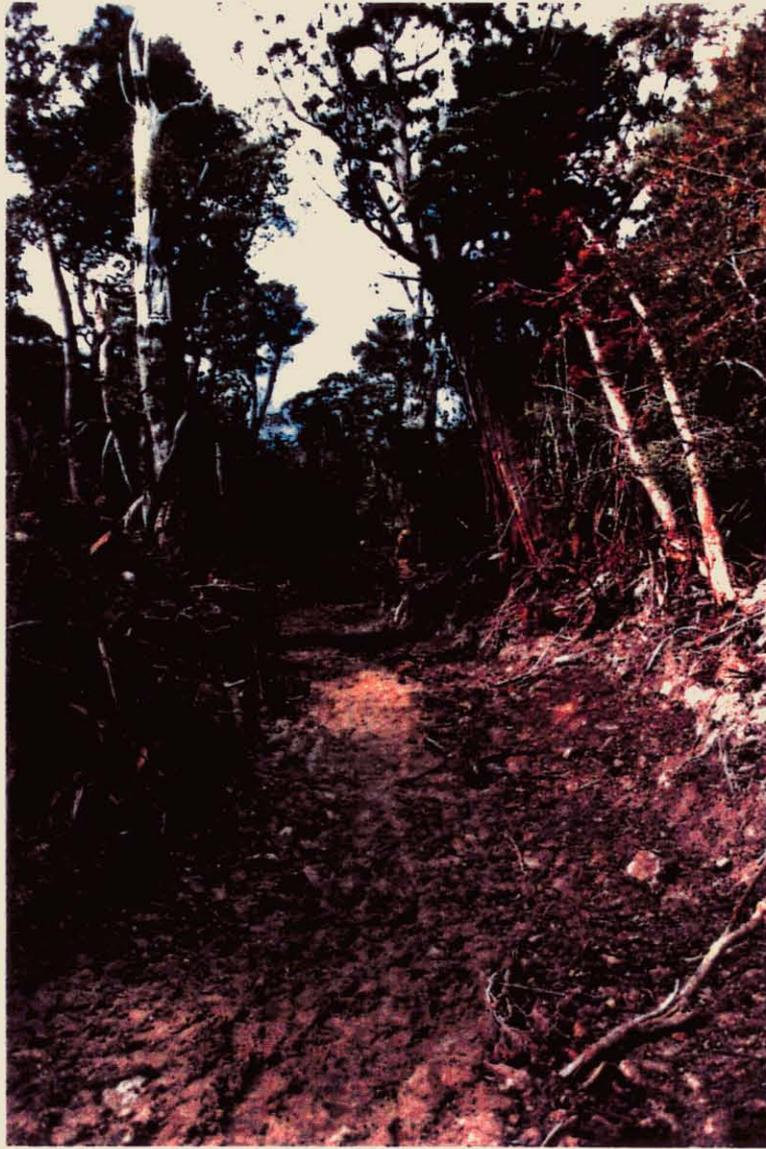
PLATE 1

1. Egress Track, near junction with original track.
2. Egress Track, near junction with Site 5.
3. Site 5, looking N. Bared area is vehicle manoeuvring space, Large stockpile of humus and other vegetable matter in background.
4. Site 5, looking S.E. Drill-rig 'pad' at centre left. Remainder of area covered with humus seedbed.
5. Original Track. N.B. healthy crown of mature *Athrotaxis* centre and proximity of trunk, roots, etc. of specimen on far R. to track.
6. Original Track. *Athrotaxis* with crown dieback but otherwise showing no effect of earlier root interference.
7. Original Track. Seedlings of *Athrotaxis* and *Eucryphia* growing in mineral soil at side of track.
8. Original Track. Seedlings of *Athrotaxis* and, at lower L., seedling of *Phyllocladus*. Other plants are *Olearia* and *Blechnum* spp. All growing between wheel ruts!
