BURNS PEAK

EL 44/88

REHABILITATION PROGRAM

H. RAE
JUNE 1990

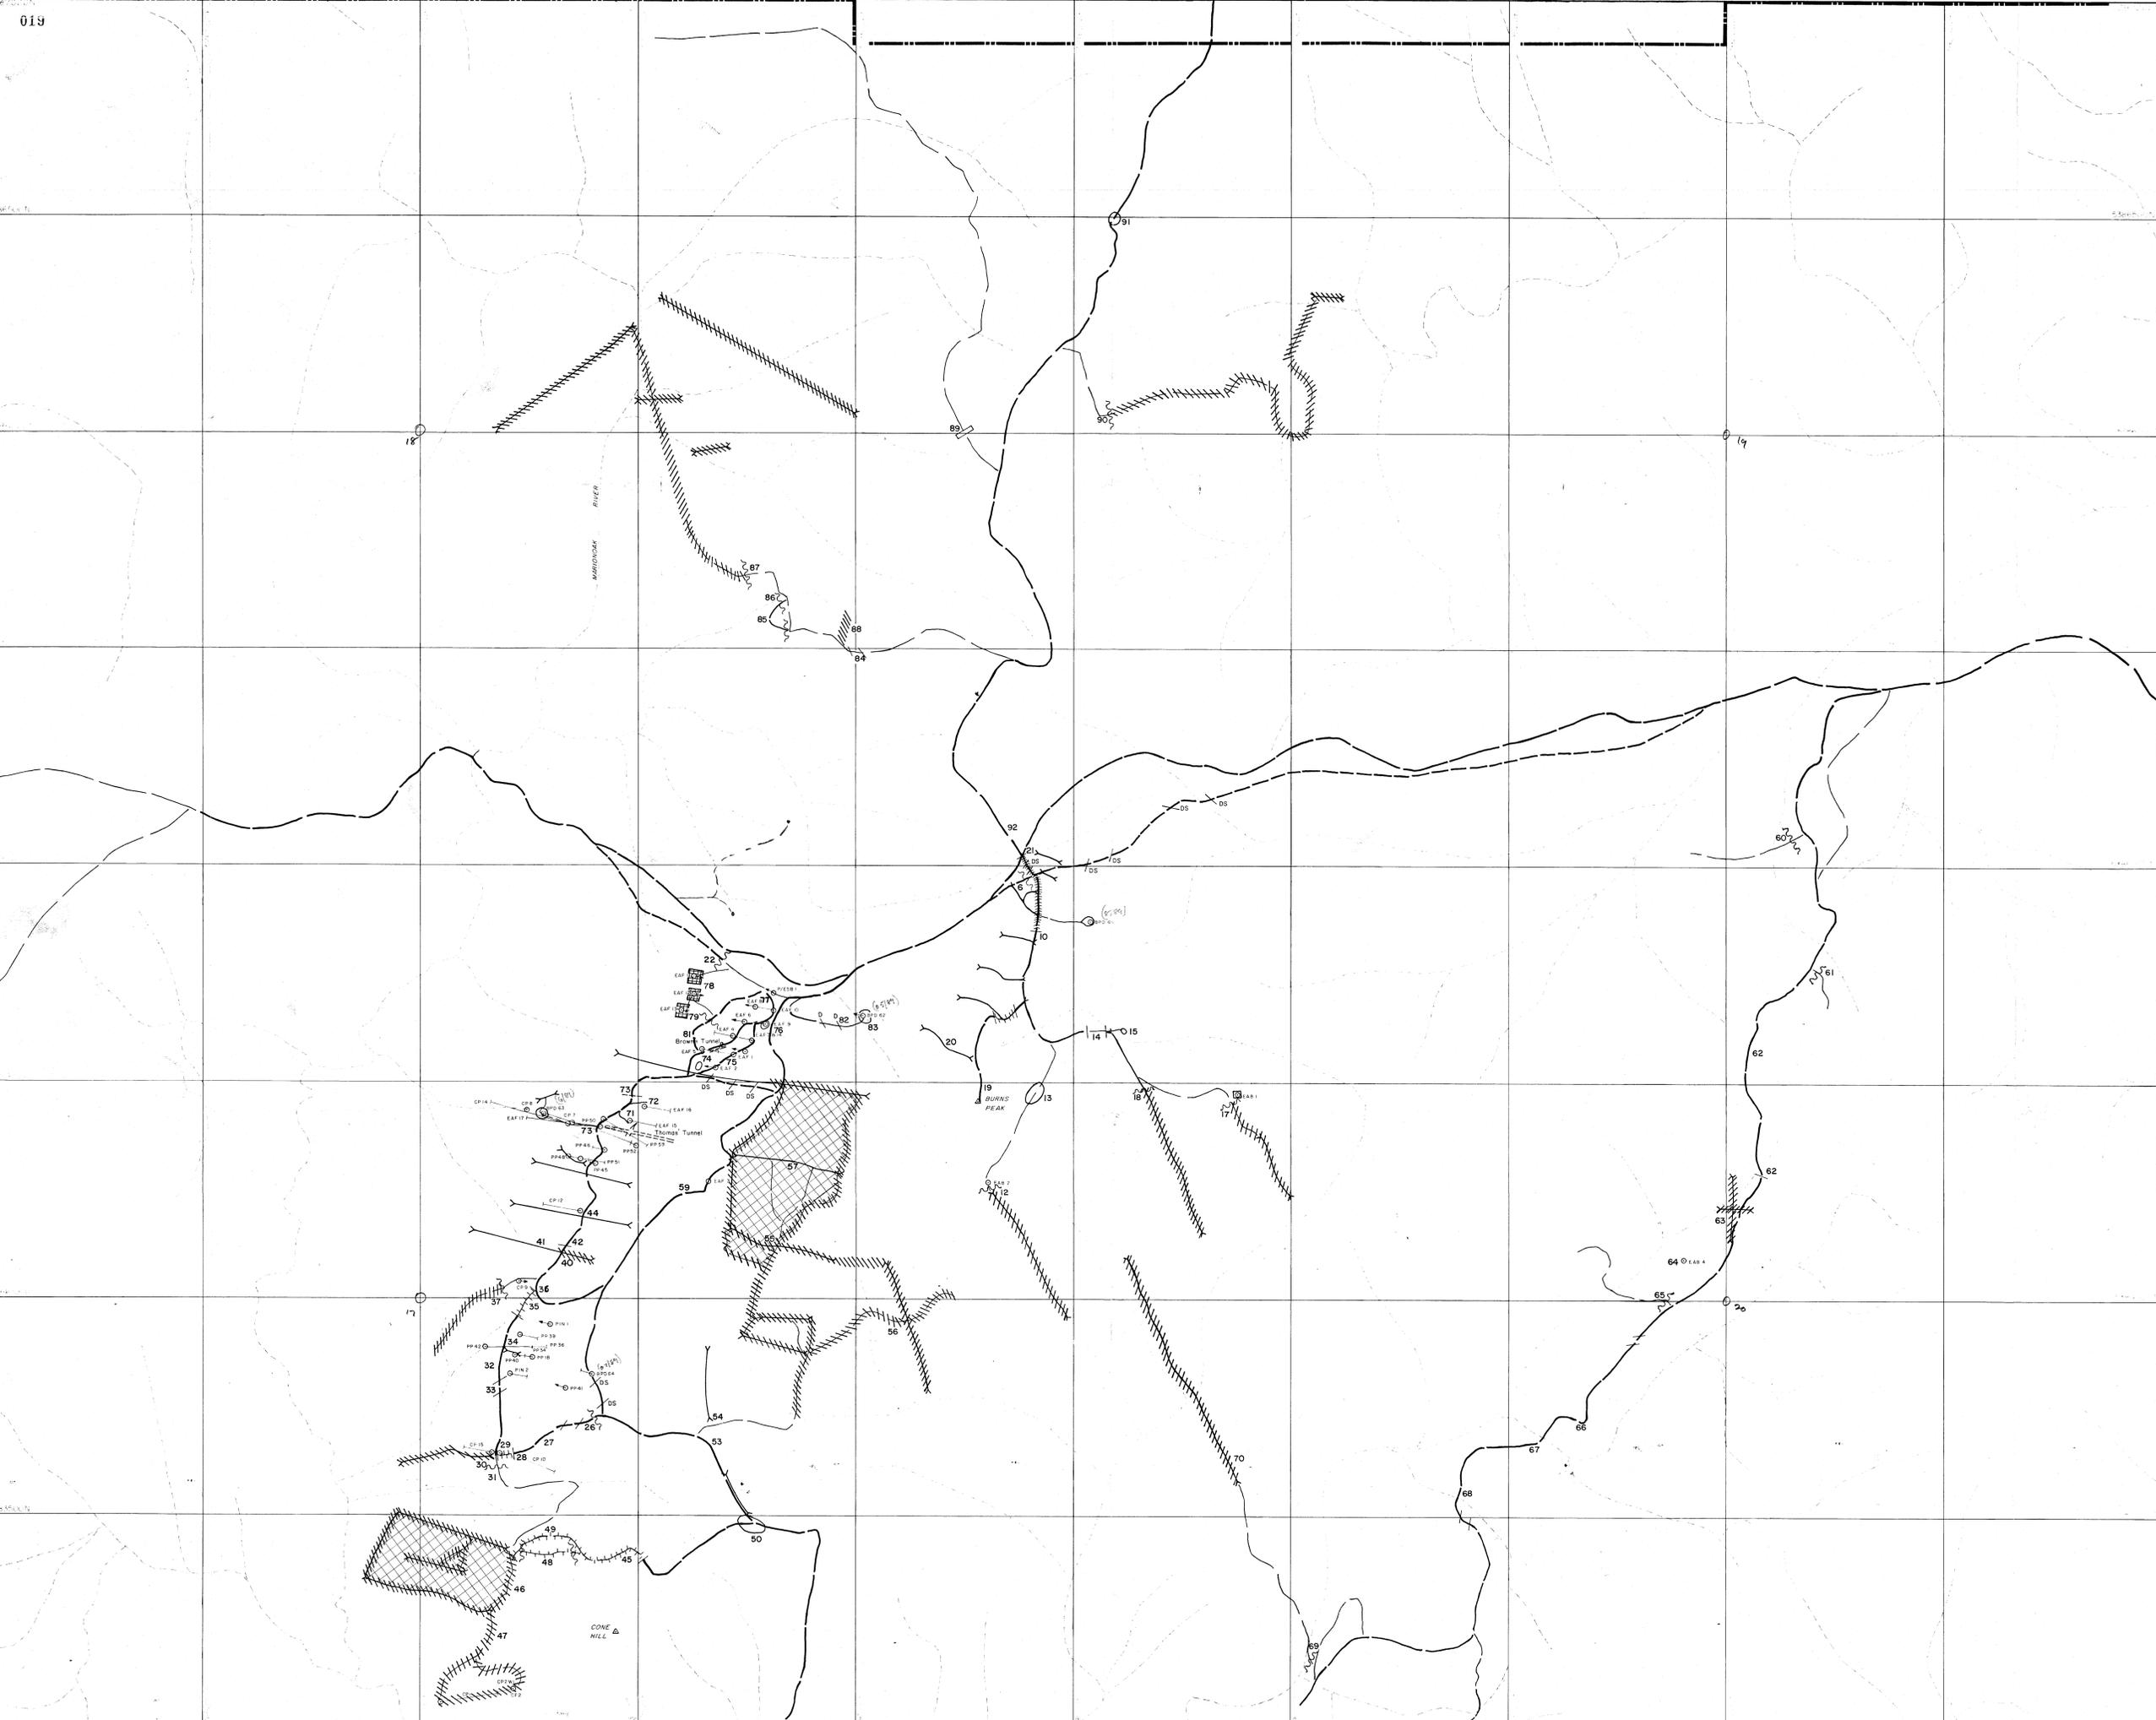
NORTH BROKEN HILL PEXO LIMITED
MINERAL RESOURCES DIVISION
PROJECT: BURN'S PEAK E.L.44/88, TASMANIA.
SHEET 1

AREA	COMMENTS
1. Drain needed on road, shovel and pick.	
2. as above	
3. as above	
4. Road cut up through vehicles turning onto access to BPO65. Drain needed, dozer to repair.	
5. Drain needed on road, shovel and pick.	
6. Road can be closed, alternative & better access available.	
7. Drain needed. 10m drop to main road, should be closed.	
8. Road no longer used, ti tree ~1m high growing on road.	
9. Best access to Leo's Find/BPO65.	
10. Drainage needed.	
11. Road impassable, drainage needed. Dozer needed to repair. Deep ruts on road.	
12. Revegetation on road. Ti tree and eucalypt over 1m high.

13. Excavator could replace soil/spoil and close road.
14. Creeks running down road, need diverting. Need sleepers to divert water as no soil. Rock outcrop.

15. Old driller dam could be filled by excavator.
16. Drill hole EAB1. Good revegetation, ti tree, eucalypt and acacias. Could use fertilizer.
17. Road could be closed. Well advanced revegetation. Eucalypts over 3m tall.

18. John Wally cut (costean). Sides of cut revegetating well, not much growing on bottom. Drainage needed, sleepers etc as water running down bedrock.
19. Road to Burns Peak trig station, 2 drains needed - pick and shovel. Bulldozer needed for lower section. Road maintained by Surveyor General.

20. Costean - revegetation good. Ti tree, acacias and eucalypts ~ .5m.
21. Short road - 7m long. Excavator could pull in banks to fill in pond.
22. Road could be closed, alternative access available.

23. Drill hole EAF11. Excavator could reduce size of pad considerably.

24. Drains needed, could be dug with shovel and pick.
25. 10m long road, excavator could fill in, 5 min work.
26. Road very steep gradient.
27. Impassable to vehicles.

28. Drains needed. Road could be closed, alternative access available. Good revegetation on road. Ti tree and eucalypt ~ 2m high. Road ends in 2m drop to drill hole CP10.

29. Drill pad, not much soil/spoil left for contouring. Some revegetation, Ti tree, eucalypt and acacias under .5m high. Fertilizer would help.
30. Costean - very good revegetation.

31. Road very overgrown. Eucalypts over 3m high.
32. Unused drill pad. Starting to revegetate. Not much soil left for excavator to replace. Could use fertilizer.

33. Deep ruts on road, not impassable but should be filled. Drains needed.
34. Southern Trenches. Some revegetation.
35. Road impassable. Dozer needed to fill in ruts, etc. Drains needed - sleepers should be laid (corduroyed).

36. Dam built by Warren for BPD64, should be knocked

- down. Excavator would be best.
37. Old track? - revegetated track.
 38. Cross drains.
 39. Cross drains.
 40. Costean - good revegetation.
 41. Some revegetation, not much; no soil left. Deep scouring from run off, no where else for water to go.
 42. Culvert needed for runoff from costean.
 - 43.
 44. *Priority. Costean crosses road. Deep scouring. Road being washed away, will need culvert. Not much regeneration in costean, will need excavator & sleepers to build drains for run off.
 45. Cone Hill Rd - major access track. Deep scouring and wash aways, needs dozer to repair. Road impassable at present. Will need drainage to divert runoff.
 46. Road in reasonable condition. Good revegetation over 1m high and thick.
 47. Road completely overgrown.
 48. Road impassable, washouts, scouring etc. Would need dozer to fix. Best to close off road as alternative access is available.
 49. See 45.

50. Cleared area, unused drill pad. Some revegetation, mostly moraine shrubs. Excavator could smooth out banks etc. Application of fertilizer and slashed vegetation may promote revegetation.
51. Dozer drive could be filled in by excavator, mostly rock and scree.
52. Short unused road, could be filled in by excavator. There is sufficient soil/spoil.
53. Cross drain needed.
54. Costean, some revegetation; may benefit from application of fertilizer. Excavator could re-contour spoil.
55. Road overgrown with bracken, ferns, etc. Very good revegetation, vehicle access should be restricted.
56. Road impassable due to large tree fallen over road, good revegetation.
57. See 56.
58. Road needs 2 cross drains dug.
59. Cross drains required. Road has been ripped up by rig being pulled over it. Bulldozer could repair.
60. Road overgrown, good revegetation.
61. Road overgrown, good revegetation.

62. Road overgrown, good revegetation, sump on road needs draining.
63. Costean, good revegetation.
64. EAB4 - road and pad overgrown, good revegetation.
65. Road is no longer used, no soil left to fill deep ruts and scouring on road. If access not required road should be closed.
66. Steep hill, needs cross drains, deep ruts and scouring would need filling.
67. Culvert required.
68. Culvert required.
69. Road to costean passable, small bog near Hollway Creek requires caution. Road should be closed unless access required.
70. Costean, good revegetation.
71. EAF15 - no spoil left for contouring. Some revegetation, may benefit from application of fertilizer.
72. EAF16 - some revegetation, could benefit from application of fertilizer.
73. Culvert required.
74. Small dam filled by runoff from Brown's Tunnel.
75. Drains needed.

76. Excavator could contour, spoil area would benefit from fertilizer.
77. EAF 8, 6, 4 - spoil could be re-contoured by excavator. Very poor revegetation, may benefit from application of slashed vegetation and fertilizer.

78. EAF12 - excavator could reduce size of pad - some revegetation, mainly eucalypts and heath, fertilizing would be beneficial.
79. EAF13 - as above.
80. EAF11 - excavator could reduce size of pad. Would benefit from slashed vegetation and application of fertilizer.

81. Road to EAF5 impassable. Cross drains required to divert water. Road should be closed if not required.
82. Road to BPD62 needs cross drains and windrows broken to divert water.

83. Creek crosses road, may become impassable. Culvert required if vehicle access to BPD62 desirable.
84. Deep ruts and scouring - dozer/excavator could repair. Cross drains needed to divert water.

85. Road could be closed.
86. Old sump, excavator could fill in.

87. Road overgrown, good revegetation - ti tree, banksia over 1m tall.
88. Costean - good revegetation.
89. Road blocked by fallen tree.
90. Road overgrown, mainly ti tree and cutting grass. Cross drains needed.
91. Road becomes boggy in wet weather. Cross drains may fix.
92. Road into Silver Falls. Generally in good condition, cross drains where required, some parts rough where bedrock protrudes.

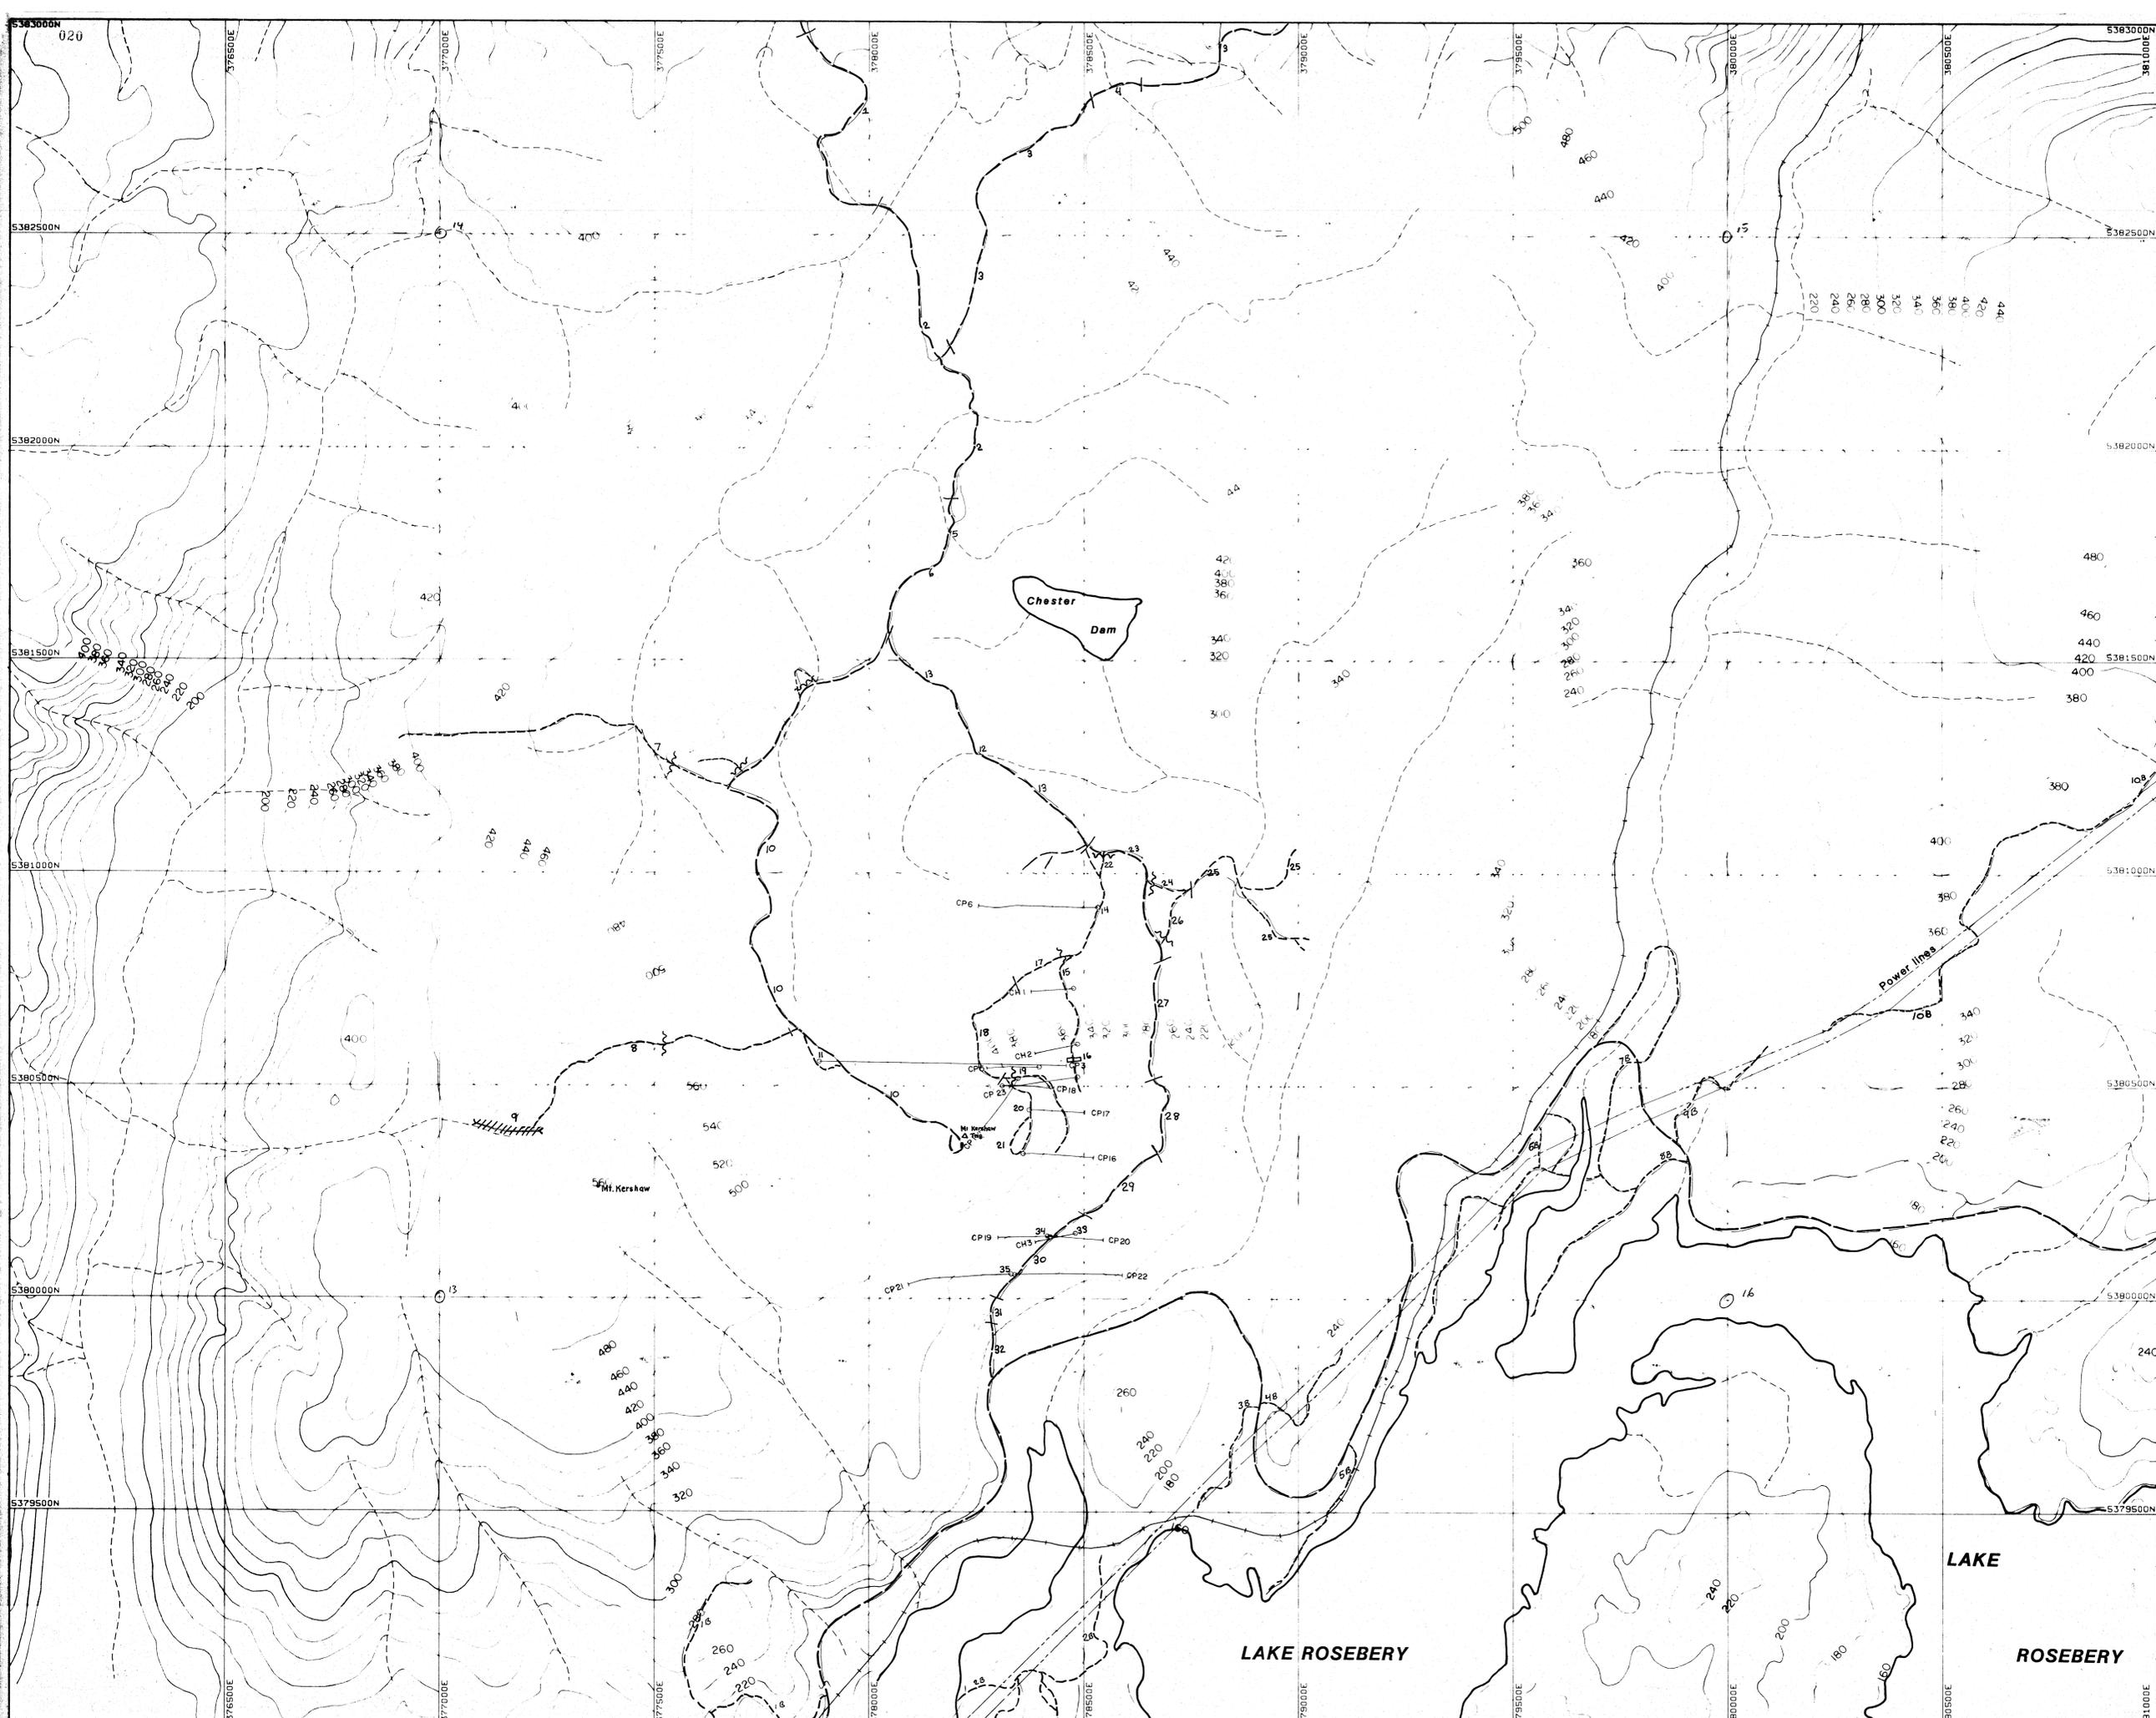
SHEET 2

AREA	COMMENTS
1. Cross drains need to be dug on Chester Rd where necessary.	
2. Hole in Hollway Ck bridge needs to be filled, water draining down road onto bridge needs to be diverted.	
3. Hollway Rd needs cross drains dug where necessary.	
4. Wash out (DIP) needs culvert and fill.	
5. Large permanent pools on road. Road needs draining, crosses low lying creek, drainage may be difficult to achieve.	
6. See 5.	
7. Road impassable due to deep ruts, could be fixed with excavator or dozer, cross drains needed at regular intervals. Apart from deep ruts, road in reasonable condition.	
8. Road impassable due to fallen trees, good regrowth of cutting grass, ti tree and eucalypts. Road should be closed if access not required.	
9. Costean. Very good revegetation in and around costean. Ti tree, eucalypt and myrtle, some regrowth over 3m tall.

Water running down costean
would be difficult to divert.

10. Road to Mt Kershaw trig
needs extensive cross
drains and breaking of
windrows on bends. Road
is passable and in
reasonable condition.
11. CP3 drill site. Poor
revegetation. Applications
of slashed vegetation and
fertilizing may assist
regrowth.

12. Culvert or log drain
required. Road scoured
to bed rock, large
washout needs back
filling.
13. Section of road needs
drains dug. Road in
reasonable condition,
however is deteriorating
with water scouring to
bed rock, most cross
drains require excavator
to dig them.

14. Sections of road in
reasonable condition
and is passable to vehicles.
Cross drains required on
some sections.
15. Very boggy area, road
almost impassable.
Would need to be corduroyed
if vehicle access required,
remainder of road in
reasonable condition.
Good regrowth on some
sections.

16. Large tree (Myrtle)
across road, vehicle
access to CP3 impossible.
17. Large volume of water
running down road, deep
scouring and rock outcrops

- make road impassable.
Large cross drain
required to divert water.
Road will have to be back
filled if vehicle access
required. Excavator would
be ideal as plenty of
loose fill on sides of road.

18. Road in fair condition.
A lot of moss on road
and good revegetation
on some sections, ti
tree, cutting grass,
eucalypt and some myrtle.
Unless vehicle access is
required, best blocked off
and allowed to rehabilitate.

19. Road impassable due to
good regrowth of ti tree
and cutting grass. Best
blocked off.
20. CP17 drill pad. Some
fill still remains for
excavator to re-contour,
slow revegetation may
benefit from application
of slashed vegetation and
fertilizer.

21. Good revegetation on road.
Best closed and left to
rehabilitate.
22. Steep incline, road needs
cross drains. Road almost
impassable due to deep ruts,
alternative access available.
Road should be closed.

23. Steep incline. Road needs
cross drains and windrows
broken at regular ~10m
intervals. Road in
reasonable condition.
24. Road impassable due to
deep ruts and scouring,
requires table drain to
divert water. Road should

- be closed unless vehicle access required.
25. Roads completely overgrown with cutting grass, ti tree and eucalypts. Impassable to vehicles.
 26. Road impassable due to deep ruts and scouring, table drain required to channel water. Road should be closed unless vehicle access required.

27. Road in good condition, some drains required.
 28. This section of road almost impassable due to large rock outcrops and all road fill washed away. Large cross drain at top of incline needed to divert water, outcrop will need blasting to improve vehicle access.

29. This section of road in good condition. Cross drains should be dug where needed.
 30. Very steep incline, old cross drains need to be re-opened and windrows broken to divert water. Road in reasonable condition.

31. Road almost impassable due to rock outcrop and loose fill. Outcrop needs blasting to repair.
 32. Section of road requires cross drains to divert water. Road in reasonable condition.

33. Drill hole CH3 access road and drill pad overgrown, good revegetation.

34. Drill holes CP19 and CP20 - some revegetation, would benefit from application of fertilizer.
35. Drill holes CP21 and CP22 - some revegetation, would benefit from application of fertilizer. No spoil left to contour.
