EL 11/93 Oonah
Final Report

FINAL REPORT - EL 11/93
OONAH, CRA EXPL.
T. VON STROKIRCH

CRA EXPLORATION
OONAH AND RAZORBACK MINING
LEASES
REHABILITATION PLAN

August 1991

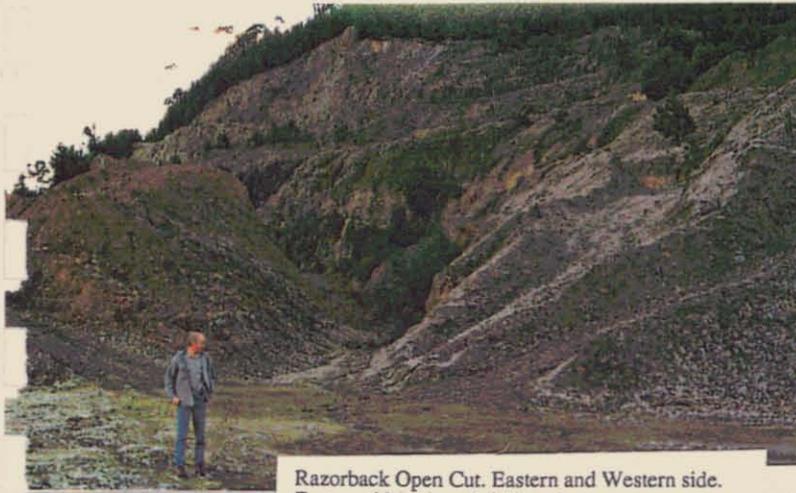
The open cut which was constructed in the early 1970's has steep slopes and high bench heights, with most of the western side now inaccessible. However, except for some local failures it is stable and the western side is revegetating naturally and successfully. This includes the the southern overburden dump. Numerous drives of the old underground workings are exposed in the open cut faces and the site itself provides diverse examples of mining history and is of some historical value.

Razorback Open Cut. Eastern and Western side.
Eastern side to be rehabilitated

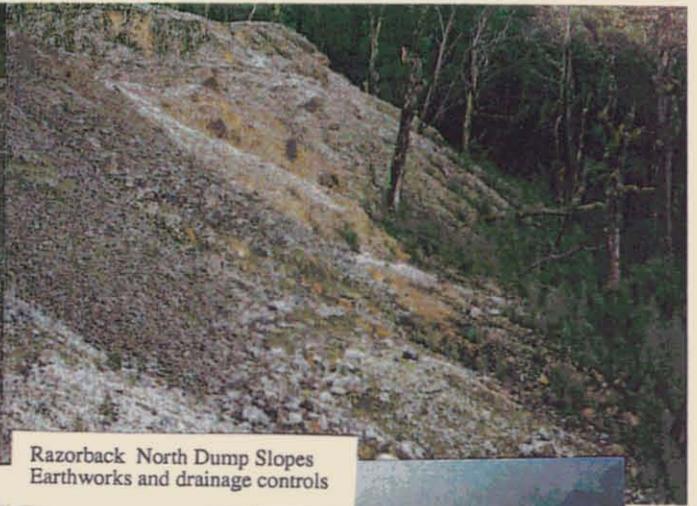
This dump contains the overburden stripped from the open cut. Overburden has been end-tipped over the hillside and has now to a large degree stabilised itself. Gully erosion is evident where uncontrolled runoff has discharged over steep areas. Revegetation is progressing slowly, due to exposure and nutrient deficiency.

Razorback North Dump Slopes
Earthworks and drainage controls

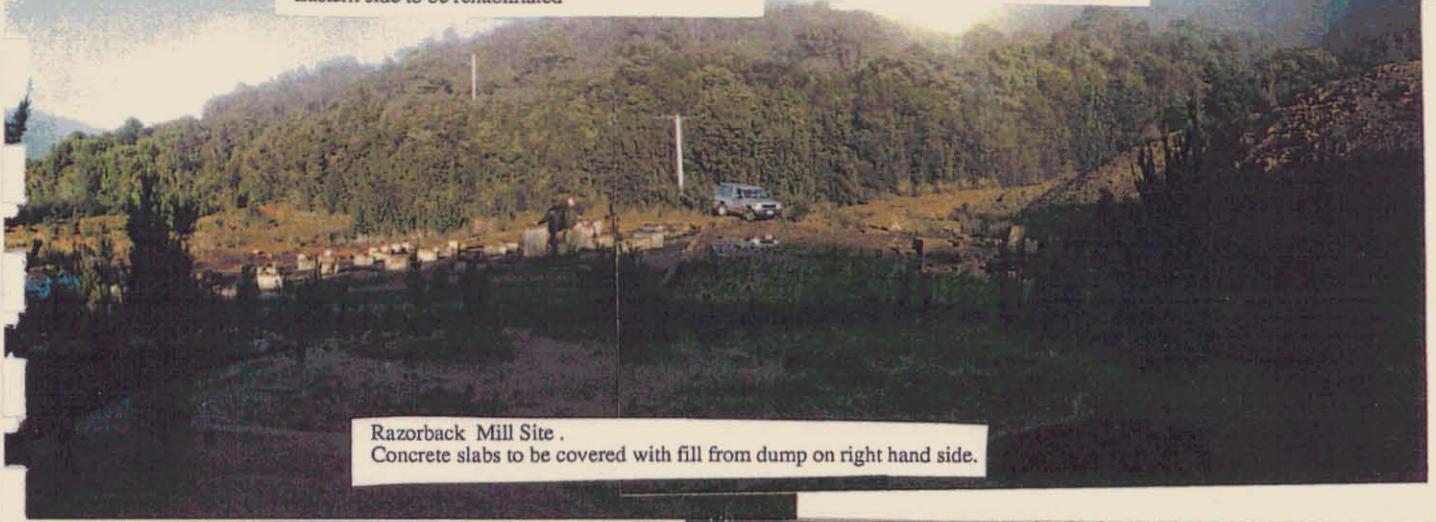
The mill site contains the concrete foundations for the mill buildings, plus associated stockpiles and overburden benches. Uncontrolled drainage from the adit also flows over the site and old steel work and general refuse also remains.

Razorback Mill Site.
Concrete slabs to be covered with fill from dump on right hand side.

The flat exposed foundations will be covered with the fill material which exists in the batter above. This fill batter will also be benched. The inclined foundations will be broken up in selected locations if possible, and fill placed in these areas.

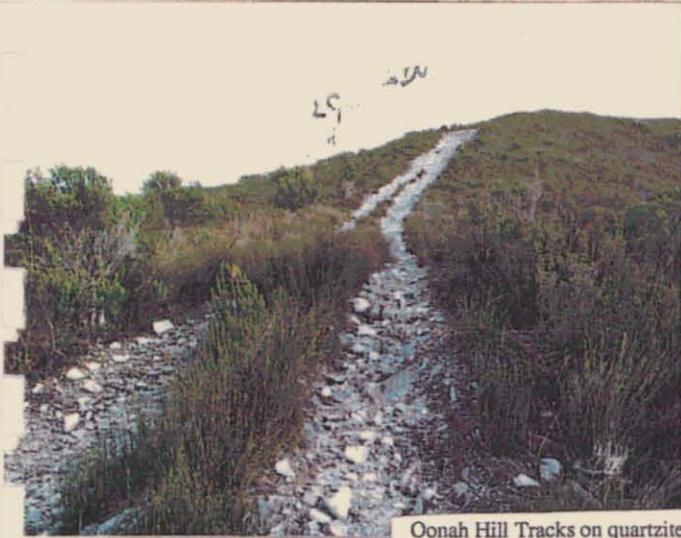
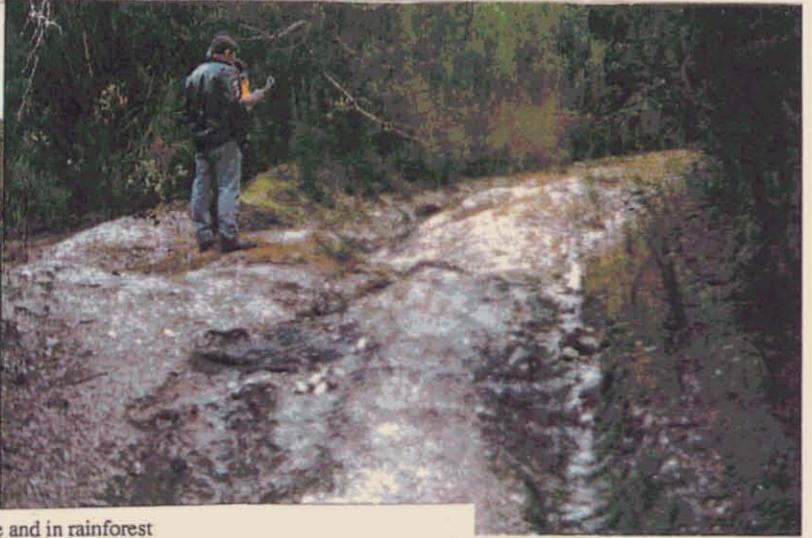
While many of these tracks and disturbed areas are revegetating naturally, many are not, and are actively eroding. These are mainly on the steeper slopes and in particular, the road past the old mill site and Minop Shaft. This road provides access to the fire trails further over Oona Hill and is used by both 4 Wheel drive vehicles and trail bikes.

Oonah Hill Tracks on quartzite and in rainforest
Tracks to be closed, ripped and gripped, soil returned from edges and revegetated.

All compacted surfaces will be ripped where possible. Tracks on slopes will be "gripped" and drainage provided to undisturbed areas.

Available soil from the track sides will be recovered and spread over the track.

Entrances to the tracks will be blocked by earthworks and fallen trees.

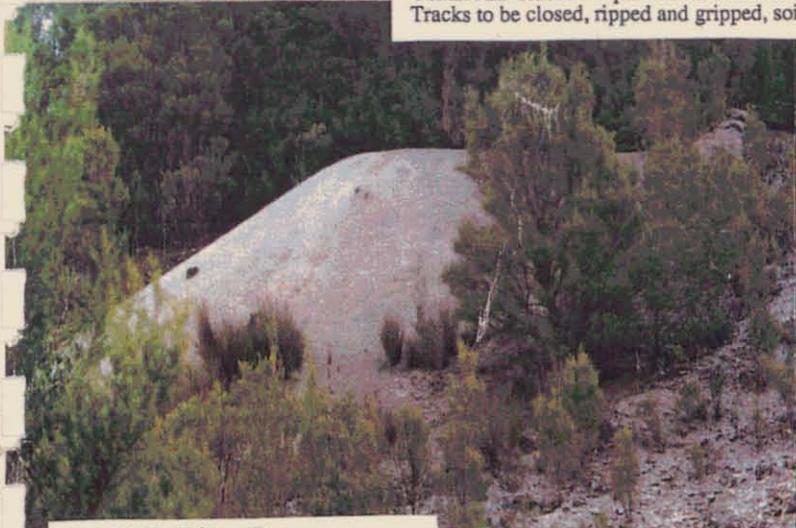
Oonah Hill Tailings Dumps.
Revegetation with pinned Tea Tree brush

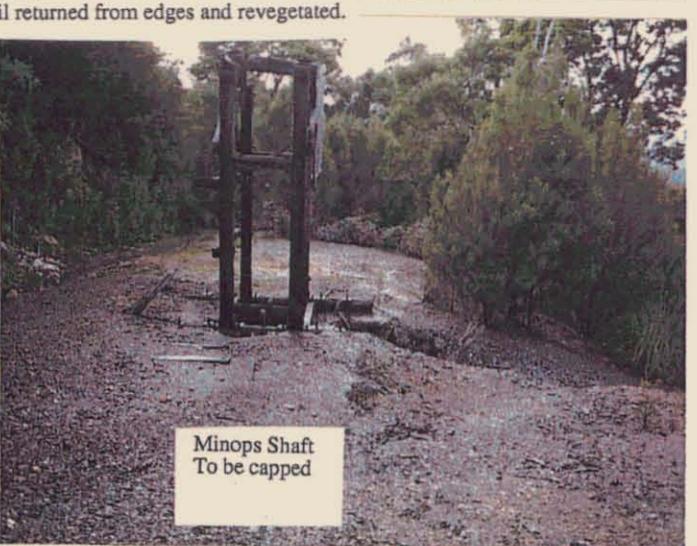
A total of four open shafts are located in the Lease area. These are the Oonah Main Shaft, near the old mill area, an unnamed shaft approximately 75 m to the north (Shaft 2), another approximately 50m north (Shaft 3), the Minops Shaft further north and the Adit near the Oonah Shaft. Only the Minops Shaft is open to any depth, with the remnants of a wooden headframe and with a concrete collar in good condition .

Minops Shaft
To be capped
