MINERAL RESOURCES TASMANIA

**Archaeological Survey Report**  
**1995/02**

**Archaeological reconnaissance of  
Storeys Creek and Aberfoyle mines  
Rossarden, Tasmania**

*Back-Tracks Heritage Consultants*  
&  
*Kathryn Evans*

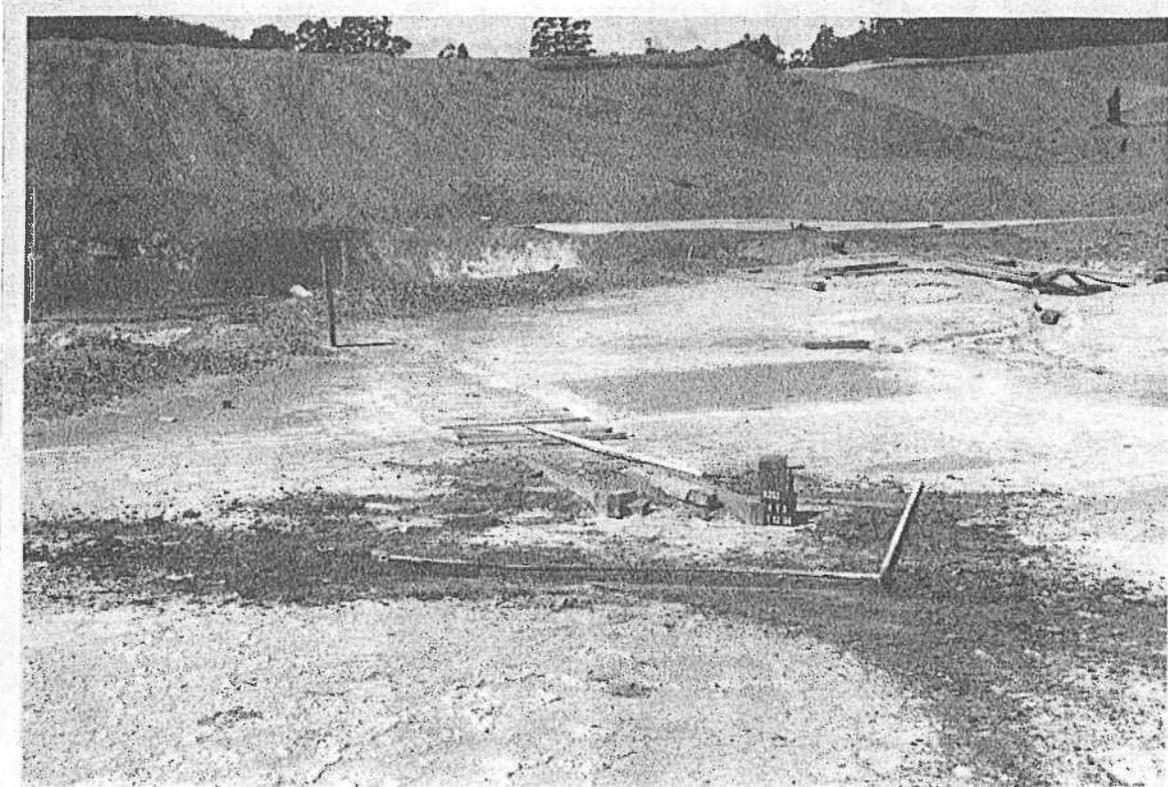
Plate 3: Feature #2, silt-trap at south-eastern end of slime dam #4..

Feature 2 Silt trap & walk-way

A length of wooden access platform runs at an angle from the silt trap across the compacted slimes surface. The platform, measuring 11.2 by 0.6 metres, probably once connected with feature 3 on its way to the dam wall.

The silt traps, access walk-ways and trestles contained within the pond are insubstantial and expedient constructions and are likely to have been modified or replaced several times during the life of the mine. While they illustrate aspects of the waste management process, the structures themselves are considered to have little historical or archaeological significance. The bucket conveyor was also associated with the transference of ore products during the milling process and has no greater level of significance than the other features in dam #4 or than many of the other items of machinery lying in piles around the site. Nonetheless it is an instantly recognisable device and one which would not look out of place as a feature on the rehabilitated landscape.

For these reasons, and despite the nominal heritage value of the site, it is considered inappropriate to leave the dam in its current condition.

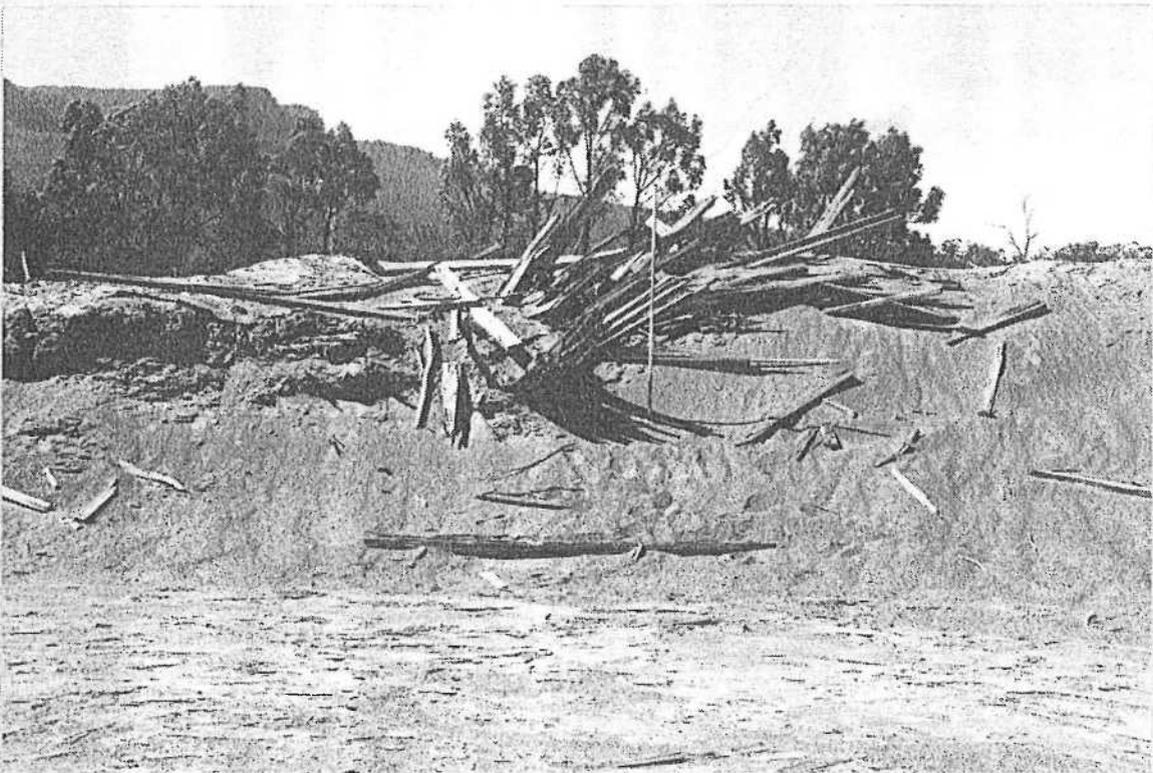
Plate 4: Feature 1, silt-trap located in slime dam #5.

Feature 1 Silt trap

A collapsed timber structure, identified as a demolished silt trap, protrudes from the northern end of the deflating and eroded tea tree reinforced bund at the edge of a shallow sand pit recently cut into the centre of the dam. Due to its state of disrepair it was not possible to determine the original dimensions of the construction.

The silt traps and launder supports contained within the #5 dam and adjacent areas are insubstantial and expedient constructions and are likely to have been modified or replaced several times during the life of the mine. While they illustrate aspects of the waste management process, the structures themselves are considered to have little historical or archaeological significance.

The heritage value of the #5 slimes area is offset by the same important factors of structural instability and toxicity as outlined for dam #4. For these reasons, and despite the nominal heritage value of the site, it is considered inappropriate to leave the dam in its current condition.

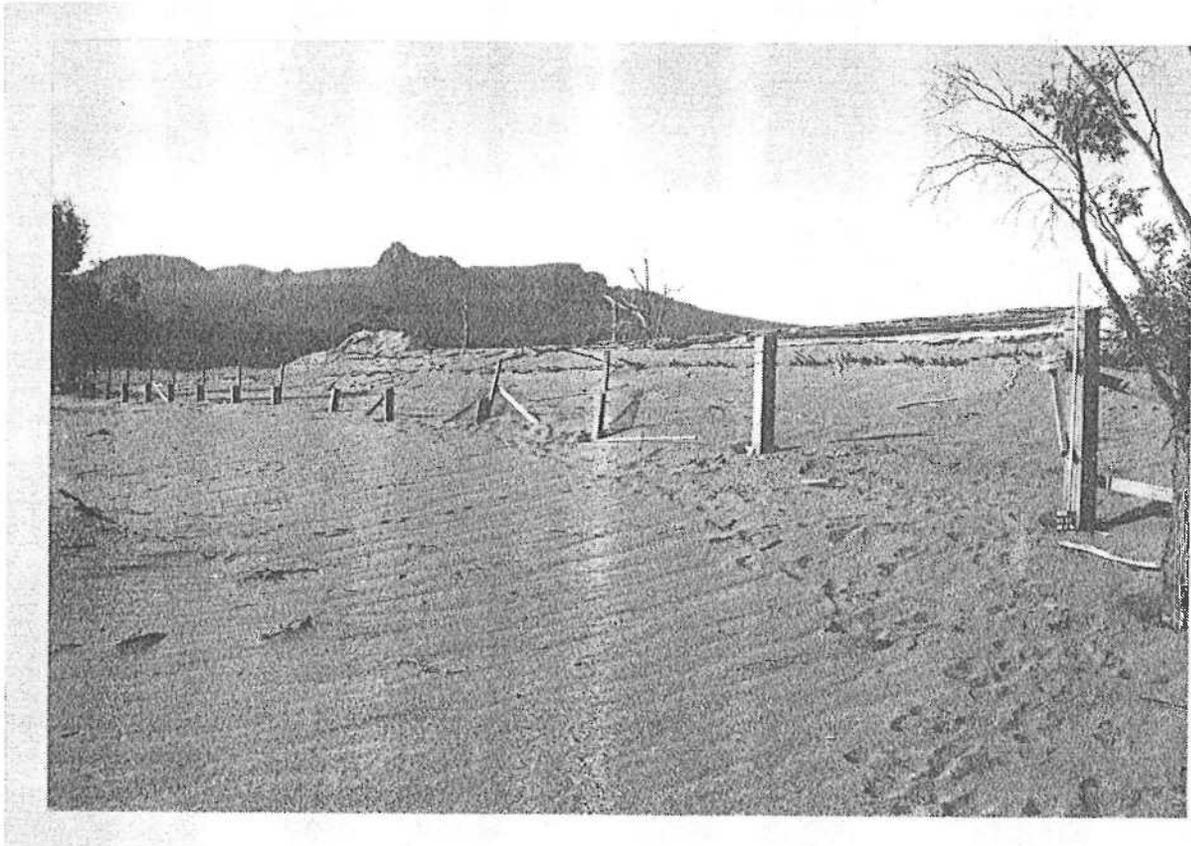
Plate 8: Feature 8, fence line to south of slime dam # 5.

Running along the southern side of the dam #5 area was a roughly constructed post and wire fence which ran for almost 145 metres. It was assumed by the consultants that this fence once formed the southern boundary of the lease belonging to J.K. Scheppein.

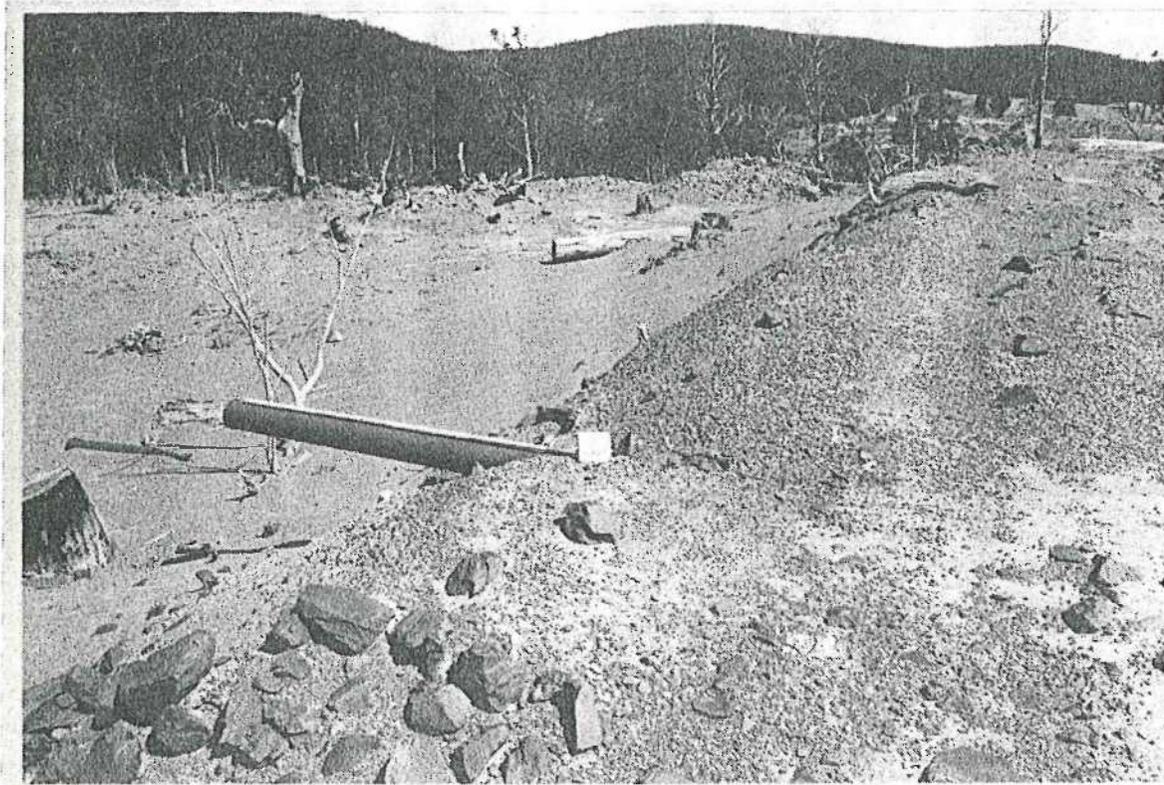
Plate 16: Feature 2, pipe overflow in settlement dam # 2

Feature 2 Steel overflow pipe

Located 4 metres to the south-east of the north-east corner of settlement dam #2 is a length of 20 cm diameter steel pipe cutting through the top of the clay bund. The pipe was assumed to have served as an over flow.

The heritage value of the #2 slimes area is offset by the same general factors of structural instability and toxicity as outlined for dam #4. For these reasons, and despite the nominal heritage value of the site, it is considered inappropriate to leave the dam in its current condition.

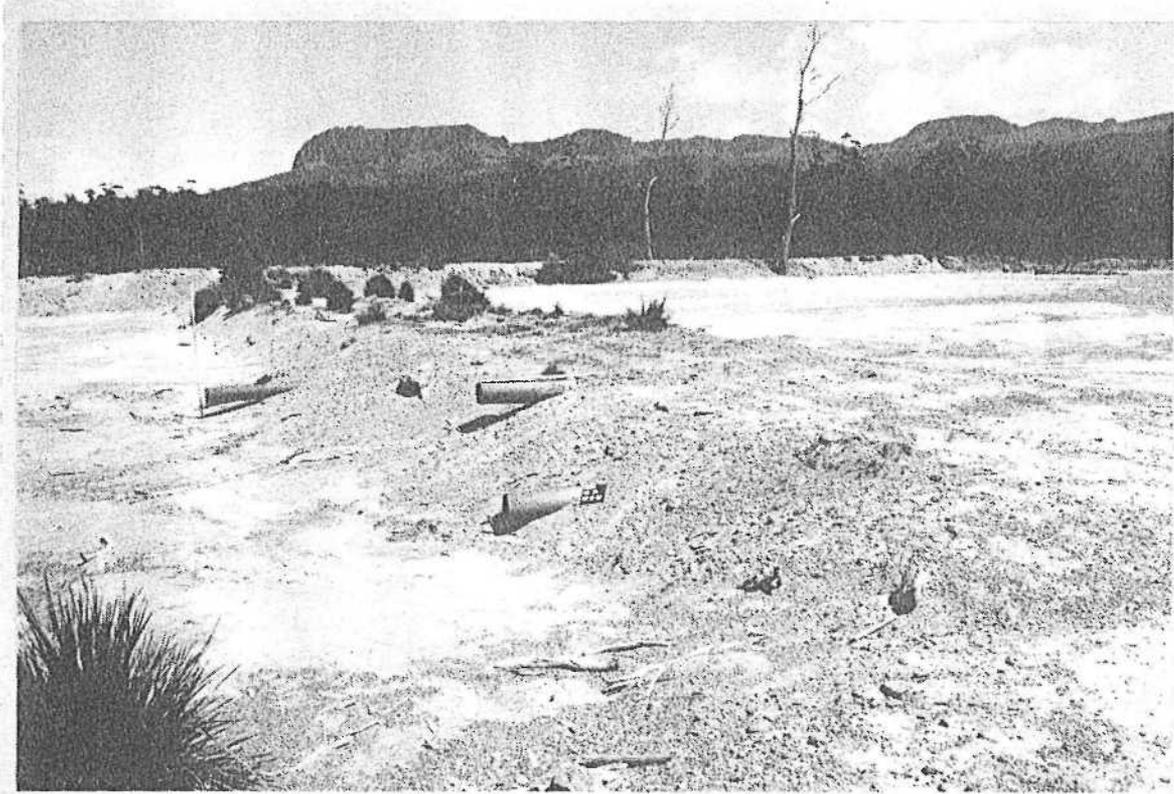
Plate 17: Feature 1, Steel overflow pipes in settlement dam #6

Three steel pipes lie embedded in the top of the bund at the northeast corner of the pond, providing a means of channelling the surface runoff between dam #6 and dam #7 to the north. The three parallel pipes, constructed of 5 mm thick steel with an internal diameter of 21 cm, have been laid at 90 ° to the bund. Each section of pipe is of a different length: the western most is 6 metres long, the central pipe is ~4.5 metres long and the eastern pipe is 5.6 metres long.

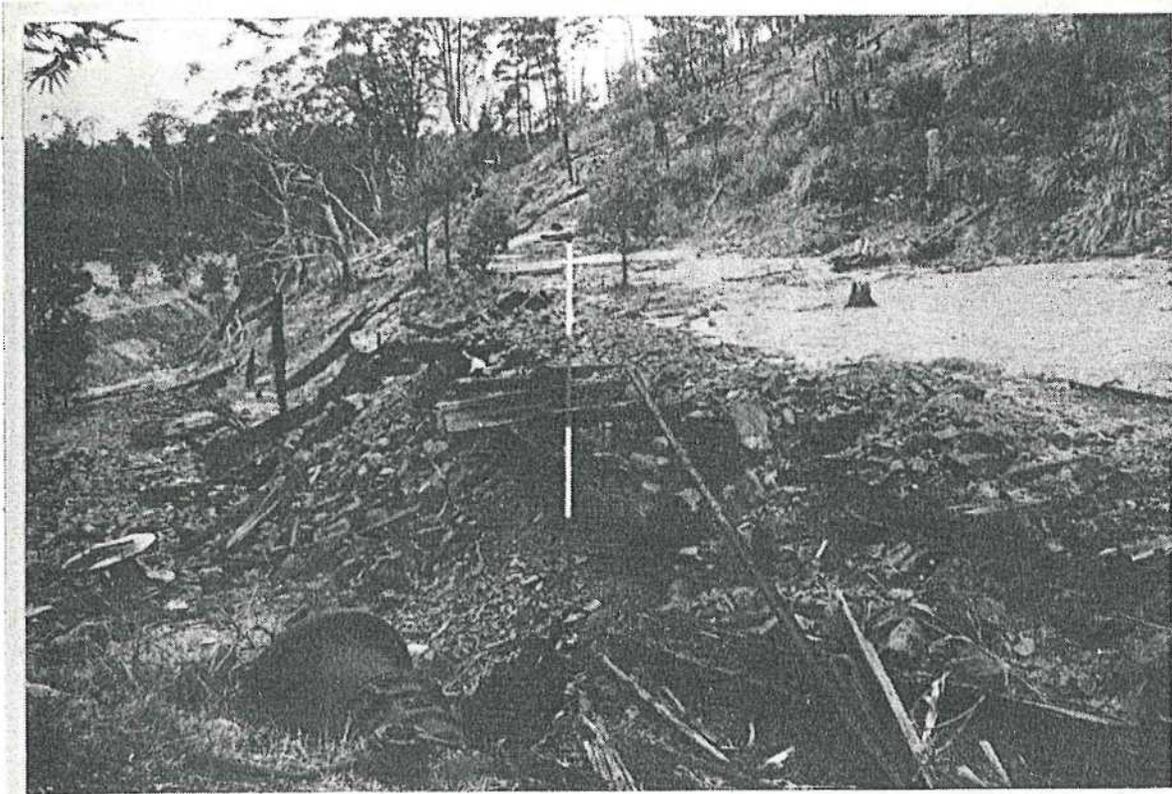
Plate 23: Shower room terrace and collapsed hopper frame, Northern workings area.

The timber reinforced mullock platform and vestigial timber uprights arguably represent the remains of a timber ore hopper constructed in 1916 (Kilner p 20). The structure and the adjacent mullock heaps relate to the process of handling and separating the ore on the surface prior to transportation to the battery, and for the temporary storage of waste for backfilling.

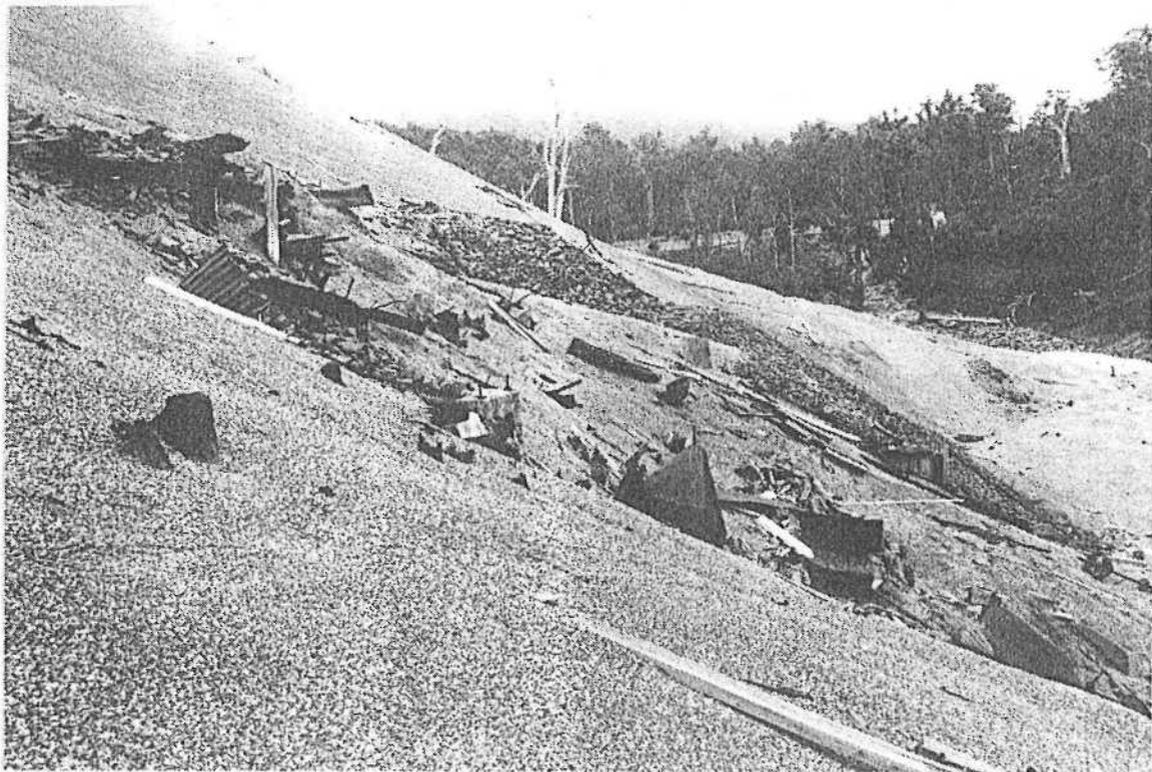
Plate 27: Storeys Creek milling plant, in use from 1916 to 1958 (Kilner p 31).

Ruins of a multi-terraced timber and corrugated iron building, measuring 16 by 20 m, extends down the face of the hill above Storeys Creek. Much of the structure is concealed beneath a thick blanket of coarse jig tailings. The underpass of an ore hopper, built of timber and mullock, and a concrete machinery footing sit at the head of the site. The edges of sections of timber floor and alignments of footings bolts protrude through the jig tailings on the terraces below. A single shaft and pulley assembly remain in situ in the centre of the ruined structure. A large quantity of discarded machinery items and scrap metal, some dating from the period of mill operation, lie scattered about the site.

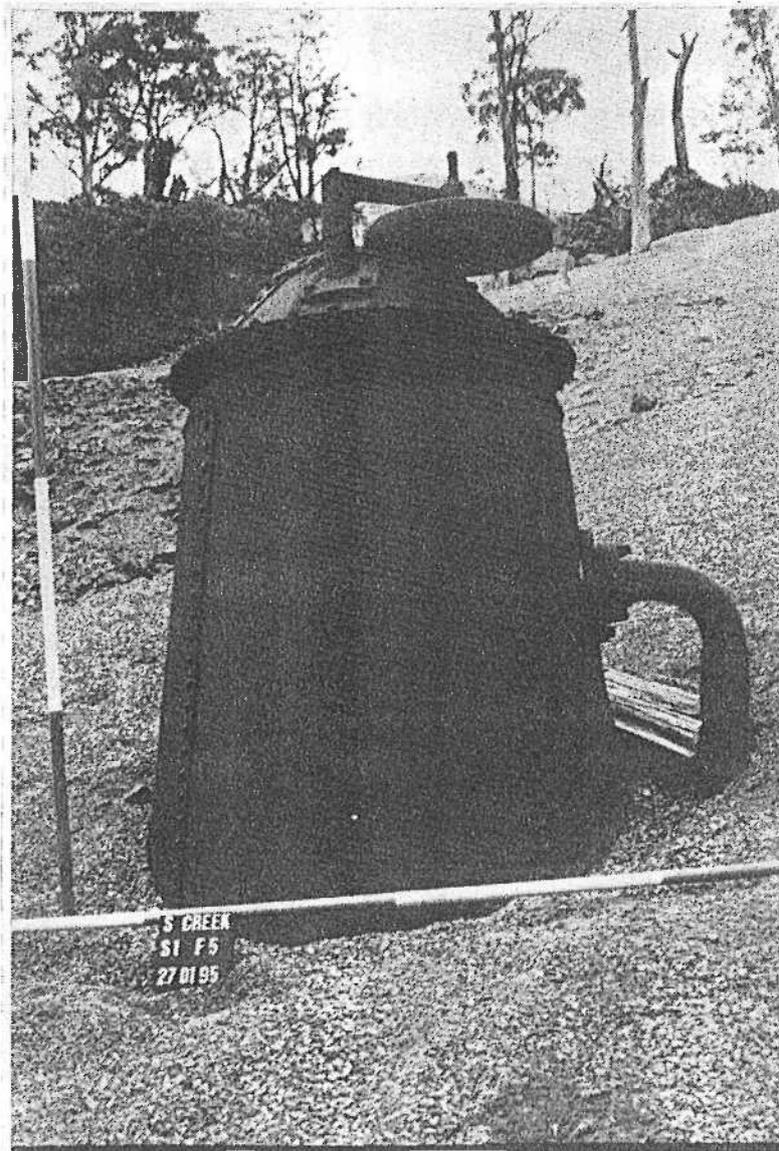
Plate 28: Gas producer, storeys Creek mill.

Constructed in 1916 and dismantled by 1959, the milling complex comprised a four terraced timber and corrugated iron crusher house and dressing shed with smaller outbuildings clustered about the main structure. The gas producer power plant for the complex was housed in a small building at a little distance on the south side of the site.

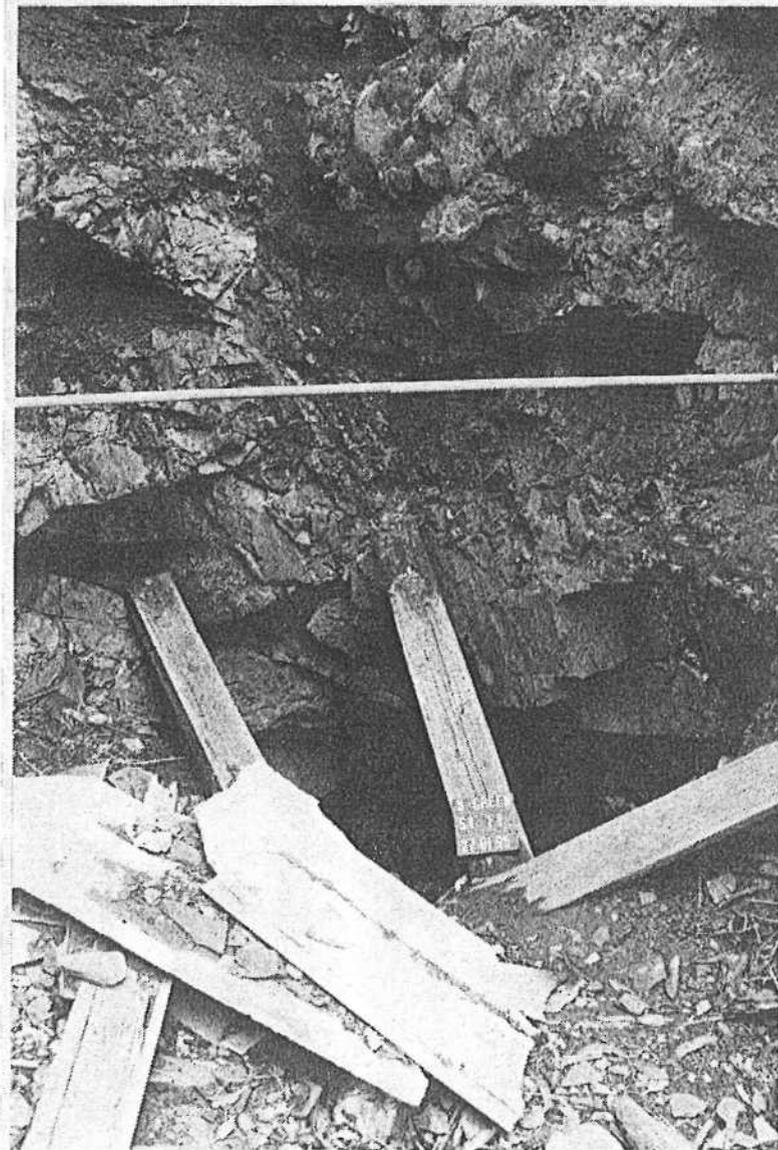
Plate 30: Collapsed portal to adit crosscut on Mier's drive.

Situated at a distance of 45 m southwest of the mill ruins is the entrance to a flat roofed adit 2.5 m wide at the base with a ceiling height of 2 m. The tunnel is timbered with heavy hardwood beams but the outer 8 m and portal have collapsed, leaving an exposed face 5 m high.

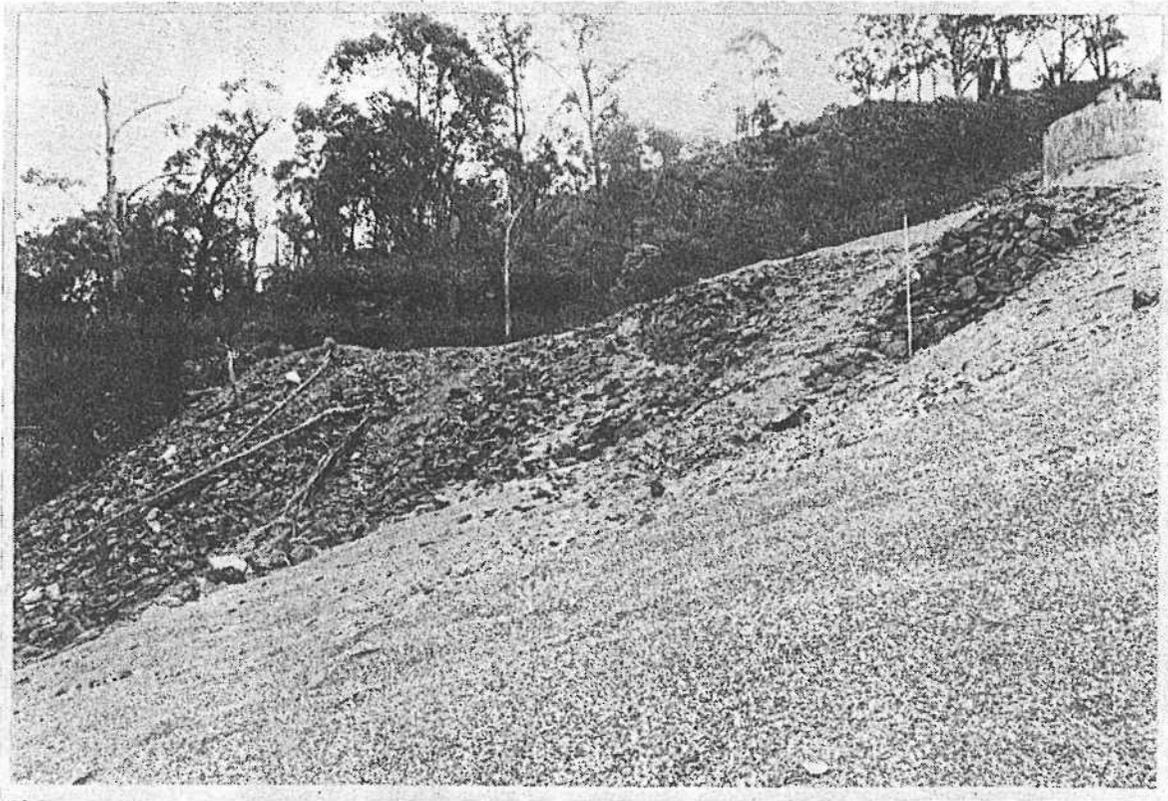
Plate 31: Mullock tramway linking adit to mill.

A spur of ore waste extends for several metres eastwards from the collapsed adit portal, and forms the corner embankment for a short mullock built tramway easement running from the portal 40 m towards the mill site. Crude dry stone walling faces several small sections of the narrow mullock embankment and the base of a "Jaques" rock breaker lies midway along the easement. An alignment of post heads protruding from the thick blanket of jig tailings at the north end of the embankment continues on for 15 m to the head of the mill terrace.

The short stone built tramway embankment appears to have been constructed some time between 1930 and 1953 in order to enable transportation of the ore from the then recently reopened southern workings to the mill (Edwards, 1953). The remains of a timber trestleway which carried the rail from the end of the easement to the head of the mill building lies buried beneath a thick accumulation of jig tailings. The tramway remains provide an important linking structural context to the sites of mineral extraction and processing on the hillside and a neat visual clue regarding the workings of the gully complex.
