**Archaeological Survey Report 1995/03**

**Devonport Mine near Black Bluff**  
report to Tasmania Development and Resources

# **Devonport Mine near Black Bluff**

November 1995

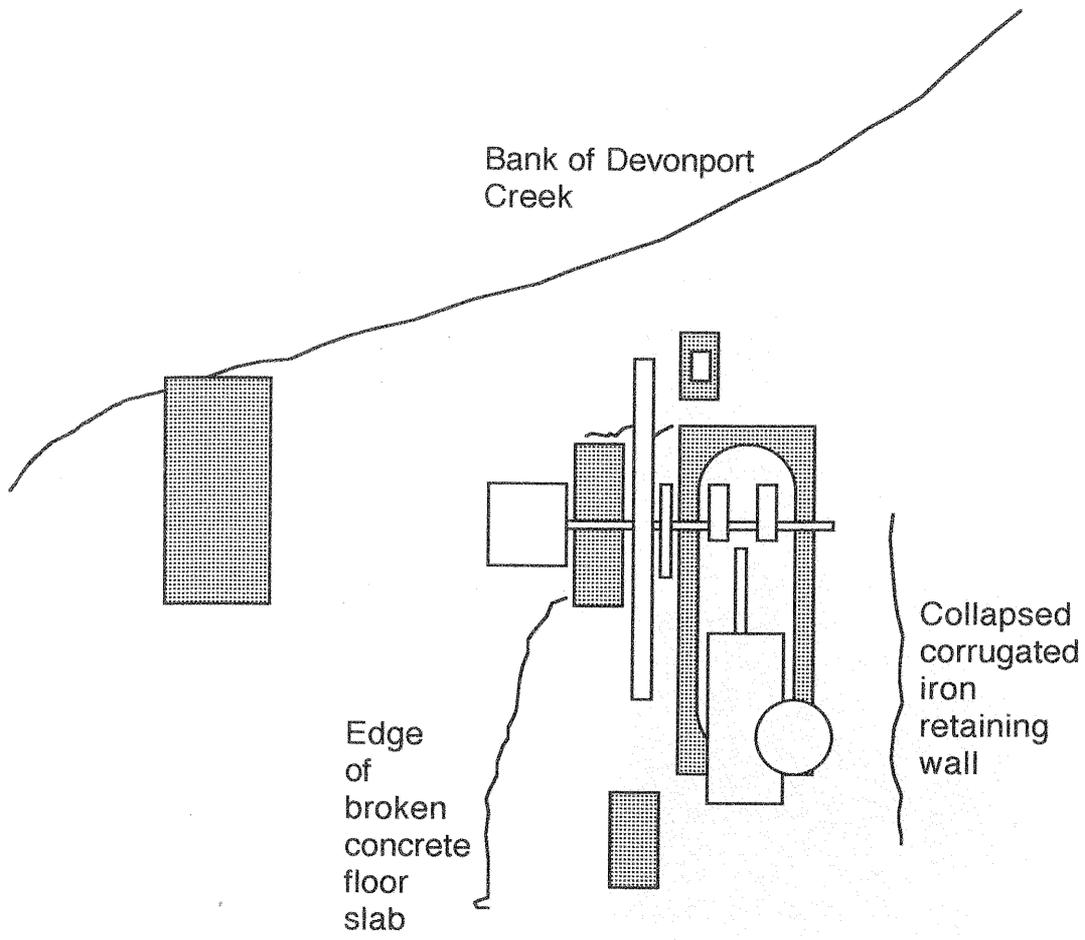
**Plan of Crossley engine surrounds at Devonport Mine**

Concrete foundation

- That nothing but the Crossley engine and its attached flywheel, beltwheels and other necessary operating parts be removed from the site (generally the mechanism shown in the plan on page 7 of this report).

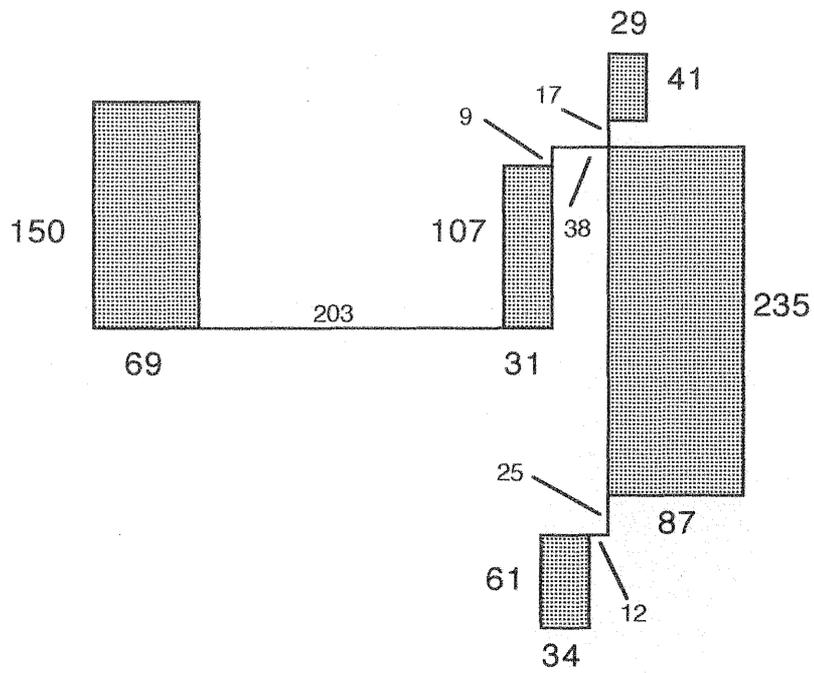
The engine is mounted on reinforced concrete foundations, obviously made with precision and skill, presumably from the original blueprints. There is a large concrete block supporting the engine proper, a smaller one beside it supporting the crankshaft, and a third even smaller block beside the flywheel which supports a fulcrum for levering the flywheel to position the piston for starting. A small block with four machine bolts close to the cylinder head and a large block with six machine bolts some distance from the belt wheel have had machinery of unknown function removed from them.

**Dimensions of Concrete Foundations (in centimetres)**

- That the engine's concrete foundations and tie-down bolts be left intact when the engine is removed.
- That removal of the Crossley engine be undertaken with the absolute minimum of disturbance to the other mining relics on the site and the natural environment.

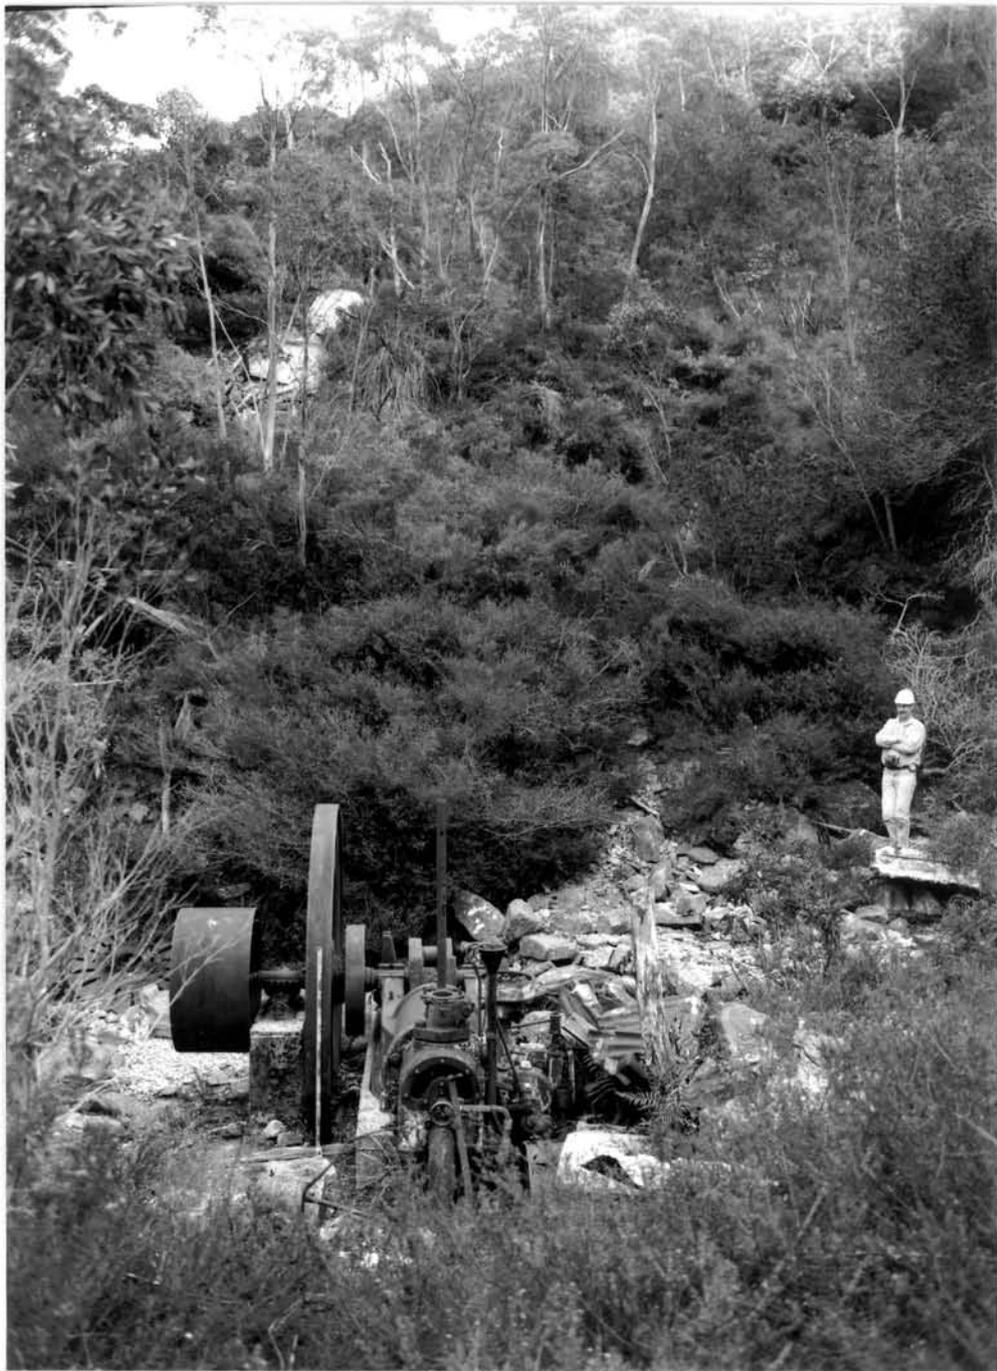
**General view of Crossley engine and mill site from northeast (Film 2 neg 55)**

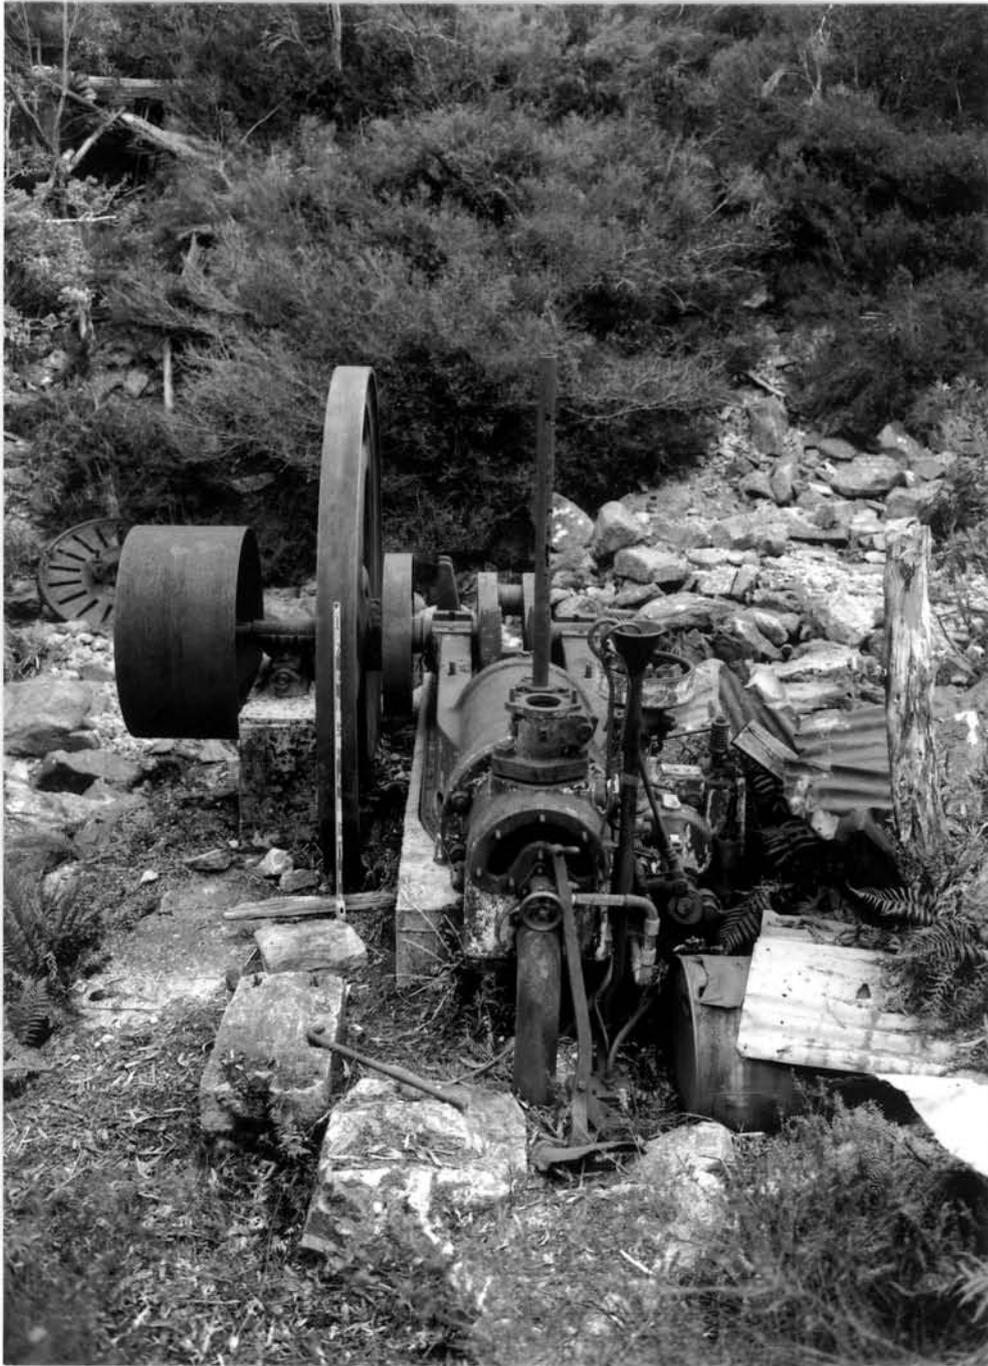
The most prominent element of the site is the Crossley oil engine on its concrete foundations. This is a one-cylinder horizontal engine with a bore of about 11" (28cm) and a stroke of 20" (51cm), implying power of around 30 bhp. It has the cylinder jacket and frame cast in one piece nearly 2.5m in length, and is fitted with a beltwheel and a flywheel nearly seven feet (2m) in diameter. Minor parts such as the crankshaft bearings, cylinder head, bulb heater, governor and oil pump have been removed.

There is some confusion in recent sources about whether this is an oil or a gas engine, as the two are very similar in appearance. This is definitely an oil engine, fitted with a hot bulb for ignition. There is no sign of a gas producer in the vicinity, and the engine was fuelled from an oil drum.

**Crossley engine from northeast (Film 2 neg 54)**

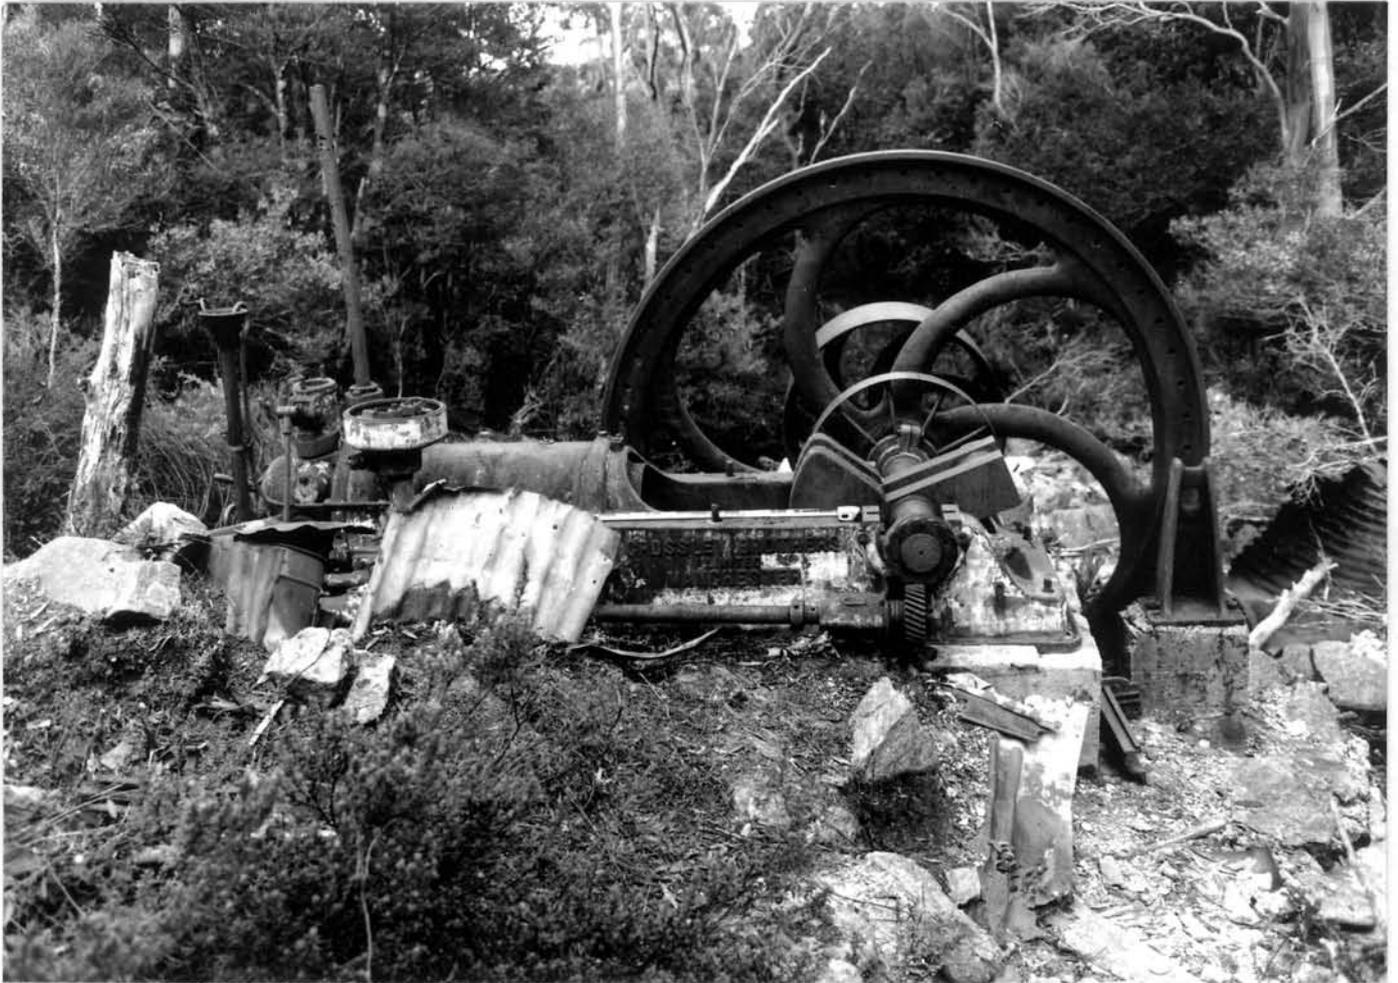
**Crossley engine from northwest (Film 2 neg 49)**

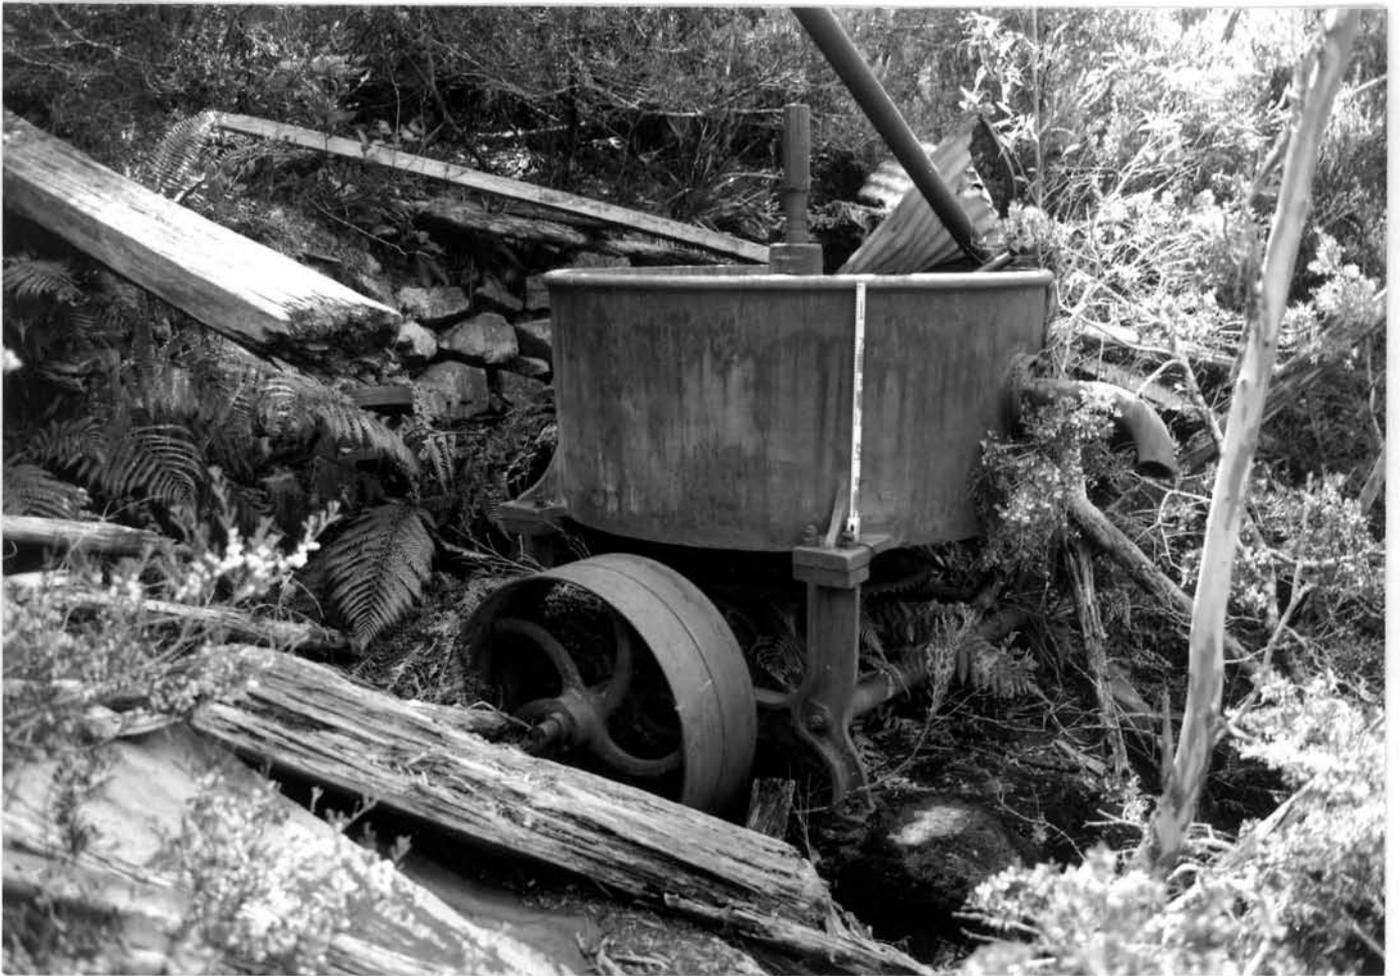
The most conspicuous piece of milling plant is a Forwood Down grinding pan standing on the steep slope about twenty metres south of the engine. The pan is 5' (1.5m) in diameter, and cast in its side is:

The pan stands on a level space, with a stone retaining wall behind it, and the remains of a timber staircase collapsed beside it. The pan proper is in situ and standing on its legs, but its working parts have been dismantled and some are identifiable in the vicinity. Its central driving column is lying beside it, curved shoes and dies are scattered nearby, and its muller is lying on the creek bank near the Crossley engine. The muller has fractured across its diameter and has been repaired by brazing the cast iron.

**Forwood Down grinding pan from east (Film 3 neg 49)**

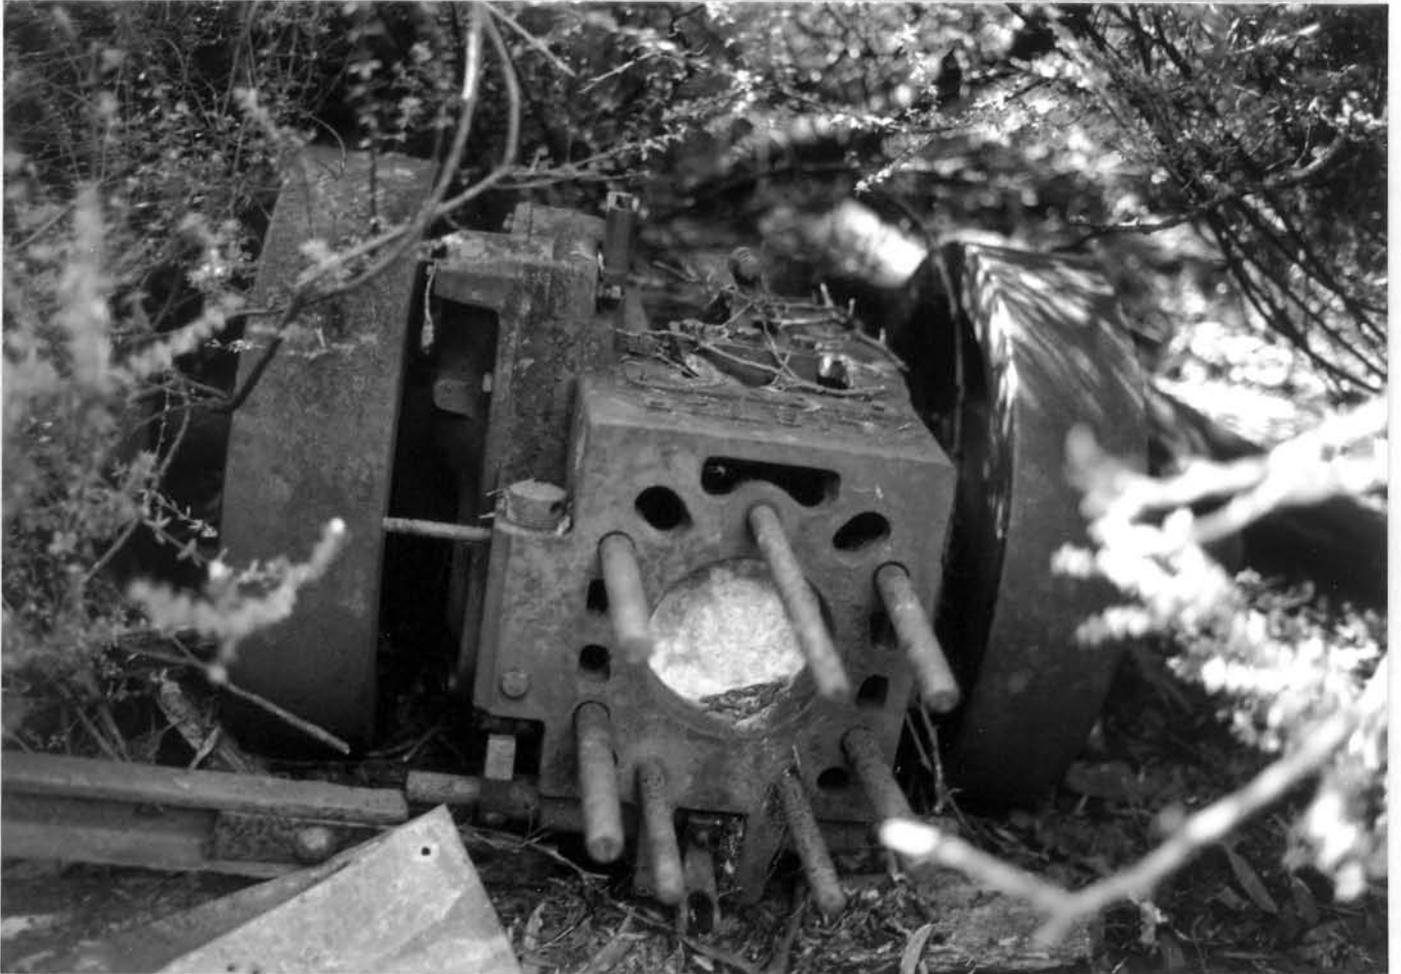
No other treatment plant is evident in the vicinity of the mill, but the site is heavily overgrown, making observation difficult. A small one-cylinder Lister oil engine lies dismantled with its cylinder head and other parts missing inside the mill perimeter, but no other machinery is present, nor are there any foundations or other indications of what was there or where it was located. The mill building has apparently collapsed where it stood, for there are some posts standing, and other heavy timbers and a few sheets of corrugated iron are lying on the site. However there appears to be insufficient material present to account for the whole building. There are no indications of fire. Near the top of the slope there is an area of bare earth and stone, mixed with planks and heavier timbers, and it appears that a timber ore bin has collapsed onto the site, spilling its contents down the slope and perhaps hiding other evidence. The stone is soft, white and friable, and seems an unlikely ore of gold. There are a few lengths of tram rail on the slope amongst the ore bin debris.

**Lister oil engine on mill site,  
note tram rail at lower left (Film 3 neg 50)**

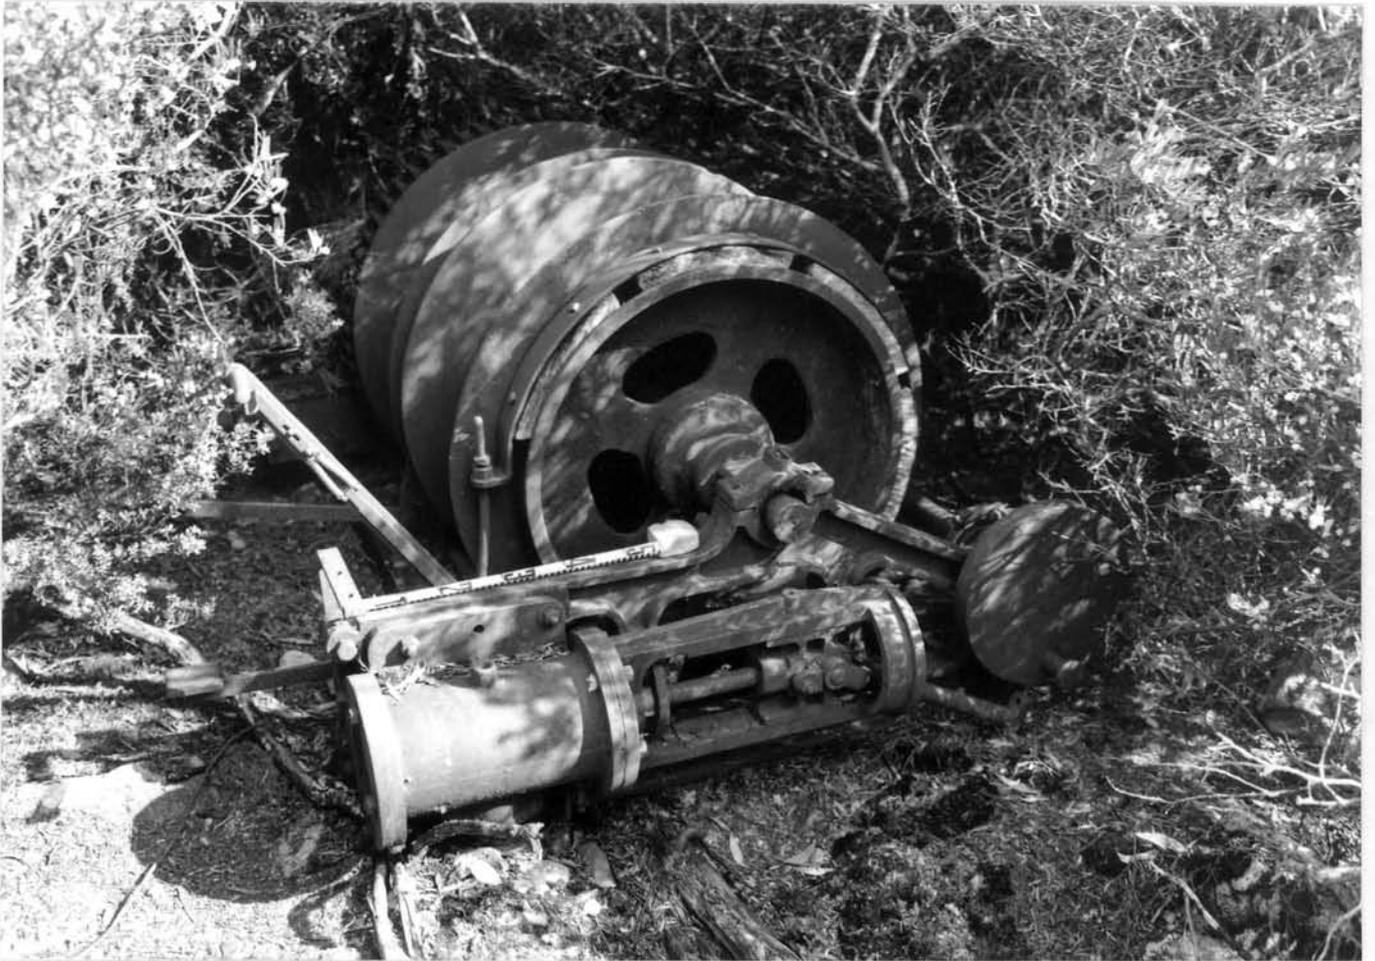
On level ground immediately above the mill site is the mine adit, still open. On the ground near the entrance to the adit is a small two-cylinder steam winding engine. There is no boiler, and the engine is not aligned with the adit or mounted on a foundation. East of the adit, mullock has been run out on a heap shaped like three diverging fingers of a hand.

**Two-cylinder steam winding engine near adit (Film 3 neg 53)**

There is no maker's name anywhere on the engine. It is a small two-cylinder steam winding engine with a bore of about 6' and a stroke of about 10', mounted on its own wrought iron

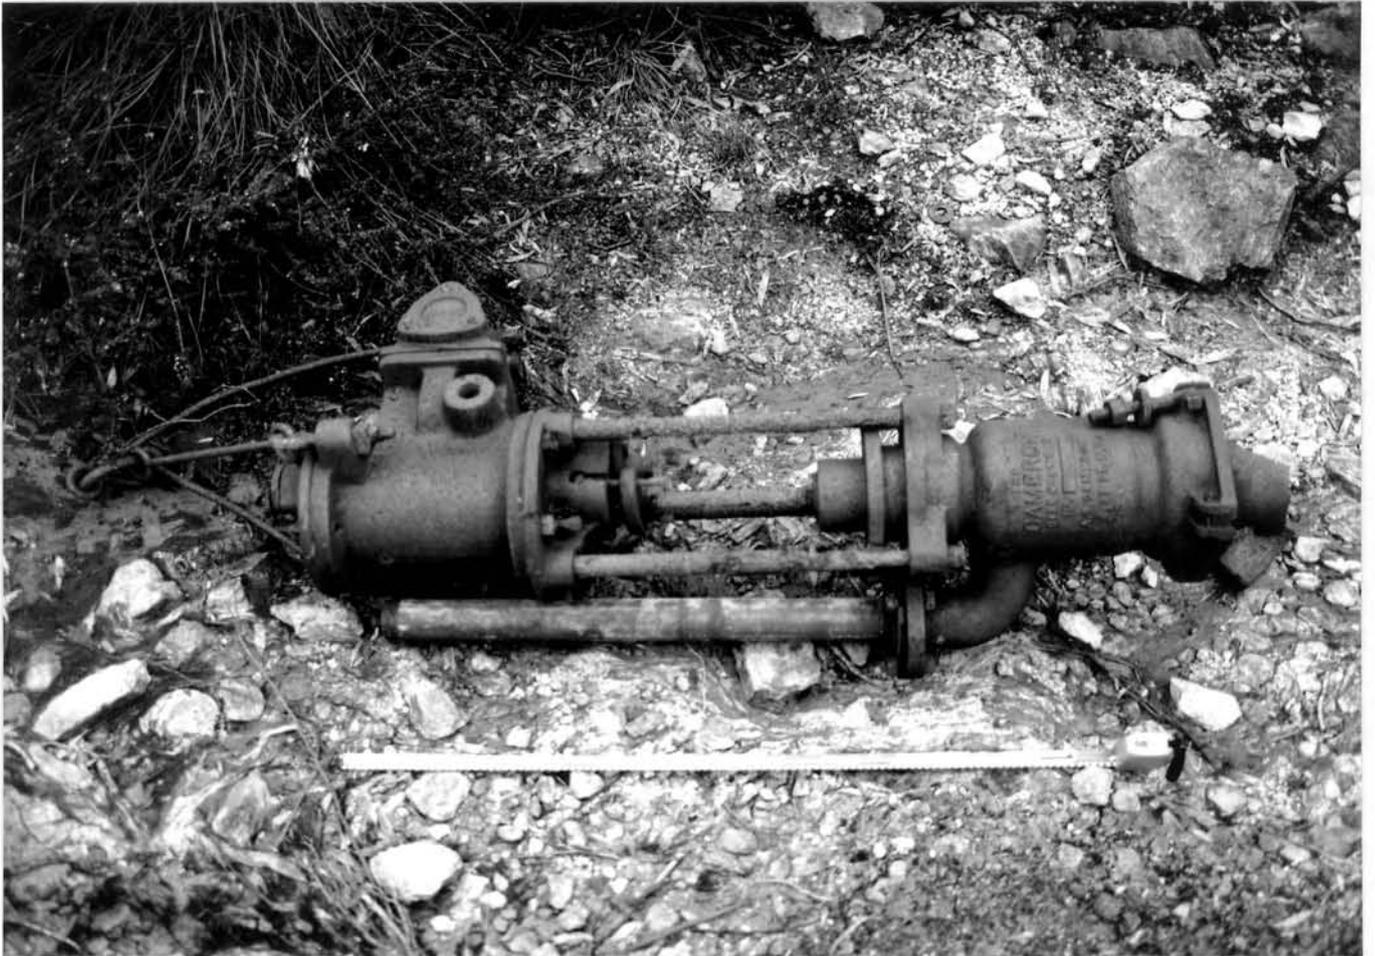
them, lying in the track itself is a small steam-operated pump, fitted with a hook and designed to hang vertically. It is a one-cylinder single-acting reciprocating pump, in other words one that operates in very much the same way as a bicycle pump. The pump is marked:

THE  
CAMERON  
SIZE Gx4 & 6x7  
No. [illegible]  
A.S. CAMERON  
E. 23 ST. N.Y.

**Cameron reciprocating steam pump (Film 2 neg 43)**

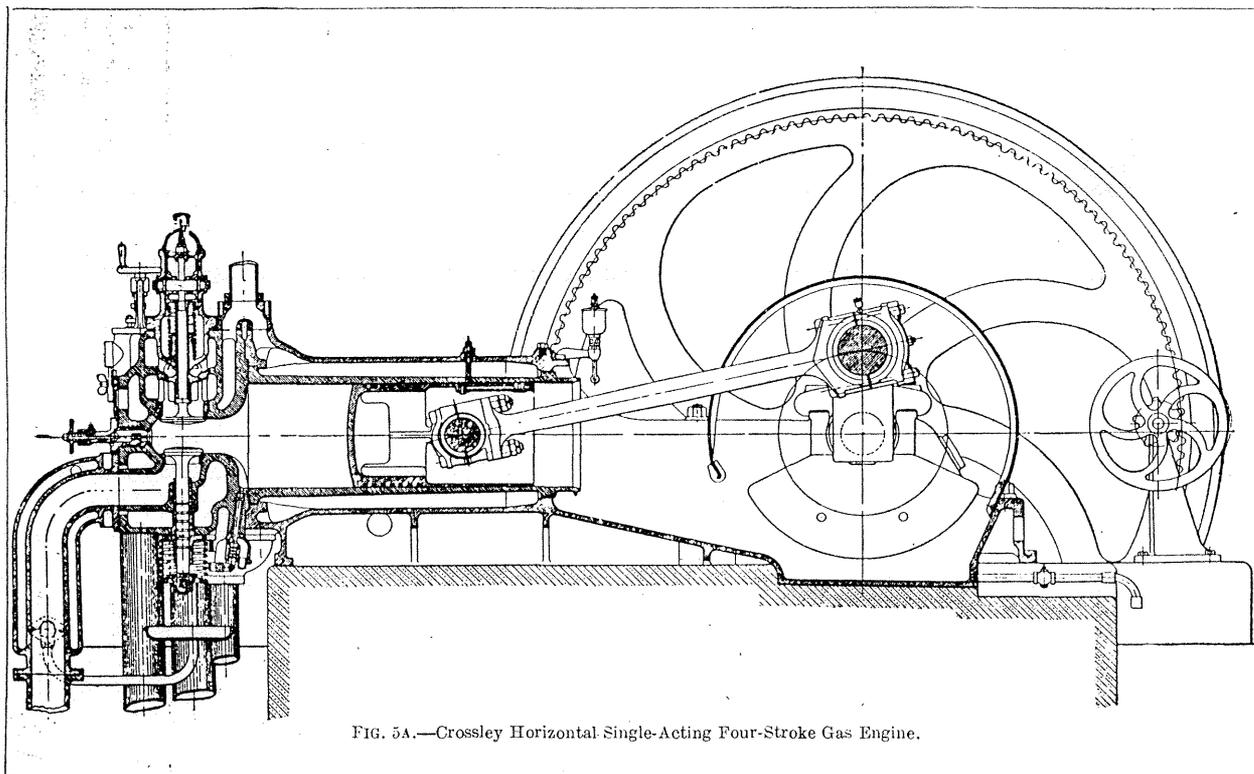
FIG. 5A.—Crossley Horizontal Single-Acting Four-Stroke Gas Engine.

Crossley gas engine of generally similar model (Kempe 1915 p. 1259)

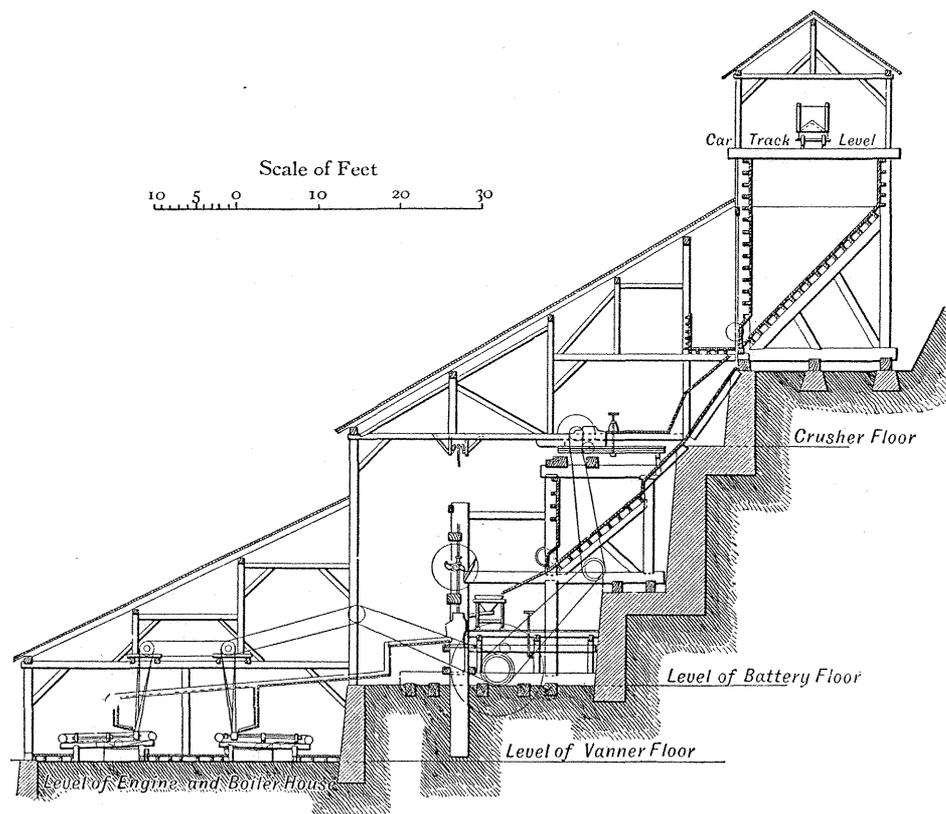
**Cross section of orthodox gold crushing mill (Louis 1902 p. 266)**

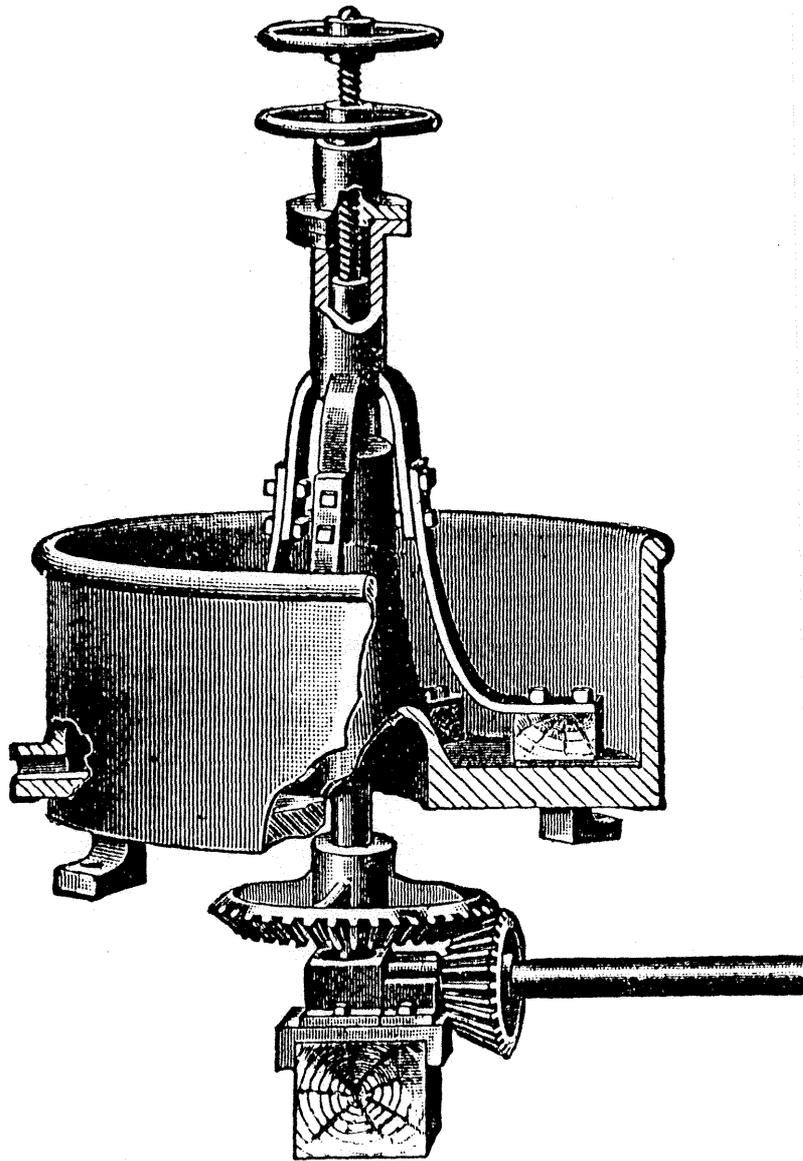
Grinding and amalgamating pans of this type were in common use in gold mills from the 1870s onward. The pans were used for fine grinding after another crushing machine had reduced the ore to a relatively small particle size. Even in the absence of other milling machinery, this logical relationship between the pan and other elements of a mill allows some assumptions to be made about where they would have been located. Flat-bottomed grinding pans are often known in Australia as Wheeler pans, which was a specific brand name; there were many other similar models. In America they were known as Californian pans. By the early twentieth century they had been replaced by ball mills for fine grinding, and most mining textbooks regarded them as inefficient and old-fashioned. However they remained in occasional use much later in Australia and were probably manufactured until the Second World War. Forwood Down patented an improved version of the Wheeler pan sometime before 1905, and Taggart describes this Forwood Down pan as still in current use in 1945. (Quartermaine 1981 plate 7.7.83, Taggart 1945 p. 5-133).

Cutaway view of a grinding and amalgamating pan (Richards & Locke 1940 p. 62)

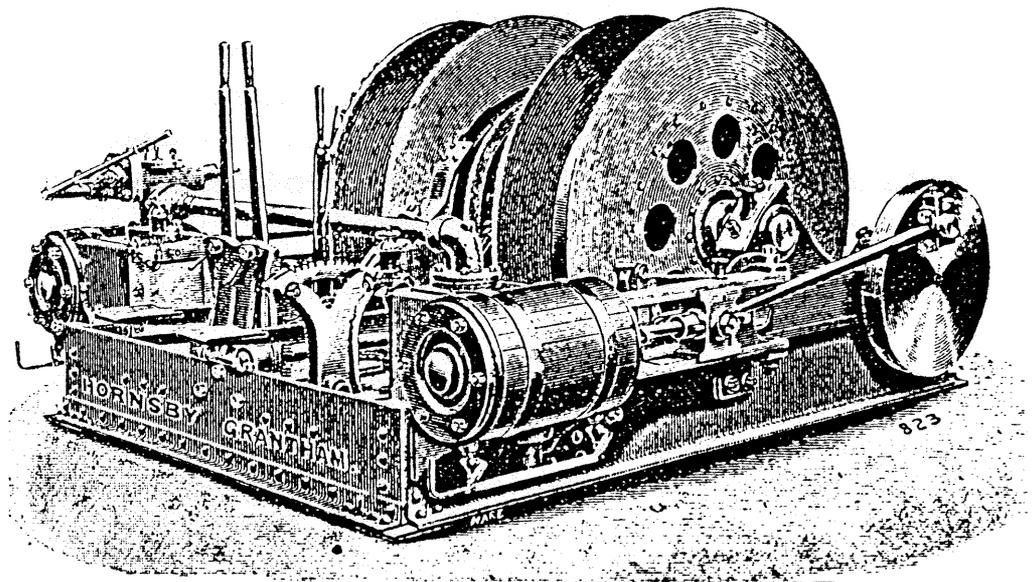
FIG. 45.—DOUBLE CYLINDER WINDING ENGINE ON IRON GIRDER FRAME.

Small two-cylinder steam winding engine (Davies 1894 p. 73)

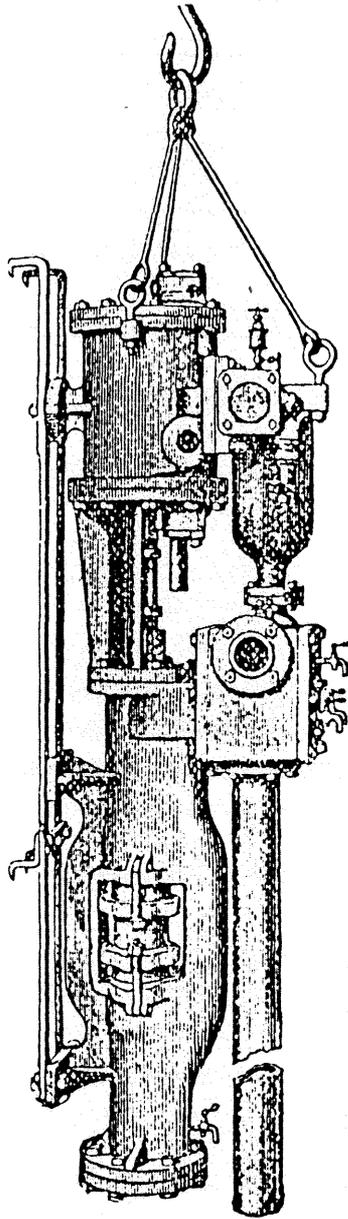
FIG. 92.—THE CAMERON PATENT SINKING PUMP.

Small Cameron reciprocating pump for shaft-sinking (Davies 1894 p. 130)
