**ARCHAEOLOGICAL SURVEY REPORT 2000/02**

# An archaeological survey of the Fenhope coal bins

*by Parry Kostoglou*

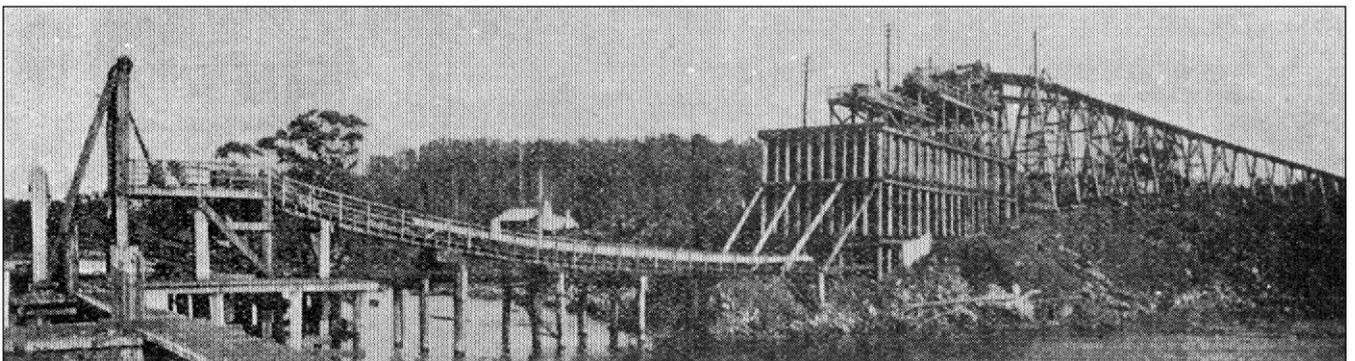
**Plate I**

However, even to the initiated, the Fenhope coal bins complex is an imposing edifice on the landscape which is a compelling signpost for the extractive activities undertaken here. The bins are furthermore a remarkable example of bush engineering using traditional materials and construction techniques which would have made the structure seem contemporary a hundred years ago. These coal bins have also been constructed in a manner and configuration identical to those built at historic collieries throughout the State (see Plate 1). These bins are in effect, if not in age, an artefact from the past which is now unique because:

*Historic view (c.1928) of similar coal bins and wharfage at the Catamaran colliery, southeast Tasmania.*

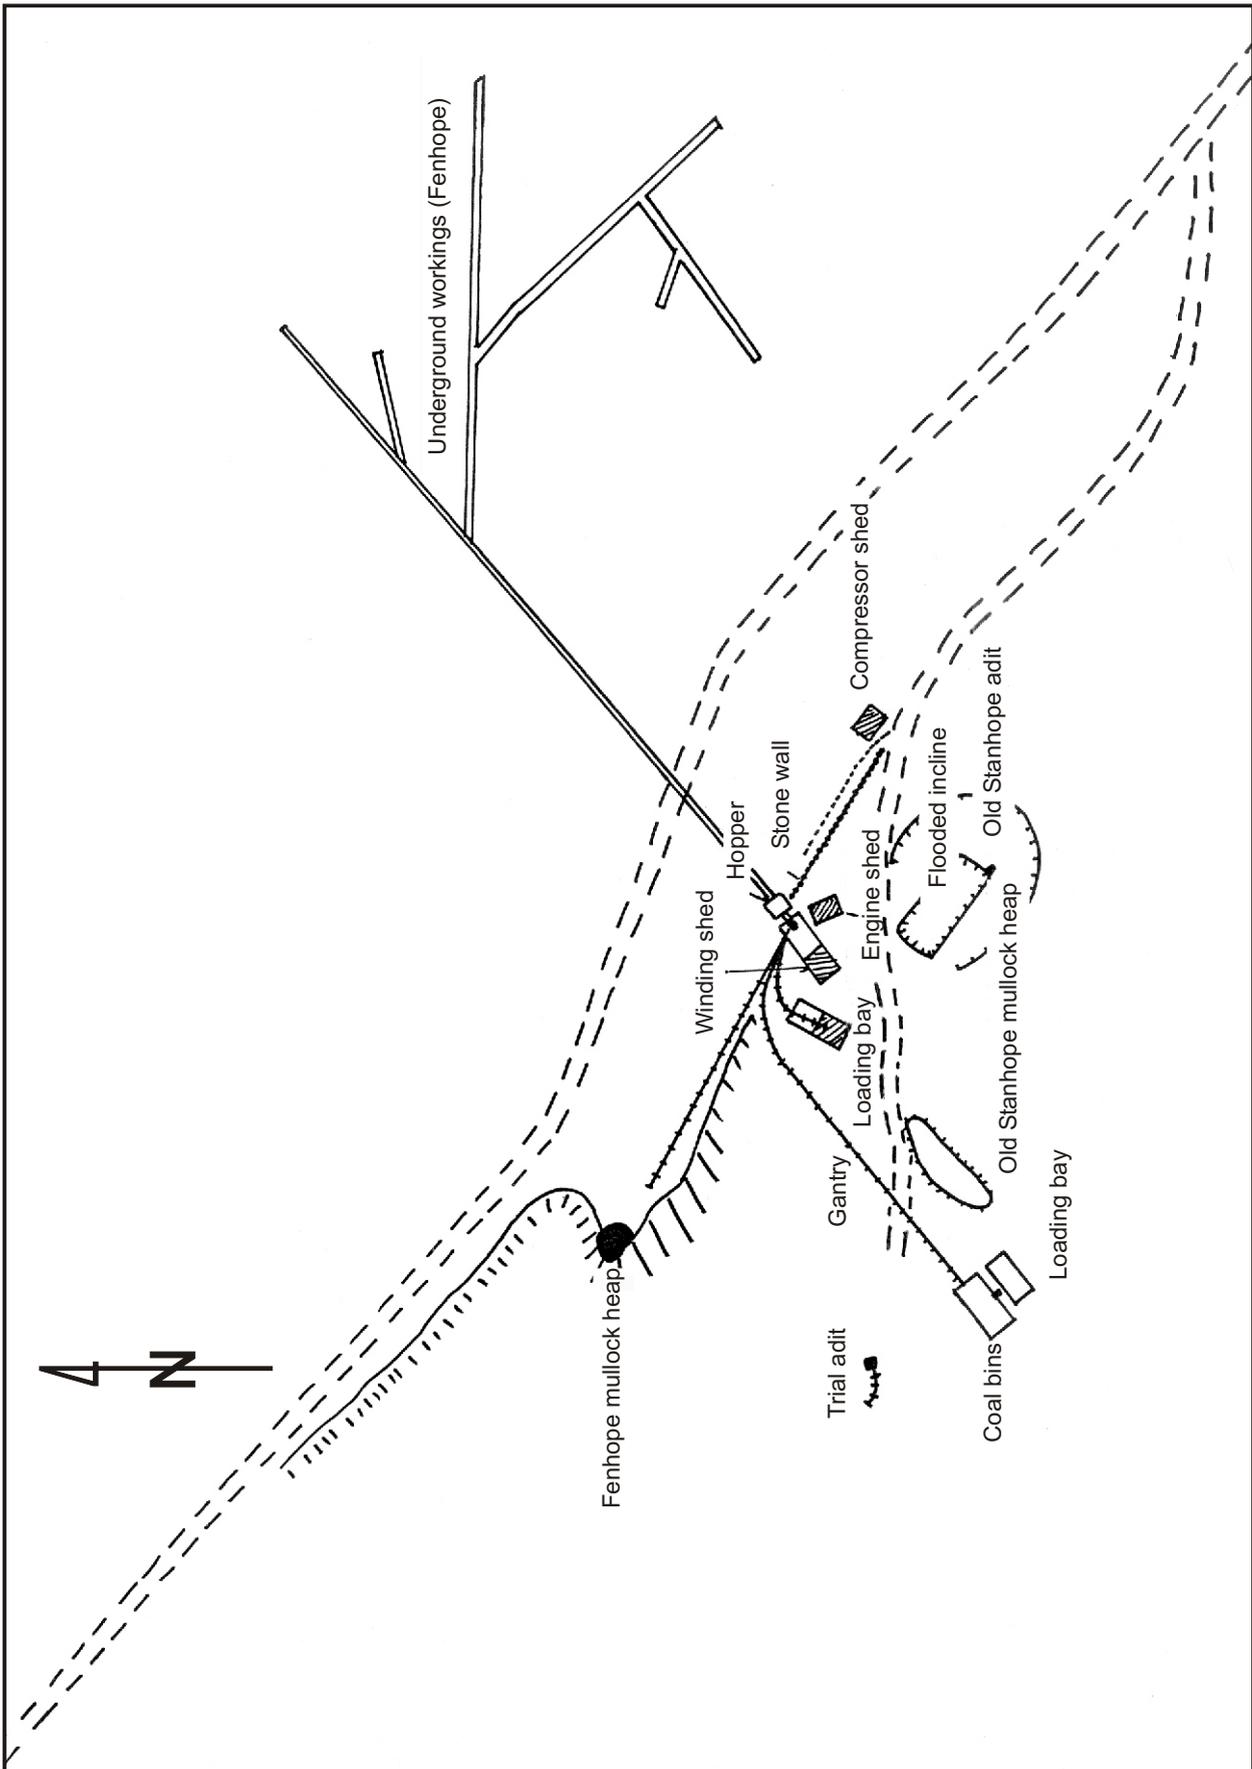
Figure 4. Current scaled plan of Fenhope colliery site and resident features.

The various features comprising the Fenhope colliery are situated in the southwest corner of a 25 hectare mineral lease (1008 P/M) held by Mr D. Fenton (see Figure 2). More specifically these occur on the south side of Stanhope Road some 300 m southeast of its passage over Hercules Creek. This colliery is marked as a set of three structures and a mine on the current 1:25 000 scale map sheet for the area (Stanhope), which is shown as Figure 3. A scaled plan of the Fenhope colliery (Figure 4) shows the disposition and relationships of the various features and structures described in this section of the report.

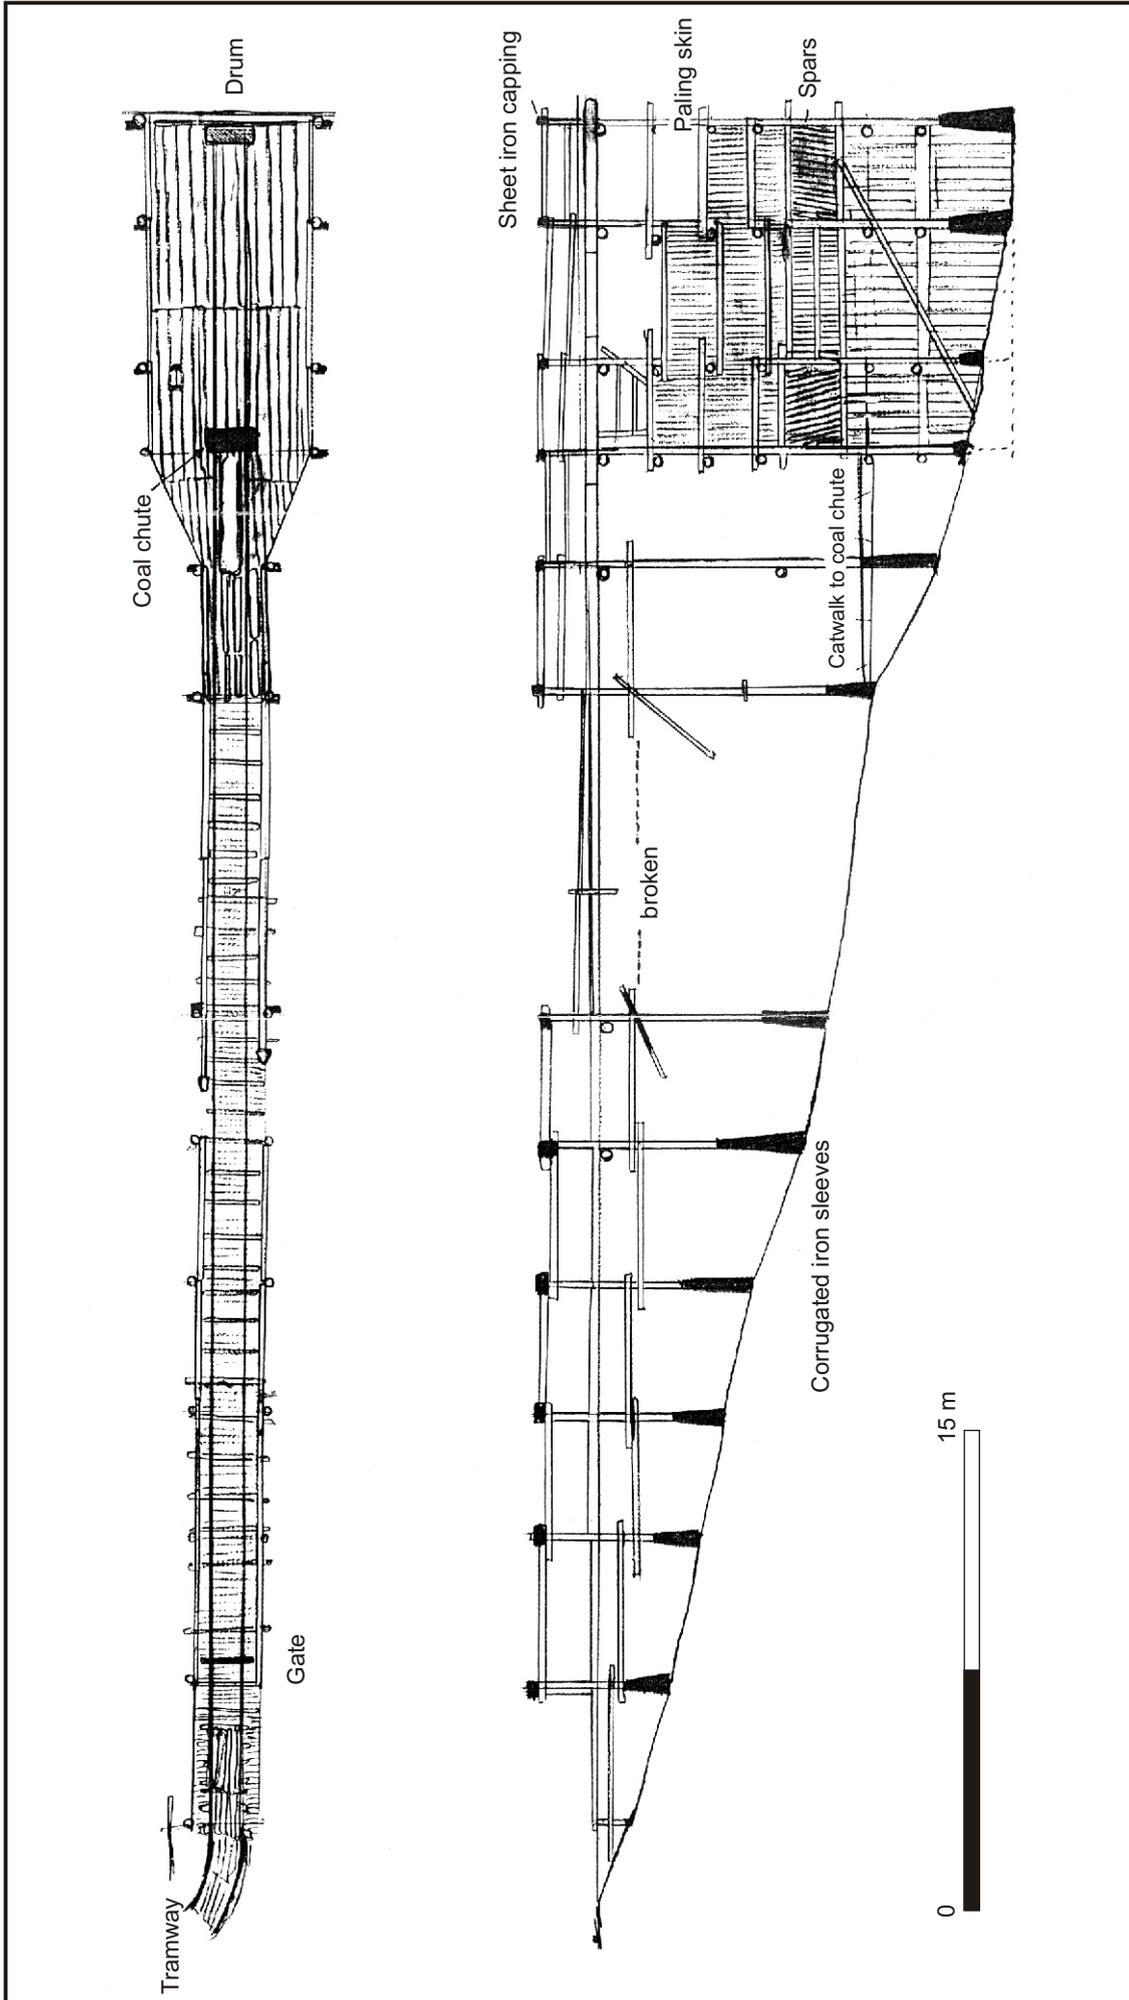
Measuring 43 m in length, 2.1 m in width and up to 13 m in height, a substantial timber gantry carried a tramway spur at an even grade from the adit precinct to the top of the coal bins. Support for the gantry is provided by a dozen trestles of increasing height to compensate for the fall in the ground below. These trestles have been made from hardwood spar logs averaging half a metre in thickness. Each trestle spar has a protective cone-shaped corrugated iron sleeve wrapped around its base to protect it from water penetration. The gantry itself consists of a continuous deck of sleeper-type timbers fastened to larger cross beams anchored to the trestle superstructure. A succession of railway sleepers then supports the narrow gauge steel tram rails above this decking. A balustrade of sorts, made of small diameter spars and measuring 1.5 metres in height, runs the length of the gantry and provides some element of safety from overbalance to the operator pushing the coal cart out to the bins. Figure 5 shows an overhead scaled plan view of the gantry. Several photographs of the gantry appear as Plates 12 to 15.

Located directly beneath the final section of the gantry stand the coal bins into which coal brought by tramcar from the mine was dumped and sorted by gravity for loading into trucks waiting at its base. The bins are made of timber palings fastened to an internal framework, but further held in place by a series of external unsquared spars bolted onto the log uprights which support the structure. The bins are further supported at their base by a foundation sequence of stout sawn logs set in two parallel rows. A timber catwalk on the southern side of the bins allows the operator to reach a control lever which opens the internal coal chute and discharges sorted coal into waiting trucks parked in a loading bay. Due to their height, the bins interior could not be viewed and their internal workings remain undocumented. Figure 5 shows a lateral plan view of the coal bins. Plates 16 to 19 show several photographic views of the bins.

Current scaled plan of gantry and coal bins.

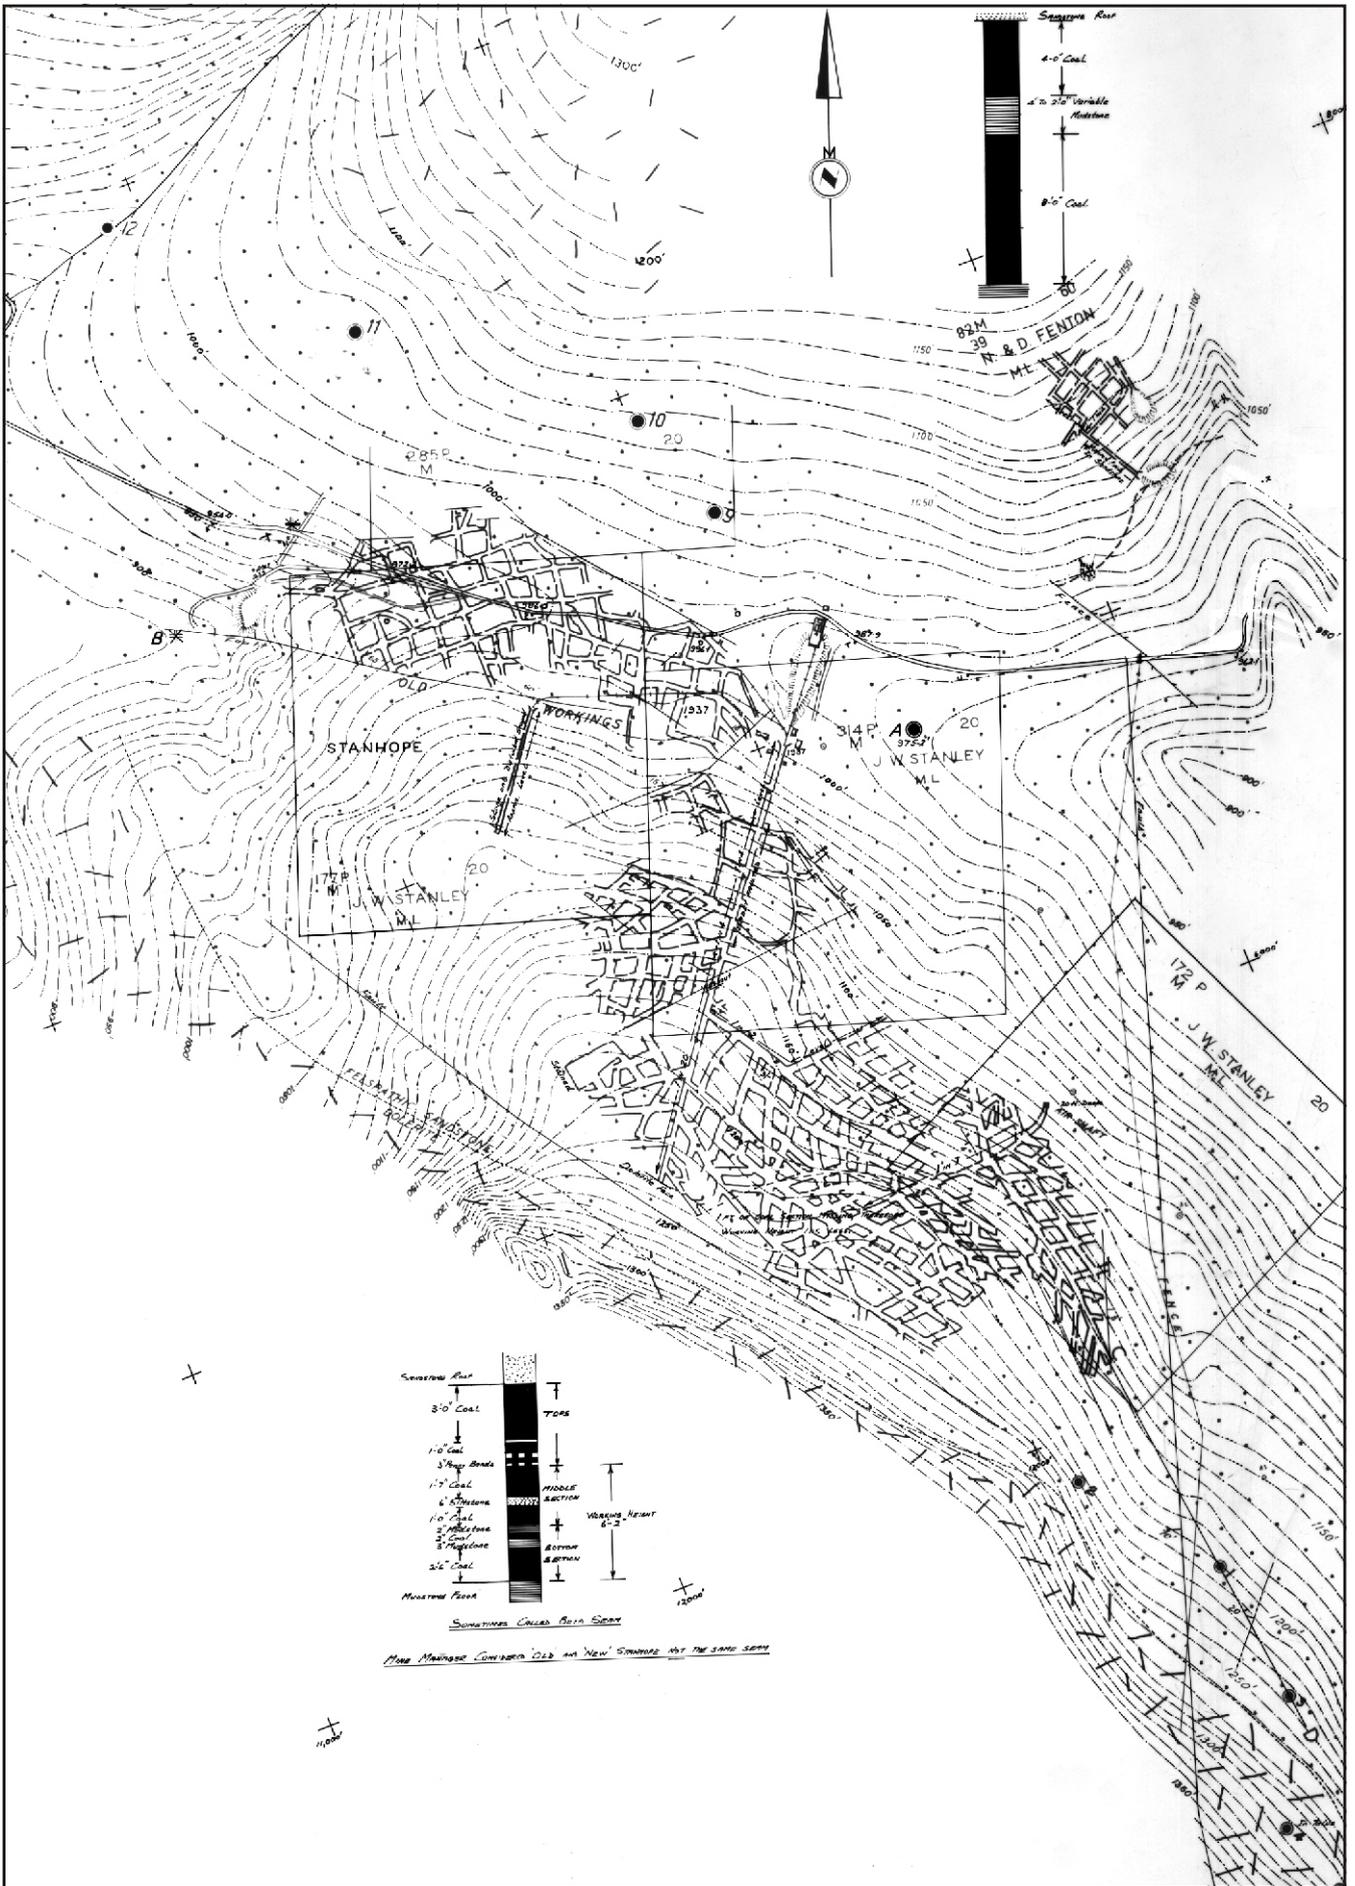
Figure 6

Part of 1971 plan of the Stanhope colliery [MRT Geological Plan 3546-48]

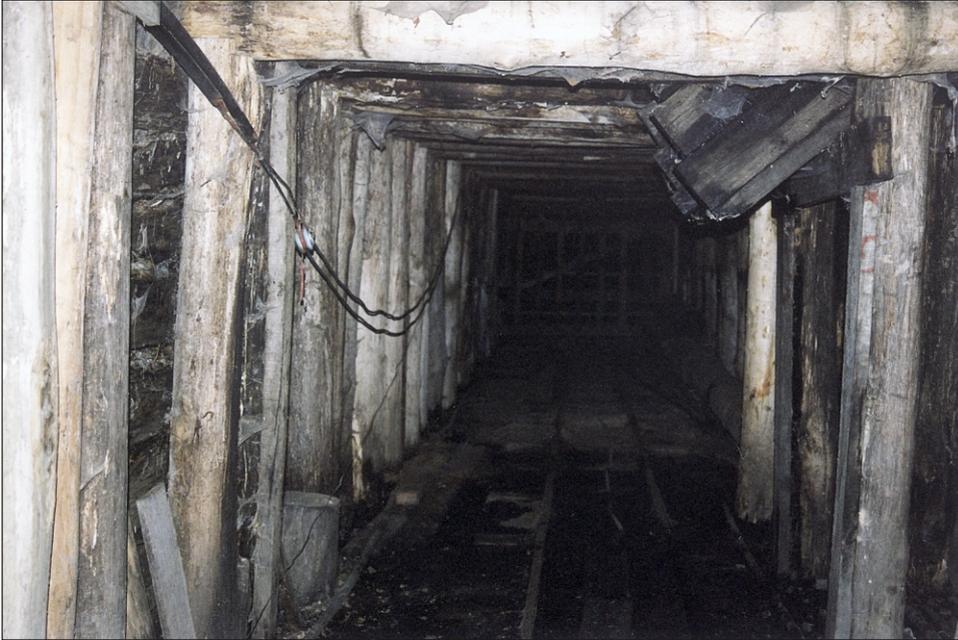
**Plate 2**

The central feature at the Fenhope colliery is the covered adit which leads to the various underground galleries comprising Mr Fenton's workings. The adit itself is shored with split timber slabs and the roof supported by unsquared spar timbers. A tramline linking the underground workings passes out through the adit entrance to the winding shed and bins beyond. The adit is protected from the elements by a two-sided roofed corrugated sheet iron structure. There is no wall on the northwestern side of the structure in order to allow the tram cars free passage out of the mine and down to the bins/mullock heaps beyond. The eastern side of the shelter is built directly onto the side of the winding shed. This structure contains the engine which retrieves the coal-laden bogies from underground by means of a continuous steel cable. The 5 x 5 metre shed was locked and its interior could not be inspected, although a diesel engine of some form could be spied through a ventilation panel. Plates 2 and 3 show views of these features.

*Interior view of Fenhope adit.*

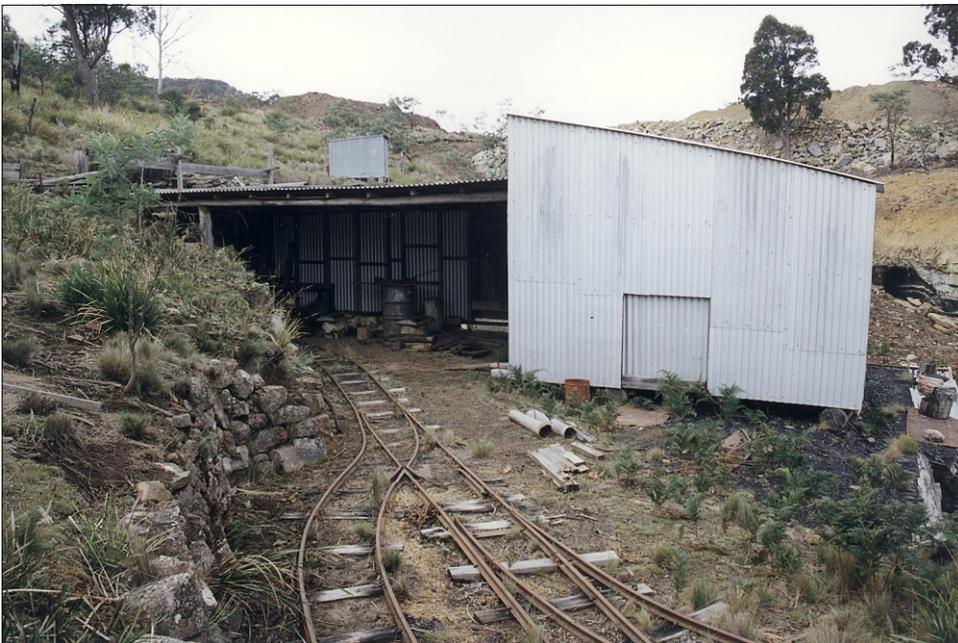
**Plate 3**

*Southerly view of winding shed and adjacent covered adit entrance.*

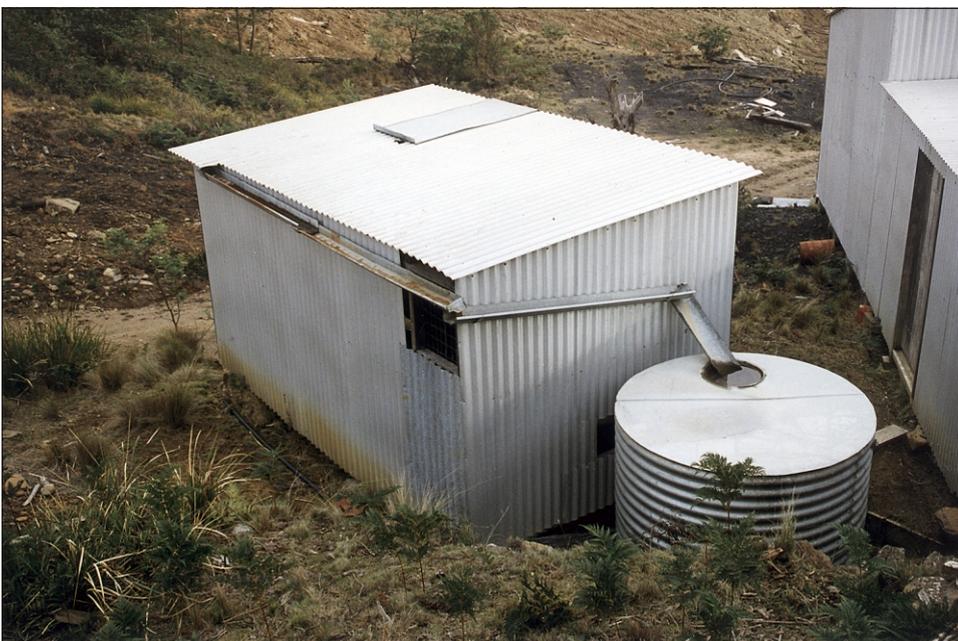
**Plate 4**

A 4 x 3 metre corrugated iron shed stands immediately southeast of the covered adit entrance and winding shed. Water from the roof is collected by a small circular water tank adjacent. This shed was also locked, although a small item of machinery (mill?) could be viewed through a loose board. Plate 4 shows a view of this structure.

*Overhead view of unknown machinery shed adjacent to winding shed.*

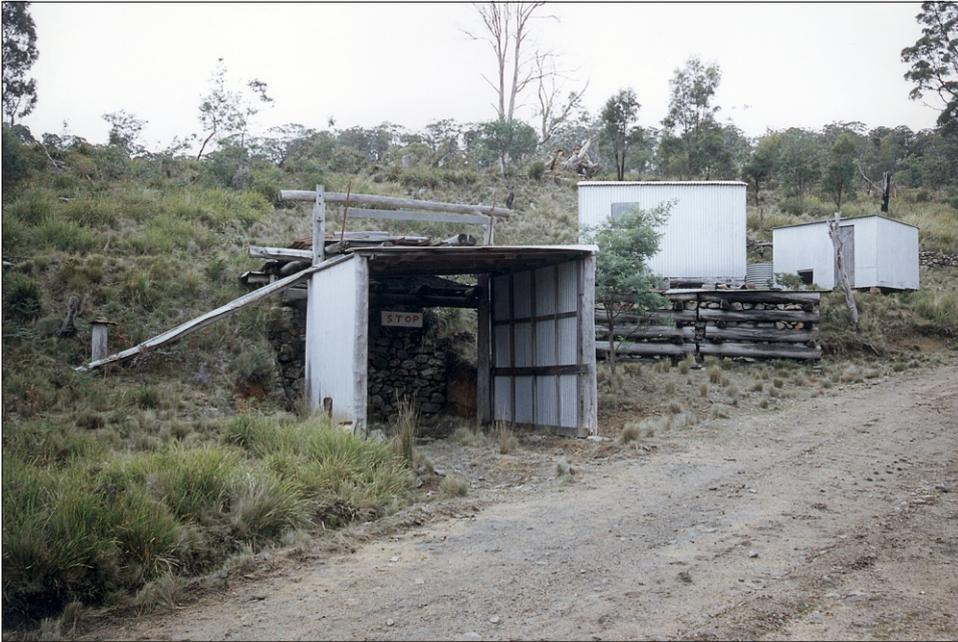
**Plate 5**

A two-sided corrugated iron roofed structure standing five metres northwest of the covered adit appears to have accommodated a vehicle within for loading/unloading purposes. Plate 5 shows a view of this structure.

*View of roadside loading bay.*

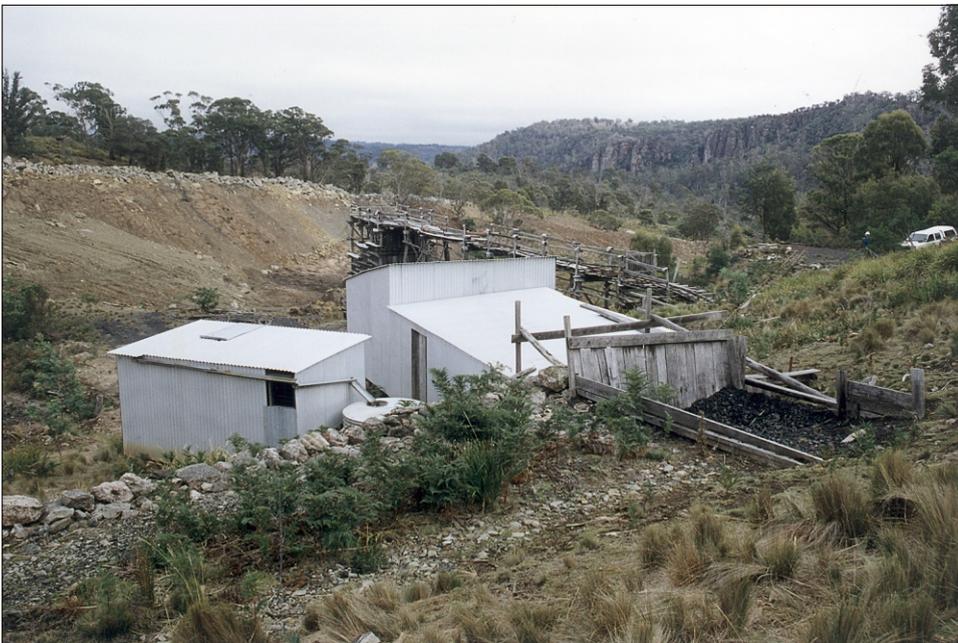
**Plate 6**

A timber hopper has been excavated/recessed into the ground directly over the covered adit entrance. This three-sided structure is made of timber boards and is full of partially crushed coal. A metal chute leads from the base of this hopper down into the side of the adit. The purpose in delivering coal back into the mine is uncertain. A short vehicle track leads from the southeastern side of the hopper to the generator shed described below. This feature appears in Plate 6.

*Northerly view of timber hopper above adit entrance.*

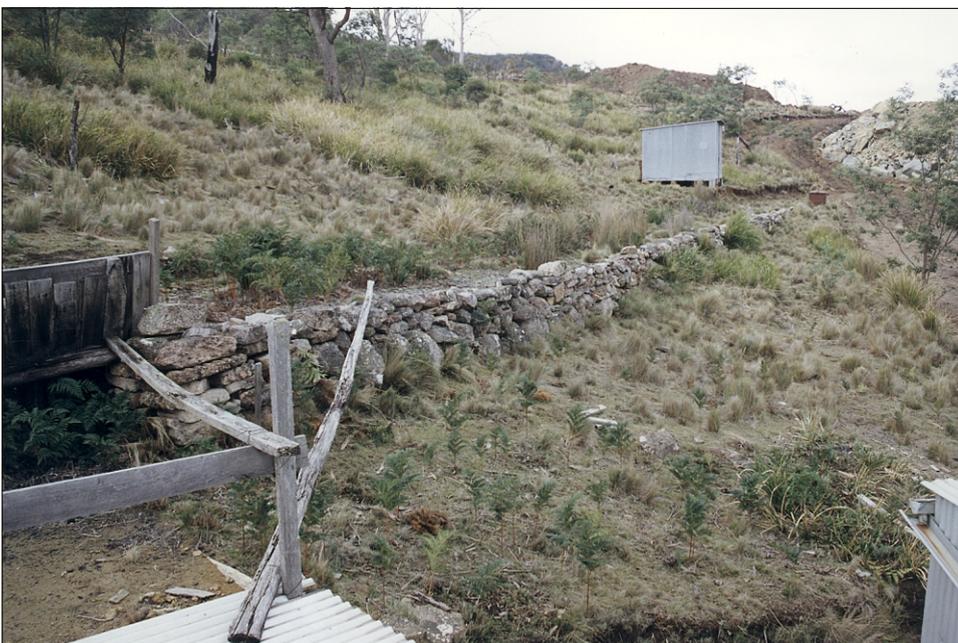
**Plate 7**

The track leading from the timber hopper to the generator shed has been consolidated on its southern downslope side by a one metre high drystone wall measuring 30 m in length. A view of this wall appears in Plate 7.

*View of drystone wall running between hopper and compressor shed.*

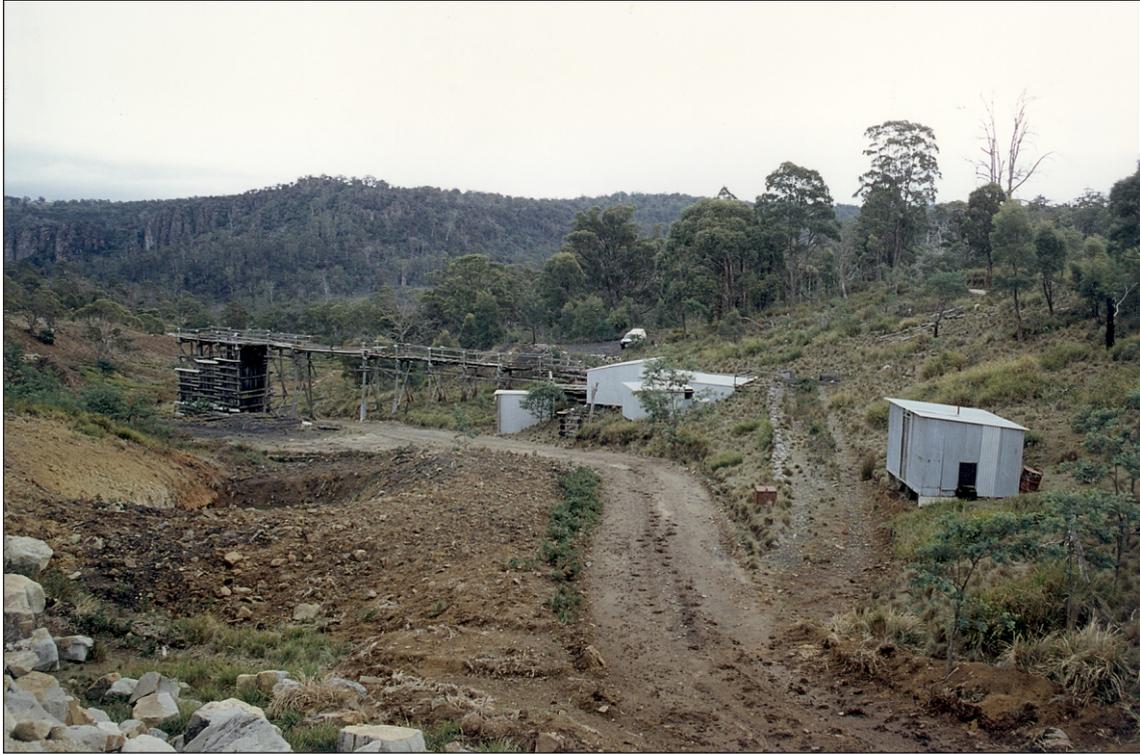
**Plate 8**

A final corrugated iron shed stands immediately east of the southeastern end of the stone wall described above. This 5 x 4 metre structure was also locked, although a large air compressor could be seen through a ventilator panel. It is assumed that this plant provides air throughout the underground workings. Plate 8 shows a view of this structure.

*General view of Fenhope colliery. Note compressor shed at mid right.*

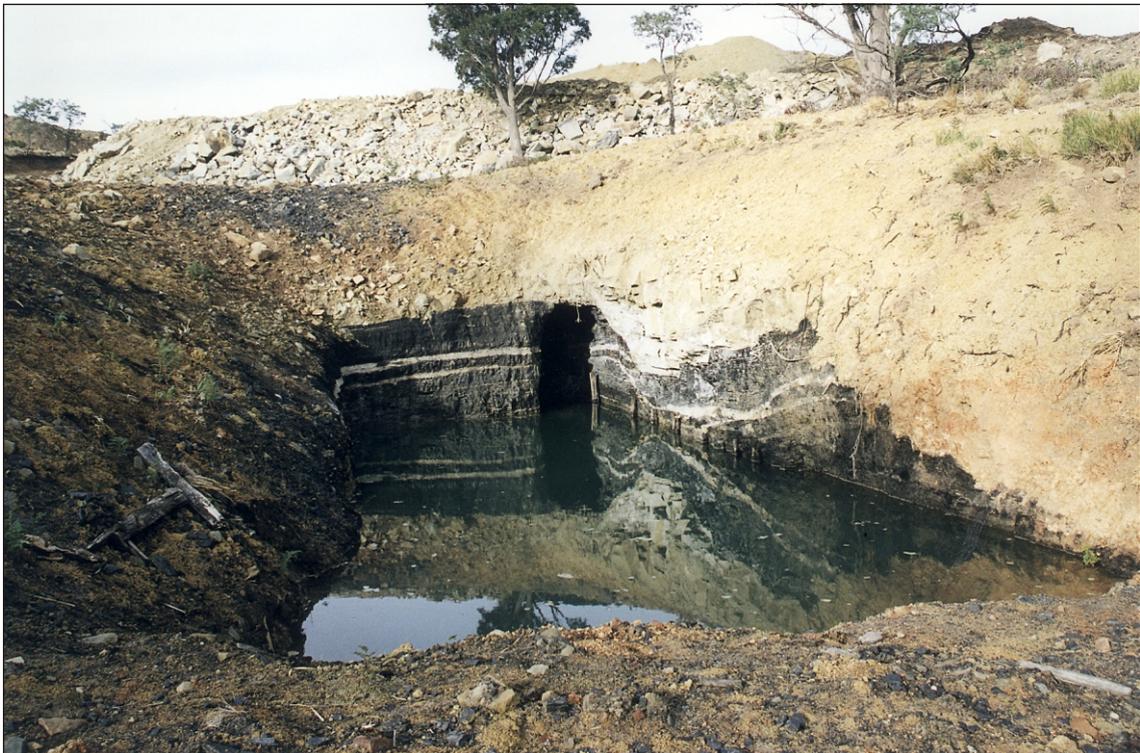
**Plate 9**

An old mine adit, which appears to relate to the 'Old Stanhope' workings (1923–1957), lies 30 m southeast of the Fenhope adit and shed precinct. The adit entrance occurs at the very southeastern corner of a 17 x 6 metre trench or incline which is now filled with water. A coal seam up to four metres in height is evident in the profile of the eastern wall of the adit incline. A photo of this feature appears as Plate 9.

*Old Stanhope incline and adit. Note banded coal seam in profile.*

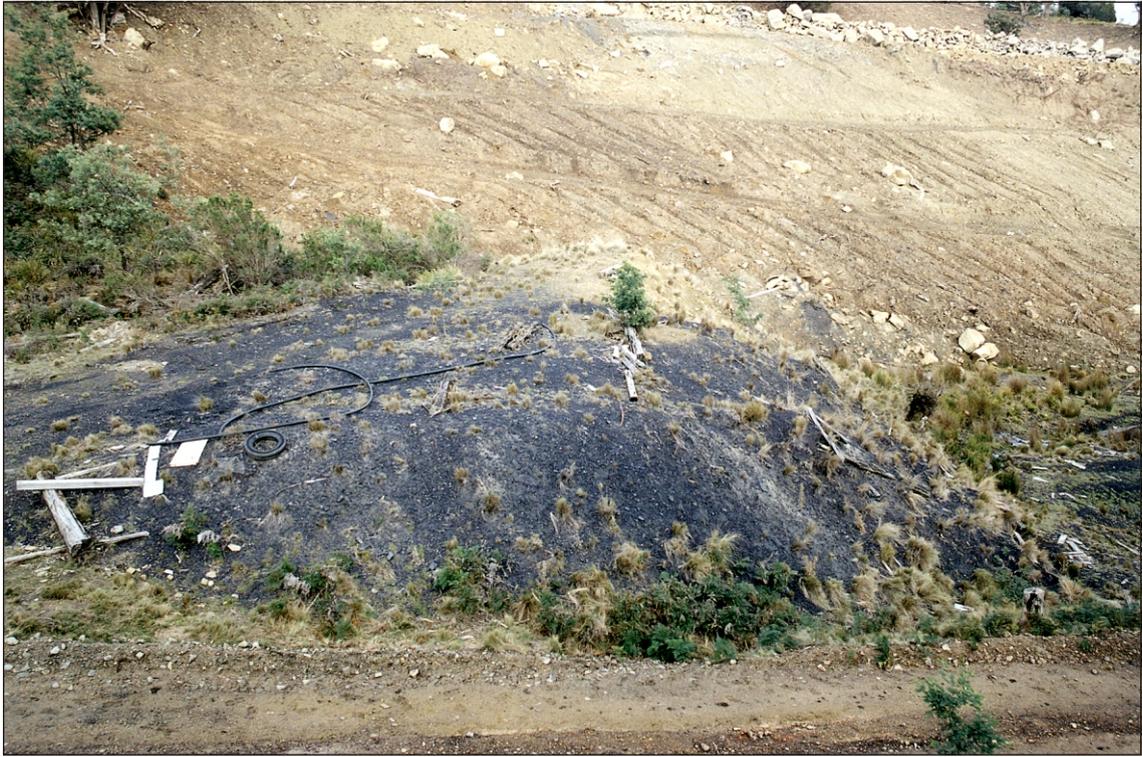
**Plate 10**

The mullock heap to which waste rock was removed from the old adit described above lies 25 m west of the adit/incline. Measuring 25 x 15 metres in extent, this mullock heap was probably connected to the adit by a short tramline or track. Plate 10 shows a view of this feature.

*Old Stanhope mullock heap.*

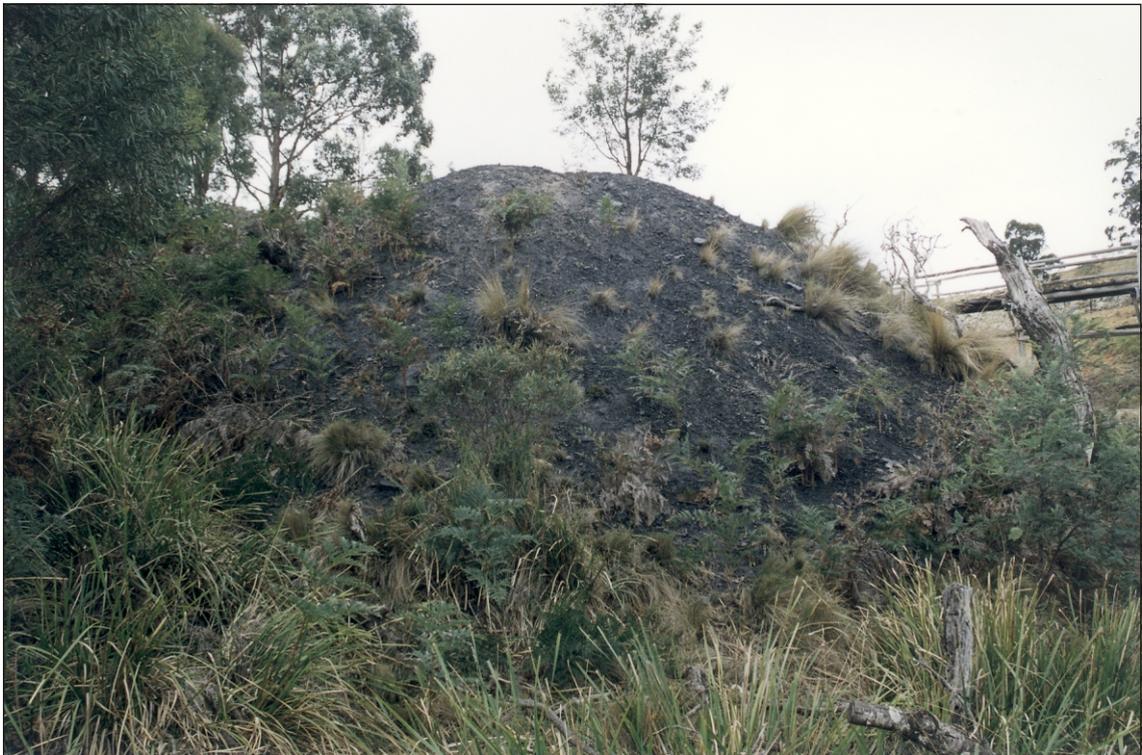
**Plate 11**

The most recent mullock generated by the Fenhope operation has been dumped 50 m northwest of the covered adit at the end of a narrow gauge tramway section which links the two features. Mullock dumped at this site has been tossed over the side of the resident slope and forms a low mound. Plate 11 shows a view of this feature.

*Fenhope mullock heap at end of tram spur from adit.*

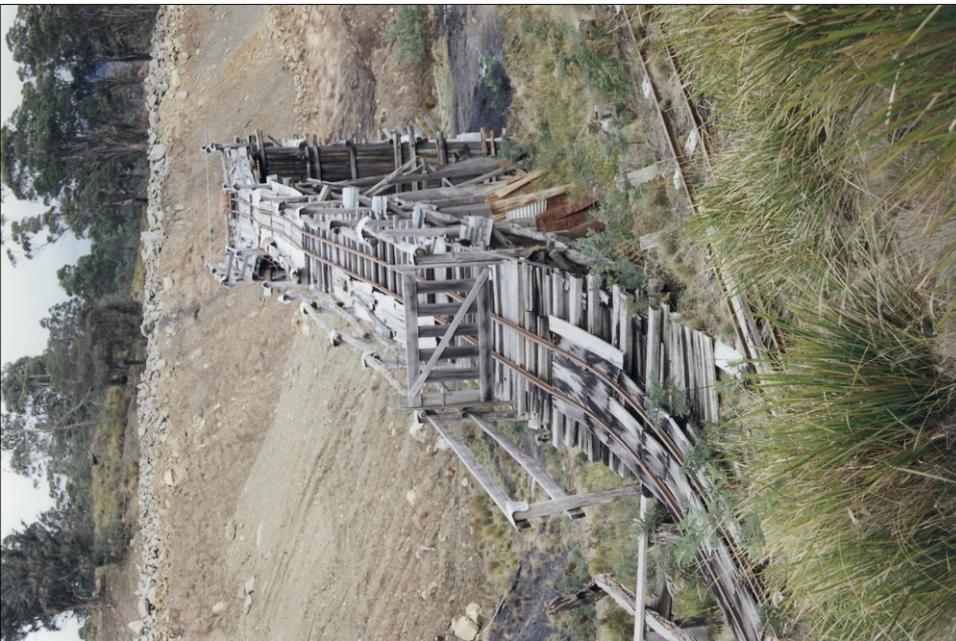
**Plate 12**

*View of gantry and coal bins beyond.*

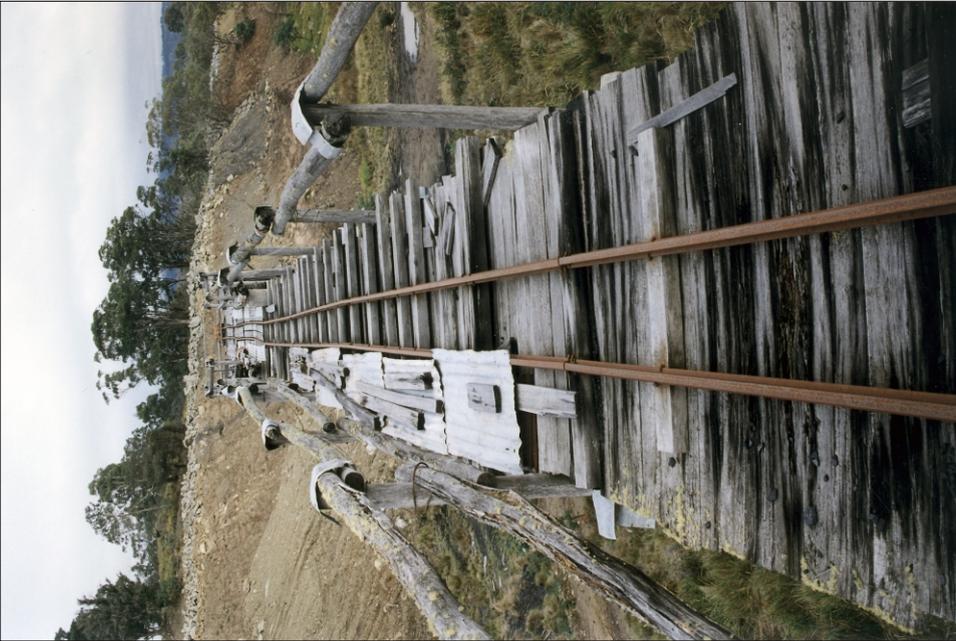
**Plate 13**

*View along gantry showing tramline, decking and balustrade.*

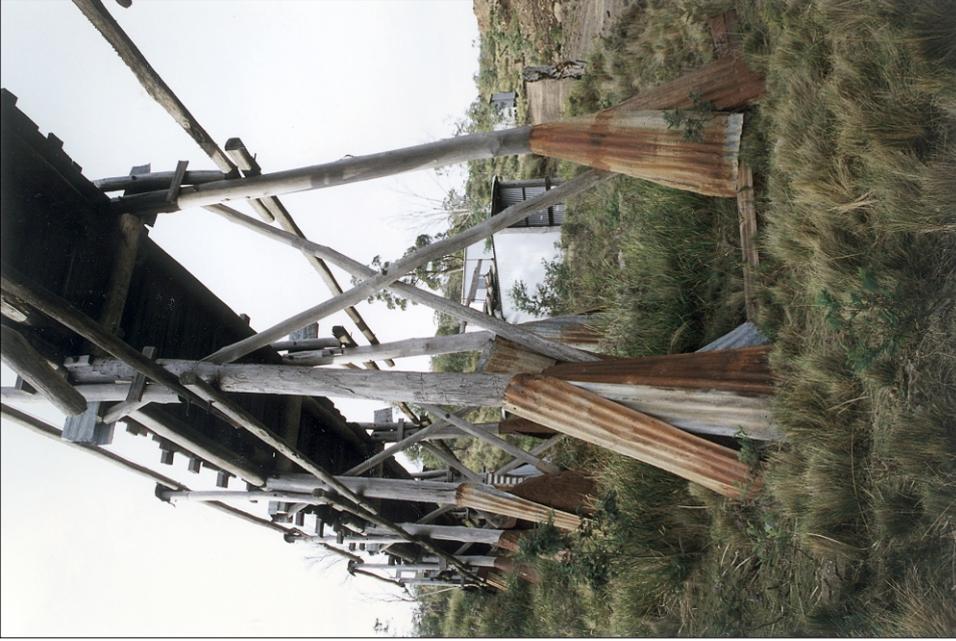
**Plate 14**

*View of supporting trestles.*

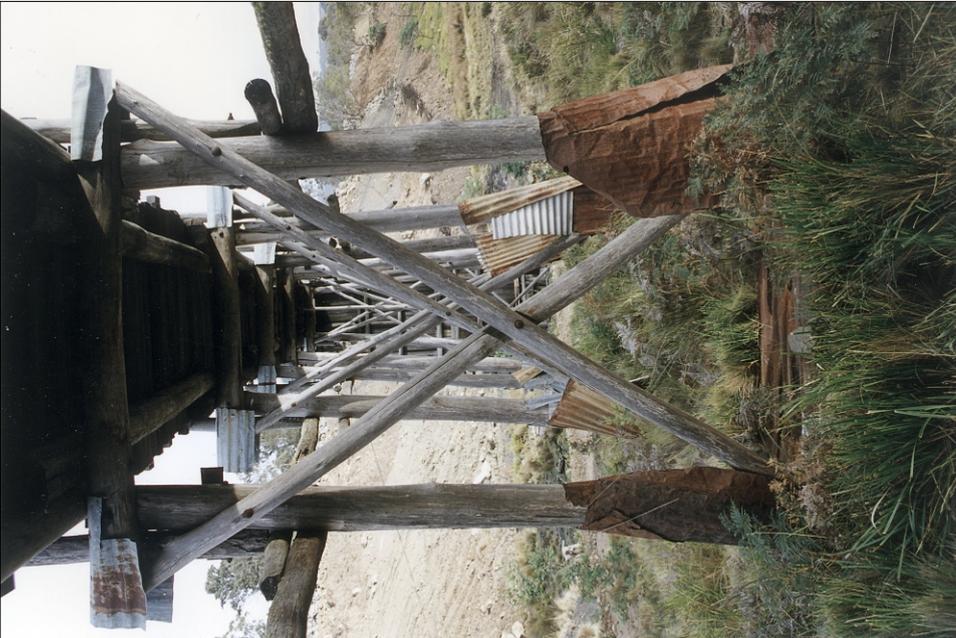
**Plate 15**

*Another view of supporting trestles.  
Note cone-shaped sleeves for weatherproofing.*

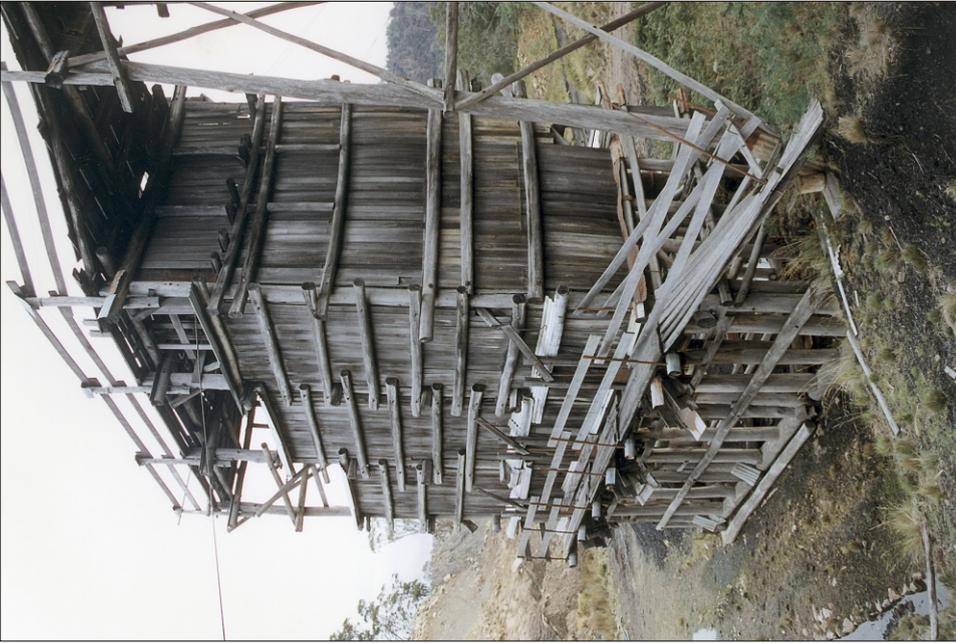
**Plate 16**

*View of southern aspect of coal bins. Note the  
catwalk to access coal chute control lever.*

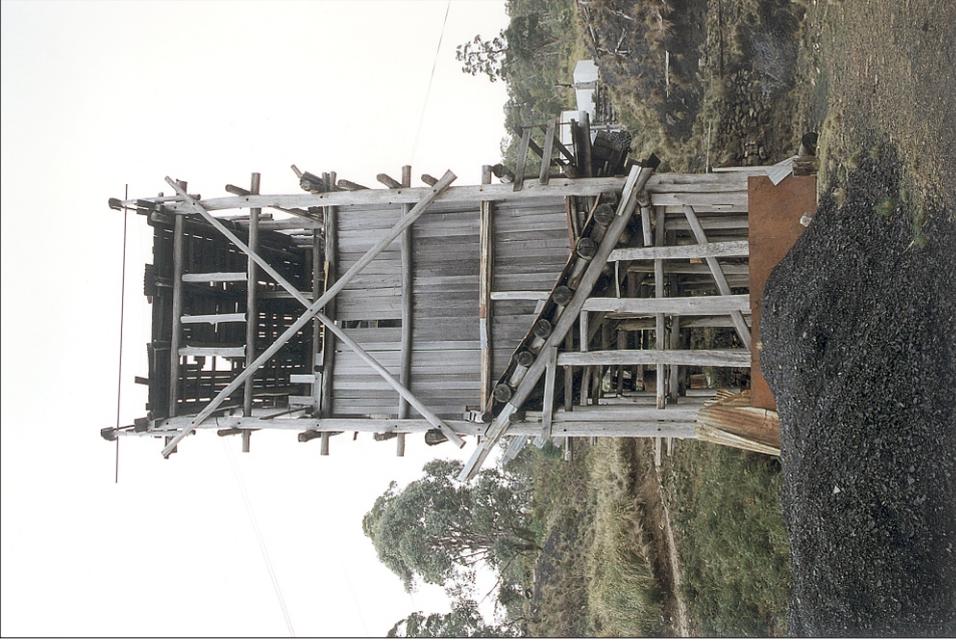
**Plate 17**

This is merely a 20 x 10 metre patch of open ground immediately south of the coal bins where trucks were directed to park below the coal chute. The bay is demarcated by a single line of stones around its perimeter. This feature can be seen in the right hand side of Plate 17.

*Western aspect of bins and loading bay to right.*

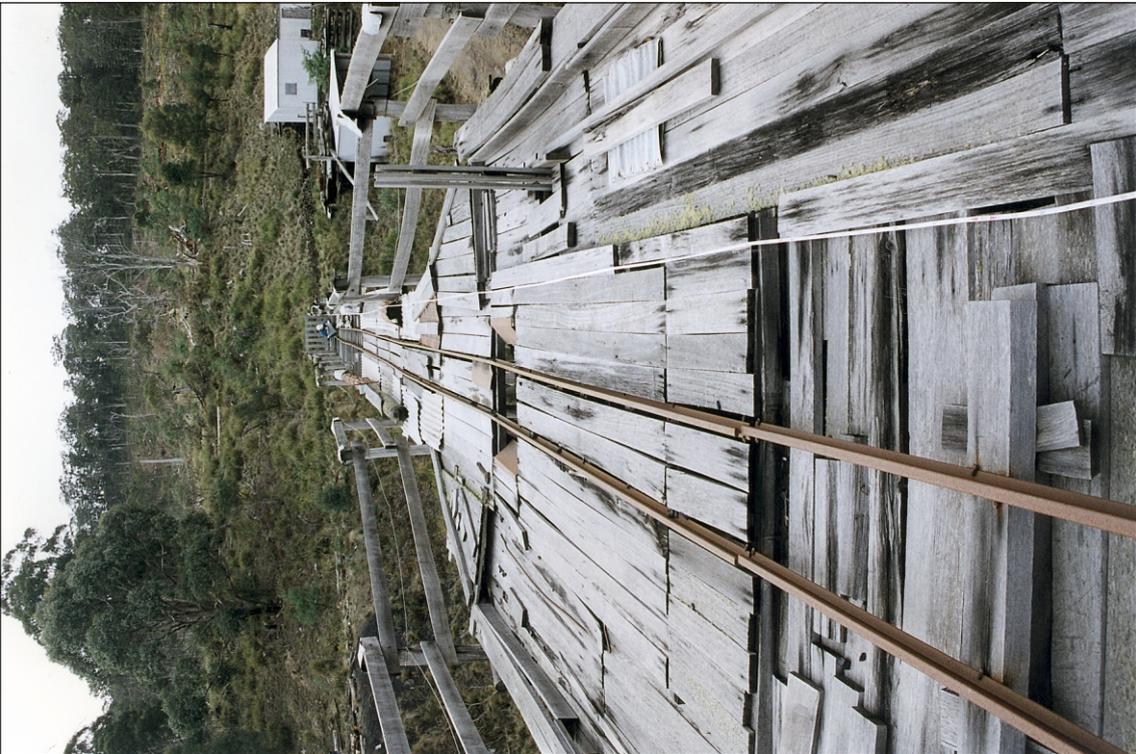
**Plate 18**

*View of decking on coal bins and coal chute.*

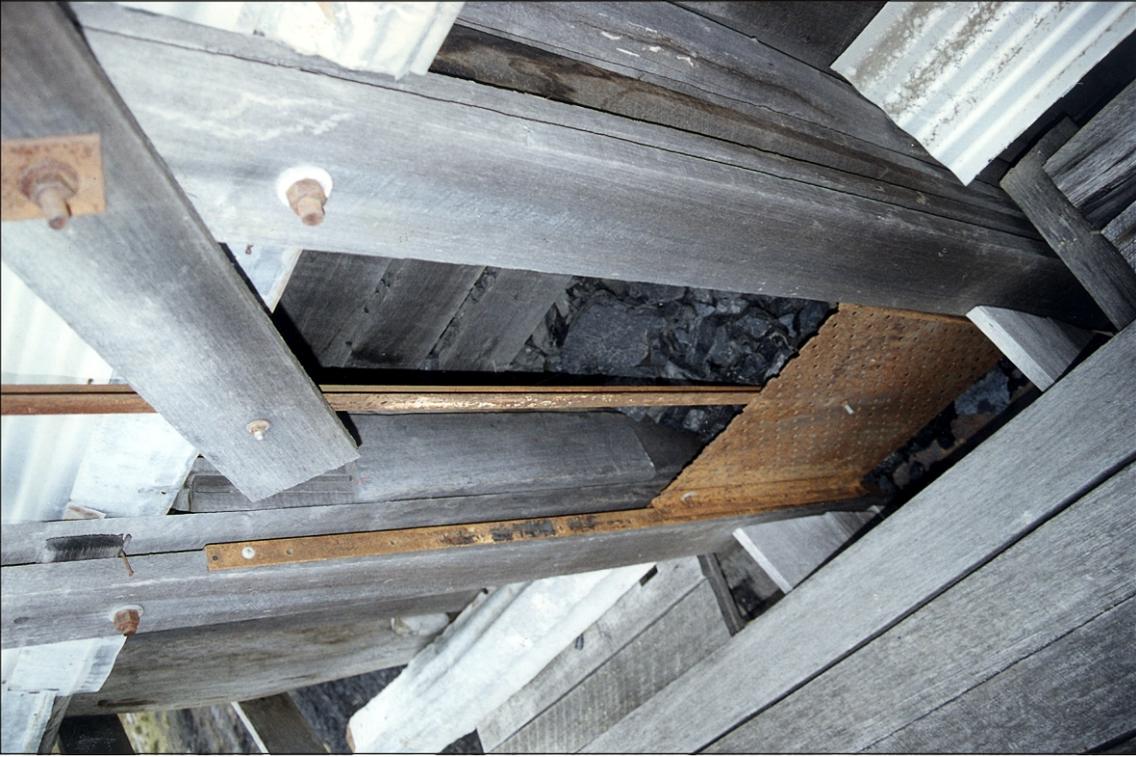
**Plate 19**

*Coal chute at end of the catwalk.*
