**ARCHAEOLOGICAL SURVEY REPORT 2000/02**

# An archaeological survey of the Fenhope coal bins

*by Parry Kostoglou*

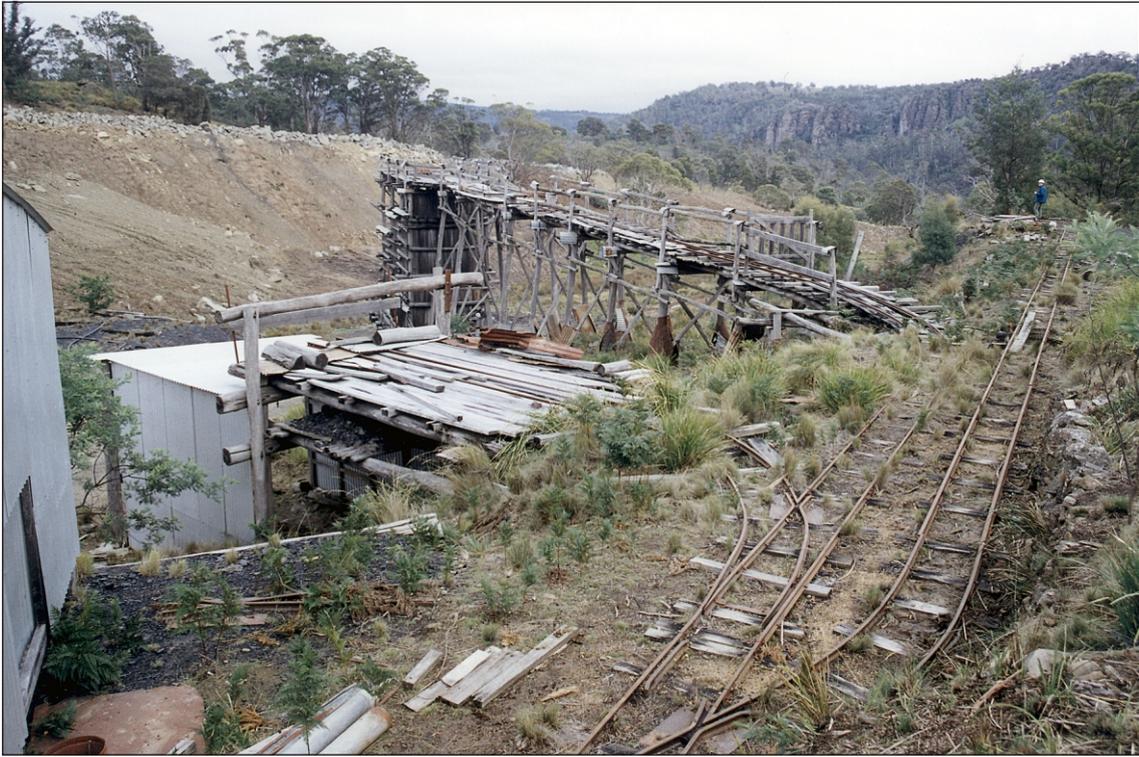
**Plate 20**

The tramway at the Fenhope mine is a narrow gauge steel rail affair. The bulk of the tramway is presumably underground, joining the various mine galleries to the surface adit. From the adit entrance the line branches into three spurs. The shortest runs 30 m to the vehicular loading bay next to the winding shed. The medial spur runs from the adit entrance some 75 m over the gantry to the coal bins. The northernmost spur runs in a straight line some 40 m linking the adit entrance to Fenton's mullock heap. Miscellaneous portable sections of track and a turntable of sorts lie disused around the adit precinct. There is also a short abandoned section of track north of the coal bins which appears to have once sought access to a test adit, which was never dug. A general view of the tramway appears as Plate 20.

*General view showing triple tram spurs to loading bay, gantry and mullock heap respectively.*

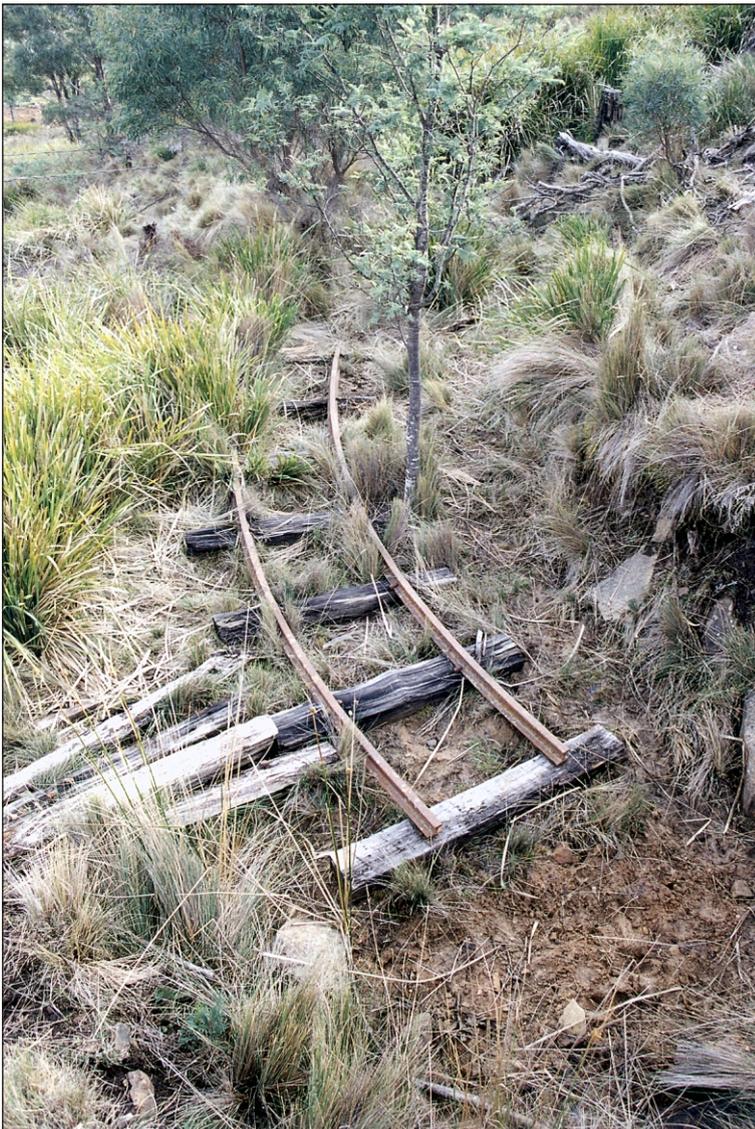
**Plate 21**

Located on the slope some 40 m northeast of the coal bins is a short section of tram track described above and a cleared 1 x 2 metre profile of the hillside, which might have been intended for development of an adit. It was never excavated and the tram spur has been disconnected. Plate 21 shows the abortive tram spur at this adit.

*Abandoned trial adit tram section.*
