**Archaeological Survey Report
1999/02**

**An archaeological inspection
of historic standing structures
at the Mount Bischoff mine**

By Parry Kostoglou

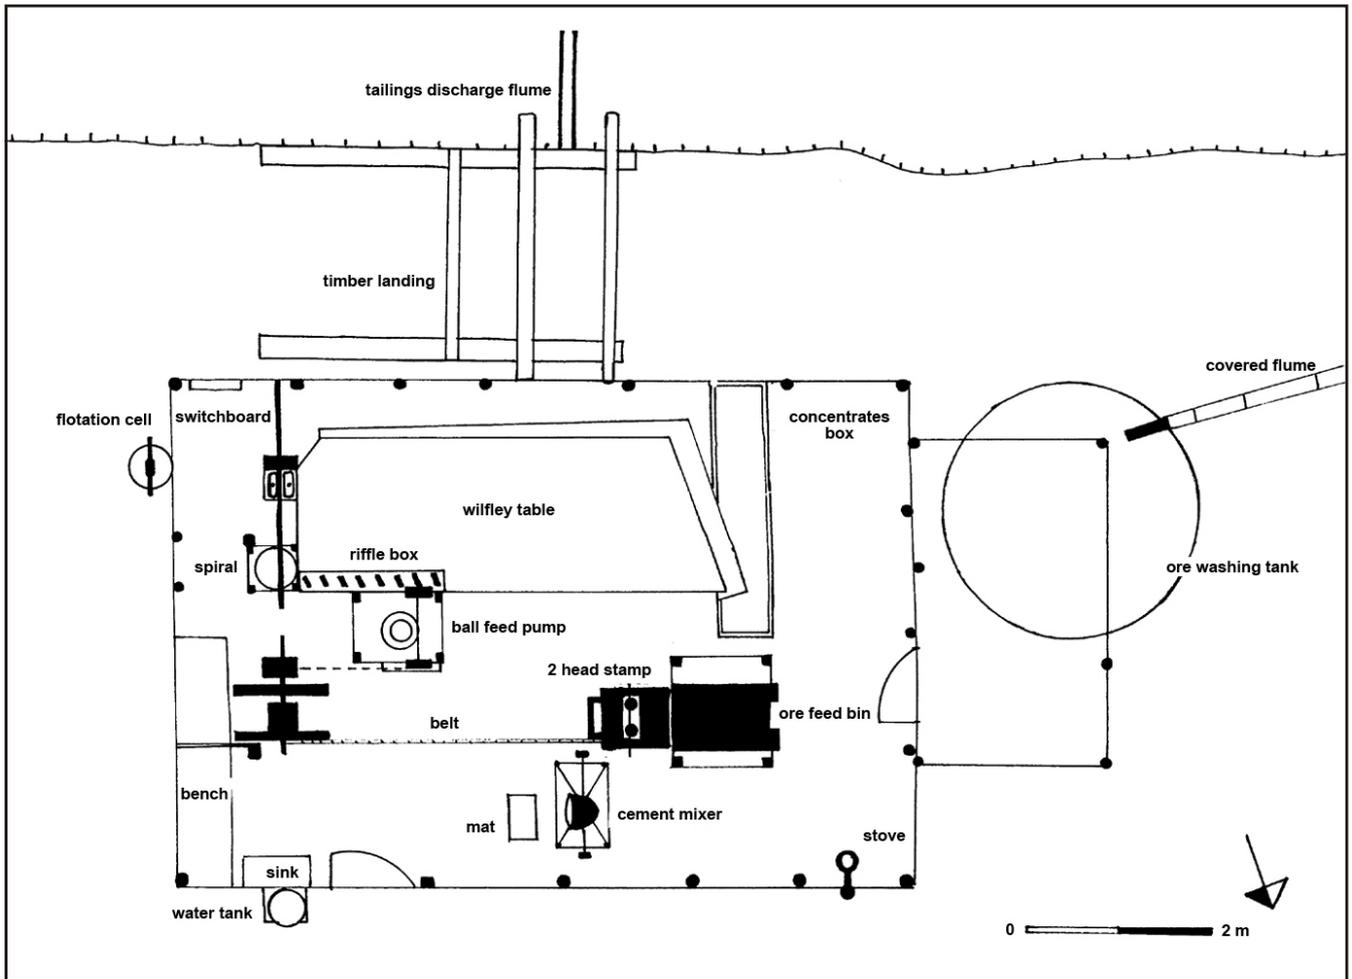
Plate 2

The Kenworthy mill plant consisted of several other features in addition to the mill building and its contents. These are briefly summarised below in conjunction with the mill. Reference should also be made to the scaled plan of the structure provided as Plate 2.

Scaled plan showing Kenworthy's mill and its various constituent features.

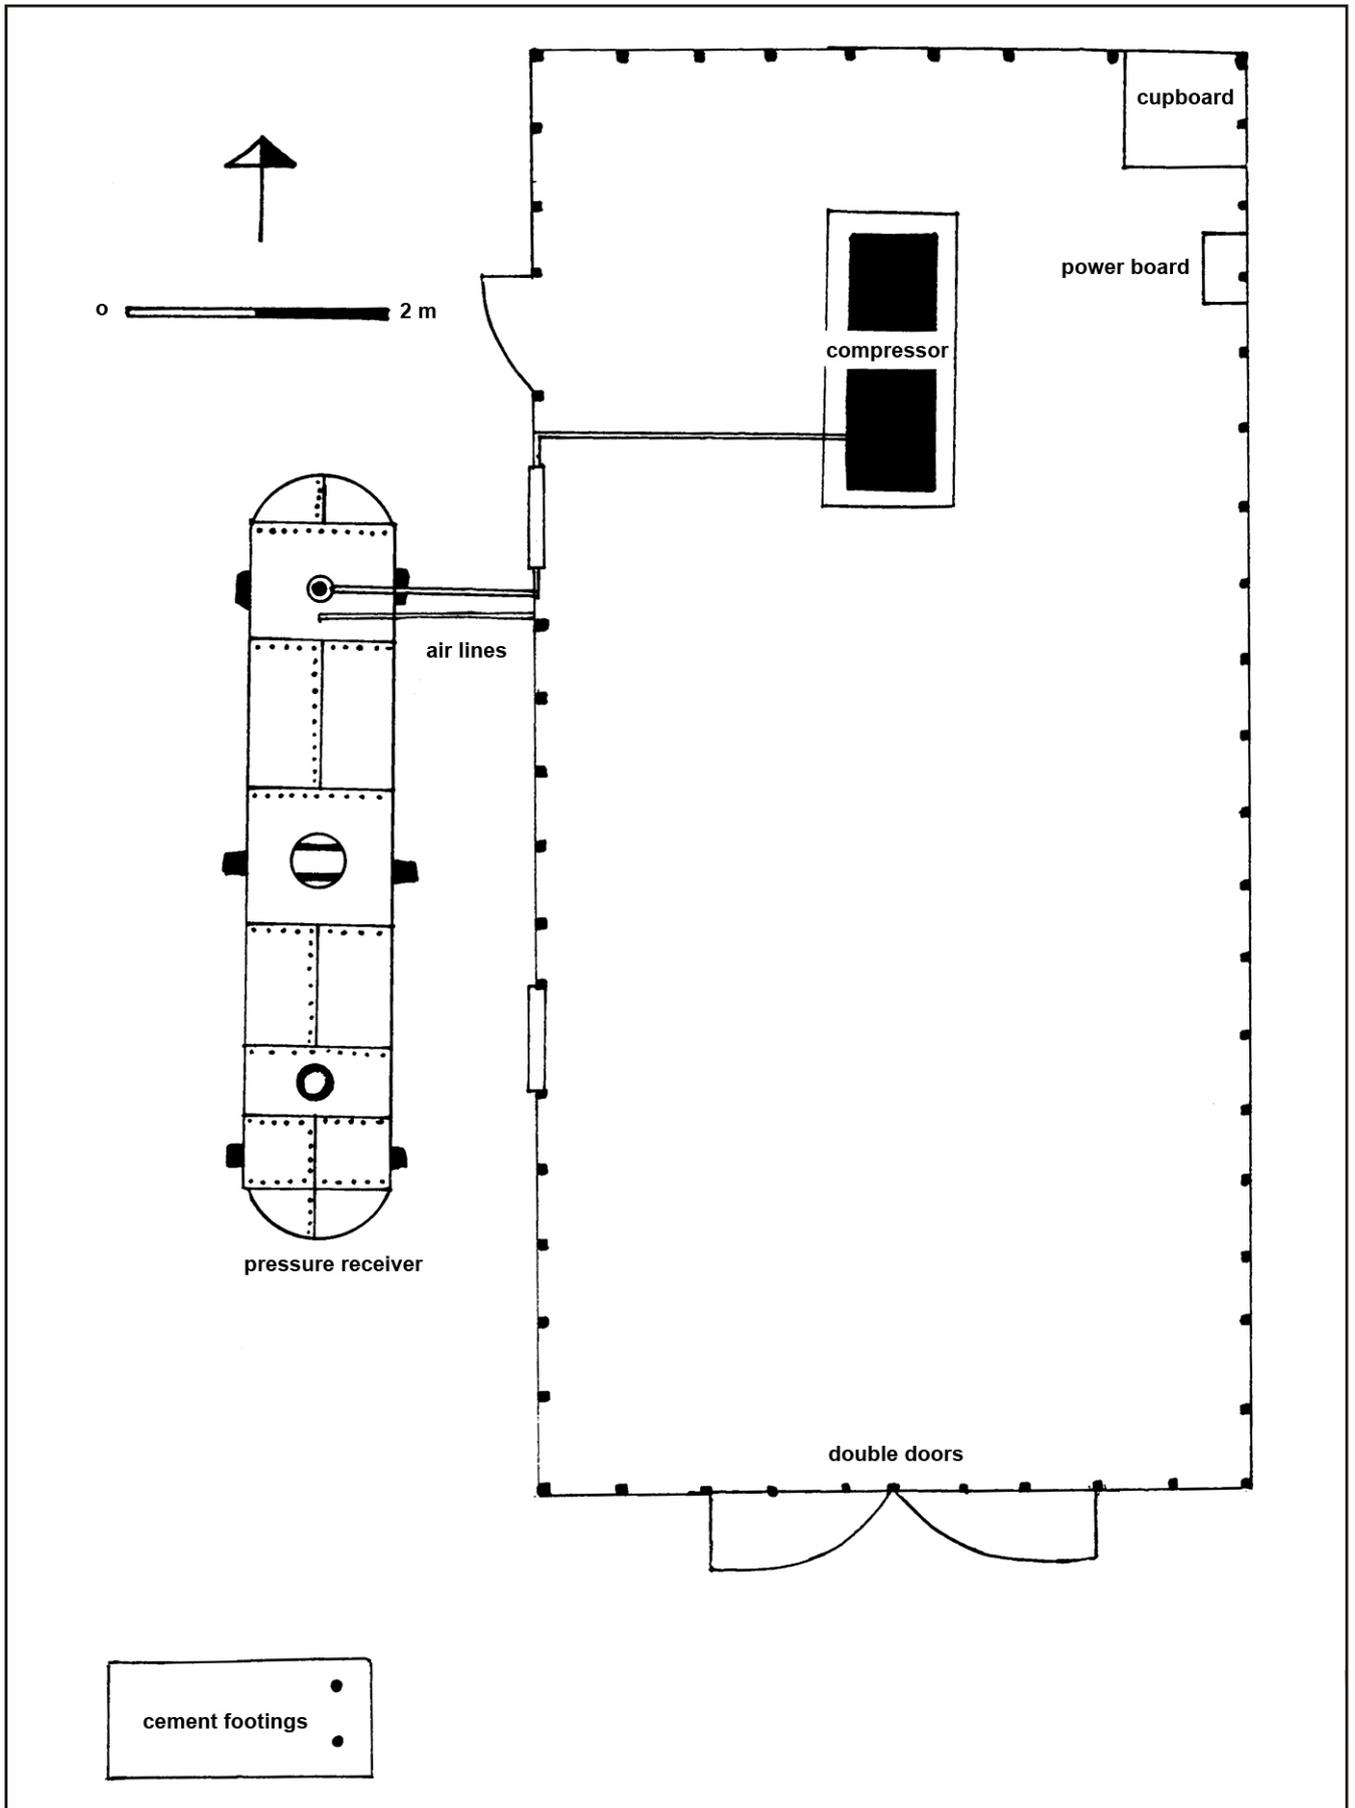
Plate 3

In addition to the so-called Commonwealth compressor shed and its contents, this site also consists of a large steel bullet or pressure receiver and two cast concrete footings. Reference should be made to Plate 3, which shows a scaled plan of the site and its constituent features.

Scaled plan showing the Commonwealth compressor shed and its various constituent features.

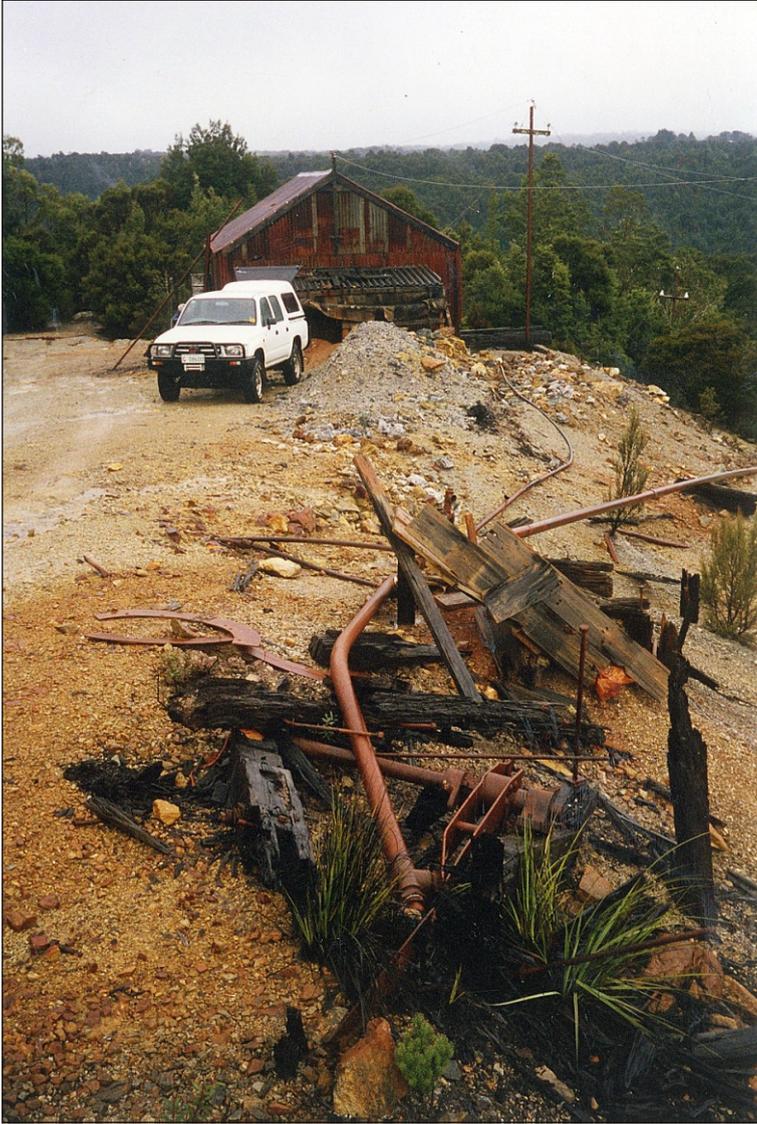
Plate 5

A 20 metre long section of 2 centimetre diameter water pipe follows the south side of the North Valley road line to the mill site. The collapsed remnants of continuous timber trestling beside the water pipe suggest that some sort of fluming to conduct untreated tin ore may have also been erected here.

Photo showing overhead power connection, roadside water lines and burnt timber trestling west of mill.

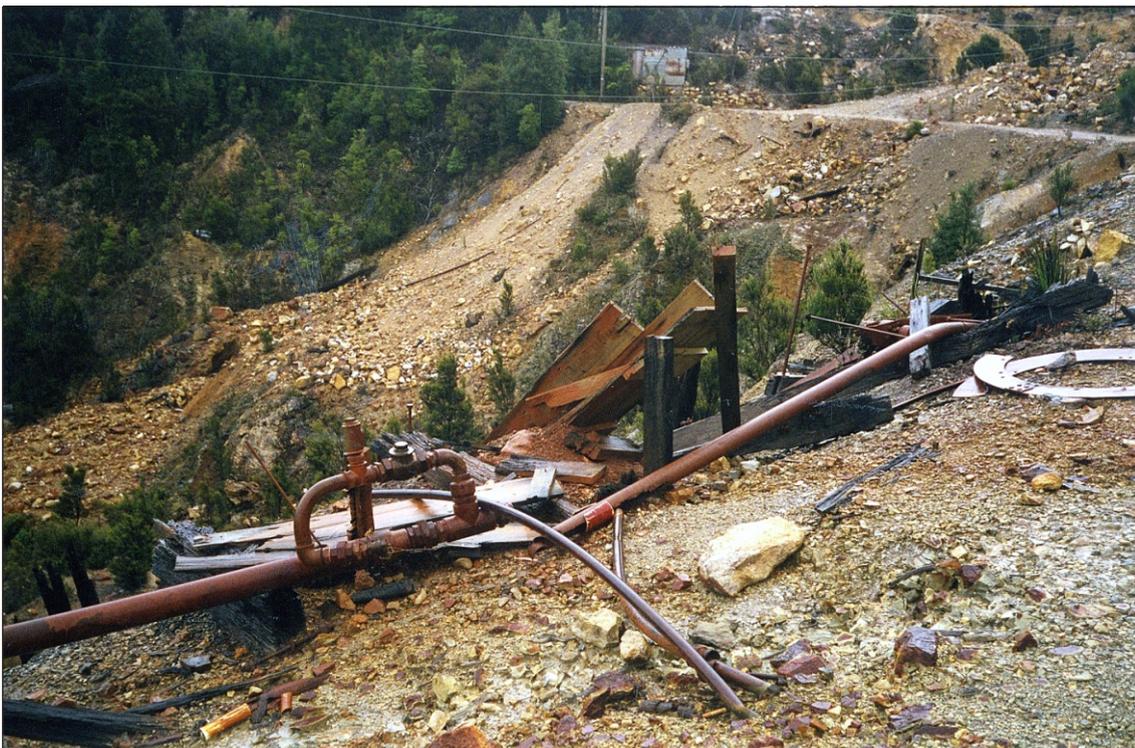
Plate 6

Detail of trestling and water lines.

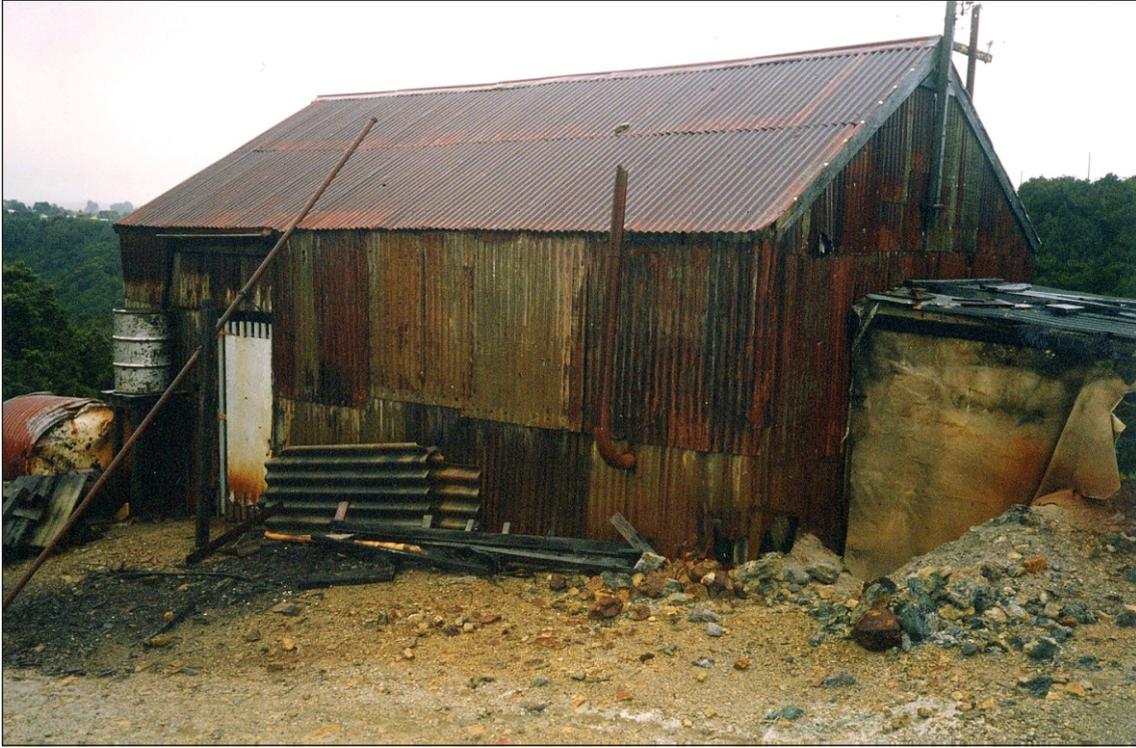
Plate 7

The mill building is a rectangular structure with a gabled roof measuring 5.6 x 8.1 x 4.3 metres in height. It is a composite iron and timber structure utilising corrugated iron sheets applied as a wall and roof skin to a timber framework. A 2 x 3.5 x 2 metre high addition has been made at the western end of the mill shed to cover the ore washing tank described above. This addition comprises a timber frame supporting a corrugated asbestos sheet roof. The three walls are equally rudimentary, and consist merely of plastic and canvas sheeting tacked to the timber uprights. A 3.5 metre high timber mast attached externally to the western wall of the mill shed

View of northern side of Kenworthy's mill.

- The current proposal to dismantle the mill building and re-erect it Waratah is endorsed.
- The dismantling of the building should be done carefully so that the re-erected shed is as faithful to the original as possible, although some sheet iron and timber framework will require replacement. Some asbestos material will also have to be removed.
- The various items comprising the milling plant should be carefully dismantled and then re-assembled in an identical configuration.
- The numerous small items such as tools, spare parts and containers should be sorted and the more interesting items selectively retained.

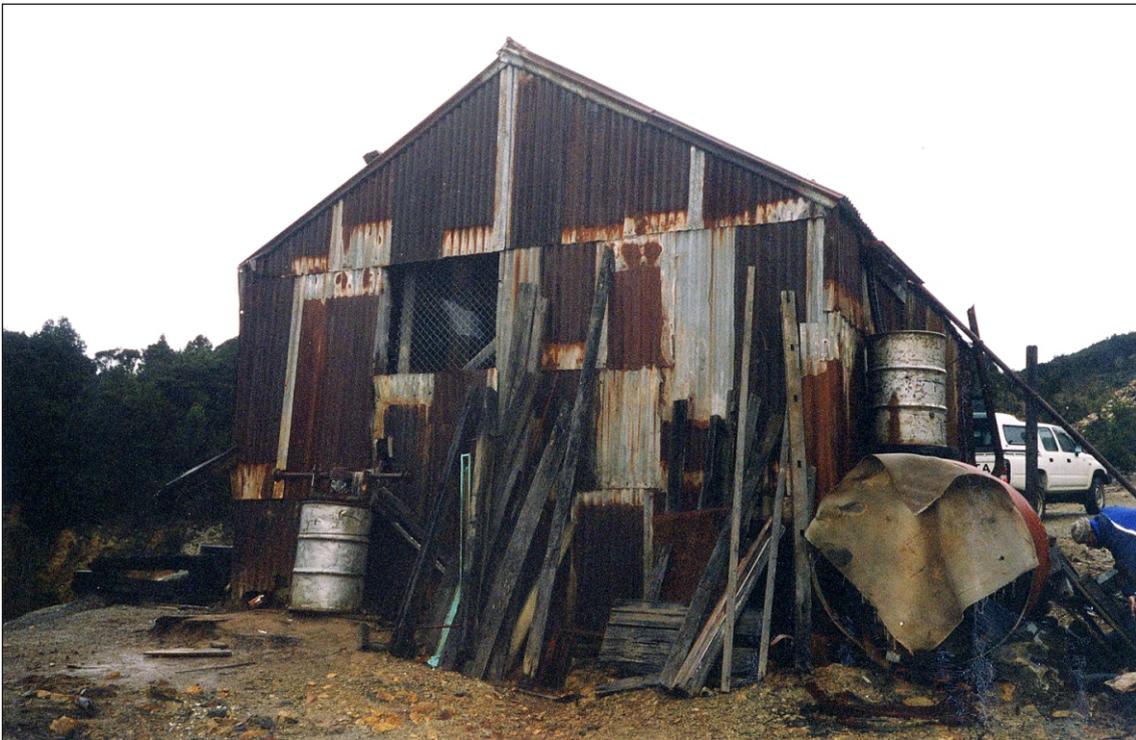
Plate 8

View of eastern side of Kenworthy's mill.

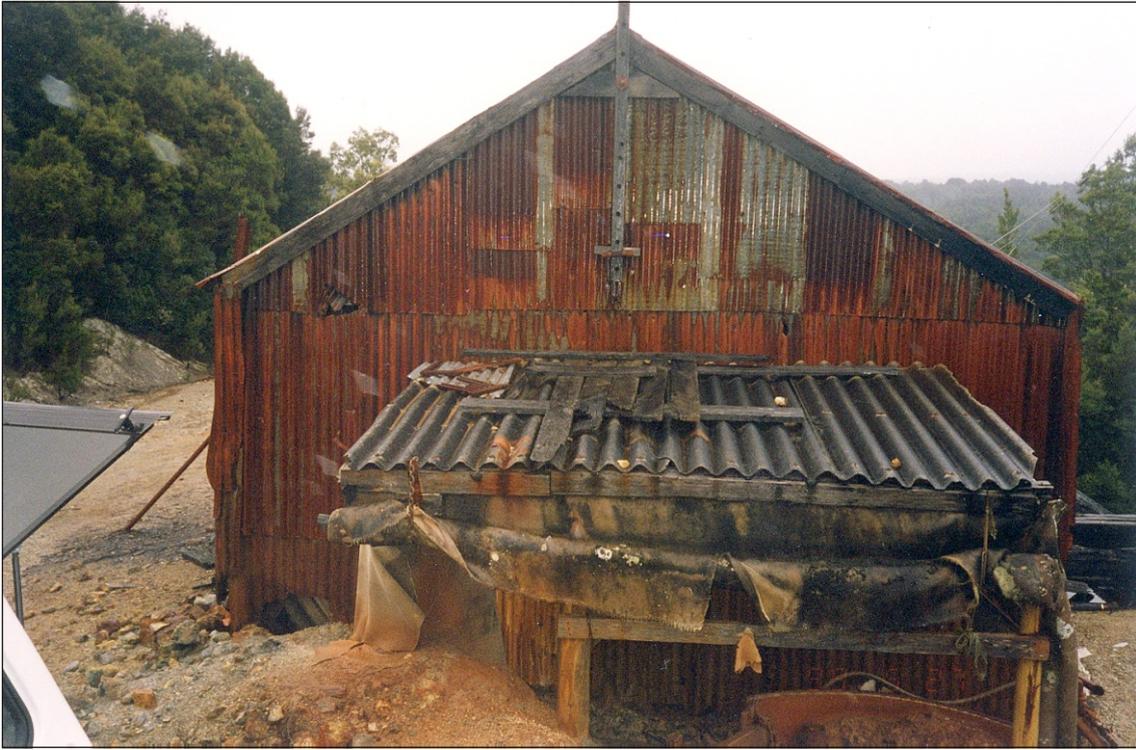
Plate 9

A 2.7 metre diameter x 0.3 metre high steel tank lies beneath a roofed addition to the western end of the mill building. A covered section of timber fluming with a rivetted metal discharge pipe may have delivered untreated ore into this tank for washing prior to it being shovelled through a hatch into the mill for further treatment.

View of western side of Kenworthy's mill. Note shelter over ore washing tank.

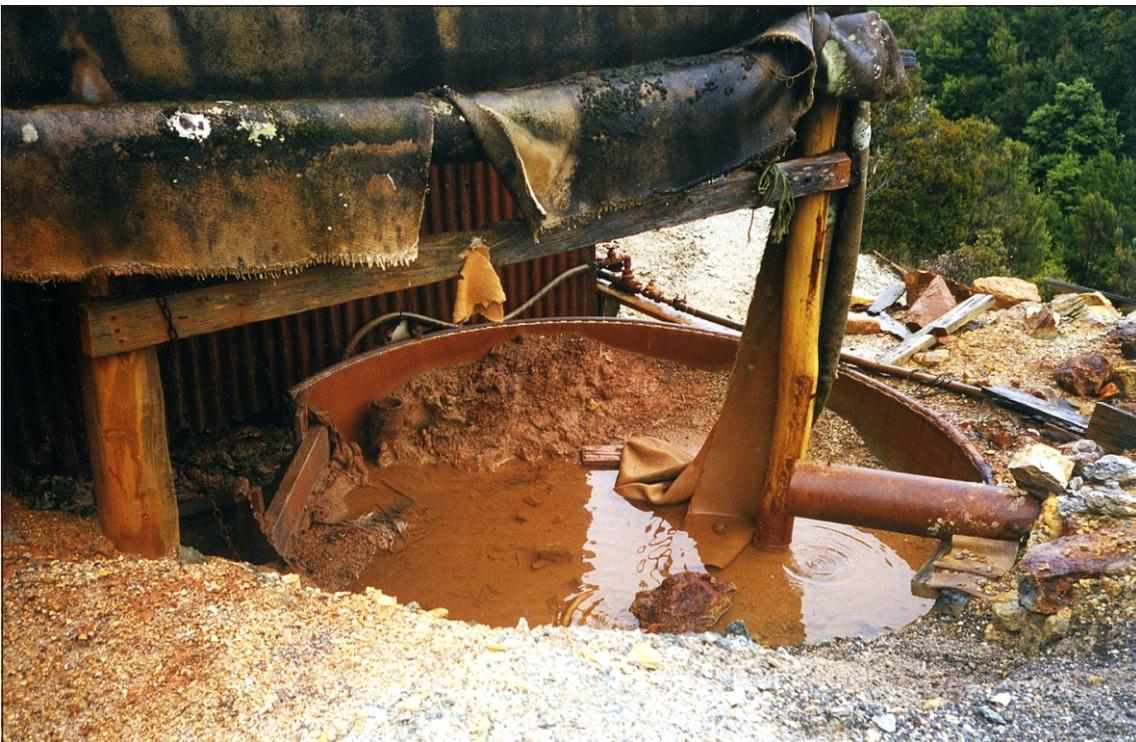
Plate 10

Detail of ore washing tank under western shelter.

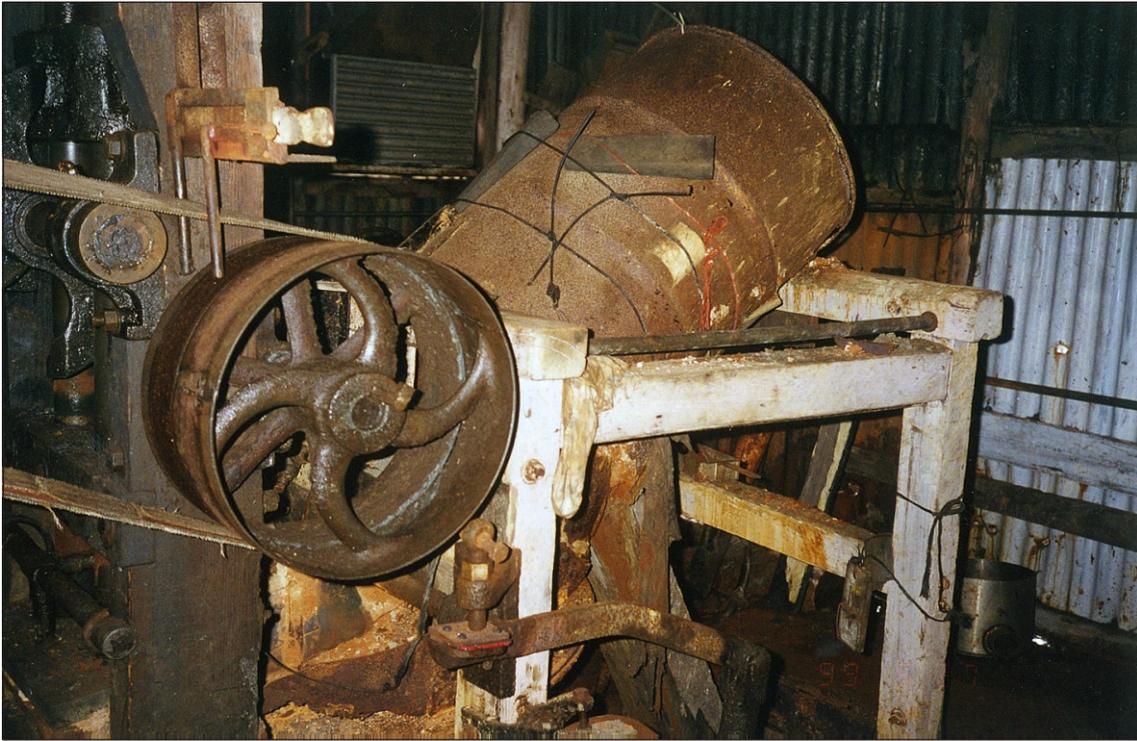
Plate 11

Once untreated ore had been washed in the external tank, it was shovelled through a feed door in the western wall of the mill building and placed in the ore feed bin prior to milling. This ore feed bin consists of a 44 gallon drum elevated on a 1 x 1 x 1 metre high timber frame, which stands immediately behind the stamp battery. Ore from the bin was gradually fed into the mill battery by means of a simple sliding feed slot at the base of the drum.

View of 44 gallon drum and timber frame rigged as ore feed bin.

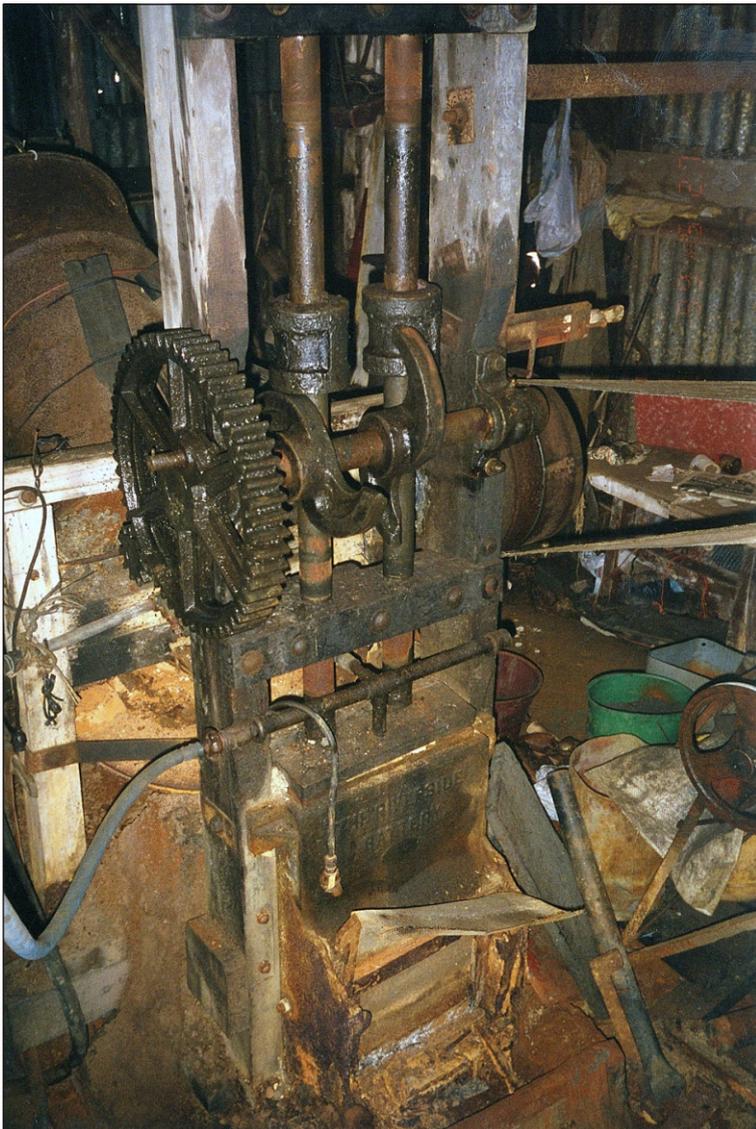
Plate 12

The resident mill battery is a two-head stamp battery, which stands immediately east of the ore feed bin. The mortar box at the base of the battery has 'THE RIVERSIDE BATTERY' stamped in high relief on one side of it. This battery is completely intact, retaining both the crushing plant and drive assembly.

View of two head stamp battery.

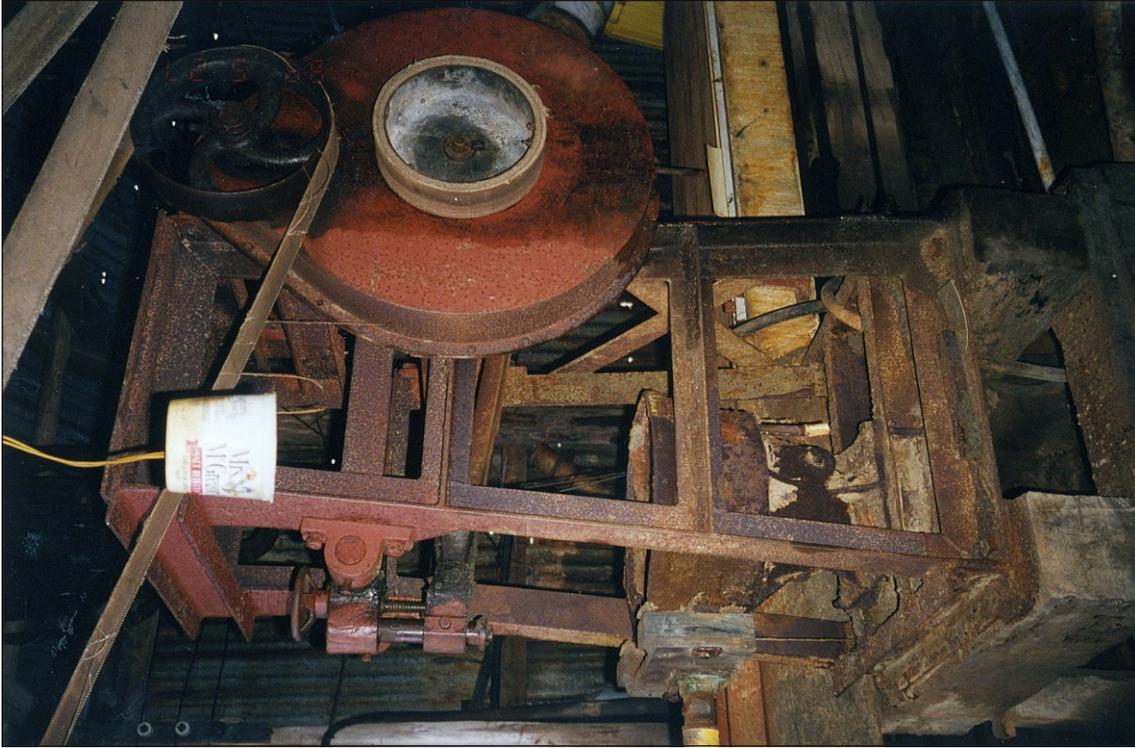
Plate 14

The crushed ore from the battery was then fed into an elevated dish where it was agitated and then forced under pressure into a funnel shaped spiral. The agitating dish was powered by a belt driven pump supported by an overhead metal frame.

View of ball feed pump frame

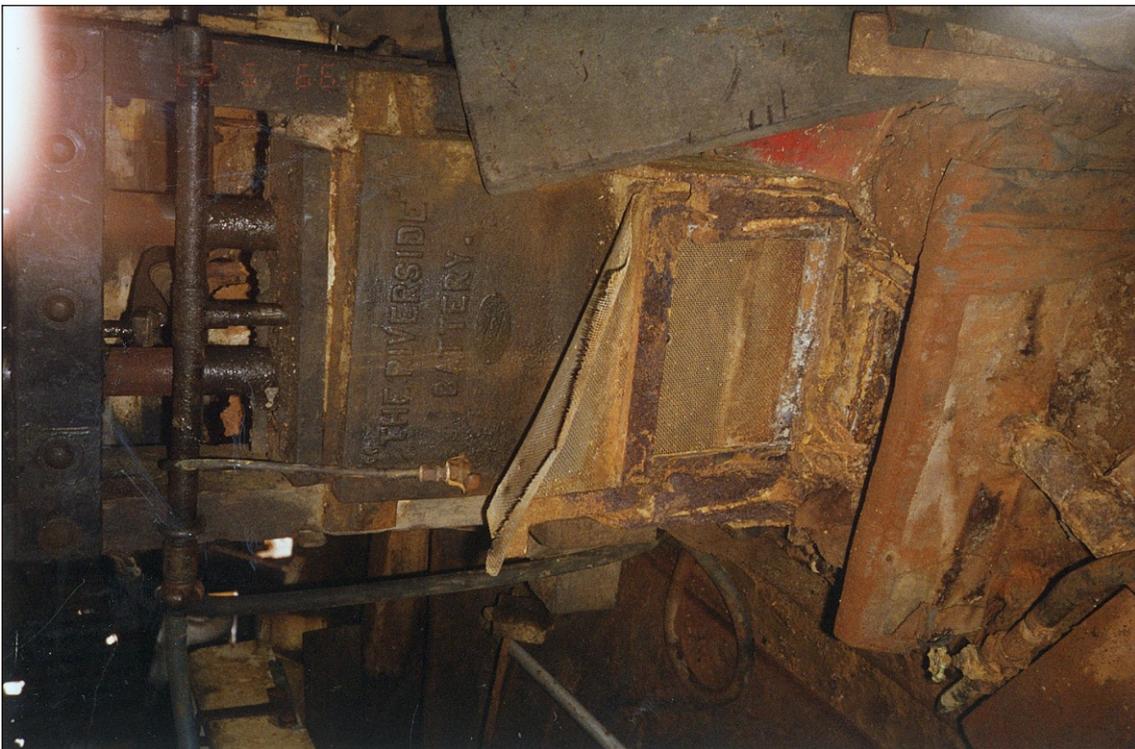
Plate 13

Detail of embossing on mortar box

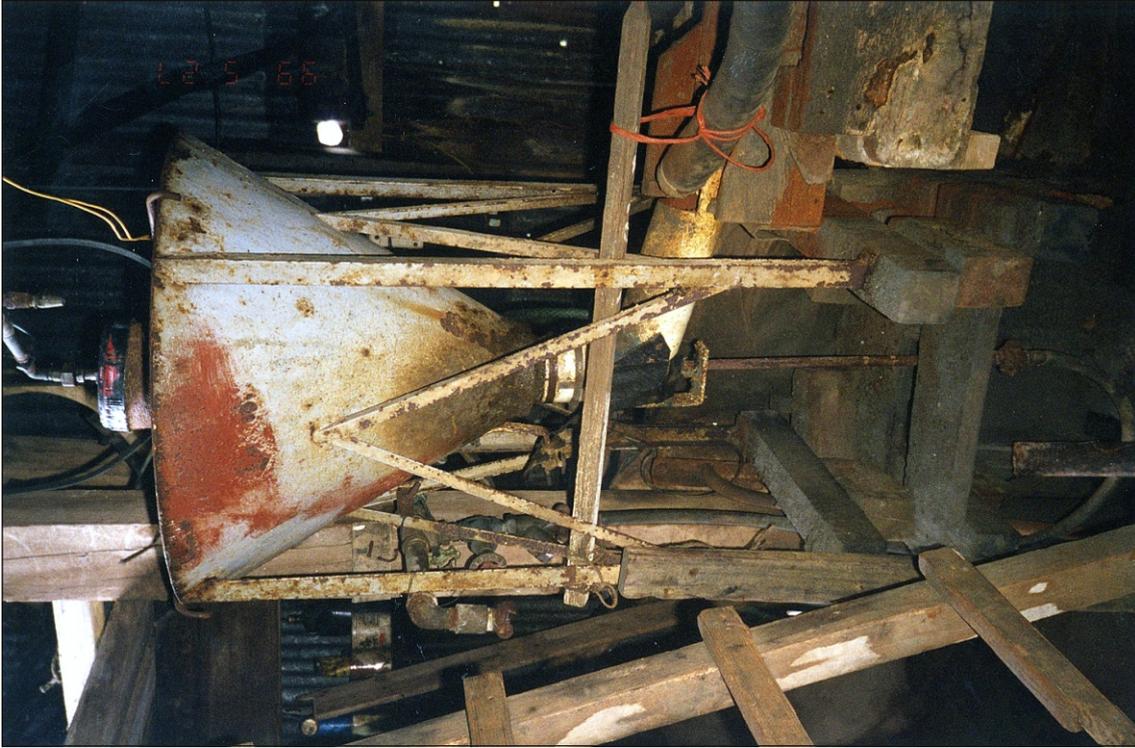
Plate 16

Material from the agitator was pumped under pressure by the ball feed pump into a metal funnel fitted with a mixing arm. After undergoing further mixing, the material was ejected at the base into a riffle box beside a wilfley table.

View of conical spiral

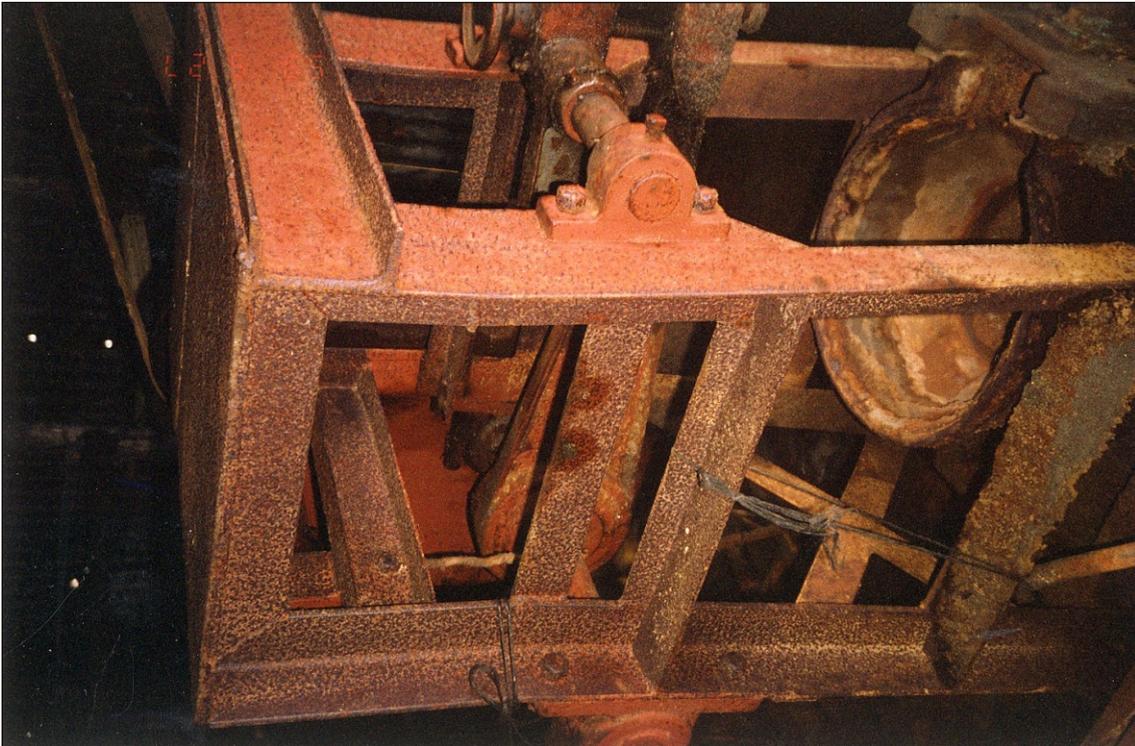
Plate 15

Detail of agitator dish

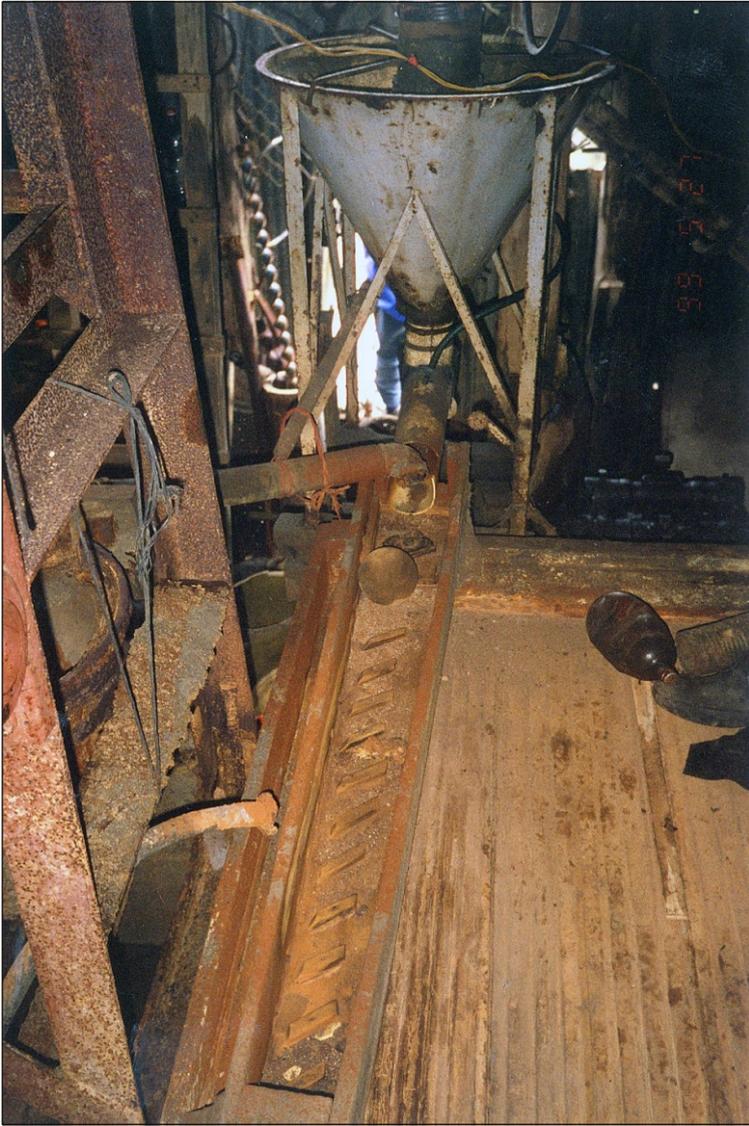
Plate 17

A 1.5 x 0.2 metre wide riffle box with a series of eleven timber batons or 'clears' on its base served to catch pieces of unwanted waste rock while the smaller particles of tin proceeded onto the adjacent wilfley table.

View of riffle box on wilfley table below spiral.

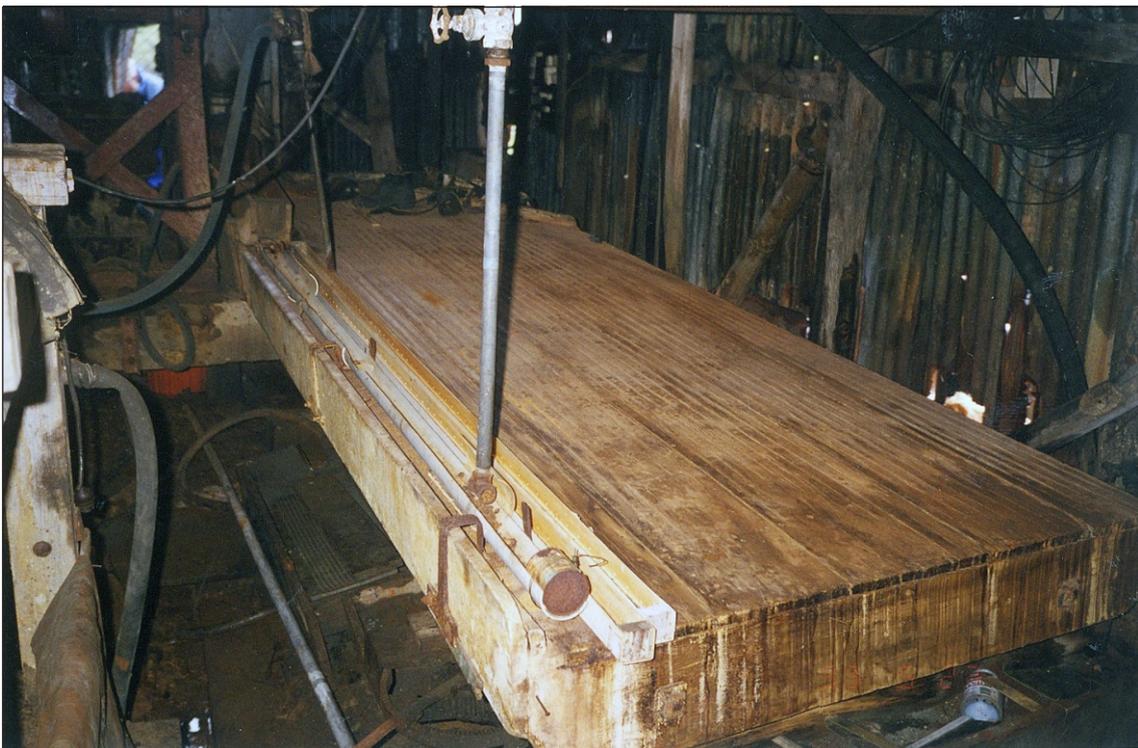
Plate 18

The resulting 'fines' were then gravity fed onto a wilfley table for final separation of the tin concentrate from other unwanted material. The roughly rectangular wilfley table measures 4.7 x 1.7 metres in dimension. An overhead water pipe supplied a continuous stream of water onto the top end of the table to move material over the corrugations on the table top. This all timber table has a waste flume built around its southern/western ends to drain off waste material for ultimate removal outside the southern side of the building.

View of wilfley table.

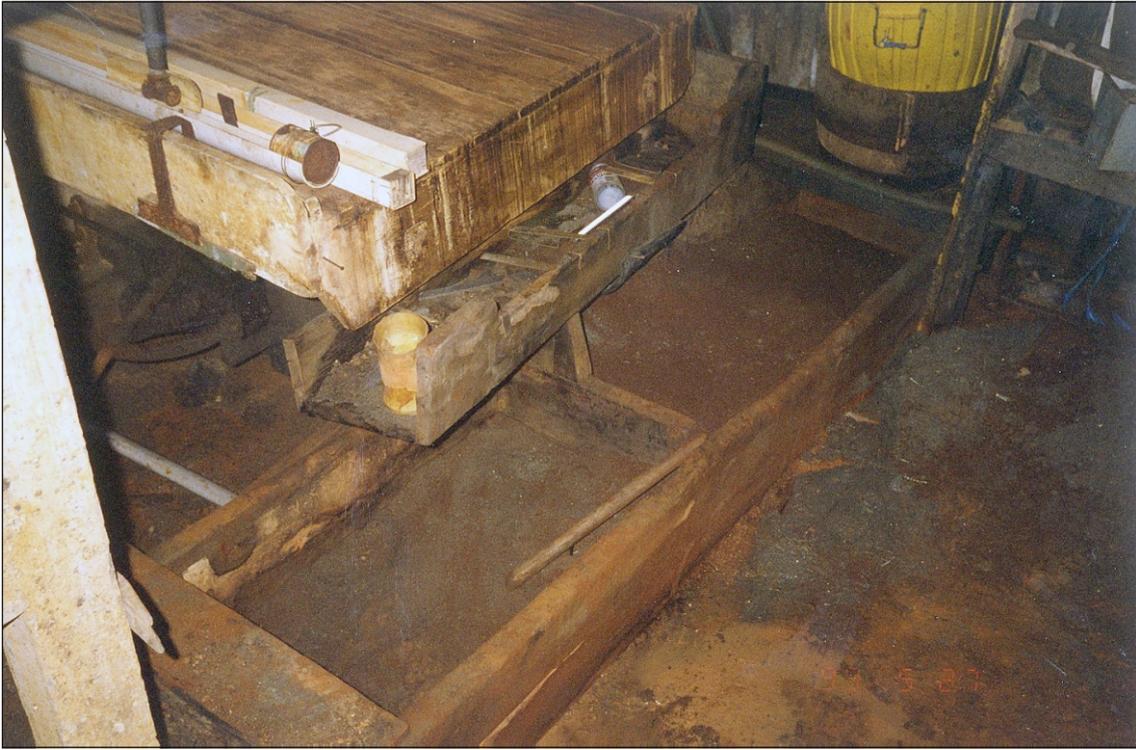
Plate 19

A 2.8 x 0.6 x 0.35 metre deep timber trough at the western/lowest end of the wilfley table captured the lighter tin particles as they ran over the end of the table.

View of concentrates box below lower end of wilfley table.

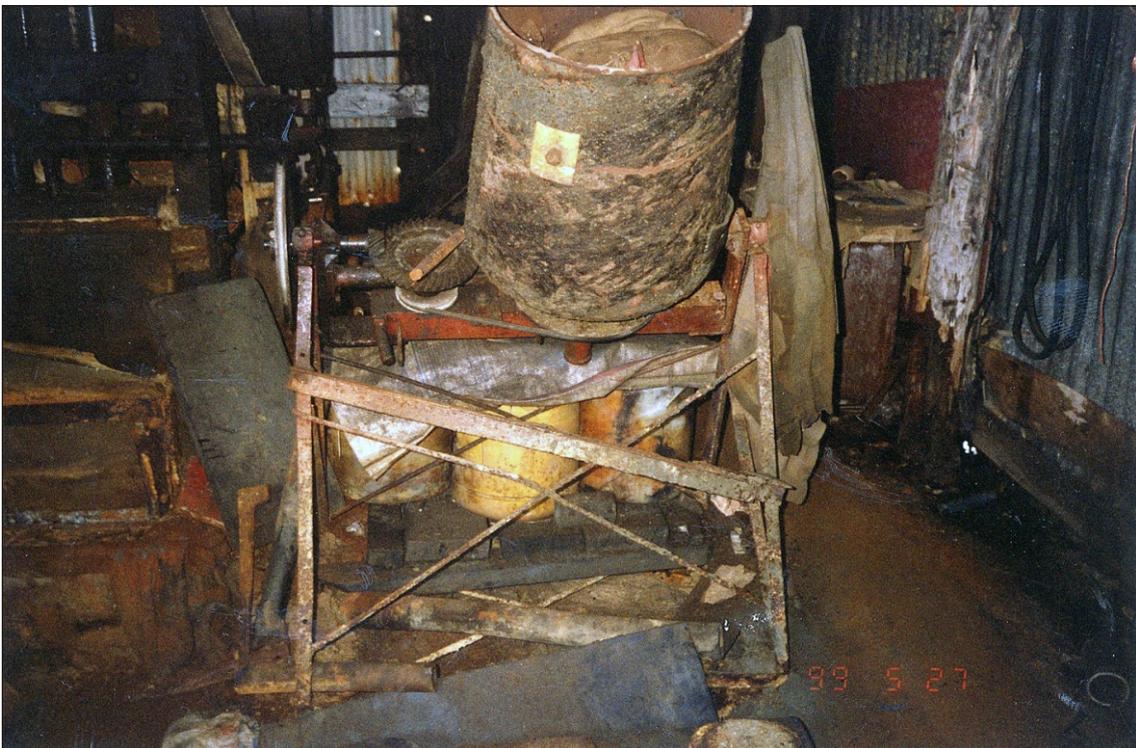
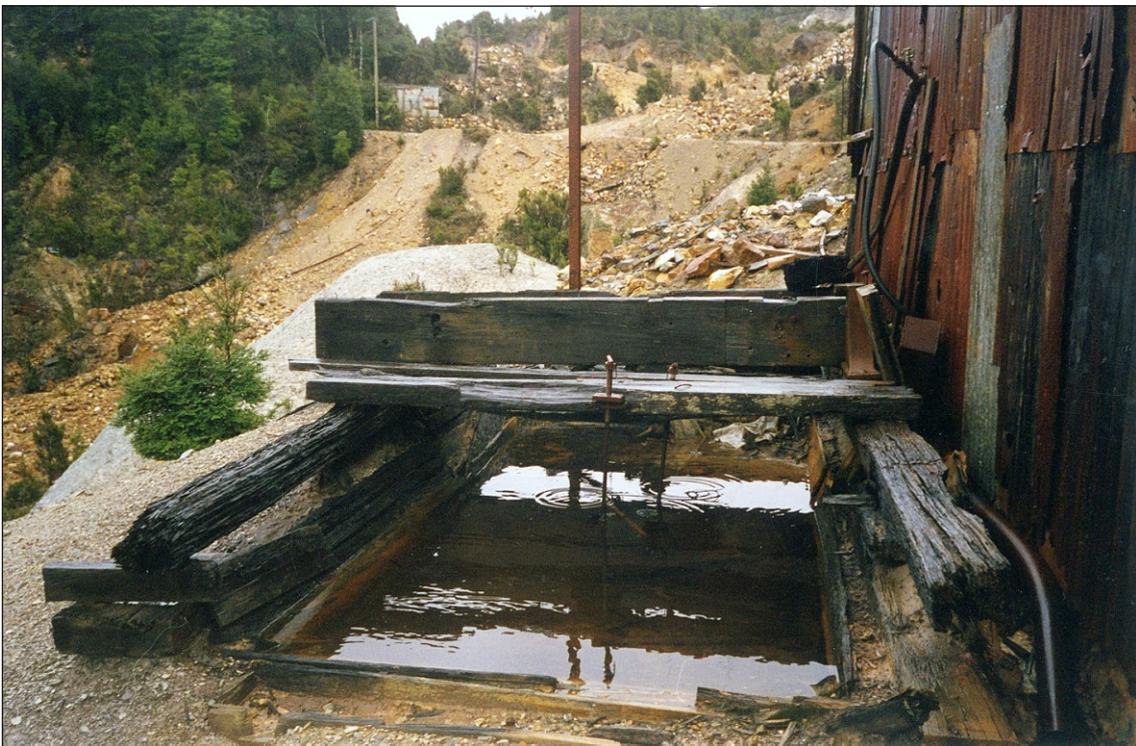
Plate 20

Tin concentrates removed from this box appear to have received one final wash in a small portable cement mixer standing adjacent to the mill's stamp battery. Cleaned concentrates were probably poured out of the mixer onto the rubber mat laid out beneath. The presence of two plastic containers of tin concentrates next to the mat and mixer further add credence to this theory.

View of portable cement mixer used to wash concentrates.

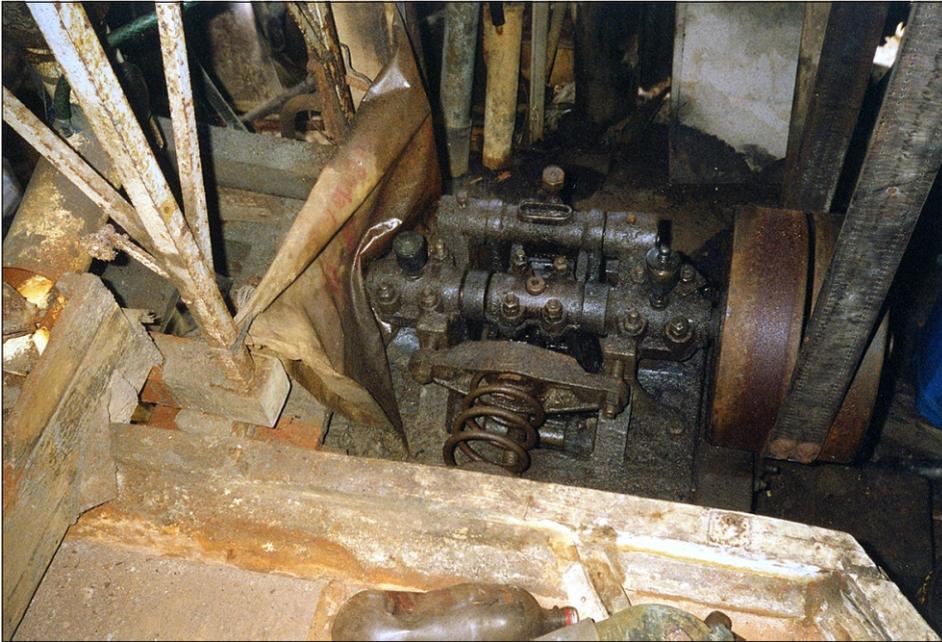
Plate 21

Electric power for the mill was conveyed by overhead wire from the nearby power house to the mill switchboard located in the southeastern corner of the building. This board still retains a circuit breaker switch, although all fuses and the meter have been removed. Power regulated by the switchboard drove a small engine installed immediately east of the wilfley table. A pulley attached to the engine in turn drove, by means of a single canvas belt, the overhead pulley system described below.

Electric plant used to power overhead pulley system.

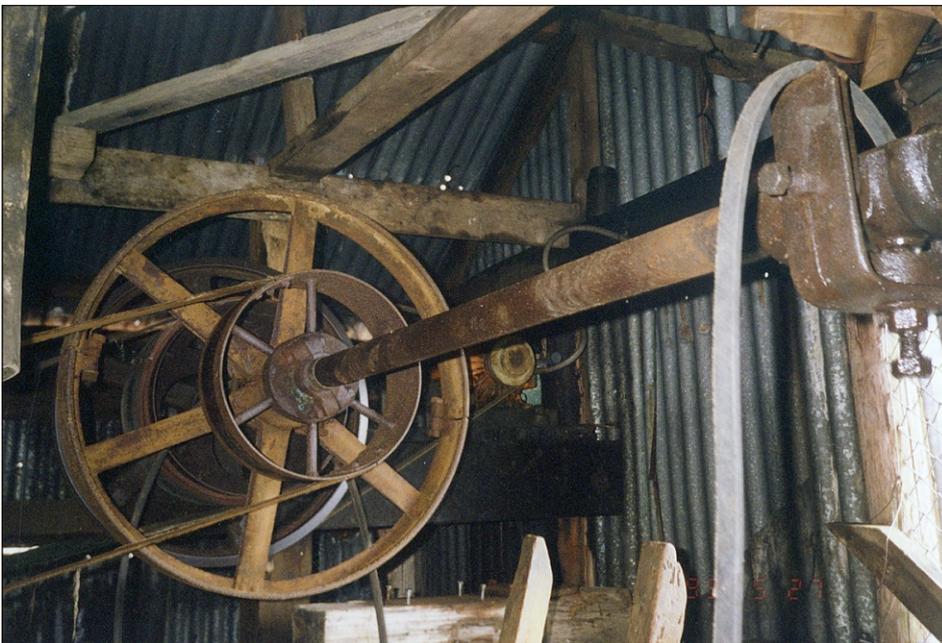
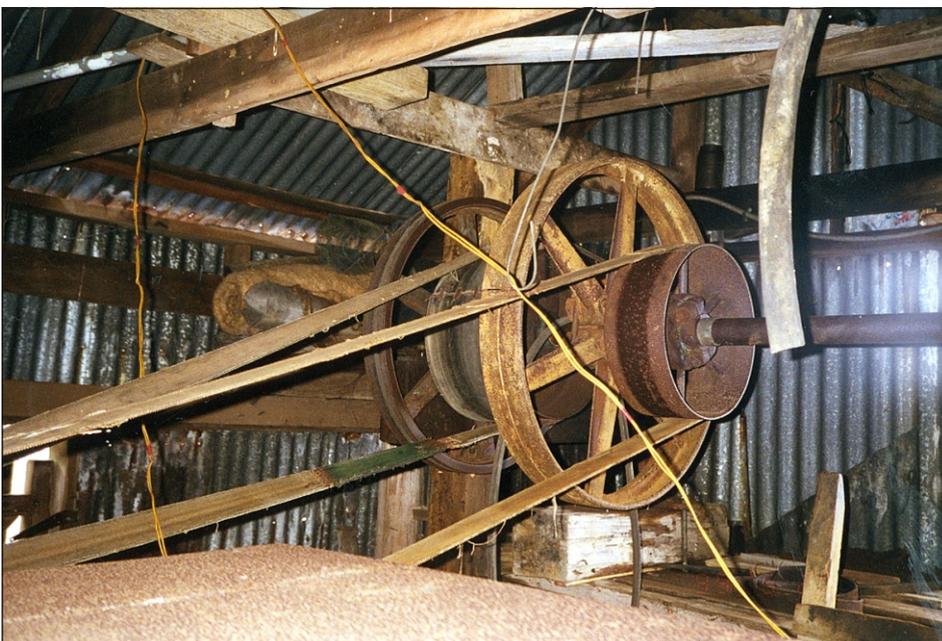
Plate 22

The stamp battery, ball feed pump and cement mixer were all run by canvas belts connected to an overhead pulley system at the eastern end of the building.

View of overhead pulleys and related belting to the stamp battery and cement mixer.

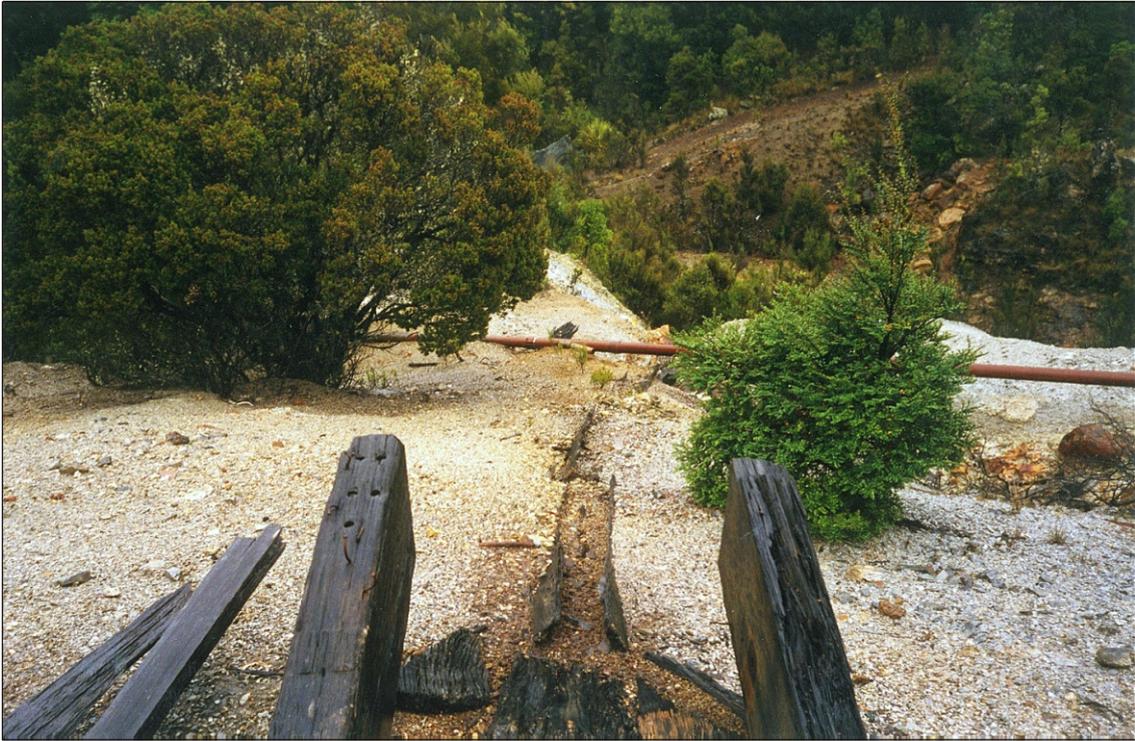
Plate 26

Waste tailings from the wilfley table and other sources were piped out the southern side of the building to a covered timber flume, which conveyed it down the hill side. The function of a timber landing, measuring 4 x 3 metres, erected outside the southern wall of the mill shed remains uncertain.

Waste tailings flume beneath timber footings.
