**Archaeological Survey Report
1999/02**

**An archaeological inspection
of historic standing structures
at the Mount Bischoff mine**

By Parry Kostoglou

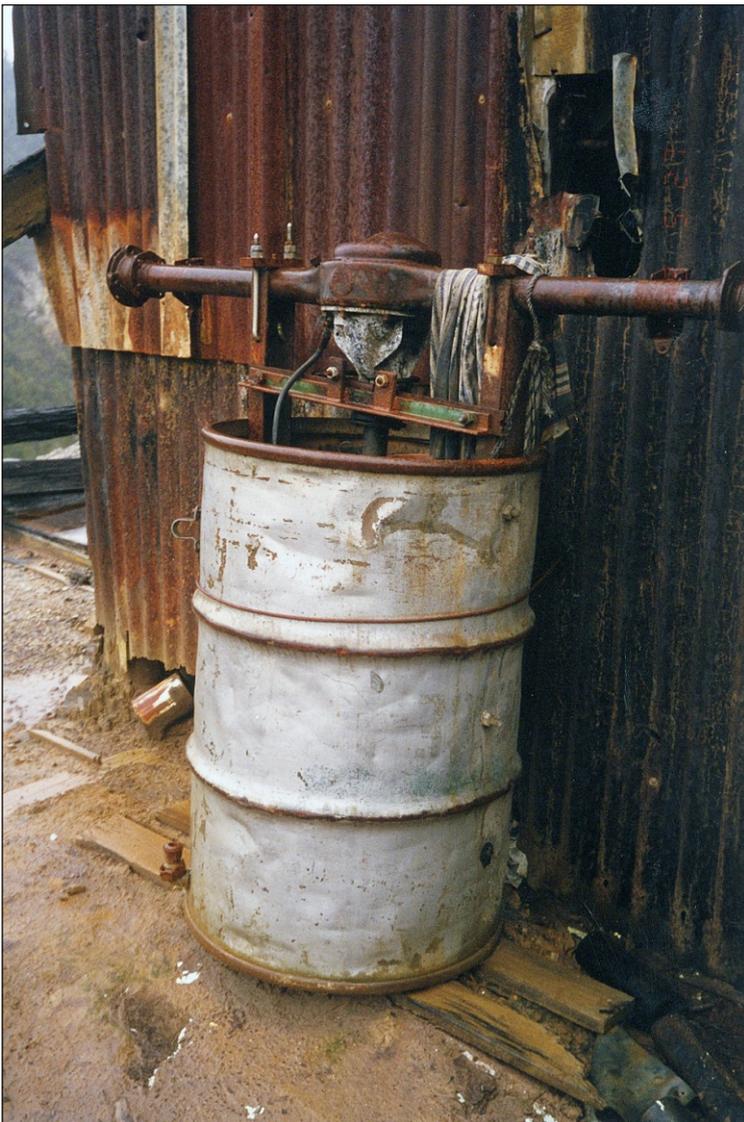
Plate 27

A toppled corrugated iron water tank and two 44 gallon drums lean against the eastern and northern walls of the mill shed. The drum on the eastern wall appears to have been used as another flotation cell for ore treatment.

Flotation cell outside eastern side of building.

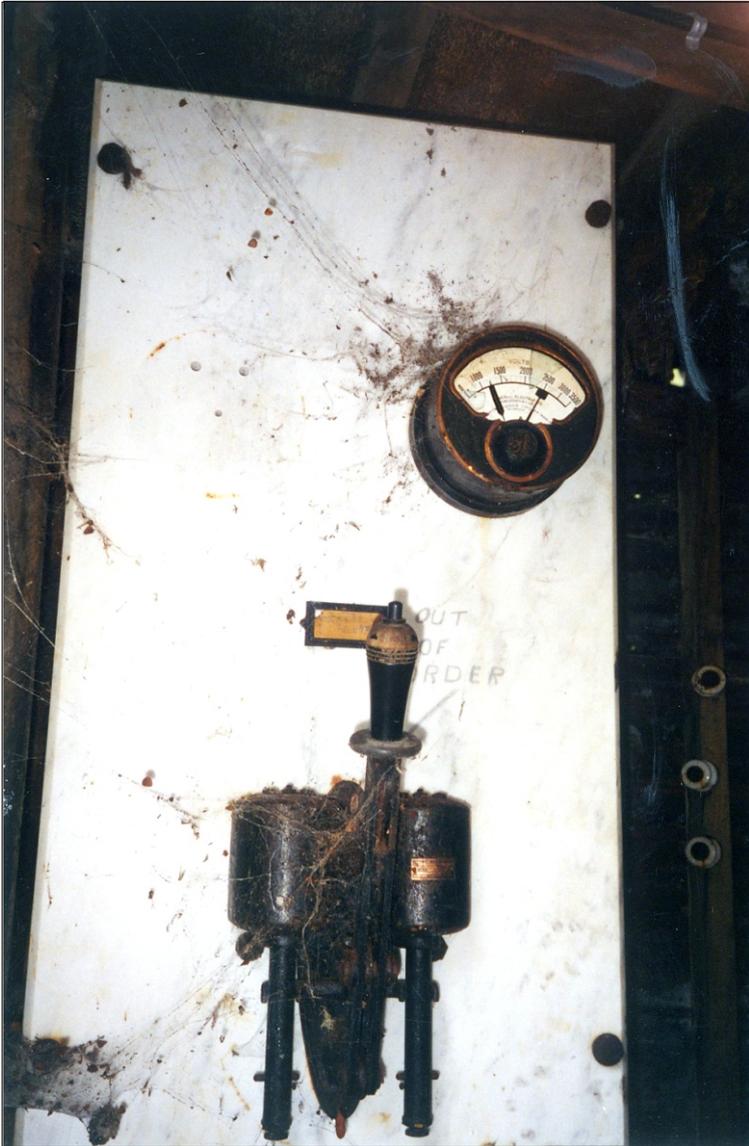
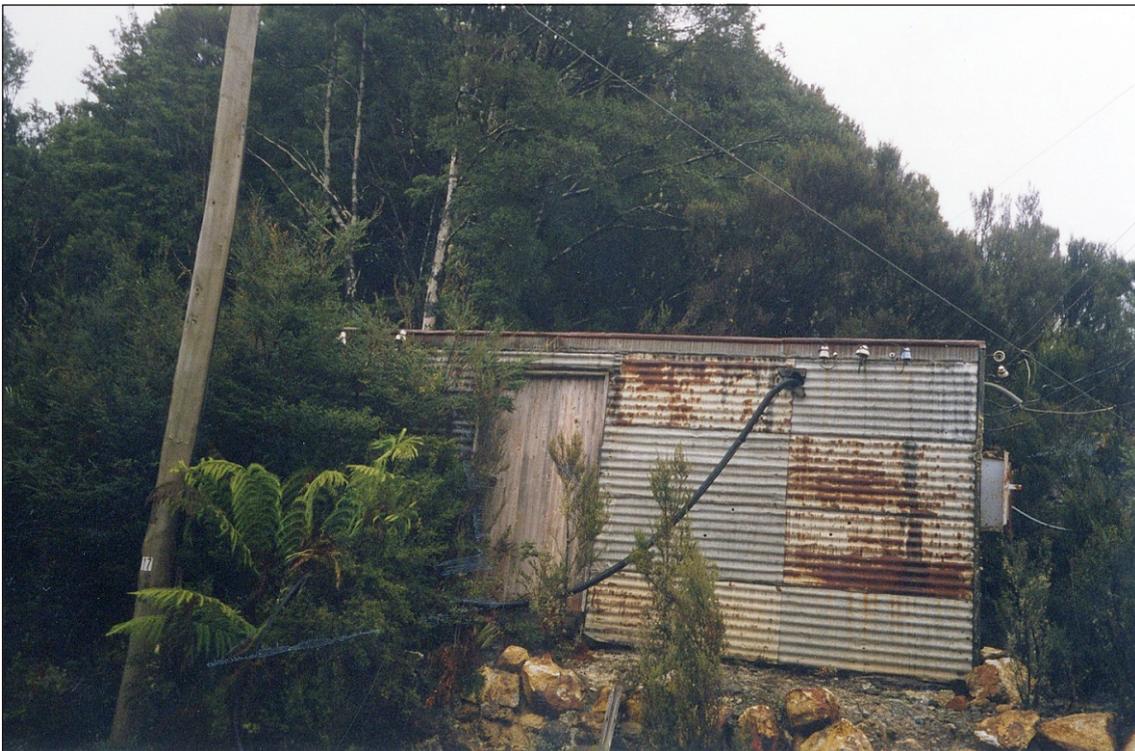
Plate 28

This is a rectangular flat-roofed structure clad in corrugated iron sheeting, which measures 5.3 x 3.2 x 3.5 metres in height. At the time of this survey, the building's contents consisted of two marble-backed switchboards. The structure rests on a form concrete slab.

Marble backed electrical switchboard at Kenworthy's power house.

Although not referred to in the brief, the powerhouse for Kenworthy's mill was also examined during this survey. The power house building itself appears to have virtually no archaeological and historical significance, and therefore requires no further work. However the marble backed electrical switchboards with attached meters and circuit breakers within the shed should be removed and either incorporated into the Kenworthy mill reconstruction or donated to the museum. If left in situ, these items will undoubtedly be destroyed by vandals.

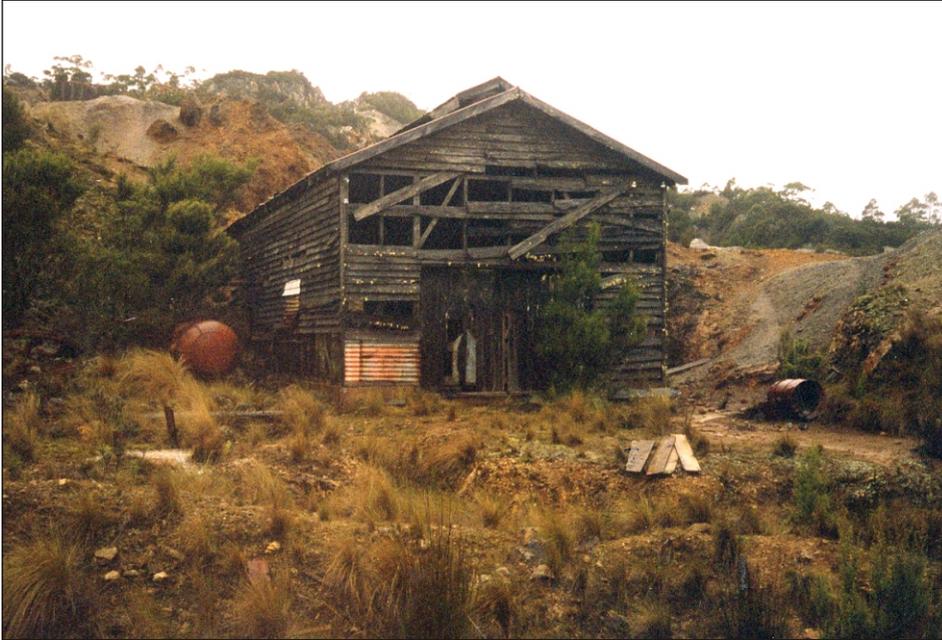
Plate 30

A hot rivetted and airtight plate steel bullet or pressure receiver stands *in situ* immediately west of the compressor shed. This chamber stands on three timber sleepers. The device measures 6 x 1.2 x 1 metre in height, and remains in an excellent state of preservation. These items were used at mines to hold compressed air at a pressure of 90–100 psi, which was then piped to the underground workings to drive an assortment of plant such as rock drills, hoists, mechanical loaders and ventilation.

Northerly view of the Commonwealth compressor shed. Note rusted pressure receiver sitting immediately west of the shed.

- The steel plate pressure receiver is not to be damaged or removed by the salvager or other parties. This item is a well crafted and increasingly rare piece of mining heritage, and should be preserved either on site or at some public facility in Waratah.
- The Ingersoll Rand compressor will also in the future become a coveted heritage item. This should also be offered to the museum.

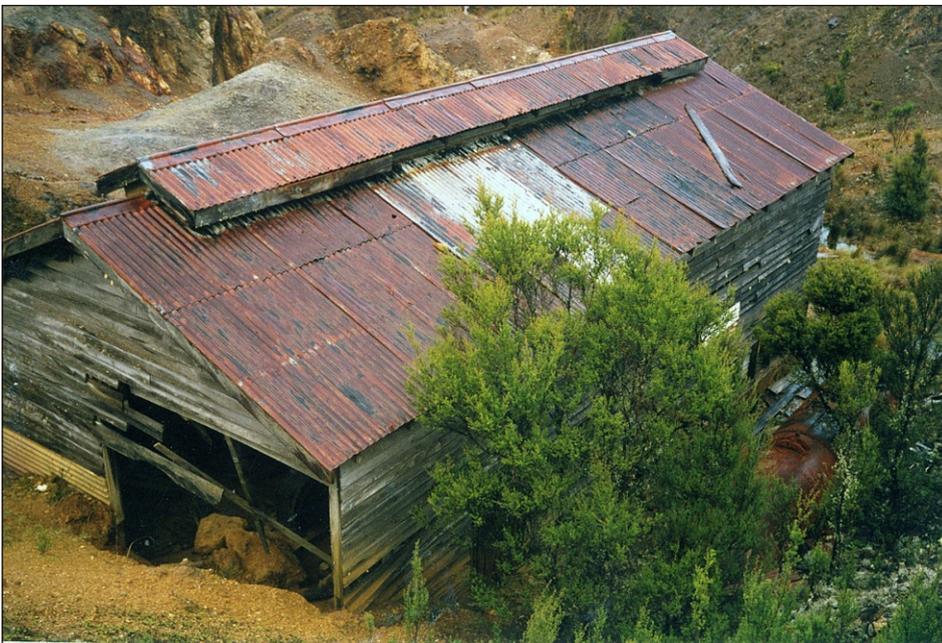
Plate 31

This is a rectangular timber framed structure clad in weatherboards with a gabled corrugated iron roof. The roof has been further fitted with a gabled ventilation ridge running along the top of the roof line. Measuring 5.6 x 11.6 x 5.4 metres in height, the shed's main entrance is a pair of double doors at its southern end, with a smaller single door at its northwestern corner. Two windows have been fitted into the western wall. A former window in the northern wall has been destroyed along with the bulk of this wall section. A great percentage of the weatherboards on the eastern and western walls have also been prized off, leaving the structure in a derelict state open to the elements. As a result of vandalism, only two features comprise the internal contents of the shed.

Elevated view of smashed northern wall and roof line of Commonwealth compressor shed.

The so called Commonwealth shed is also an unremarkable wartime structure, with no noteworthy heritage significance. Its extreme deterioration makes the structure a public liability. As such, the proposal that a salvager be given permission to remove all the timber fabric is endorsed subject to two conditions.

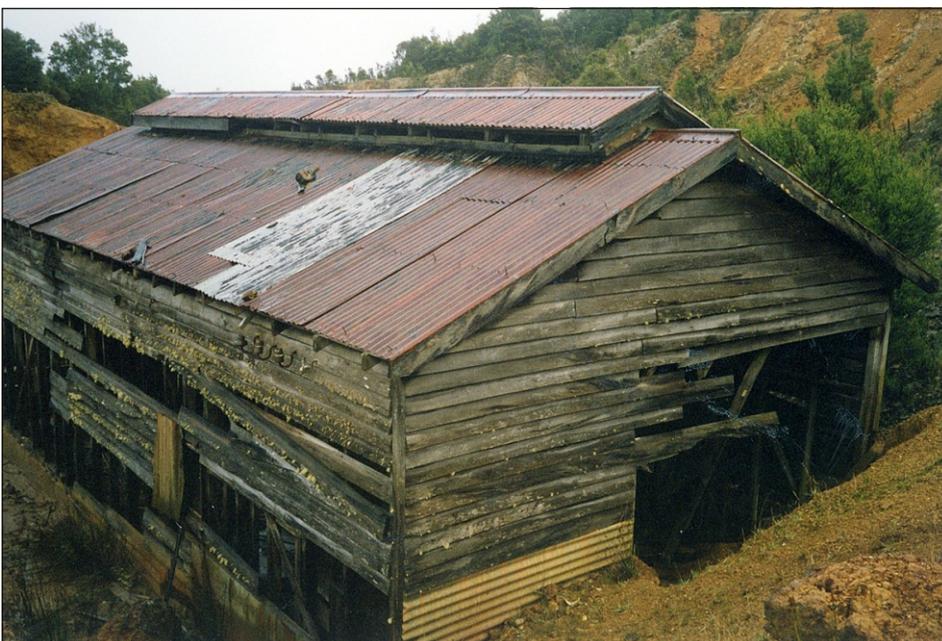
Plates 32

View showing northern/eastern wall and elevated ventilation ridge on roof.

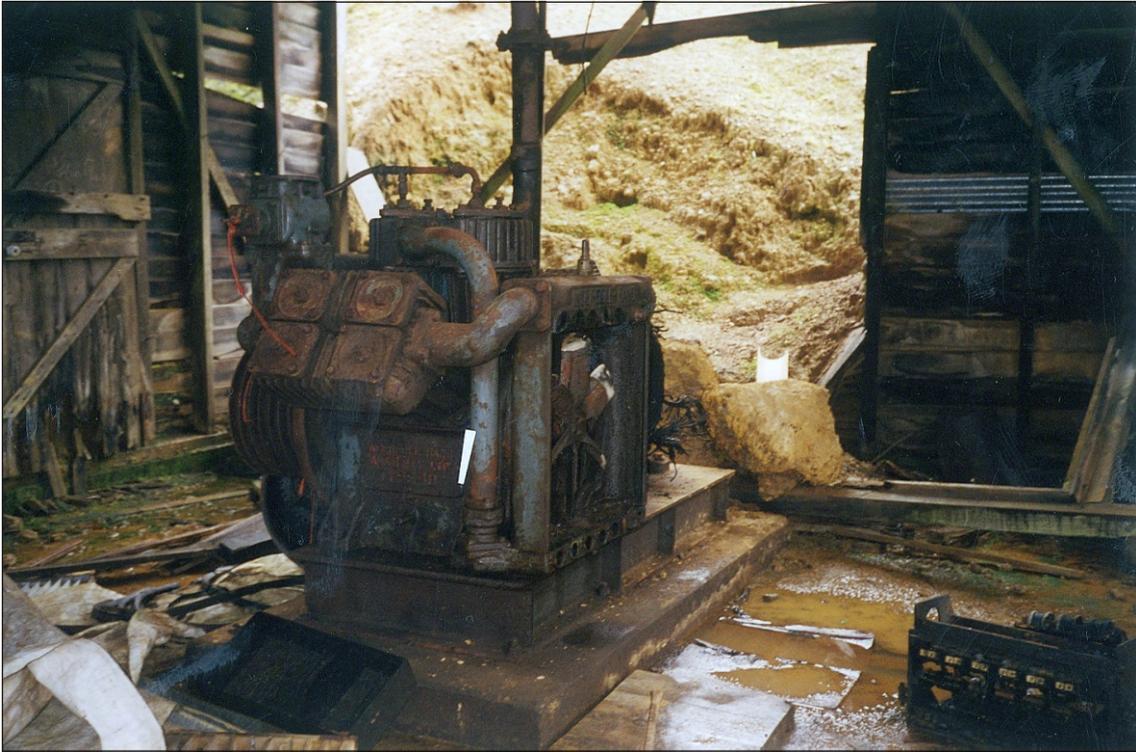
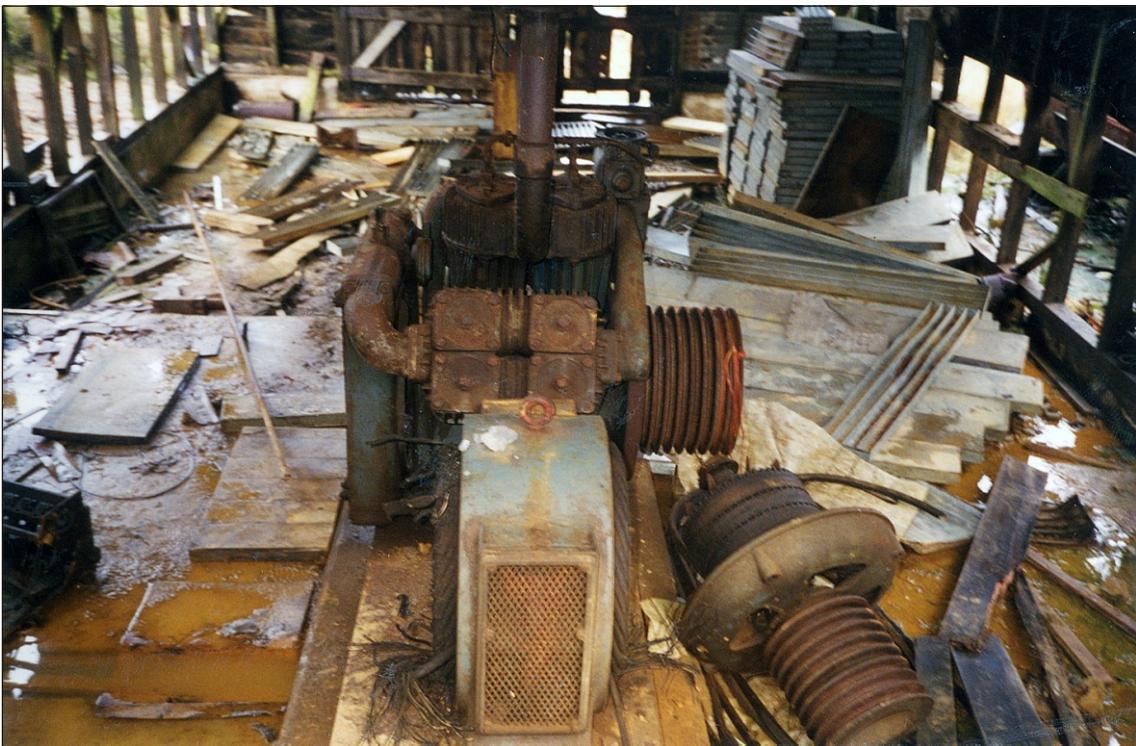
Plate 33

The Ingersoll Rand compressor still remains in position in the north central section of the shed, although some external components have been removed. The main air pipe linking the compressor to the pressure receiver located immediately west of the shed is still intact.

Ingersoll Rand compressor within the shed.
