STORYS CREEK ACID DRAINAGE REMEDIATION

REPORT ON REMEDIATION WORKS AUTUMN 2000

JULY 2000

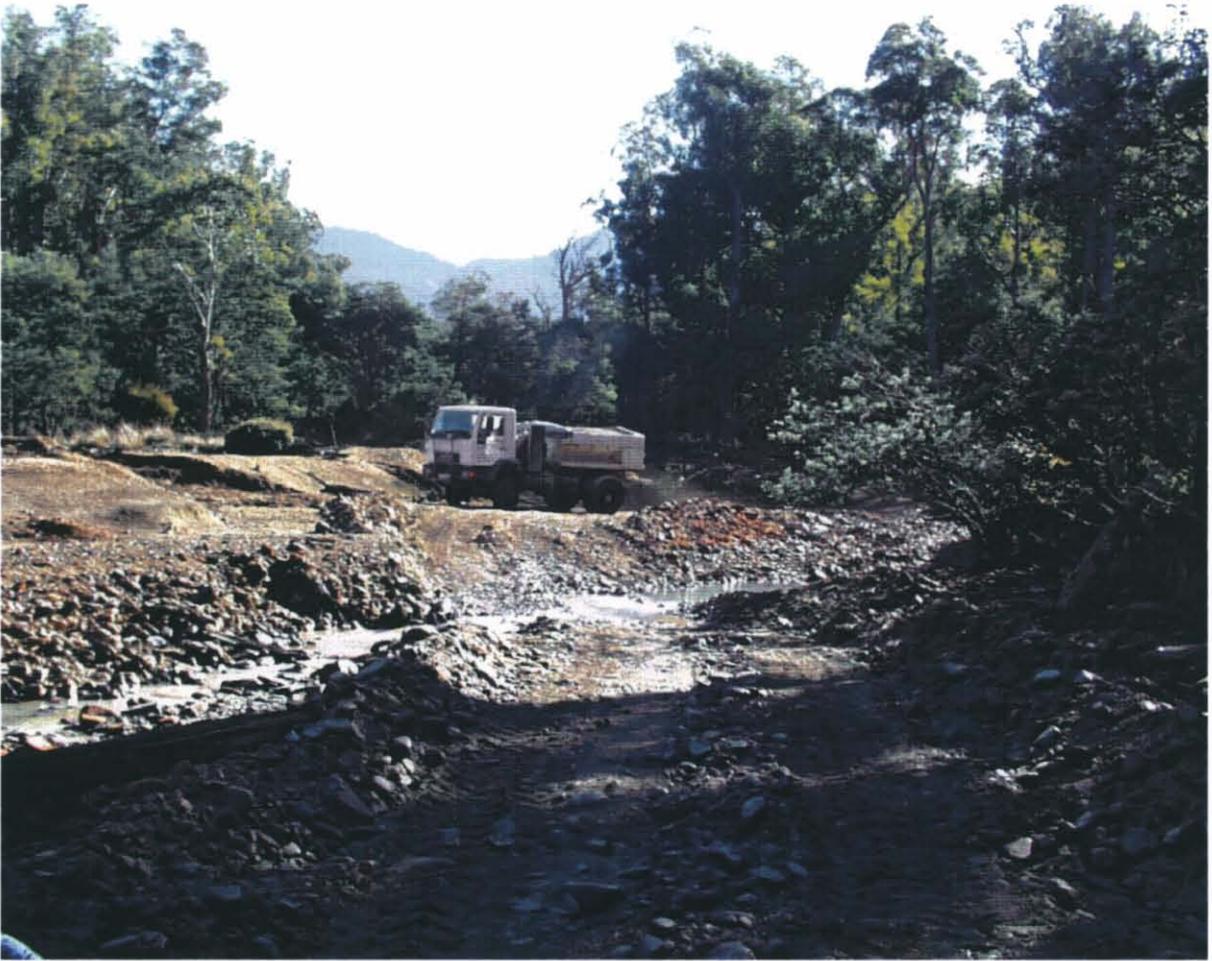
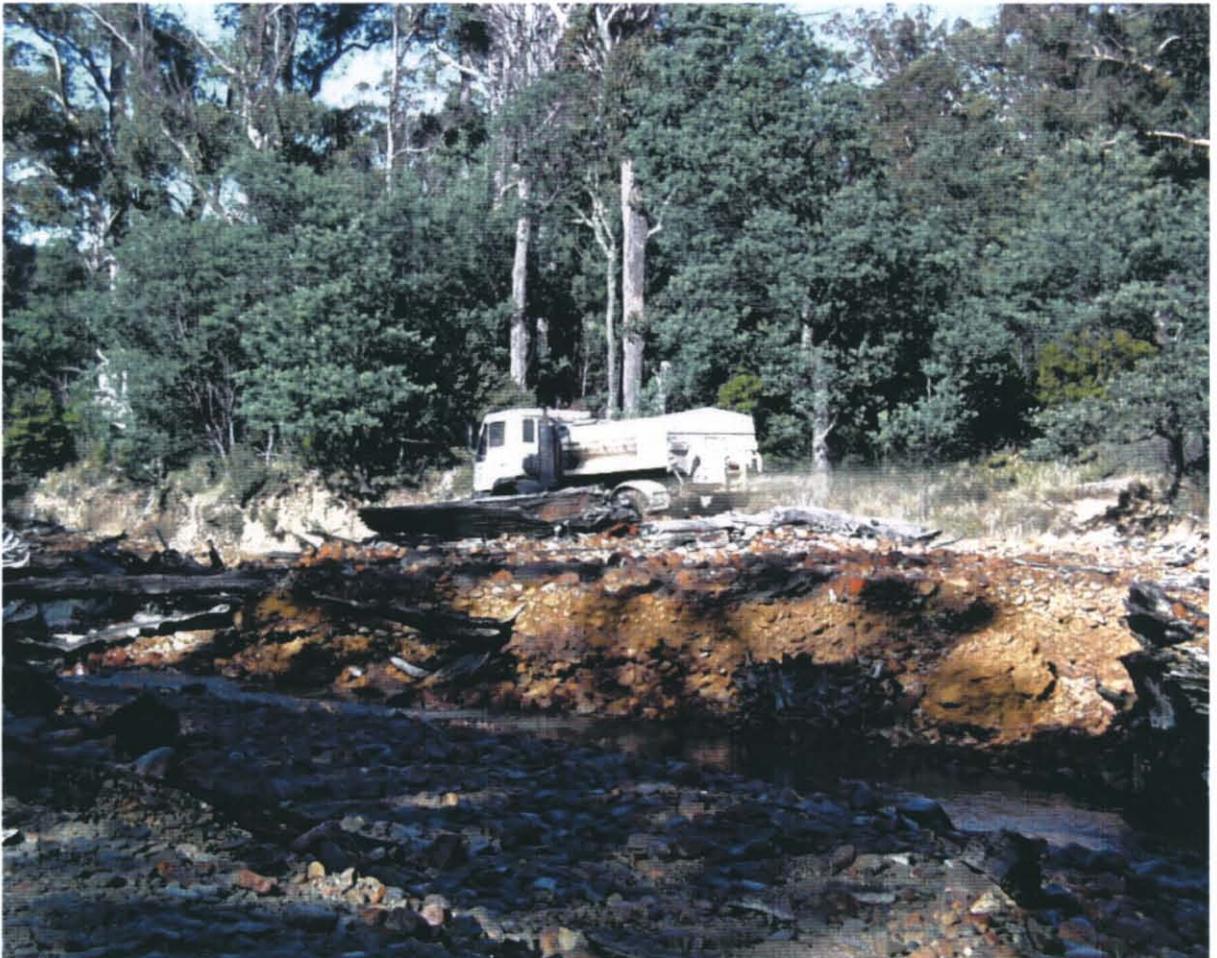
Spreading limestone in Storys Creek

A total of 170 tonnes of limestone was applied over accessible areas by a MAN fertiliser spreader (see Figure 4). Most areas were treated, however some were impractical to treat because of access and topography.

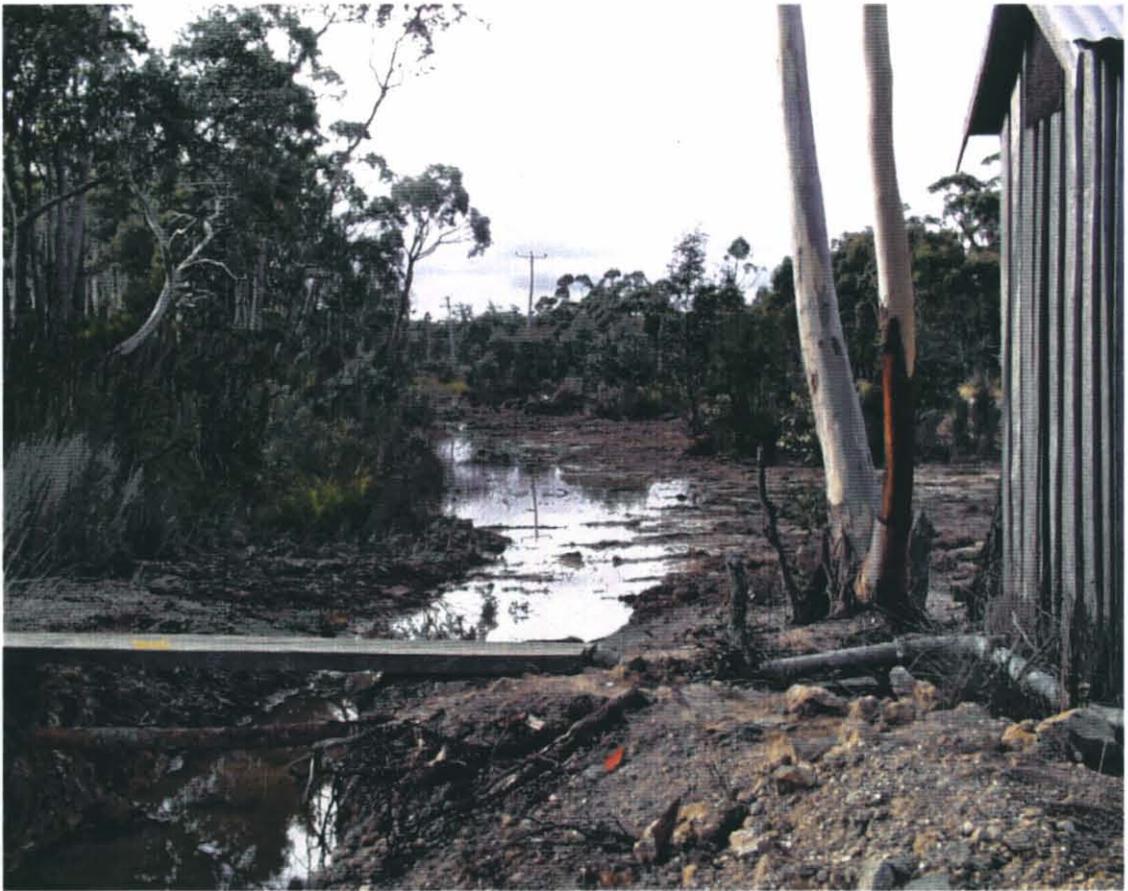
April 2000. Rossarden Water Supply Dam Drain Clay filled

It had been noted that the embankments of the water supply dam were leaking and seepage was ponding in channels around the embankments. A channel was excavated to drain the area and the channel on the eastern side excavated and backfilled with clay to provide free draining and cover bedrock (see Photographs). Excavated materials were used to construct a wetland in the Precipitate Dam area.

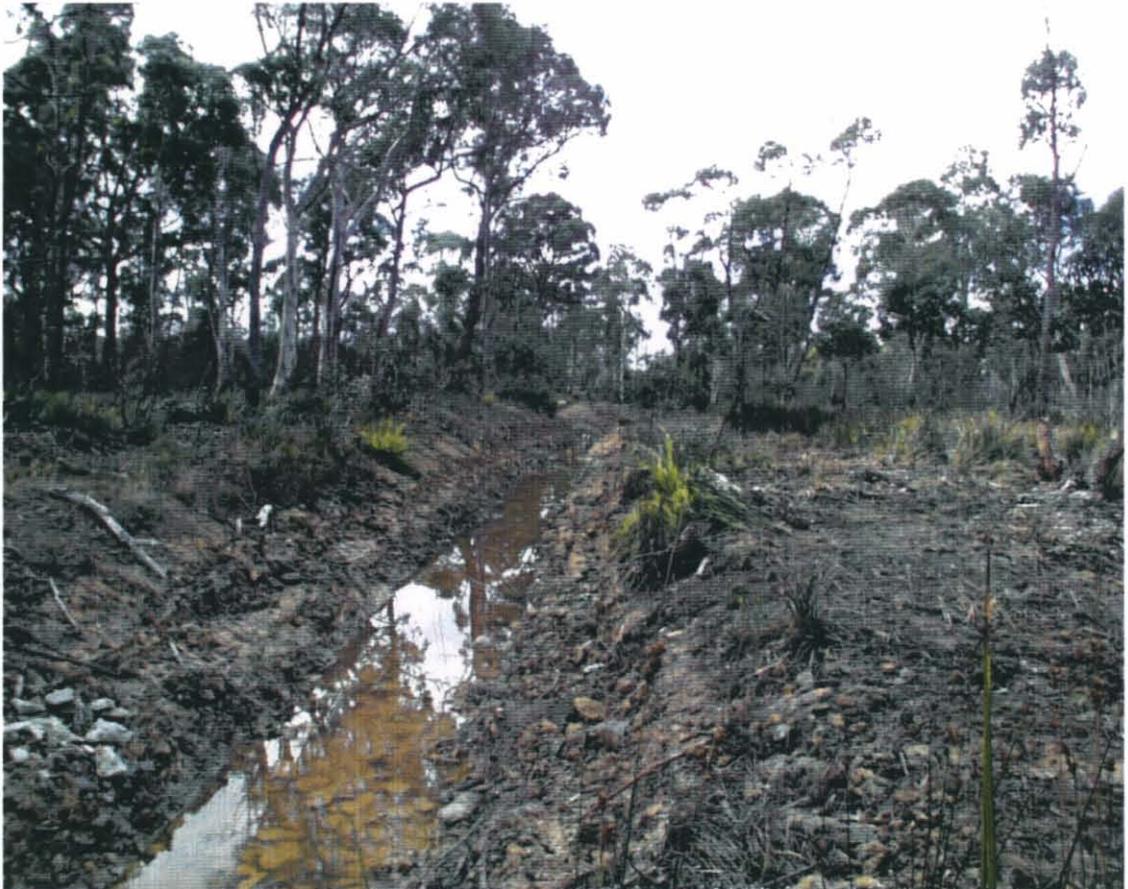
April 2000. Rossarden Water Supply Dam Drain
