STORYS CREEK

PRECIPITATE DAM RELOCATION CONSTRUCTION REPORT

JUNE 2000

Mineral Resources Tasmania : Storys Creek
precipitate dam relocation construction report /
John Miedecke and Partners Pty Ltd 2000

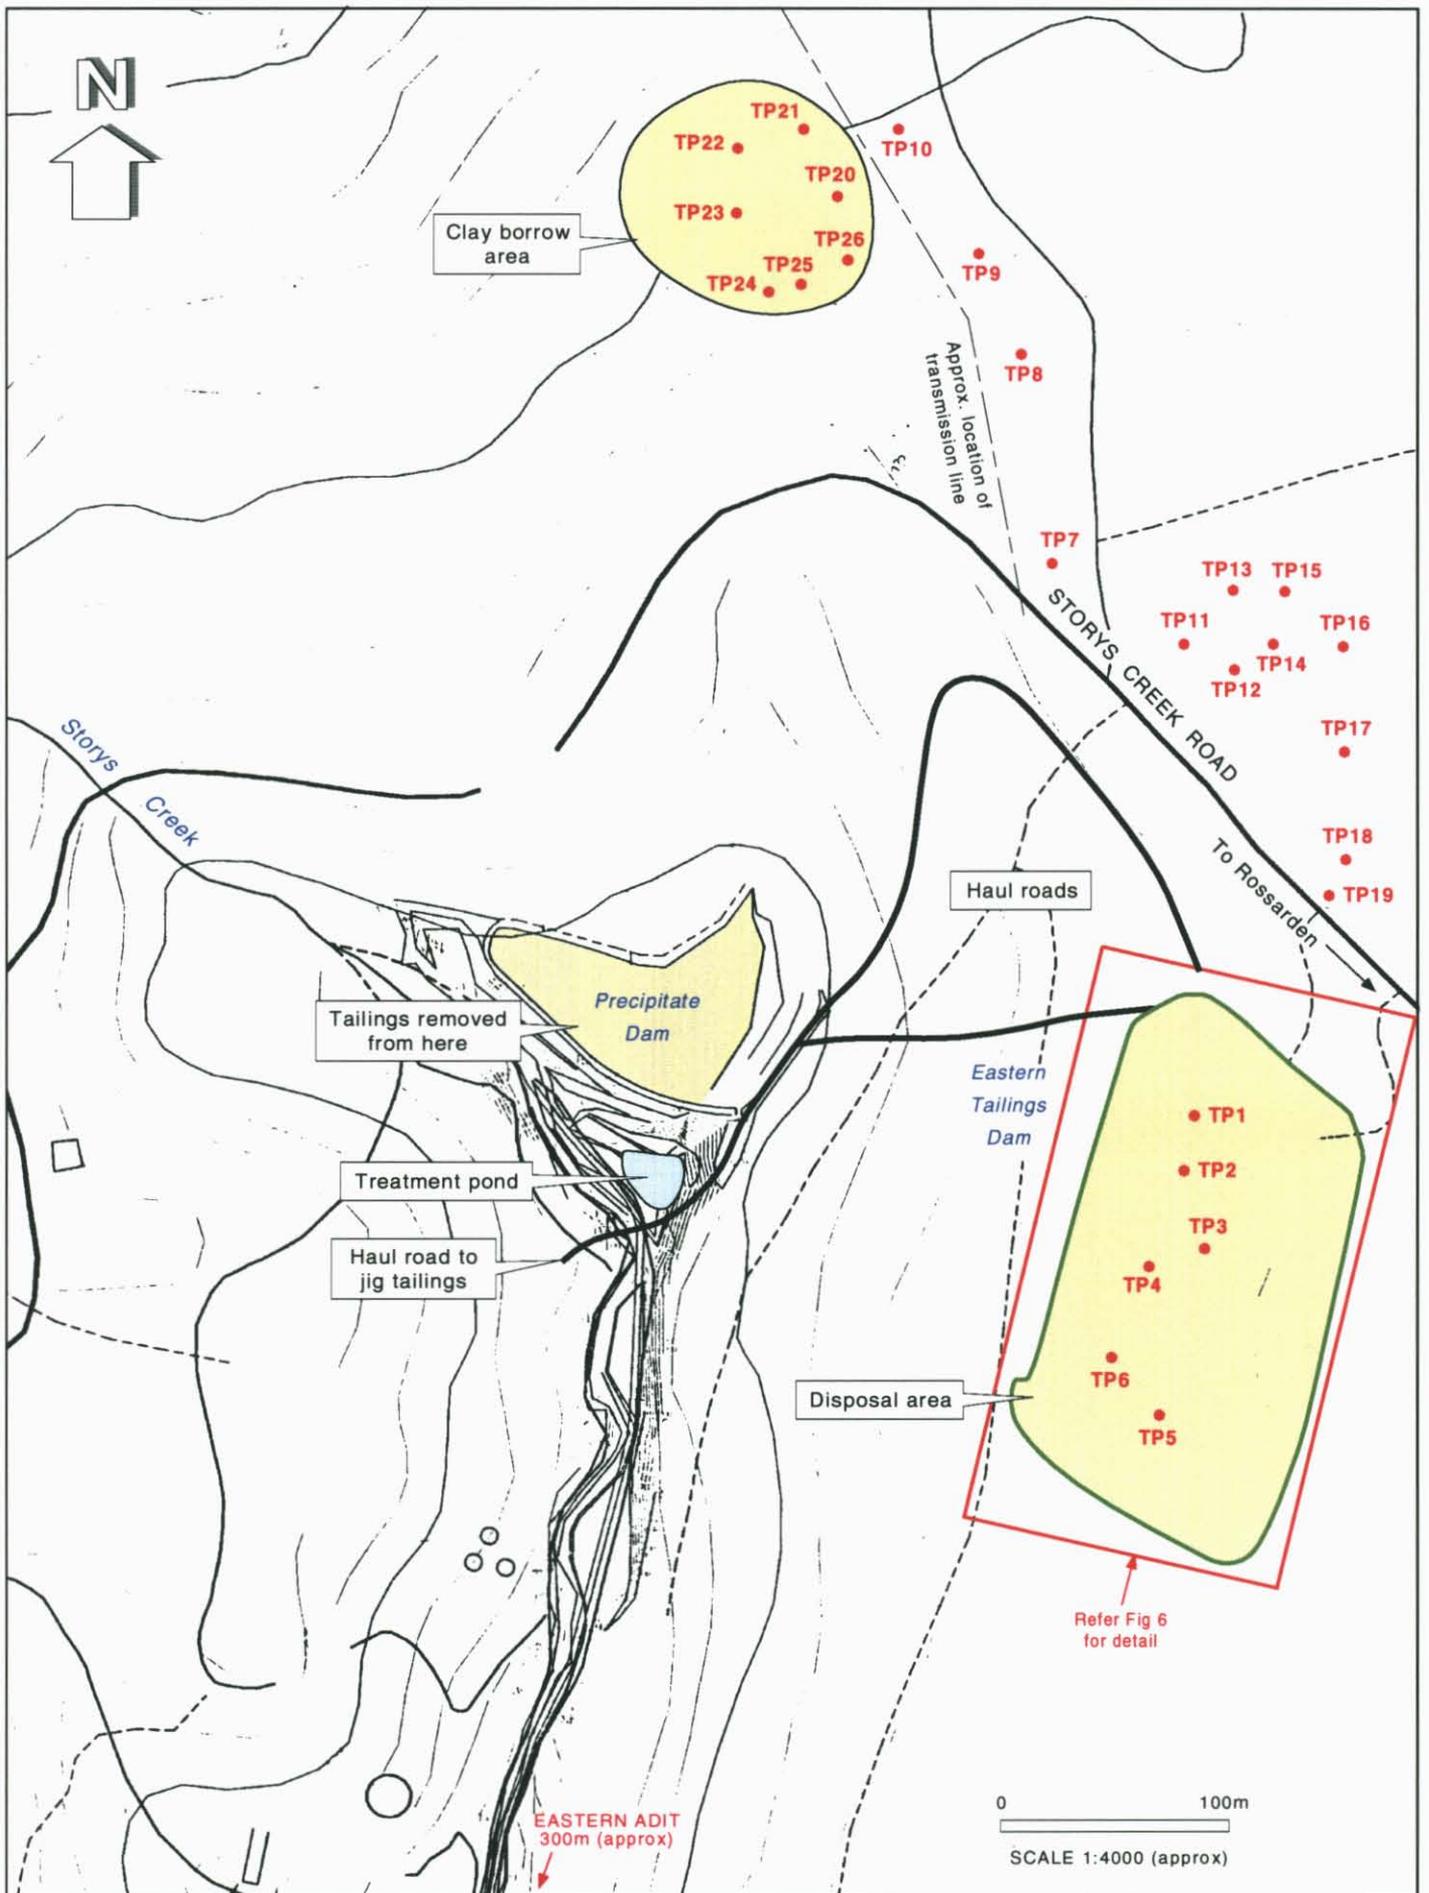
MINERAL RESOURCES TASMANIA	
Storys Creek & Rossarden AD Remediation Projects Storys Creek Area Plan	
John Miedecke & Partners P/L	FIG 2

Figure 2 shows the location of the access roads, clay sources and water treatment pond.

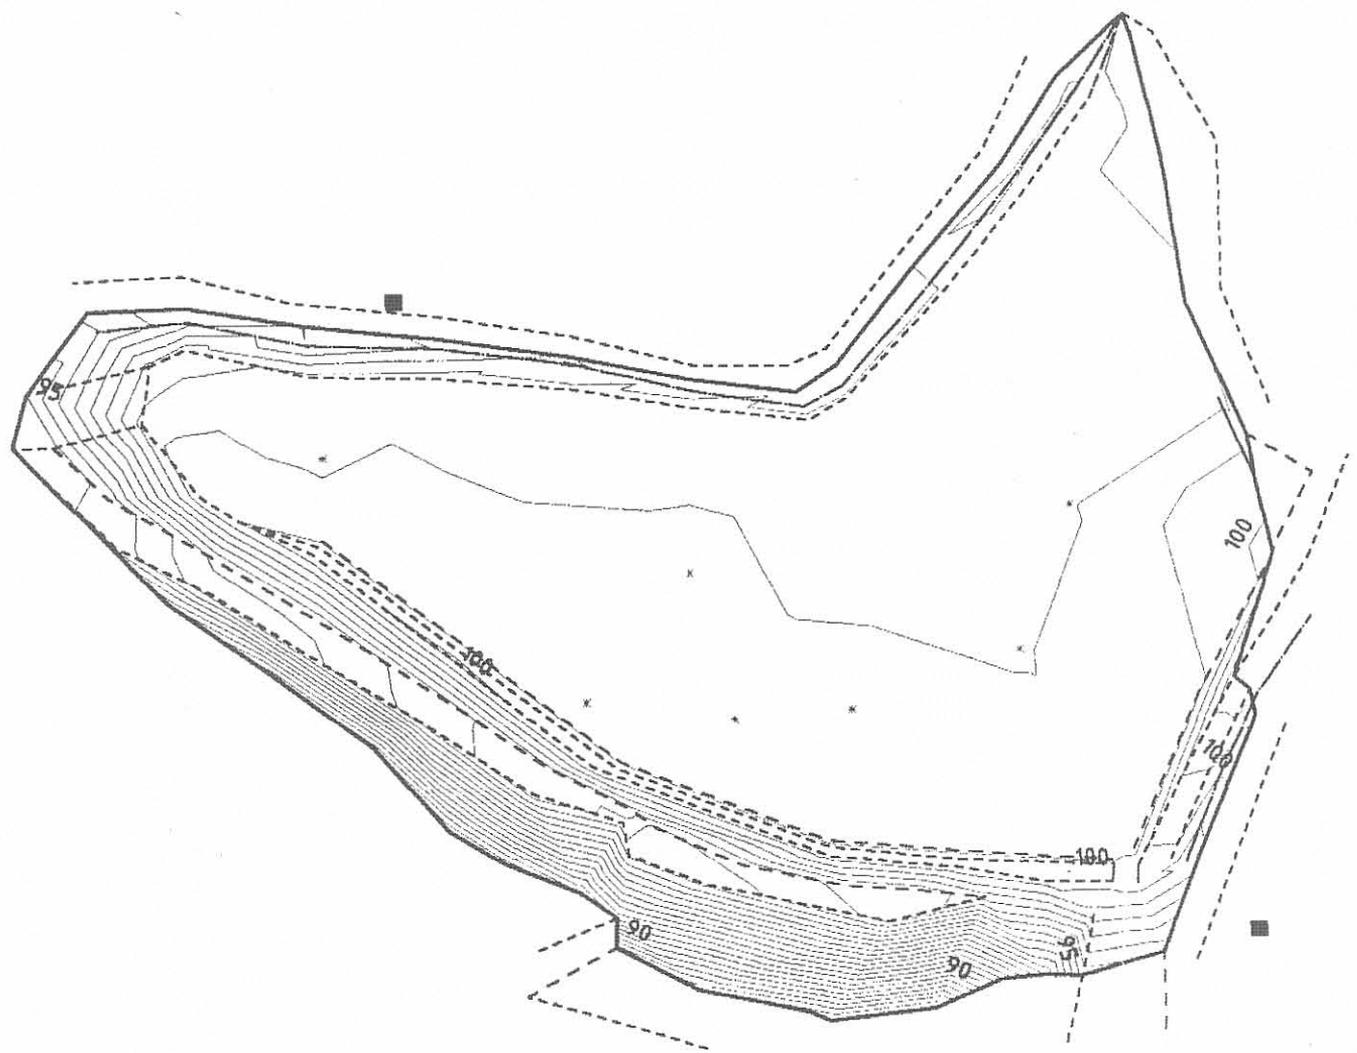
Storys Creek & Rossarden AD Remediation Projects
Precipitate Dam Plan - Prior to Removal

The Precipitate Dam was a storage impounded by an embankment which adjoined Storys Creek. Figure 3 shows a plan of the dam.

The estimate of the volumes was 64,000m³.

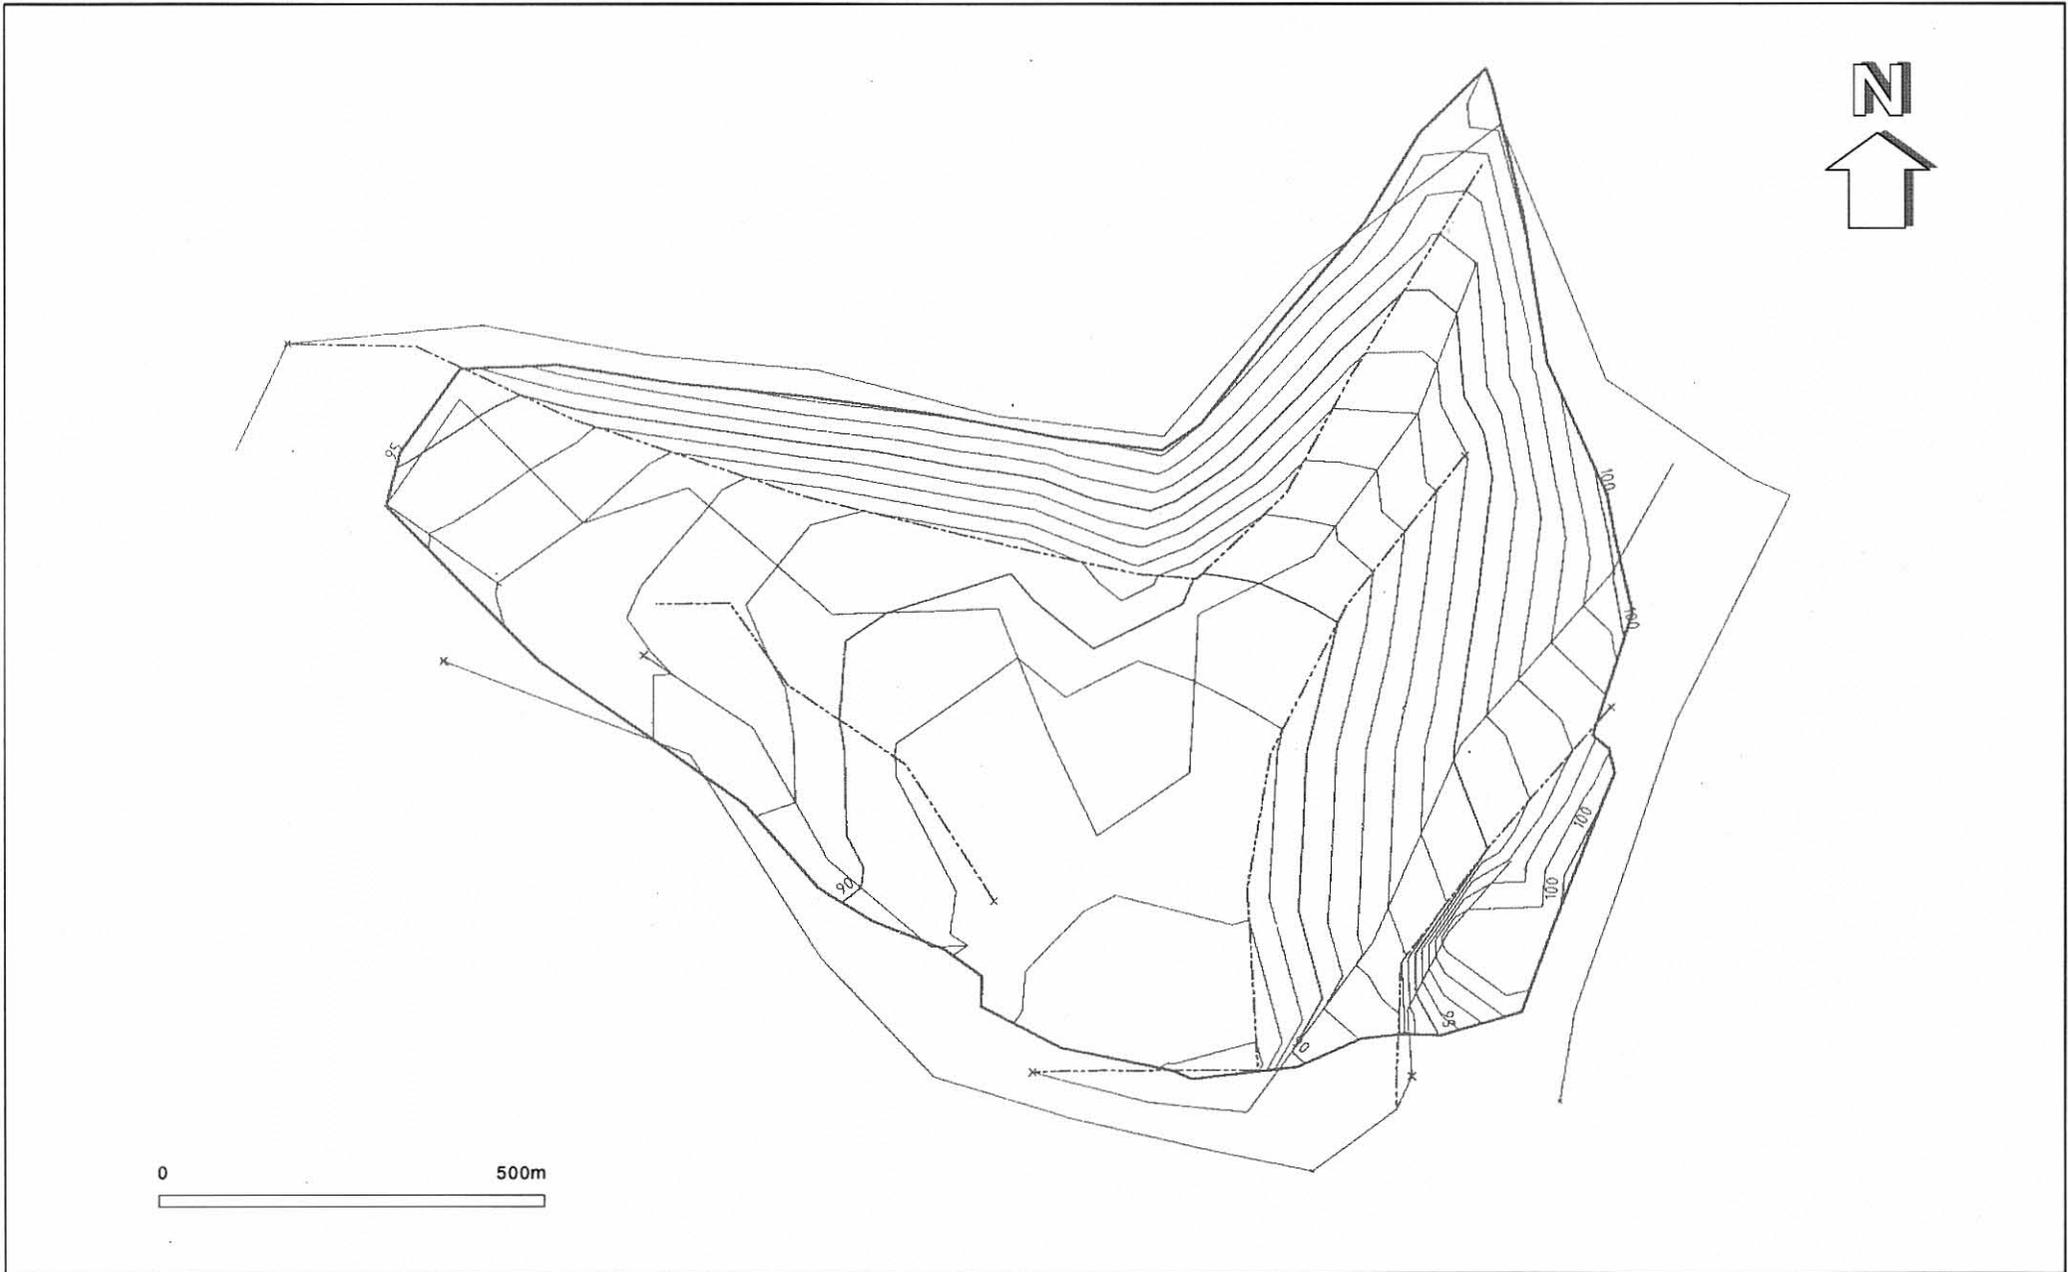
MINERAL RESOURCES TASMANIA
Storys Creek & Rossarden AD Remediation Projects
Precipitate Dam Plan - After Tailings Removal
John Miedecke & Partners P/L **FIG 4**

A topographic survey was carried out of the finished levels and the total volume removed calculated at 66,339 m³. This compared well with the estimate of 64,000m³. The as constructed surface after removal of the tailings is shown in Figure 4.

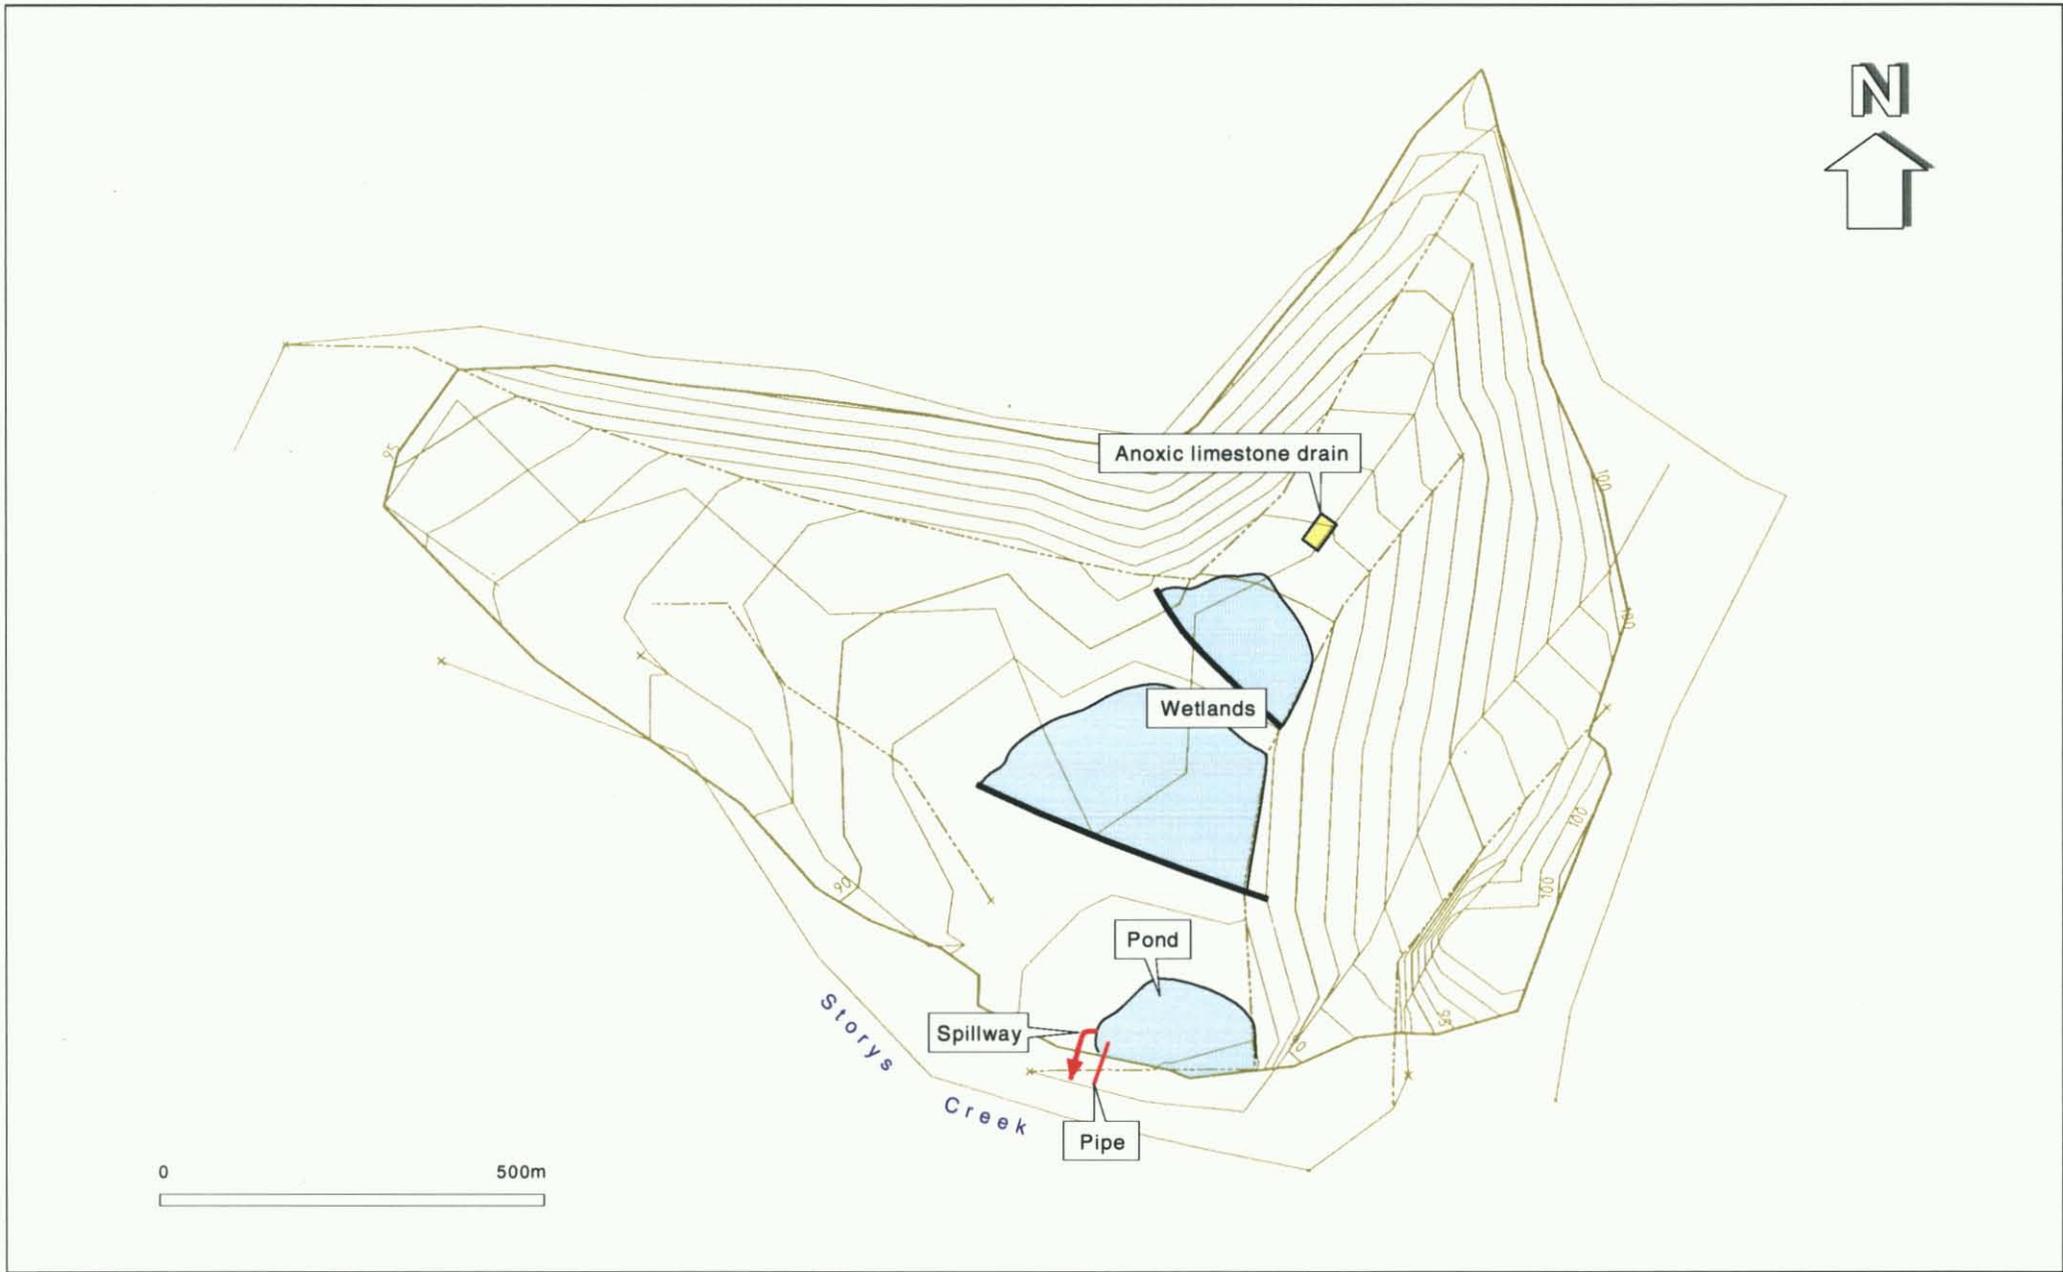
MINERAL RESOURCES TASMANIA	
Storys Creek & Rossarden AD Remediation Projects Precipitate Dam - Wetlands and Ponds	
John Miedecke & Partners P/L	FIG 5

The base of the dam was subsequently flooded with the creation of two wetlands developed by the building of two low embankments (as additional works separate to the contract), and anoxic limestone drain. This provided for the flooding of the tailings materials remaining to stop oxidation and acid generation. The original creek alignment was re-established.

Figure 5 shows the base of the dam and the constructed wetlands and anoxic limestone drain.

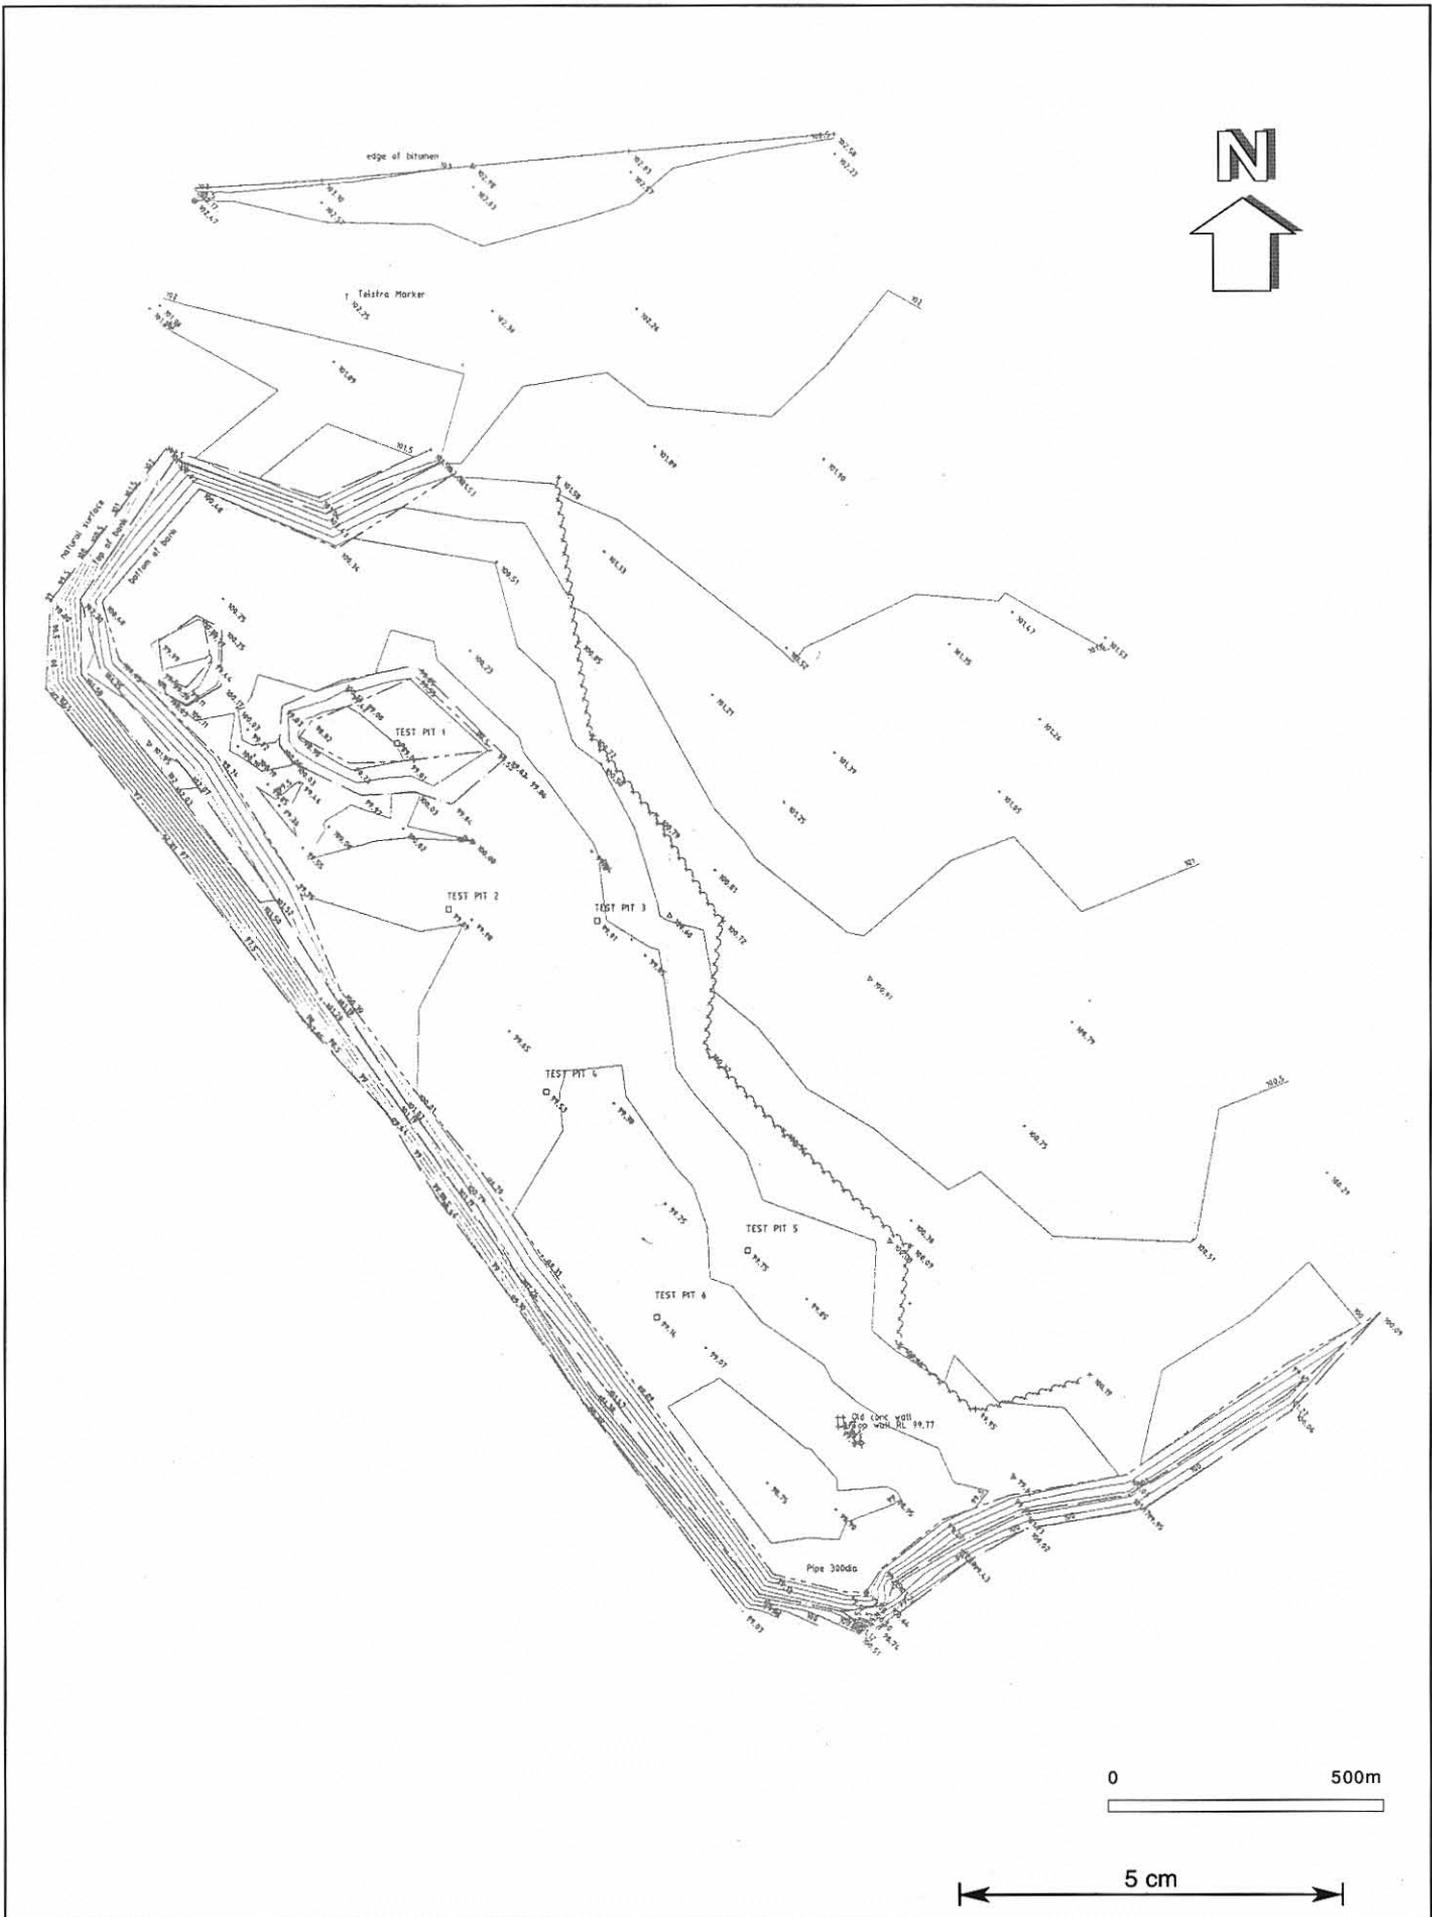
MINERAL RESOURCES TASMANIA	
Stories Creek & Rossarden AD Remediation Projects Tailings Disposal Area - Prior to Construction	
John Miedecke & Partners P/L	FIG 6

A detail survey prior to works is shown in Figure 6.

The site occupied an area of approximately 2.3 ha. The topsoil and subsoil has been previously removed and formed an embankment around the site. These materials were suitable for return and reuse as a growth medium.

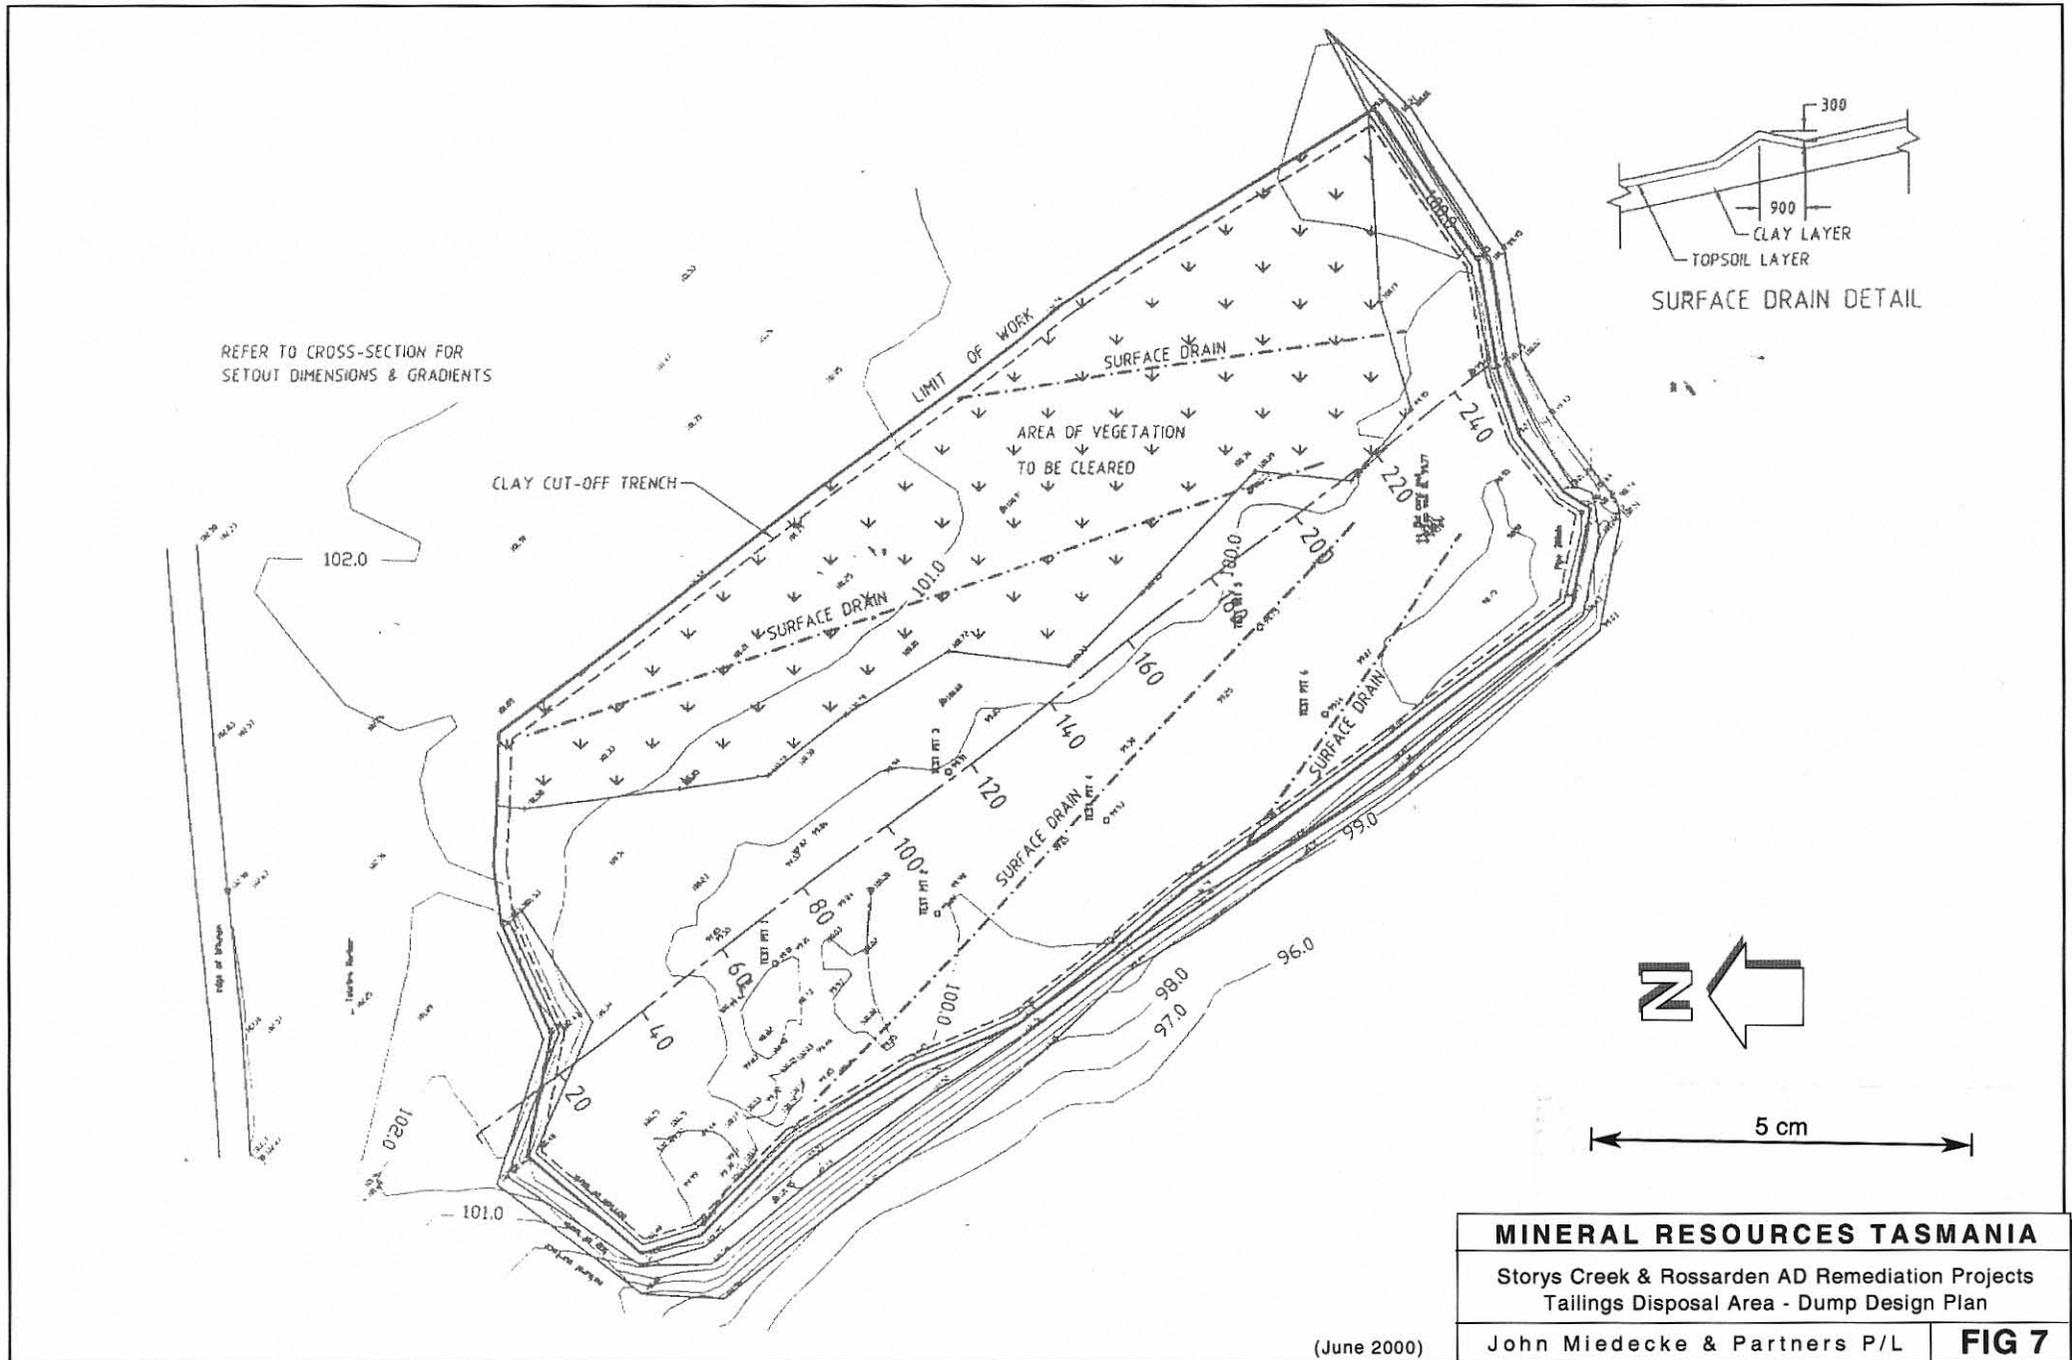
MINERAL RESOURCES TASMANIA	
Storrs Creek & Rossarden AD Remediation Projects Tailings Disposal Area - Dump Design Plan	
John Miedecke & Partners P/L	FIG 7

The design was as a mound with side slopes consisting of between 1:4 and 1:6 side slopes, with a surface area of approximately 2.3 hectares. Figures 7 and 8 show the design plan and sections of the proposed storage. The slopes graded into

The boundaries of the storage was excavated through the existing tailings (on the western side into basement material to form a key and leachate barrier. This excavation was backfilled with clay (see Figures 7 and 8).

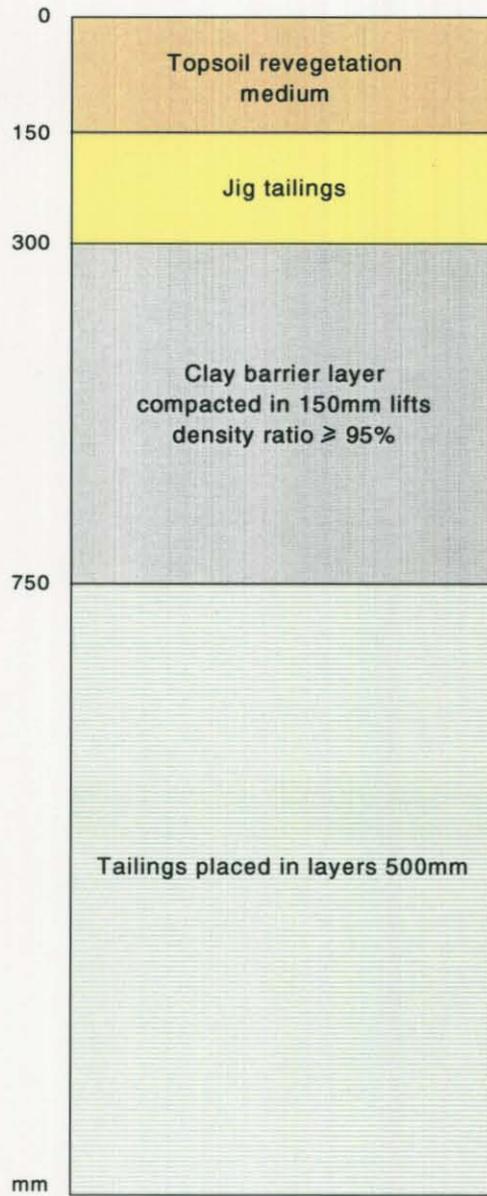
FIG 9

The cover design provided for a 150mm of topsoil/ growth medium, a 150mm of sands/gravel drainage layer and 450mm of compacted clay over 200mm of gravel/sands track rolled as a cover of the tailings. The cover was to be keyed into bedrock on all sides.

The clay source was to have been in an area adjoining the transmission line, adjacent to the previous borrow area (see Figure 2). However, further investigations showed that this area had only relatively shallow clay zones. Clay lenses were found between the HEC transmission line adjoining the disposal site and the site itself. This area was subsequently cleared and topsoils and clays removed and directly placed on the tailings surface. Figure 9 shows the cover over the tailings, as constructed.

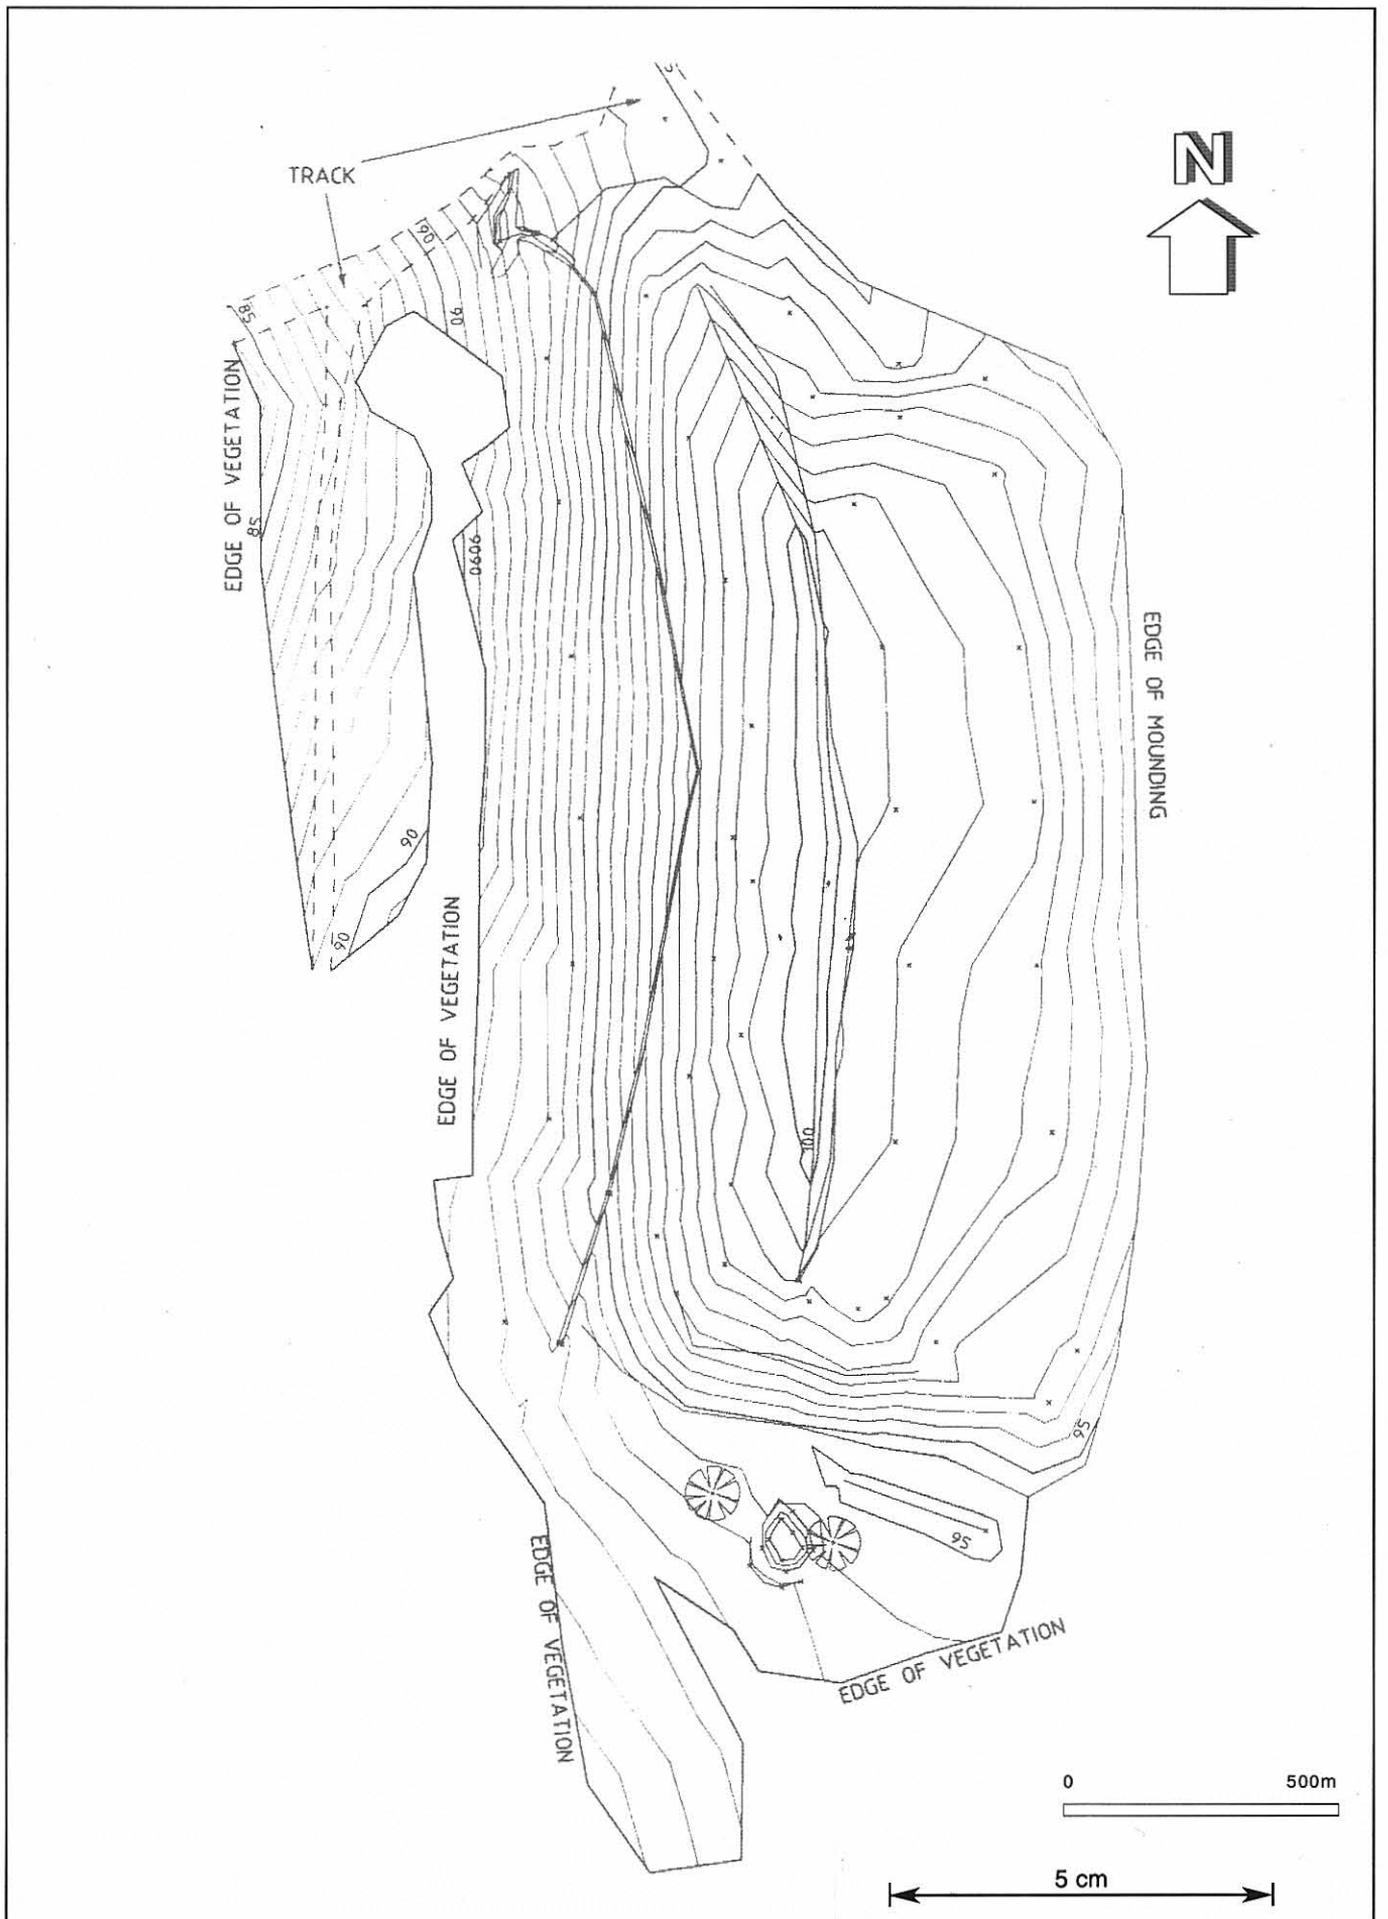
MINERAL RESOURCES TASMANIA	
Storrs Creek & Rossarden AD Remediation Projects Tailings Disposal Area - As Constructed	
John Miedecke & Partners P/L	FIG 10

The final topsoil layer was placed with a dozer using materials from the area to the west. A drainage berm was established to control drainage and directed to natural surface. Vegetation previously cleared and stockpiled was also placed on the storage surface prior to revegetation (see Figure 10).

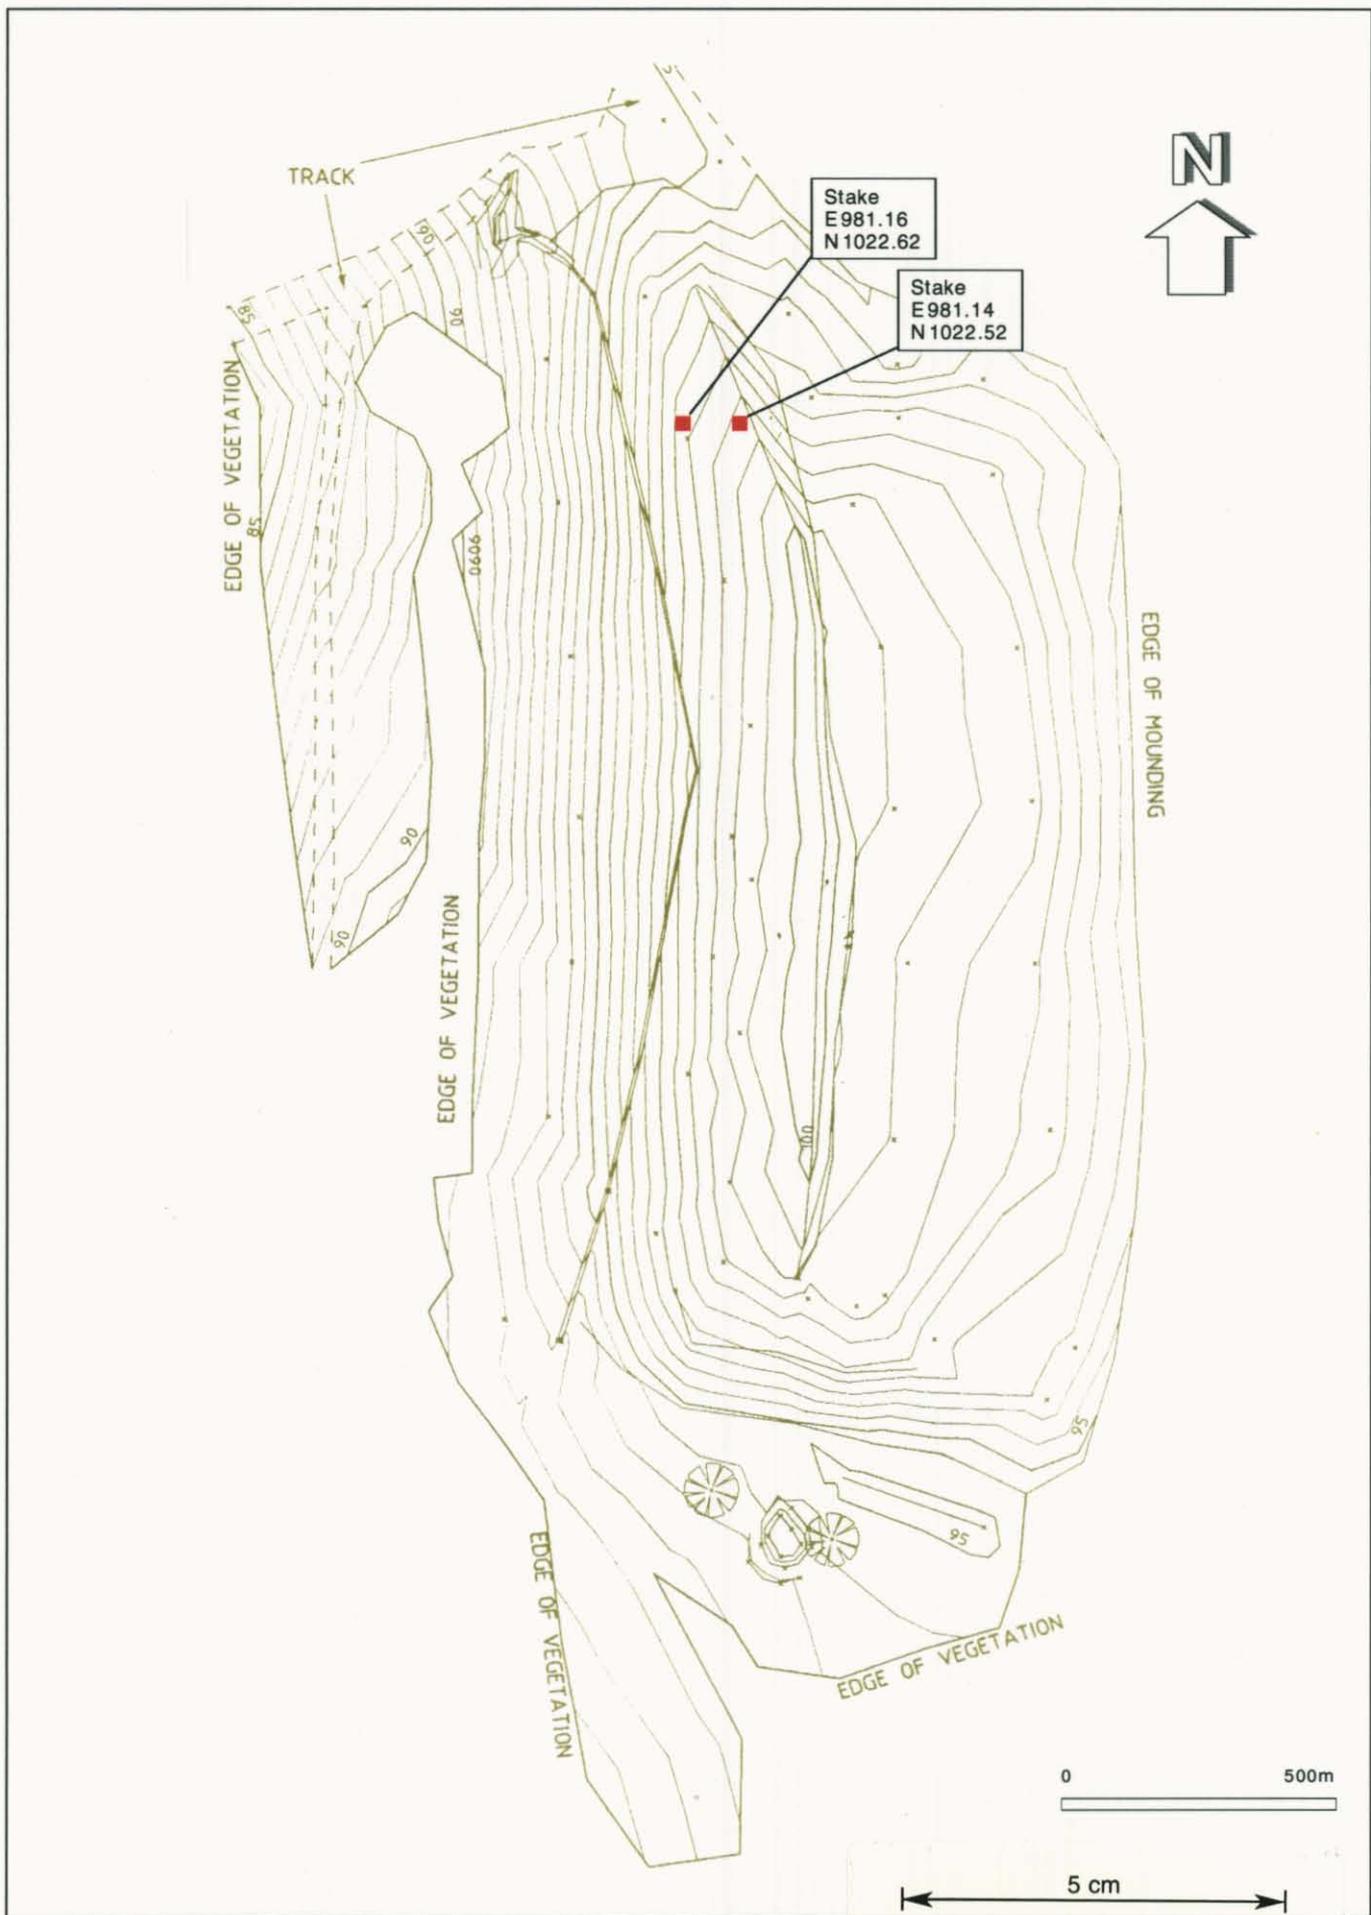
MINERAL RESOURCES TASMANIA
 Storys Creek & Rossarden AD Remediation Projects
 Lysimeter Locations
 John Miedecke & Partners P/L **FIG 11**

Two lysimeters were installed at the northern end of the dump. These consisted of two HDPE water troughs, filled at the bottom with sand and then buried in the tailings material. The lysimeters are drained by pipes to two containers placed in the base of a large tree. It is proposed that the quantity of leachate will be monitored to establish infiltration through the cover (Figure 11 shows the location).

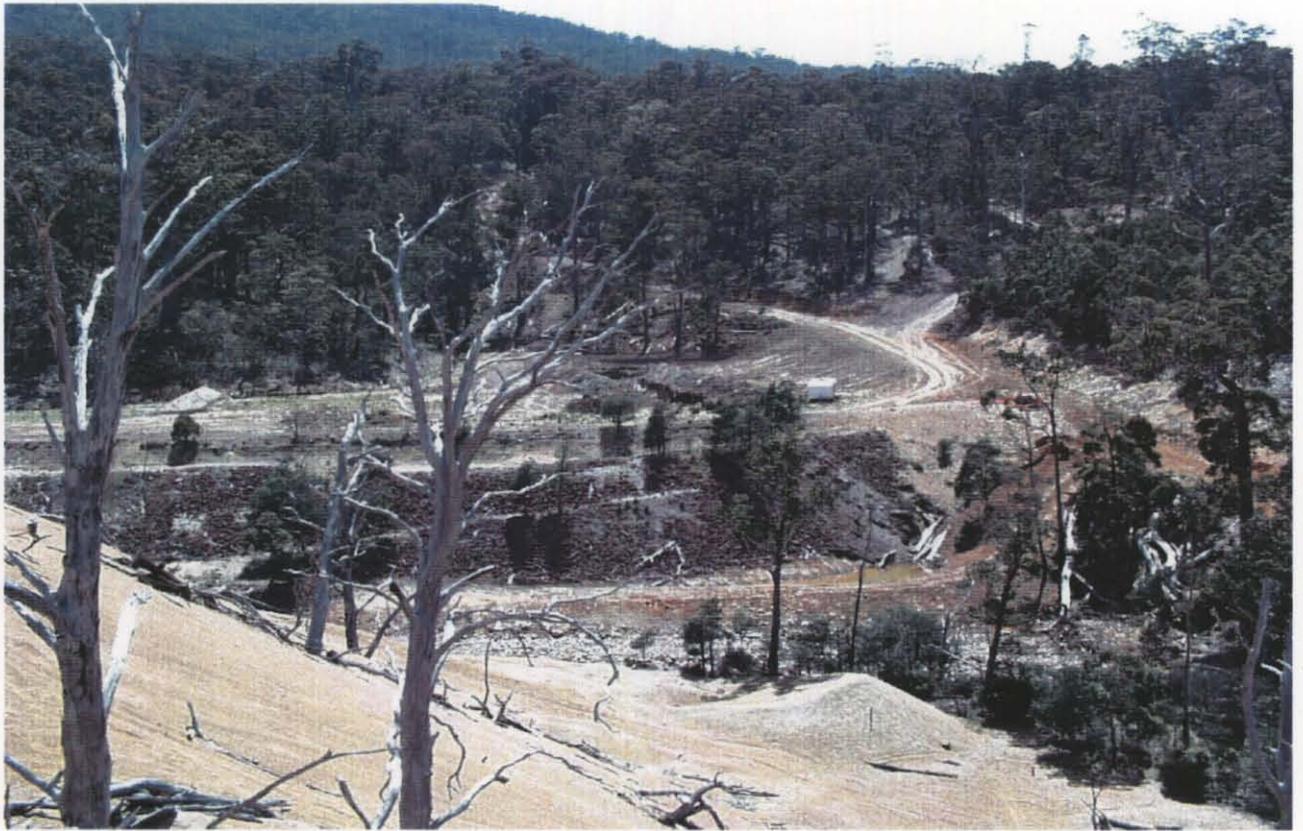
Dec 1999 Precipitate Dam - Drainage channel commenced
