STORYS CREEK

PRECIPITATE DAM RELOCATION CONSTRUCTION REPORT

JUNE 2000

Mineral Resources Tasmania : Storys Creek
precipitate dam relocation construction report /
John Miedecke and Partners Pty Ltd 2000

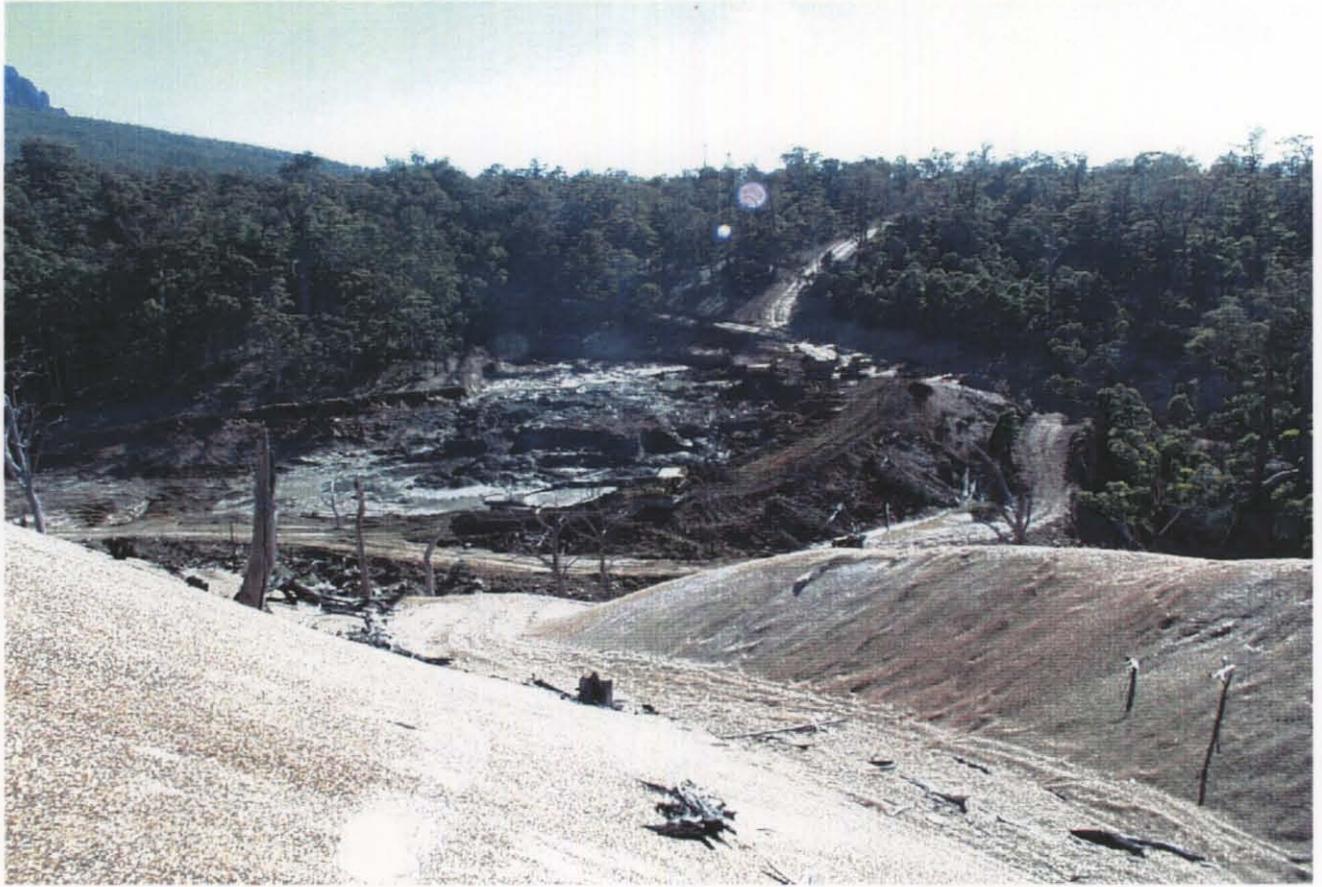
Feb. 2000. Precipitate Dam - Tailings removal underway. Tailings allowed to consolidate

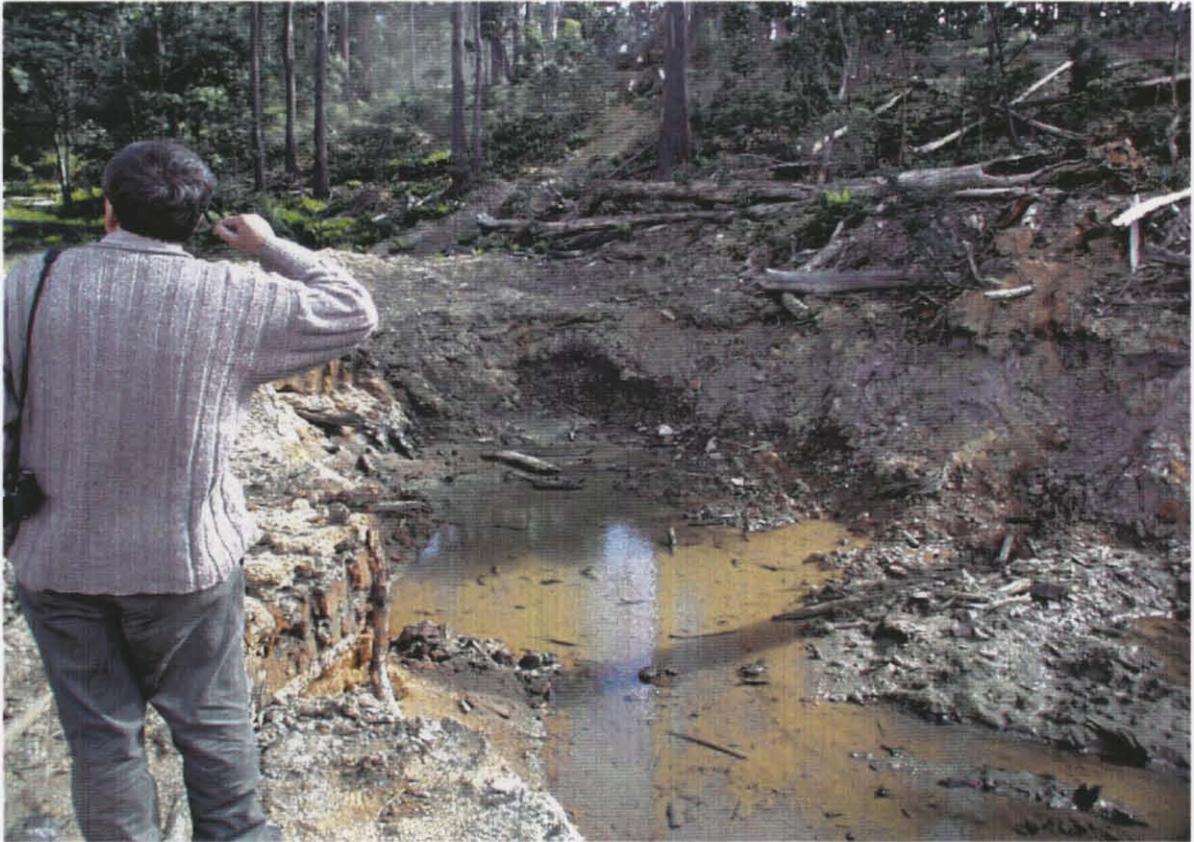
A continual seepage was noted in the NE corner of the storage along the alignment of the creek (see photographs). This explains the failure of the previous works attempts to cap the tailings and reduce infiltration. A cut off trench should have been constructed to intercept subsurface flows down the creek and this may have been effective in reducing water inflows.

Jan 2000. Precipitate Dam - seepage in NE area near creek inflow. A cutoff drain may have prevented this saturating the tailings.

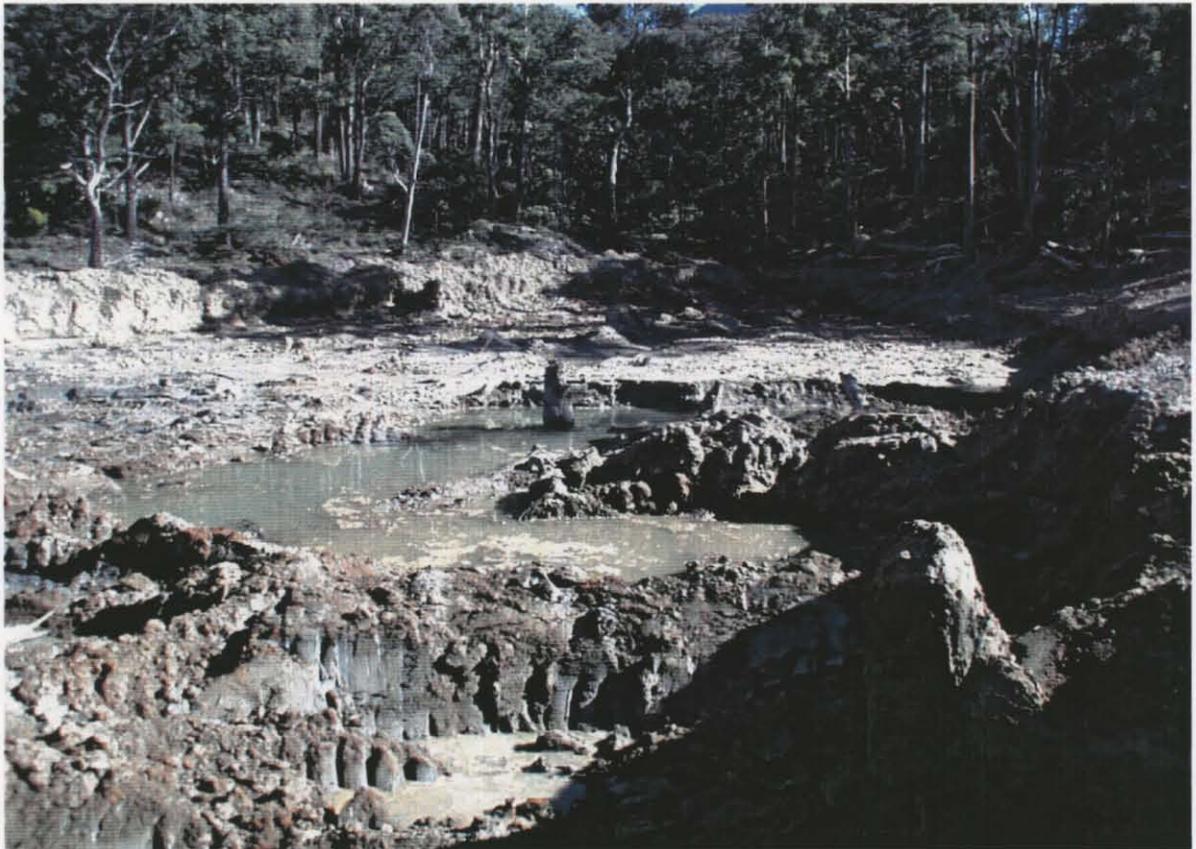
The contractor had few problems in completing the contract. The major problem area was draining the tailings sufficiently to allow machinery access. Drainage channels were excavated through the tailings and the materials progressively drained and allowed to consolidate.

After removal of the coarser materials near the wall and the NW of the storage, a zone of fine saturated tailings required a period for consolidation to allow machinery access. Removal of tailings was suspended for four weeks in February and March.

Feb 2000. Precipitate Dam - seepage and saturated tailings. This required cessation of work and drainage.

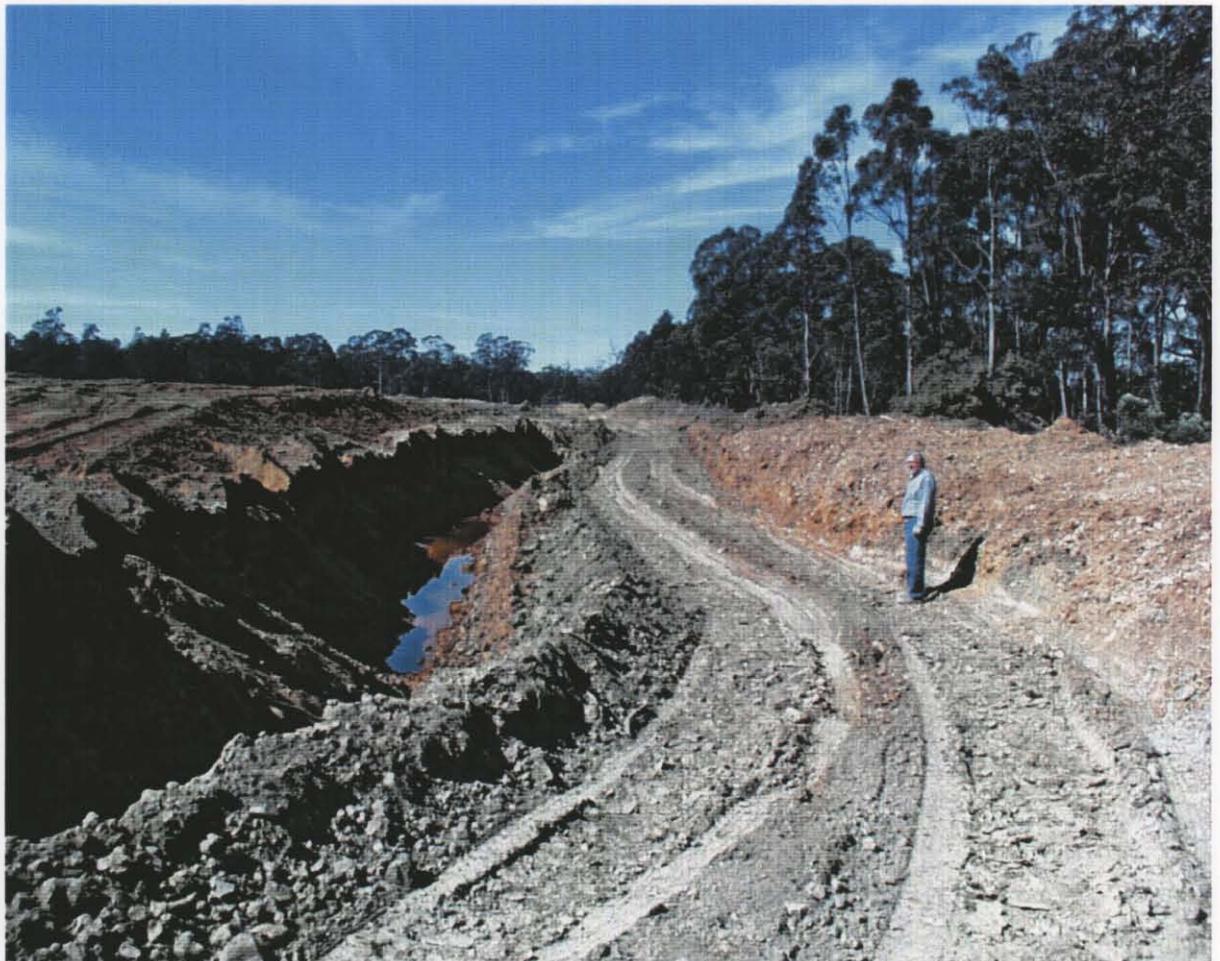
Dec 2000. Disposal Site - Clay Cut off construction

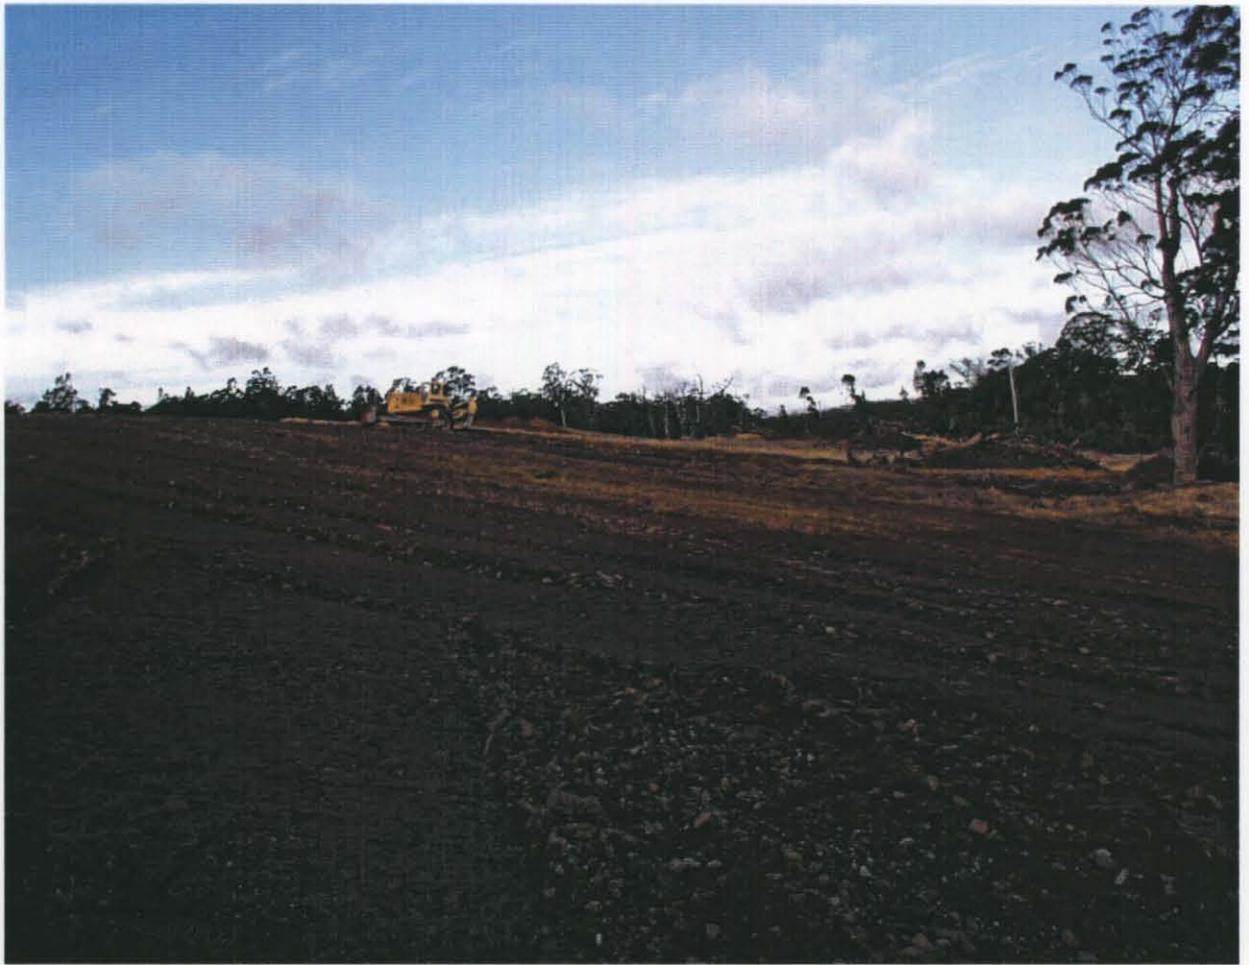
May 2000. Disposal Site - Shaping of clay cap

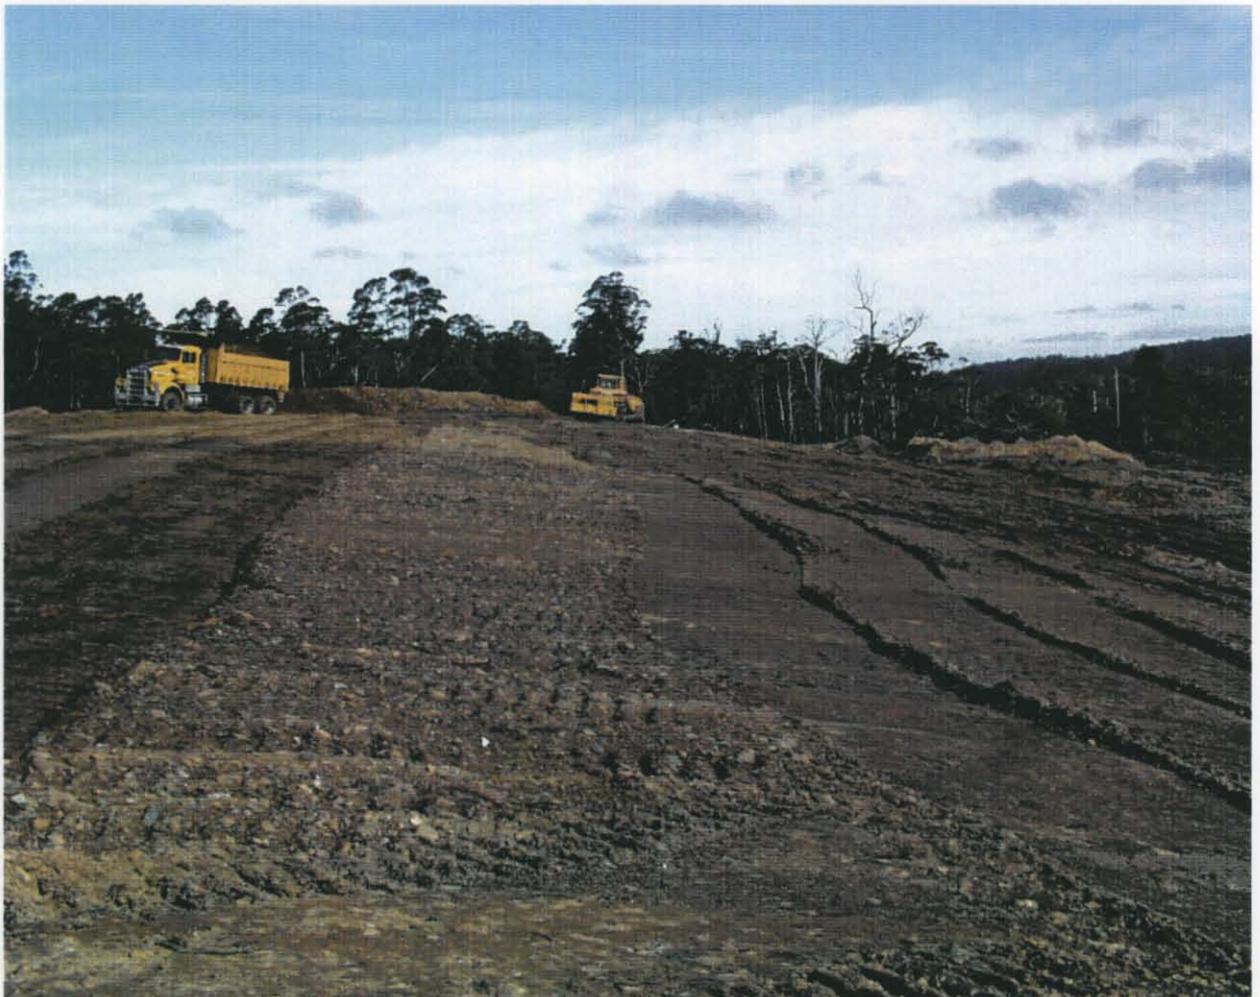
The clay capping was placed in layers to a minimum 95% compaction and keyed into bedrock through the underlying tailings materials. A compaction test section was constructed and tested by BFP Consultants using a nuclear densometer.

May 2000. Disposal Site - Compaction of clay cap

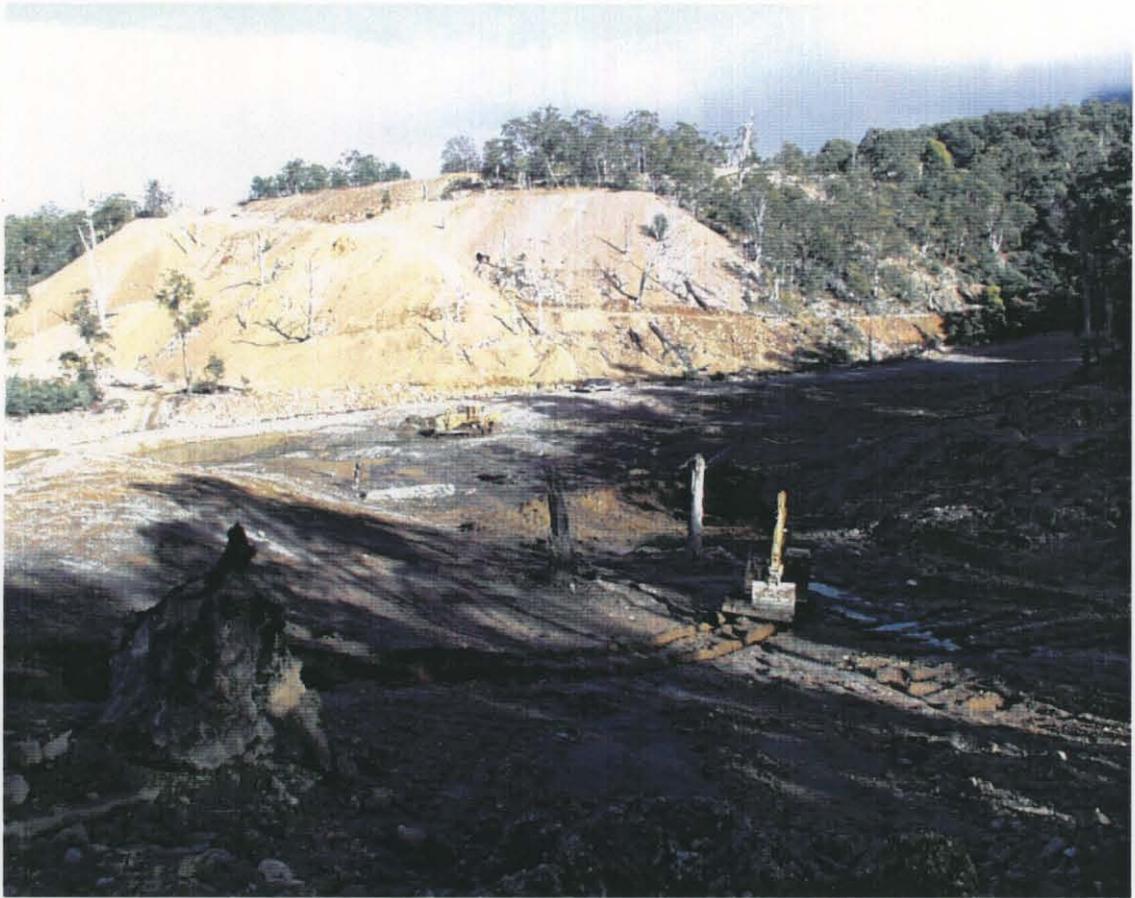
May 2000. Precipitate Dam - Wetland construction

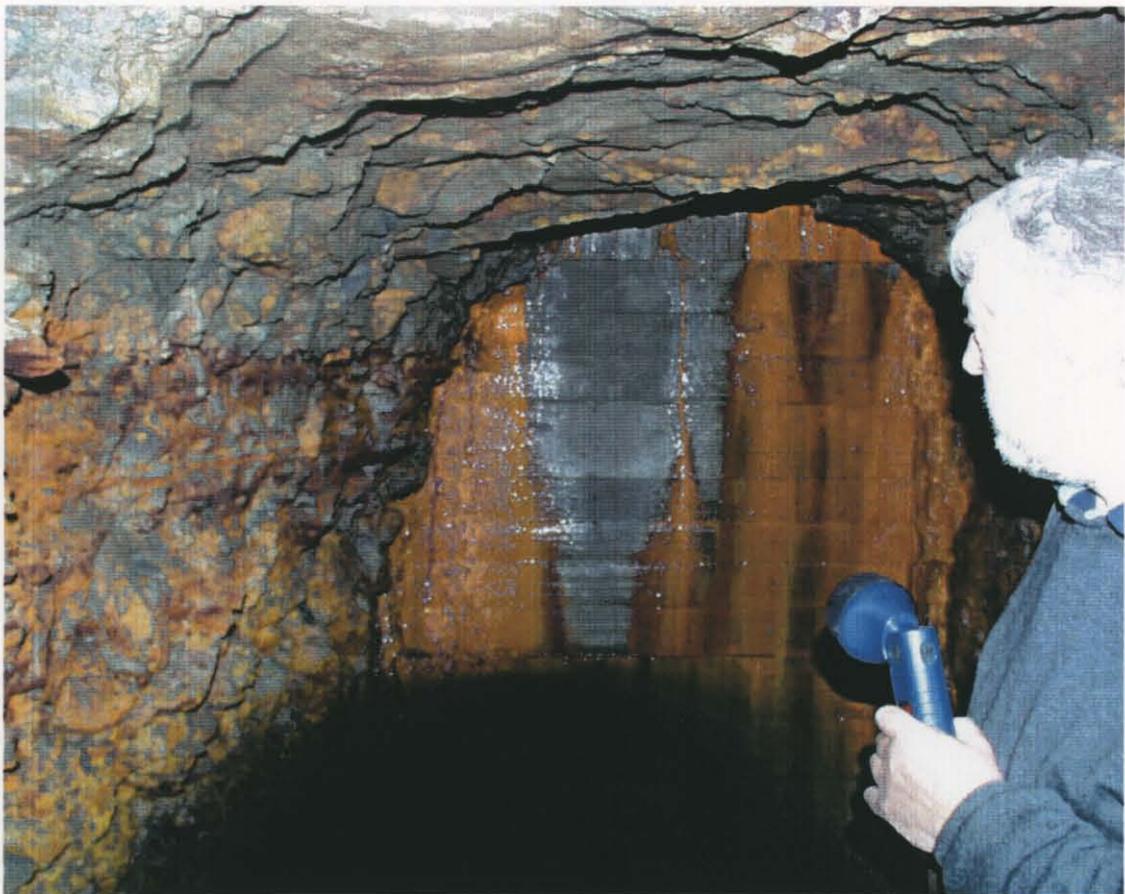
The work was completed in February 2000. After capping of the pipe, the plug developed several leaks at the edges of the plug and the contractor drained the adit and grouted the leaks in the plug. After refilling, several small leaks in another location and the procedure was repeated before final capping. The leaks were attributed to minor movement in the formwork after placement of concrete.

May 2000. Eastern Adit Concrete Plug
