A proposed program to rectify severe gully erosion in the vicinity of Cat Gully, the Endurance Mine, South Mt Cameron, N. E. Tasmania.

Cat Gully Rehabilitation proposals -Endurance Mine, South Mt Cameron										TABLE 1		
Proposed works to alleviate severe gully erosion - Funded by the Rehabilitation of Mining Lands Trust Fund

South Mt Cameron
NE Tasmania
Mineral Resources
Tasmania
Sept. 2000

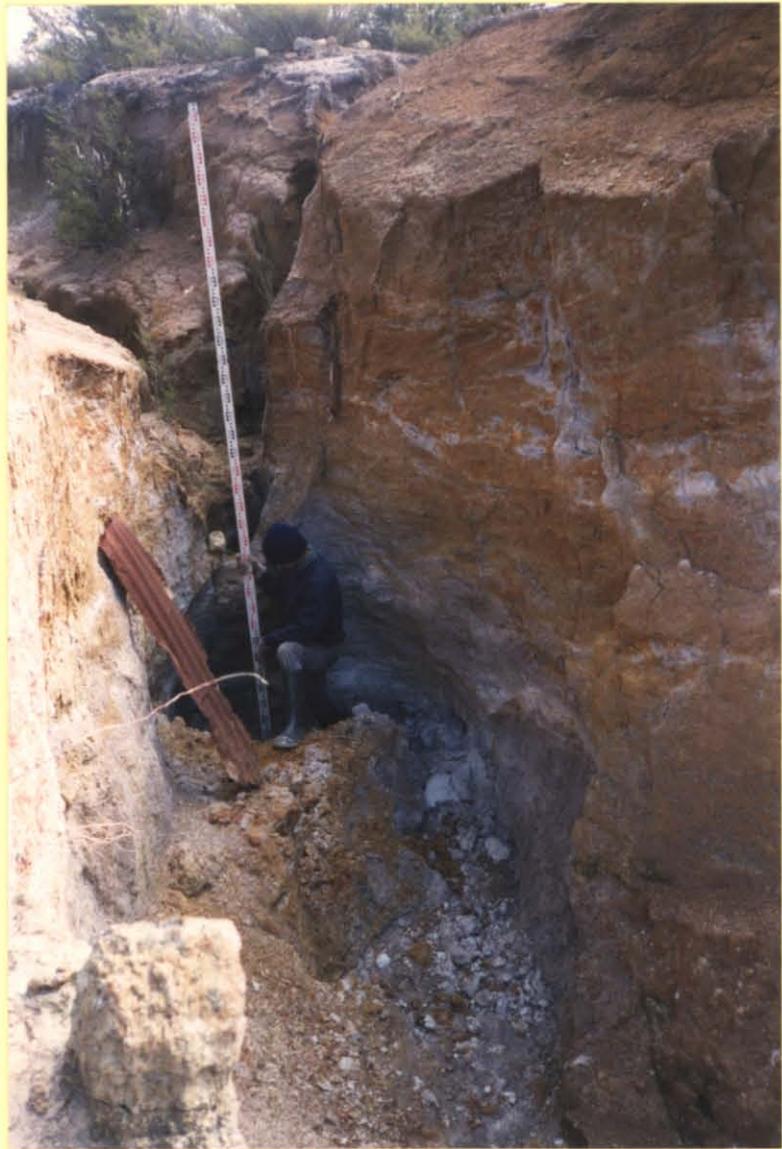
Photo 1 RIGHT>>>>>
Cat Gully Area
Gully B

old tail race
circa 1974

Shows 1.6m nick
point in the gully
cut back process.
In Quaternary
sediments

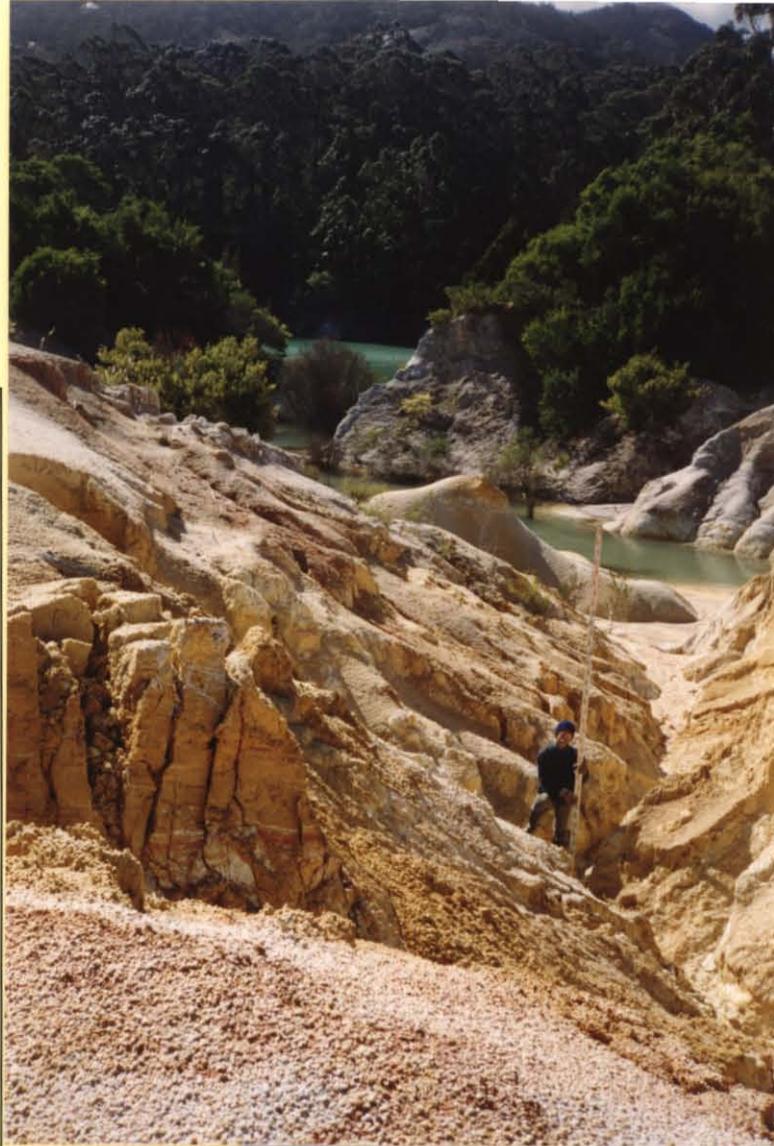
Photo 3 RIGHT>>>>>
Cat Gully Area
Gully F

Shows youthful
short gully, active
and close to Cat
Gully
Mt Cameron & Blue
Lake in background

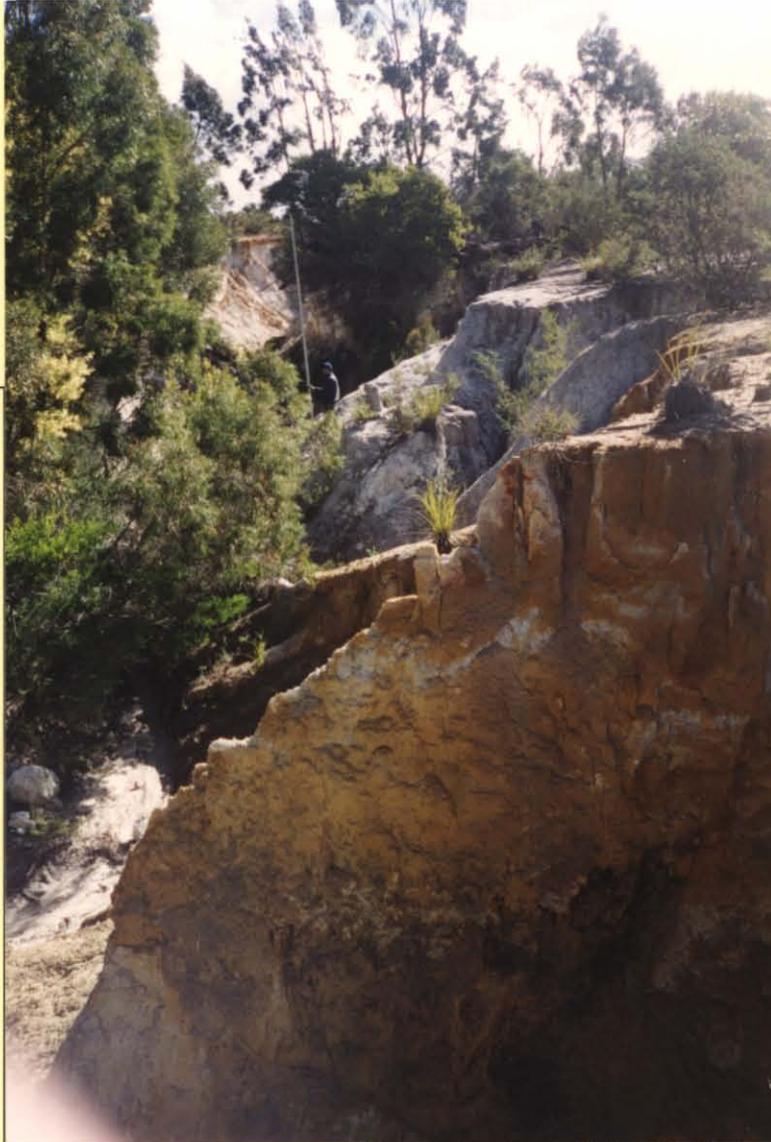
Photo 5 RIGHT>>>>>>
Cat Gully Area
Gully k

Shows stable 6m
deep, long gully.
Advanced regrowth
on tailings layer.
Solid floor with
meandering channel.

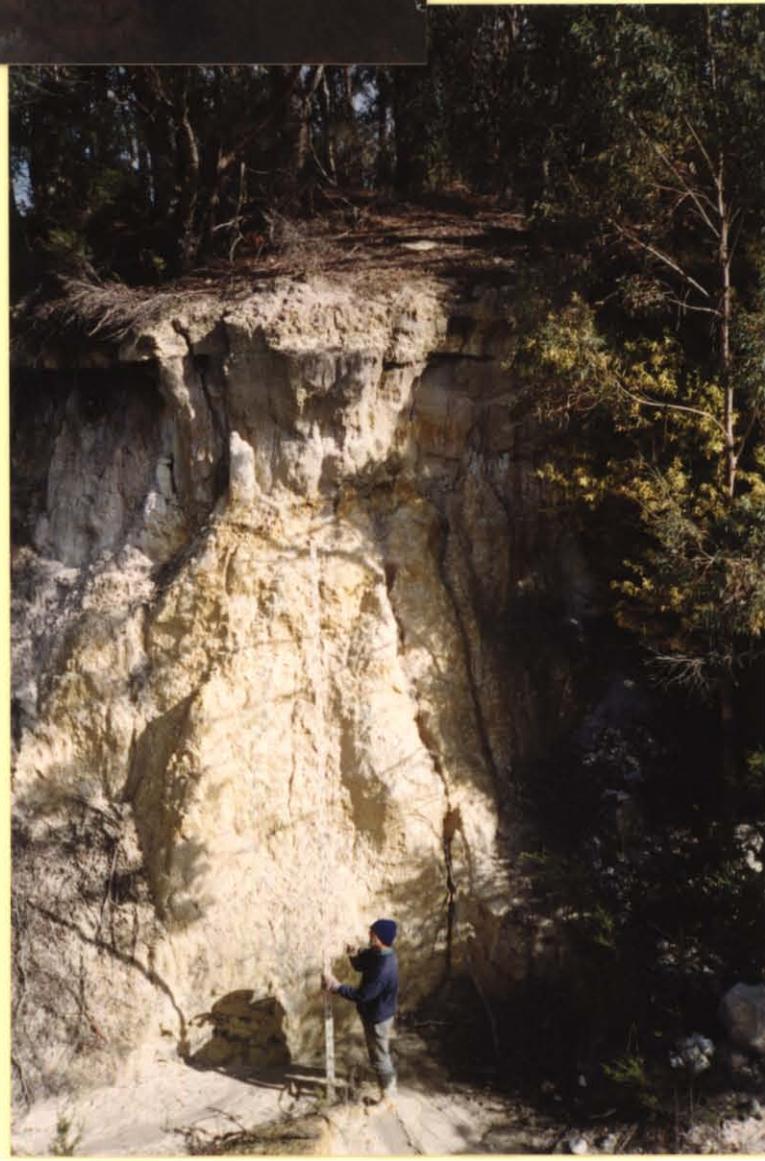
Photo 6 >>>>>>>>
Cat gully area
Gully k

View up same gully
showing short but
active side
gullies, K.2 & K.3.
A gully primarily
predating scrapers.

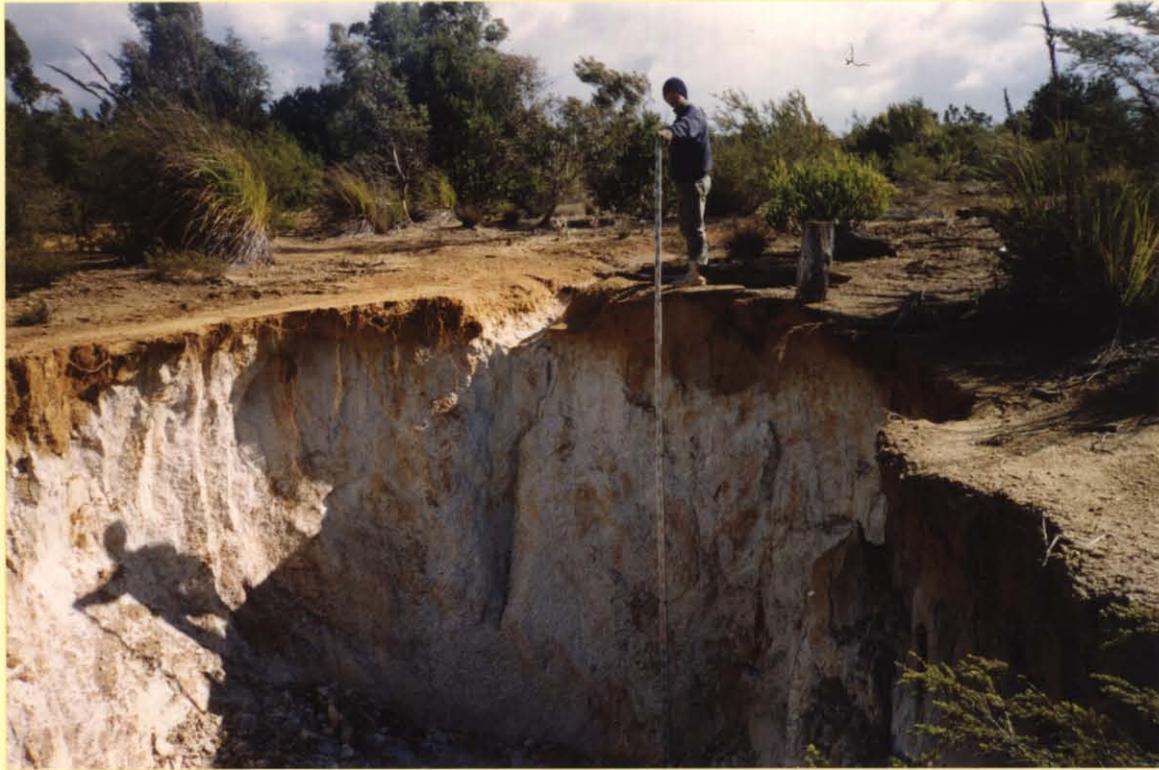
Photo 7
RIGHT>>>>>

Shows a 3.8m
drop at the head
of K gully.

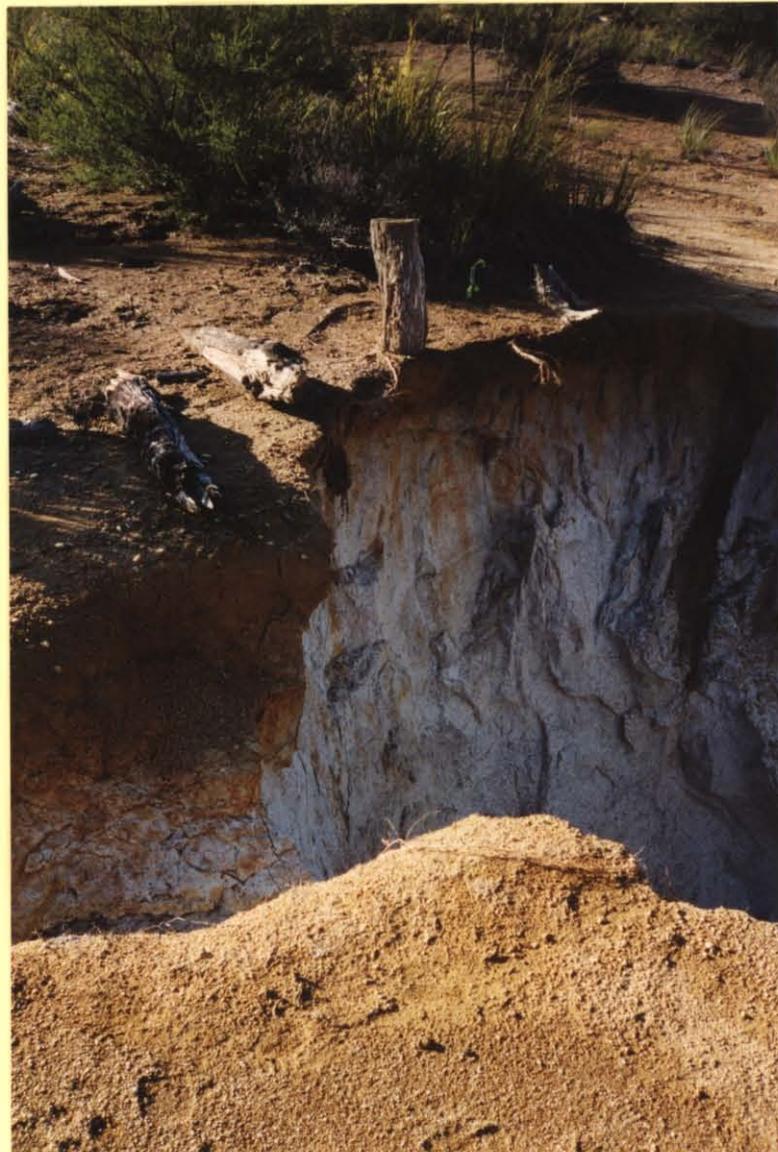
Photo 8 >>>>>>>>

View of head
showing the retreat
of the gully head
over a period of
several years.
Retreat crudely
shown by four log
markers ~ approx.
2m movement.

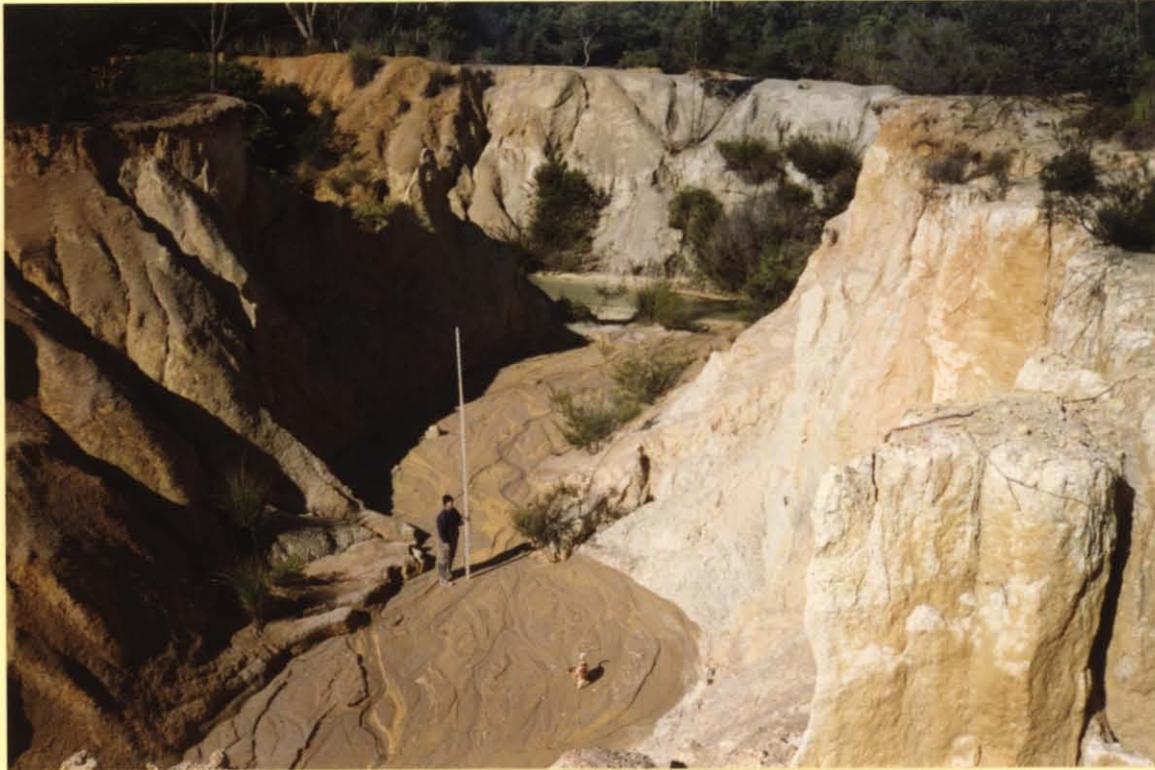
Photo 9
RIGHT>>>>>

Cat Gully Area
Gully L
Person with a 5m
staff shows the
large dimensions
of gully L.
Estimated depth
here is 8.5m.
The northern side
of this gully is
vegetated and
stable. The
southern side is
very active.

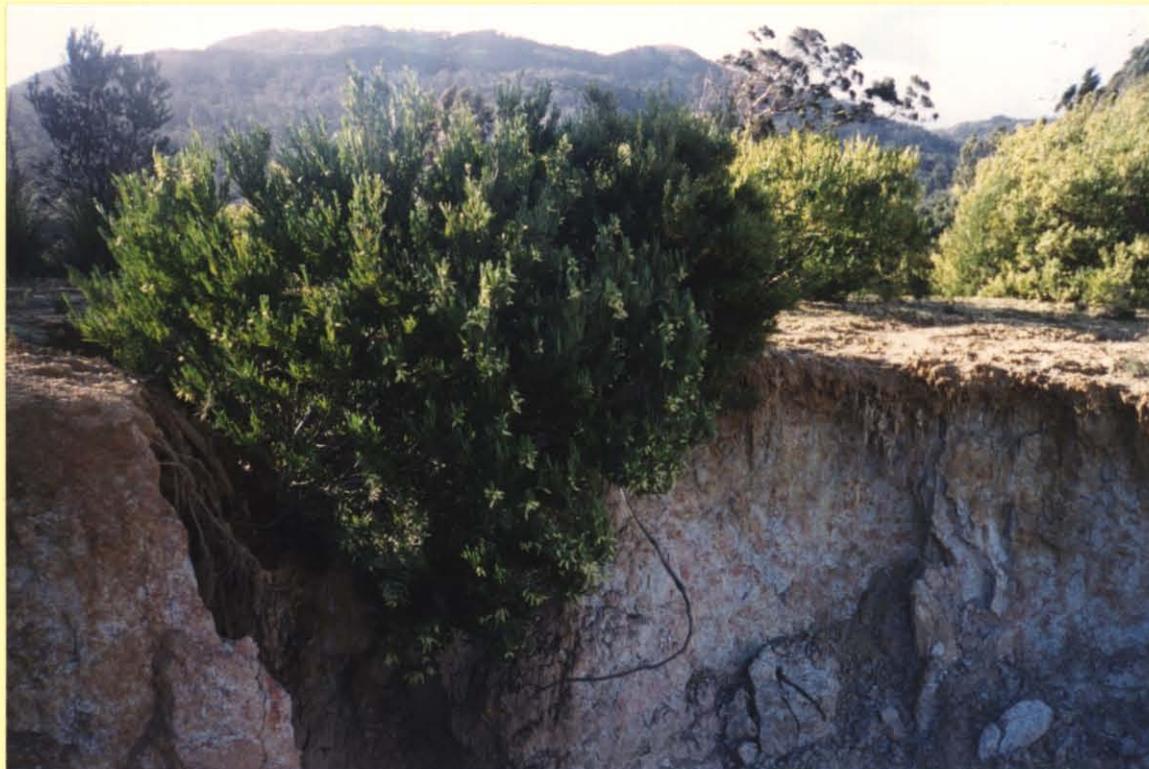
Photo 10
>>>>>>>>>

View of head
showing the an
Acacia mucranata
shrub partially
undermined. *A.*
mucranata is
clearly the
premier
rehabilitation
species, some
covering many
square meters.

There is considerable variation in the erosional activity of the gullies. Ranking based on remedial prioritization has been made (see TABLE 1). Gully system [N] differs somewhat from the others in respect of morphology. This dendritic system, see FIGURE 2, and PHOTOS 10 to 16, is particularly active and more advanced with respect of reaching a more stable equilibrium. It contains sedimentological features such as alluvial fans, braided streams and drainage capture, see PHOTO 23, on a scale suitable for scientific research. Indeed further study of Cat Gully erosion, perhaps comparing it with older, less youthful badlands sites (such as the Clifton mine of the Mark Ireland era – PHOTOS 19 to

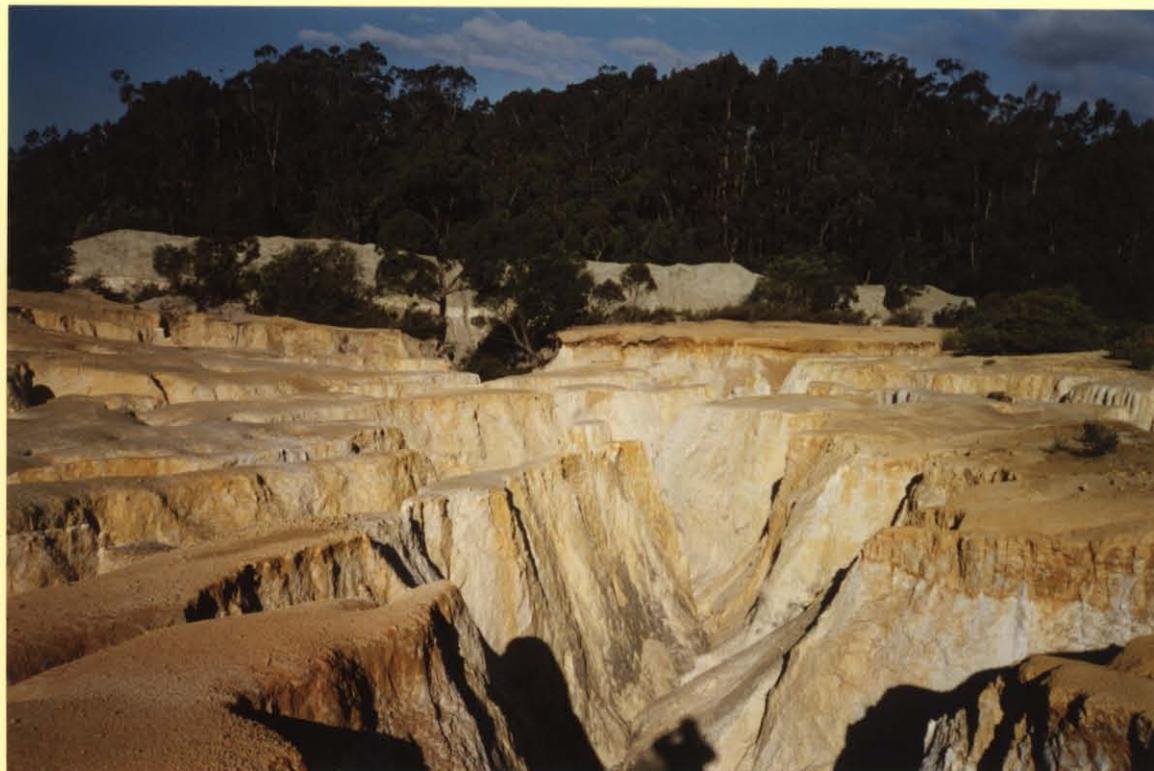
Photo 12
RIGHT >>>>

Overall view
looking towards
the outlet.
Mounds from the
dragline?
Excavation of
Cat Gully circa
1968 in middle
ground.

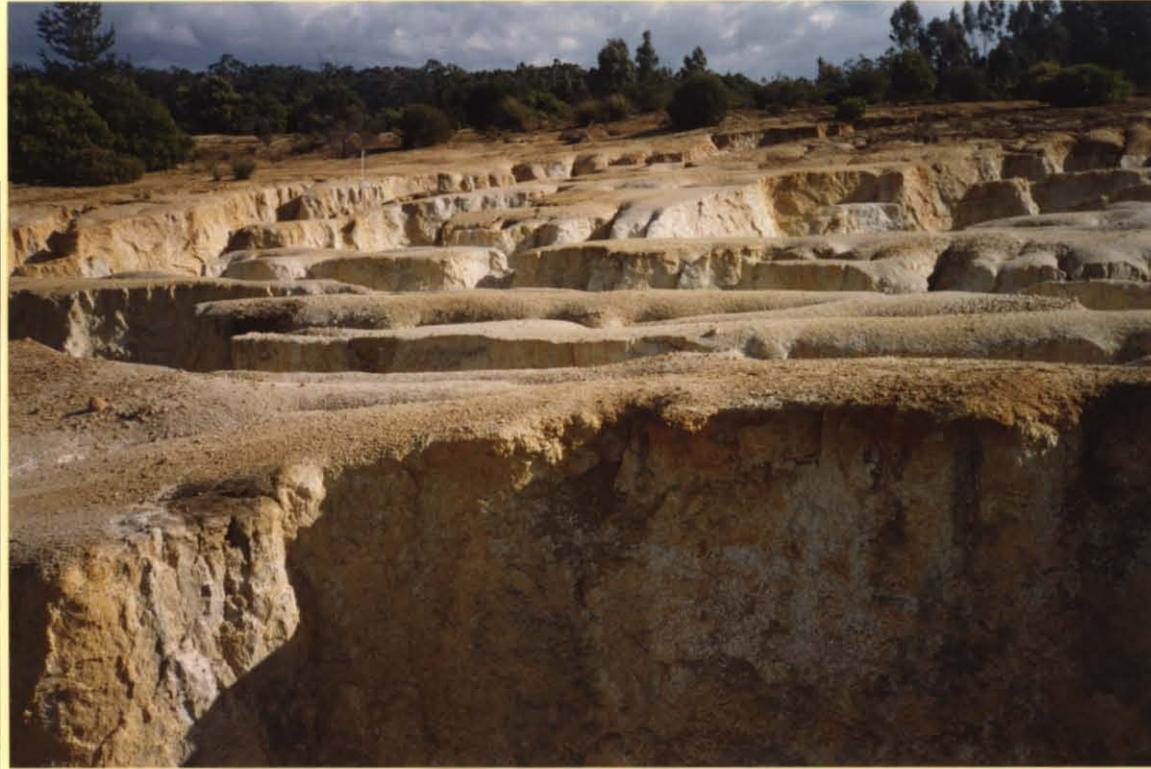
Photo 13
RIGHT>>>>>

Person with a 5m
staff is hidden
in this
dendritic gully.
Can you find
him?

The gully is
uniformly about
3.5m deep

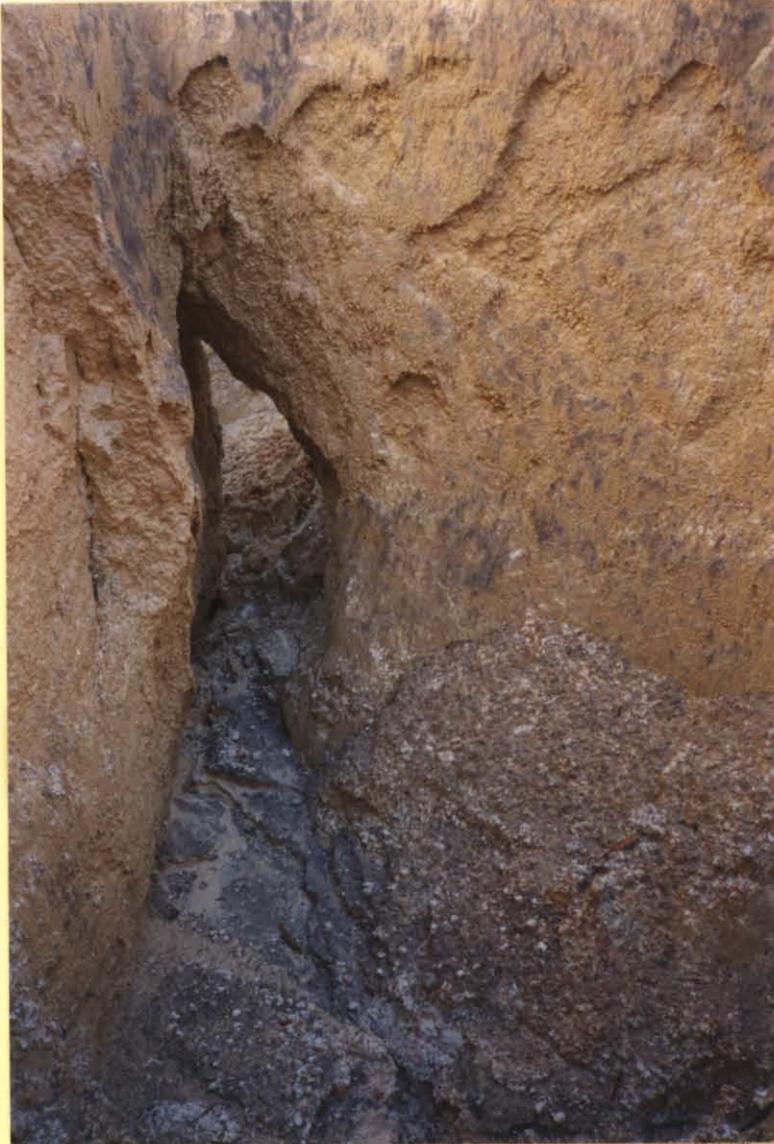
Photo 15
RIGHT>>>>>

Detail showing
common tunnel
erosion. Quasi
sinkhole
features are
also found.

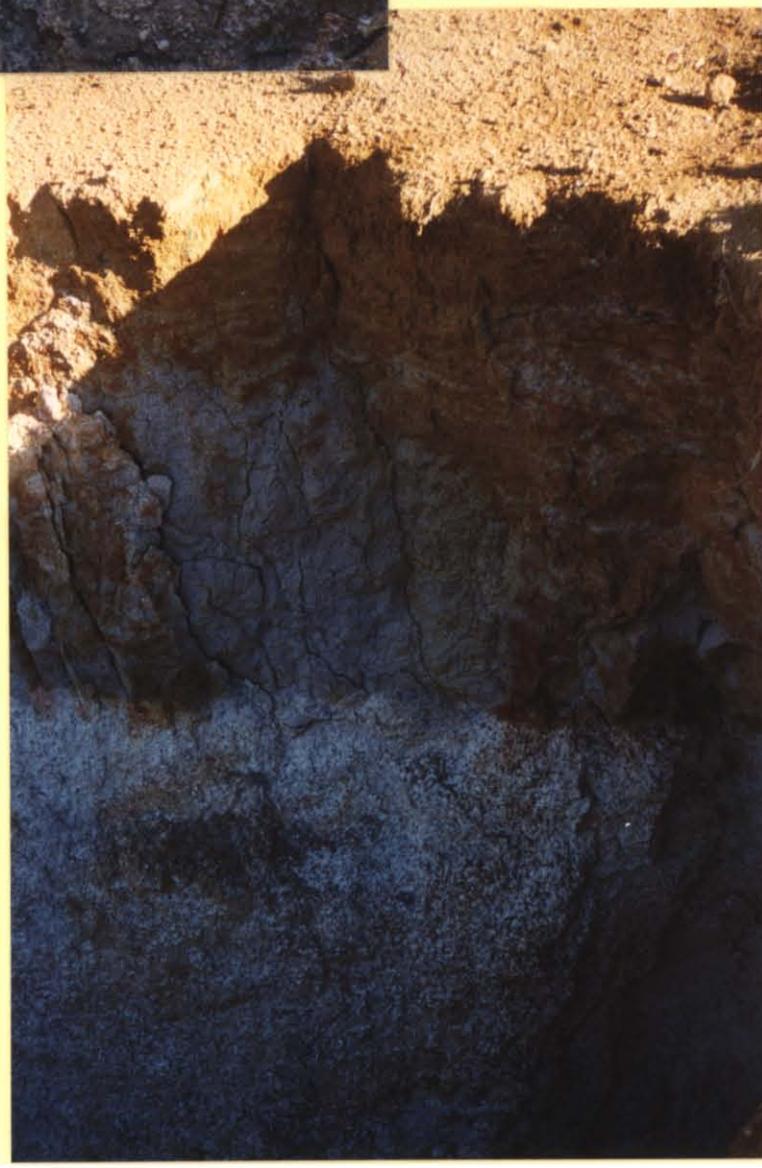
Photo 16
RIGHT >>>>

Detail showing
clays and clay
grits (non-
stanniferous)
overlying
decomposed
granite. The
Quaternary
sediments form a
slightly more
erosion
resistant
capping.

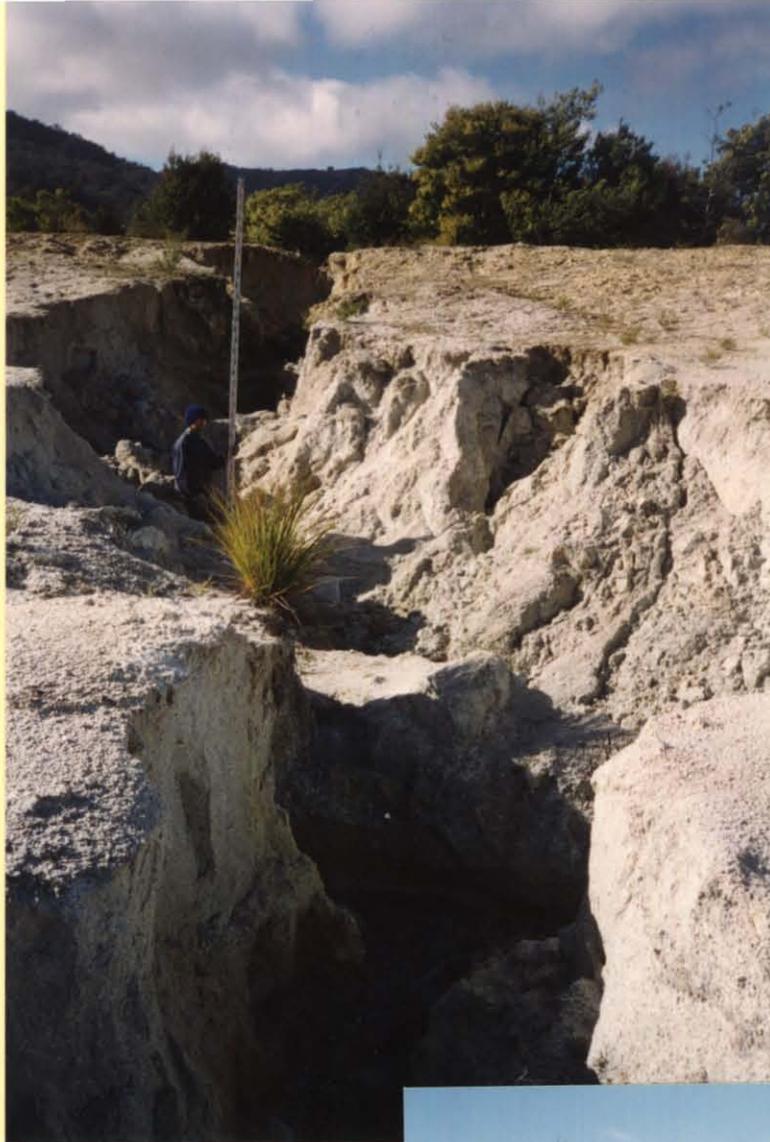
Photo 17
RIGHT>>>>>

Gully 0 is in an area with less fall. It is a system with two narrow, entrenched gullies only some 1.5m deep.

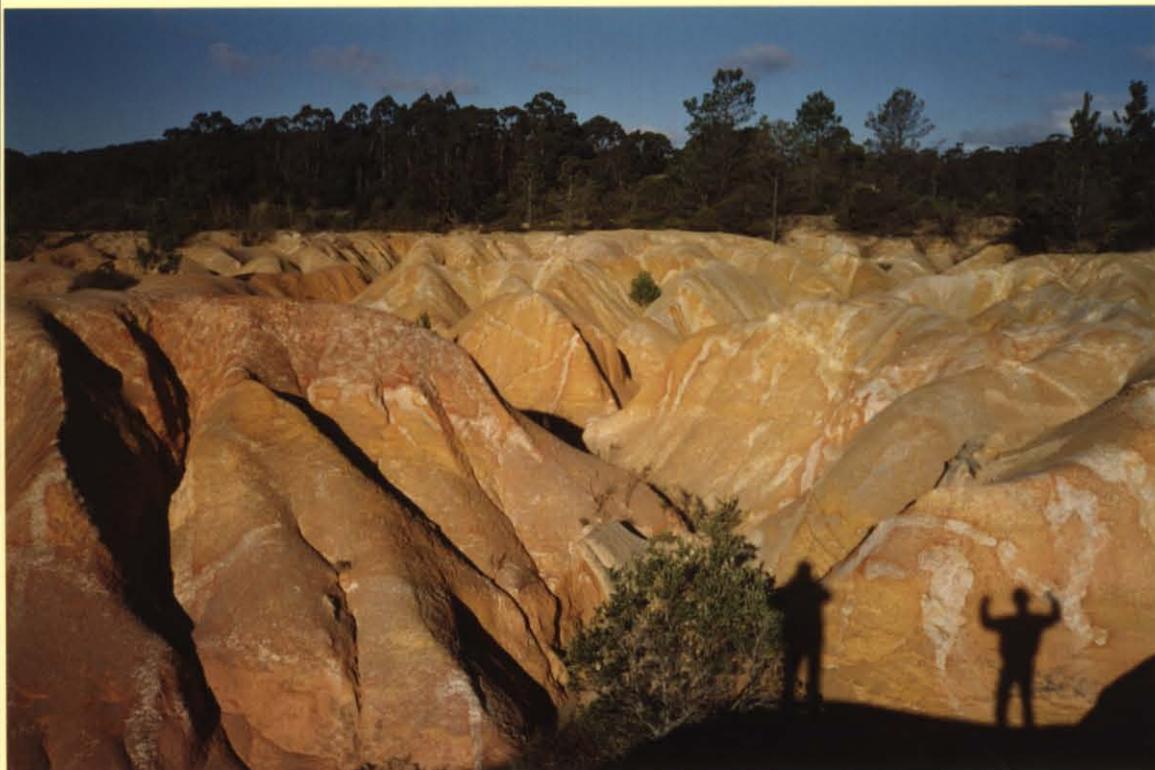
Photo 19
RIGHT>>>>>

Clifton Mine?
Area circa turn
of the century.
Decomposed
granite with
some veination
showing the
effects of the
gullying process
over time. Note
the rounding of
all surfaces.

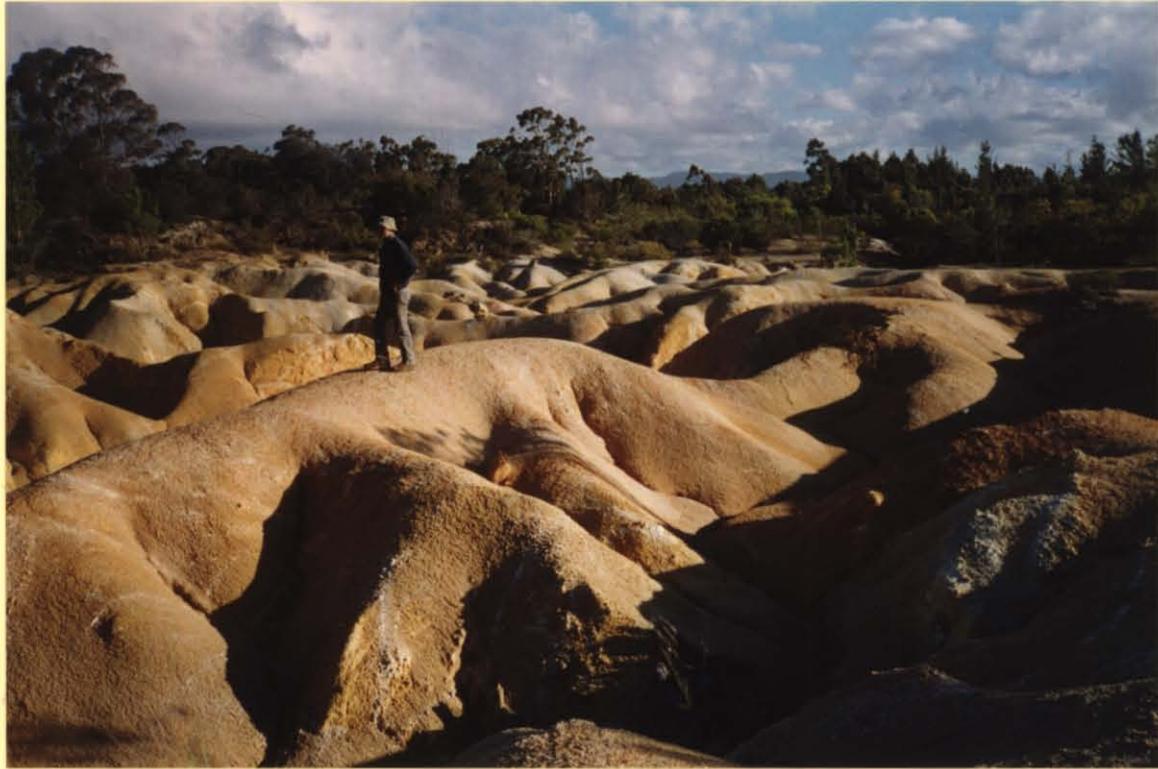
Photo 21
RIGHT>>>>>

Note the
rounding of all
surfaces.
