STORYS CREEK ACID DRAINAGE REMEDIATION

ANOXIC LIMESTONE DRAIN CONSTRUCTION REPORT

FEBRUARY 2001

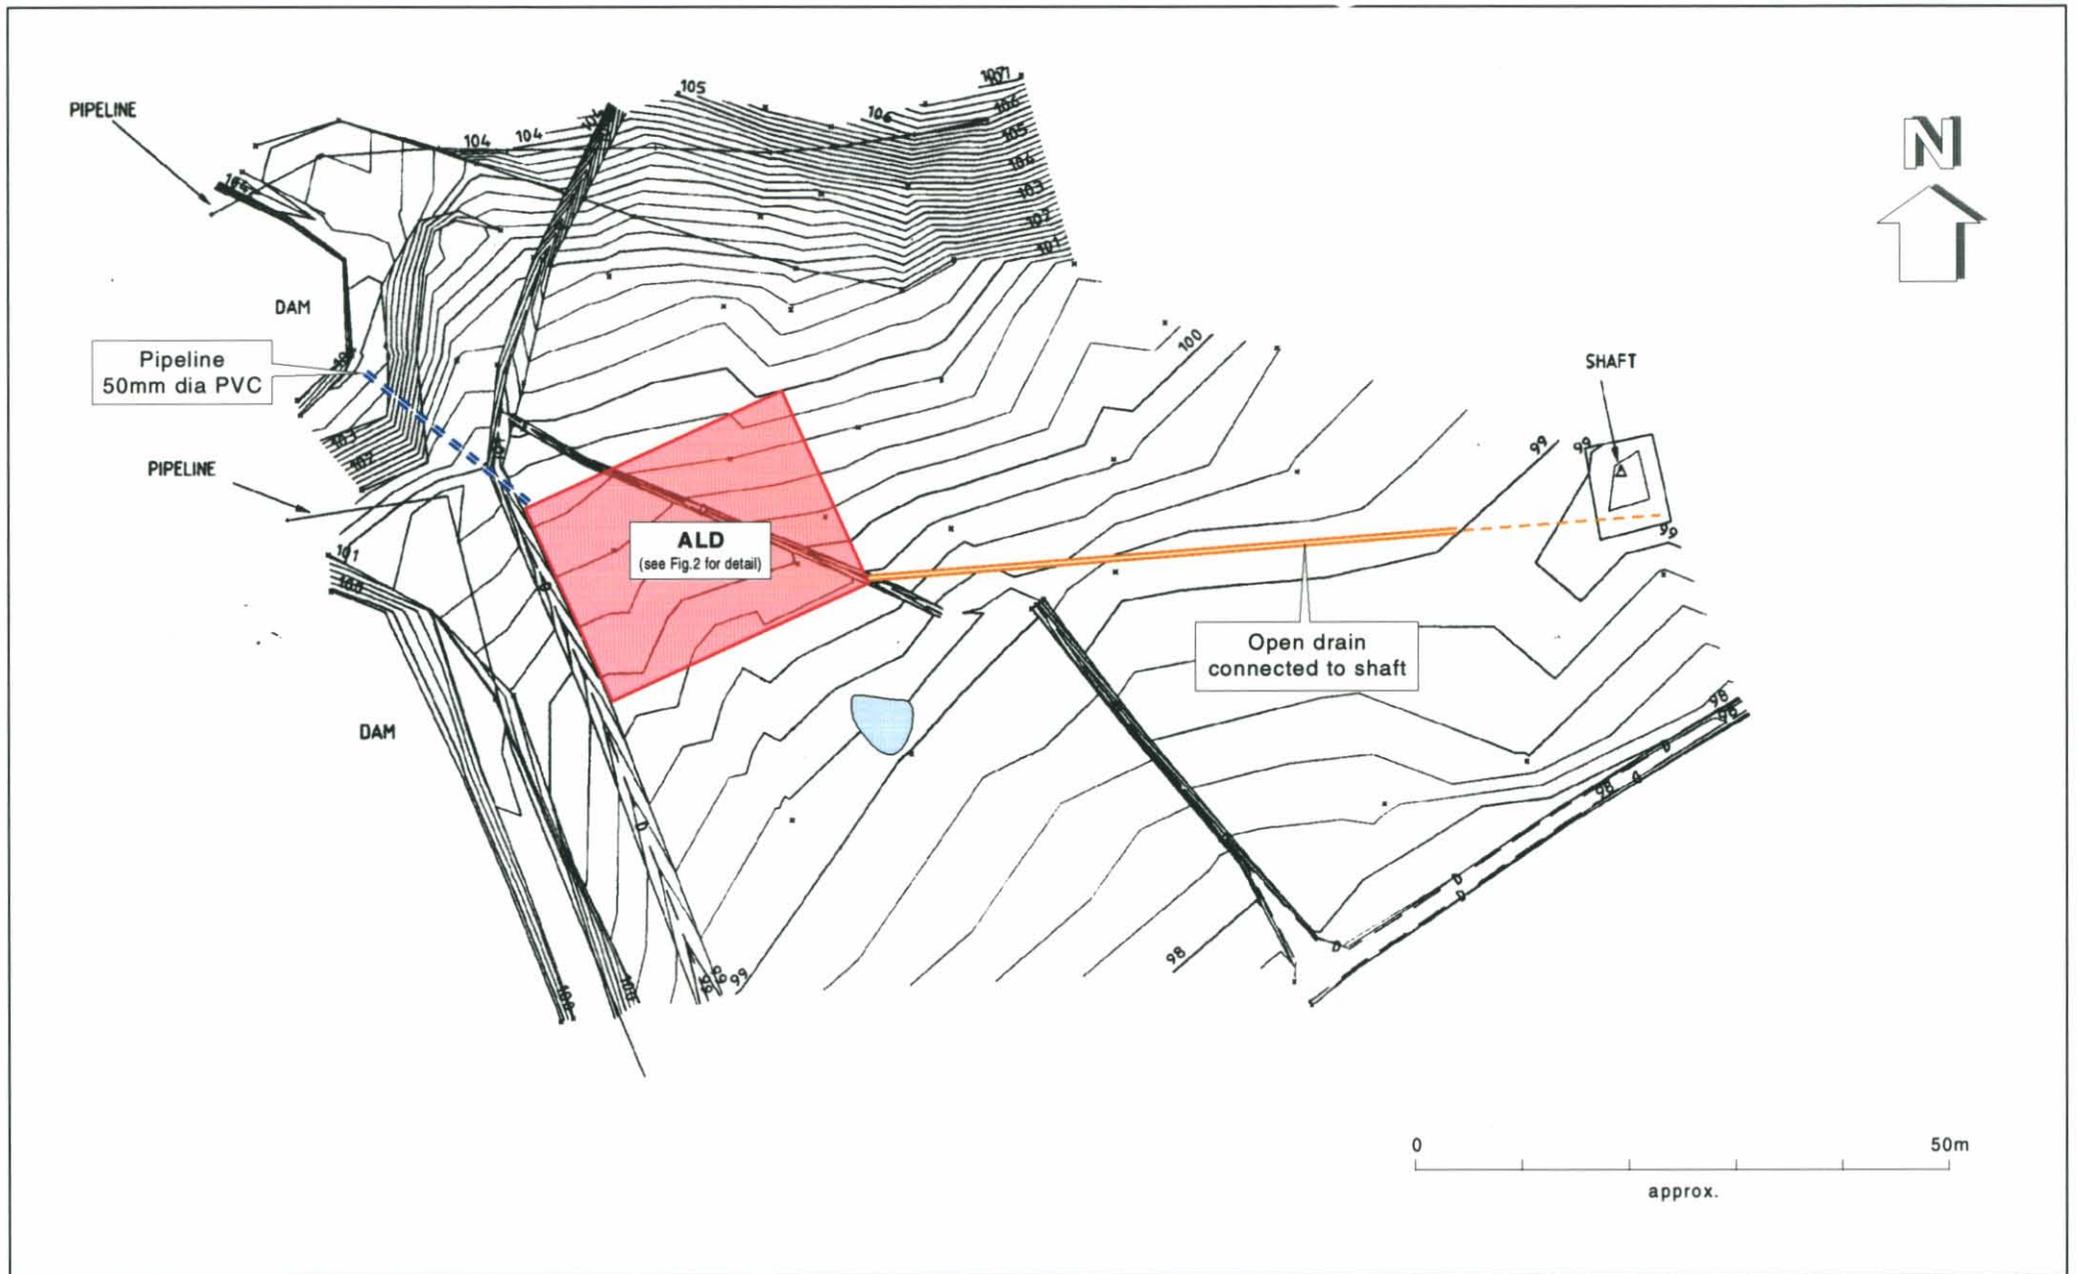
MINERAL RESOURCES TASMANIA	
Storys Creek Remediation ALD Location	
John Miedecke & Partners P/L	FIG 1

The drain was constructed up-slope from the main shaft in January 20001 and in an area which was saturated from leakage from the ponds constructed in the area for mine use (see Figure 1).

Figure 1 shows the location.

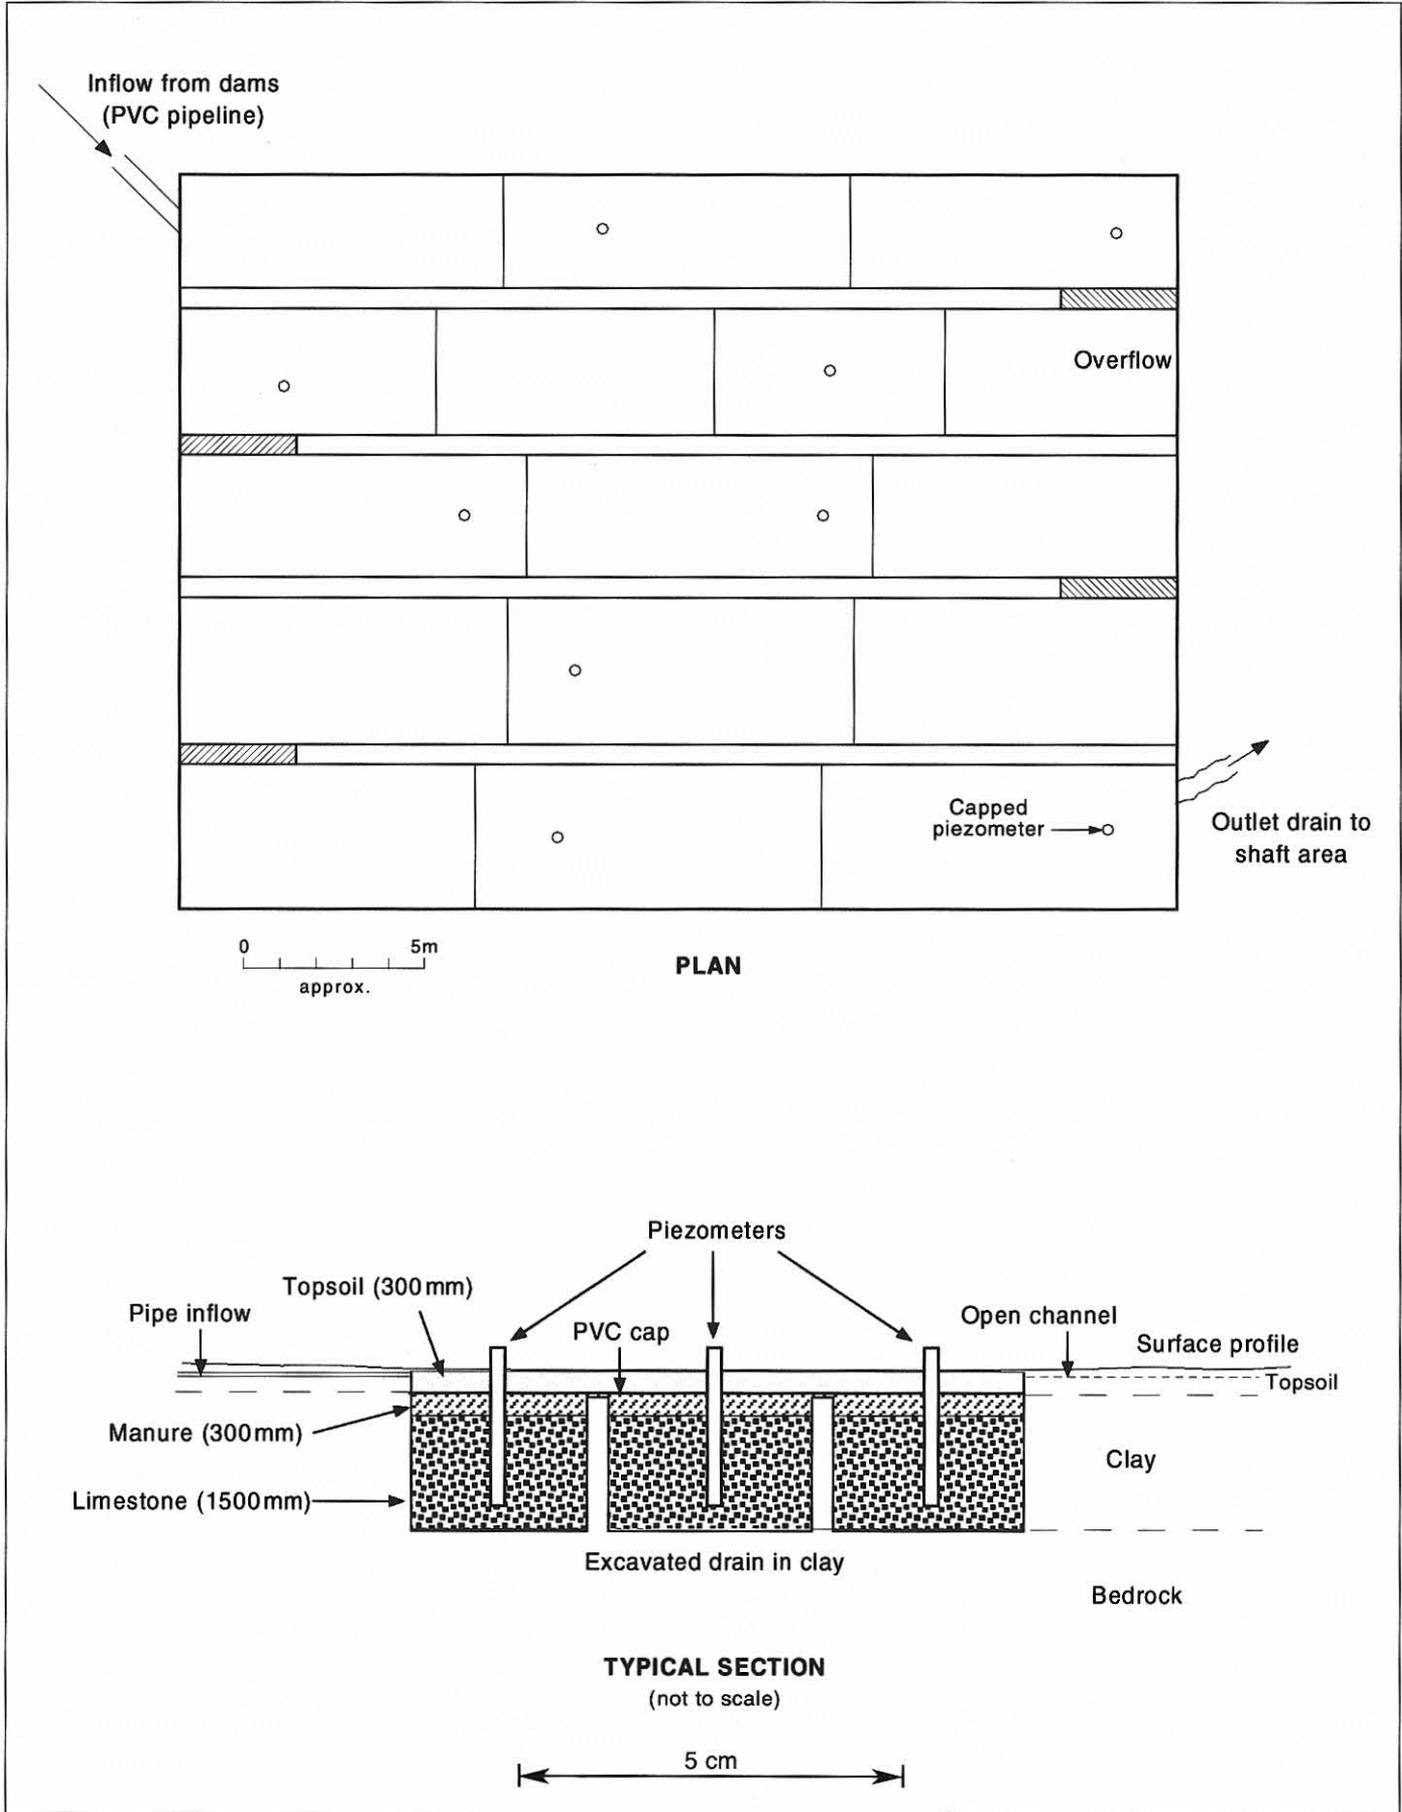
The drain was excavated in clays to a depth of approximately 1.9 m in a series of cells and filled with 1100 tonnes of limestone (size approx 25-75mm). Figure 2 shows the as constructed details.

A layer of organic material - comprising /feedlot manure (150m³) was mixed with 5 large round bales of straw was placed on top of the limestone and capped with polythene and then covered with topsoil.

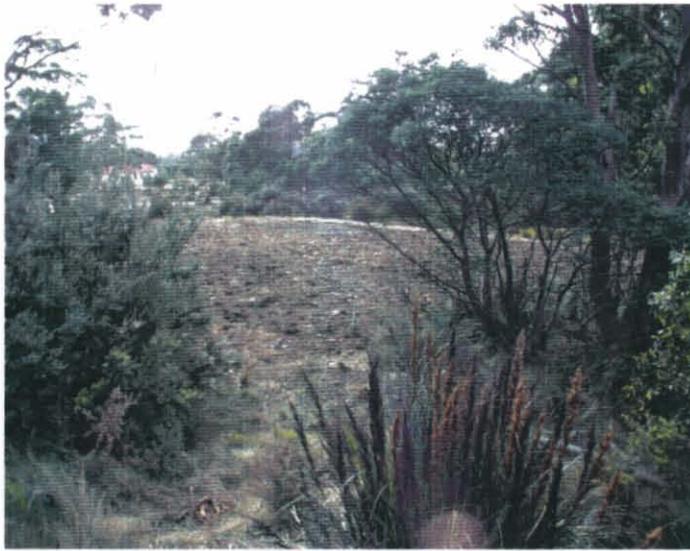
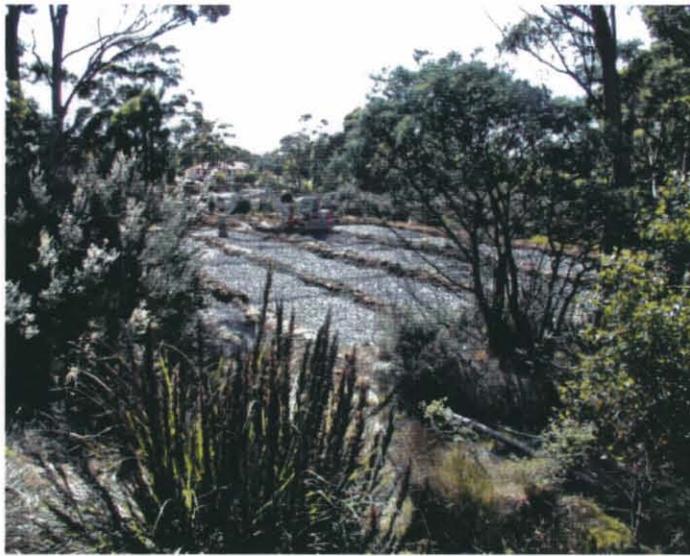
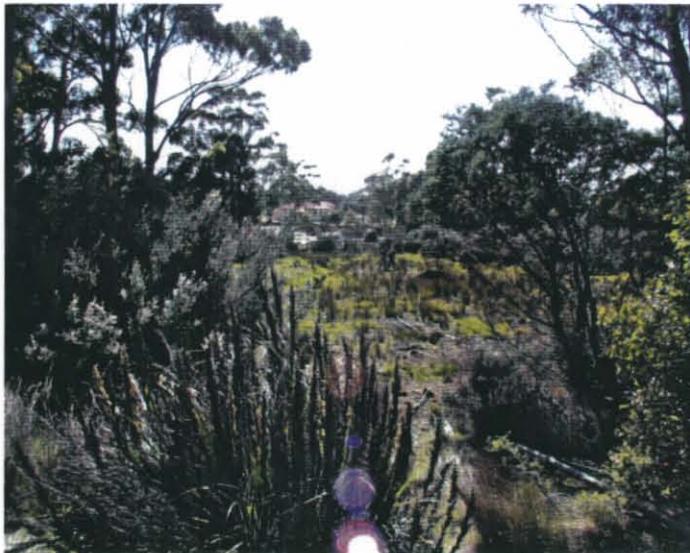
January 2001 ALD UNDER CONSTRUCTION AND COMPLETED.

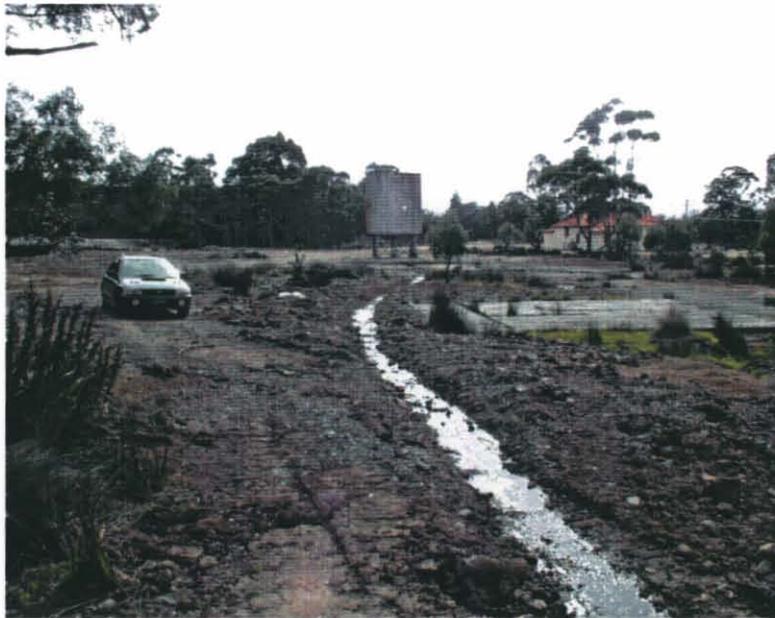
An open channel directs the alkaline water to the shaft.

January 2001 ALD DRAINING TO SHAFT .

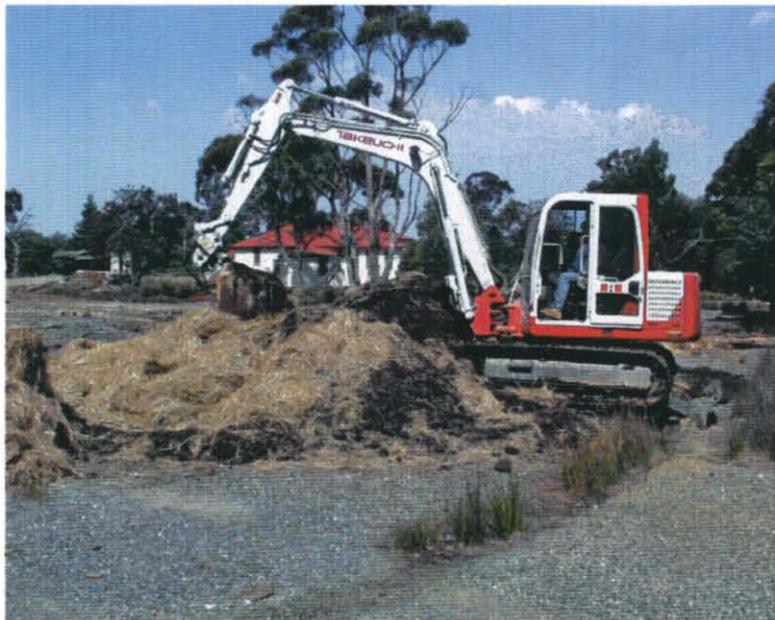
January 2001 MIXING MANURE AND STRAW.

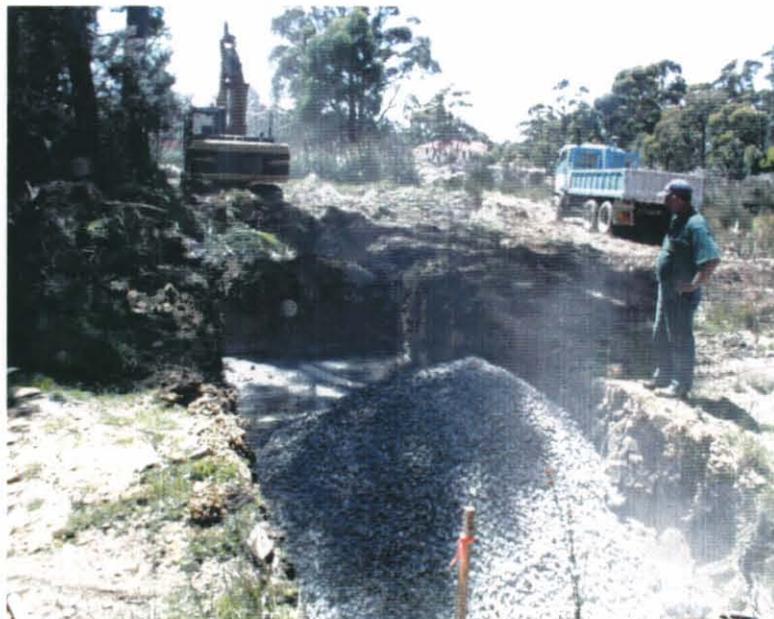
January 2001 ALD UNDER CONSTRUCTION.
