**Report on Works undertaken ~ 2001 – 2002 Financial Year for the
REHABILITATION OF MINING LANDS TRUST FUND
Project: rehabilitation of alluvially mined land, North East Tasmania**

Report by: Revel Munro

September 2002

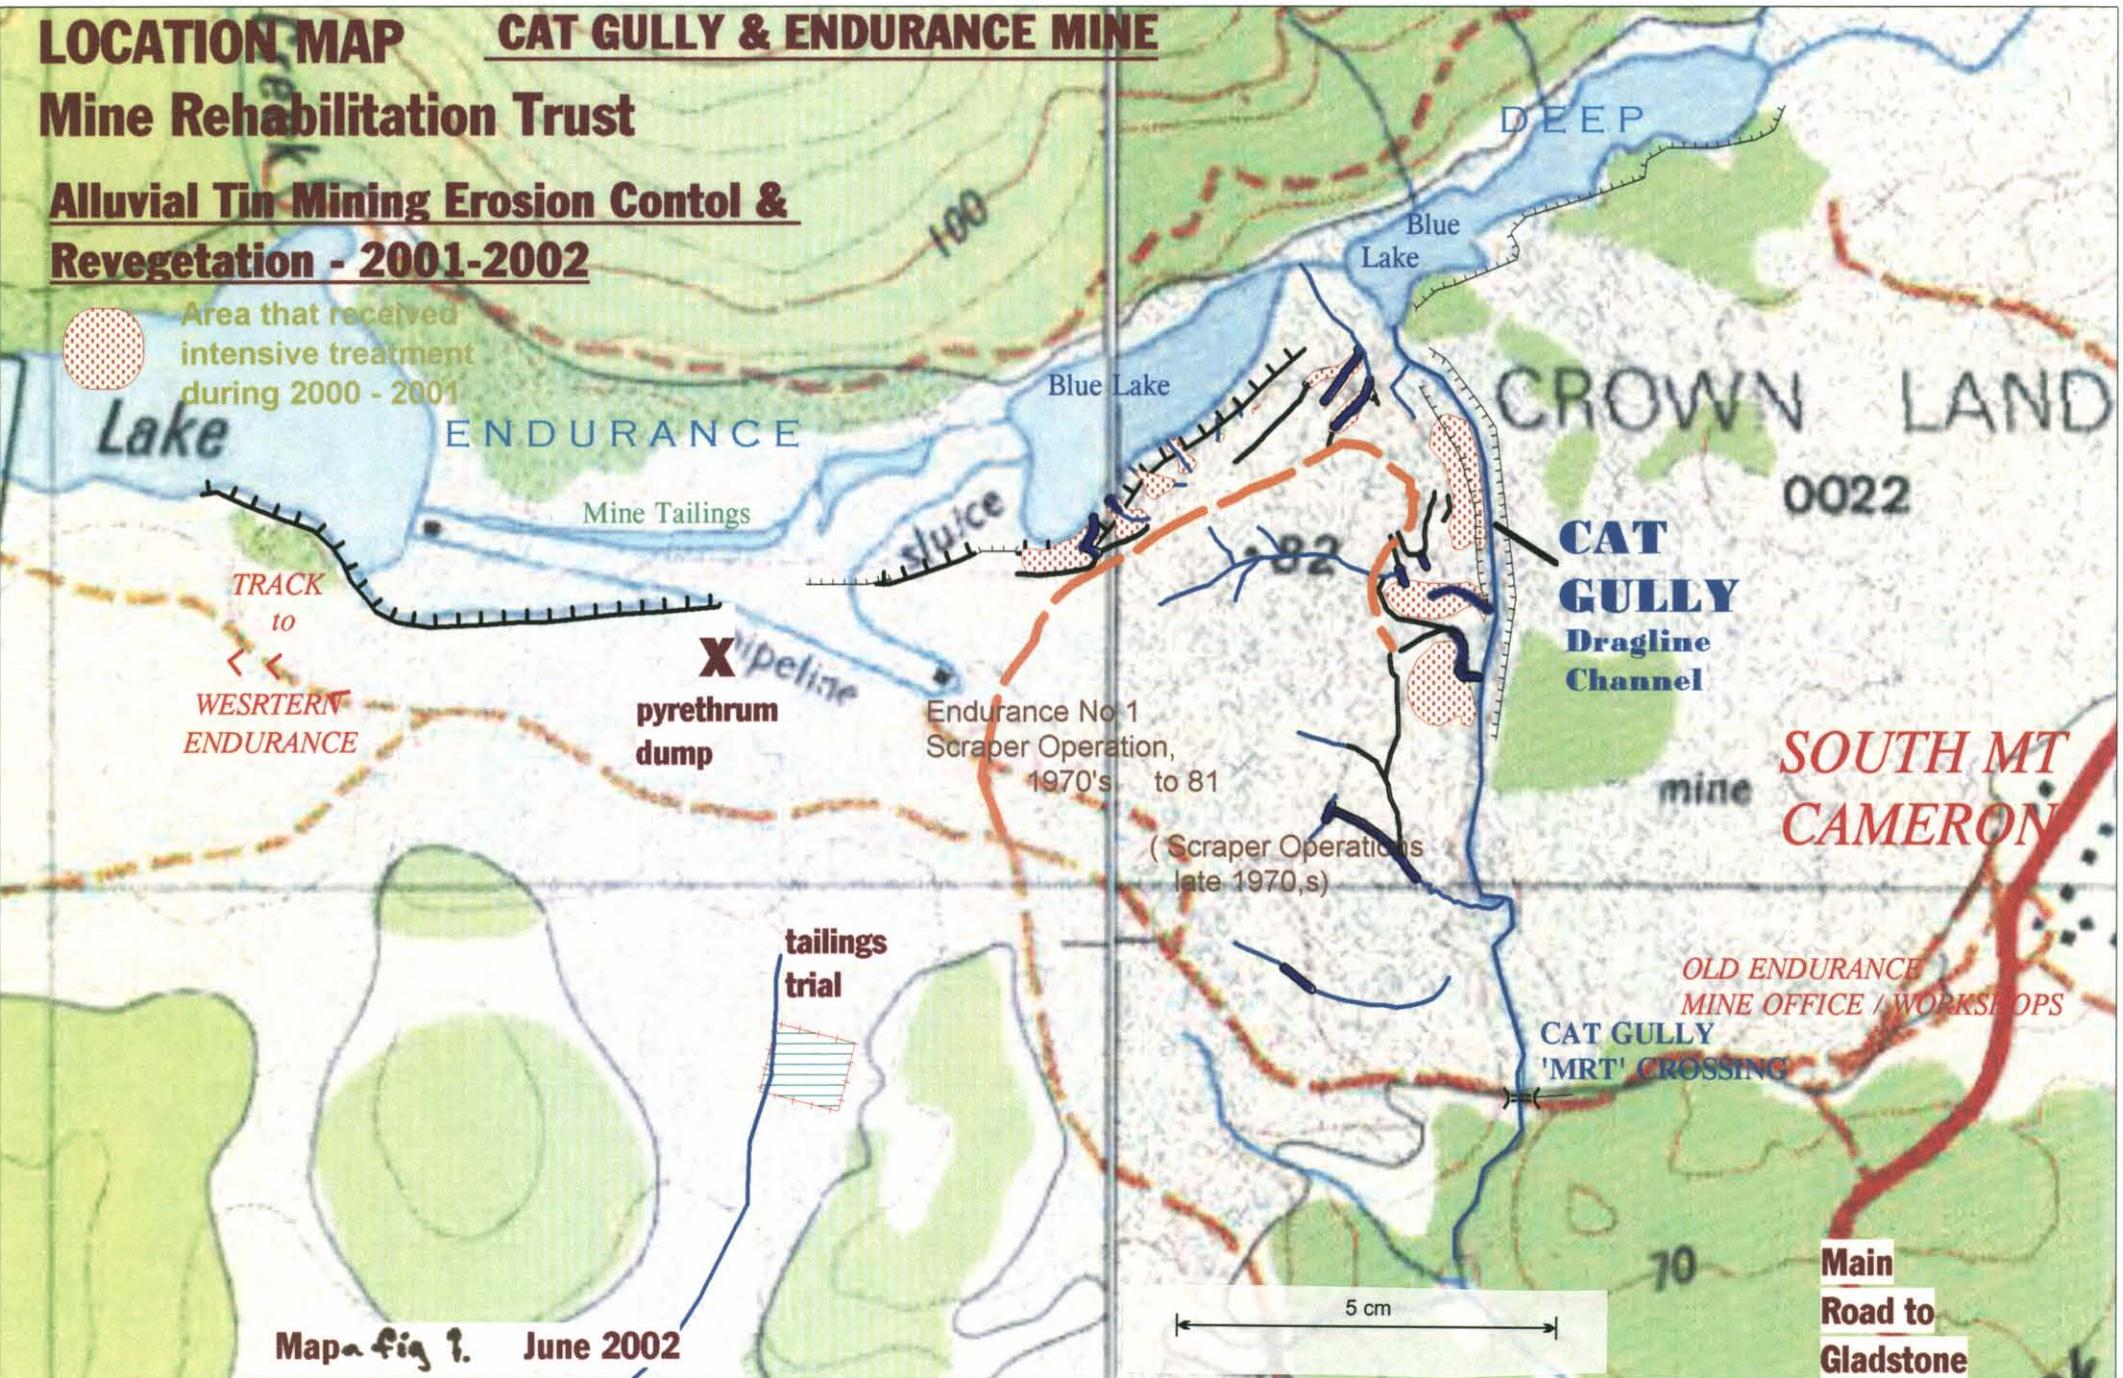
Mapa fig 1. June 2002

Area that received intensive treatment during 2000 - 2001

The general features of the ongoing Cat Gully Project area are shown on Figure 1. The area was once a part of the Endurance No1 BMI scraper area. The eroding gullies catchment area, of about 15 ha was sparingly rehabilitated by Boral in the 1980's and was supplementarily treated with scarifying, seed, fertiliser and mulch last year to decrease runoff and encourage vegetative growth. The area lies to the east of the access road sign, **pictured right**.

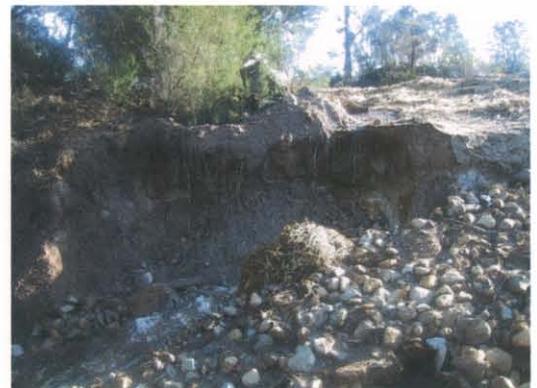
The works undertaken in 2000 – 2001 most successfully withstood the winter wet season. There was no back cutting of treated gullies and all ground treated was stable. Erosion only occurred in two limited areas where cutoff drains were breached due to insufficient levee bank height. Though easily repaired by hand, one breach, **pictured right**, amply demonstrated the erosive power of flowing water across unconsolidated sediments.

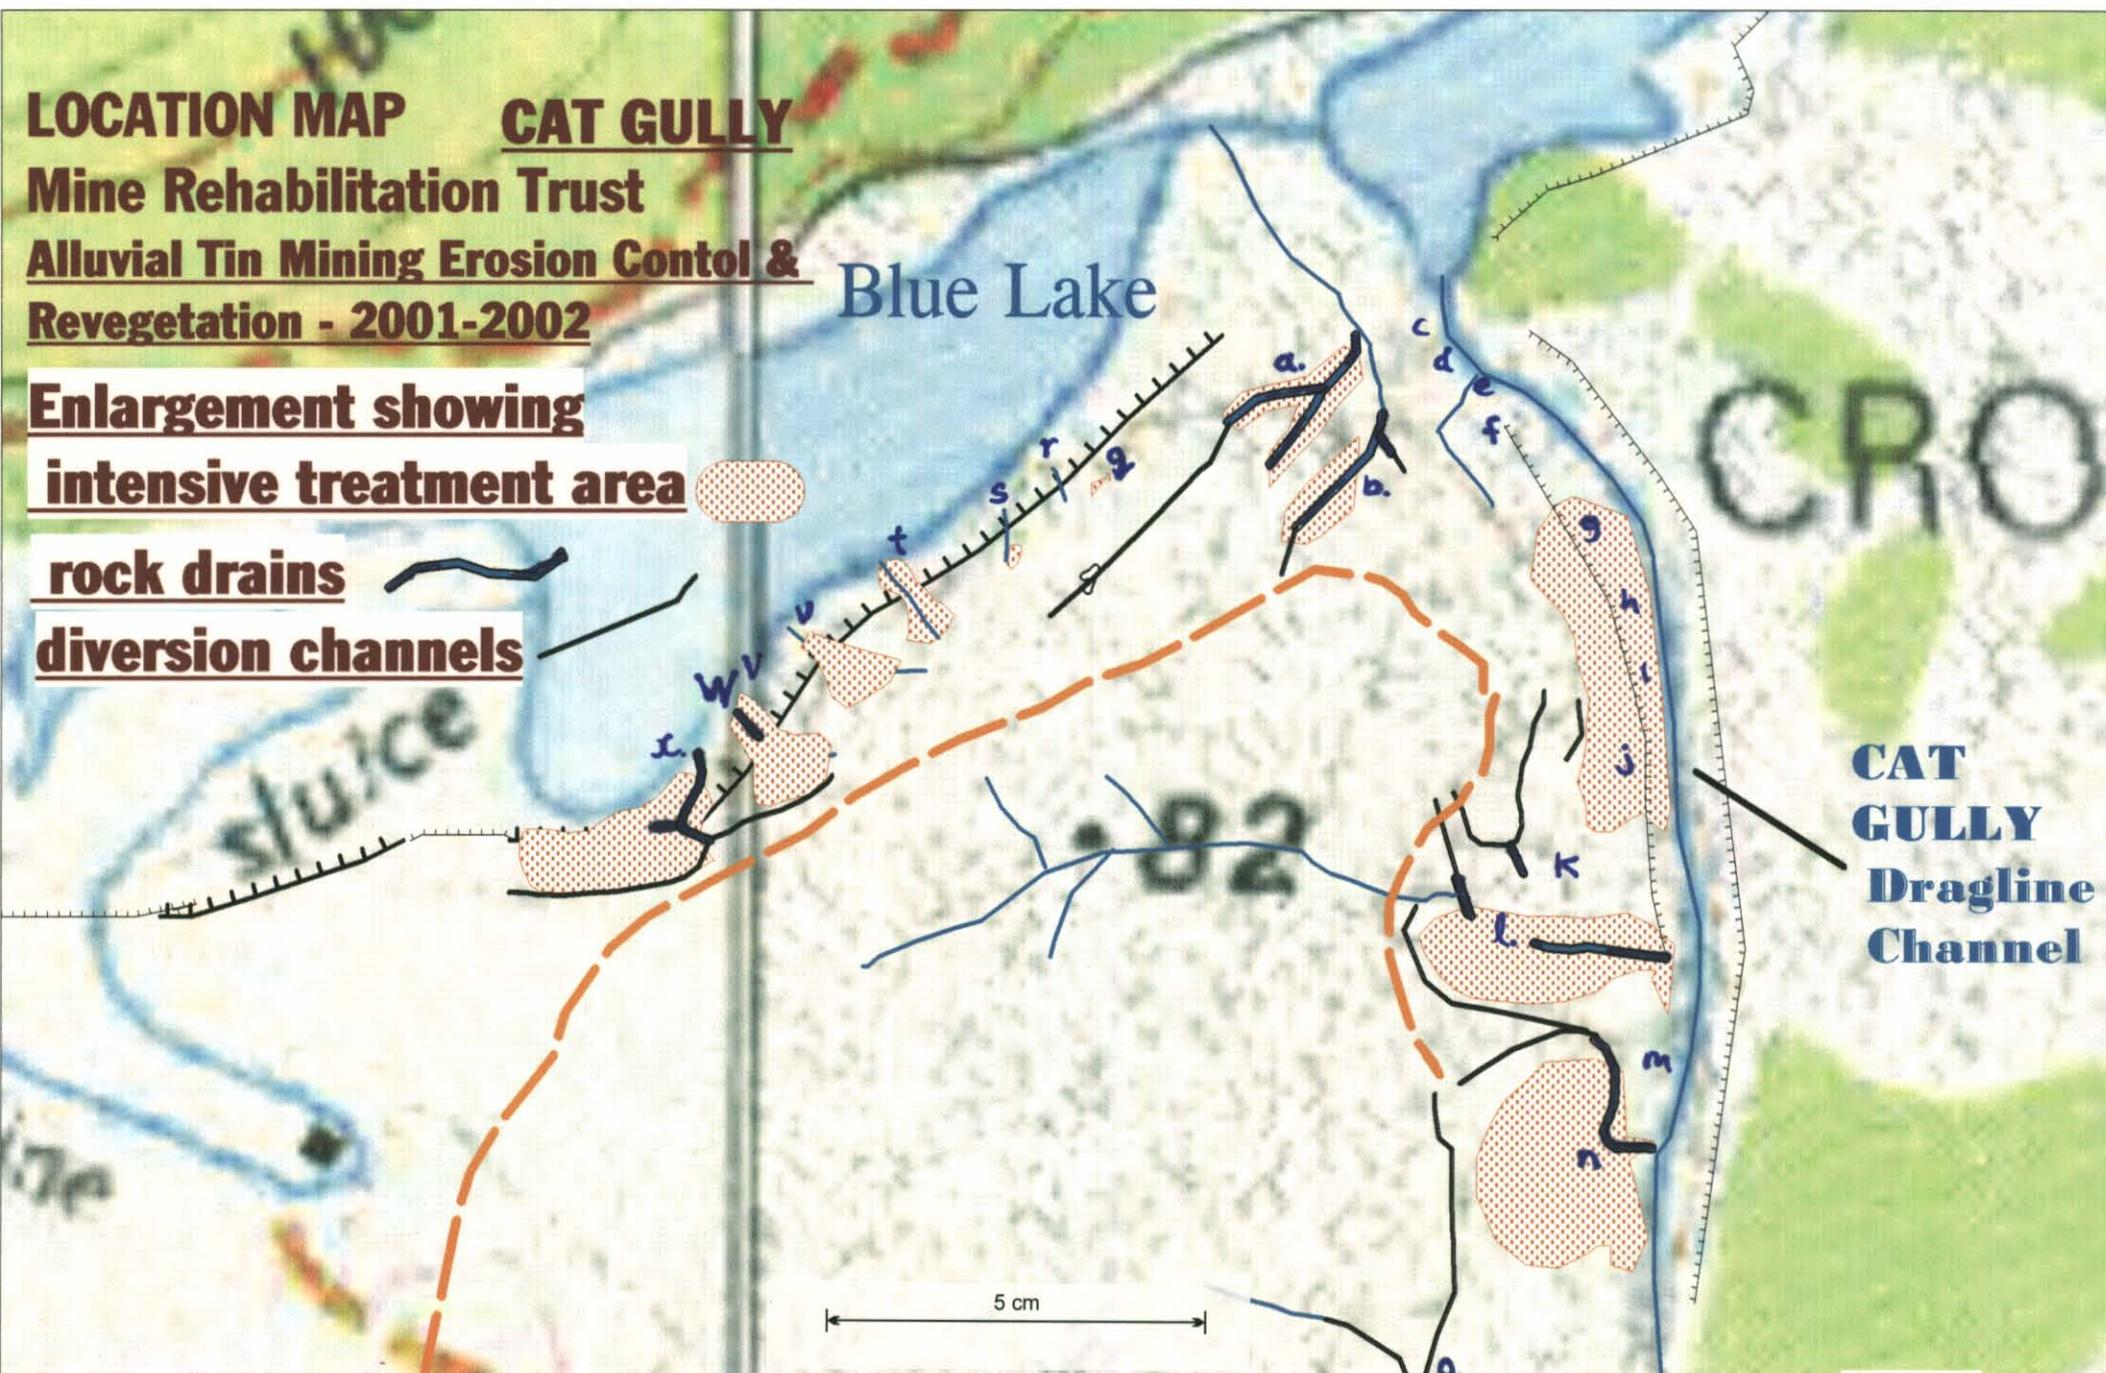
figure 2.

Figure 2 is an enlargement of Figure 1. It shows the location of the gullies listed in Table 1 as well as cutoff drains, rock lined drains and the areas intensively treated during this period.

Enlargement showing intensive treatment area

rock drains

diversion channels

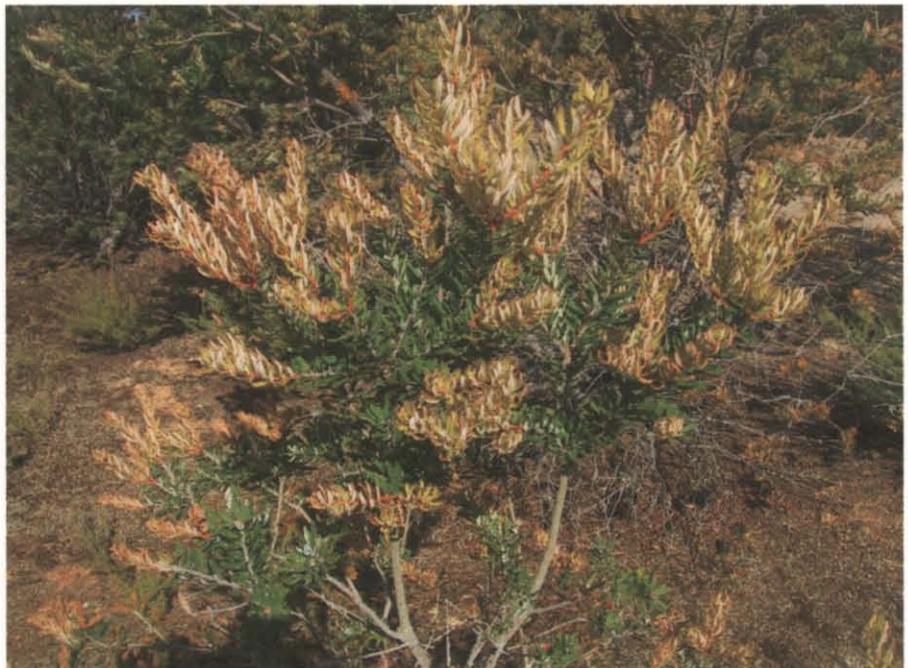
The 15 ha of catchment associated with these gullies systems was treated last year. No further works were needed apart from further top dressing this year. The response from the previous application of pyrethrum mulch and fertiliser was profound. Spring growth on existing vegetation such as *Banksia marginata*, **[pictured right]**, *poa* sp. and mosses **[also photographed, figure 16]** was most apparent.

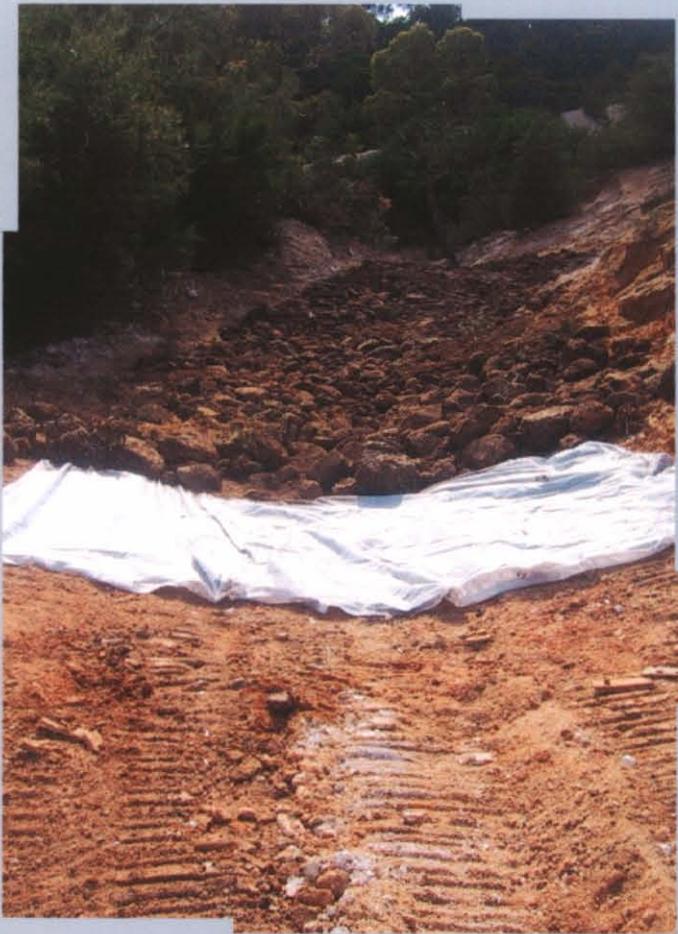
Gully 'a' ~ rock drain construction

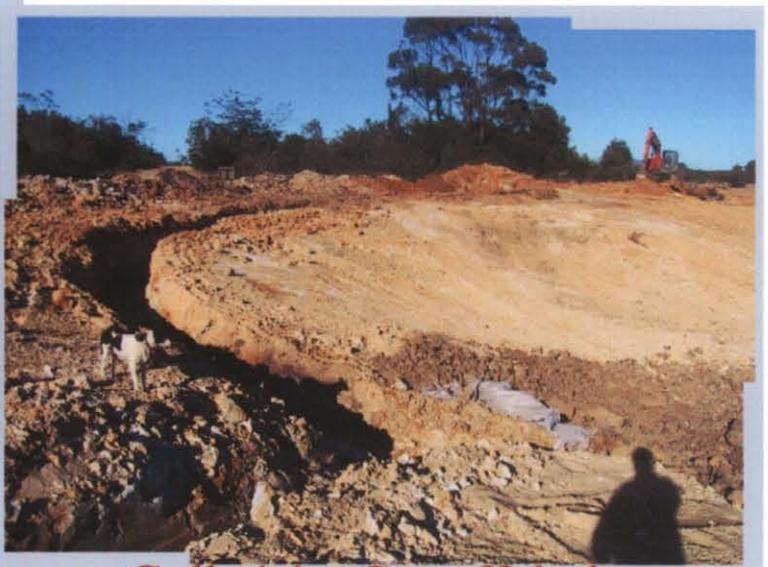
Gully 'x' ~ Cut off drain construction

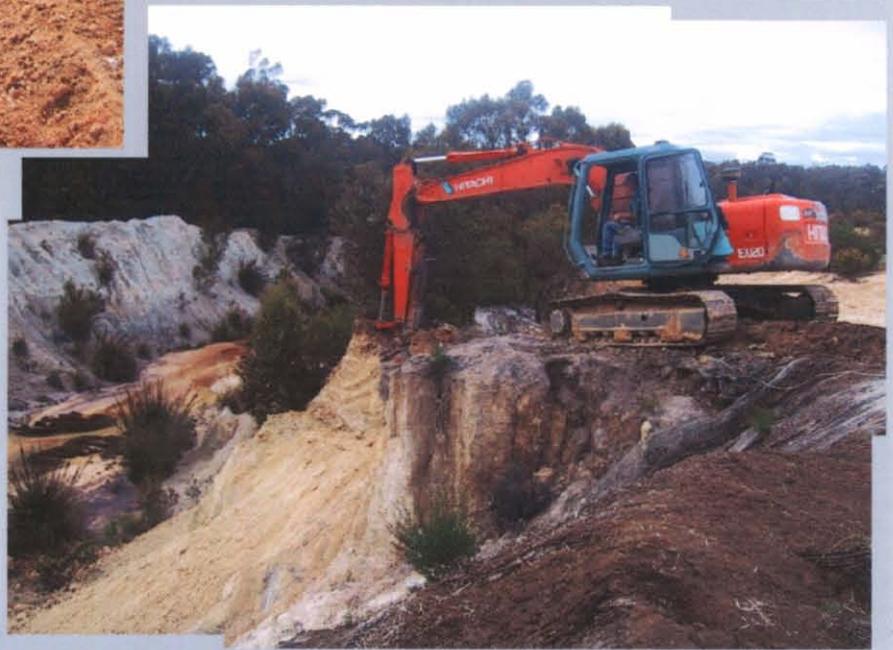
Gully 'm' ~ battering vertical face and benching

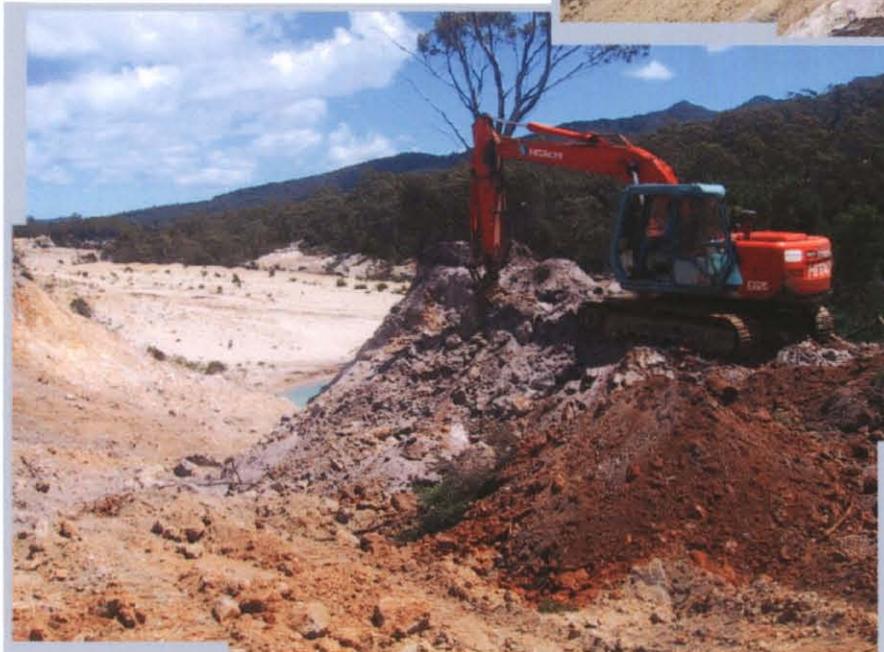
Gully 'v' ~ shaping

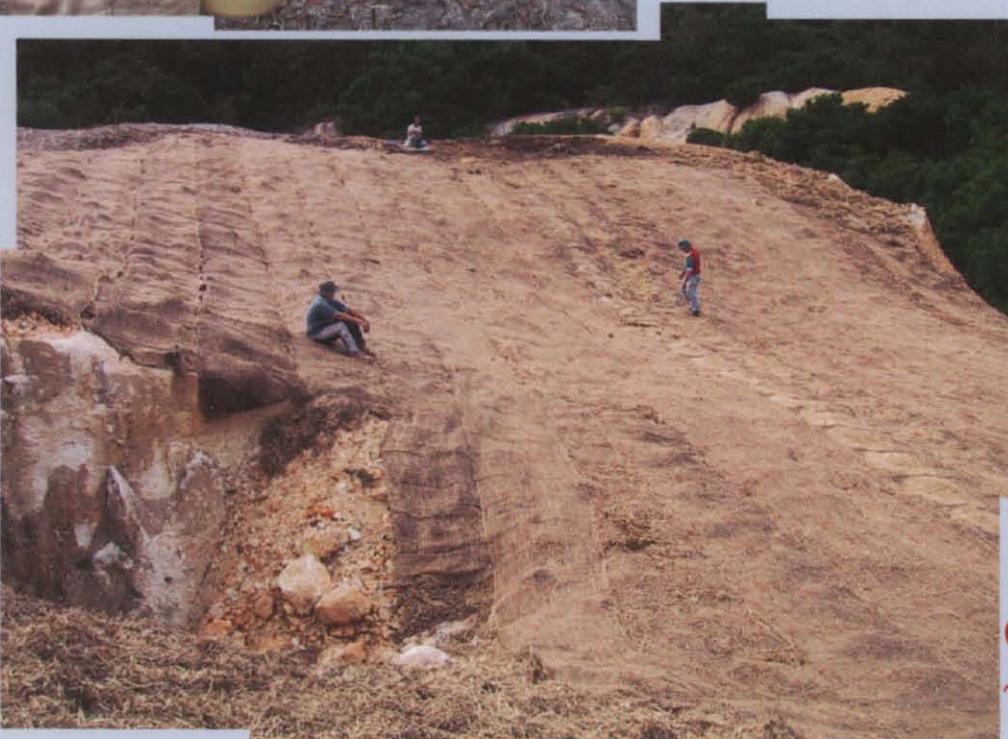
figure 4

Gullies 'g , h, i & j'
~ laying jute matting

- “Fluffed” straw with an overlay of pinned jute matting was used wherever possible. This amounted to a labour intensive 1.52ha being covered at this site. [**See Labour based activities photos, figures 4 & 5**]. A number of sources of straw were used. Some scotch thistles and cape weed were introduced from the large bales. The cape weed has not persisted. The small bales of oaten hay were easiest to deal with. Some hay on the very windy exposed sites blew away if left uncovered.
- Where possible, the native seed was hand broadcast as a split application, i.e. before treatment and after the laying of the hay and jute.
- The laying of scrub was limited to steep banks.
- Some 272 m of rock drains have been constructed at this site. Many loads of basalt rock has been imported from the Winnaleah – Derby area. All rock drains are proving to be very stable and are superior to gabions.

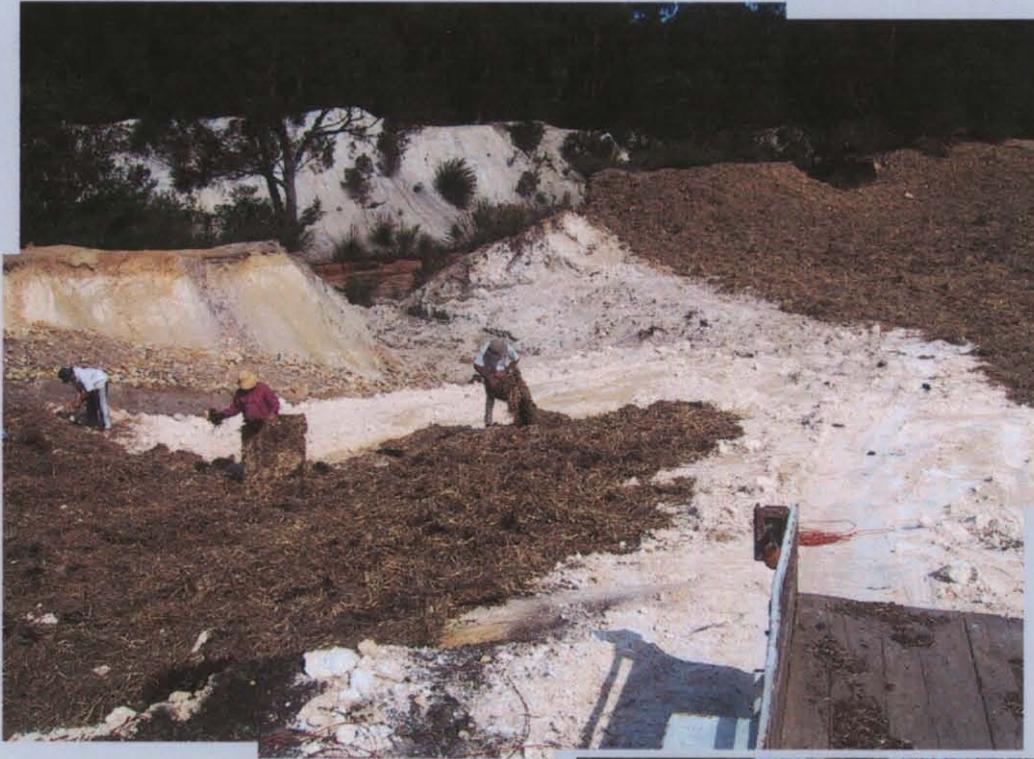
Gully 'n' ~ "Fluffing old seasons straw, big square bales"

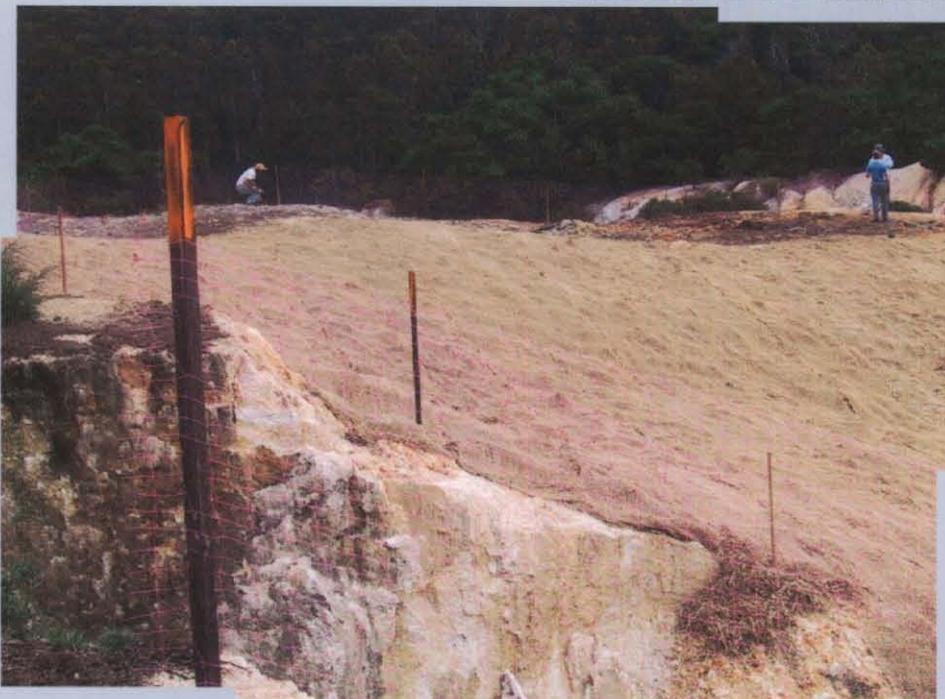
Gullies 'g & h' ~ erecting vermin proof fence around plantings

- A further 225 m of jute lined, cutoff and subsidiary drains have also been constructed.
- Two areas were selected to trial the establishment of seedlings behind a temporary net wrap fence. It was envisioned that, similar to bale wrapping, several laps of the enclosed area would make the area vermin proof. Shortage of net wrap (a hard to obtain S/H roll indicated to contain about 2km of material by the seller only measured at about 800m of length in the field) limited the fence to one lap. Though the fence worked for several weeks a very high browsing pressure increasingly breached the fence, particularly at corners. The fence would have needed to be browsing animal proof for at least 6 months to allow seedling establishment. After 1 month most of the seedlings had been heavily browsed. Many of the *Poa lab.* had been pulled out.

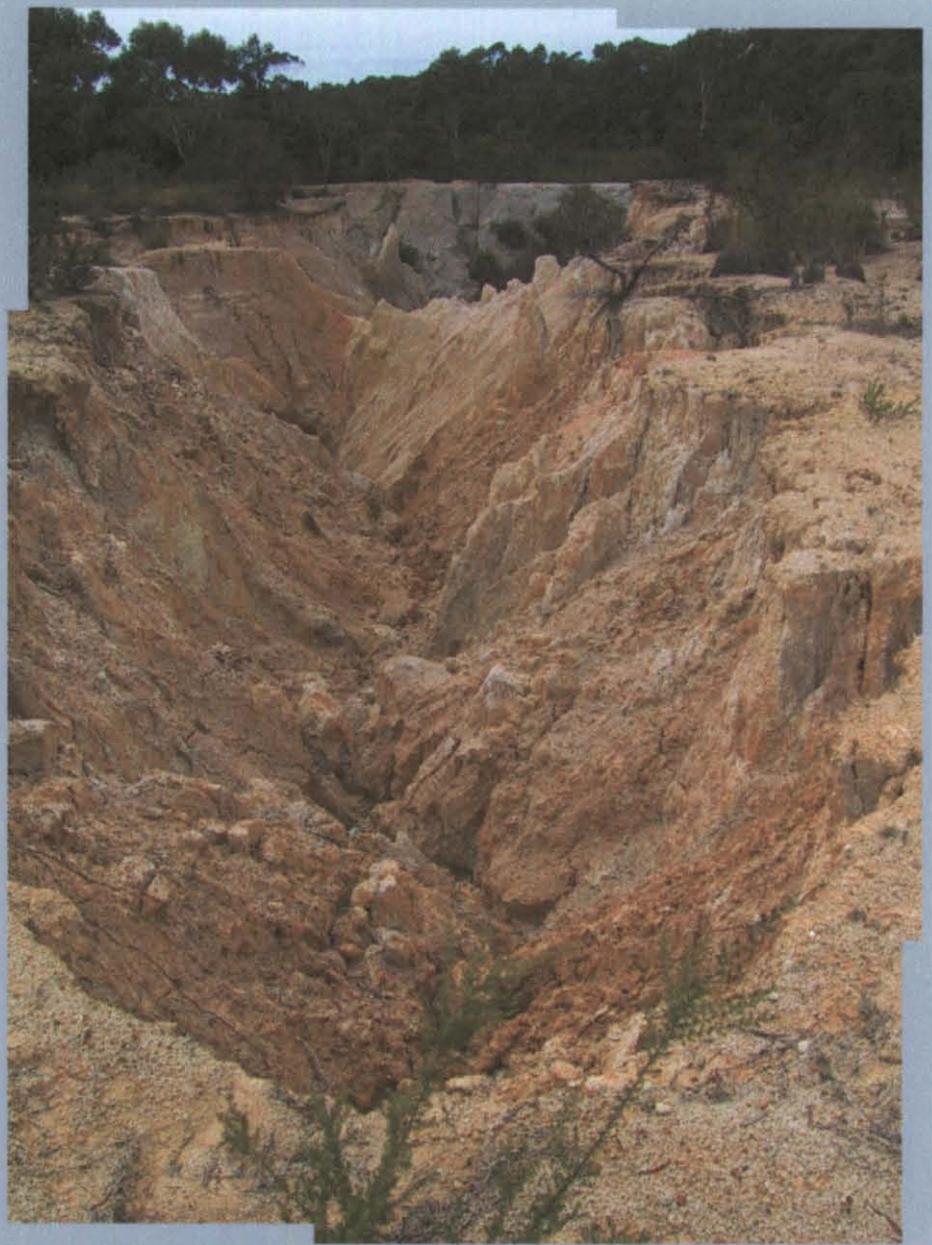
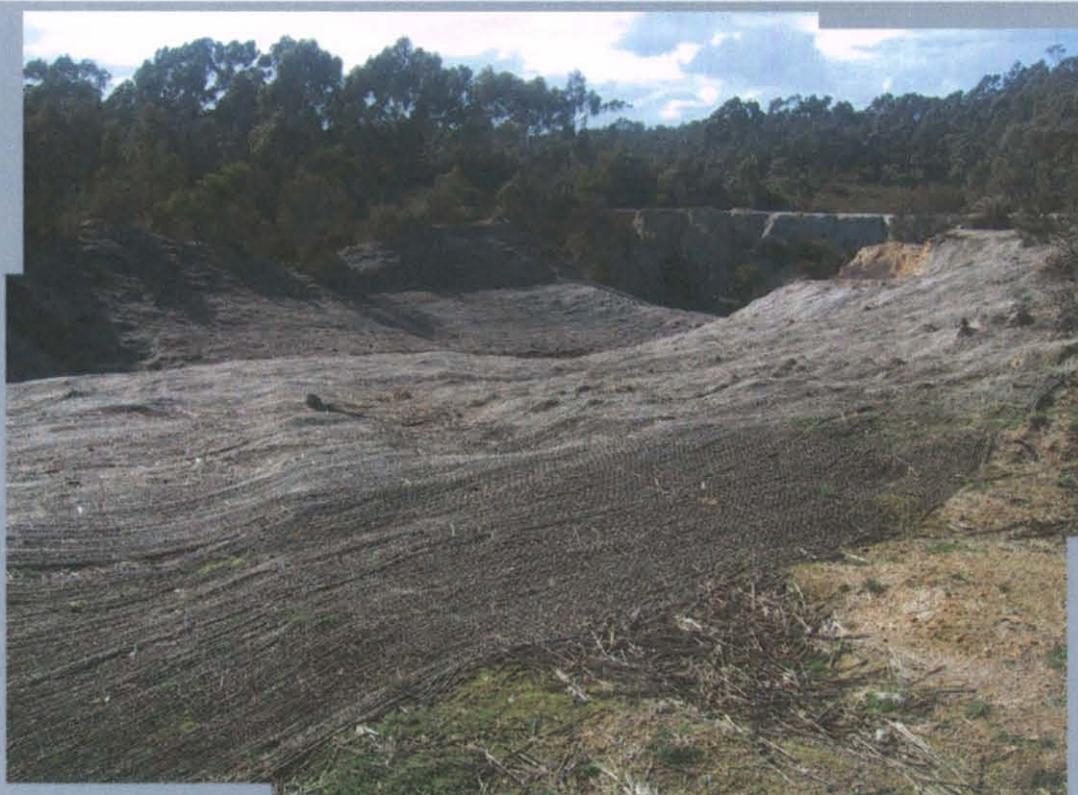
figure 6

Before
Treatment

Gully 'I', the largest that now incorporates a small impoundment

Final
Treated
Product

Neighbouring 'l' gully system, the deepest with very active branch gullies and the conveyer of most catchment runoff, was similarly reshaped. As per usual a geotextile lined rock drain was constructed, this time damming the upper portion of the main gully. Benching of the steep portions of the gullies was required. **[Gully 'l' works are also depicted on a page of photographs ~ figure 6].**

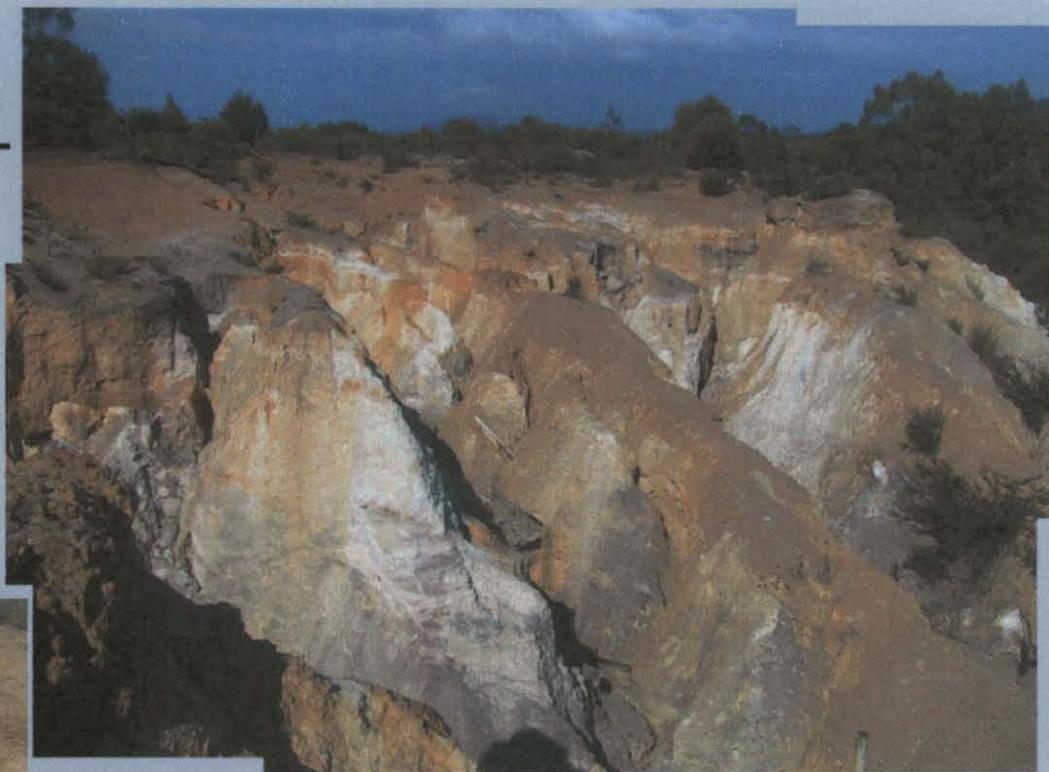
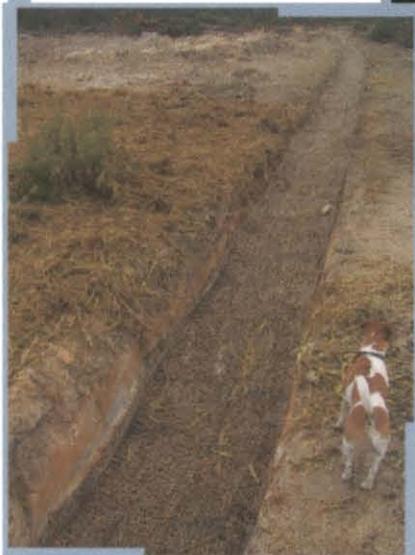
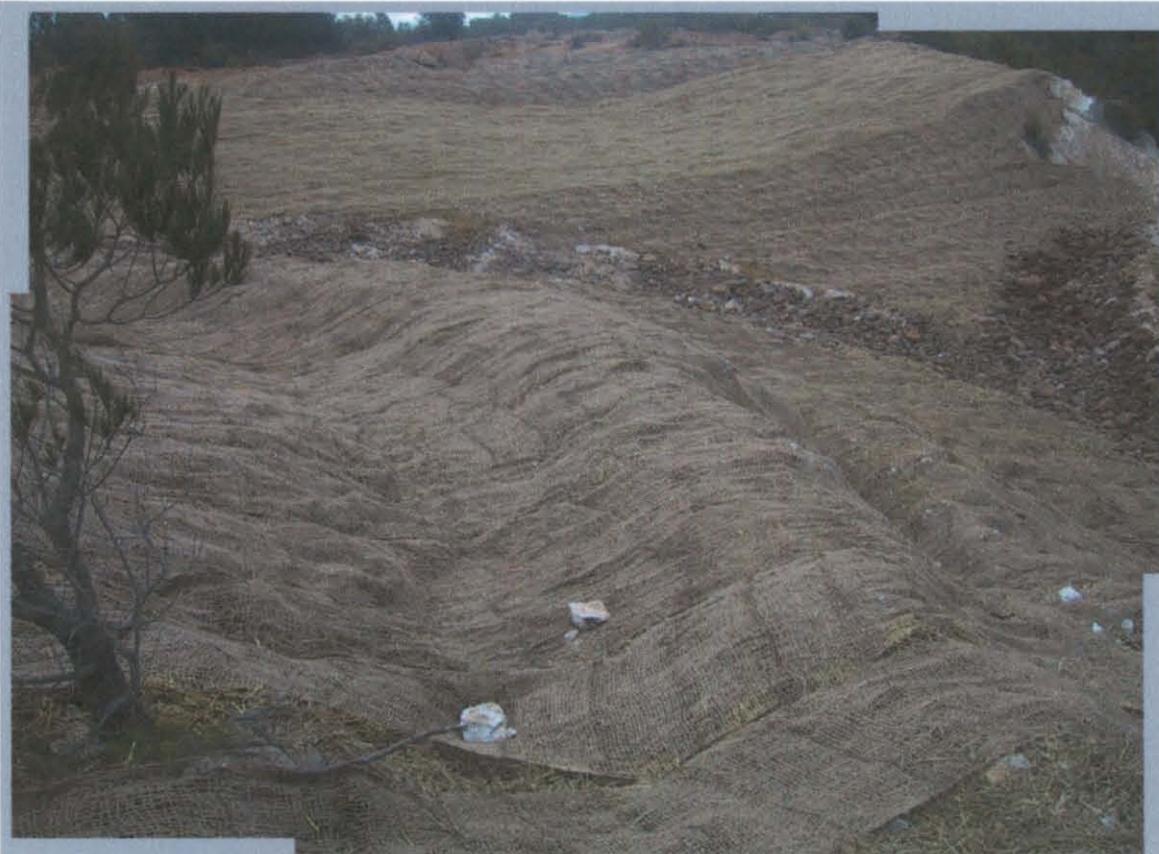
figure 7

Before
Treatment

Lined Cutoff
Drain

Gully 'x' before
and after treatment

Final
Treated
Product

Building on the better-than-anticipated experiences rehabilitating the Cat Gully facing gullies, a similar though not initially planned program of treatment of gullies bordering a section of the Endurance Deep Lead was then undertaken. Sizeable steep gullies shown as 't' through to 'x' located on figure 2 and also listed and ranked in table 1, amounted to approximately one third of this year's expenditure. Before and after photographs of gully 't' **[figure 9]** and gully 'x' **[figure 7]** accompany this report.

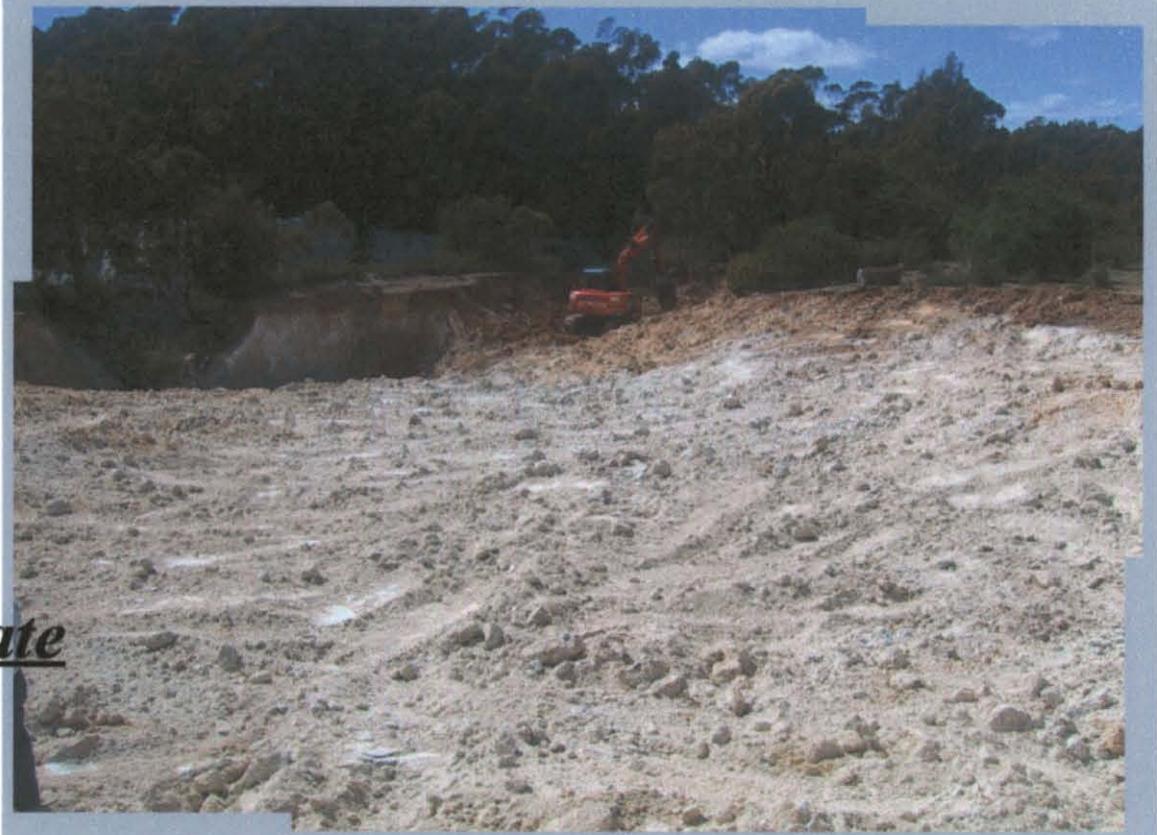
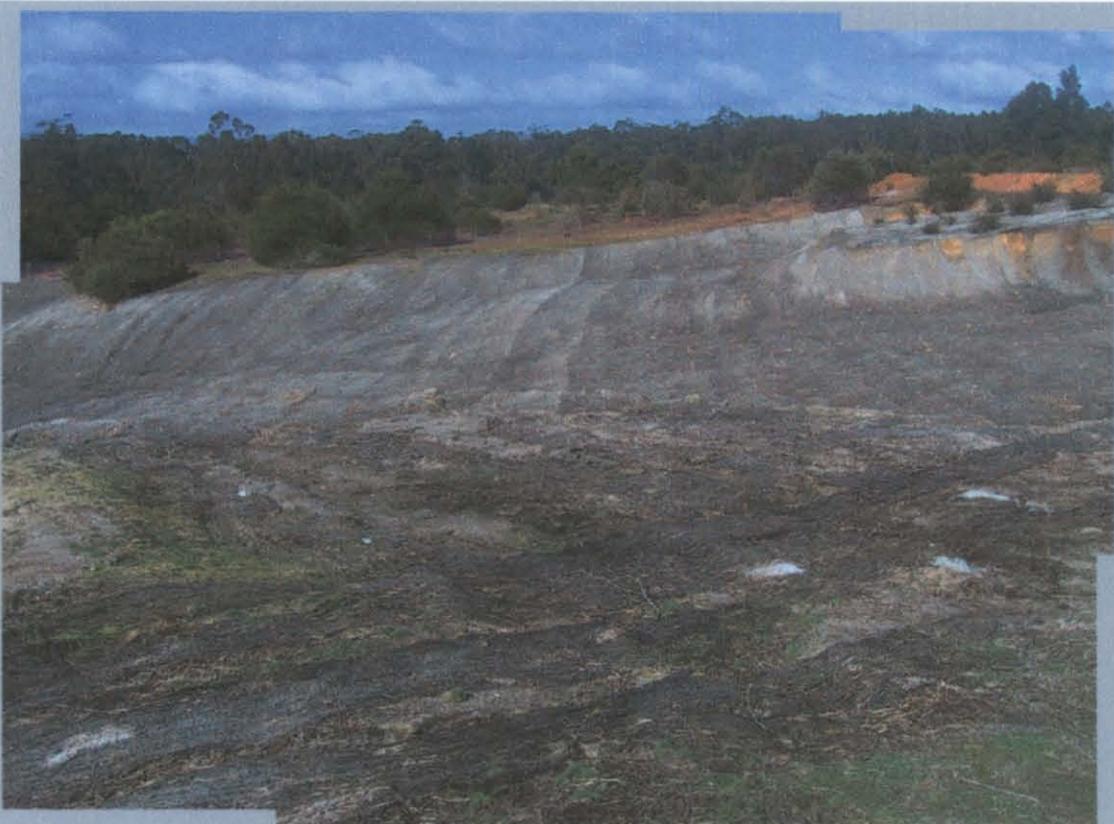
figure 8

*Intermediate
Treatment
Stage*

The "Bowl"
of Gully 'n'

*Final
Treated
Product*

weathered granite provided easy digging for the excavator. The initial conversion of the series of dendritic, narrow incised gullies known as gully 'n' to a shallow basin occupying 0.4 ha in less than two days, **[see page of photos ~ figure 8]** stimulated confidence to similarly treat the two other large gullies bordering Cat Gully.

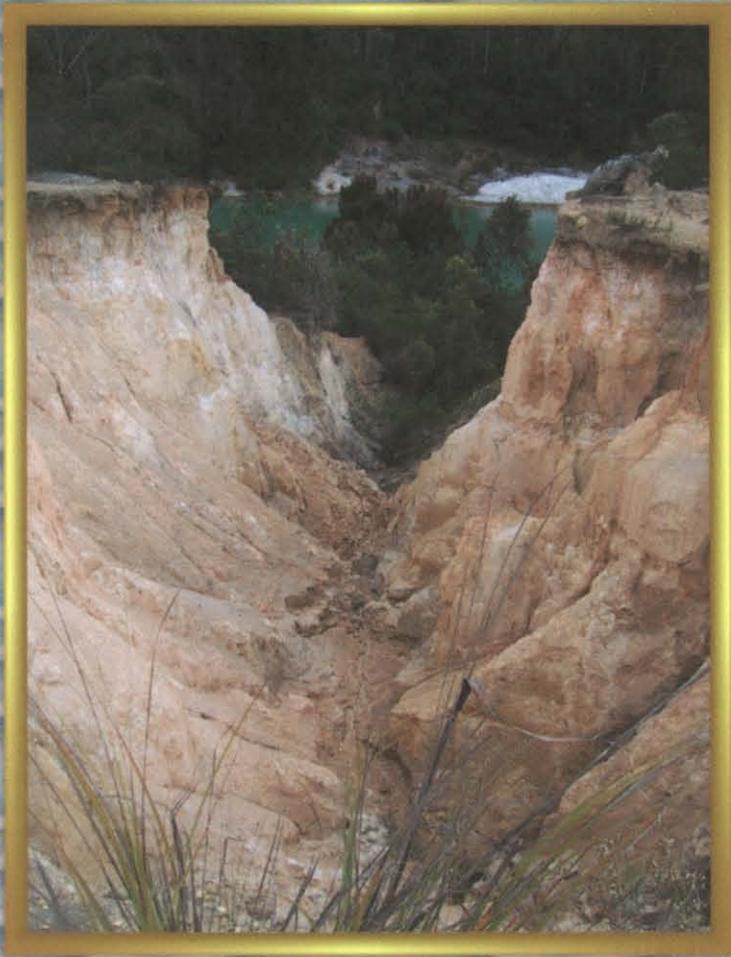
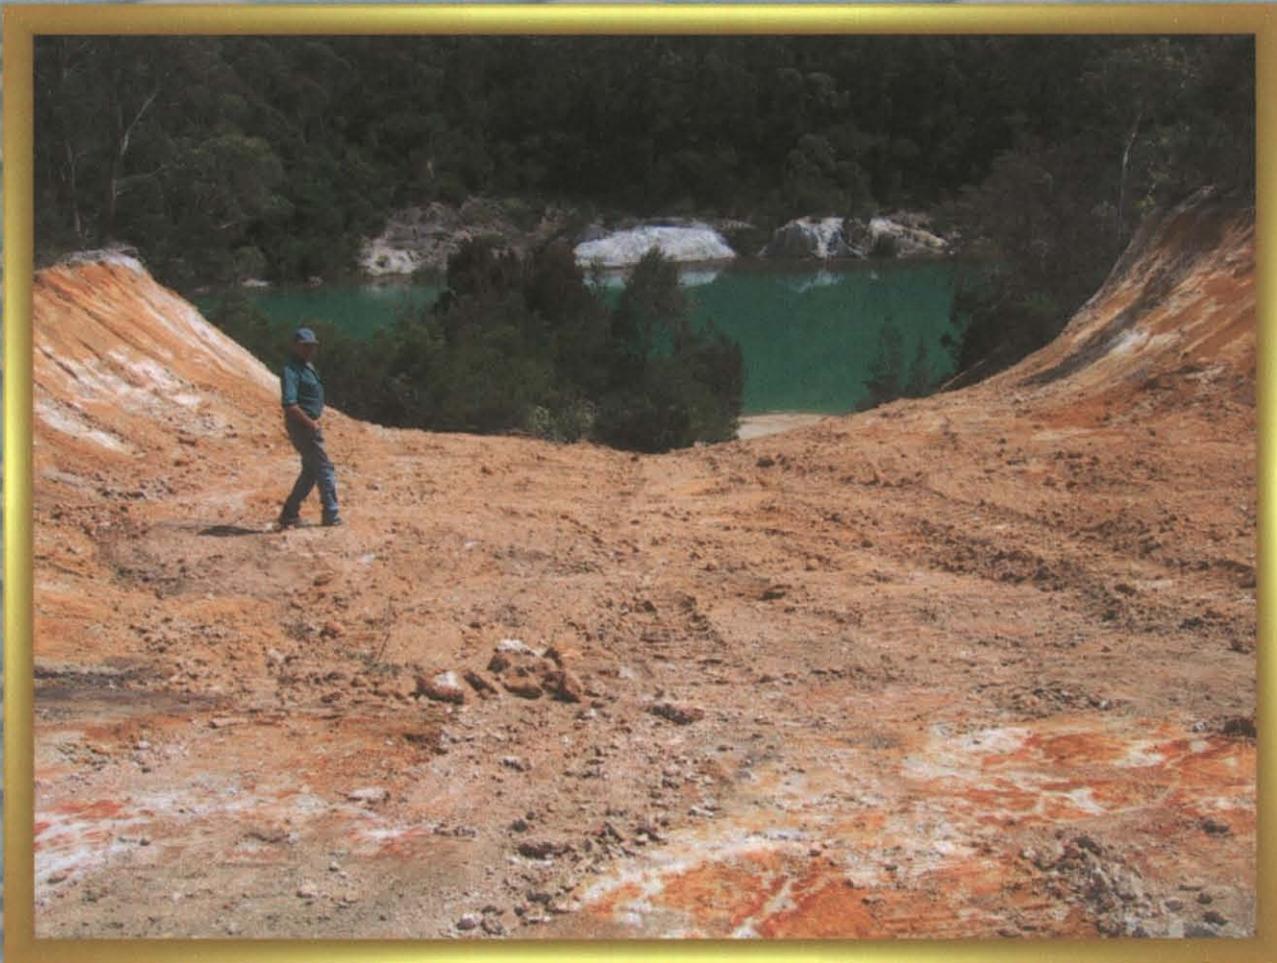
figure 9

*Gully battered and filled . Erosion control
using straw, slash, and jute matting
treatment with associated organic
mulching, fertilising, liming and direct
seeding to follow*

Gully 't'
