**Report on Works undertaken ~ 2001 – 2002 Financial Year for the
REHABILITATION OF MINING LANDS TRUST FUND
Project: rehabilitation of alluvially mined land, North East Tasmania**

Report by: Revel Munro

September 2002

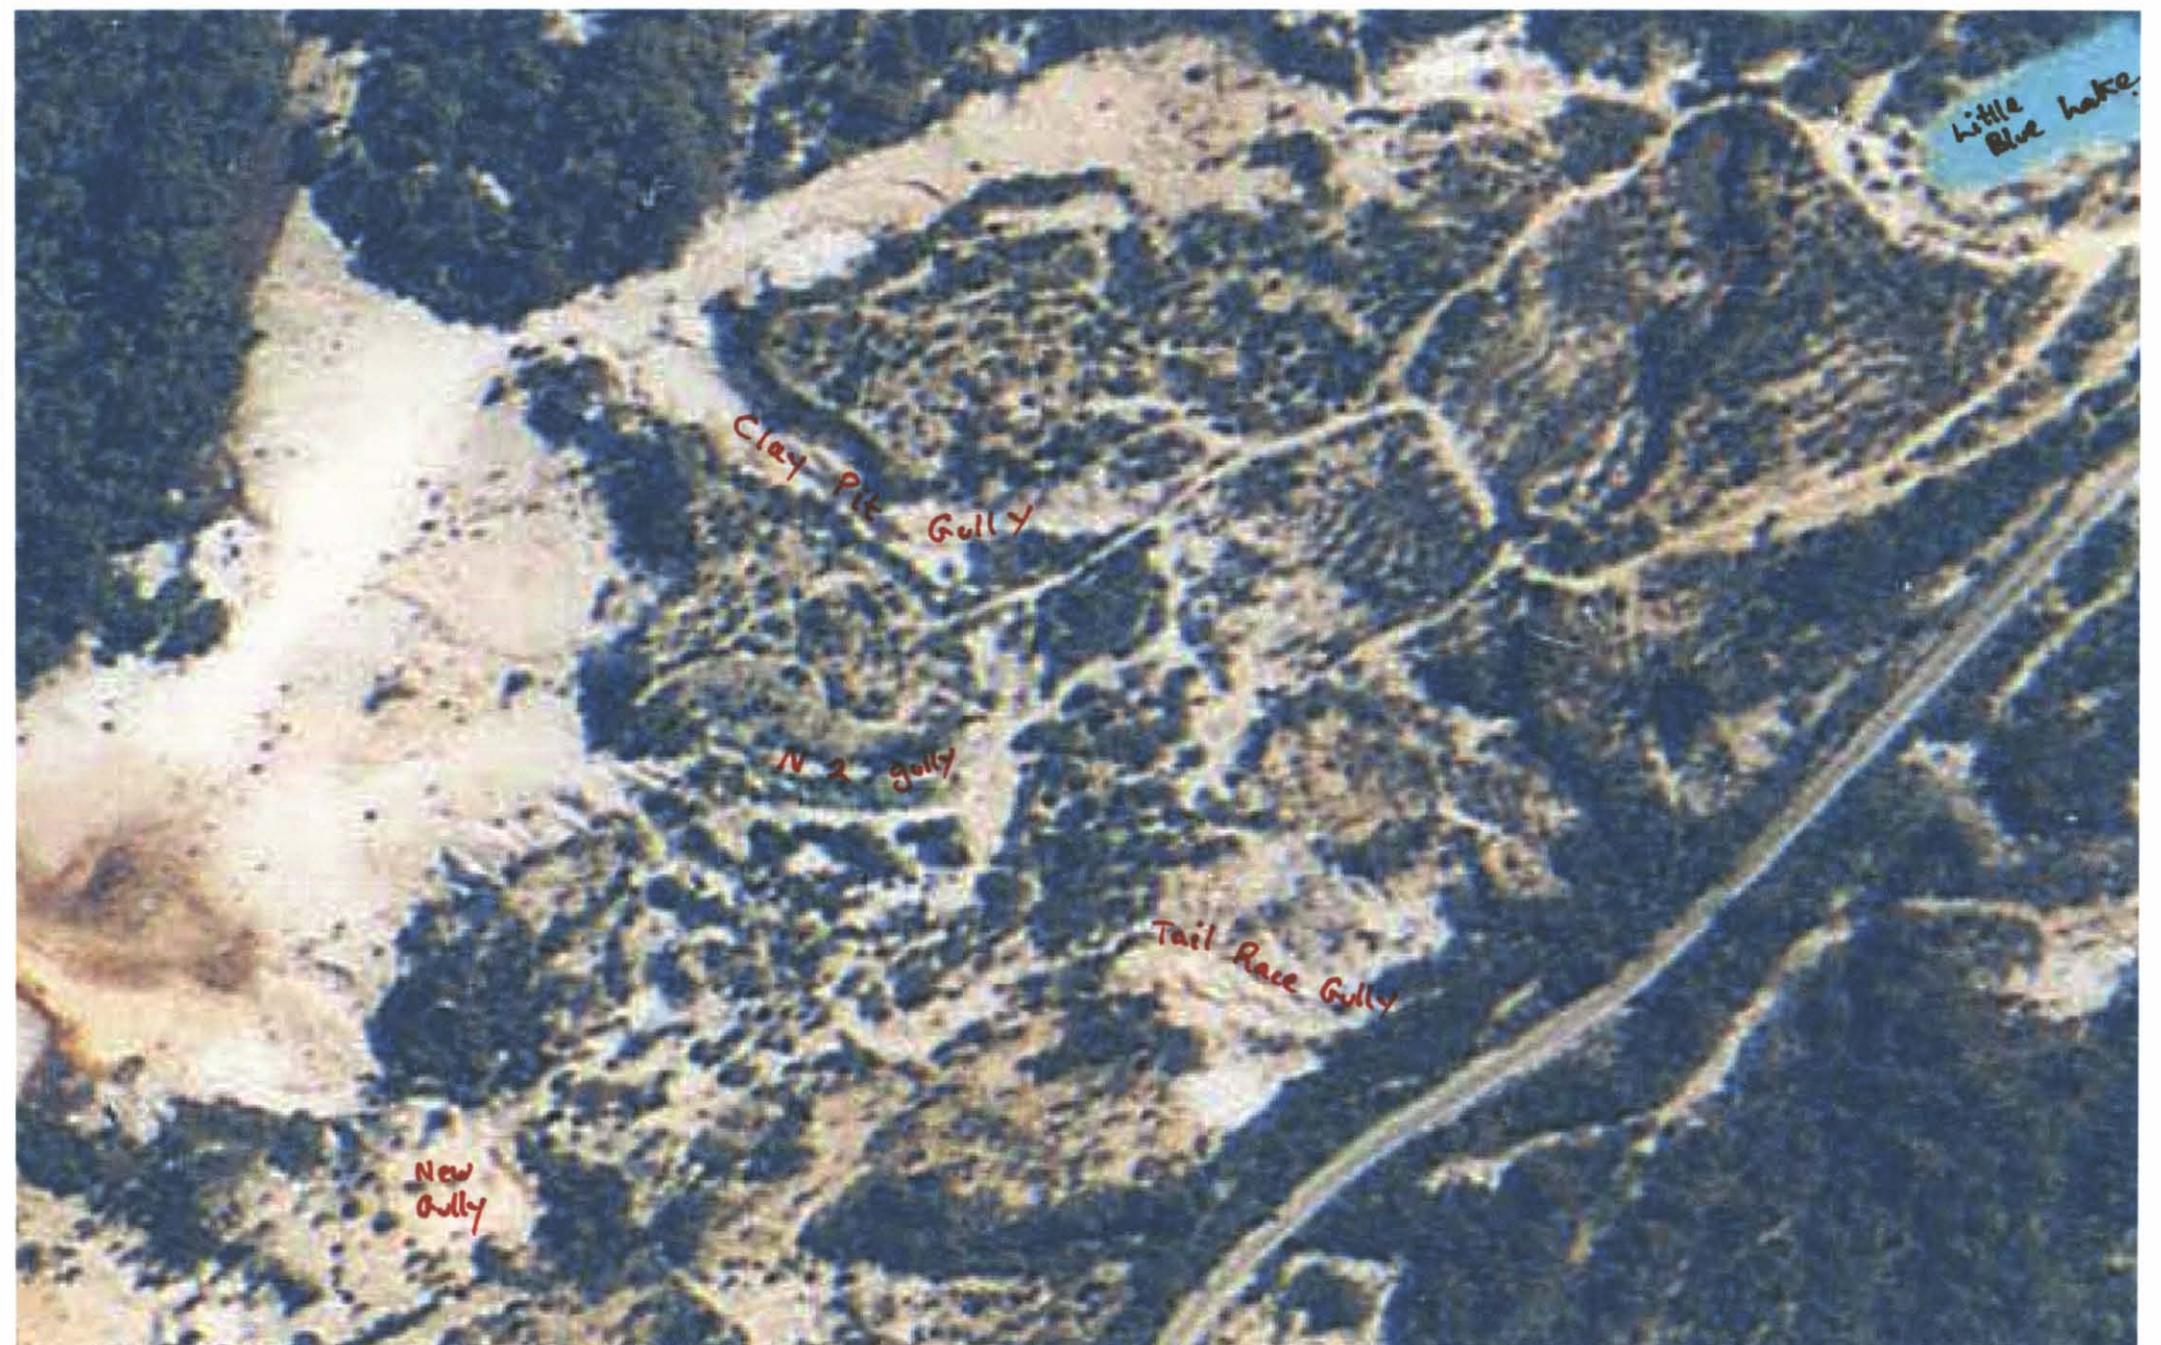
figure 10. Clay Pit 2002 aerial photo enlargement

The Clay Pit gully was a elongate [see **picture right**] (250 metre) gully that lies to the north of the rehabilitated N2 gully. It deepened significantly from its mid point downwards and was probably an old tailrace structure that was only back cutting slowly. **Figure 11** and the 2002 aerial photo enlargement, **figure 10** show the location and shape of the treated site.

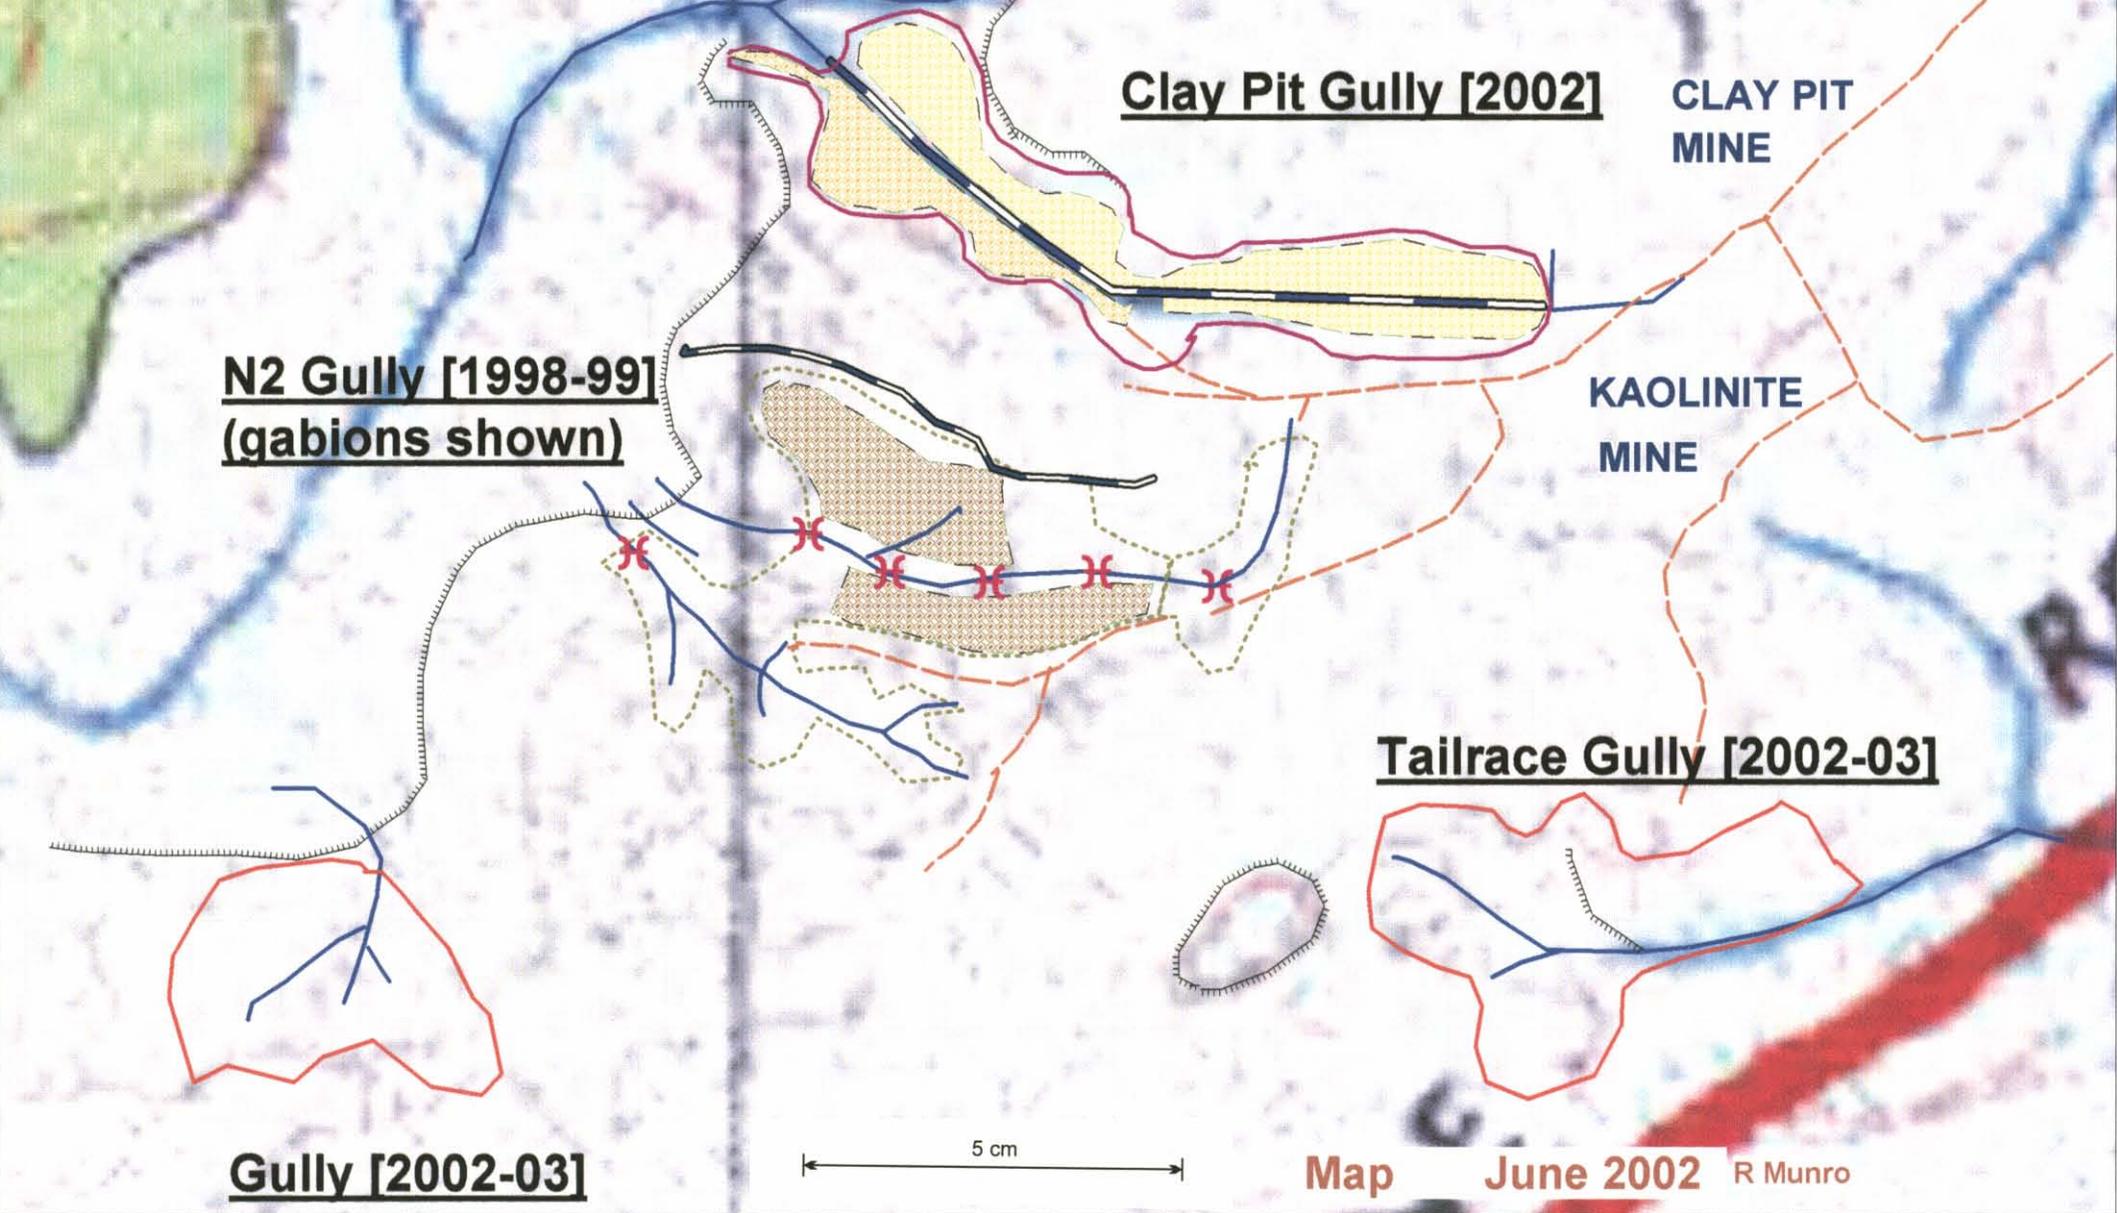
figure 11.

Location Map ~ Clay Pit Area, South Mt Cameron

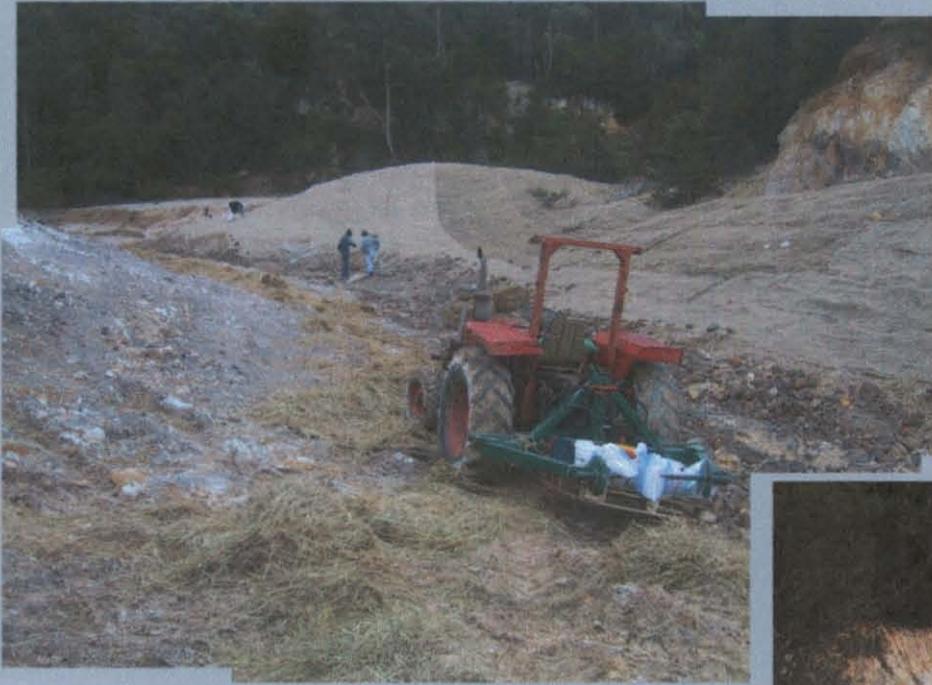
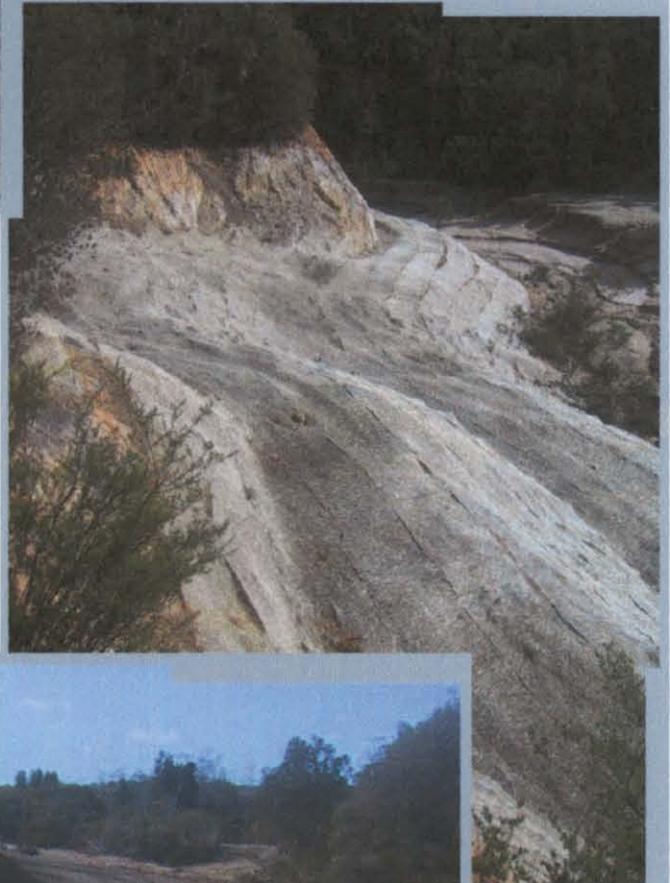
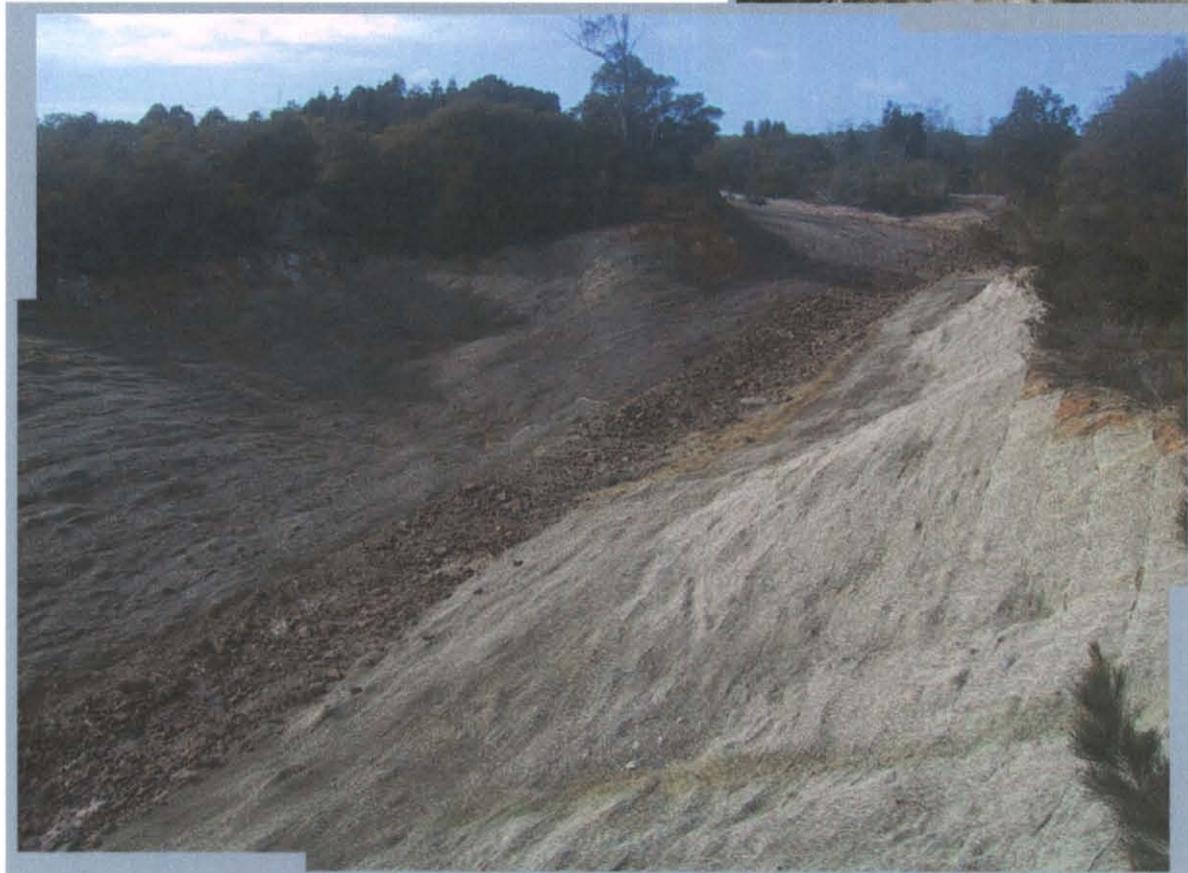
figure 12.

[figure 12] is included. The lower photo shows the central rock drain 125 m long flanked by hayed and jute covered slopes. The upper portion of the drain is a jute and hay lined spoon drain structure of a similar length.

Lower Portion

Benched
western section

Middle
portion

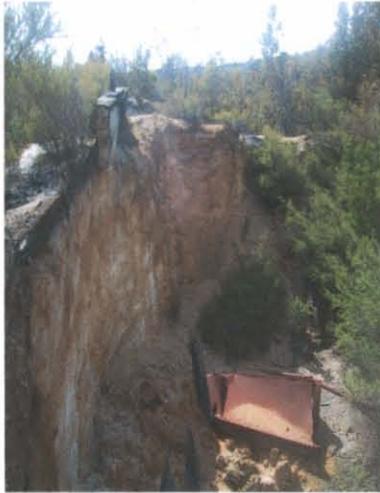
- ❖ The remains of the last Deep Lead Endurance Tin Mining Co. treatment plant (their only jig plant of the late 1960's) ~ **see left**, some disturbed excavations and concrete pads of the area
- ❖ Remnants of the scraper fed Endurance No1 stockpile heap with associated ground sluice race. The remains consist of oversize forkings and scrap steel, **see below**.

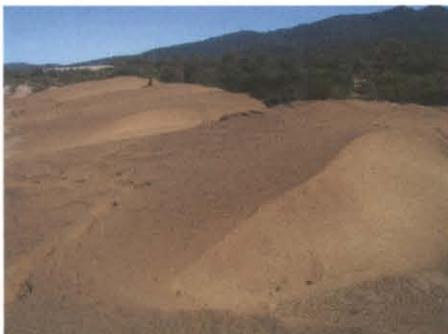
A further eight loads of pyrethrum spent marc, was delivered by a large walking floor prime mover. This dry and dusty organic matter was dumped in the middle of this treatment area. **See photo, left**. One load was used on Cat Gully 'x'. A small proportion was dispersed by the wind. The balance [bar wet "left overs"] was eventually spread over half this area. It is apparent that fertiliser spreading

contractors are not keen to apply this dusty mulch. The wait was over six months before a contractor undertook the task, and then only with mediocre performance.

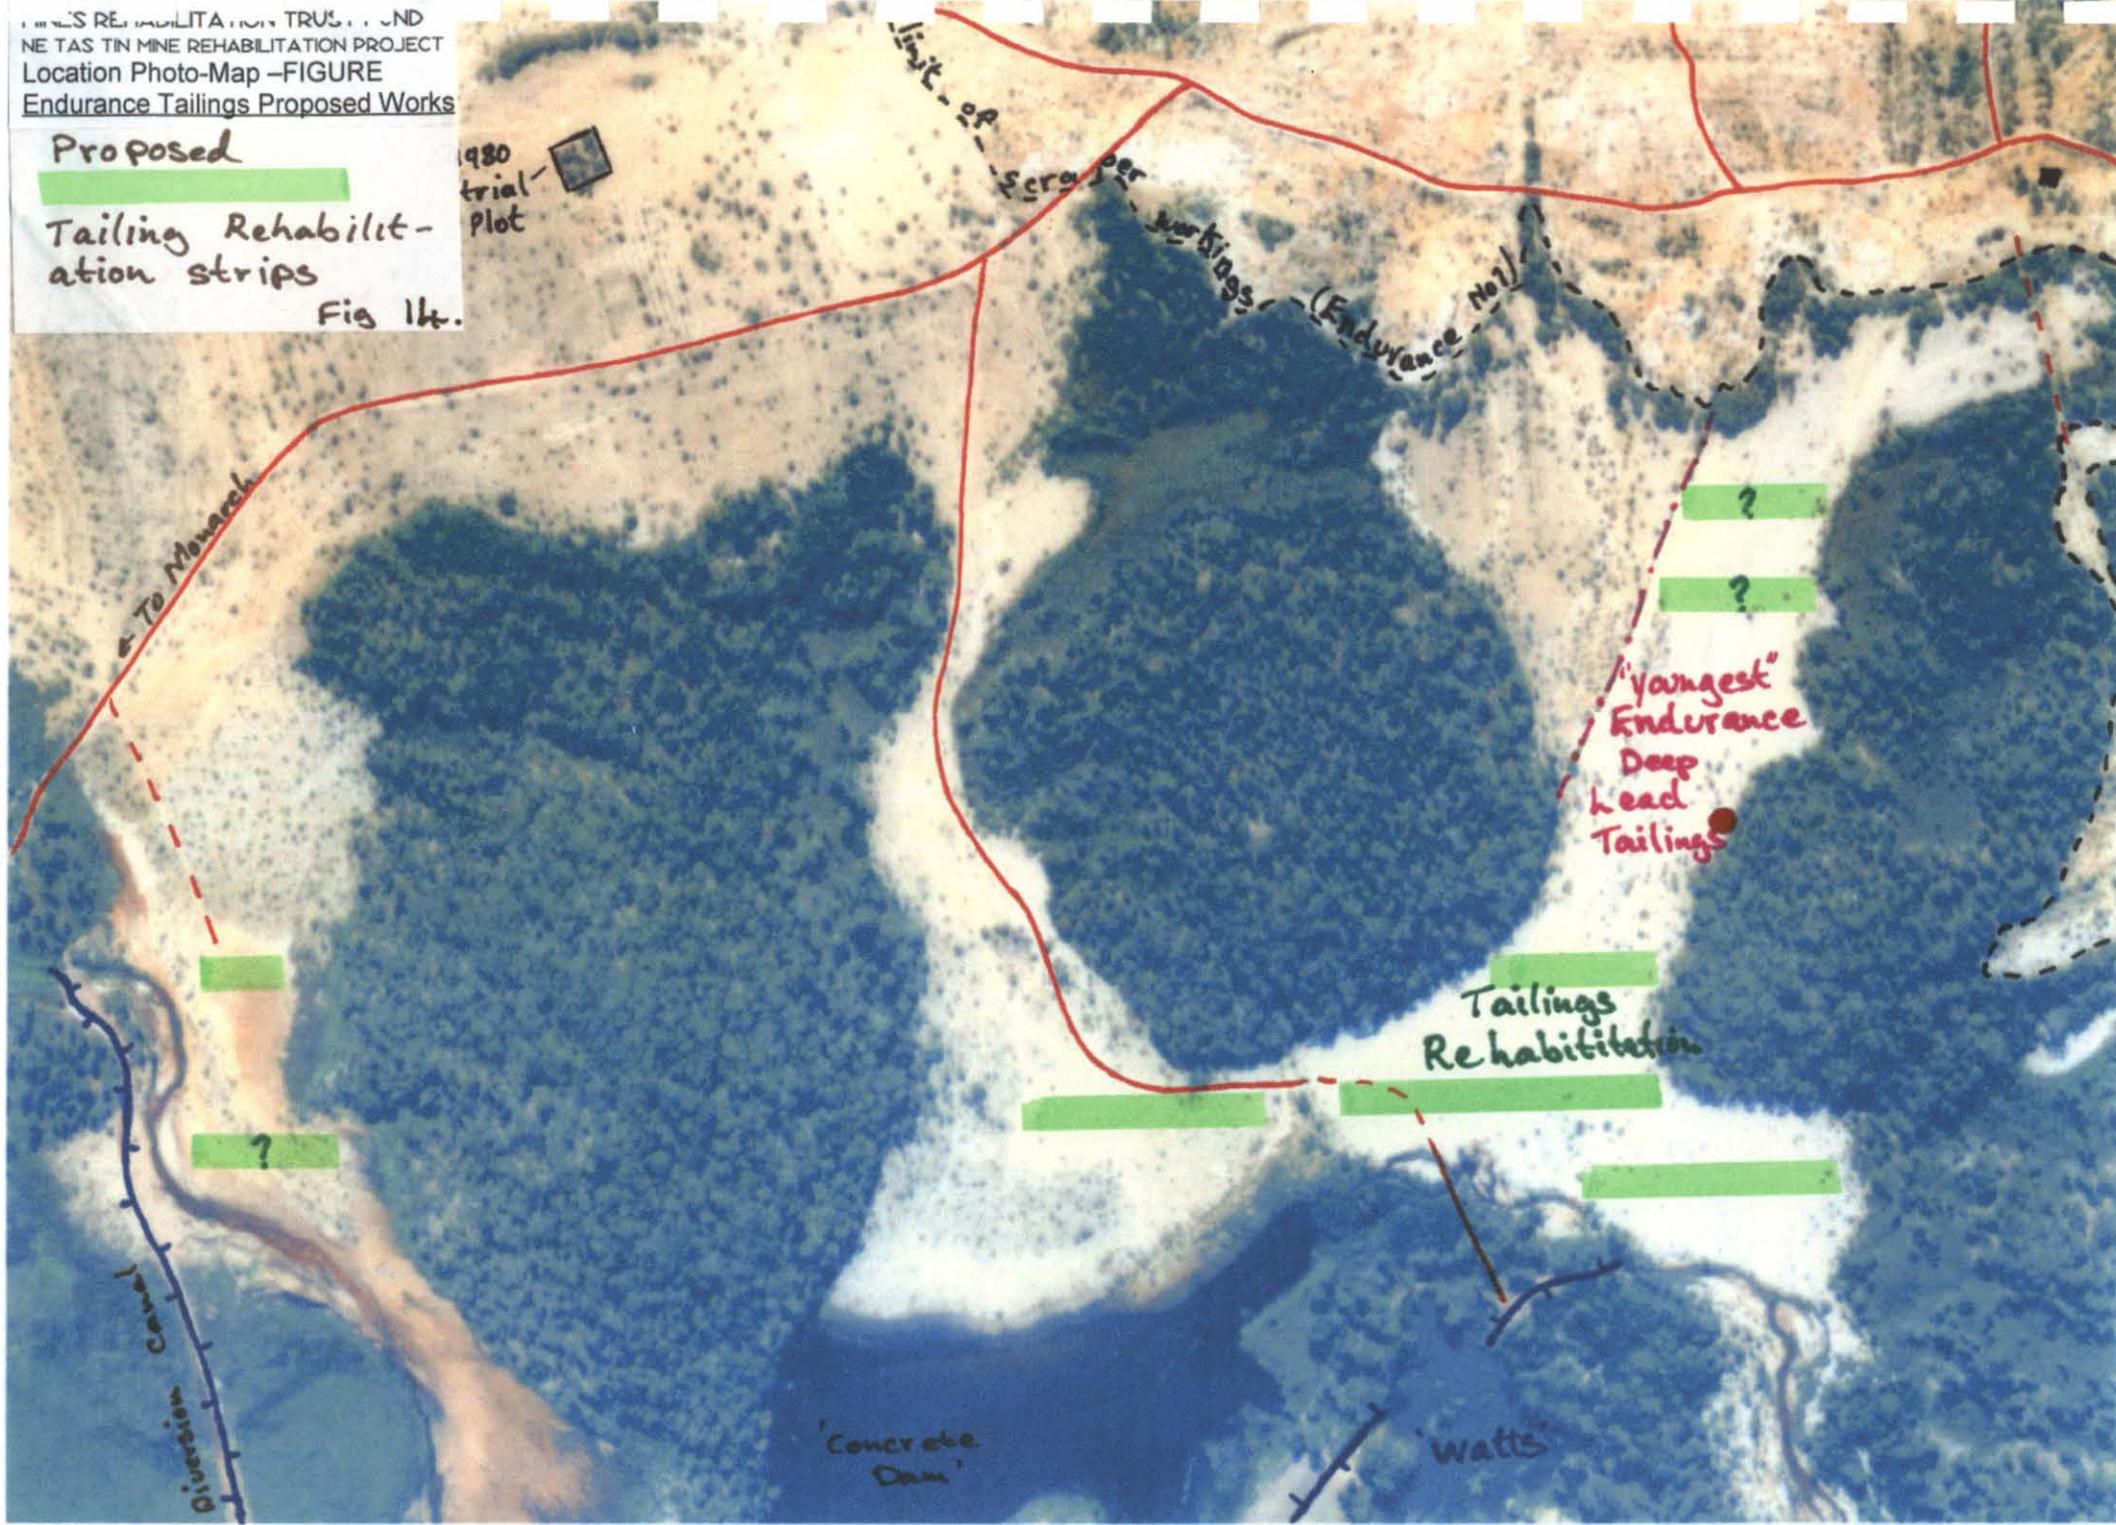
figure 14

**LOCATION MAP -Endurance Tailings
Mine Rehabilitation Trust Fund
Tailings revegetation trial strips
Native seed sown May 2002**

- Complete restoration of "Tailrace Gully", Clay Pit area, South Mt Cameron.
An area of 0.75 ha pictured right that drains into the Ringarooma River and was once use for the conveyance of deep lead tailings to the river in conjunction with a tunnel under the Gladstone Road. These workings are located on **figure 11**
- Similar complete rehabilitation of a steep and active unnamed gully system backcutting from the mine face of old deep lead Endurance workings. The area of 0.5 ha is also located on **figure 11** and photographed, **right**.
- Revegetation works on the lower reaches of the Endurance tailings fans. See **figure 14** for approximate locations.

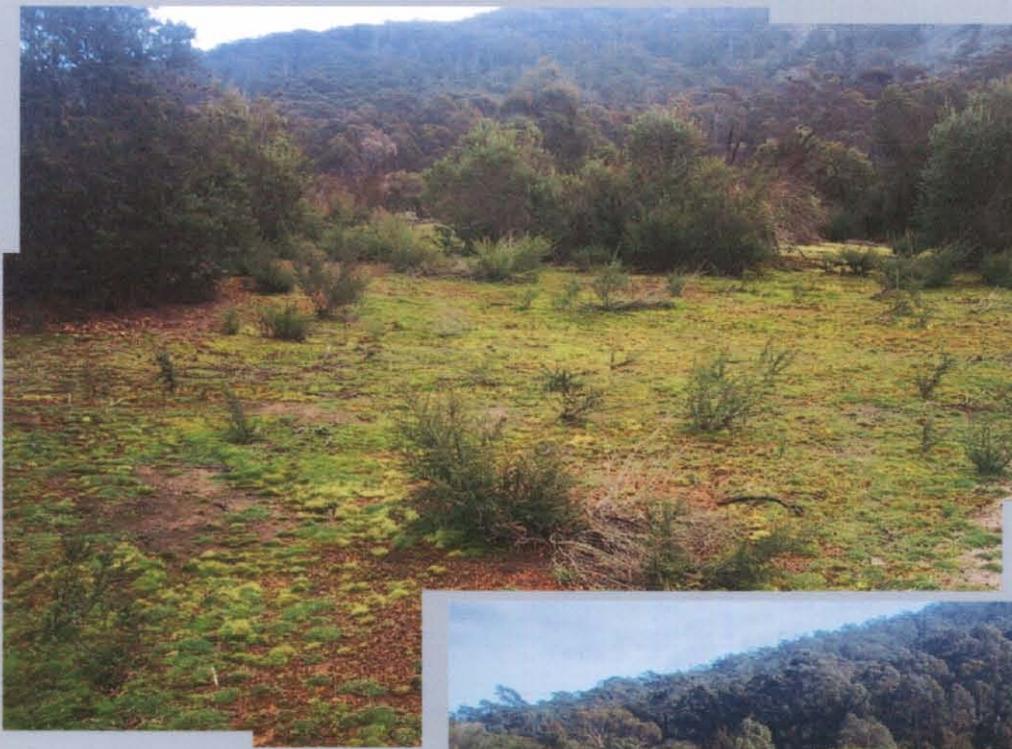
Response to fertiliser and mulch
~ vigorous growth of moss

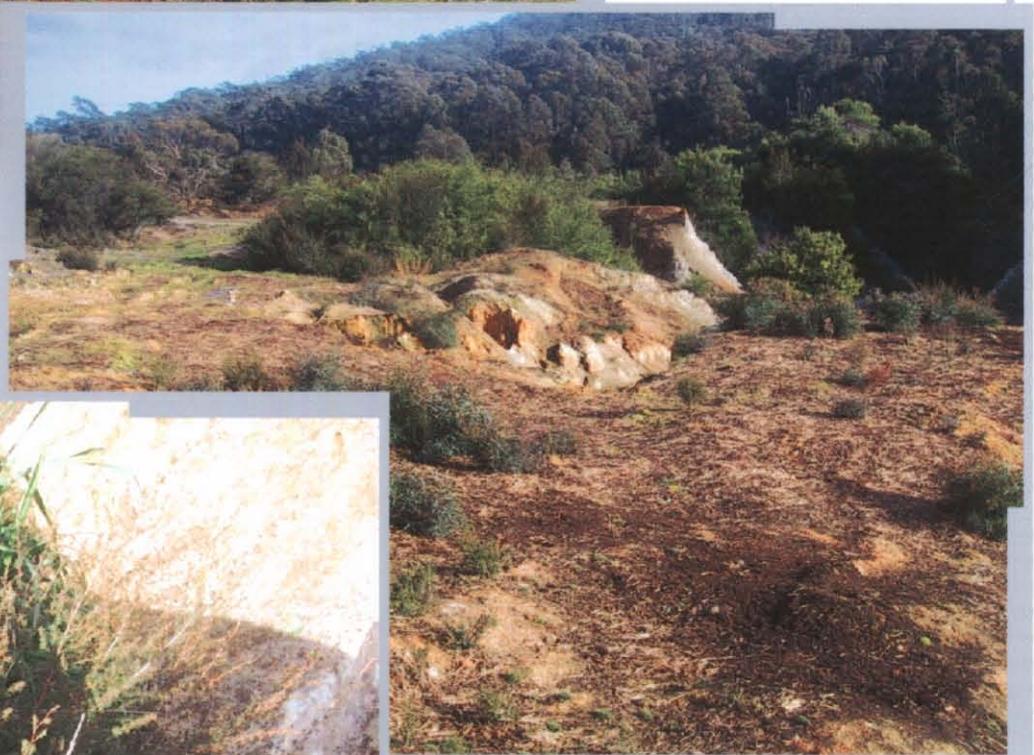
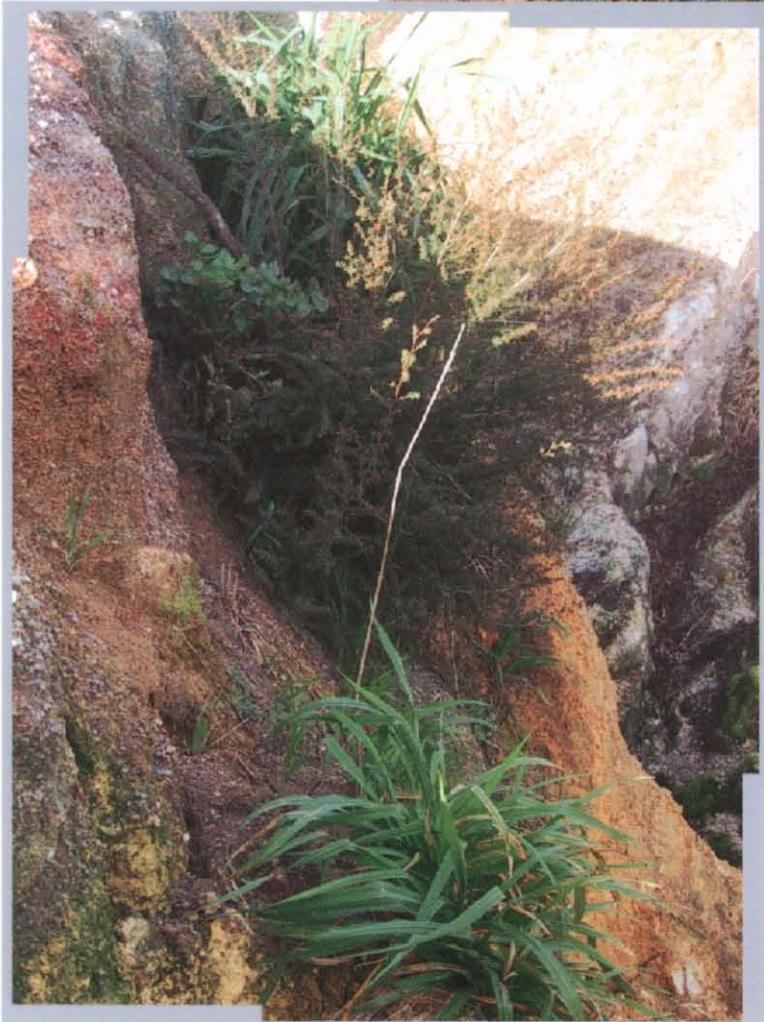
Peppermint and melaleuca
germination ~ 8 months

Abundant growth where
browsing not possible

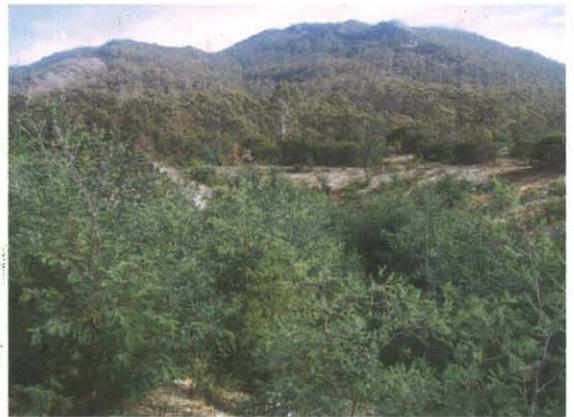
The N2 gully continues to show excellent vegetation growth across a range of substrates and environs. A small area with suspected sulphur / pyritic contamination remains bare. The annual application of about 100 kg/ha of high analysis fertiliser over an area of 1.12ha has continued. Some of the best regrowth is pictured, **left**.
