## St Helens Rehabilitation — Project Report Summary

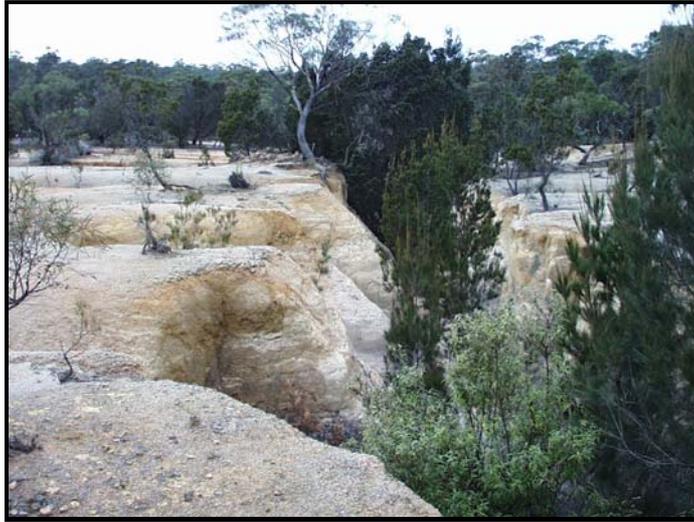
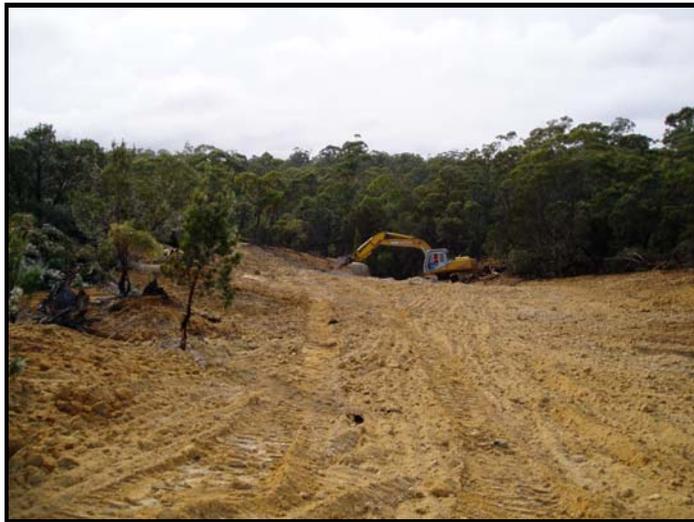
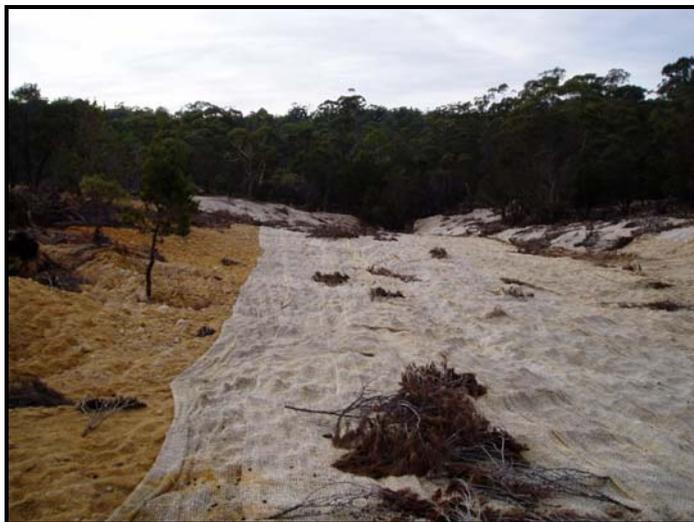
**Site 3.** *Looking down gully to the north*

- Site recontoured, gully system battered.
- Two cut-off drains leading into a central drain constructed.
- Geotextile-lined high impact/flow sections of drain.
- Rock-lined drains.
- Seed spread.
- Jute applied.
- Seed-bearing and non seed-bearing slash spread.
- Fertilizer applied.

Some trial sections on this site. Head of system root rake cultivation with seed-bearing slash. Also below northern-most cut off drain there is no fertilizer or jute. Monitor results 6-30 months.

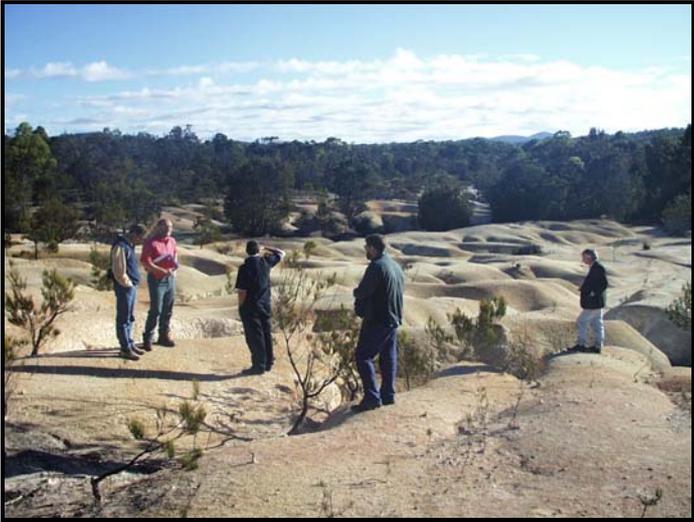
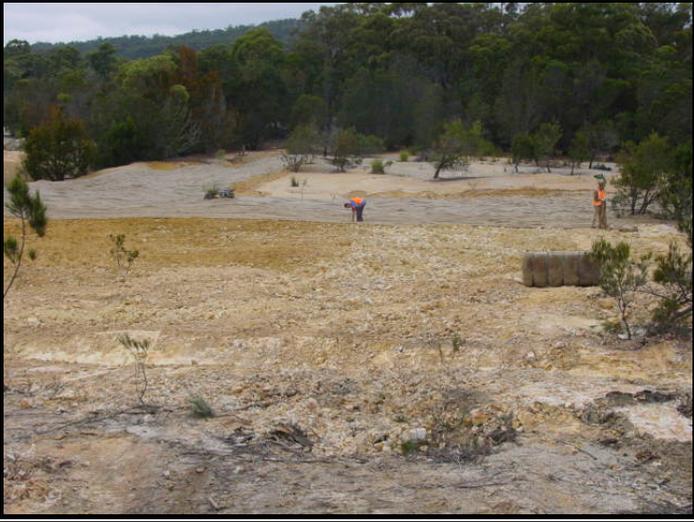
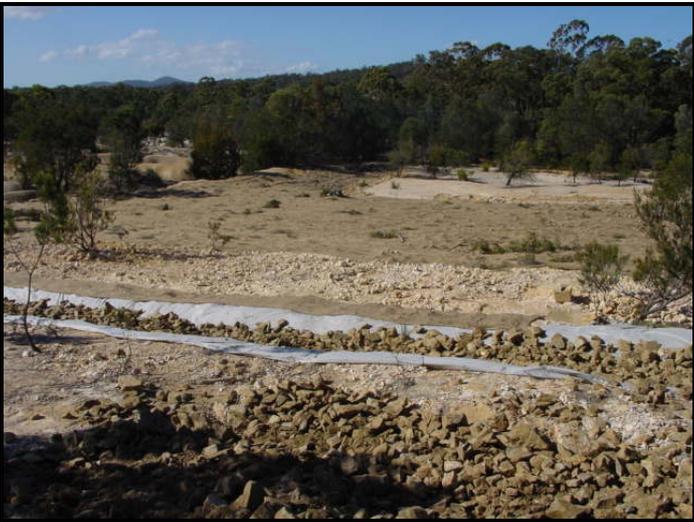
**Site 5.** *Looking to the north and east.*

- Site recontoured.
- Cut-off drain above site.
- Geotextile-lined high impact/flow sections of drain.
- Rock-lined cut-off drain to central drain.
- Jute laid down.
- Seed-bearing slash, seed and fertilizer applied.

Our first attempt and a reasonably uncomplicated site.

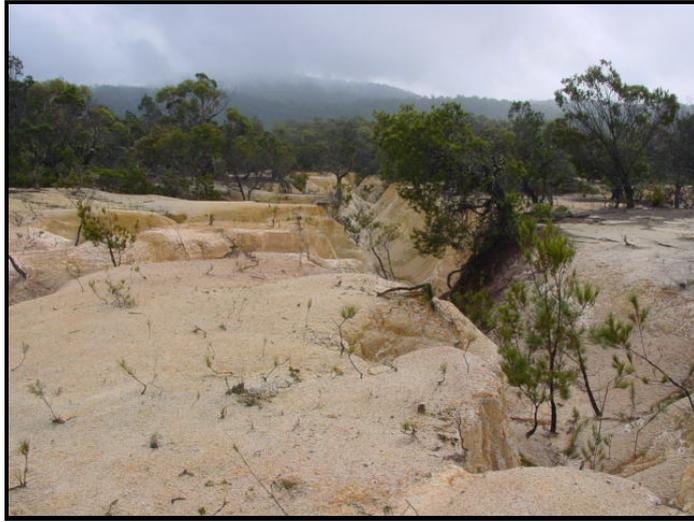
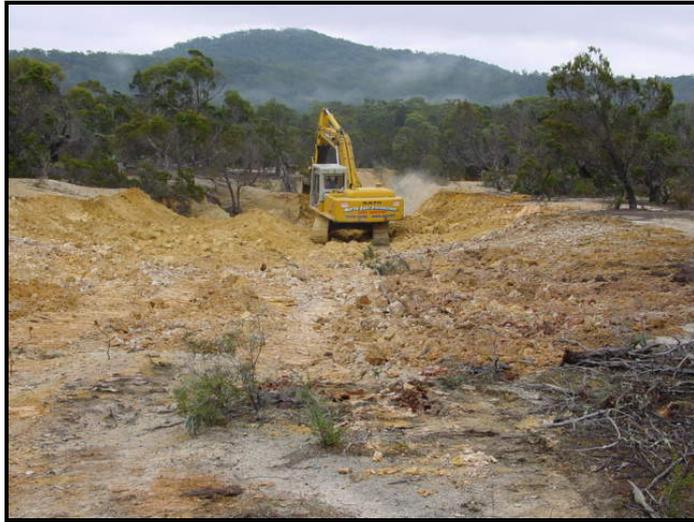
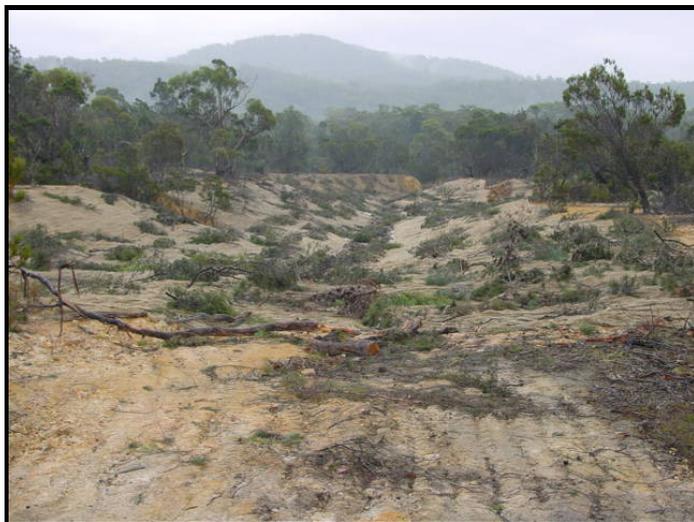
**Site 6.** *Looking down gully to the west*

- Site recontoured and gully systems battered to best possible gradient.
- Two central drains constructed with a small cut-off drain from the access road.
- Geotextile-lined high impact/flow sections of drain.
- Rock-lined drains and gully heads.
- Seed spread over site.
- Jute spread over site.
- Seed-bearing and non seed-bearing slash spread.
- Fertilizer applied.

We didn't use enough rock in the central drain. In hindsight one-two more loads would give a better result. Also could have allowed a deeper drain to accommodate rock (100-150m depth) for the length of the drain.
