# Mt Bischoff Webster Creek Diversion Drain Inspection August 2005

Prepared for

Mineral Resources Tasmania

August 2005

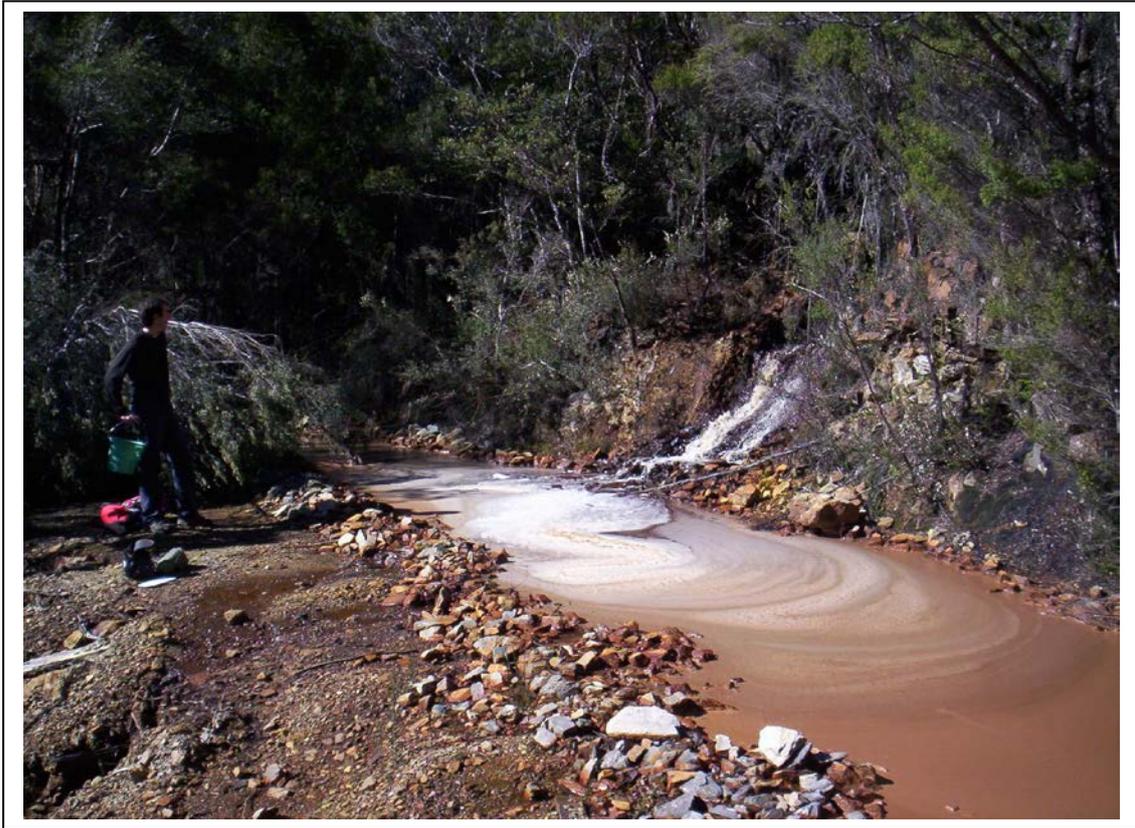
3. Track is fundamentally sound and the integrity of the diversion drain appears intact. Refer to photographs in Appendix B.
4. Short-circuiting of acid mine drainage is occurring at the top of the diversion drain where it is designed to pick up all the Webster Creek drainage. The original dam works consisted of mainly limestone and this has now been consumed by the acid mine drainage and the dam breached. Refer to photographs in Appendix B.

**Photo 2. Webster Creek collection pond - bypassing due to limestone dissolution in containment wall.**

- Fallen trees need removing.
- Regular limestone reinstatement is required in the drain to maintain water treatment effectiveness.
- It is estimated that approximately 250 tonnes of limestone is required annually.
- Repairs are required to prevent the acid mine drainage bypassing the Webster Creek diversion drain collection system.
- Before implementing the above recommendations, the likely impact of future mining activity at Mt Bischoff on the Webster Creek diversion and acid neutralisation drain should be taken into consideration.
- All culverts need to be checked regularly.

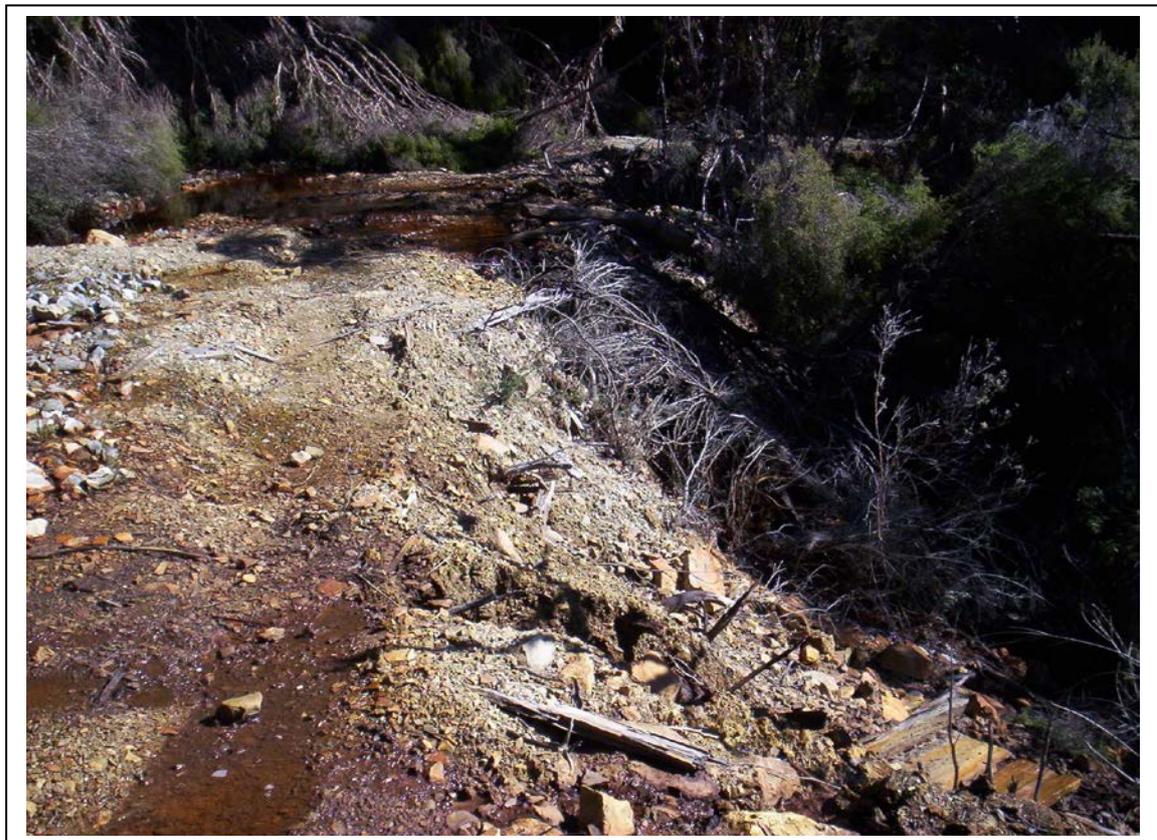
Approximately 60 % or 4.6 L/s of the total Webster Creek flow to the diversion drain collection area is being lost directly to the Waratah River.

**Photo 3. Webster Creek bypassing over track to Waratah River (top left).**

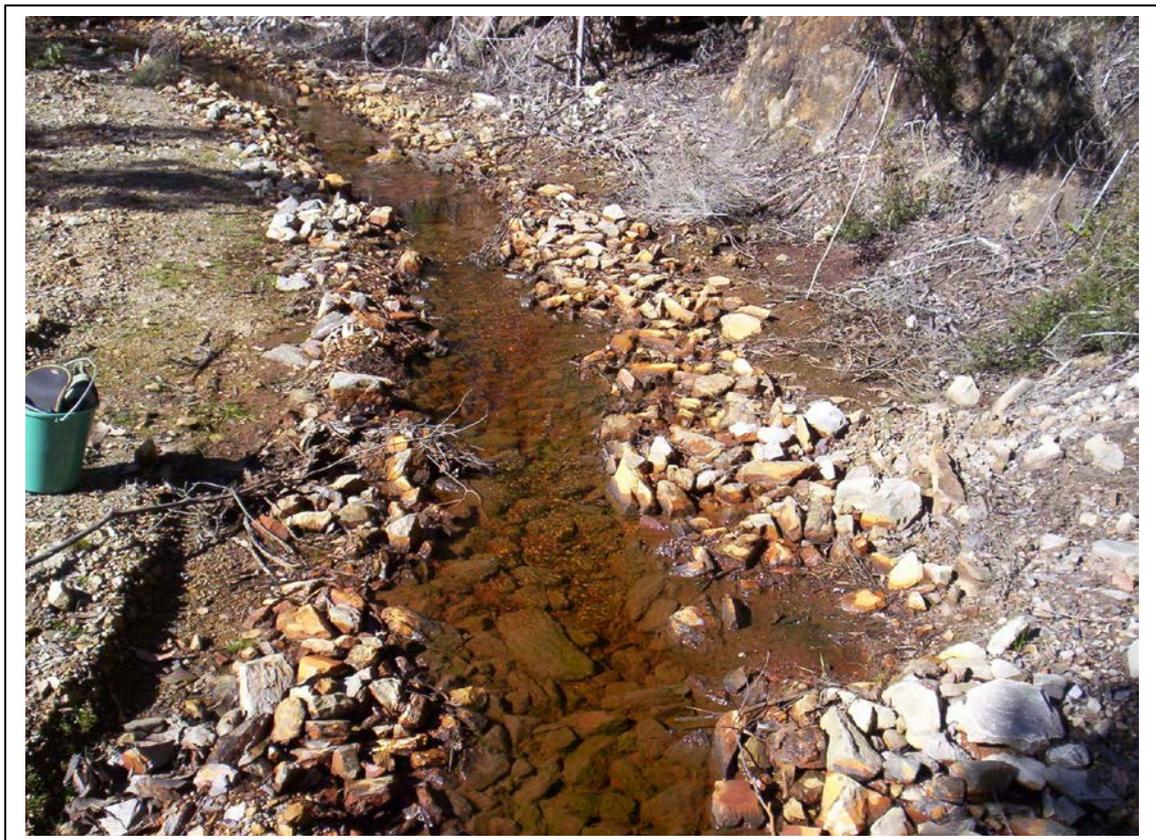
2. A major amount of the limestone has been consumed or washed downstream. It is estimated that two thirds of the limestone (approximately 500 tonne) has been used. Refer to photographs in Appendix B compared to original photographs in Appendix A.

**Photo 6. Loss of limestone from drain and coating of remainder evident.**

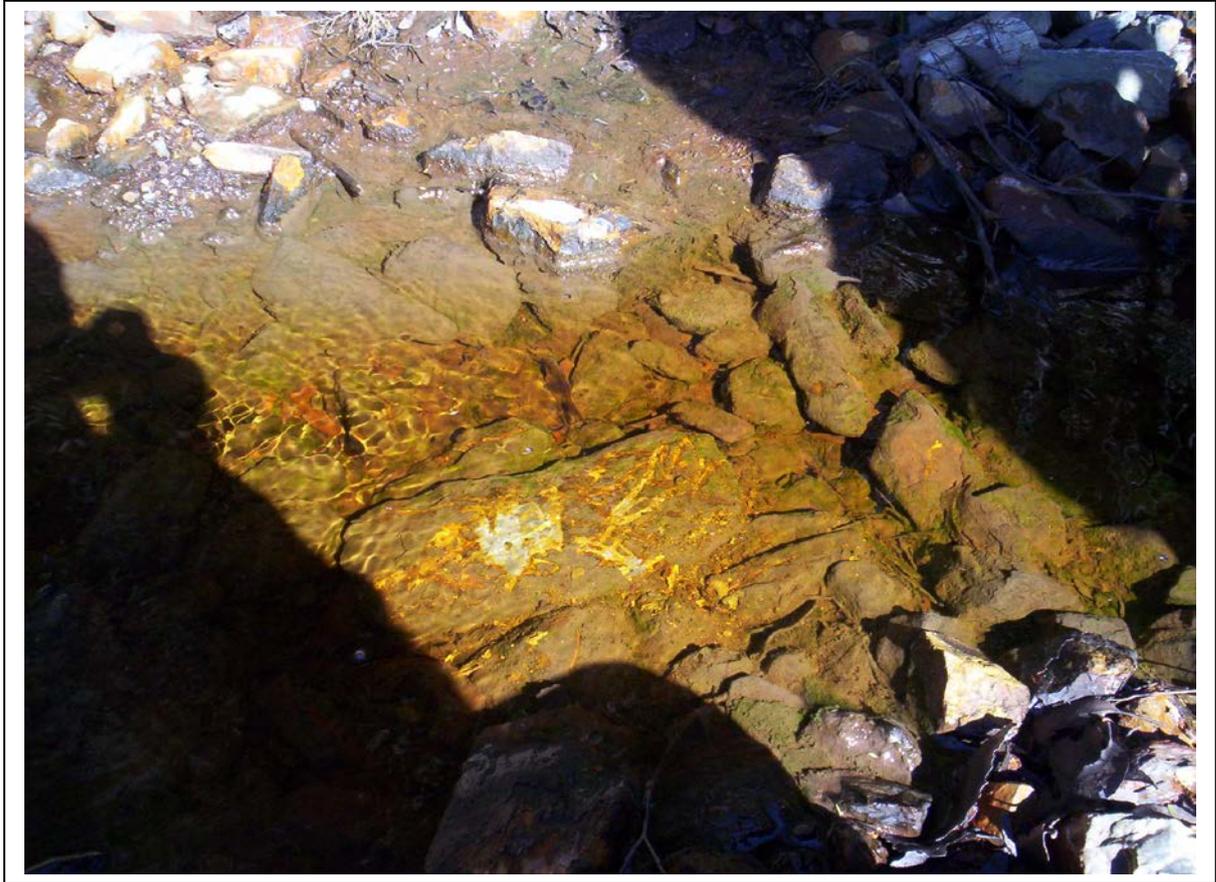
Permanent armouring of the limestone was evident at the time of the investigation with the metal hydroxide and gypsum flocs difficult to removed from the limestone to expose new limestone surface. Refer to photograph in Appendix B.

**Photo 7. Coating not easily removed to expose fresh limestone (Centre rock shows scratching of the coating).**

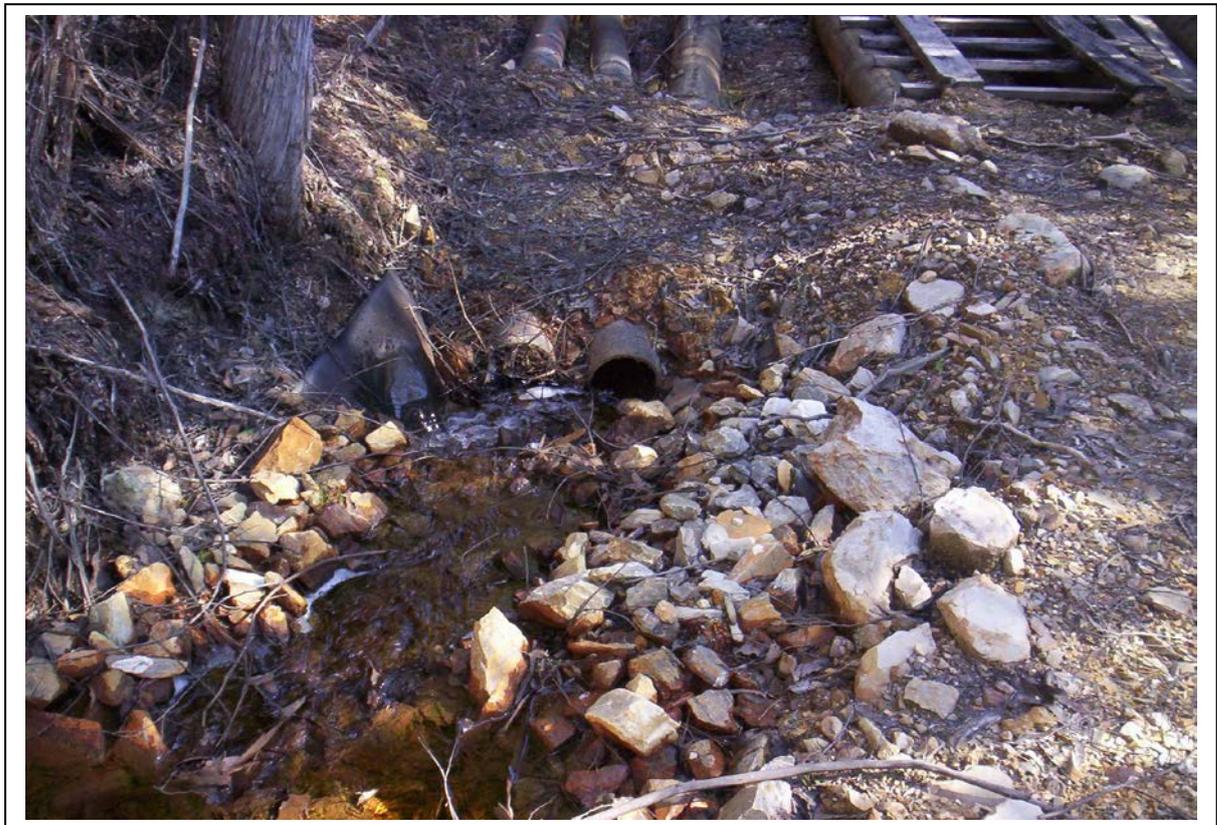
5. A partial blockage of one drain culvert at the old workings with twigs and leaves was evident. Refer to photograph Appendix B.

**Photo 9. Upstream end of two culvert pipes at bridge over all mine workings. Left one partially blocked.**

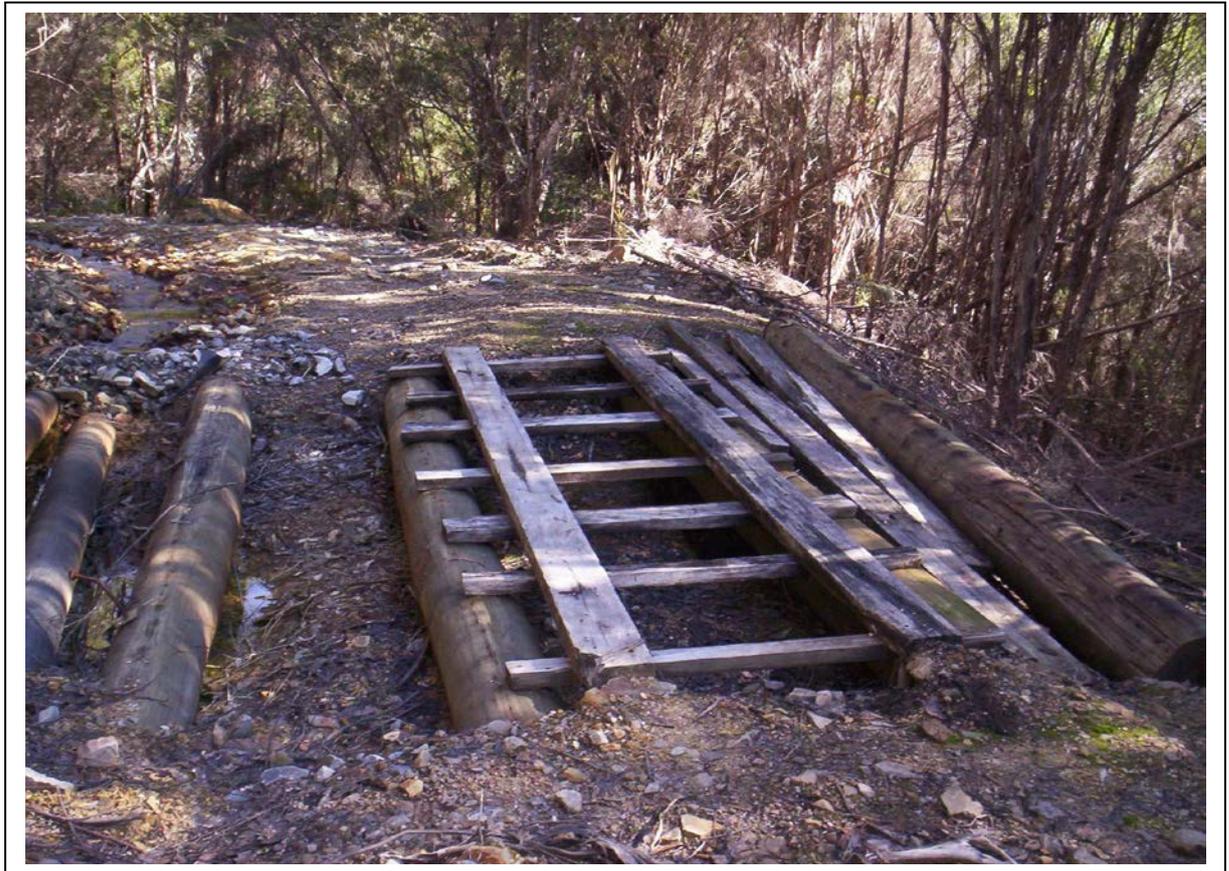
**Photo 10. Bridge over old mine workings appeared in good order.**

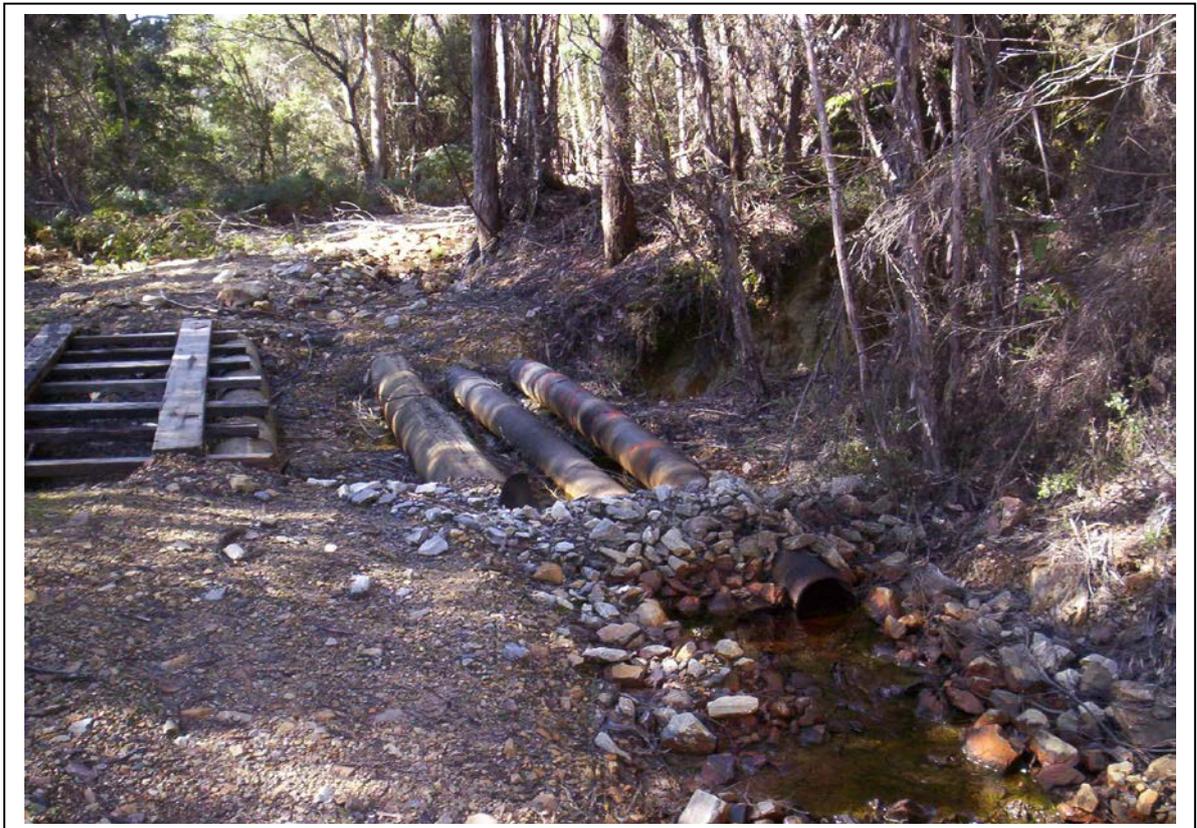
**Photo 12. Northern side of bridge over old workings. Left culvert submerged on the downstream end.**

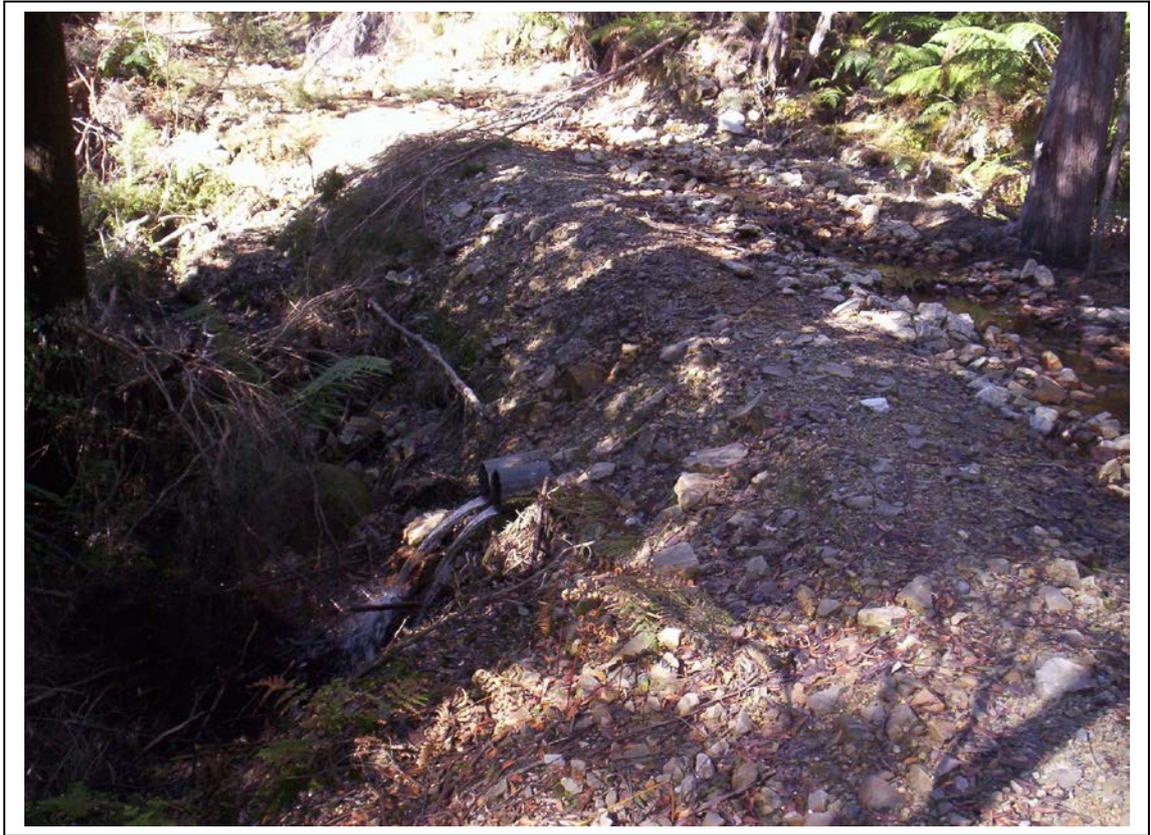
**Photo 13. Gun Club Creek culverts OK.**

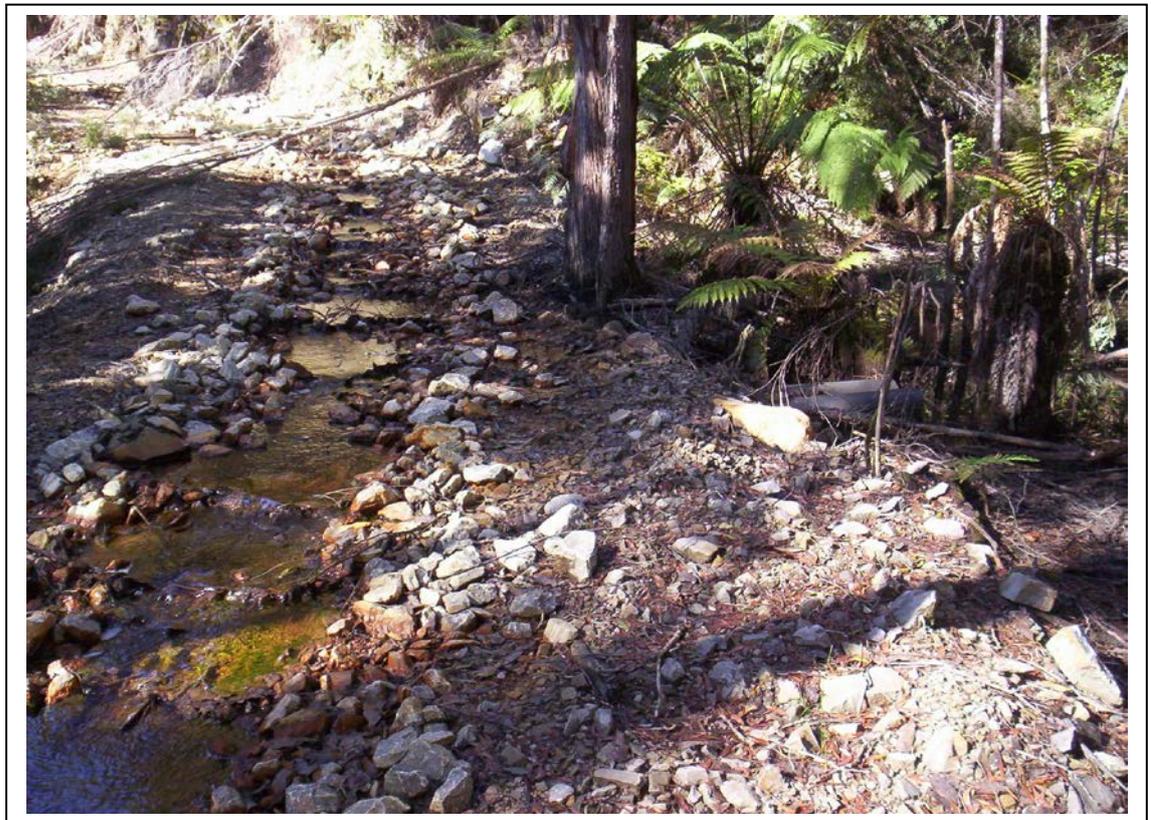
**Photo 14. Gun Club Creek culverts OK.**

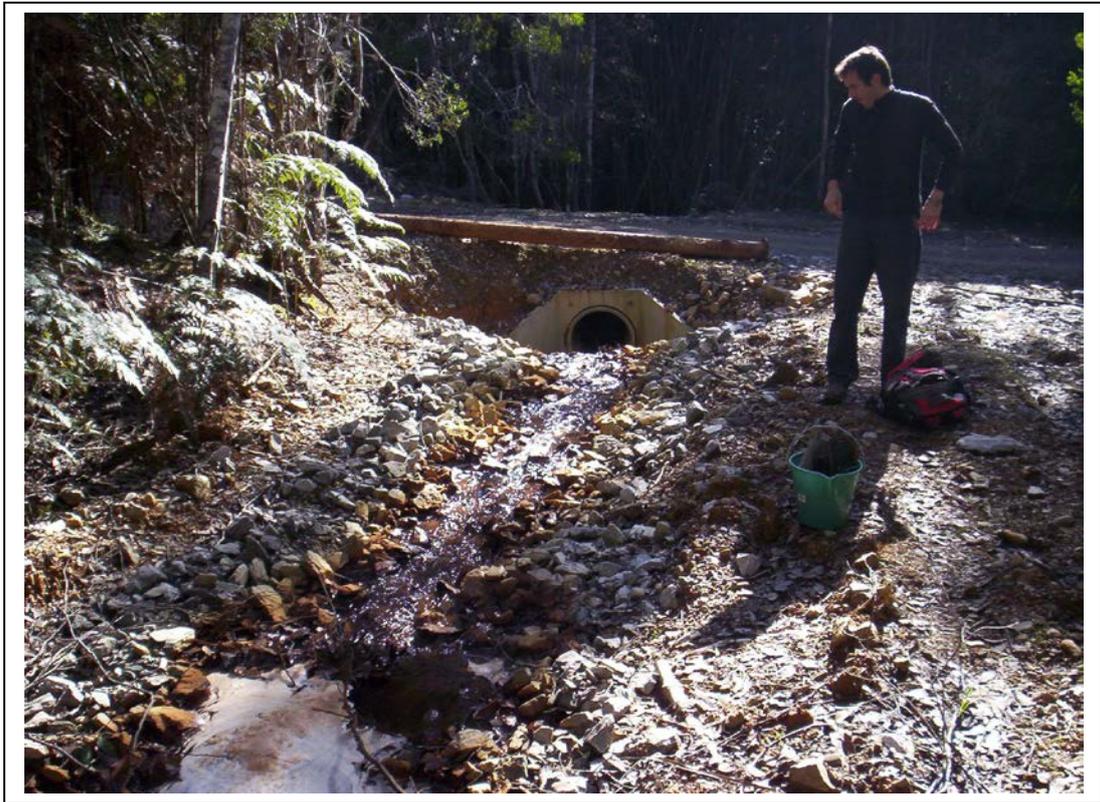
**Photo 16. Gun Club Road culvert. Note loss of limestone compared to similar photo 29/04/04 in Appendix A.**

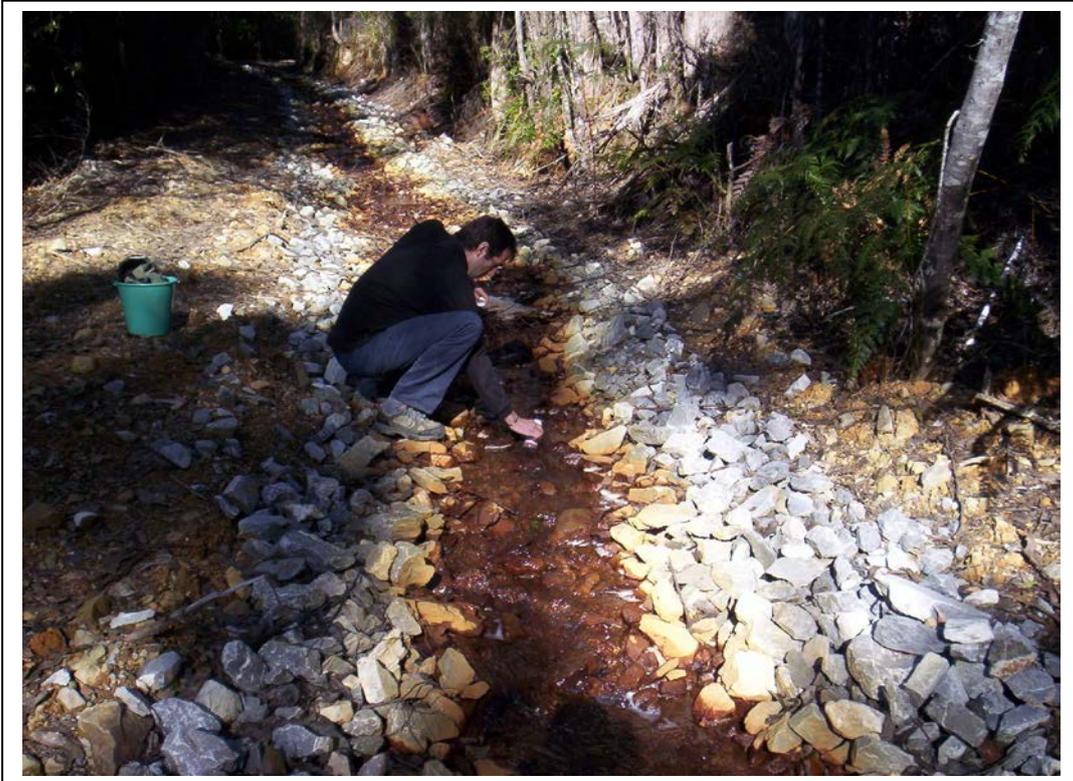
**Photo 17. Gun Club Road. Again note lack of limestone and the un-neutralised nature of the water in the drain.**
