MINERAL RESOURCES TASMANIA

Storys Creek and Rossarden

Revegetation Works Summary

May 2019

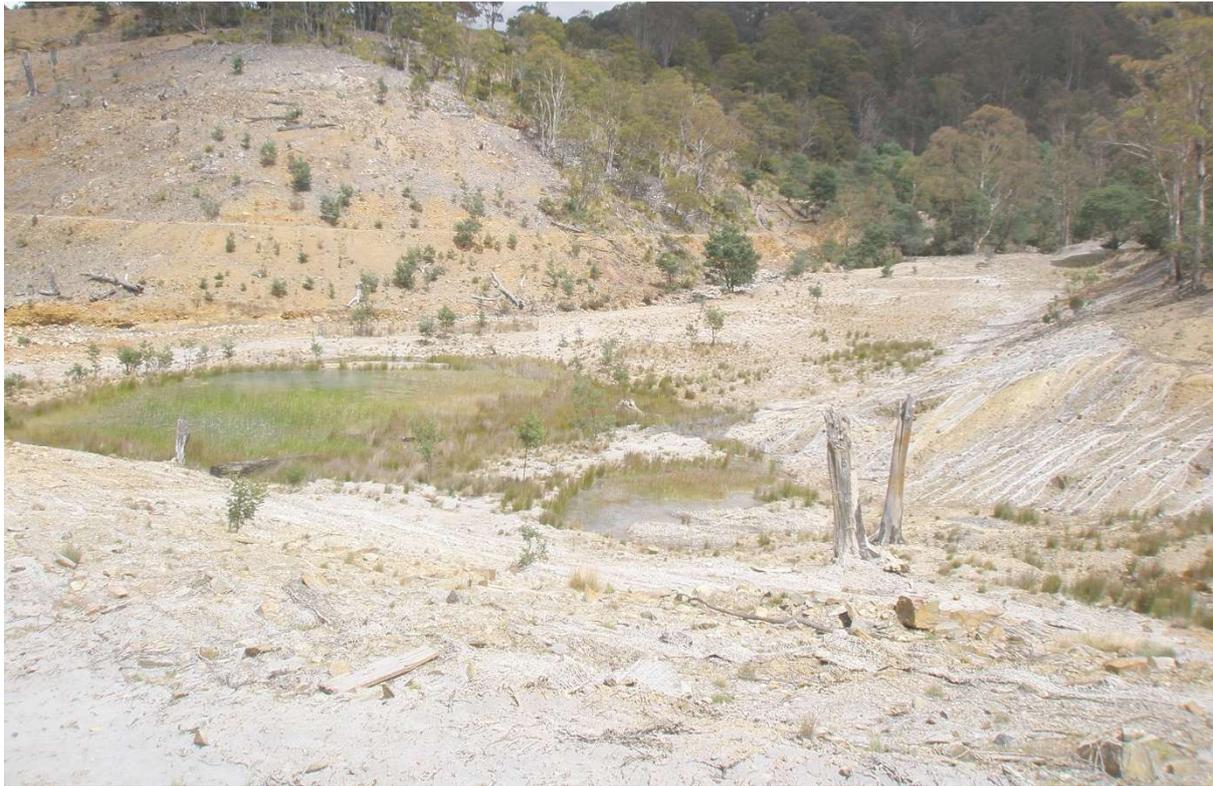
Plate 1. The Storys Creek Precipitate Ponds area immediately following lime application in 2013.

Approximately twelve tonnes of ag-lime and 450 kg of 8:4:10 fertiliser was applied to the main ~1.6 hectare Old Precipitate Ponds area of the Storys Creek site (application rates of ~7.5 tonnes and 300 kg per hectare respectively).

Plates 1 and 2 compare the Old Precipitate Ponds site between 2013 and 2019. Note that both photos were taken immediately following lime application and the resulting pale lime coverage has resulted in an ‘over-exposed’ image masking the true extent of vegetation.

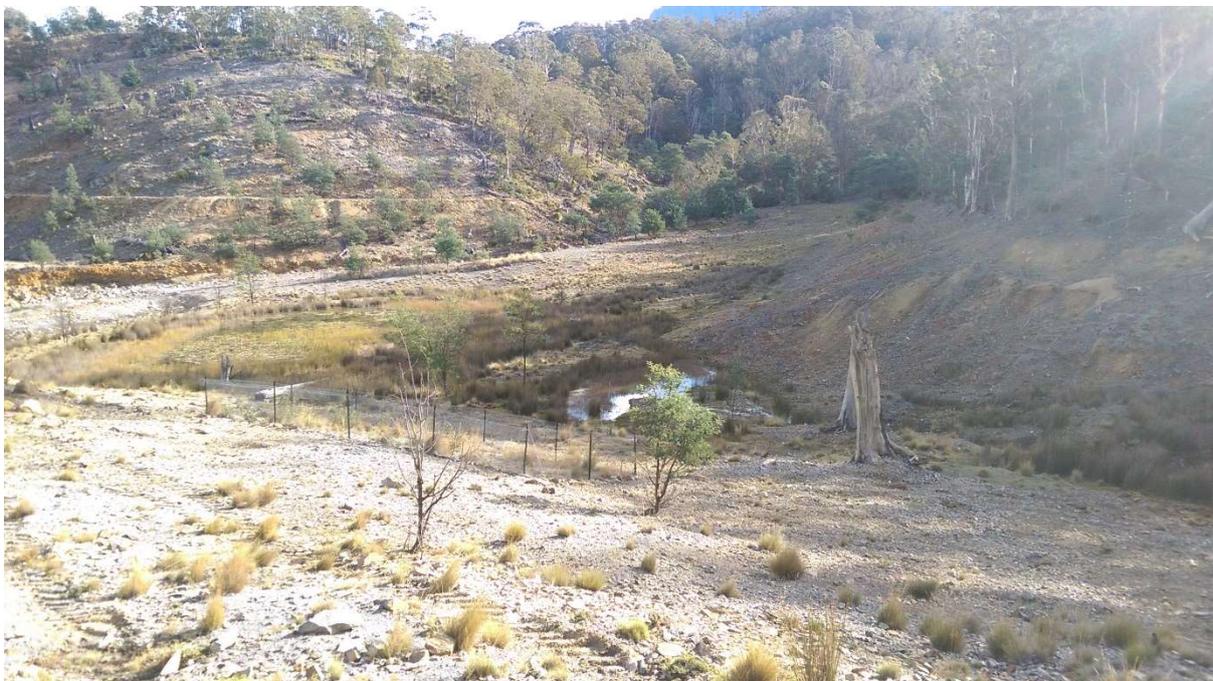
Plate 2. The Storys Creek Precipitate Ponds area immediately following lime application in 2019.

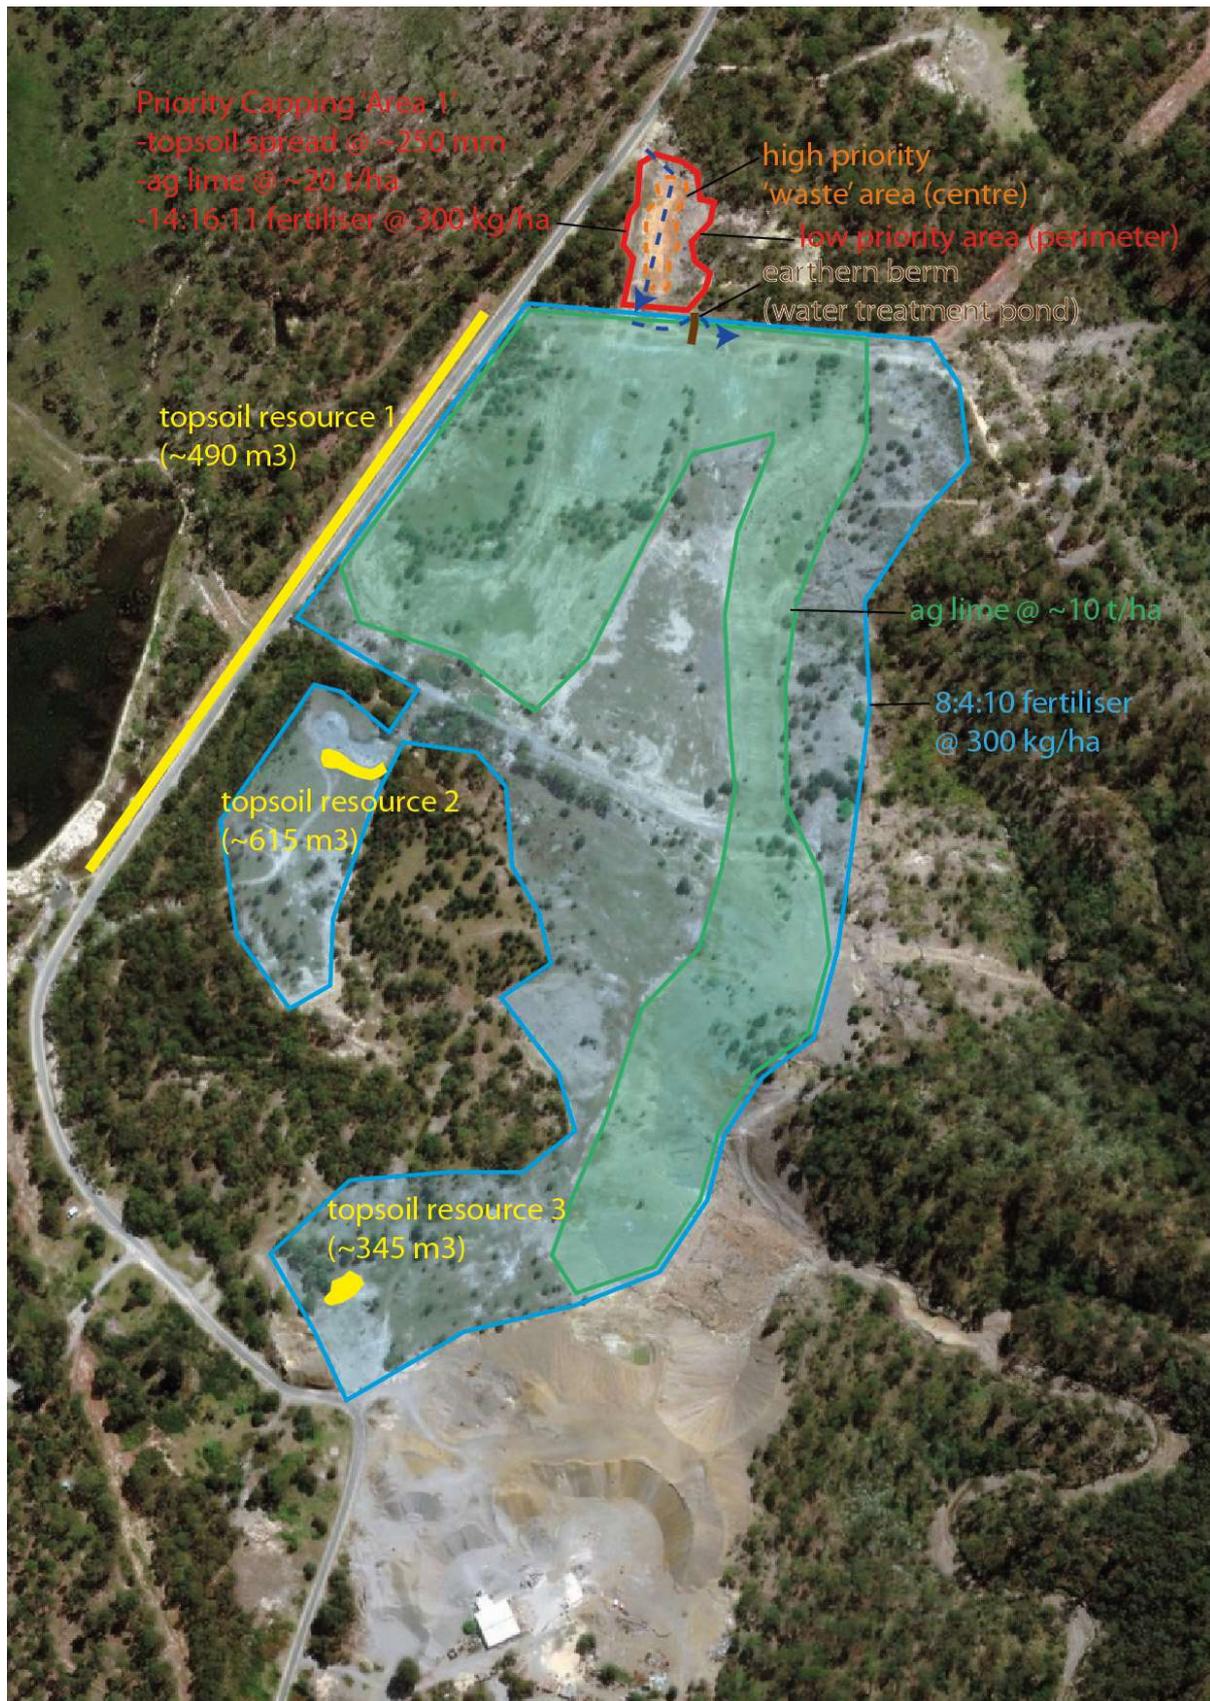
Figure 1. Rossarden tailings deposit 2019 rehabilitation treatment zones and topsoil sources.

2019 ag-lime and fertiliser application location and rates varied based on specific site conditions. Figure 1 roughly maps the areas and types/rates of fertiliser application undertaken. The bulk of the site received 8:4:10 fertiliser at 300 kg/ha (4.95 tonnes in total). Selected areas received ag-lime at ~10 tonnes per hectare (total of ~57 tonnes). Application rates and quantities for the 'priority' capping area in the northern-most section of the site are described in Section 3.2.

- Ag-lime was applied at ~20 tonnes per hectare (~10 tonnes in total);
- Approximately 1450 m³ of topsoil was collected from three locations (refer to Figure 1 for locations and respective volumes) and dumped on both the 'high' and 'low' priority components of 'Area 1' in LMRS (2018);

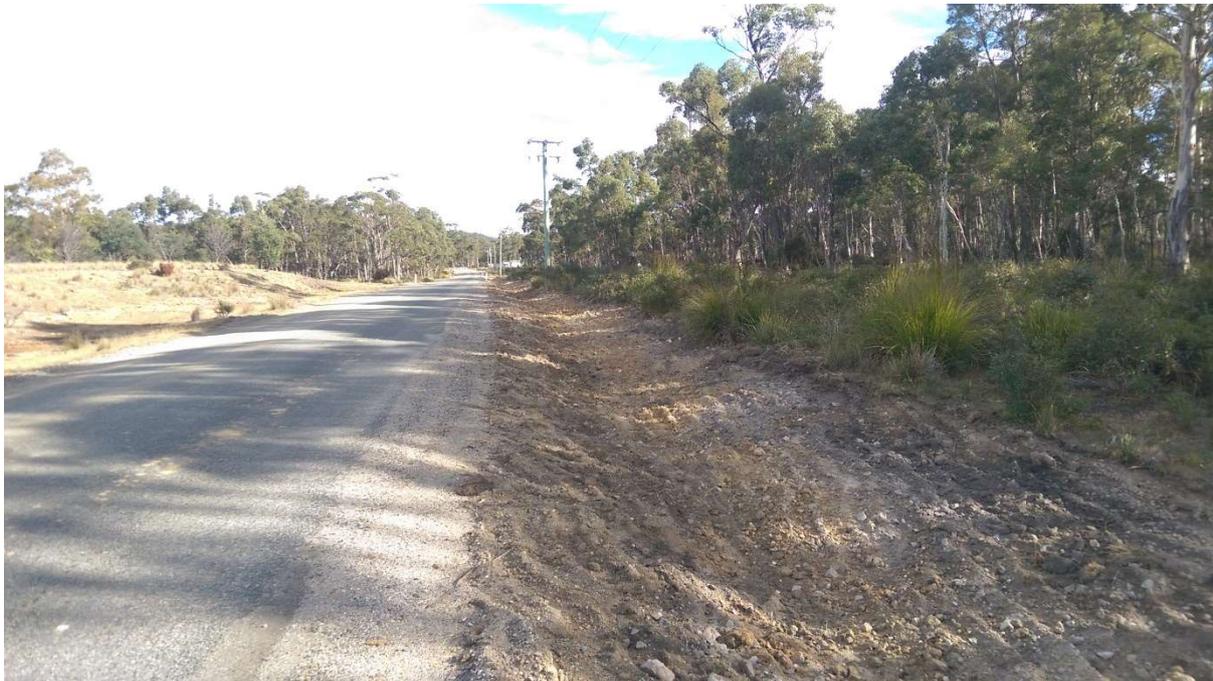
**Plate 3.** Topsoil resource 1 (Rossarden Rd) following topsoil recovery, loosening and seeding/fertilising.

- All topsoil source locations were left loose and level;
- The dumped topsoil was spread roughly/loosely over the 'high' and 'low' priority zones to an average depth of 250-300 mm;

- Native seed was applied at ~5 kg/ha to all topsoiled areas (refer to Table 1 for species and quantities);
- Ryegrass was applied at ~30 kg/ha to the three topsoil source locations;

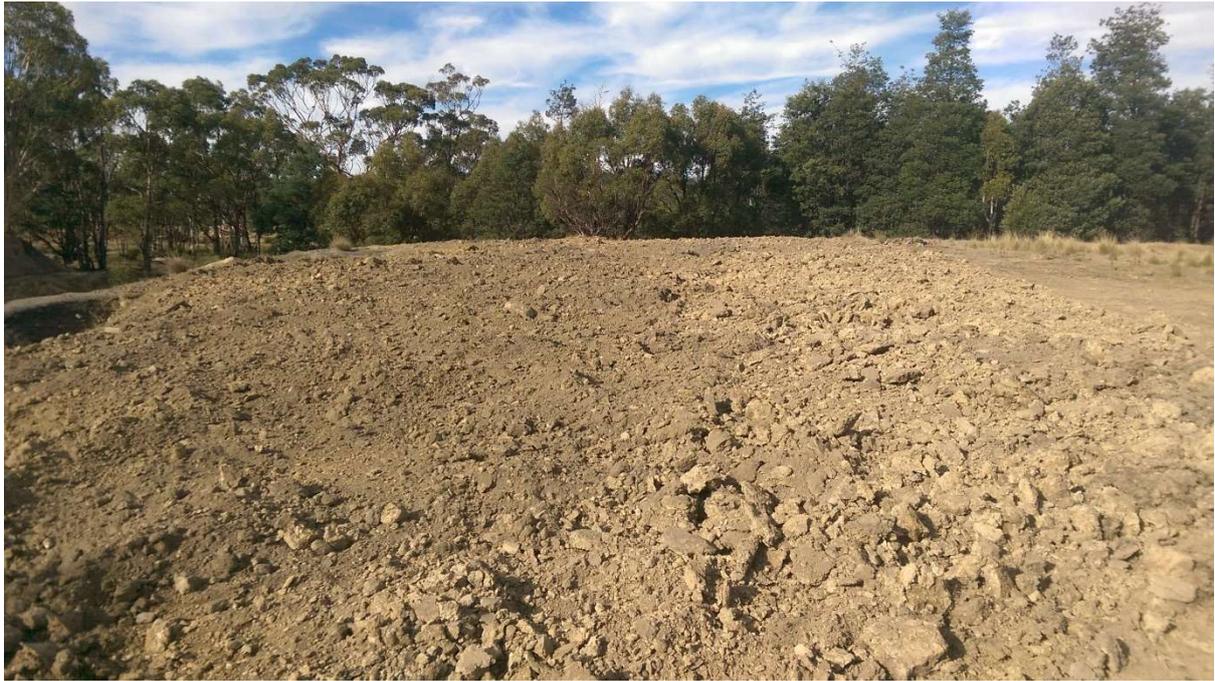
Plate 4. Topsoil resource 2 (old Scheppien lease) following topsoil recovery, loosening and seeding/fertilising.

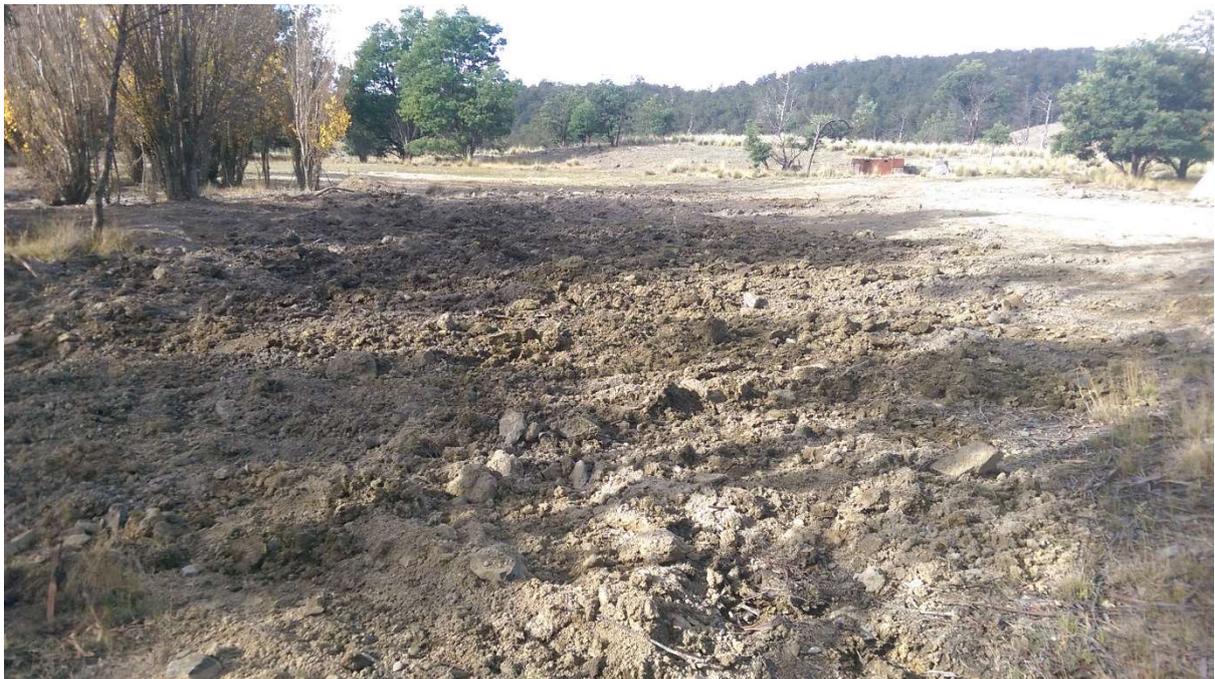
Plate 5. Topsoil resource 3 (Taswater dump) following topsoil recovery, loosening and seeding/fertilising.

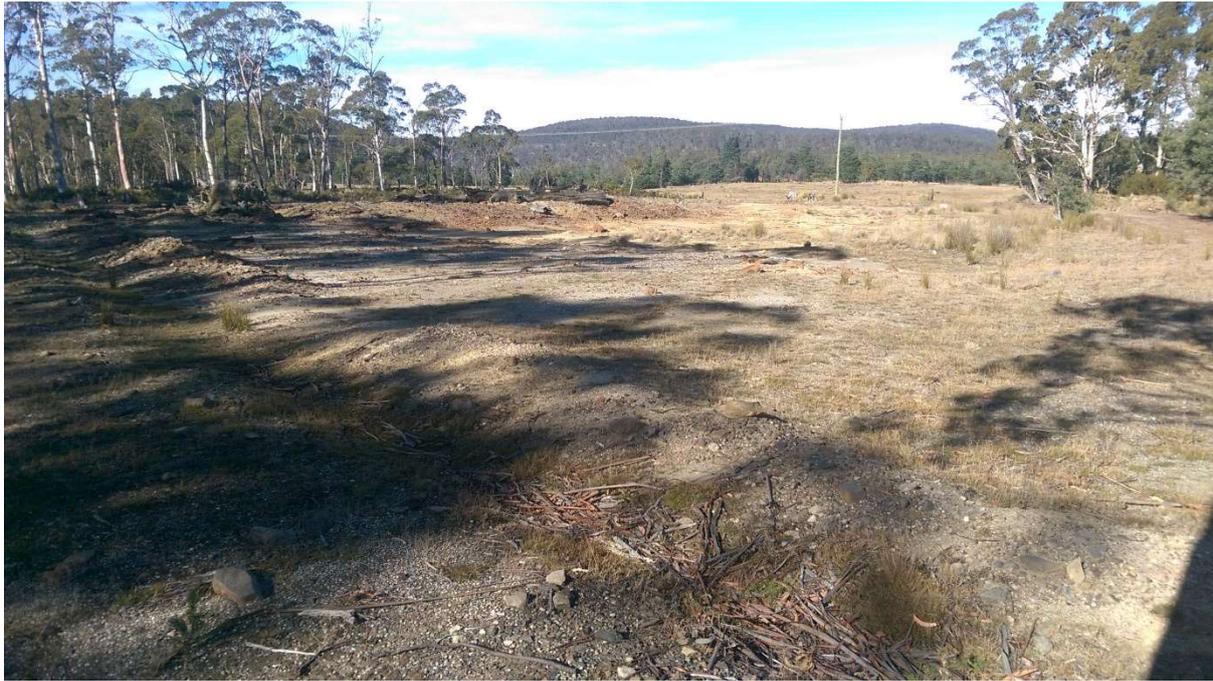
Plate 6. Priority Capping area ('Area 1') prior to topsoil dumping and spreading.

- The high point was excavated to form a gently sloping profile and the existing gravel track loosened to ~300 mm depth;
- The drain at the north of the site was redirected from draining east and directed south through the centre of 'Area 1' to the existing drainage line under the Tasnetworks feeder line;

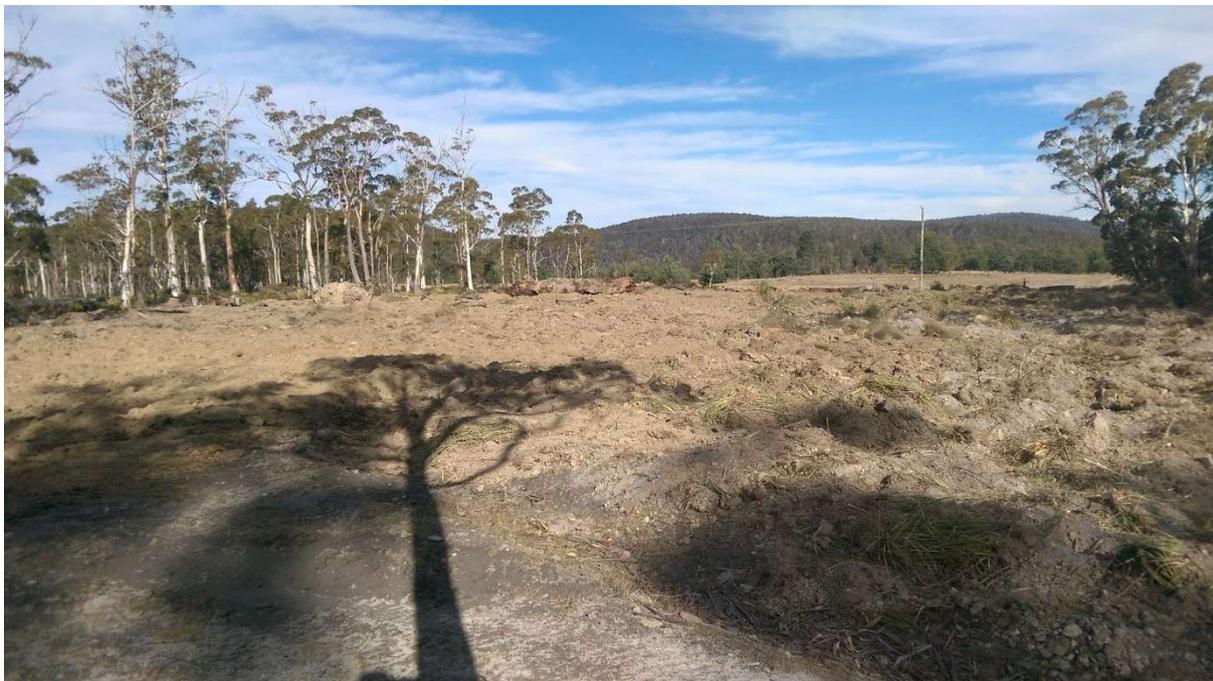
Plate 7. Priority Capping area ('Area 1') following topsoil dumping and spreading.

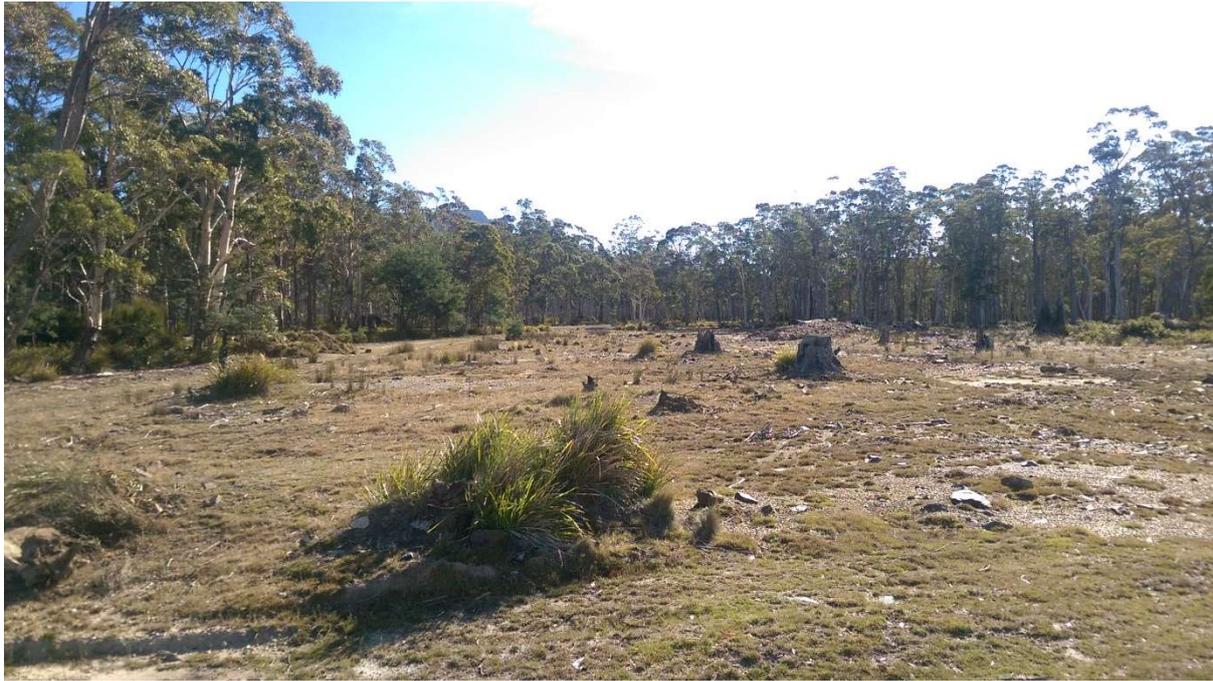
Plate 8. Priority Capping area ('Area 1') prior to topsoil dumping and spreading.

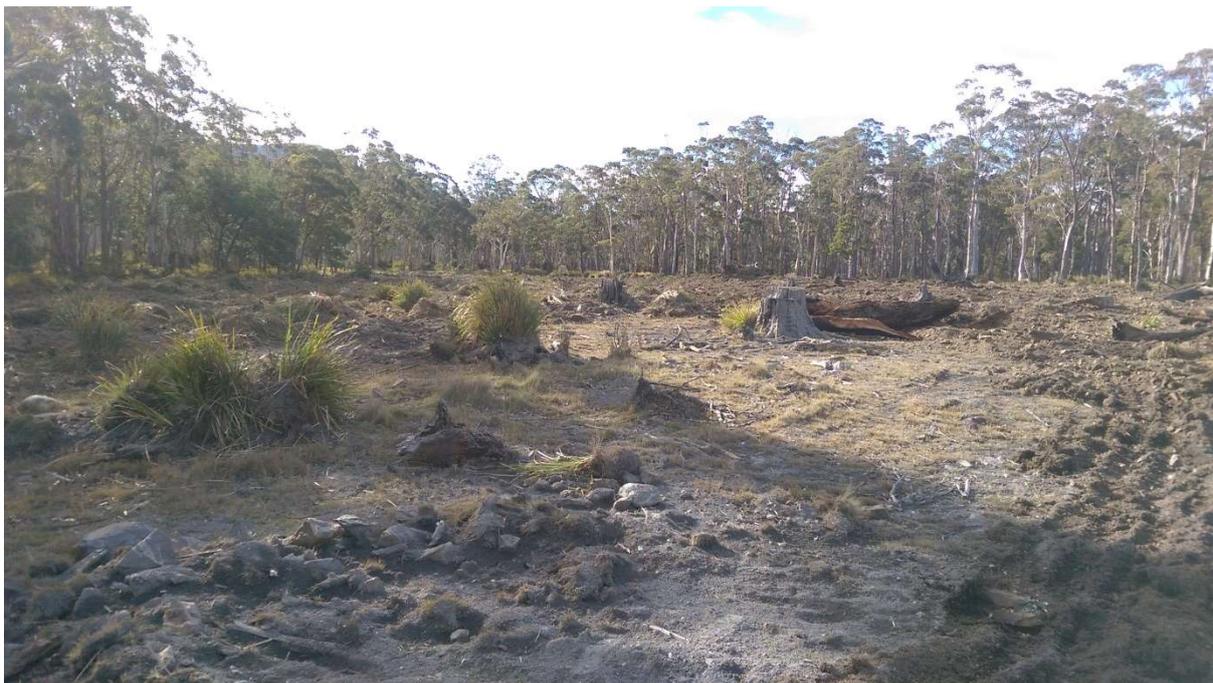
Plate 9. Priority Capping area ('Area 1') following topsoil dumping and spreading.

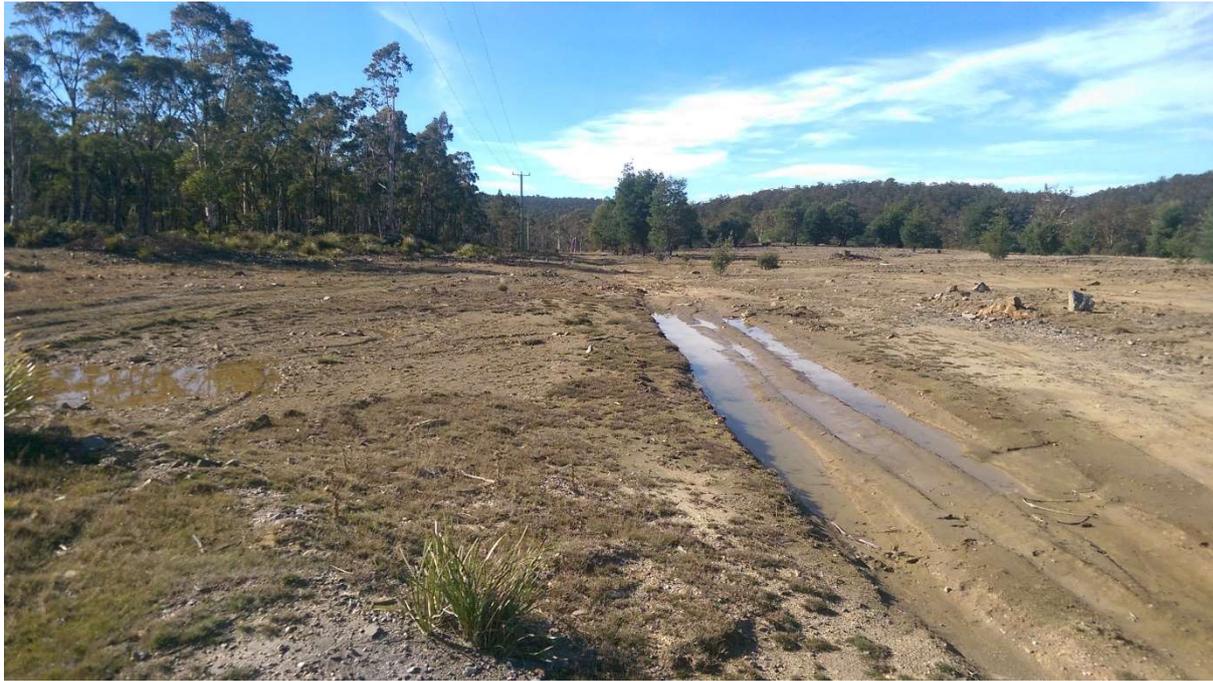
Plate 10. Water treatment pond area prior to earthen berm construction.

- NPK 14:16:11 fertiliser was applied at 300 kg/ha to 'Area 1' and the three topsoil source locations;
- The 'upper', larger pond only, of the two recommended in LMRS (2018) was constructed. Strategic log placements and small excavations were placed to deter unwanted 4WD access.

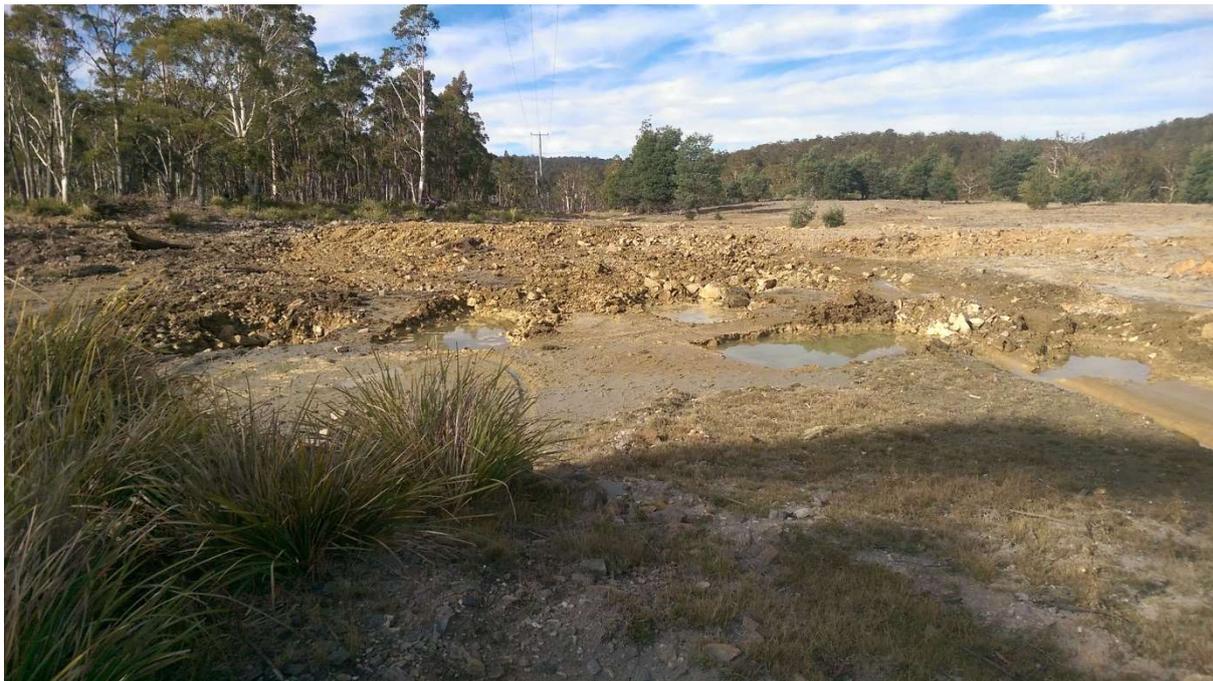
Plate 11. Water treatment pond area following earthen berm construction.

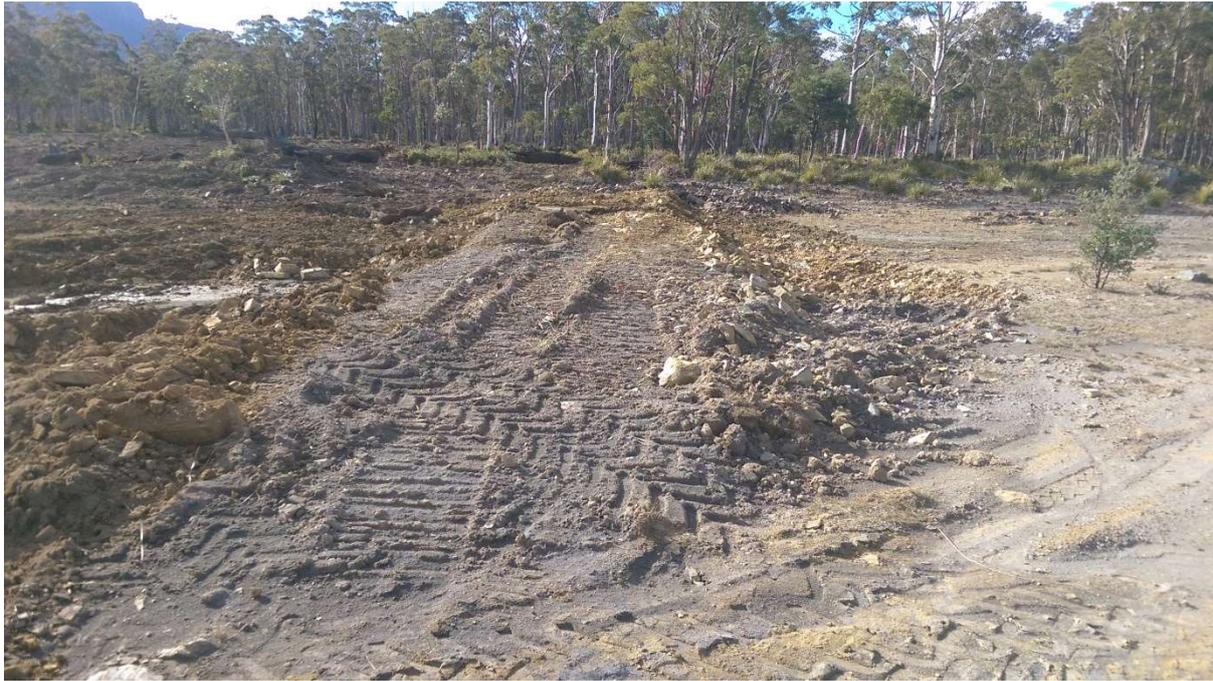
Plate 12. Water treatment pond area earthen berm.
