Rehabilitation of abandoned mining lands trust fund

Summary of activity 2022-23

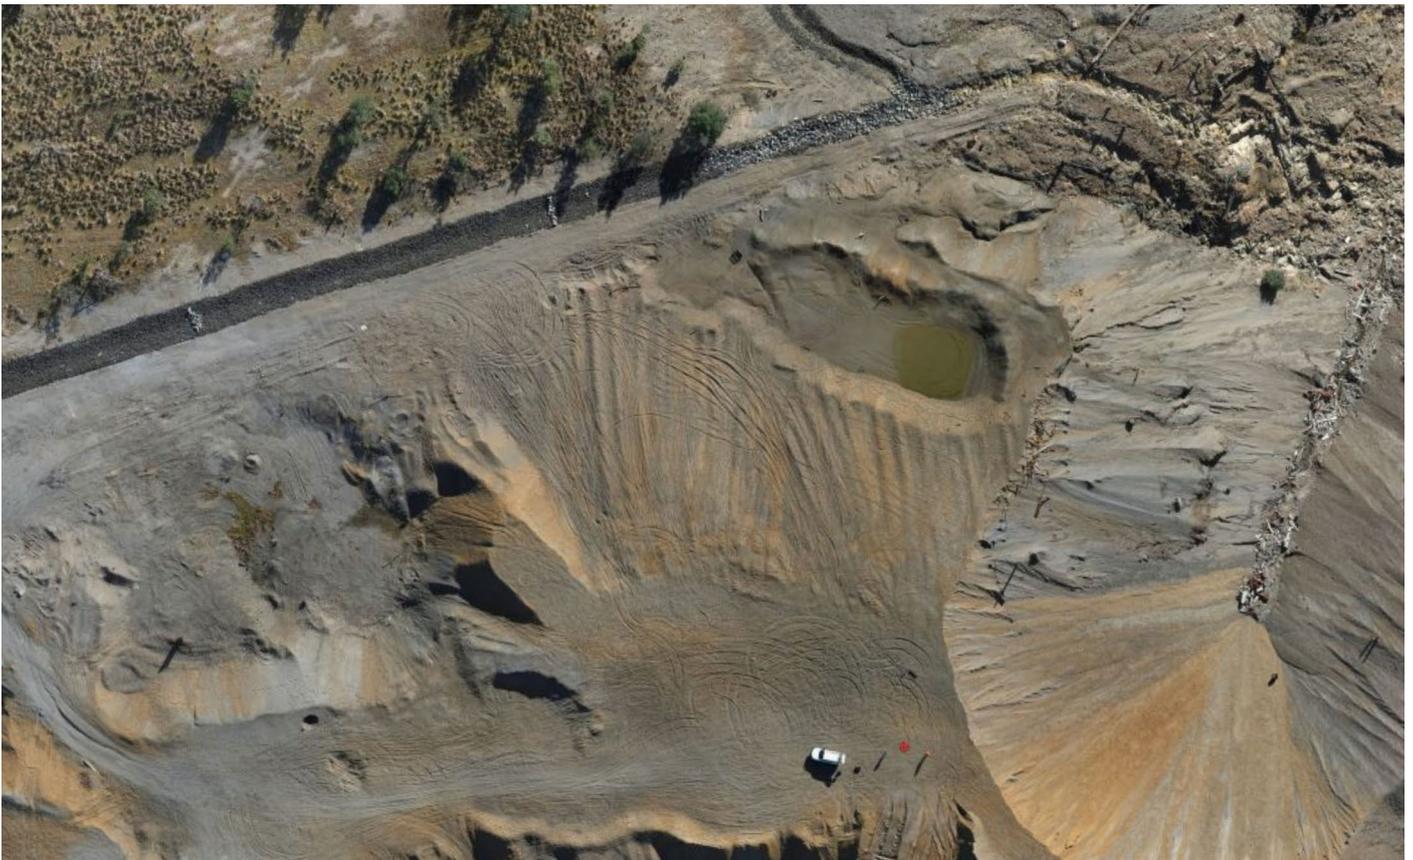
In October 2022, March 2023, and May 2023, MRT completed visual inspections of the coarse tailings dump as well as the recently constructed diversion drains and subsidence repairs (completed May - June 2020) at the Aberfoyle mine site. The coarse tailings dump has experienced significant erosion over the year. The diversion drains are performing as expected, preventing water from creating various flow pathways over the coarse tailings.

Inspection of installed drainage, north of the tailings (May 2023).

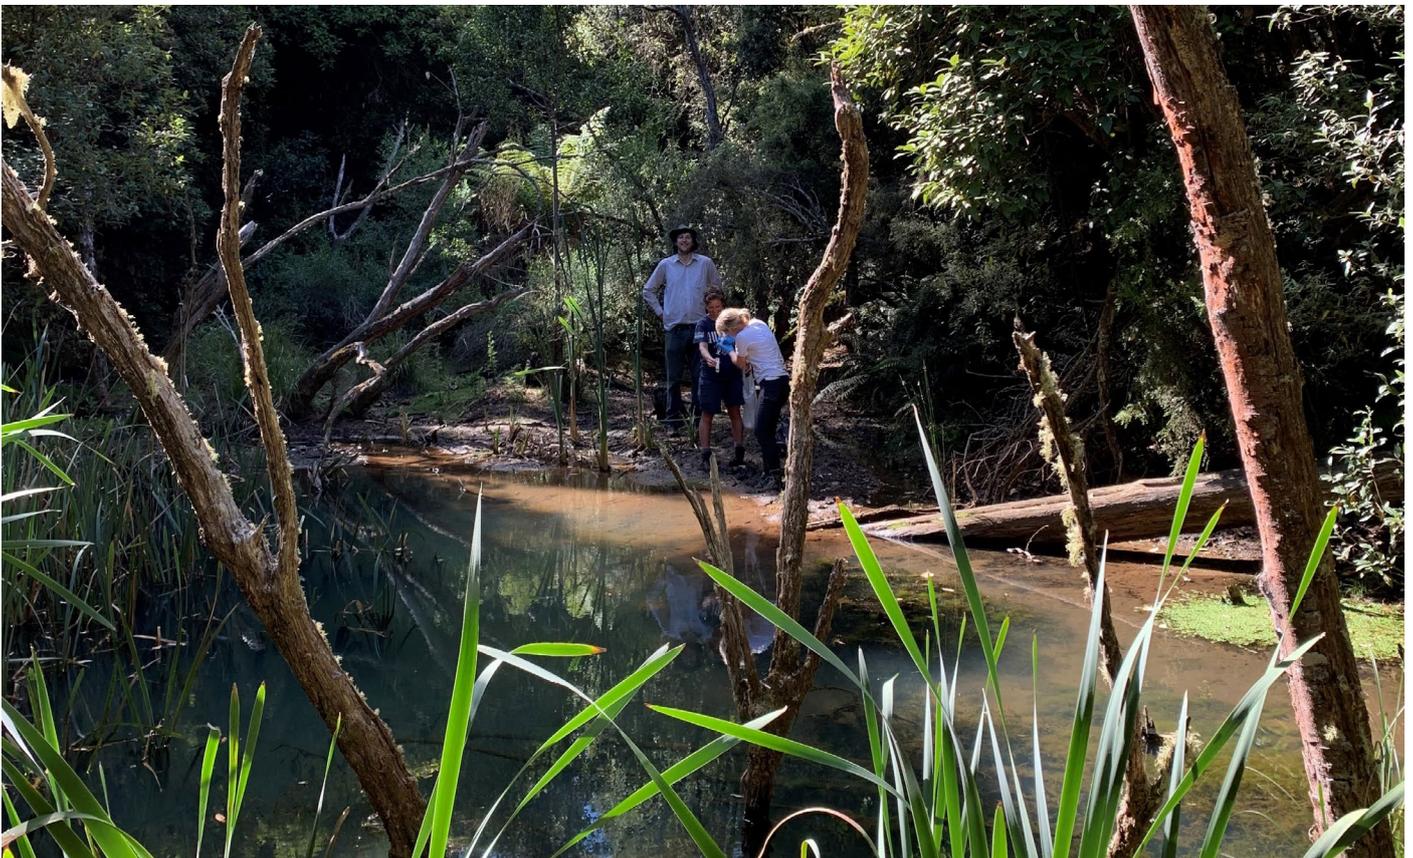
In August 2021, MRT received an inquiry from a member of the public regarding water quality in Merrywood Creek, downstream of the former Merrywood Coal Mine. Water quality monitoring aims to quantify impacts on the downstream environment, including an in-stream farm dam on the Merrywood River. MRT conducted a drone mounted water sampling program to sample the Merrywood farm dam at various depths. Follow-up drone sampling is planned for the 2023-24 financial year.

University of Tasmania staff sampling Merrywood Creek (source: C. Steyn, March 2023).

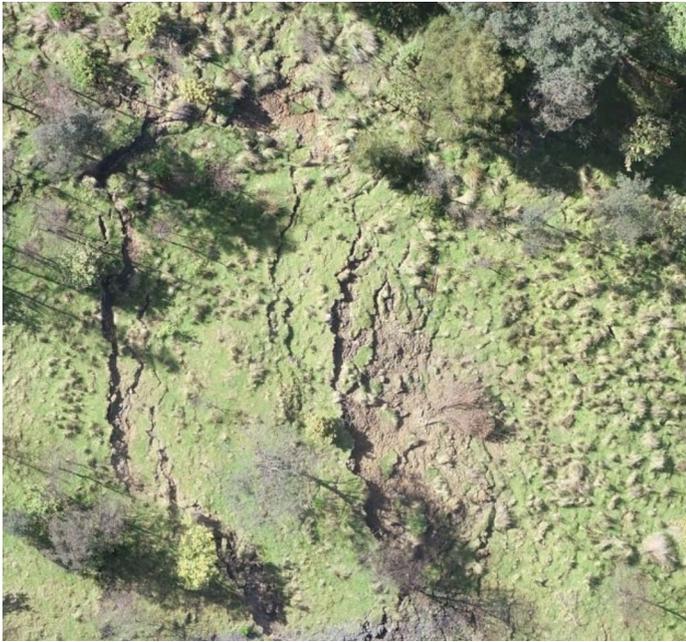
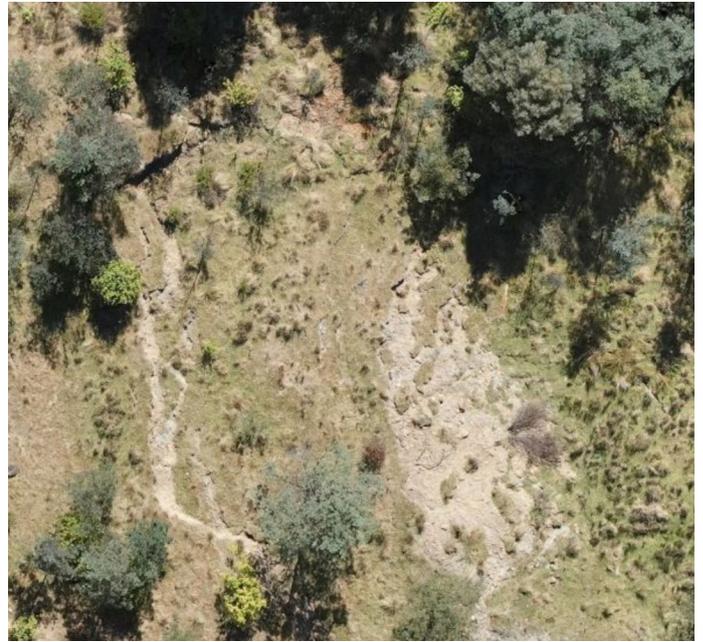
Ongoing landslide monitoring has been initiated at the former Merrywood Coal Mine following the discovery of substantial ground displacement after a large rainfall event in October 2022. In addition to traditional monitoring techniques, MRT is using drone-acquired data to better understand and track the movement of the Merrywood landslide. The use of drones to collect high quality local survey-grade photogrammetry and LiDAR data provides the ability to scan the entire area to detect surface changes quickly and accurately. Drone-acquired data, in conjunction with geological, meteorological, and site-specific information, provides us with the tools to best manage risk and predict future landslide activity.

Comparison of photogrammetry from November 2022 (left) to March 2023 (right).

MRT will continue to monitor the landslide as part of ongoing rehabilitation management of the Merrywood Coal Mine.

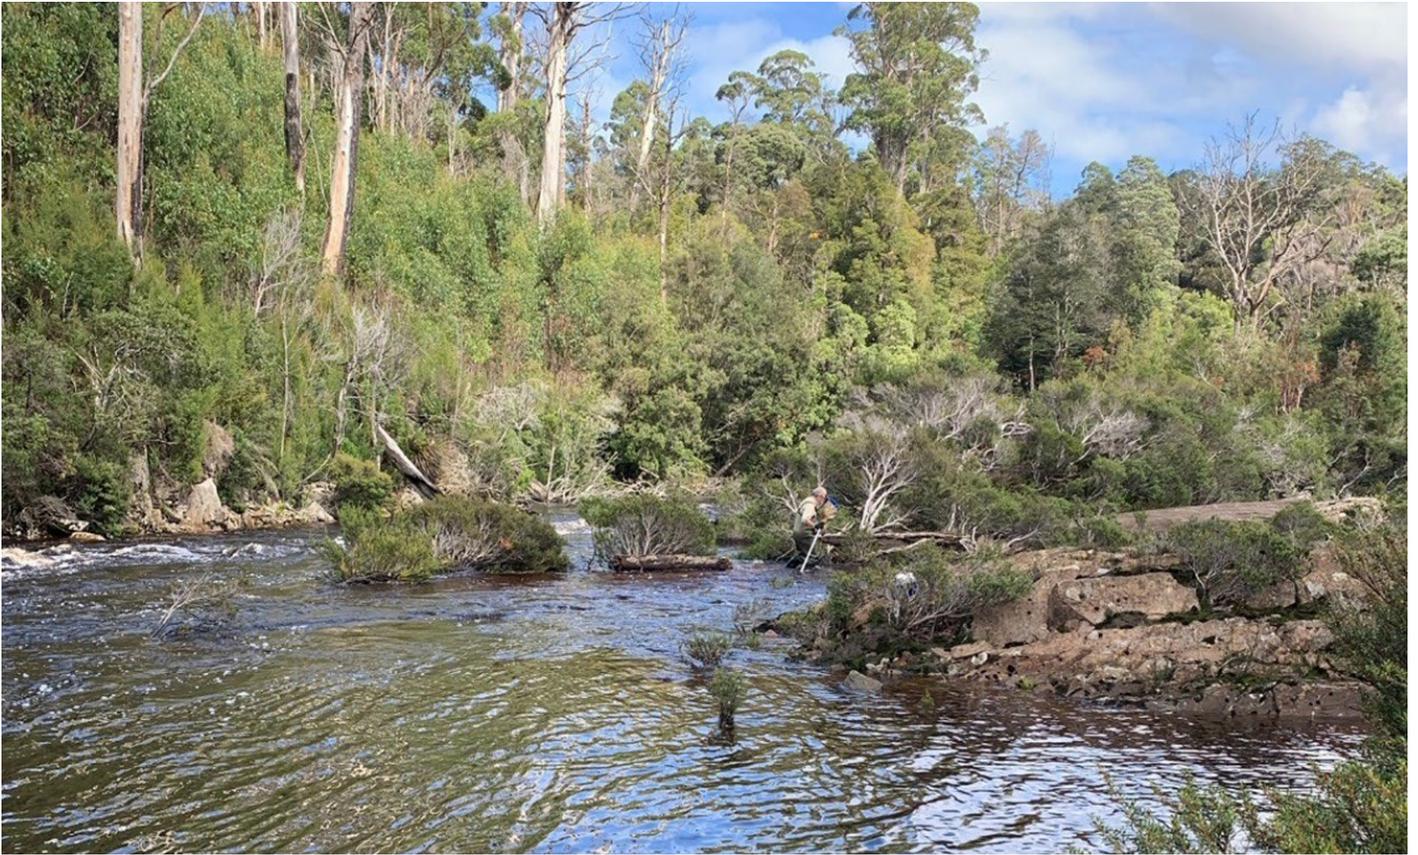
Sampling was conducted at three sites along the Frankland River. The Frankland River downstream of the Balfour site was shown to have similar or above levels of biodiversity to reference sites. Samples collected in the Frankland River, downstream of the central Balfour shaft, did not exhibit any toxicity.

Biological sampling the Frankland River near Blackwater Road.

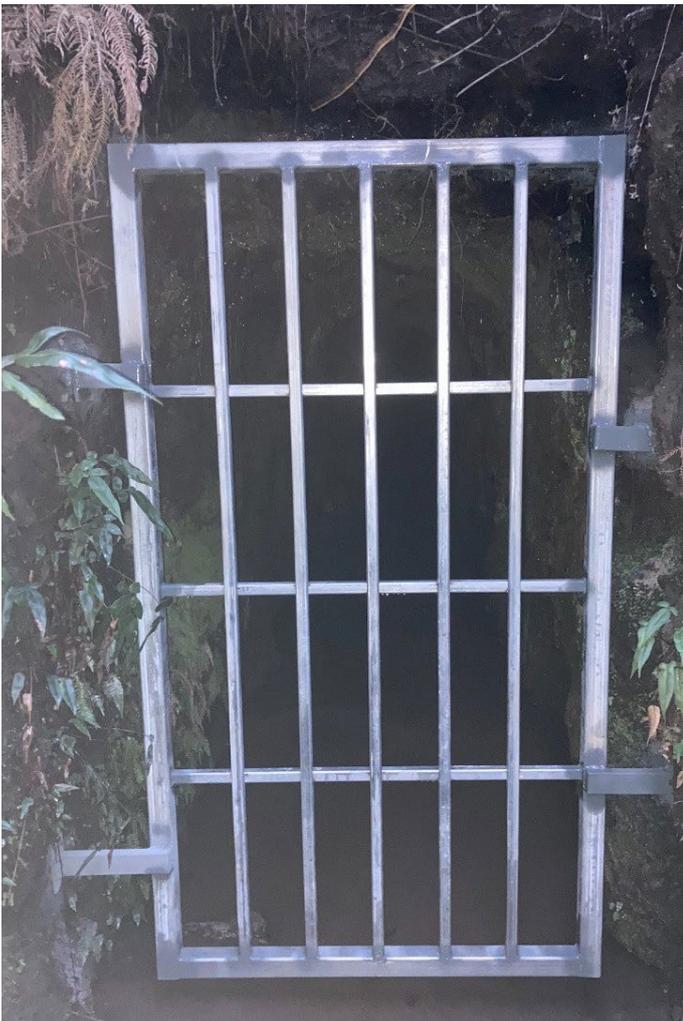
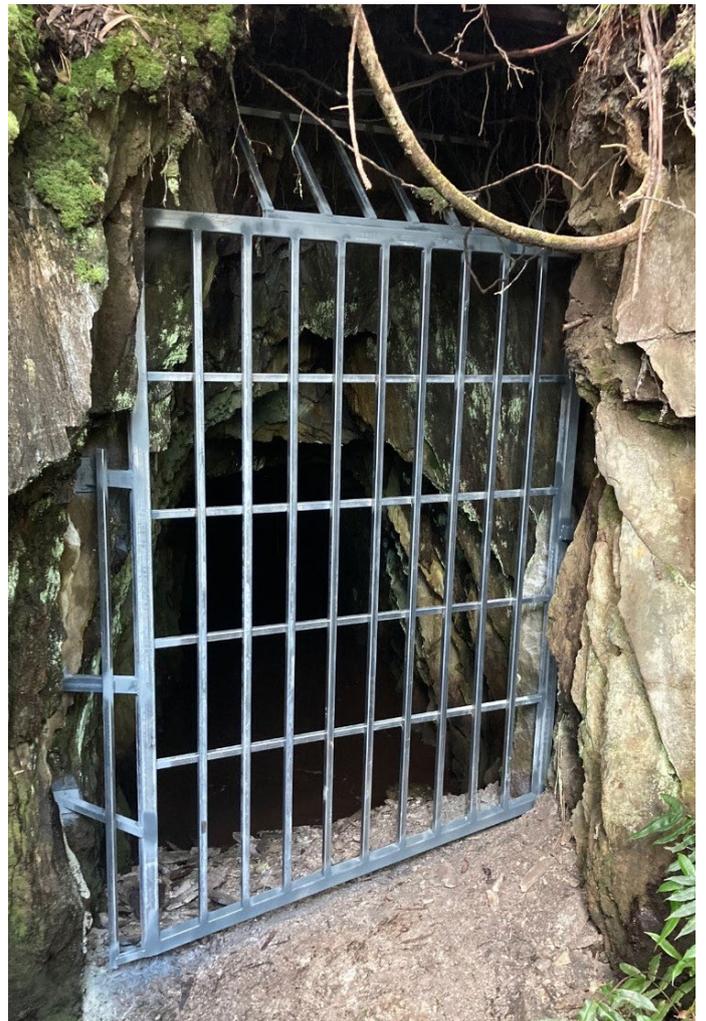
Additionally, MRT capped two adits at the Balfour site due to public safety concerns.

Newly installed Balfour adit gates (source: Ben Edmunds).

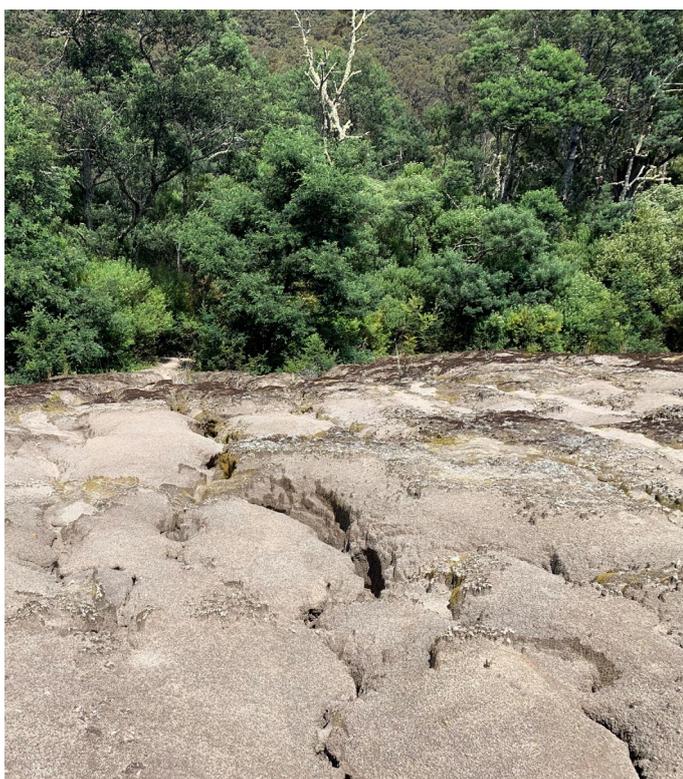
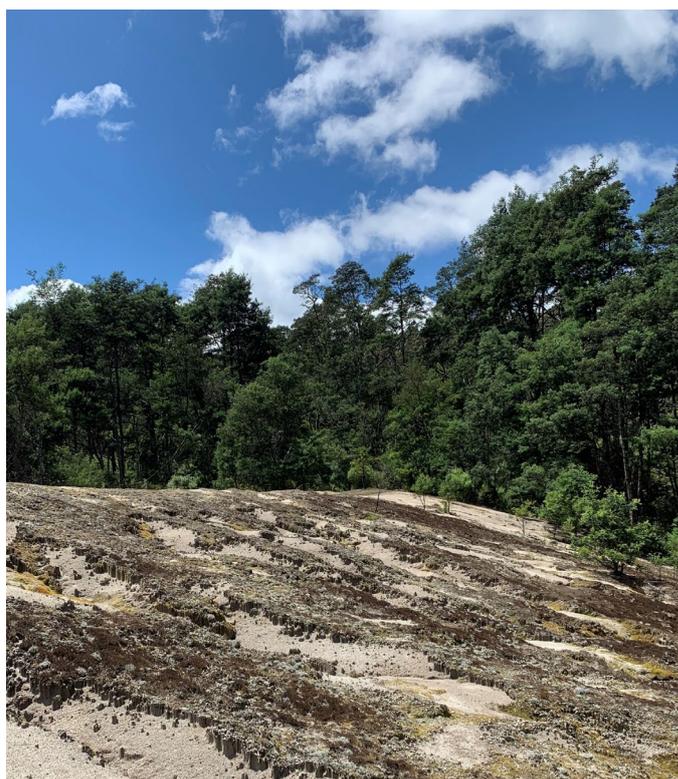
There has been some historical community concern regarding the stability of the gabion dam wall. The tailings are piled on an abutment of gabions, which makes it potentially somewhat unstable and susceptible to erosion.

During a site inspection in October 2022, MRT noted that there was significant erosion on the dam wall, likely due to high rainfalls in October. MRT received advice exploring remediation options to stabilise the tailings, which will be evaluated in the budget for 2023-2024. MRT continue to conduct routine inspections to ensure the erosion is not accelerating.

Erosion on the Anchor dam wall (December 2022).

MRT organised for prisms to be installed in March 2023 to monitor the erosion of the dam wall. A follow-up survey was conducted in May 2023, with negligible difference between the March and May surveys. A further survey is planned for May 2024.

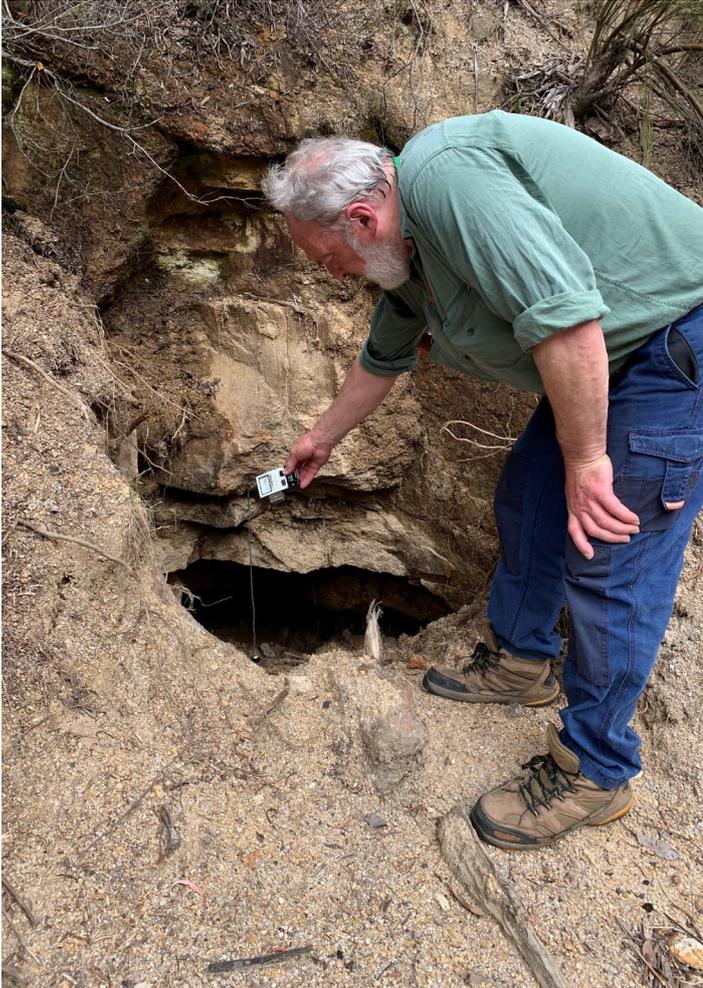
MRT staff completed an inspection of the abandoned Tasmanian United Uranium (TUU) mine due to concerns of public safety following a social media post showing a member of the public uncovering some of the abandoned workings in September 2022. The site can be accessed by a trafficable road until about 1.3km from the site, where a large Eucalypt tree has recently fallen across the road. Using a Mini ConRad radiation survey meter (Geiger counter), it was determined that there were high levels of radiation on a small ore dump, but the remainder of the mine site area was only slightly above background levels. The site was not deemed to be a risk to the public as recent flooding has largely backfilled the opening. Signage was installed on site to warn visiting public of the radiation risk and mine workings.

Use of handheld meter to determine radiation levels.

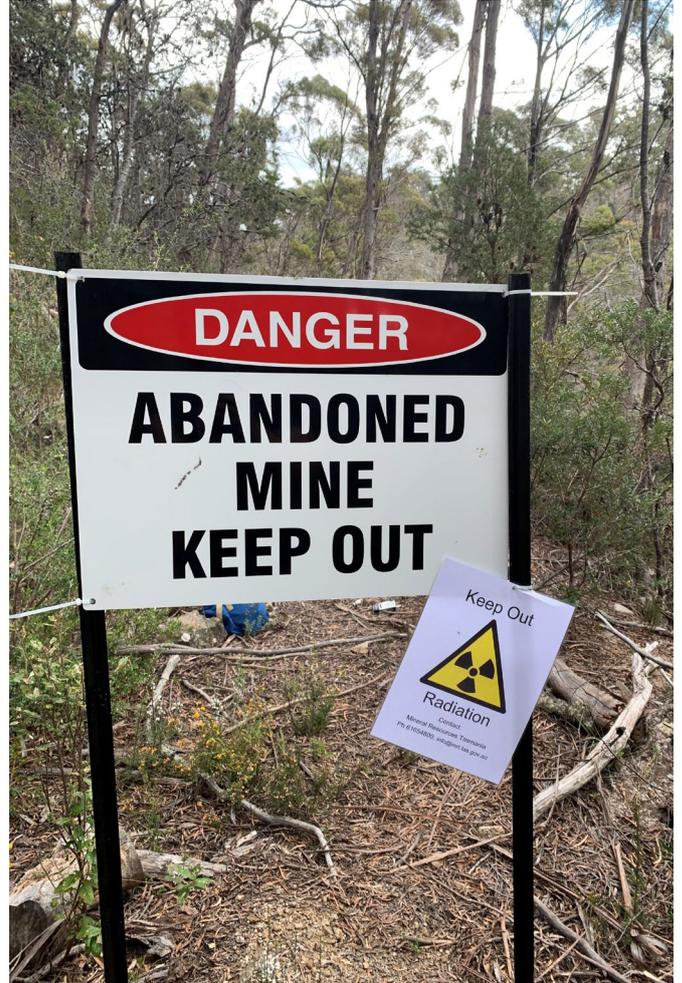
Signage installed to warn visiting public of the radiation risk and mine workings.
