**Tasmanian Department of Mines
Unpublished Report 1975/79**

**Stratigraphy and landslips
in the Craighburn and
Beauty Point areas**

by N.J. Turner

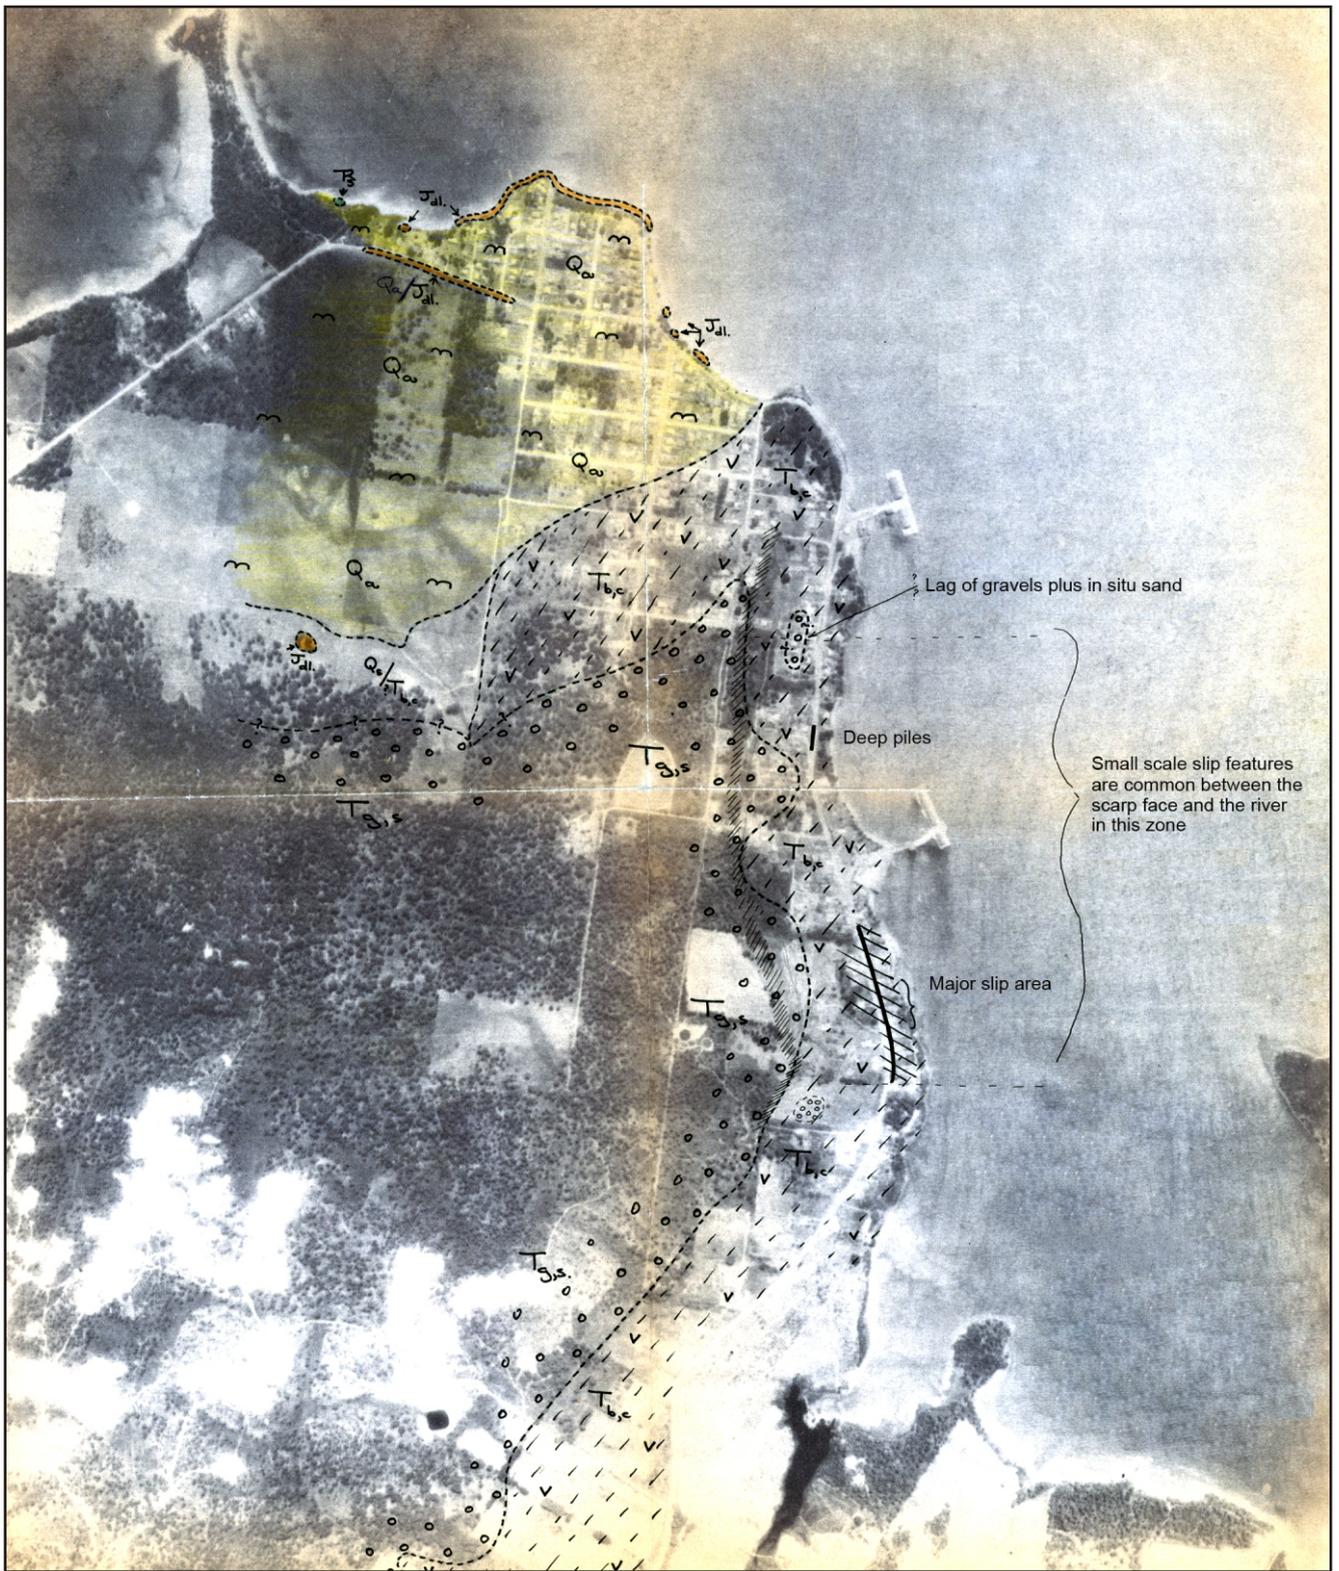
Figure 3

Regional map of the Beauty Point area

- Qa = Low level surface covered by silt and gravel
- Qs = Soil
- Tg,s = Well washed gravel and sand
- Tb,c = Basalt and clay, probably some coarse clastic fragments
- Jdl = Jurassic dolerite
- TRs = Triassic sandstone
- ▨ = Low scarp

The disconformity between the upper and lower units is exposed in the cutting at Bagot Street hall (fig. 3), where channels filled with poorly-sorted siliceous gravel are incised in weathered basalt. Poorly-sorted gravel containing well rounded quartz and quartzite pebbles is widespread. The gravel's finer fraction is angular, and coarse angular sand is also widespread. Better sorted medium-grained sand interbedded with gravel is exposed on the scarp in Bagot Street, and similar material occurs in Ross Street just above Flinders Street. No good sections are exposed, and the stratigraphic relationships between the various materials were not determined. The unit is considered

Clay-rich materials showing relict texture are exposed in the cutting at Bagot Street hall (fig. 3), in a laneway about 200 m north of the hall, and in fractures at the top of part of the steep slope in the main slip area south of Beauty Point jetty. These materials show a sand-grade granularity and are finely mottled dark bluish-grey and white. They are massive, uniform, even grained and show no bedding structure, and contain veinlets of soft white material. Very similar material occurs in the leached zone of a lateritic profile developed on basalt and exposed near 484 776 mE, 5 443 409 mN. This profile passes from fresh basalt into textured clay-rich material and is capped by a ferruginous, pisolitic horizon which is overlain by coarse sand of the upper unit. In addition to being similar in hand specimen, the material at Bagot Street hall occupies the same stratigraphic position. These facts are considered proof that the material at the hall was produced by lateritic weathering of basalt. Pisolitic ironstone lag occurs in association with basalt lag just south of Bagot Street, but is not present in the cutting. Comparison of the sequences at the hall and at 484 776 mE, 5 443 409 mN indicates that the laterite pre-dates the upper unit and was eroded at the hall but preserved at 484 776 mE, 5 443 409 mN. Although the stratigraphic relationships are not exposed the textured clays in the other two localities are correlated with the hall exposure on the basis of hand specimen similarity. At TEMCO, Bell Bay, McLaren and Taylor (1961) found 'soft clay either blue or brown in colour and resulting from in situ decomposition of the basalt' overlying much of the basalt. Similar material was also found in places at the base. Where the base of the basalt is exposed at Inspection Head no such alteration is evident.
