1022/00. Site investigations at a proposed dam site on Nicholls Rivulet, near Cygnet

D.J. Sloane

The construction of a 15 m high thin-arch concrete dam is proposed at a site on Nicholls Rivulet, near Cygnet.

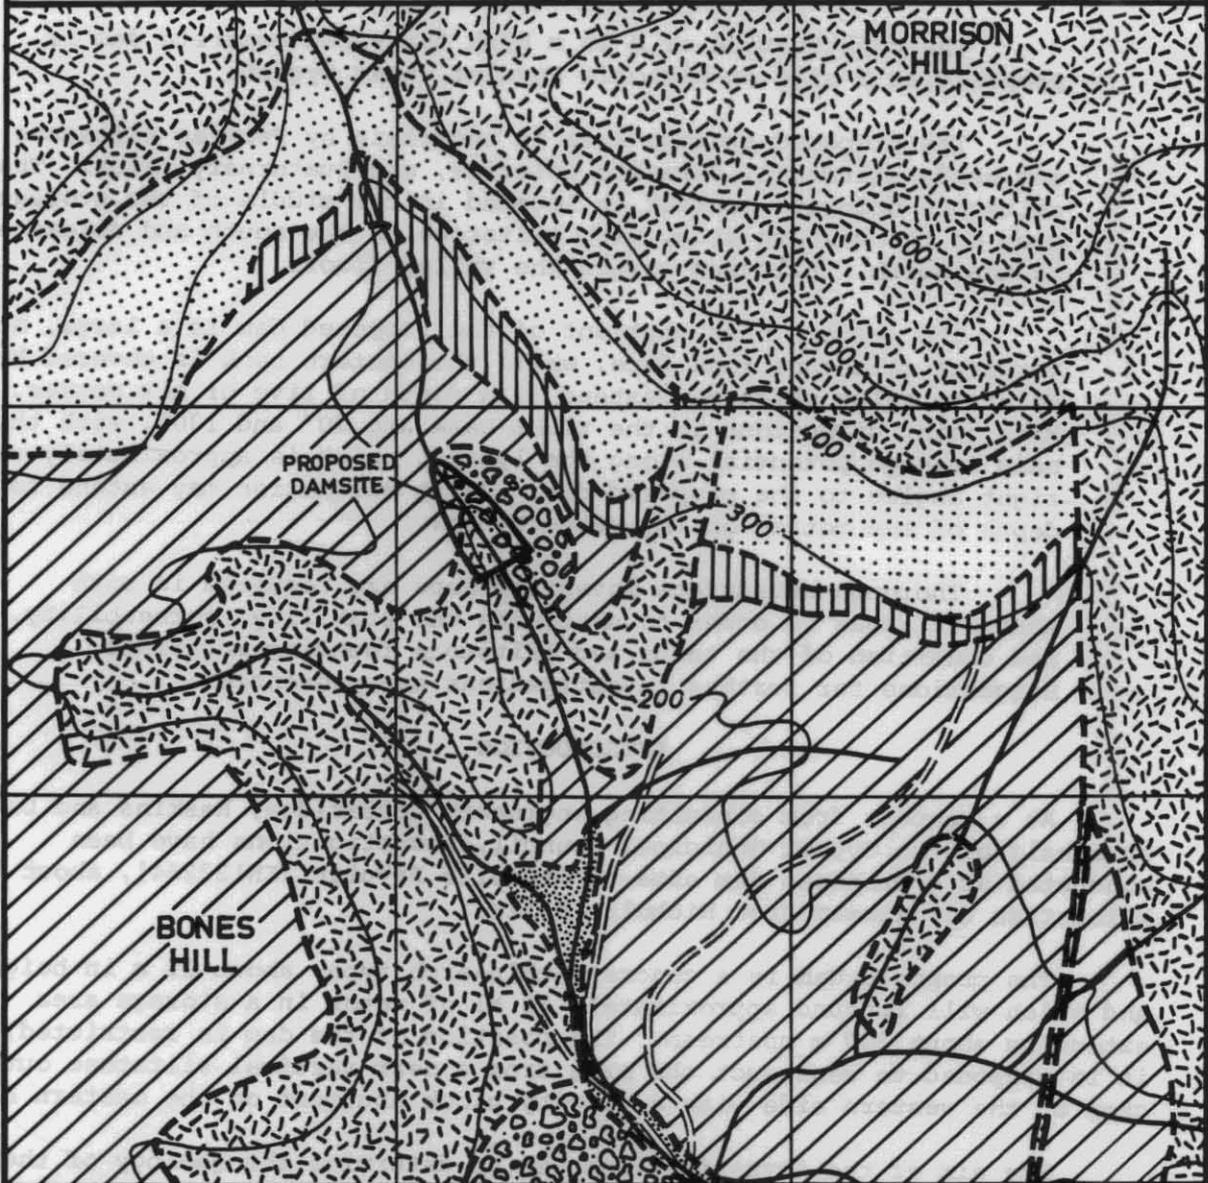
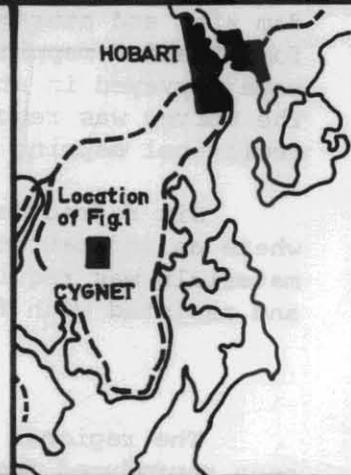
FIGURE 1

The regional geology of the area is shown in Figure 1, which has been reproduced from Farmer (1981). The bulk of the sedimentary rocks of the area consist of siltstone and sandy siltstone of the Abels Bay Formation, a correlate of the Fernree Mudstone of Upper Permian age.

# PROPOSED DAMSITE NICHOLLS RIVULET LOCATION AND REGIONAL GEOLOGY ADAPTED FROM FARMER (1981)

Further north, at higher altitudes on the flanks of Morrison Hill, Lower Triassic sandstone crops out. The sedimentary rocks have been faulted and intruded by Jurassic dolerite. Leaman (1968) considers that the dolerite intrusions have often occurred along pre-existing faults. Dolerite talus, considered to be of Quaternary age, occurs on the eastern side of the Nicholls Rivulet valley in the area of the proposed dam. The talus is probably of Last Glacial age and has formed under cold climatic conditions. During this time vegetation cover was sparse and physical weathering and mass movement were the dominant processes.

Leaman (1968) considered that the Ferntree Formation shows the strongest jointing of any Permian Formation. A study at Abels Bay indicates that the most pronounced directions are  $244^{\circ}$  and  $159^{\circ}$ . The dolerite is also extremely jointed, with joints vertical or near-vertical, columnar in large masses, but platy and close columnar adjacent to contacts.

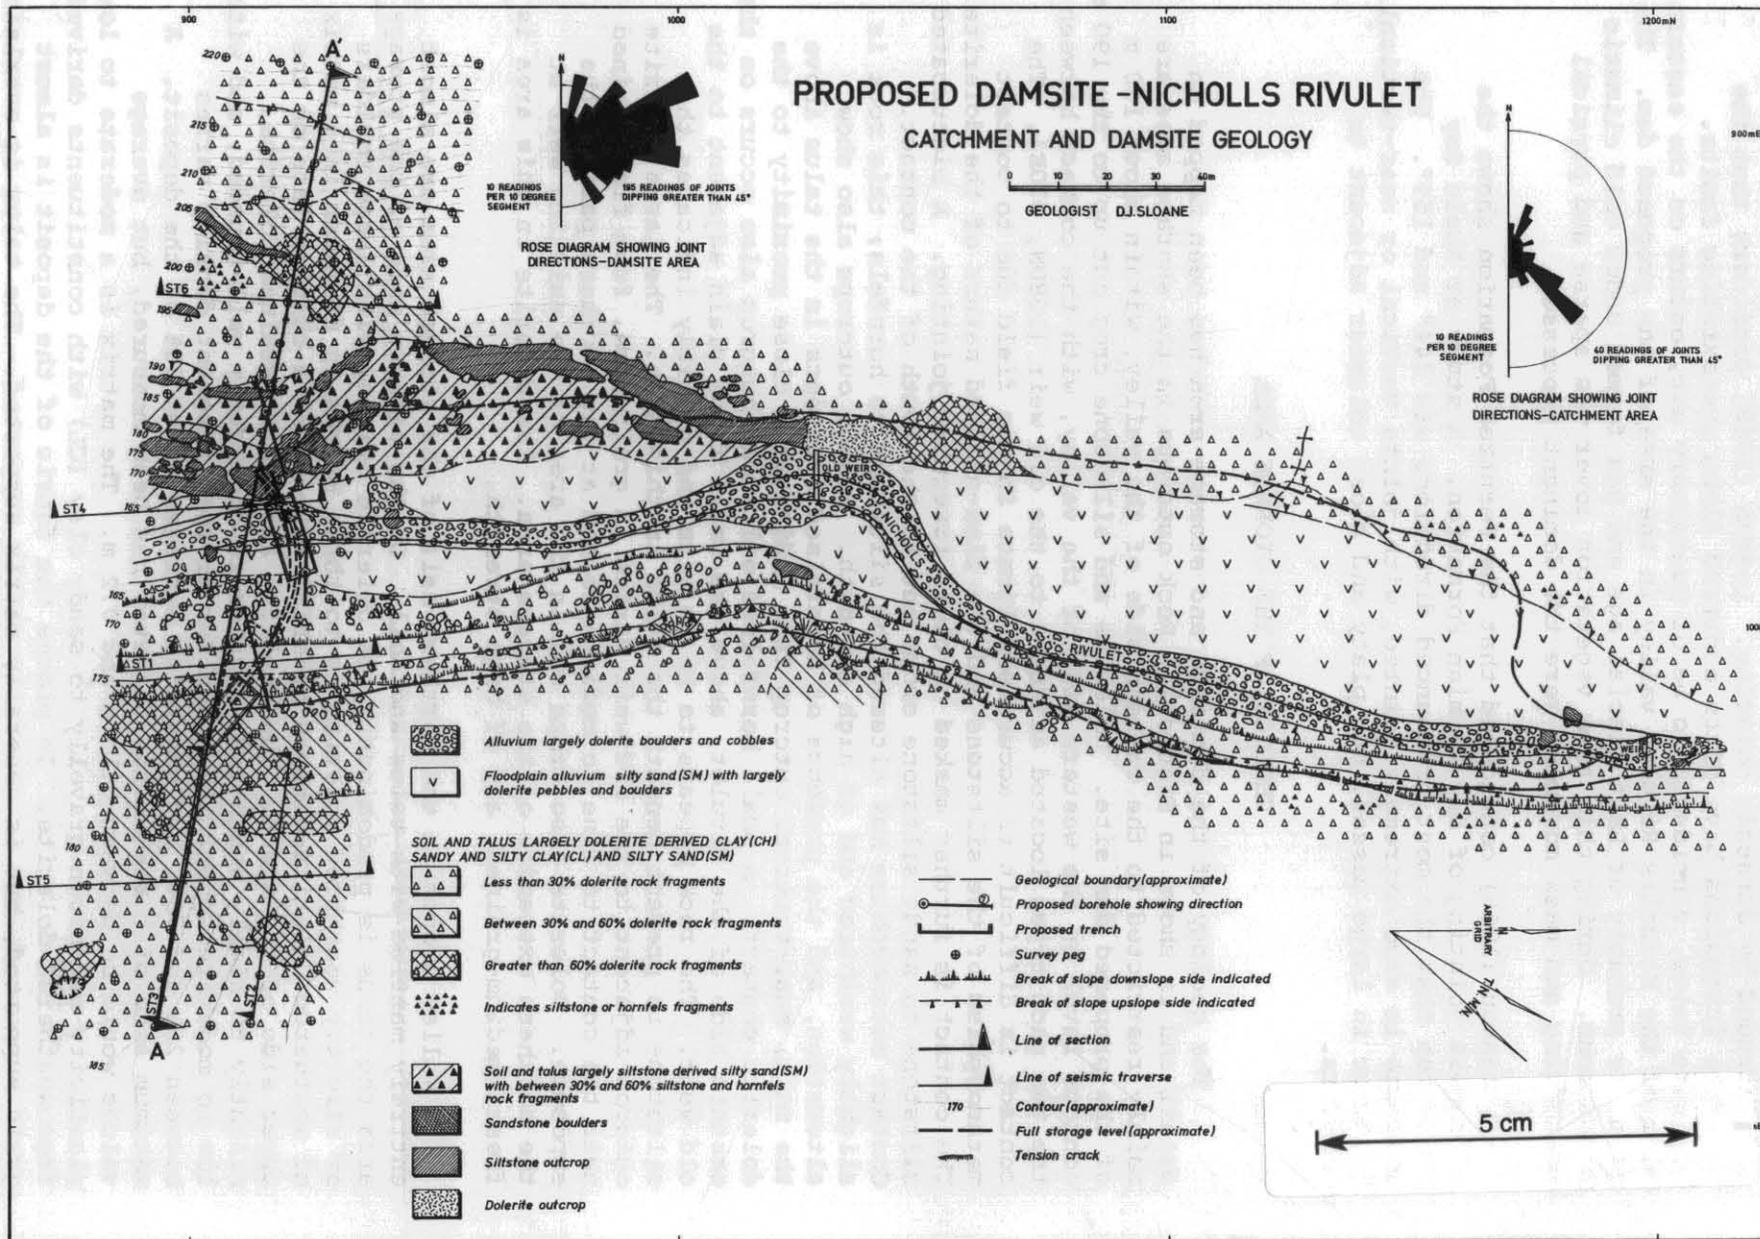
The geology of the dam site and storage area has been mapped in detail and is shown in Figure 2. Rock outcrops in the storage area are mainly restricted to the western side of the valley, within about 120 m of the proposed dam site. Dolerite and siltstone crop out up to the 190 m contour level on the western side of the valley, with the contact between the two rock types located adjacent to the old weir [1080N, 970E]. The contact is difficult to accurately locate in the field due to contact metamorphism of the siltstone and the fine-grained nature of the dolerite. The contact is further masked by close irregular jointing. A bioturbated siltstone to sandy siltstone crops out to the south of the contact. Contact metamorphism has altered the siltstone to hornfels; this rock is slightly weathered and of high strength. Higher outcrops also show alteration, and the presence of hornfelsed fragments in the talus above the main, near-vertical outcrop face indicates a close proximity to the dolerite contact. A small hornfelsed siltstone outcrop also occurs on the eastern side of the rivulet, above the small flood plain adjacent to the old weir. The rock appears to be *in situ* and possibly indicates that siltstone is present beneath the talus in this area. The large dolerite outcrop adjacent to the old weir varies in grain size, from fine-grained near the contact to fine to medium-grained at the northern part of the exposure. Dolerite also crops out in the area of the existing weir at the northern extremity of the storage area. The dolerite in this area is fresh, medium-grained, and of high strength.

The geology of the dam site and storage area is shown in Figure 2. Rock outcrops were mapped on a scale of 1:500, apart from the main 15 m high near-vertical rock face in the immediate vicinity of the western bank abutment.

Suggested investigation of the eastern bank abutment includes trenching, material testing, and possible diamond drilling. Trenching should be attempted first, in the area indicated on Figure 2. Excavation is required to determine the nature, permeability, and depth of the talus material.

inclination are shown in Figures 2 and 3 and Appendix 2. Core obtained must be logged in detail and water pressure permeability tests conducted to determine possible leakage and grouting treatment required.

The positions of six seismic refraction traverses are shown on Figure 2. Depth interpretations were made by critical distance, reciprocal, and time delay methods. The interpretations are included in the cross-section (fig. 3) and the results are summarised below.

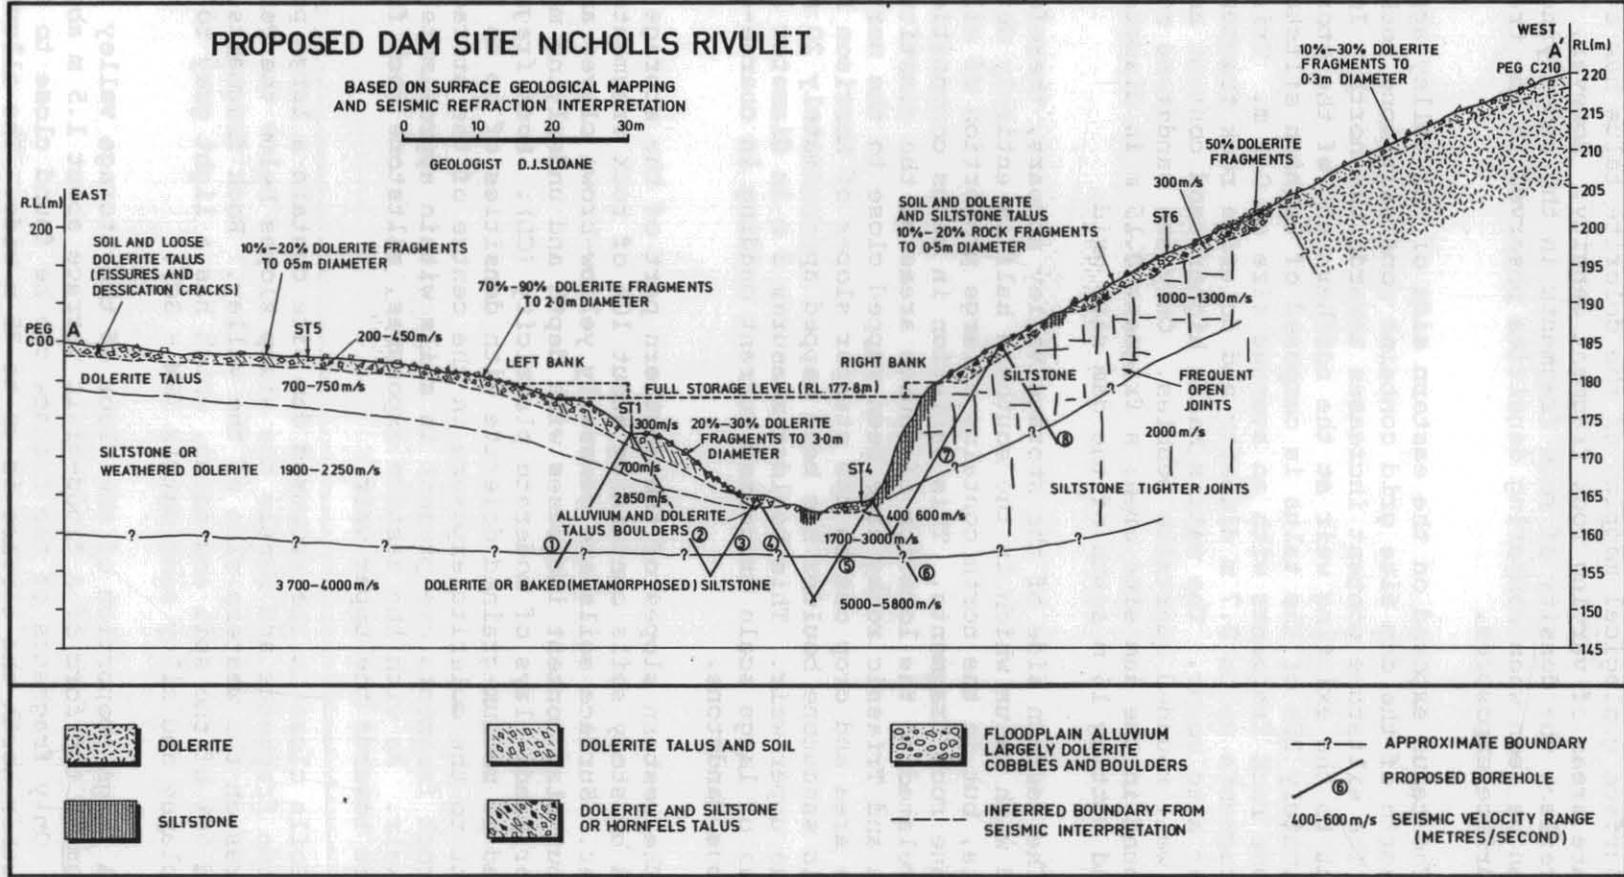
Figure 3

### PROPOSED DAM SITE NICHOLLS RIVULET

BASED ON SURFACE GEOLOGICAL MAPPING  
AND SEISMIC REFRACTION INTERPRETATION

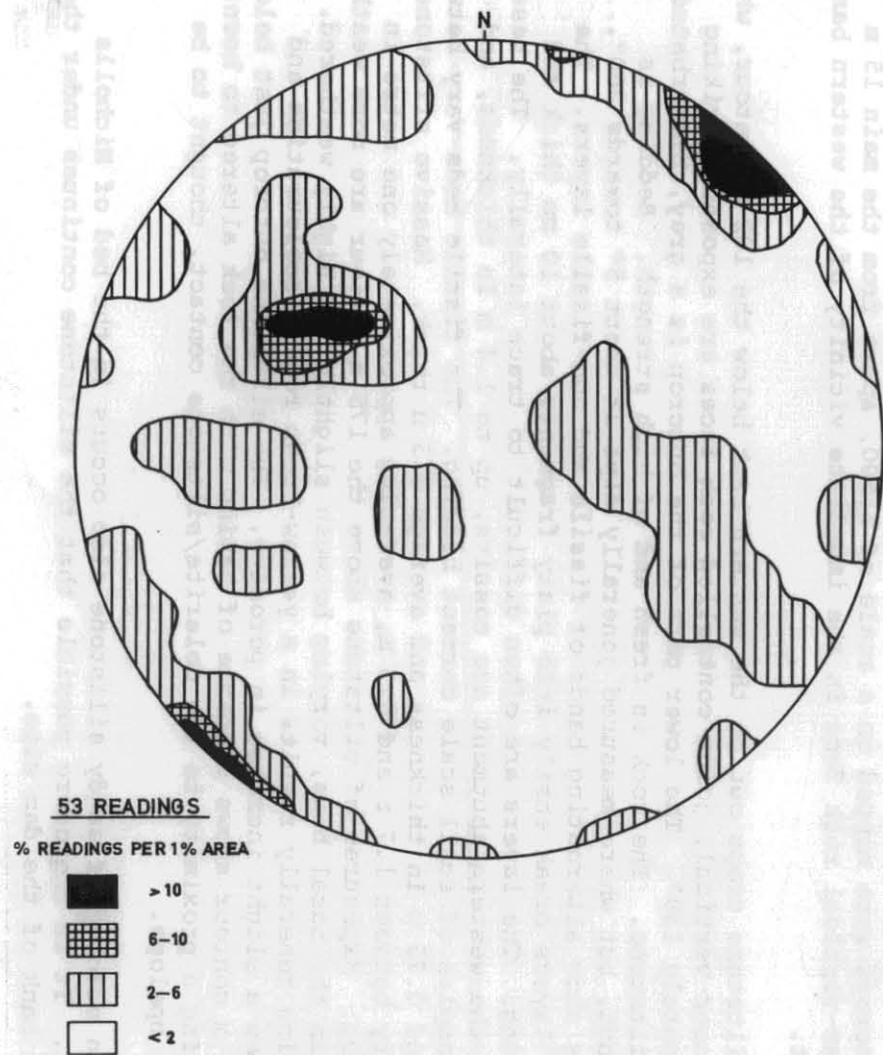
Joints are the main rock defects occurring in the storage area. A small, steeply dipping sheared zone of close irregular jointing on or close to the dolerite/siltstone contact is located near the old weir in the centre of the catchment area. This zone appears to trend approximately at right angles to the rivulet direction. Elsewhere joints are generally clean and planar but are sometimes curved, irregular and discontinuous. The rose diagram (fig. 2) shows the direction of steeply dipping joints, and the poles to 53 joint planes measured have been contoured after plotting on an equal area stereographic projection (fig. 4). There is a scatter in the results, with five or six sets apparent, but two major sets. One major set is vertical to near-vertical with a strike of 130°. Most joints are clean and planar, and some are curved, irregular and discontinuous. Where joint filling is observed there is minor iron mineral deposition and staining. The second major set strikes at 40° with a dip of about 40° towards the south-east. This latter set is similar in type to the 130° set previously described, but with a defect spacing of about 0.8 m. Occasional small areas of closer jointing occur where defect spacing may be as low as 10 or 20 millimetres. Again, joints are often curved, irregular, and discontinuous, especially near the siltstone/dolerite contact.

Access to outcrops is difficult due to the steep nature of the terrain. The sample size is small and the scatter of the joint diagram could be partially attributed to this, together with the effect of the contact zone resulting in the irregular and often curved joints.

Figure 4. Contoured stereoplot of catchment joints

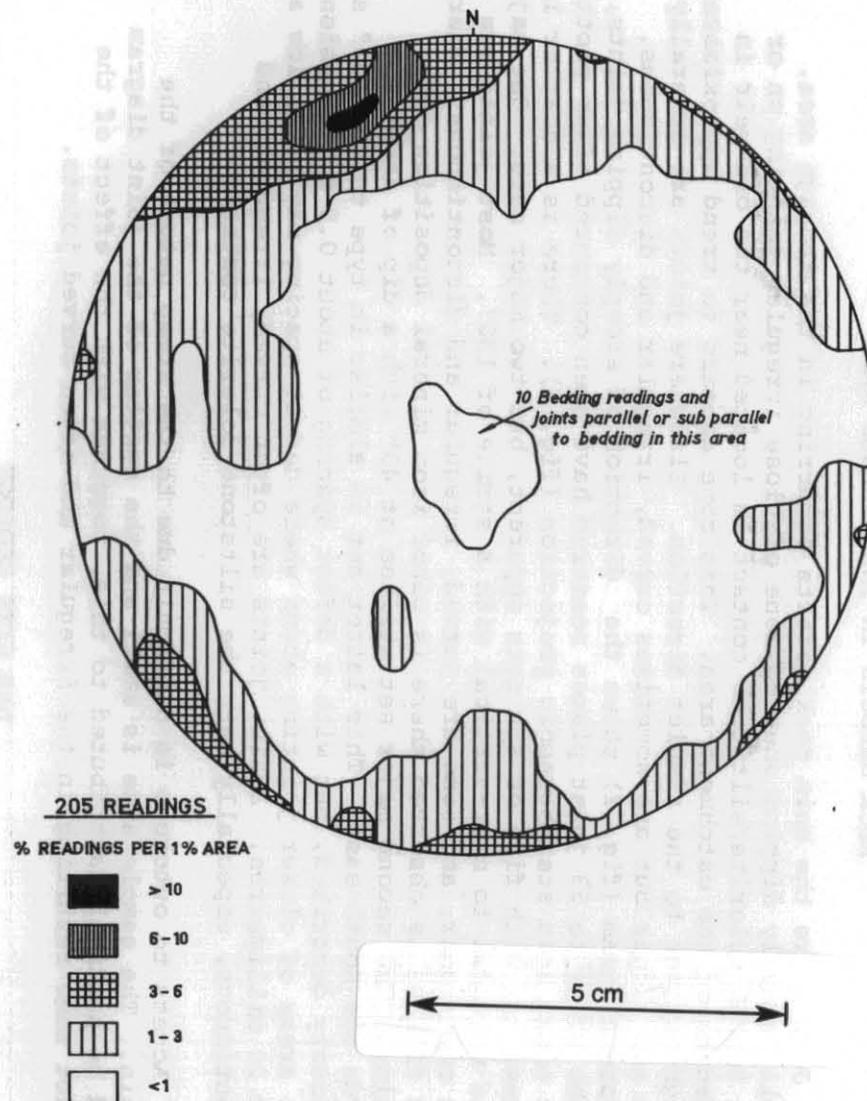
Figure 5. Contoured stereoplot of dam site joints

Joints and bedding fissility are the major rock defects observed on siltstone exposures. Three minor and two major joint sets have been mapped. The rose diagram on Figure 2 shows the direction of all steeply dipping joints, and the poles to joint planes have been plotted on an equal area stereographic projection and contoured (fig. 5). One major joint set strikes at 70° with a dip of about 75° to the south-east, while the other is near-vertical with a 130° strike. Fissile beds generally dip at about 5° towards 360° and some jointing or bedding parting occurs in this direction. The major set striking at 130° controls the major exposure faces. Major joint spacing is at about one metre, and this is reflected by outcrop benches and terraces. Major joints are continuous, but discontinuous joints with a spacing of between 0.2 m and 0.3 m also occur with a 130° strike direction. The 70° joint set is not as continuous and joint spacing varies between 0.3 m and 0.7 metres. All joints are generally planar and clean, but curved, irregular, and discontinuous joints do occur. Joints are often not continuous across bedding, with small scale joints restricted to a single bed. Iron mineral deposition and staining has occurred along occasional joints. Joint relaxation is evident in exposures above about the 170 m contour. Joint blocks approximately one metre in diameter and rock fragments 0.2 m to 0.3 m in diameter are often found at the base of exposures, again reflecting joint control. Information

obtained from seismic spread 6 indicates that joint relaxation may extend to a depth of about ten metres. The major vertical to subvertical joint set with a strike direction of 130° will require further investigation because of its leakage potential, with the joint direction being almost parallel to the Nicholls Rivulet.

Further work is required to investigate potential leakage areas. The western bank abutment may have joint relaxation extending to about 10 m in depth and a major joint direction lies parallel to the rivulet. Siltstone beneath the valley floor appears to be in better condition, as evidenced by much higher seismic velocities. The number and condition of joints in this area requires further investigation. The nature, permeability and stability of the talus requires investigation in the eastern bank area. Trenching and sluicing are required on the western bank abutment and valley floor to enable detailed mapping, probably at a scale of 1:100. Bedrock in these areas is considered to be between one and two metres below the ground surface. Suggested diamond drill sites with borehole length, inclination, and direction are shown in Figures 2 and 3 and Appendix 2. These holes will require detailed logging and water pressure tests to determine rock permeability and possible grouting treatment. Their final location will depend on the results of the detailed mapping suggested above. Access to the western bank drill site will be difficult due to the steepness of the terrain. It is, however, considered essential to accurately determine the nature and condition of the rock which has a seismic velocity of between 1000 m/s and 1300 m/s (Appendix 1) and which may extend to a depth of about ten metres. This seismic velocity may indicate extensive jointing, joint relaxation, and/or weathering.

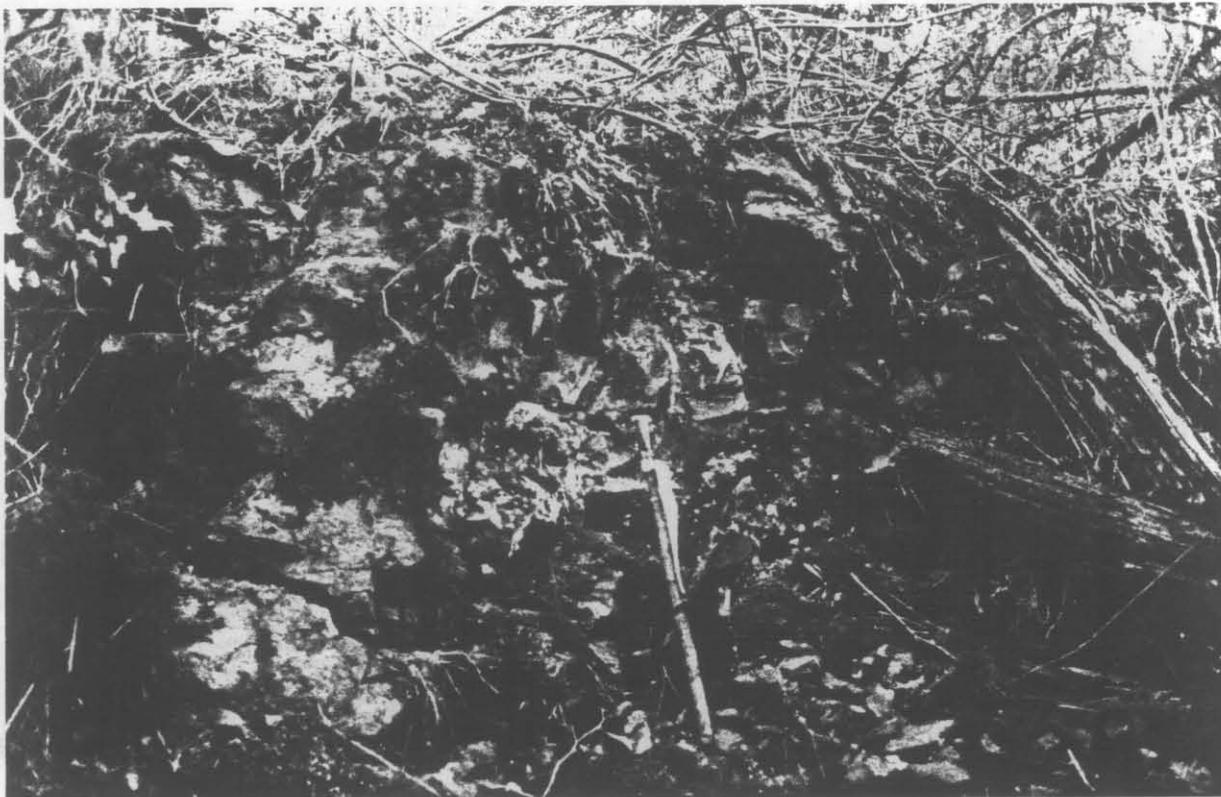
Plate 1. Siltstone outcrop at the foot of the western abutment rock face. Note the major joint set of  $70^\circ$  strike and dipping at about  $75^\circ$  to the south-east.

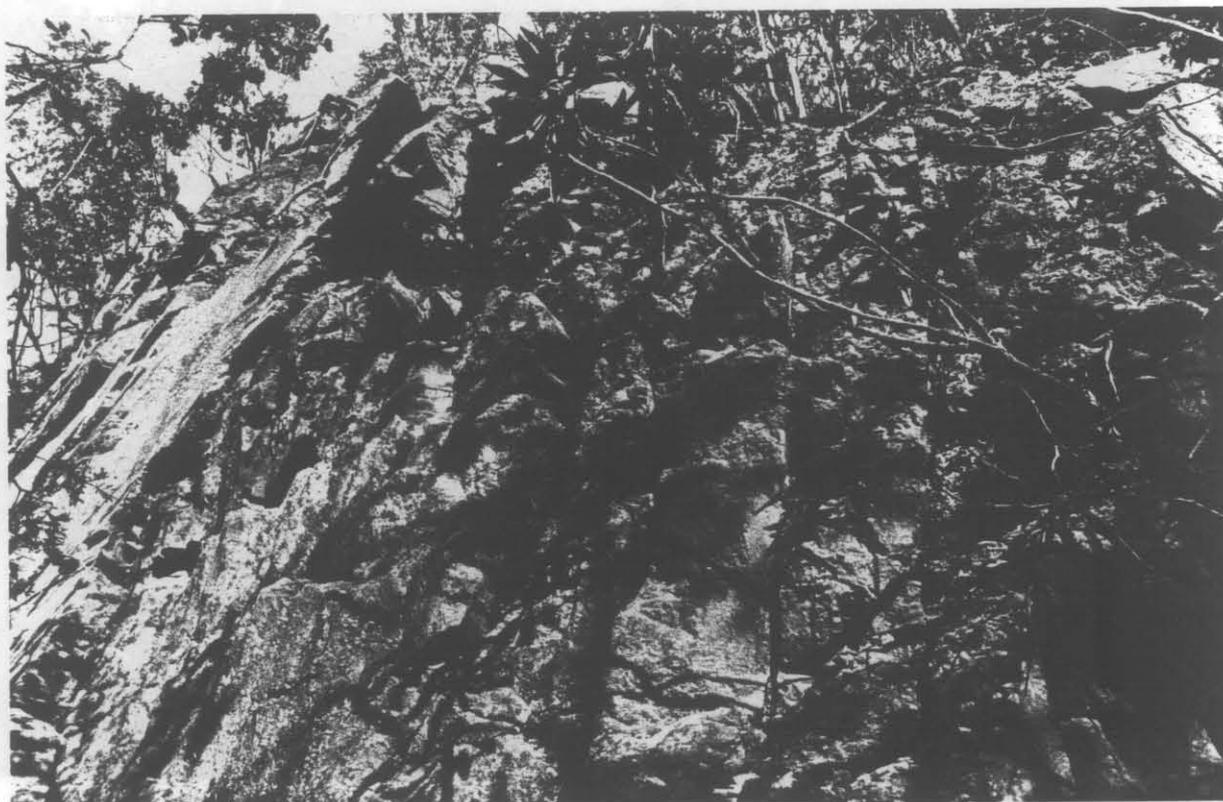
Plate 2. Northern part of the western abutment siltstone outcrop (looking south). Major  $130^\circ$  strike vertical joint set can be clearly seen.

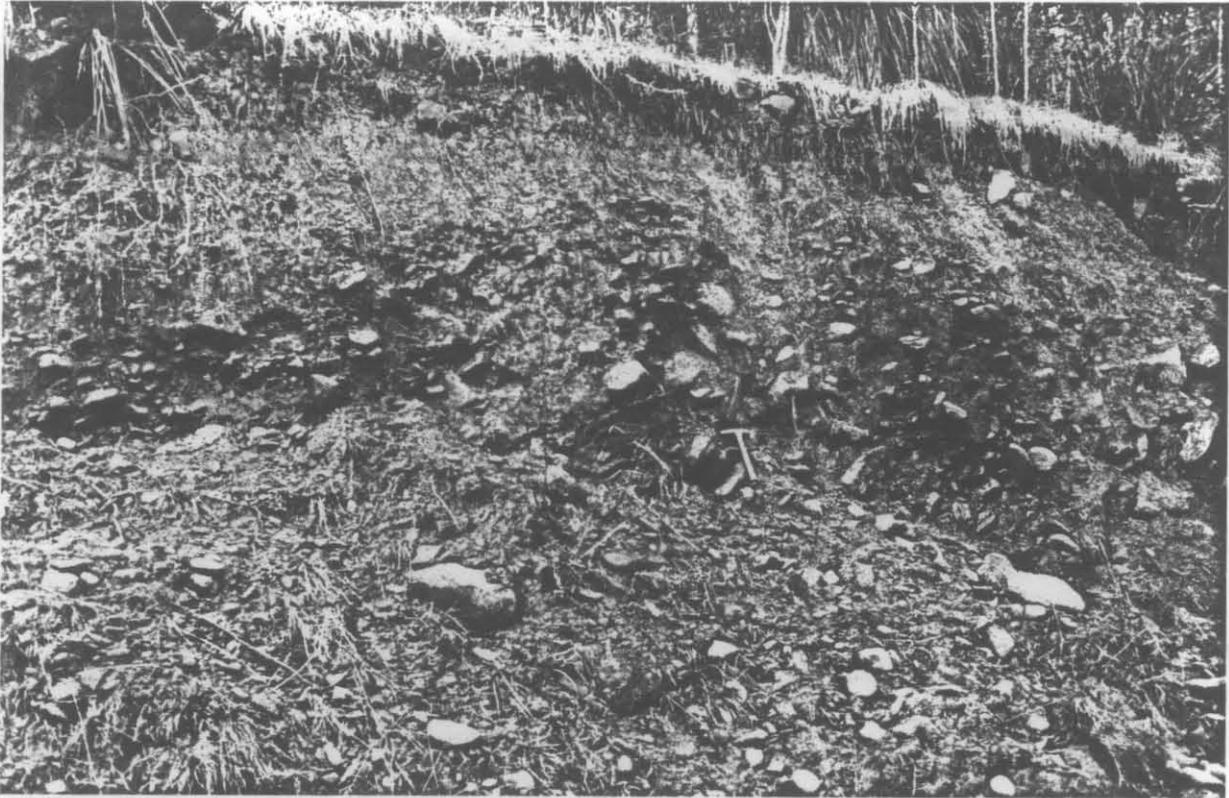
The eastern bank of the proposed dam site is entirely covered by dolerite talus. Surface rock fragment density has been mapped, but as described previously, does not necessarily reflect the rock fragment density in the underlying deposit. Rock fragments are composed of medium-grained dolerite, apart from one sandstone fragment found south of the grid. Track cutting exposures show that the dolerite boulders range up to 1.5 m in size (averaging 0.2 m), while densities vary between 30% and 50%. Fragments vary from angular to rounded, are of low to moderate sphericity, and are slightly to highly weathered. The matrix is a low to moderate plasticity gravelly and silty clay (CL), but becomes a clayey gravel (GC) where abundant gravel-sized decomposed rock fragments occur. Some fill is present at the foot of the eastern bank where large boulders of dolerite up to 3 m in diameter are mixed with logs and talus. Seismic spreads indicate that the dolerite talus is likely to extend to a depth of five to six metres. Below this depth it is possible that Permian siltstone occurs, as indicated by seismic information and creek bed exposures. Alluvial deposits in the valley floor have been described above. In the dam site area these deposits appear to be between 1.0 m and 1.5 m in thickness.

Plate 3. *Dolerite talus. Exposure in track cutting, eastern bank of dam site.*

Excavation to a depth of about 5 m to 6 m is required to attempt to determine the nature and condition of the 1900 m/s to 2250 m/s seismic velocity layer. Permeability tests of the talus material are required as well as stability calculations, especially under fully saturated and rapid drawdown conditions. In talus areas investigated elsewhere in Tasmania (Sloane, 1978), a highly permeable talus horizon often occurs at the talus-bedrock interface. This should be considered during site investigations. Diamond drilling may be required, depending on the results of the eastern bank trenching. Suggested sites showing hole lengths, direction, and

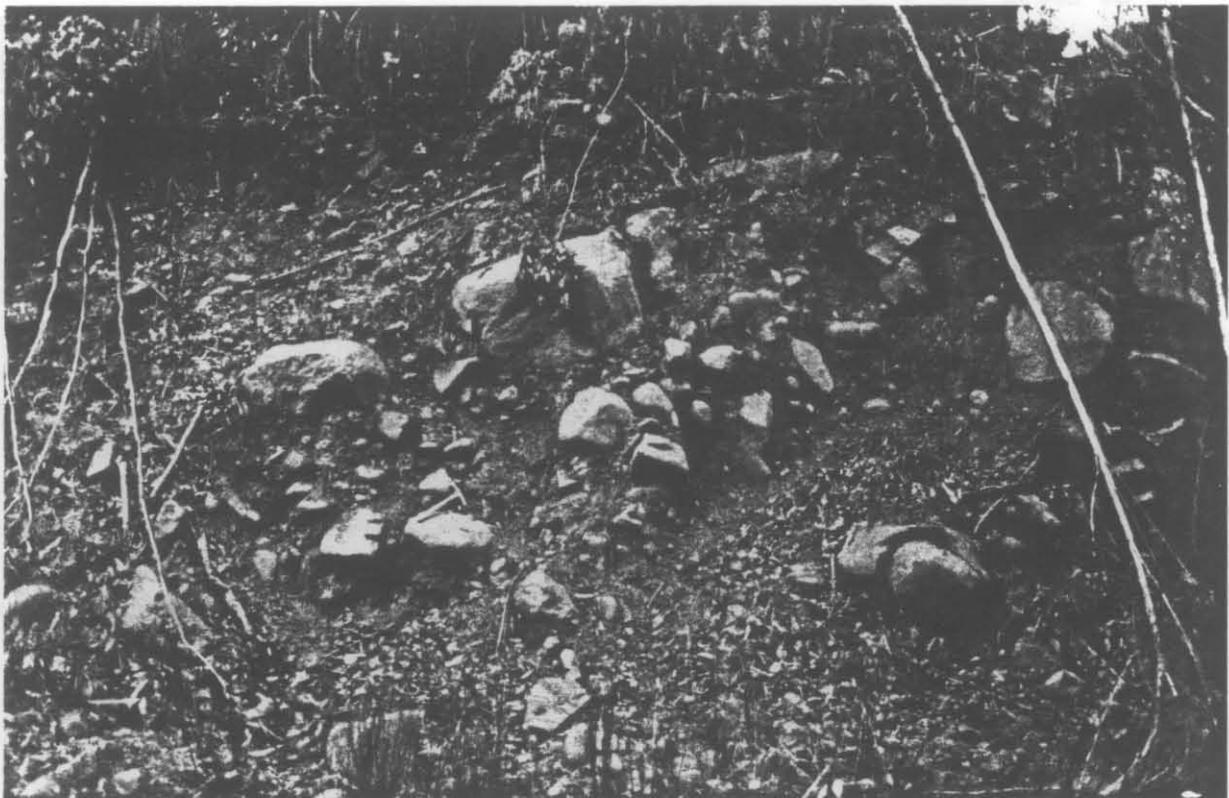
The talus exposed on the eastern side of the valley approximately 150 m north of the dam site grid contains some siltstone rock fragments (2%). The siltstone content increases towards the north. In the cutting adjacent to the existing weir at the northern end of the storage area, approximately 25% of the talus is composed of Permian siltstone or Triassic sandstone rock fragments with an average size of 0.3 m. Triassic sandstone rock fragments up to 0.7 m diameter and dolerite rock fragments up to 0.5 m diameter also occur. The matrix has a higher sand content and also contains small, well rounded quartzite pebbles. Only one sandstone rock fragment has been found in the dam site area; a fragment 0.15 m in diameter was found in the road cutting 15 m south of the dam site grid.

Plate 4. *Dolerite, siltstone and sandstone talus exposed in track cutting in the northern part of the storage area.*

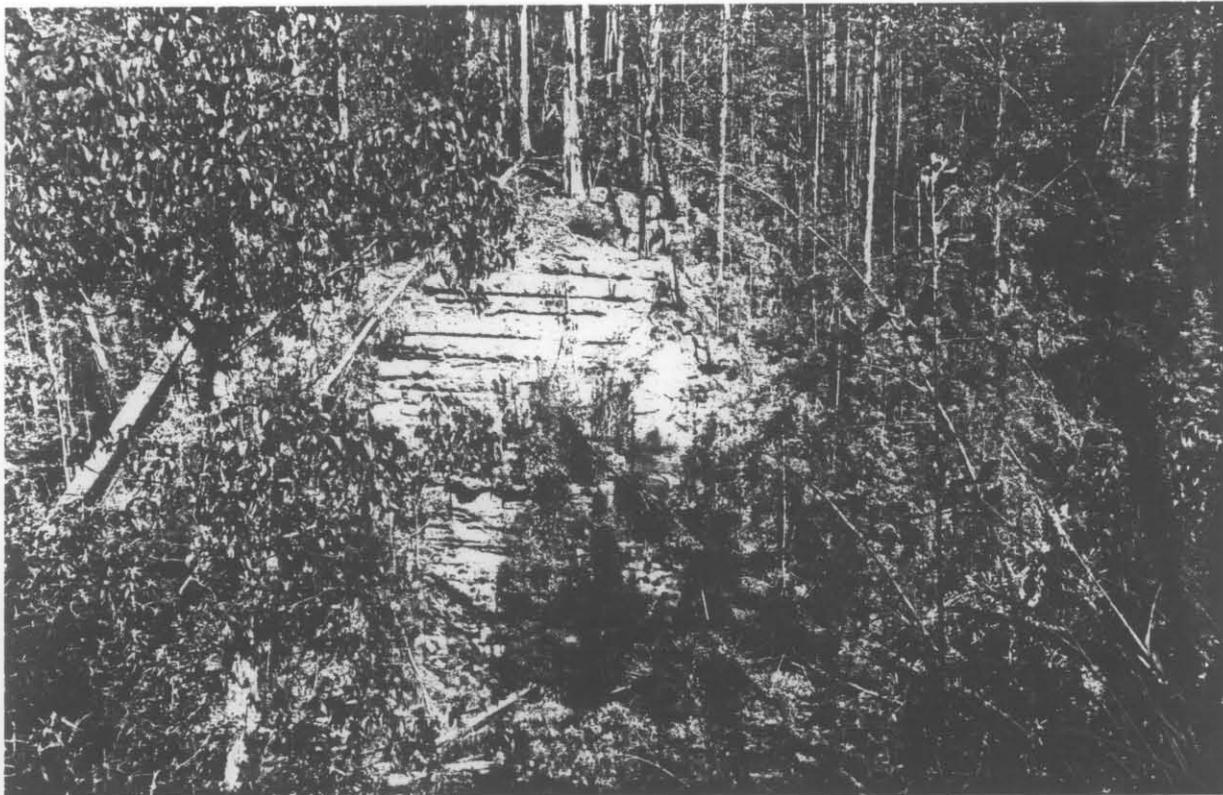
Plate 5. *Siltstone outcrop of western bank abutment, showing alternating fissile and non-fissile beds.*
