### Division of Mines and Mineral Resources — Report 1990/09

# Use of the Magellan GPS Nav 1000 Pro in a helicopter

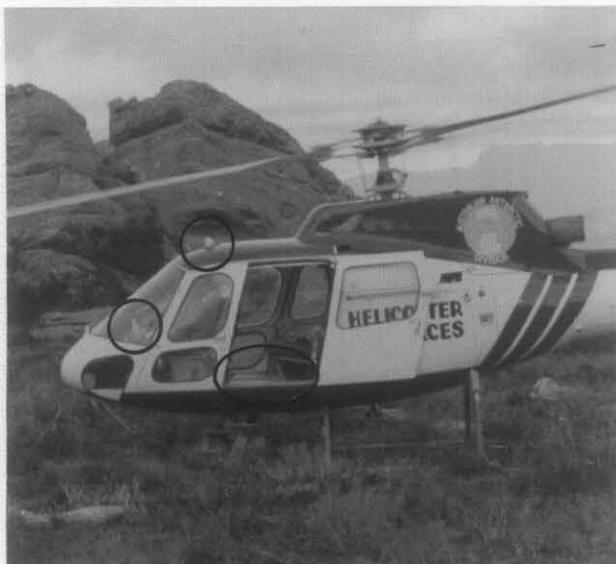
For this field trip the external antenna was mounted in the window above the co-pilot's seat in an Aerospatiale AS350B Squirrel owned by Helicopter Resources. The lead from the antenna ran towards the rear of the machine to maintain the minimum recommended distance between the receiver and the external power supply (through which the external antenna is connected). Plate 1 shows the final configuration, with the position of the antenna, instrument, and power lead circled.

During flight the navigation and velocity functions worked as described in the receiver manuals. At 200 km/h it was found that updates were being made every 2.7 km, that is about every 48 seconds, rather than the 13 seconds expected. I attribute this to the rotor disc above the antenna interrupting the signal and lengthening the time for a fix.

- (i) The external antenna should be mounted on the top of the helicopter tail fin at the rear end.
- (ii) The receiver should be wired to the helicopter power supply in such a way as to allow operation when the machine is shut-down. This would allow the receiver to search for and change satellites during short times of shut-down and avoid any problems with gaining the initial fix.
- (iii) The receiver should be used in 3D mode with interrupted terrain setting and in continuous operation.
- (iv) When approaching the end of a course or a specified point the approach should be sufficiently slow to allow fixes to be acquired at a realistic rate.
- (v) All users should be familiar with using the receiver and have an understanding of possible causes of accuracy loss, including poor satellite geometry, low signal strength and selective availability (deliberate degradation of GPS signals).
