The effects of waste disposal on groundwater quality in Tasmania

McRobies Gully waste depot, South Hobart

Tasmanian Geological Survey Record 2002/16

Hydrogeological investigations at the McRobies Gully waste depot, South Hobart

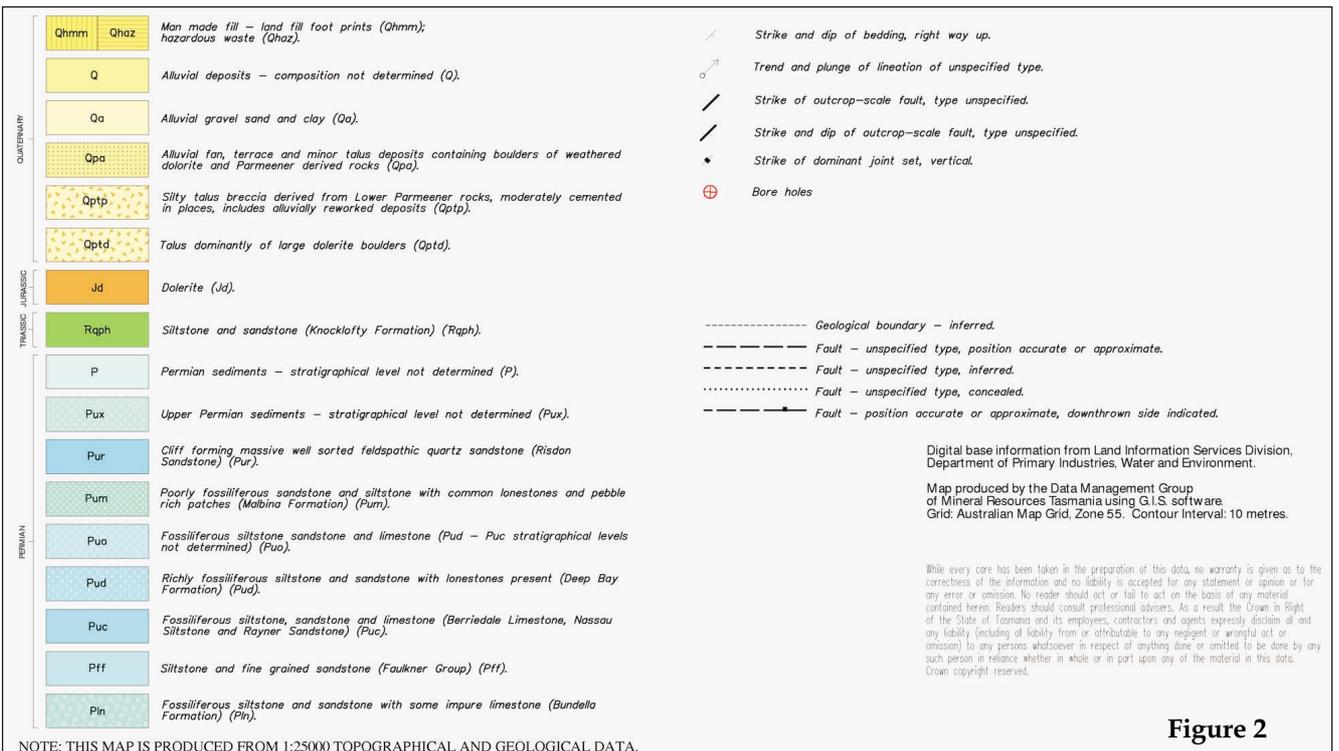
Figure 2

The geology of the McRobies Gully area is shown in Figure 2. This geological map was based on geological data compiled for the MRT Hobart 1:25 000 scale geological map sheet (Clarke and Forsyth, 2002). Several small changes have been made near the landfill footprint and to the distribution of the Permian rocks.

The landfill footprint is variously located on Jurassic dolerite or Permian and Triassic rocks. Areas of Quaternary colluvium (derived from all rock types) exist on the valley walls.

The main shear zone of the regional horst and graben structural system passes beneath the toe of the landfill. This structure is known as the Cascades Fault Zone (CFZ) and has produced a complex set of faulted and fractured features within all rock types in McRobies Gully. A seismic risk assessment, undertaken by geological consultants Leaman Geophysics, is included as Appendix 1. This report concluded that Hobart is subject to earthquakes of moderate magnitude and areas on poorly consolidated materials, or close to main faults, are likely to suffer damage. As these conditions are both present at McRobies Gully, the risk of significant damage is high in the event of an earthquake. The report recommended that "It is important that this risk be recognised and that measures be enacted which improve the consolidation and drainage of the fill".

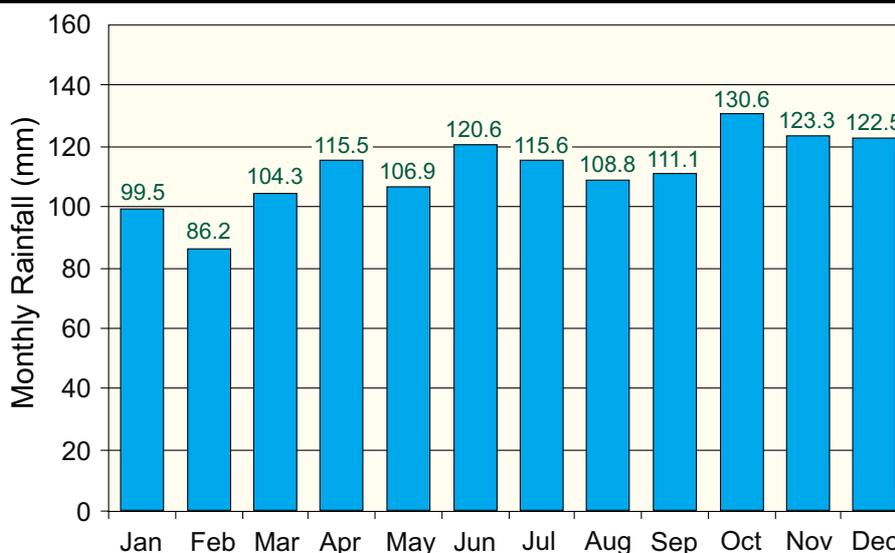
Figure 3

Average monthly rainfall for Australian Bureau of Meteorology rainfall station 094066, Mount Wellington, The Springs.

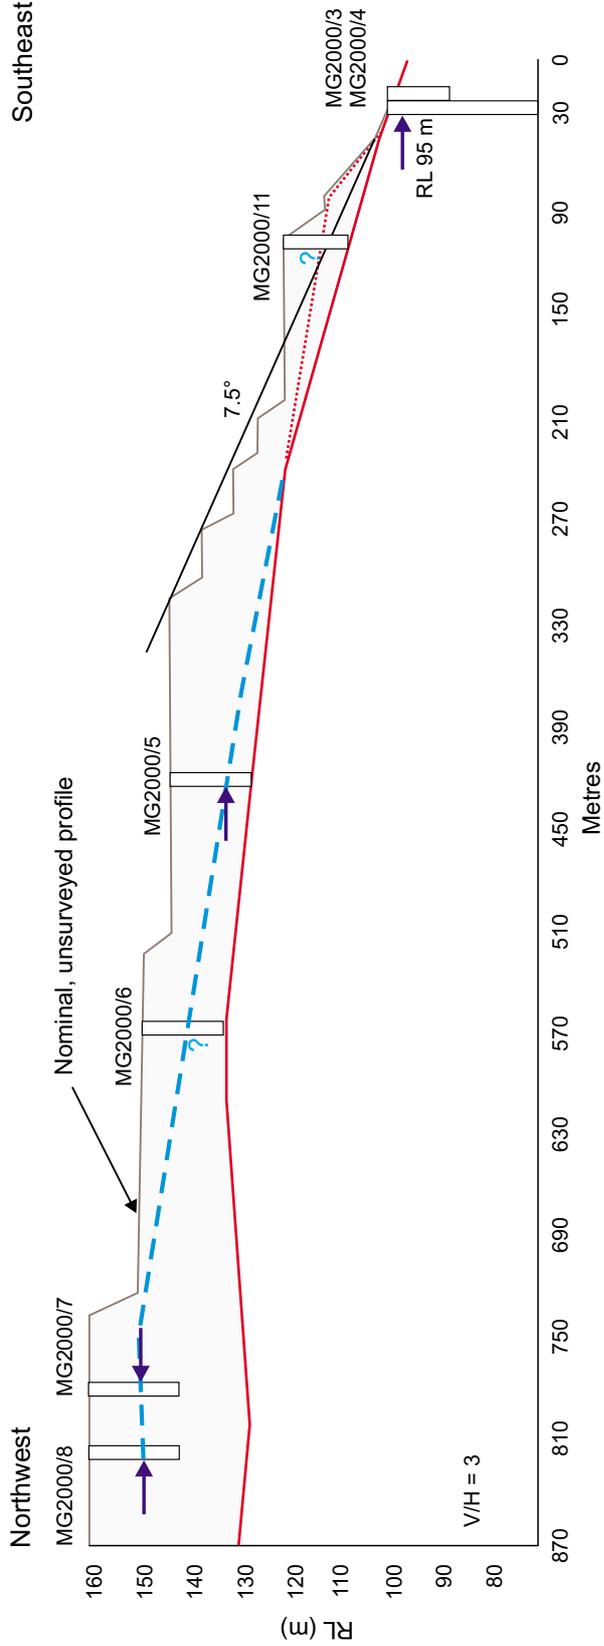
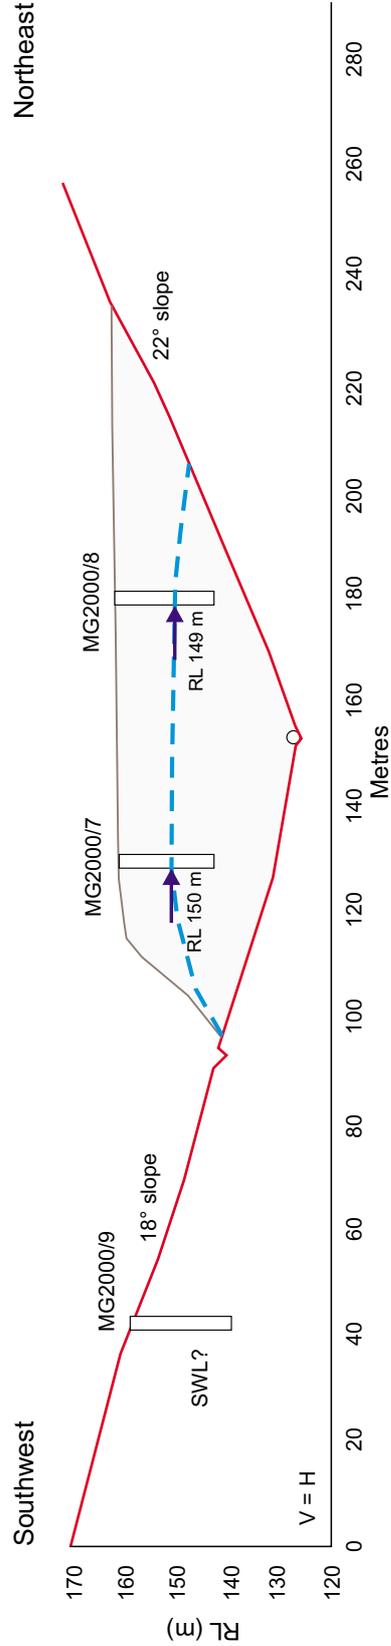
Figure 5 Cross sections at McRobies Gully, showing standing water level of fill water in the landfill (after Cromer, 2002)

LONGITUDINAL SECTION

CROSS SECTION, NW END

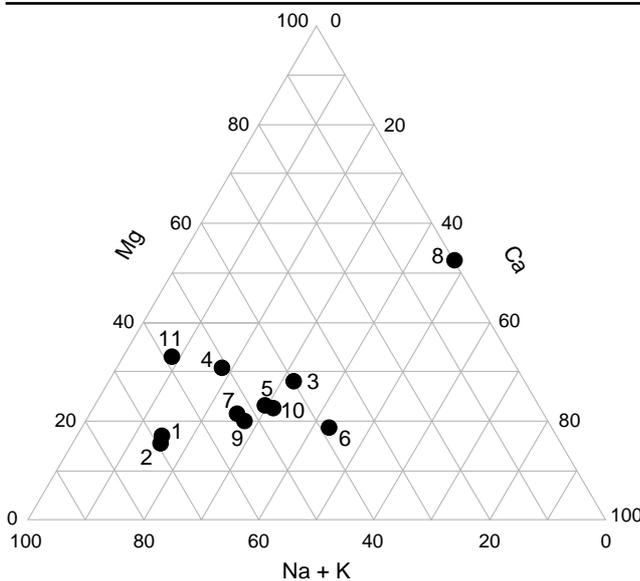
Figure 6a

Cation Ternary plot for surface water samples at the McRobies Gully waste depot. 1 – Western drain base; 2 – Western drain middle; 3 – Eastern pipe; 4 – Stage 2 spring; 5 – Hobart Rivulet outpour (24/04/2001); 6 – Hobart Rivulet outpour (17/05/2001); 7 – Western drain base; 8 – Car park flow; 9 – Western drain middle; 10 – Western drain top; 11 – leachate line.

site maps in Appendix 5. Figure 6 shows cation Ternary plots from the results of testing surface and groundwater samples at the McRobies Gully waste depot. Tables 3 and 4 compare the groundwater analytical results against international standards where a guideline/emission value is stated by the relevant standard.

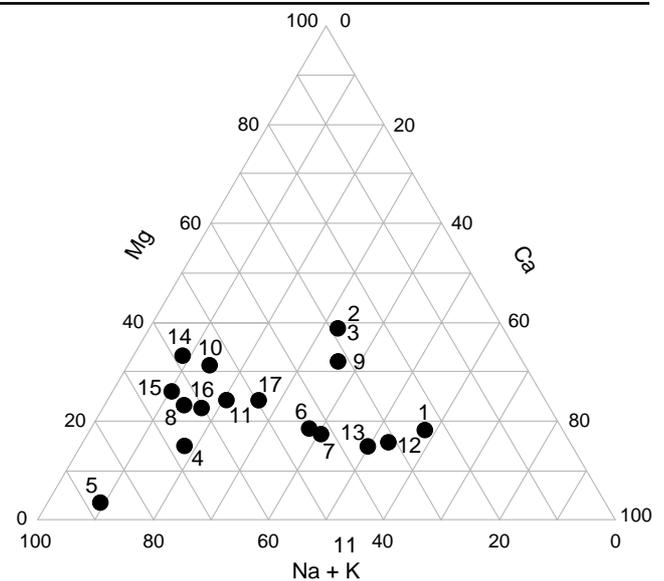
Figure 6b

Cation Ternary plot for groundwater samples at the McRobies Gully waste depot. 1 – MG1996/1; 2 – MG1996/2; 3 – MG1996/3; 4 – MG2000/1; 5 – MG2000/2; 6 – MG2000/3; 7 – MG2000/4; 8 – MG2000/5; 9 – MG2000/6; 10 – MG2000/7; 11 – MG2000/8; 12 – MG2000/9; 13 – MG2000/10; 14 – leachate line; 15 – average of all MRT groundwater records for Triassic rocks; 16 – average of all MRT groundwater records for Permian rocks; 17 – average of all MRT groundwater records for Jurassic dolerite.

The Ternary plot for groundwater demonstrates a cluster of the degraded ammonia/chloride contaminated waters. The remaining spread of points reflects the chemical variations within the boreholes screened in the various lithologies and their position with respect to the Cascades Fault Zone and the landfill footprint.

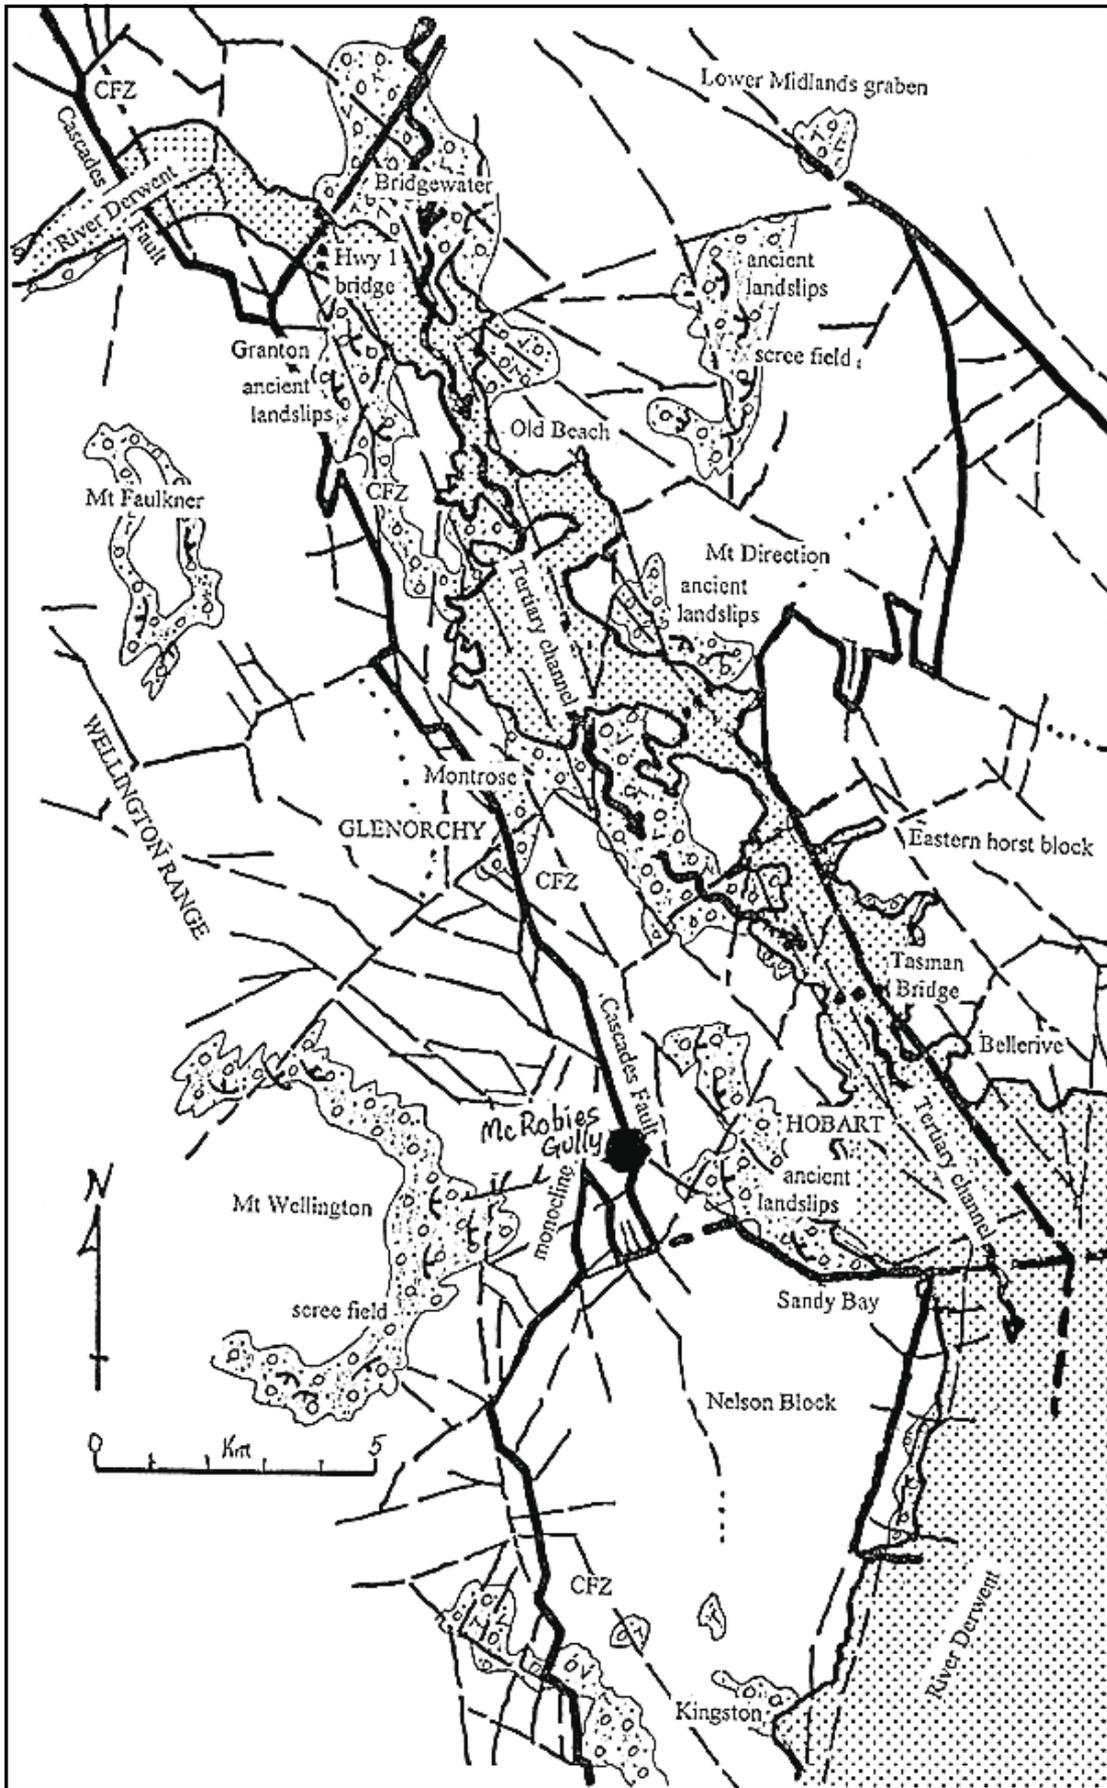
Figure 7

Simplified outline of rift zone faults between the River Derwent and the Wellington Range near Hobart. Major faults are indicated by heavy lines. Rock and fill materials subject to vibration resonance or failure are patterned. Note the unfortunate location of the McRobies Gully waste depot within this structural framework.

The McRobies Gully waste disposal site is located upon the intensely disrupted CFZ west of Knocklofty; one of the most active and stressed parts of the rift margin. The structure will fail again. The only uncertainty attaches to 'when?'

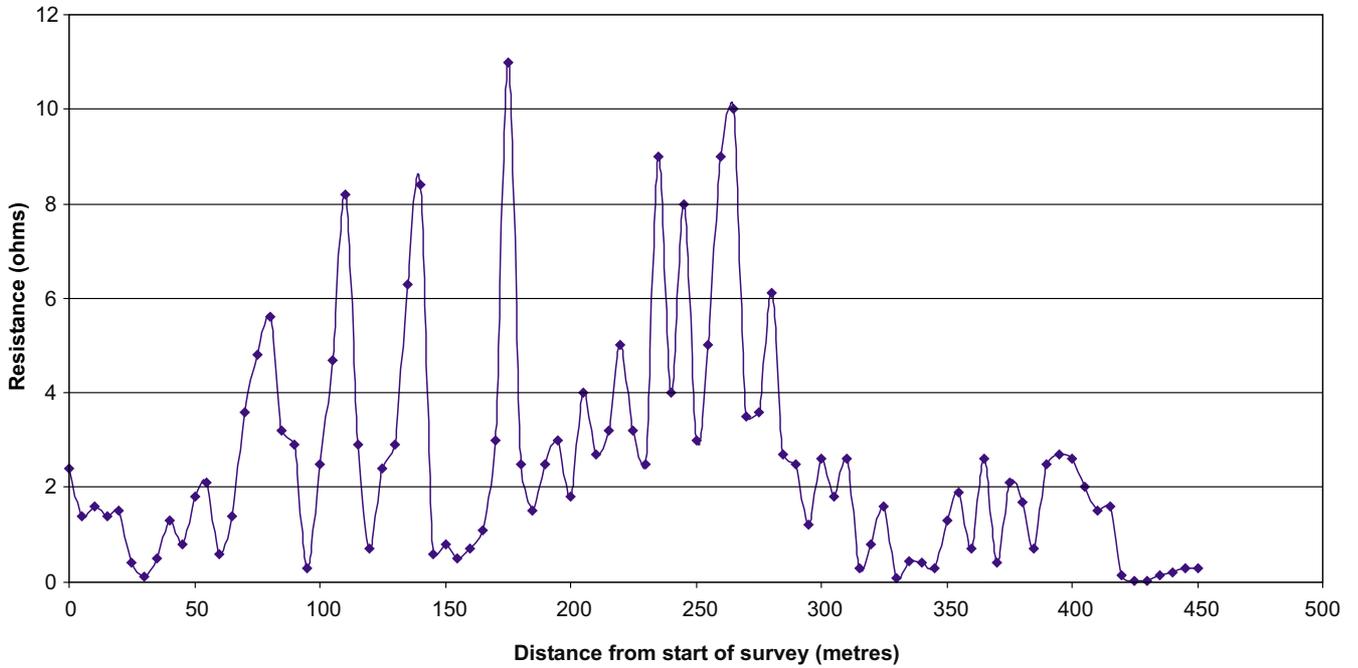
See Figure 4 for location of traverse

McRobies Gully – Wenner Resistivity survey 13 July 2000

Bore MG 2000/2 is located on a hill spur cut by the fault zone. This bore was sited on the main shear fault zone down-gradient of the landfill footprint to investigate the permeability of the fault zone. Two resistivity surveys were conducted on the same traverse line (fig. 4). A Wenner-style 20 m array spacing survey was initially undertaken and followed by an EM31 survey. Appendix 3 contains the profiles of both surveys. Both surveys clearly identified the contacts between the main shear area of the Cascades Fault Zone and less fractured Permian and Triassic rocks to the north and south. This work implied that the Cascades Fault Zone is approximately 70 m wide along the nose of the spur line.

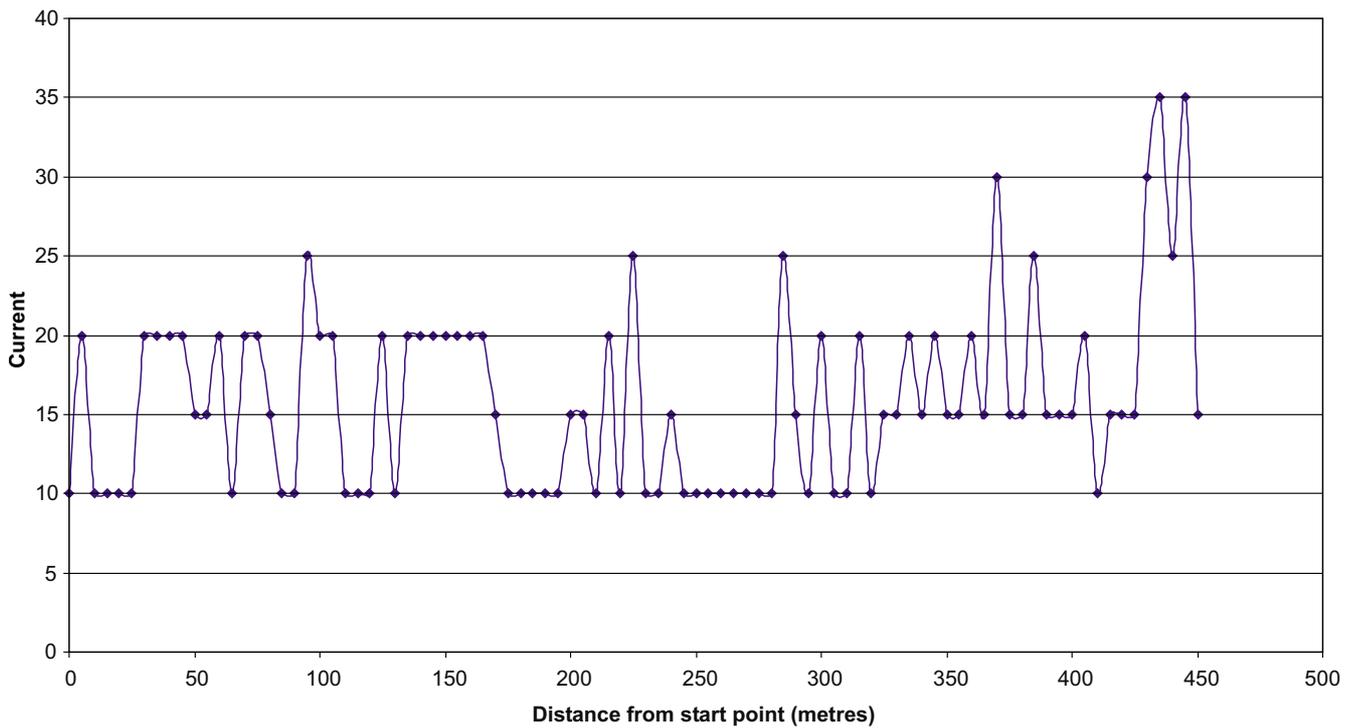
McRobies Gully – Wenner Resistivity survey 13 July 2000

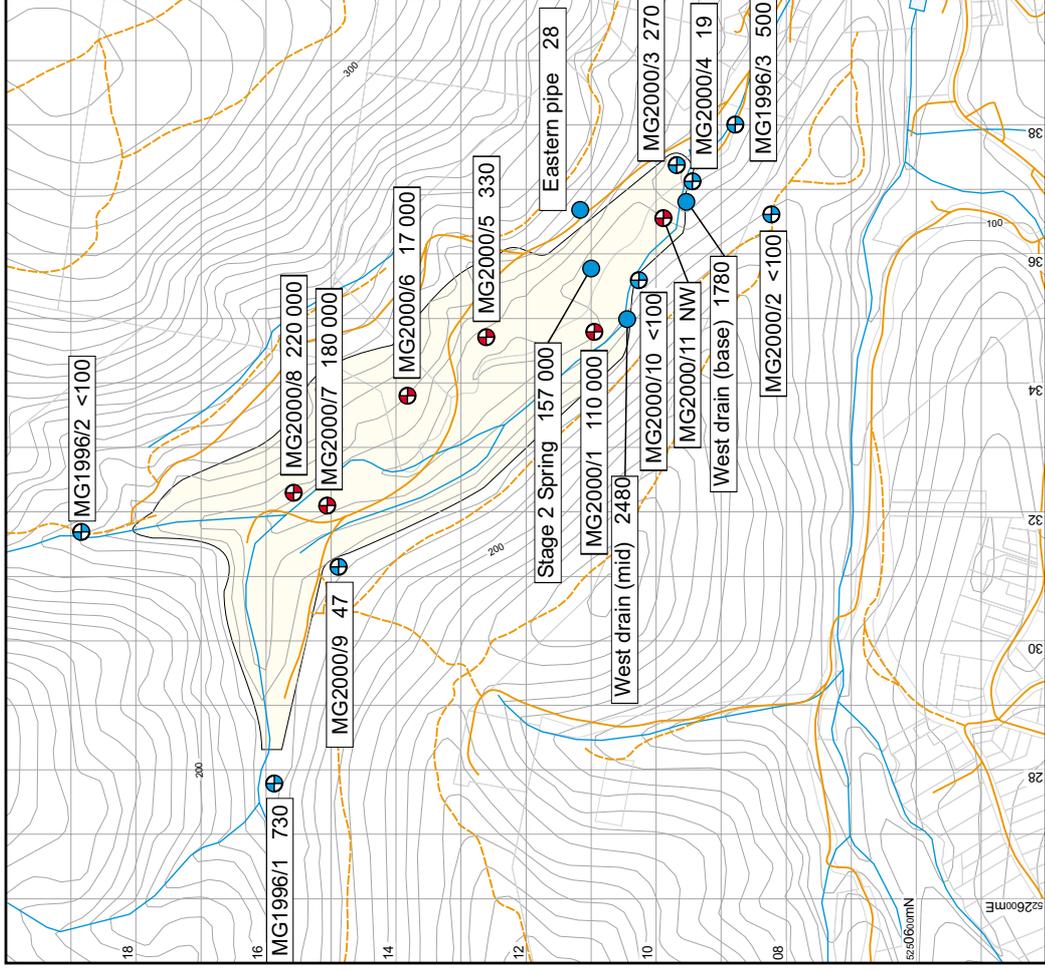
**McRobies Gully waste depots
April 2001
Ammonia ($\mu\text{g/L}$)**

Locally the results indicate that there is an area of degraded groundwater in the northwest end of the valley, with elevated ammonia and nitrate levels in the groundwater. It appears that this may be due to the significant volumes of fish waste which have been disposed of in this area over a number of years. Better management of surface water in this area will be required to lower the hydraulic level in the fill and reduce the potential for further groundwater contamination.

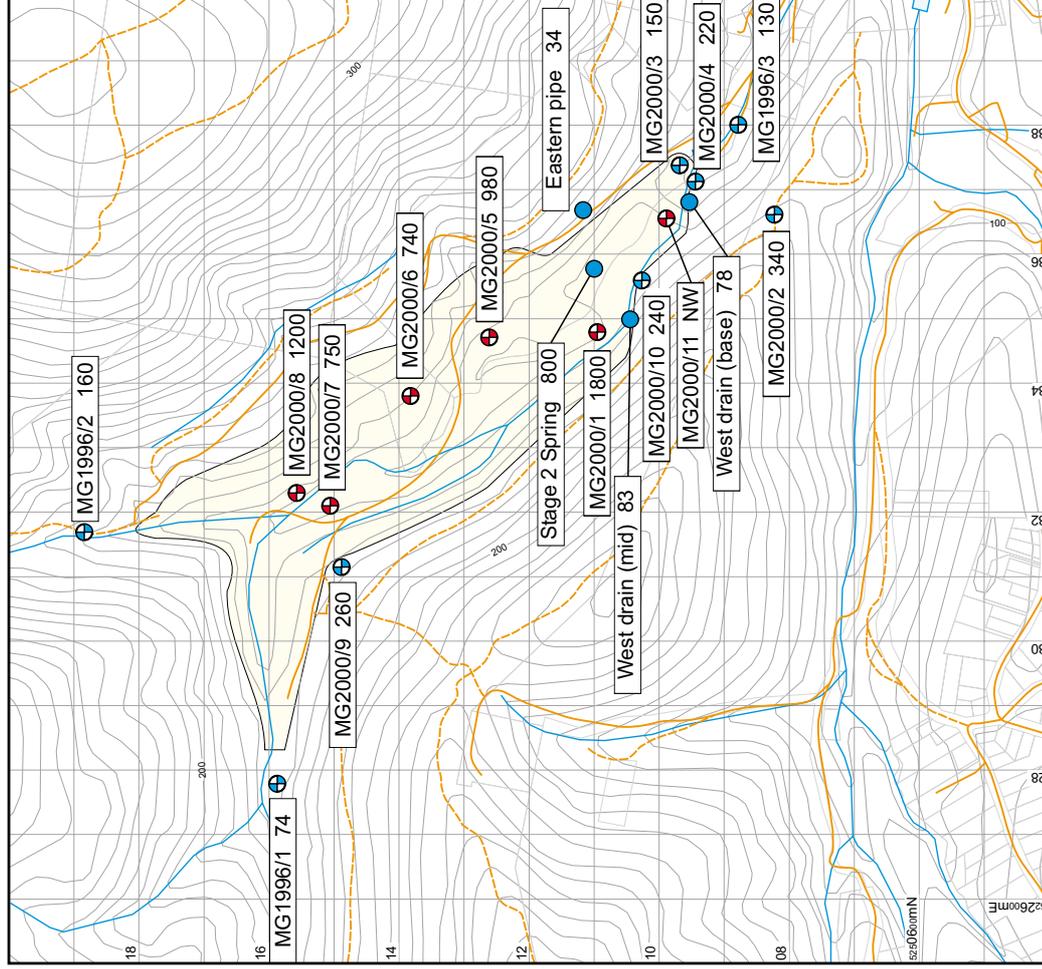
McRobies Gully waste depots
April 2001
Chloride (mg/L)

Chloride and hydrocarbon migration into the bedrock aquifers seems to be occurring, as shown by bores MG1996/1, MG2000/3, 4, 9 and 10. Nitrogen contamination of MG1996/1 may be related to the large volume of fish waste disposed of in this part of the valley over the last five years. Ammonia detected in MG1996/3 could indicate migration of degraded groundwater to the south of the site.

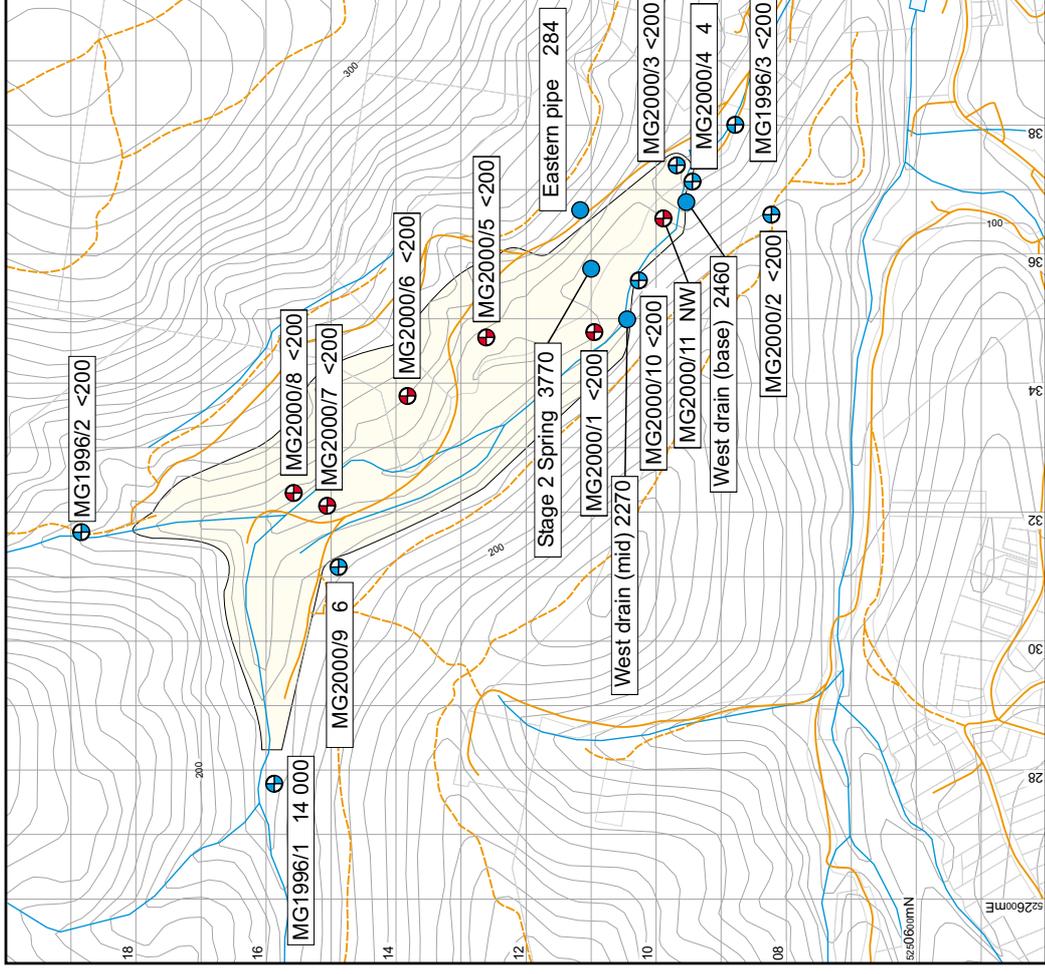
**McRobies Gully waste depots
April 2001
Nitrate + Nitrite ($\mu\text{g/L}$)**
