Tasmanian Geological Survey
Record 2011/02

**Anchor mine tailings dam
site investigation, June 2011**

*by Jennifer Parnell, Mine Leasing and Liaison Officer, Mineral Resources Tasmania
and Greg Dowson, Manager — Water Section, Environmental Protection Authority*

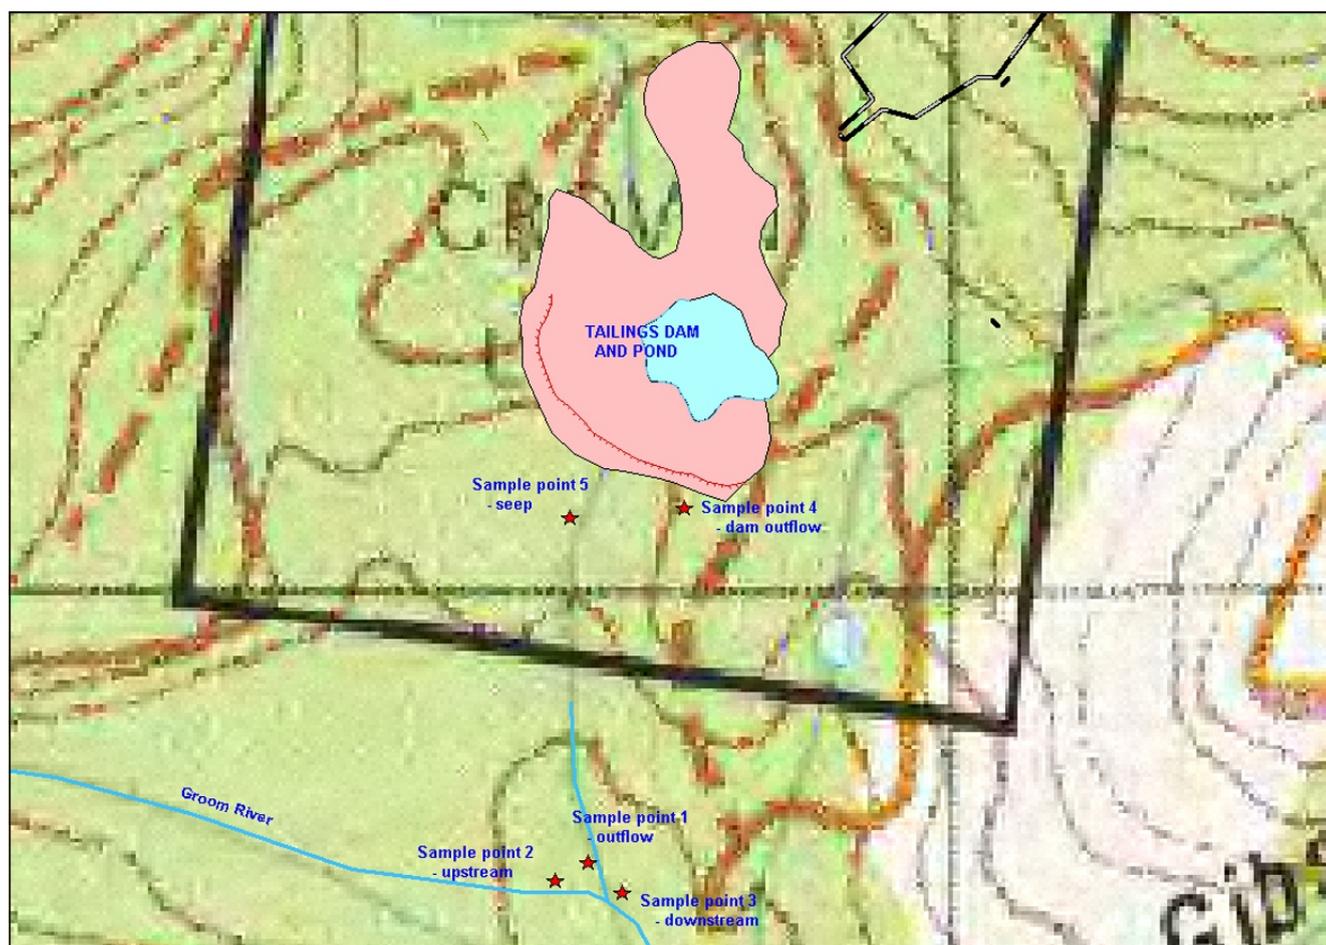
Figure 2

A sampling run was conducted on 15 June 2011. Five samples were collected, three on the Groom River and two between the tailings dam wall and the polishing pond. The location of each sample point is shown in Figure 2. The sample points are described in Table 1 and photos of each point are included in Appendix 1.

Location map of sample points

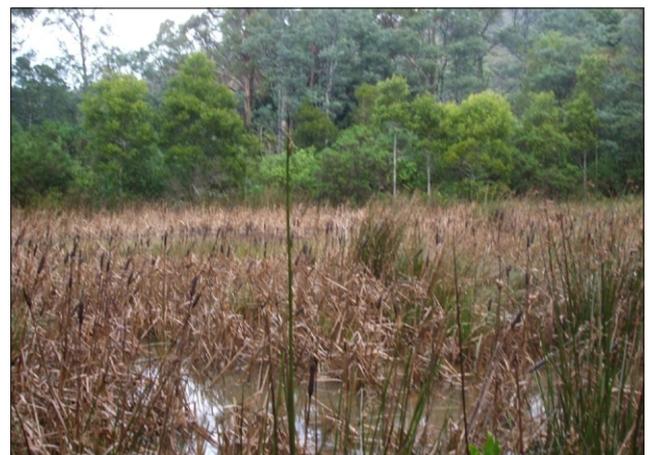
The polishing pond (fig. 3), which has developed a wetland plant community, is effectively reducing some of the identified metal pollutants, significantly cadmium, copper and zinc, although some levels, namely iron and to a lesser extent manganese, are elevated at the discharge. The iron is most likely associated with colloidal fluxes and adsorbed to suspended solids, while the manganese is principally in a dissolved form. Depending on the pond residence time some anomalies between input and output, particularly complicated by storm flow events, would be expected to occur.

Figure 3
Polishing pond.

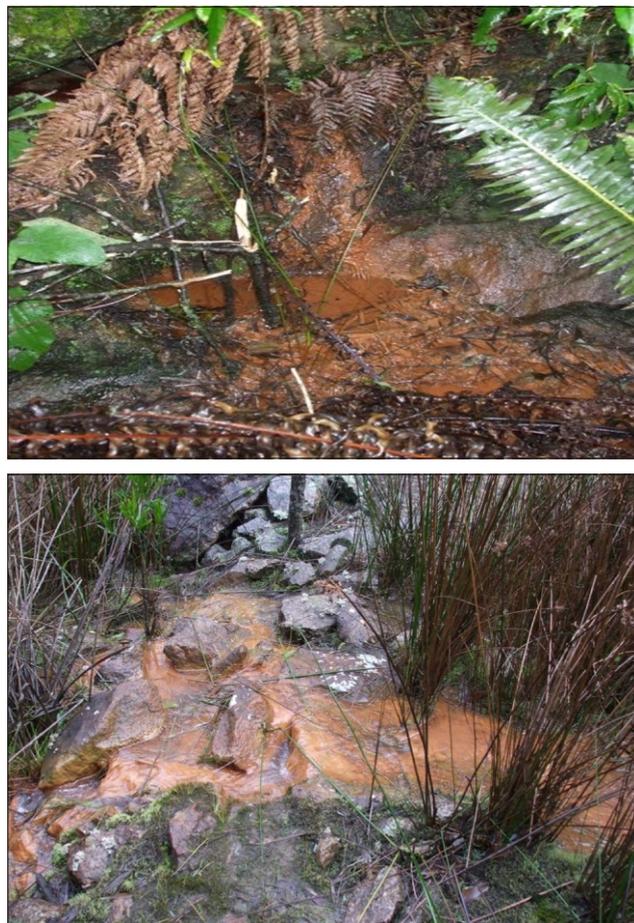
Figure 4

Acute toxicity to aquatic insects has been reported at iron concentrations ranging from 320 g/L to $16\,000 \text{ g/L}$. Iron is principally found as colloidal suspensions of ferric hydroxide, and may remain suspended in water or settle and harden. Although elevated levels were not being reflected on the day at the upstream and downstream locations, it is evident from the photos of the treatment system and seeps that suspended colloidal material is causing elevated turbidity and discolouration, noticeable in Figure 4.

Evidence of discolouration around the polishing pond.

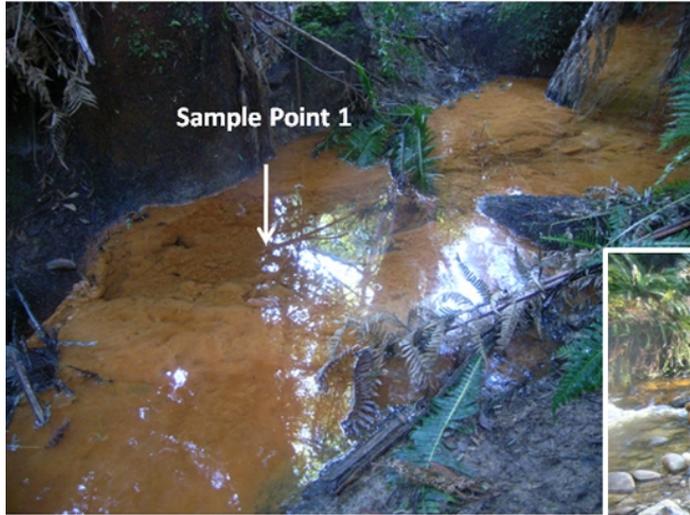
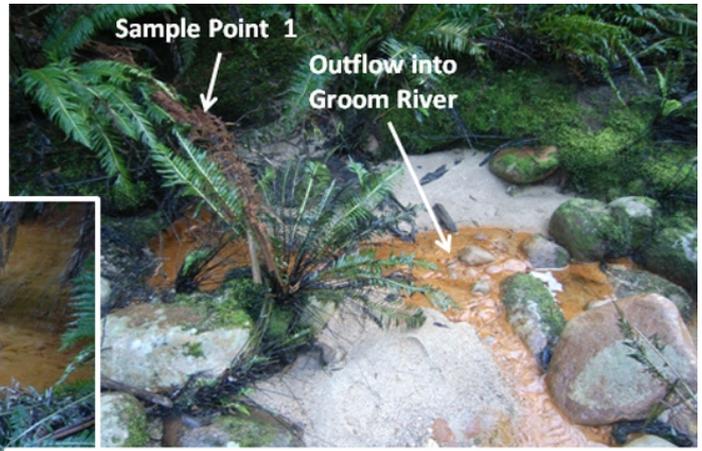
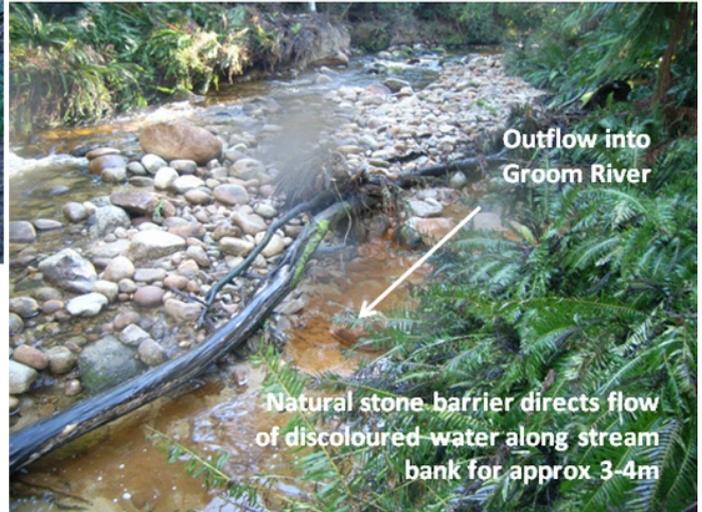
Sample Point 1 – outflow to Groom River

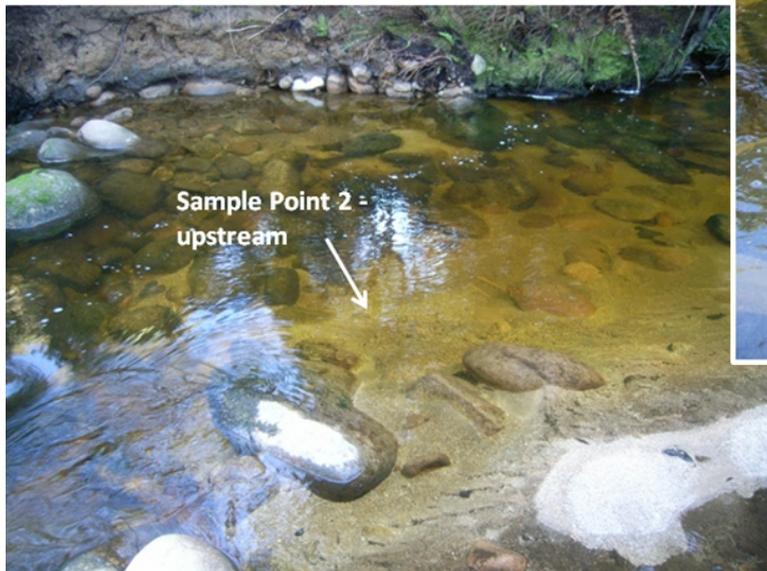
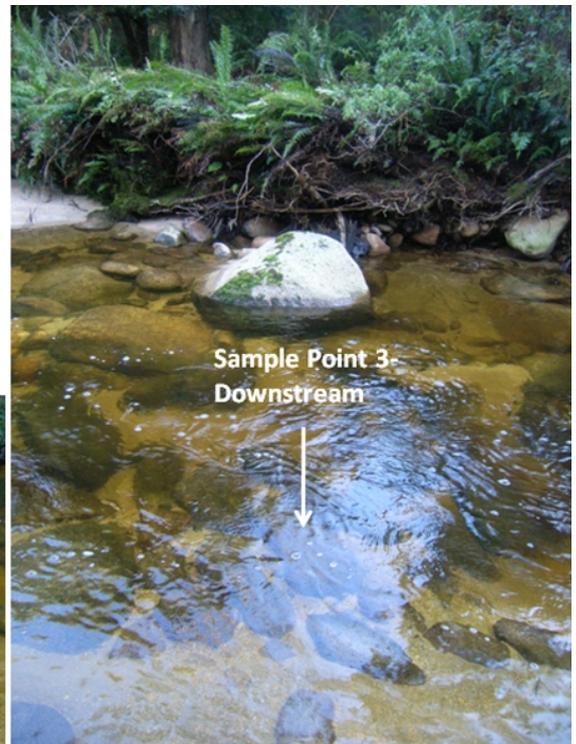
Sample Points 2 and 3 – Groom River

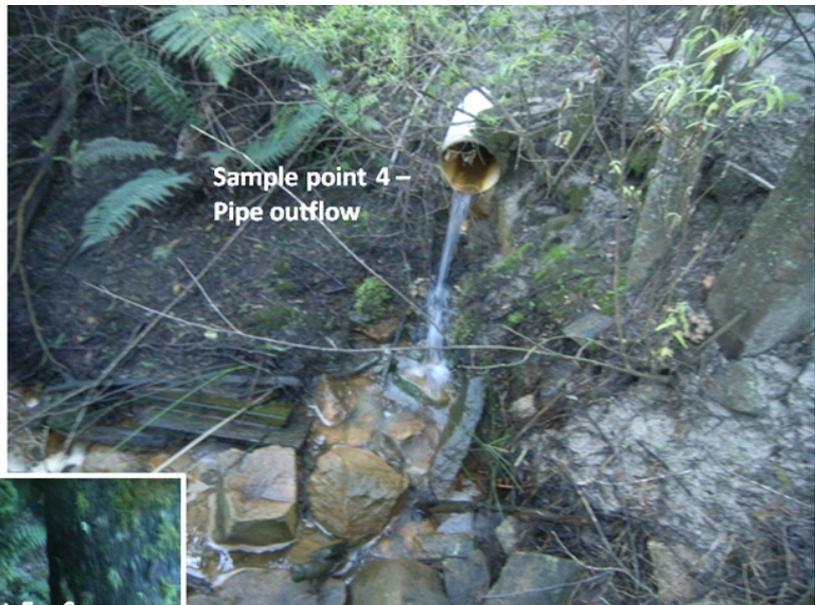
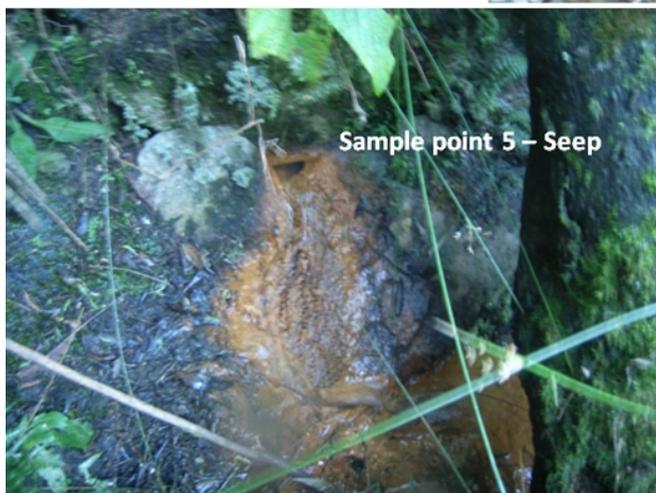
Sample Points 4 and 5 –
Anchor Mine tailings
