Tasmanian Geological Survey
Record 2016/02

1872 Glenorchy debris flow

Historical assessment of the 1872 Glenorchy debris flow: a basis for modelling the large debris flow hazard from the Wellington Range, Hobart.

March 2016

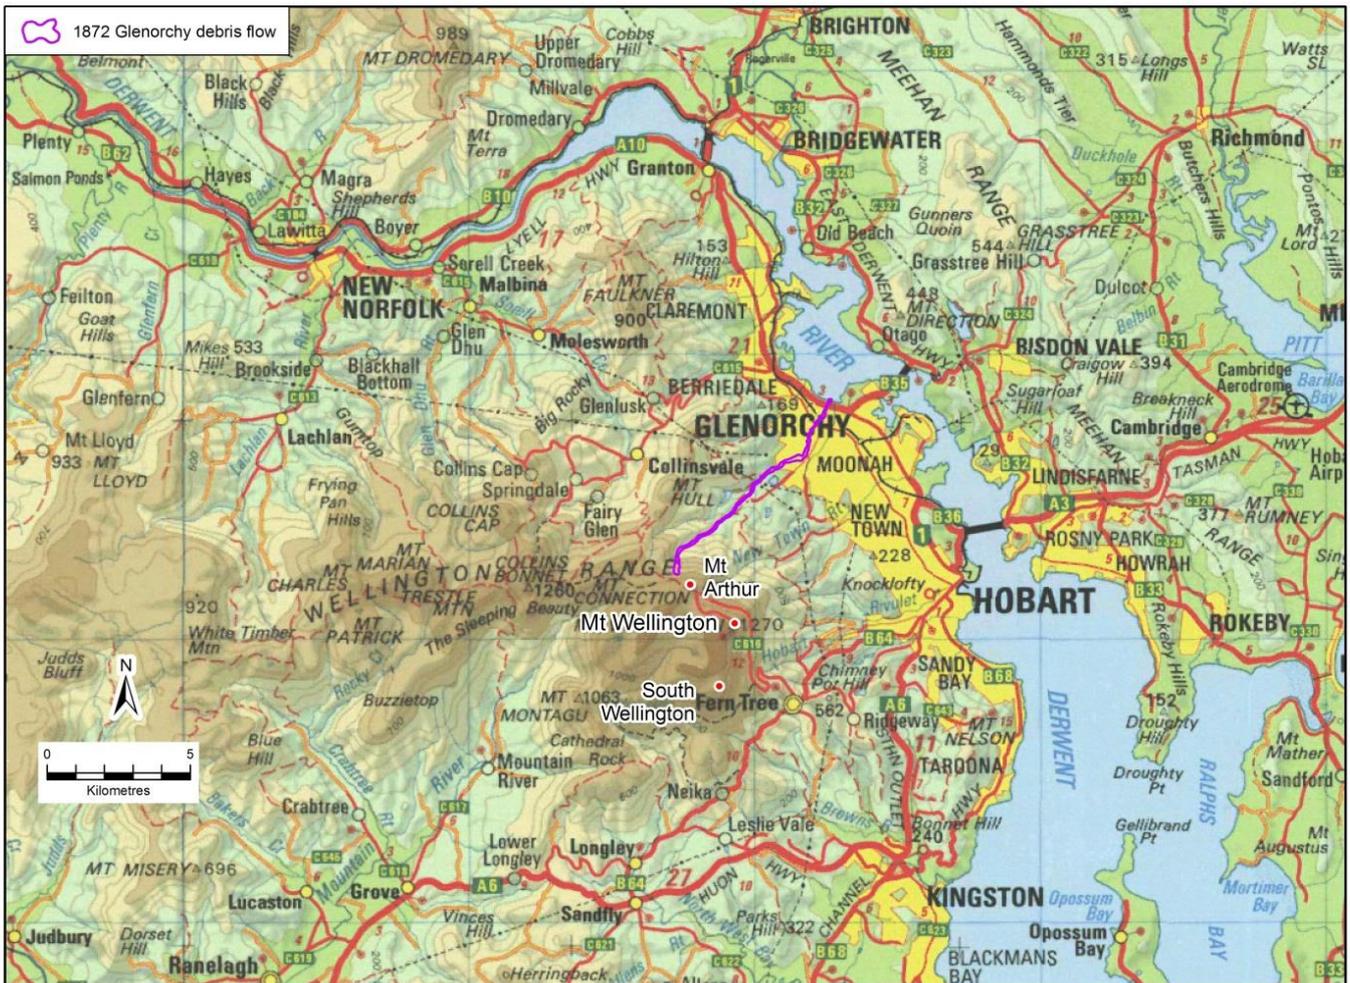
Figure 1. Location of Hobart and its suburbs in relation to the Wellington Range, showing the site of the 1872 Glenorchy debris flow.

The geology, topography and climate make the steep slopes above the city of Hobart and its suburbs prone to landslides and debris flows, which are fast-moving torrents of water, mud and debris (including boulders and broken trees). A number of debris flow events are known to have occurred around Mt Wellington since European settlement, but by far the largest was a debris flow that resulted from a very large landslide that occurred in 1872 on the slopes of Mt Arthur (Figure 1 and Figure 2).

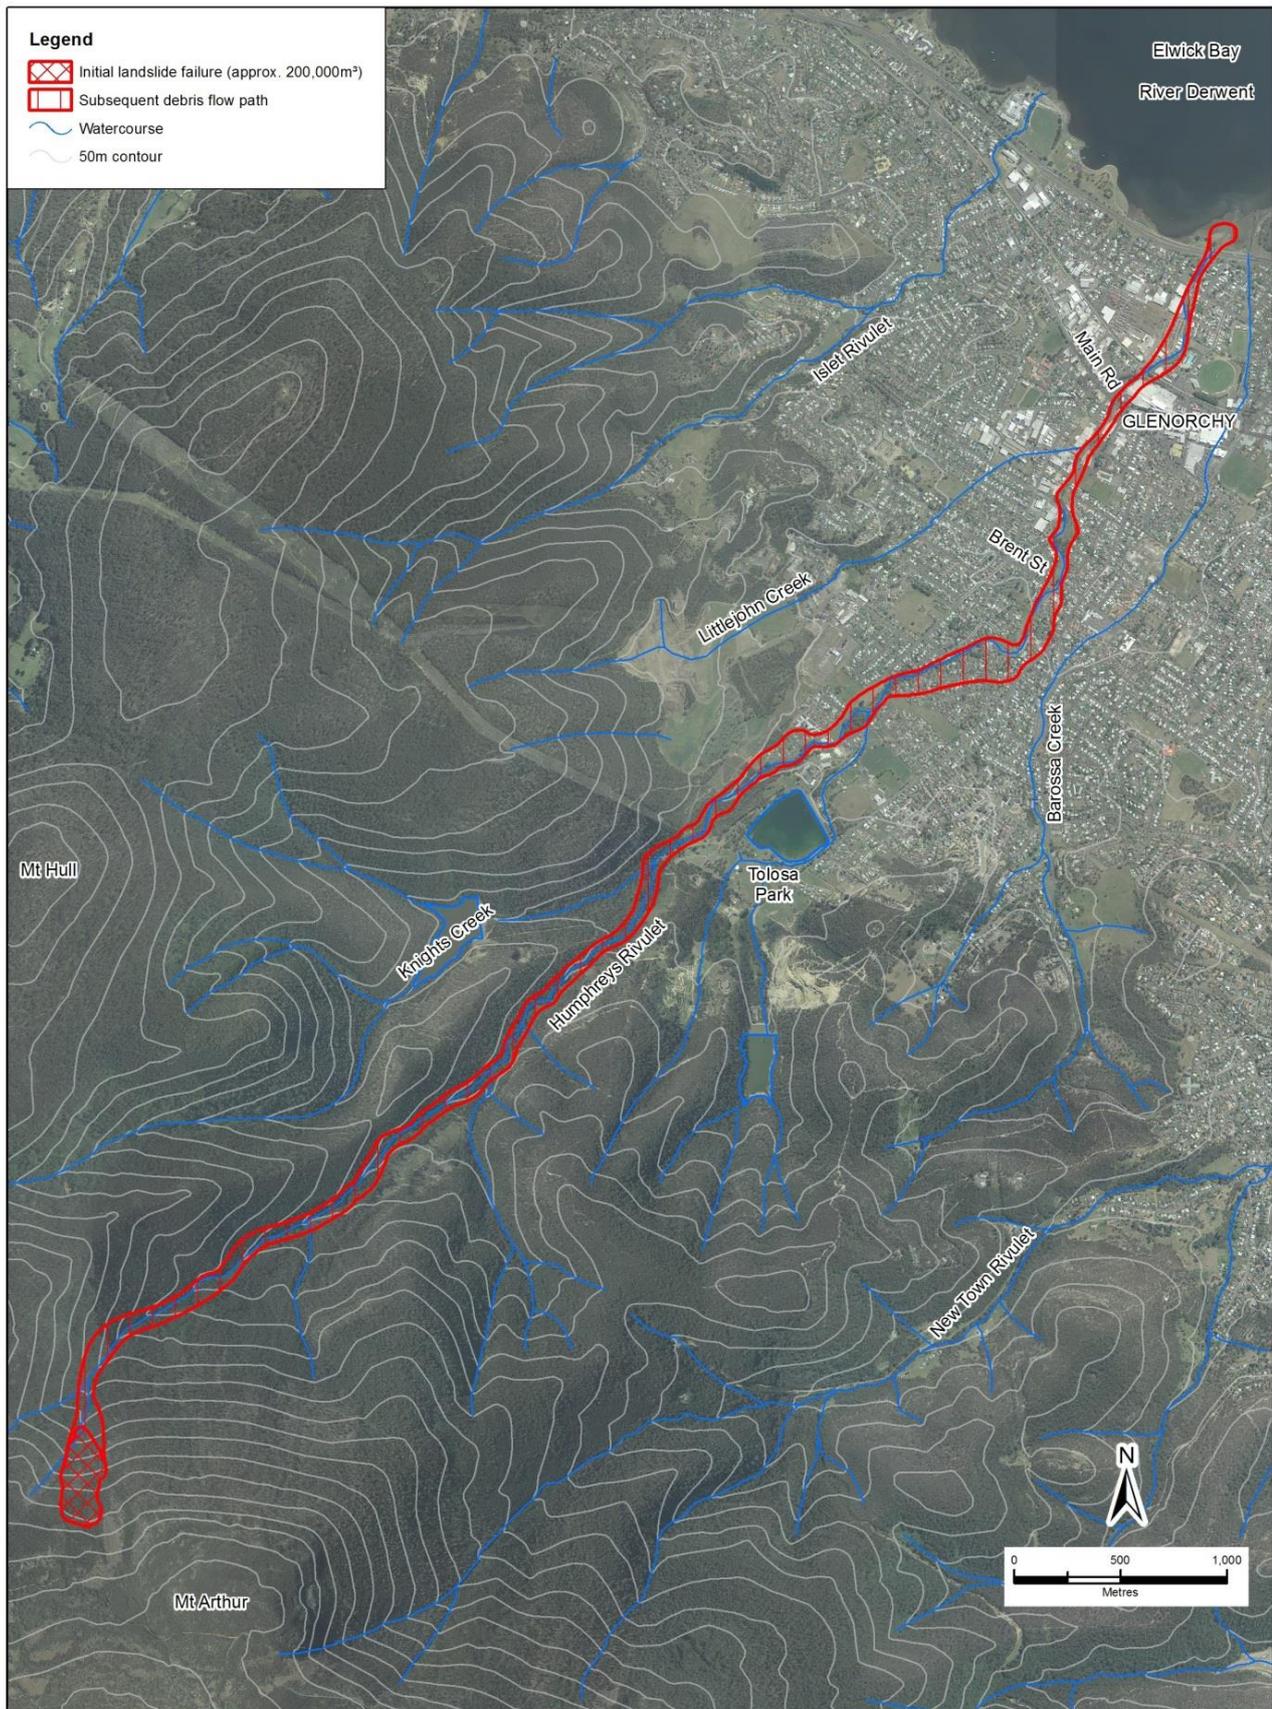
Figure 2. Location of the 1872 Glenorchy debris flow and the initial landslide source area on the flanks of Mt Arthur, Wellington Range. The debris flow travelled along Humphreys Rivulet to the River Derwent, passing through the township of Glenorchy, now a densely populated northern suburb of Hobart.

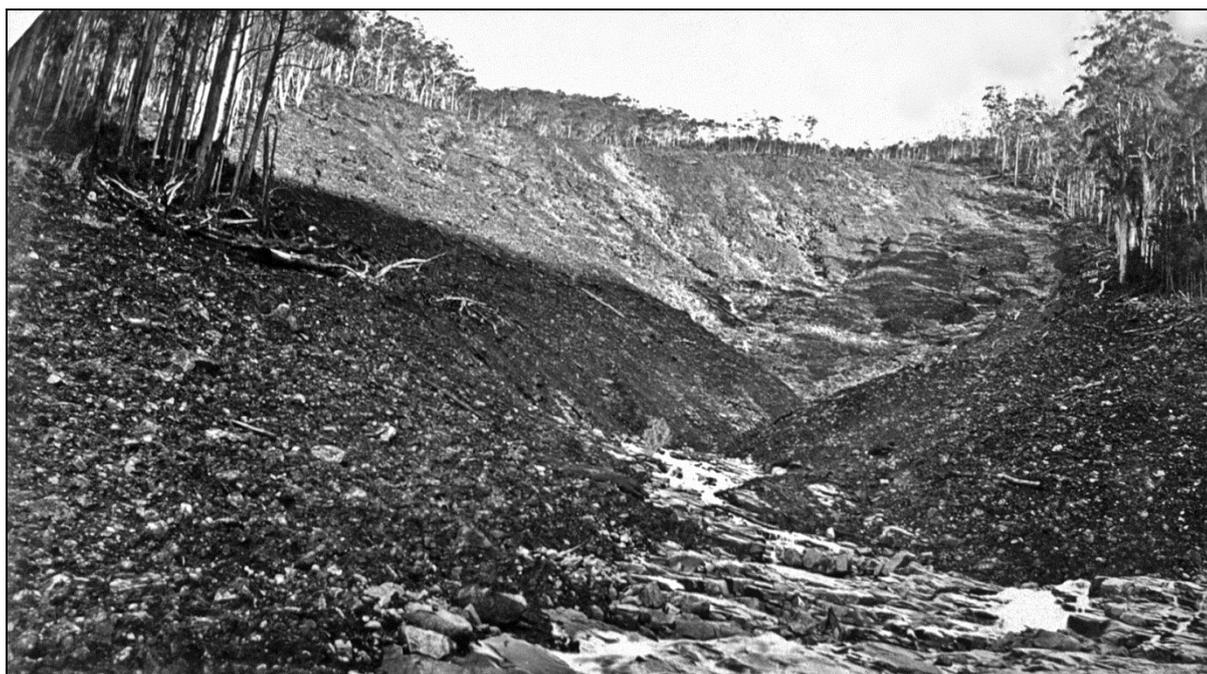
Figure 3. An 1872 photograph of the landslide affected area in the upper reaches of Humphreys Rivulet (image enhanced), from a commercial album by Samuel Clifford. (Photograph reproduced with the permission of the Tasmanian Archive and Heritage Office.)

The photographs in Figure 3, Figure 4 and Figure 5 all show a very similar view and appear to have been taken at around the same time shortly after the event. In fact the photograph in Figure 3 (Clifford, c1873) and the stereograph in Figure 5 (Nevin, 1872a) appear to have been taken from precisely the same viewpoint, whereas the photograph in Figure 4 (Baily, 1872) is taken from a slightly different angle. Close examination shows the details of the surface debris to be identical in these photographs but the shadows differ in each of the three photographs, suggesting that they are separated perhaps by less than an hour, given the steep topography. So it is

An examination of the 1872 photographs (Figure 3, Figure 4 and Figure 5) showing the landslide affected area in the upper reaches of Humphreys Rivulet seems to show a large hollow area, suggestive of the source area for the landslide, but also seems to show slopes of a much lower overall gradient than would be expected around the source area on the flanks of Mt Arthur (refer to Figure 11). The foreground in these photographs certainly shows stripping of the surface within the path of the debris flow, but it was initially unclear if the upslope areas represent a landslide failure surface or more stripped surfaces.

An ascent was made of Humphreys Rivulet and it was found that the present day *in situ* outcrop in the bed of the Rivulet at one point could be correlated with the outcrop detail that is shown in the foreground of the photograph in Figure 3 and Figure 5. This correlation is shown in Figure 9 and gives a high degree of certainty as to the camera location for this 1872 photograph – being 517375E, 5253125N (MGA) ± 10 m. It was observed that the bed of the Rivulet upstream from this location is quite steep and it is obvious that the apparent lower gradient in the 1872 photograph is an optical illusion. In the 1800s the photograph would almost certainly have been taken using a tripod and the camera appears to have been pointing significantly upslope. It is also obvious from the orientation of the corresponding points in the two photographs (Figure 9), and the lean of the nearer trees in the 1872 photograph, that the camera used in 1872 had a lean to the left.

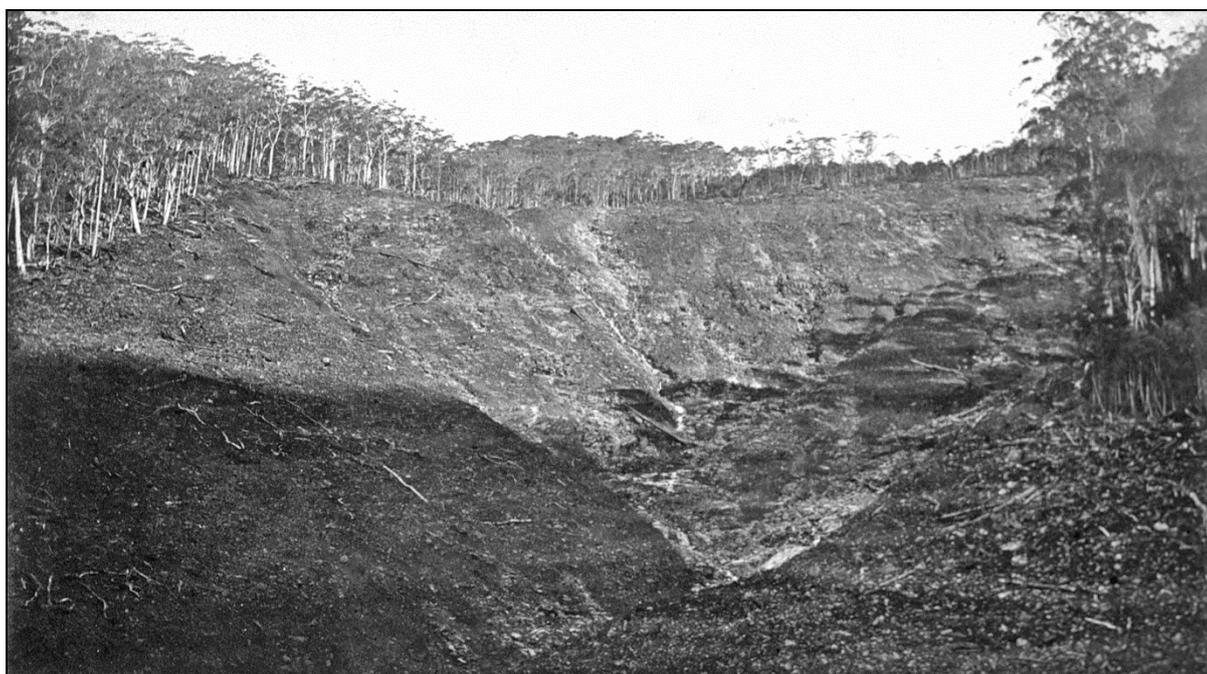
Figure 4. A similar 1872 photograph of the landslide affected area in the upper reaches of Humphreys Rivulet (image enhanced), attributed to Henry H. Baily. (Photograph reproduced with the permission of the Tasmanian Archive and Heritage Office.)

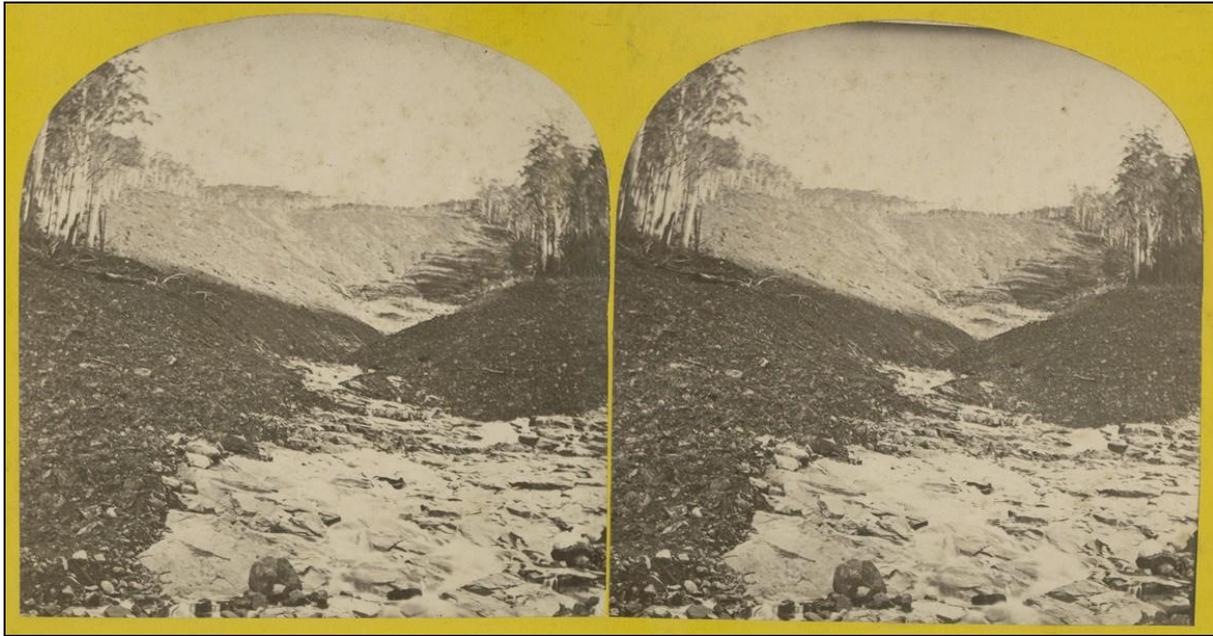
Figure 5. A stereoscopic pair of photographs of the landslide affected area in the upper reaches of Humphreys Rivulet, attributed to Thomas J. Nevin. Note: this photograph has an identical viewpoint to the photograph in Figure 3 but with more foreground area showing. (Stereograph reproduced with the permission of the Tasmanian Museum and Art Gallery.)

The upper portion of the landslide source area, including the deep hollow, is fairly well defined in the LiDAR derived DTM (Figure 10), but the limits of the source area on the slopes below this are not obvious. Having identified the camera location for the 1872 photographs, shown as ‘Photograph Point-1’ in Figure 10, it is possible to conduct a view-shed analysis. Using the LiDAR derived DTM, a view-shed analysis reveals the parts of the landscape that would actually be visible from a particular point (assuming the vegetation were absent). This analysis clearly shows that from the camera location for the 1872 photographs the observer would not be able to see the upper part of the landslide source area where the deep hollow exists (Figure 10). The upslope limit of the view-shed matches a clear break in slope in the DTM that crosses the landslide source area diagonally, as observed in the stereoscopic pair of photographs (Figure 5).

The lower portion of the source area, below the observed diagonal break in slope, has a low scarp around its margins marking the sides of the lower failed area in the 1872 stereoscopic view (Figure 5 and Figure 10). It is apparent that the failure of the slopes across this lower area was relatively shallow, and would have occurred largely within slope deposits. The 1872 stereoscopic view also appears to show bedrock on the exposed steep slope in a number of places that is horizontally jointed. Whereas the deep hollow apparent in the upper part of the landslide source area (Figure 10 and Figure 11) is consistent with the failure surface extending well into the underlying weathered bedrock within that area.

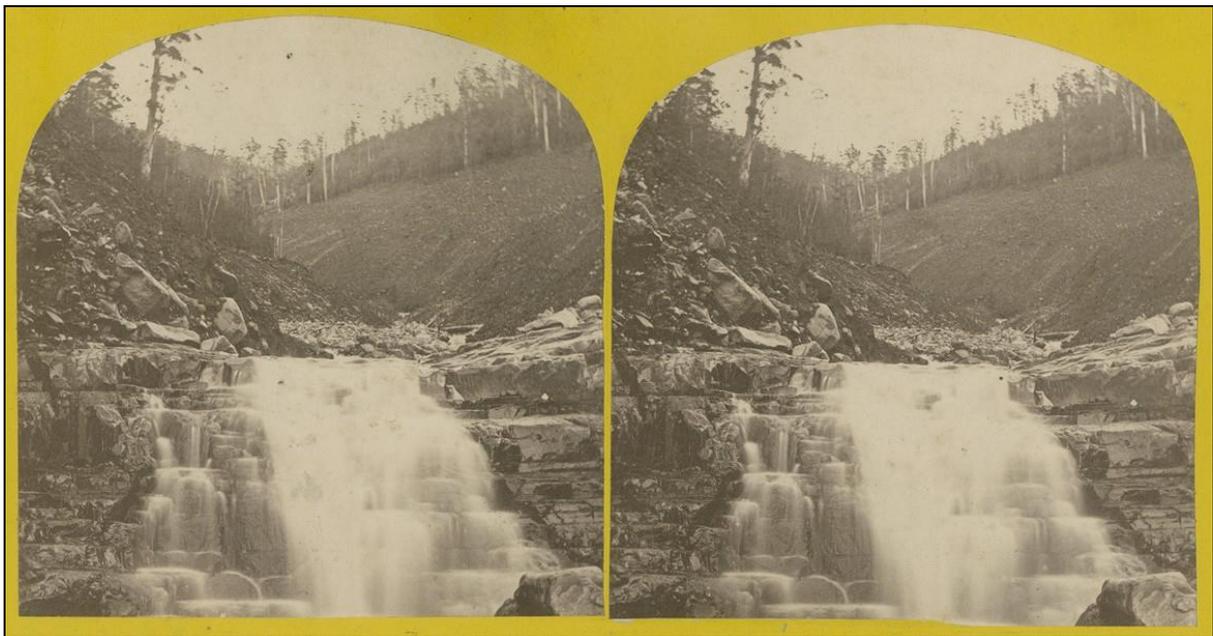
Figure 6. A stereoscopic pair of photographs of upper Humphreys Rivulet, attributed to Thomas J. Nevin, showing a broad zone of stripped vegetation caused by the passage of the debris flow; and also showing significant super-elevation on the right (see later section for discussion). (Stereograph reproduced with the permission of the Tasmanian Museum and Art Gallery.)

The stereograph in Figure 6 (Nevin, 1872b) shows a waterfall in the bed of Humphreys Rivulet with a broad zone of bare slopes stripped of their vegetation by the passage of the debris flow down the Rivulet (see later section). The site of this photograph is well established by the position of this waterfall, which is still recognisable in the present day (Figure 7).

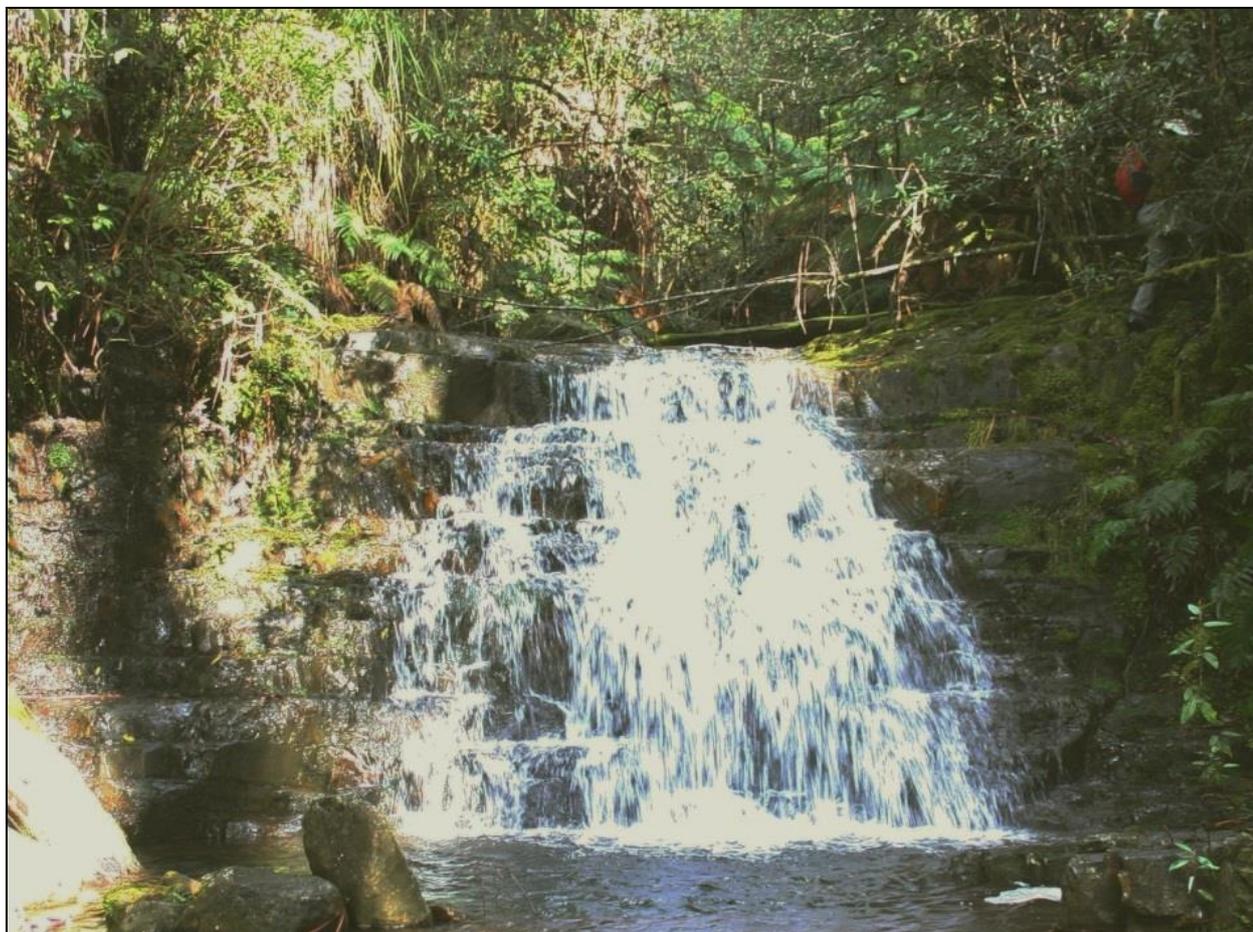
Figure 7. Present day view of the waterfall on Humphreys Rivulet that appears in the 1872 stereograph shown in Figure 6.

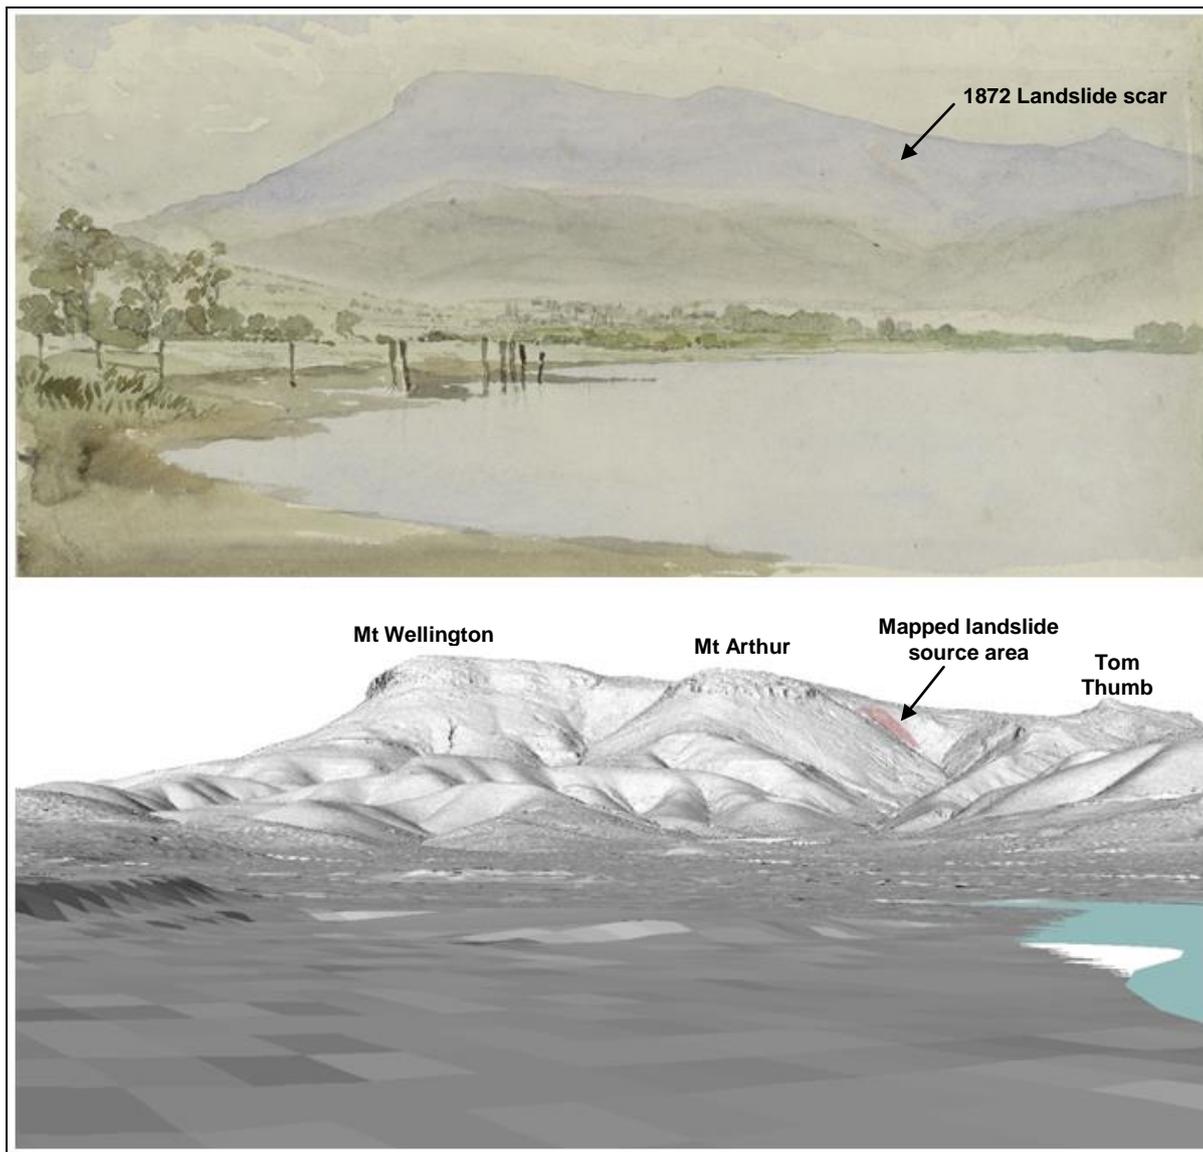
Figure 8. Painting by W.C. Pigenit (c1893), “Mt. Wellington from near O’Brien’s Bridge” (detail with enhanced colours), compared with a perspective over the modern topography from a similar viewing point; both of which show the 1872 landslide scar on the north-western flank of Mt Arthur, at the head of Humphreys Rivulet. The lower image has been produced using ArcScene™ software and a DTM derived from the 2011 LiDAR survey over Mt Wellington. Note: the foreground area was reclaimed in the 20th century. (Painting reproduced with the permission of the Tasmanian Museum and Art Gallery.)

The only other image discovered that shows the 1872 landslide is a painting by W.C. Pigenit (c1893) titled “Mt. Wellington from near O’Brien’s Bridge” (Figure 8). This watercolour painting shows the clear yellowish scar of the landslide still obvious after about 20 years on the north-western flank of Mt Arthur, at the head of Humphreys Rivulet. A newspaper article in *The Mercury* (14 Aug. 1976), in recounting the events of 1872, states that “for many years the sight of the great yellow scar on the mountain slopes had marked the scene of the landslide until, gradually it became hidden by encroaching trees and finally, about 1940, disappeared altogether”. Stancombe (1968) also states that “nowadays even the yellow gash of the landslide has been softened by time and few have ever heard the story”. So it is expected that the landslide scar would have been very obvious in 1893.

ArcScene™ software was used to construct a perspective from a similar viewing point as the Pigenit painting, utilising a digital terrain model (DTM) derived from the 2011 airborne laser scanning (LiDAR) survey over Mt Wellington (Mineral Resources Tasmania, 2011). Figure 8 shows a comparison of this ArcScene™ perspective with the W.C. Pigenit painting and confirms Pigenit’s reputation for producing accurate representations of the landscape. The viewing point of the original painting was close to where the present day Derwent Entertainment Centre is located and much of the shallow bay in the foreground of the painting is now reclaimed land.

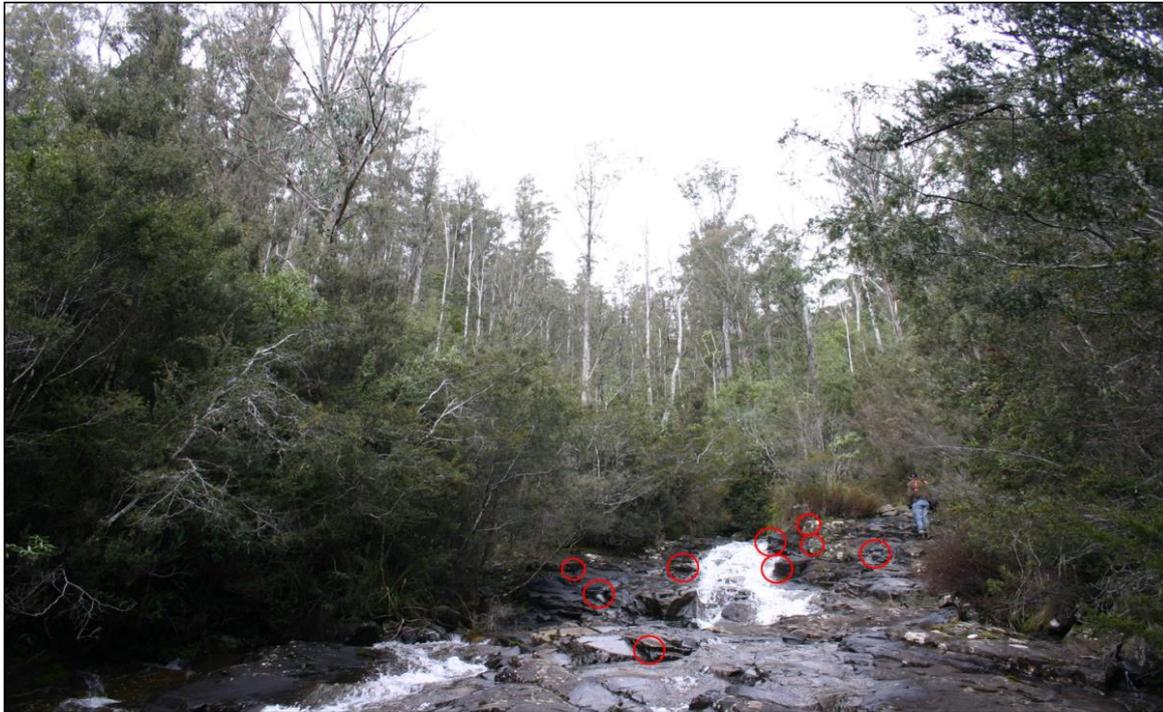
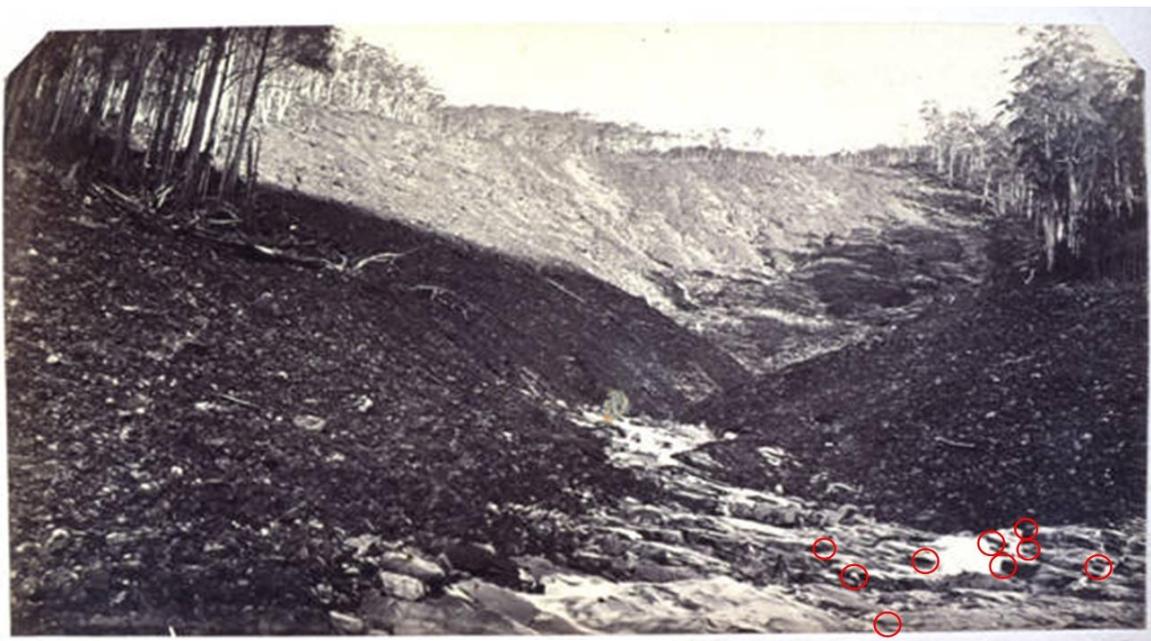
○ Point of correspondence with 1872 photograph

○ Point of correspondence with present day photograph

Figure 9. Correlation of the present day outcrop in the bed of Humphreys Rivulet with that shown in one of the 1872 photographs of the landslide affected area in the upper reaches of the Rivulet.

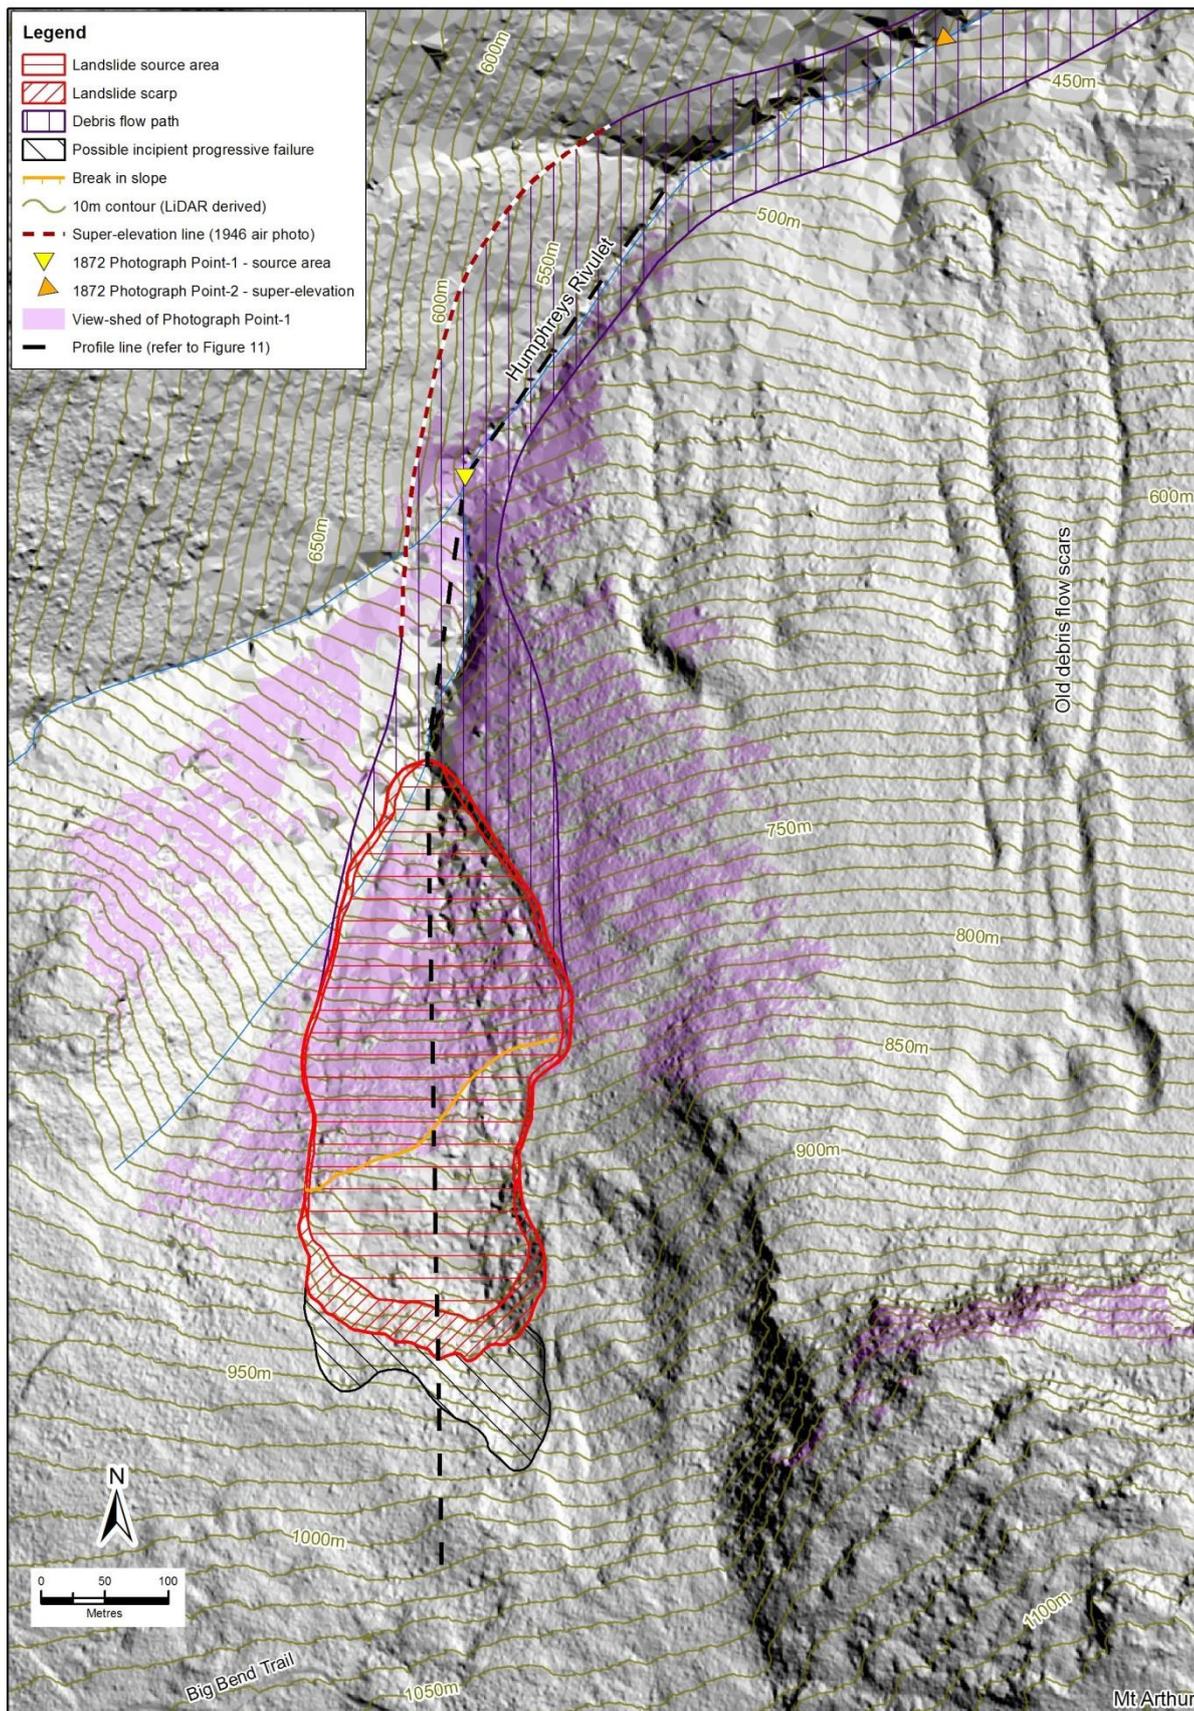
Figure 10. Detailed mapping of the landslide failure of the 4th of June 1872 at the head of Humphreys Rivulet, shown over a LiDAR derived hillshade (with an artificial north-east sun angle). Also shown is the view-shed of the 1872 camera location and the super-elevation line above the first major bend (see later section for discussion). Note the evidence of other debris flows on the slopes to the east.

The stereoscopic pair of 1872 photographs, the 1946 aerial photography and the LiDAR derived DTM in combination allow an accurate map of the original landslide source area to be produced (Figure 10). The stereoscopic pair allow the failed area on the slopes, below the break in slope, to be clearly outlined. The ArcScene™ perspective shown in Figure 8 includes a pinkish area on the flank of Mt Arthur that represents the mapped landslide source area. This perspective matches very well with the landslide scar shown in the Pigenit (c1893) painting and provides confidence that the extent of the landslide's source area has been accurately identified.

The form of the landslide source area and its two distinct parts strongly suggests the failure mechanism. Failure probably initiated as a large block failure in the upper part, extending well into the underlying weathered dolerite, and slid on a low sloping failure surface (of about 15°). This large block will have moved toward the steeper slopes of the lower part, where it would then have rapidly accelerated (perhaps as a 'debris avalanche'), and removed material from the lower slopes as it passed over them down to a depth of about 1m (Figure 11). The failed mass would have disaggregated into a very large debris flow as it was funnelled into the channel of Humphreys Rivulet (Figure 10).

The LiDAR derived DTM also reveals evidence of other landslide activity in the vicinity of the 1872 landslide source area. To the east, on the right side of Figure 10, is evidence of a group of smaller past debris flows on the northern flank of Mt Arthur. The hollows of the source areas are evident as well as the debris flow runout paths. Immediately above the headscarp of the 1872 failure is an irregular depressed area (Figure 10), extending up to 100m further upslope, that may be a large incipient failure. This would represent a progressive failure developing since the 1872 landslide (Figure 11) and could have initiated at any time since then, but possibly shortly after the first failure. As mentioned above, the steep slopes of the headscarp appear to have remained unstable for many decades and had little vegetation established on them in 1946. A small part of the western side of the headscarp remains unvegetated to the present day and is still the source of small debris flows. A small debris flow occurred off this slope in the early 1970s and a larger one, of about 130m length, had occurred by the early 1980s; with further reactivation in the mid-1990s. It is possible that the continued instability on the headscarp could be related to slow movement of the broader incipient failure.

This Mercury (12 Jun. 1872) account provides a maximum height for the super-elevation at the first bend that supports the super-elevation line as mapped in Figure 10.

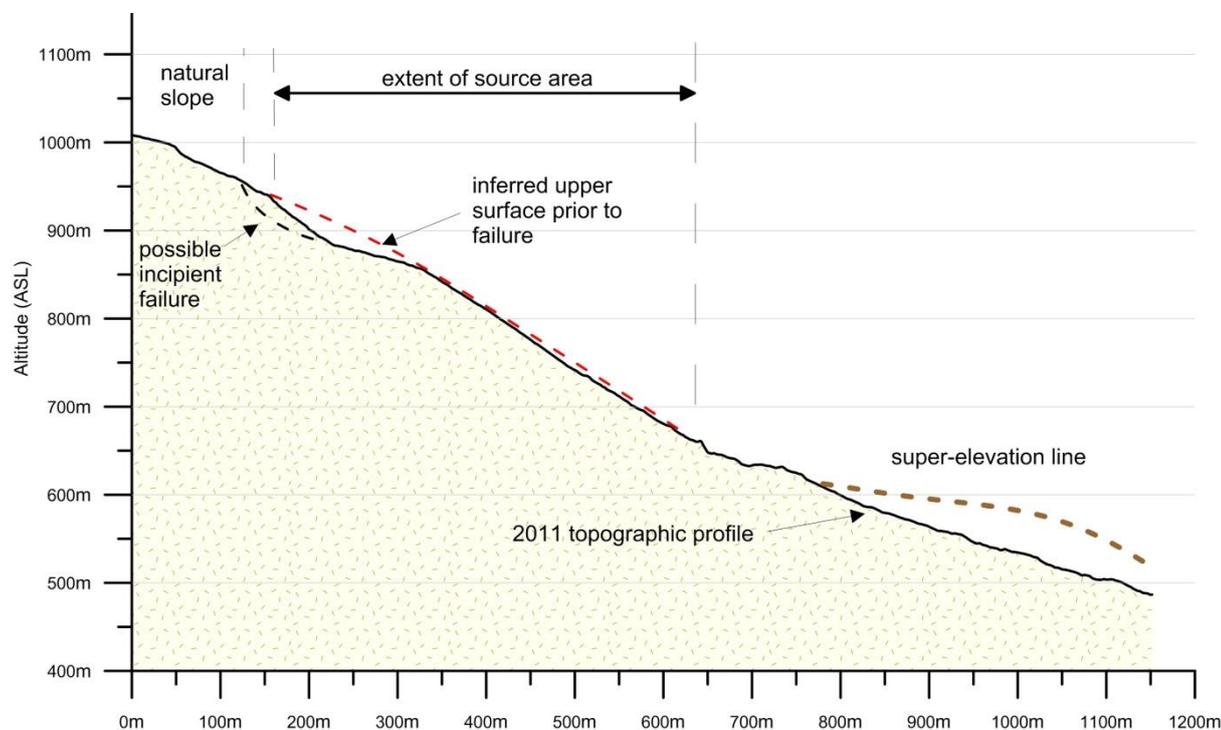
Figure 11. Slope profile through the source area of the 1872 landslide at the head of Humphreys Rivulet – profile line shown in Figure 10. Also shown is the height of the subsequent debris flow super-elevation at the first major bend below the landslide (see next section for discussion).

With the true extent of the initial landslide failure being well defined it is now possible to reconstruct the dimensions of the failed mass. The landslide source area in total is about 540m long (measured downslope) and is about 190m across at its head, or about 210m across at its widest point. There being two distinct parts: 1) a deep hollow, where the headscarp and side scarps are at their highest in Figure 10, and 2) the steep lower 70% of the source area below this (crossing the diagonal break in slope). Using the LiDAR derived DTM slope profiles were produced, both within and adjacent to the mapped landslide and it is evident that most of the lower area had a failure depth of around 1m, however it does appear to thicken within about 100m of the toe of the failure to around 2m depth (Figure 10). The upper hollow area is quite deep with a depth of up to about 17m perpendicular to the general slope (Figure 11). The DTM allows an estimate of the volume of the original failed mass by making

the assumption that the original surface approximately followed the trend of the contours adjacent to the landslide area. The volume derived for the upper hollow area is approximately 150,000m³ and that for the lower area of shallow failure is approximately 60,000m³. Thus giving a total failed mass in the order of 200,000m³. There is some uncertainty in this value but it is based on reasonably conservative assumptions about the original surface and it is certainly possible to derive a larger volume.

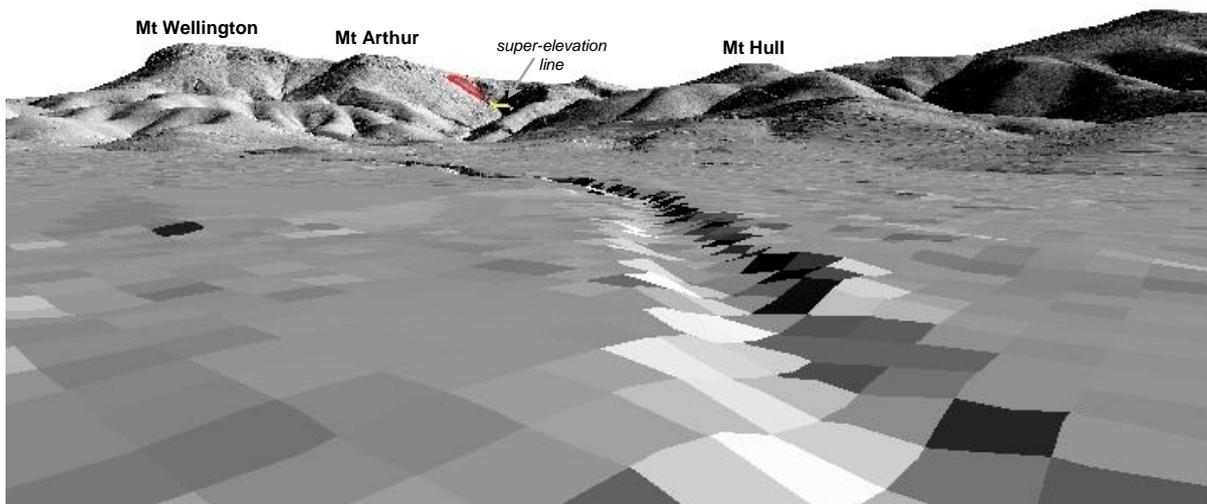
Figure 12. View of the terrain from Glenorchy towards the source of the 1872 landslide with Humphreys Rivulet in the foreground – created using ArcScene™ software and a DTM derived from the 2011 LiDAR survey over Mt Wellington. The red outline is the mapped landslide source area and the yellow line represents the super-elevation line at the first major bend below the landslide.

Figure 12 shows a constructed ArcScene™ view from Glenorchy looking up towards the source area of the 1872 landslide. In this view the mapped super-elevation line (in yellow) at the first major bend is clearly visible from Glenorchy, below the mapped landslide source area (in red), which itself is partly obscured from view by a spur in front. It is evident that the view of the debris flow path at the first bend would have been separated from the source area by the same spur, thus creating the impression of two separate landslide scars. It is also evident from Figure 12 that the super-elevation line at the first major bend could not have been much lower than currently mapped; otherwise the debris flow path would not have been particularly visible from Glenorchy and thus mistaken for a second landslide scar.

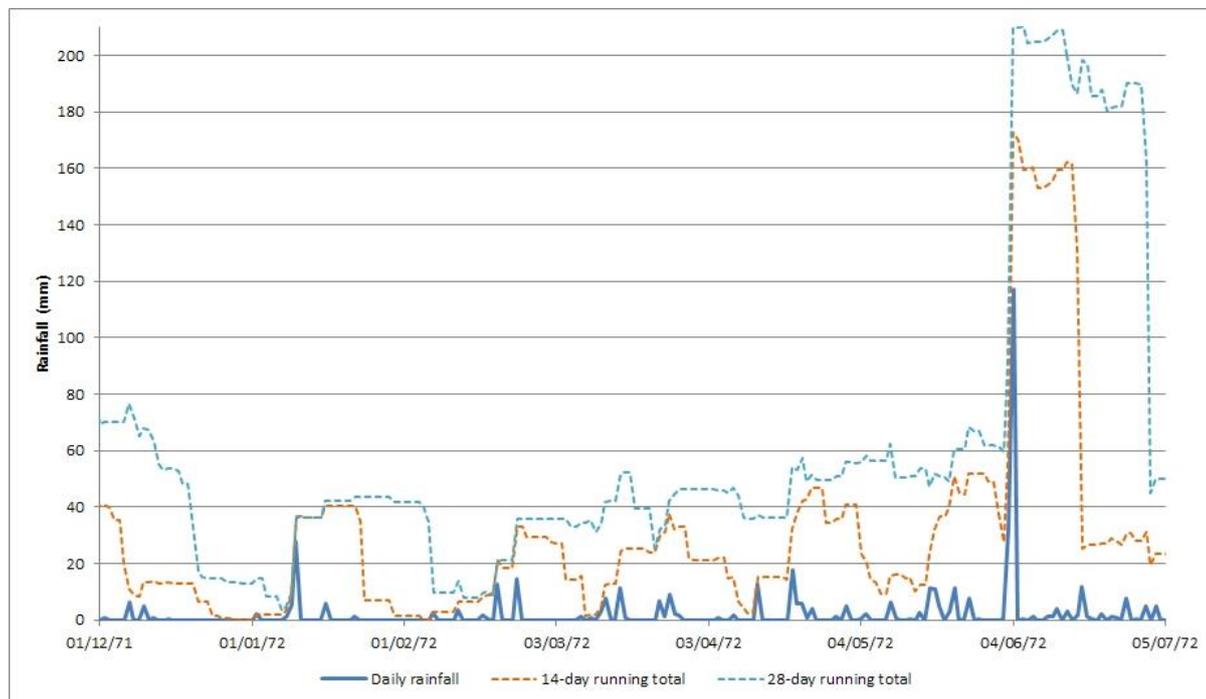
Figure 13. Francis Abbott’s daily rainfall data for the 1st of December 1871 to the 5th of July 1872, showing the antecedent rainfall as 14-day and 28-day running totals. Note: the rainfall shown for the 4th of June, 1872, is the adjusted total of 117.3mm (4.62 inches) derived from Dr Hall’s records (see below) – the total rainfall event is reported over 3-4 June, 1872.

Francis Abbott’s summarised daily rainfall data for the period of November 1871 to July 1872 are presented in Appendix 2 and shown in Figure 13. Abbott’s summarised daily meteorological observations (rainfall, atmospheric pressure and temperature) for early June 1872 are presented in Appendix 3.

It is not stated why Dr Hall reported his total rainfall for this event to the Royal Society of Tasmania (1873), which he did not normally do, but possibly because it was recognised that Abbott’s recorded total was deficient. In any case it is difficult to explain, other than an over-flowing rain gauge, why Dr Hall would have a significantly higher rainfall recorded for this one rainfall event. Therefore it is assumed here that Dr Hall’s measurements more accurately reflect the true total rainfall of this event (150.1 mm). An adjustment to Abbott’s rainfall data is then necessary for the 4th of June, to 4.62 inches (117.3mm), and this is reflected in Figure 13 and Table 1.

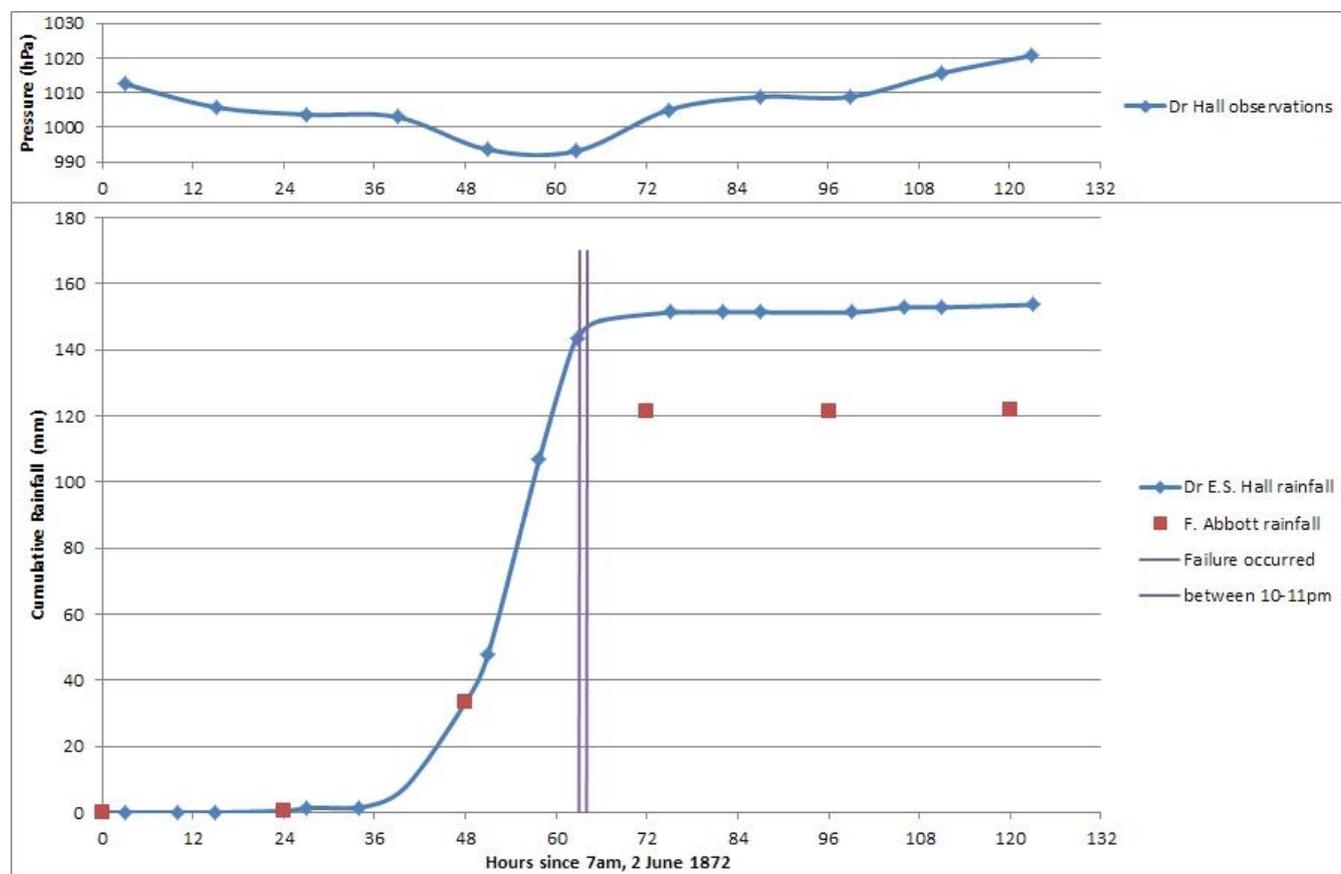
Figure 14. Cumulative rainfall from 7am on the 2nd of June to 10am on the 7th of June, 1872, as independently recorded by Dr Edward Swarbreck Hall and Francis Abbott. Also shown is the atmospheric pressure as recorded by Dr Hall and the period within which the landslide and debris flow are known to have occurred (10-11pm on the 4th of June, 1872).

Abbott records 1.29 inches (32.8mm) for the 3rd of June (i.e. up to 7am on the 4th of June) and 3.46 inches (87.9mm) for the 4th of June (i.e. up to 7am on the 5th of June). Plotting the cumulative rainfall for the records of both Abbott and Dr Hall shows that Abbott's first rainfall measurement (at 48 hours, Figure 14) would be consistent with Dr Hall's observations, but the second measurement (at 72 hours, Figure 14) is not consistent. Abbott's second rainfall measurement (up to 7am, 5th of June) gives a cumulative rainfall greater than Dr Hall's 4.45pm measurement (about sunset, 4th of June) but less than his 9.45pm measurement (4th of June). Given that Abbott is known to have been making observations at 7am, 1pm and sunset (Abbott, 1866; Ashcroft, *et al.*, 2014), it appears that the discrepancy occurred between sunset on the 4th of June and 7am on the 5th of June (58 to 72 hours, Figure 14). A likely cause for such a large discrepancy in the rainfall would be an over-flowing rain gauge in

the intervening 14 hours – an approximate period within which Dr Hall records 1.75 inches (44.5mm) of rain, on top of the 2.87 inches (72.9mm) of rain that he had recorded in excess of Abbott’s 7am, 4th of June, measurement (1.29 inches). If Abbott’s rain gauge had over-flowed then this suggests that his rainfall measurement for the 4th of June (i.e. up to 7am on the 5th of June) should have been about 4.62 inches (117.3mm).
