Tasmanian Geological Survey
Record 2016/02

1872 Glenorchy debris flow

Historical assessment of the 1872 Glenorchy debris flow: a basis for modelling the large debris flow hazard from the Wellington Range, Hobart.

March 2016

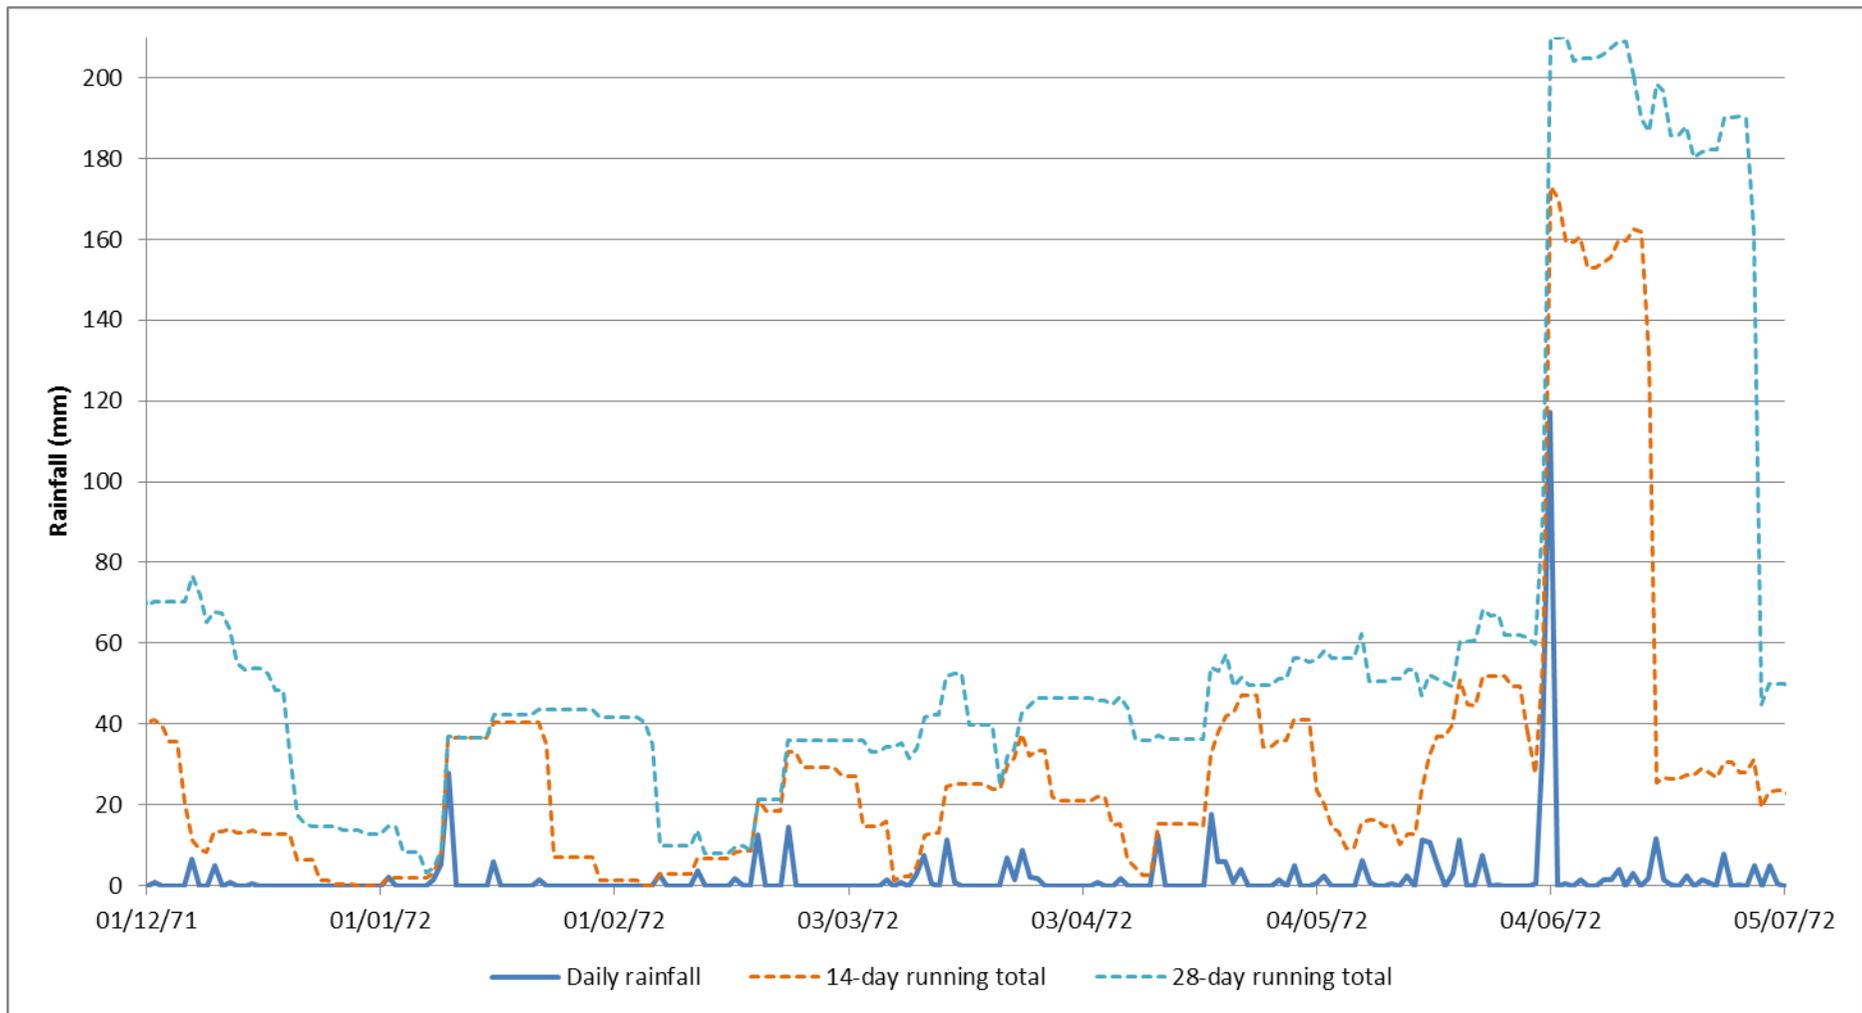
Francis Abbott's daily rainfall data for the 1st of December 1871 to the 5th of July 1872, showing the antecedent rainfall as 14-day and 28-day running totals. Note: the rainfall shown for the 4th of June, 1872, is the adjusted total of 117.3mm (4.62 inches) derived from Dr Hall's records – the total rainfall event is reported over 3-4 June, 1872.

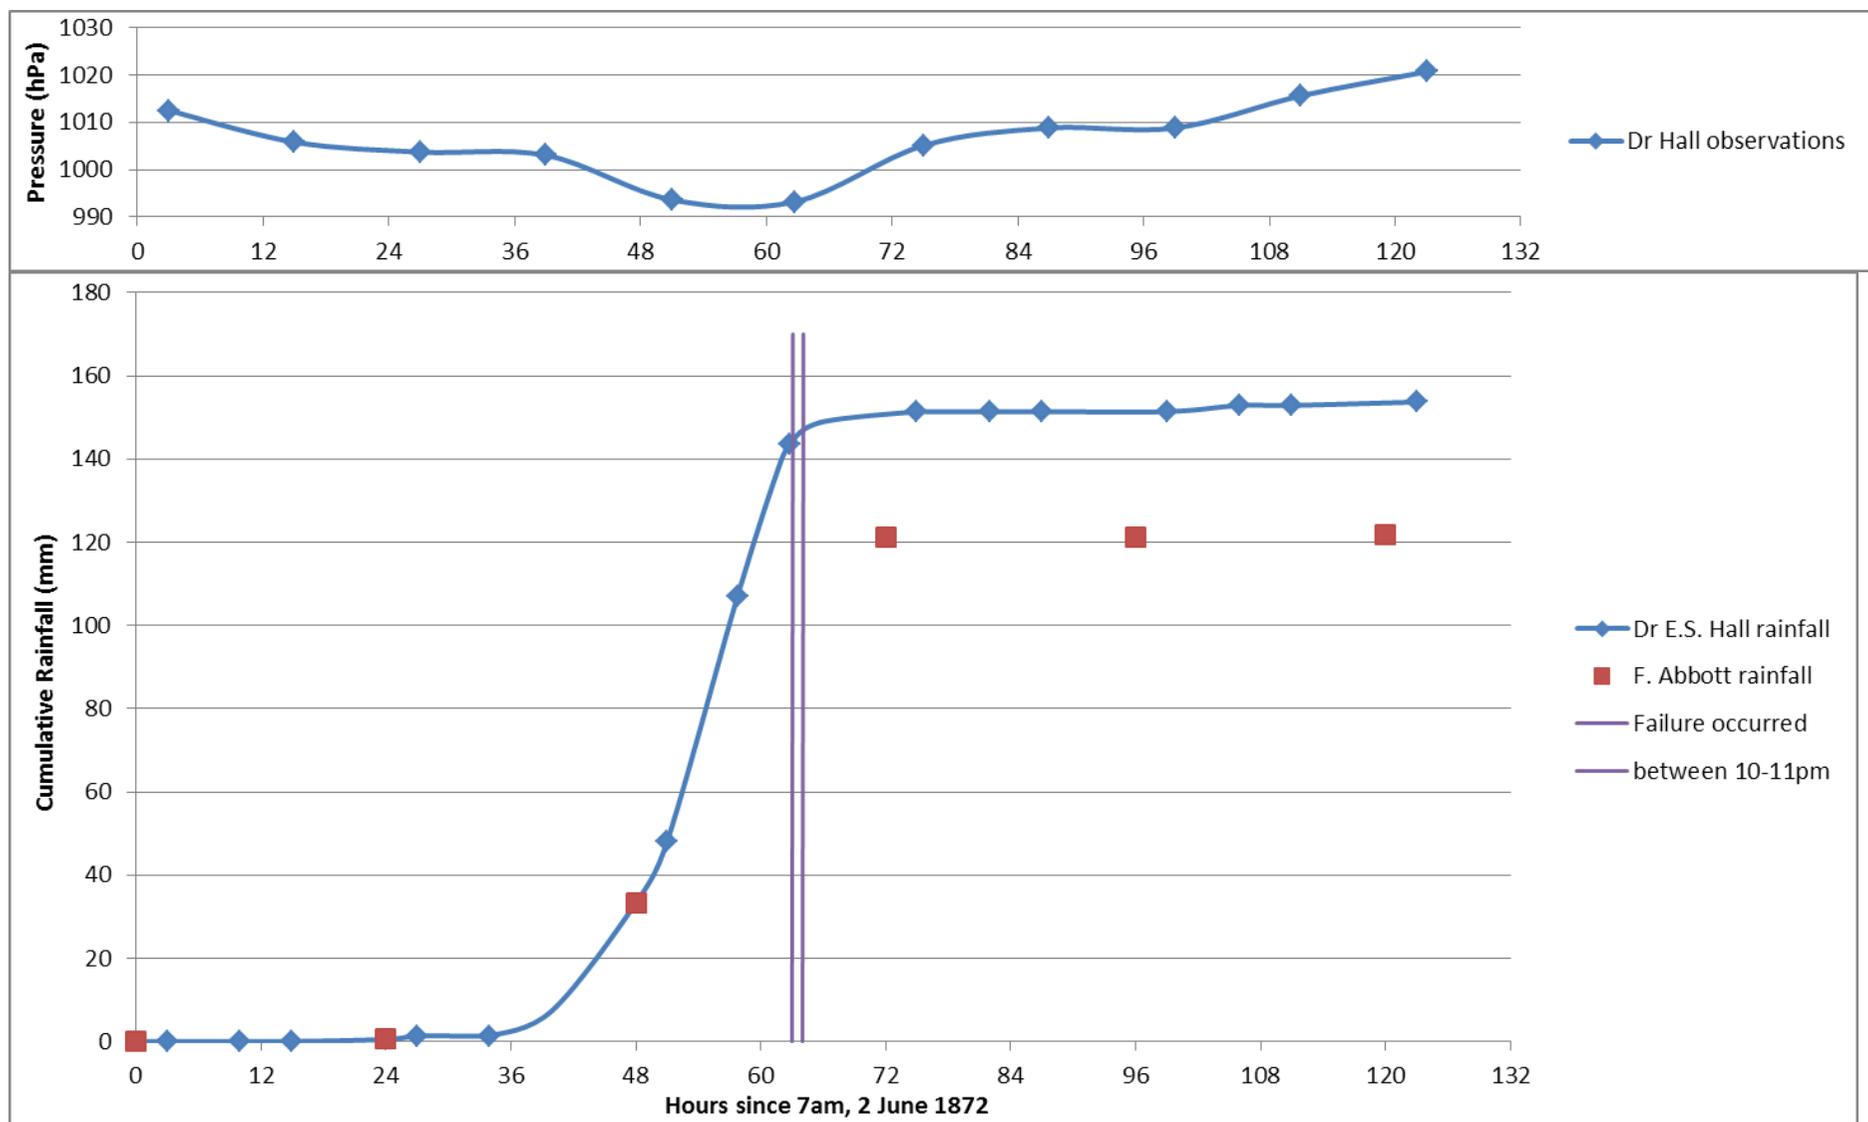
Cumulative rainfall from 7am on the 2nd of June to 10am on the 7th of June, 1872, as independently recorded by Dr Edward Swarbreck Hall and Francis Abbott. Also shown is the atmospheric pressure as recorded by Dr Hall and the period within which the landslide and debris flow are known to have occurred (10-11pm on the 4th of June, 1872).
