Map 2 - 1872 Glenorchy Debris Flow - Runout Interpretation based on Recorded Damage and Historical Reconstruction

M.D. Stevenson, 2016

To accompany: 'Historical assessment of the 1872 Glenorchy debris flow: a basis for modelling the large debris flow hazard from the Wellington Range, Hobart' Tasmanian Geological Survey report 2016/02

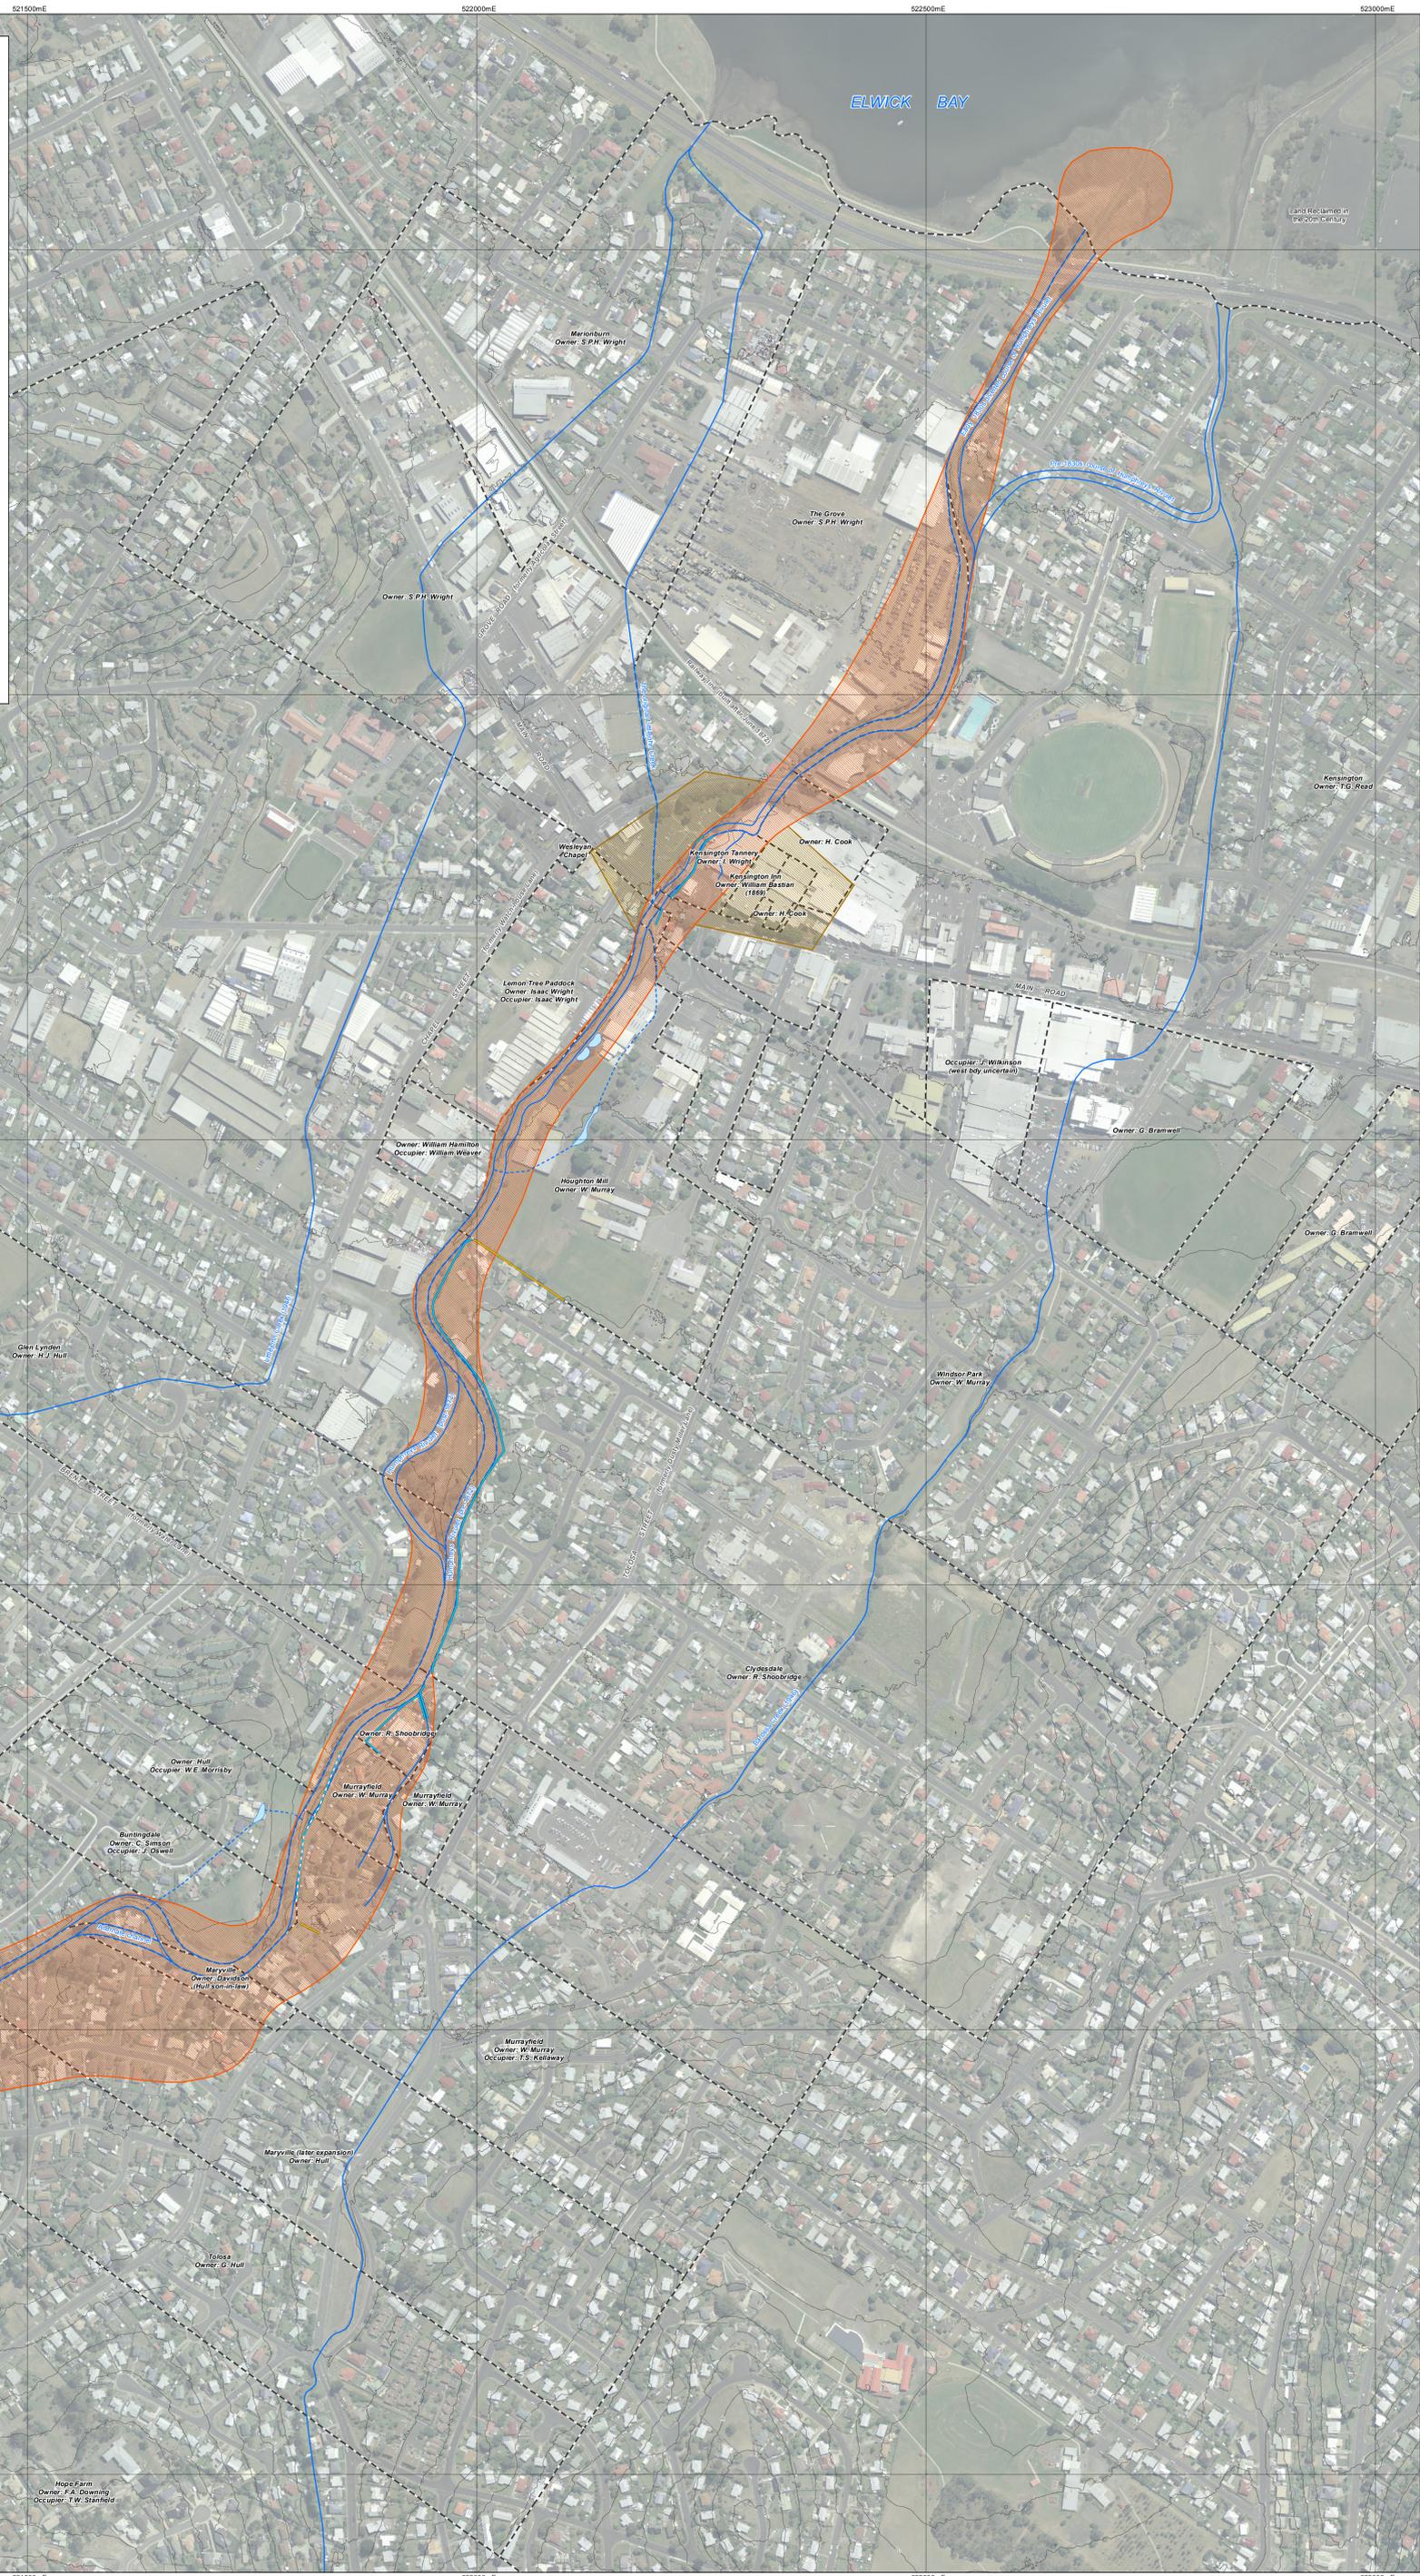
| 1872 Features | 1872 Debris Flow Interpretation |
| Flood wall (1858) | Coarse debris |
| Flood wall (post-1872) | Mud (limited extent information) |
