## 5. FIGURES AND CAPTIONS

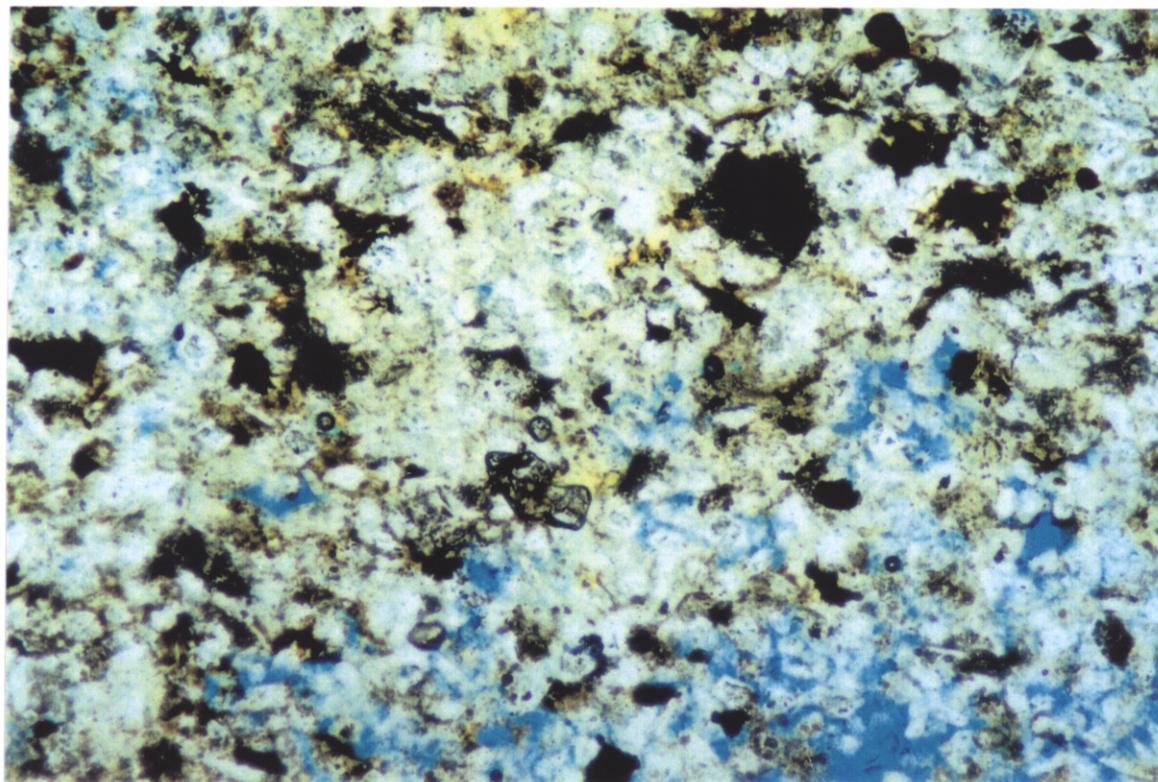
Figure 1a.

General view illustrating the irregular contact between laminae with differences in porosity (blue). King #1, Core plug 2, depth 1398.60m. Plane light. Field of view 0.88mm.

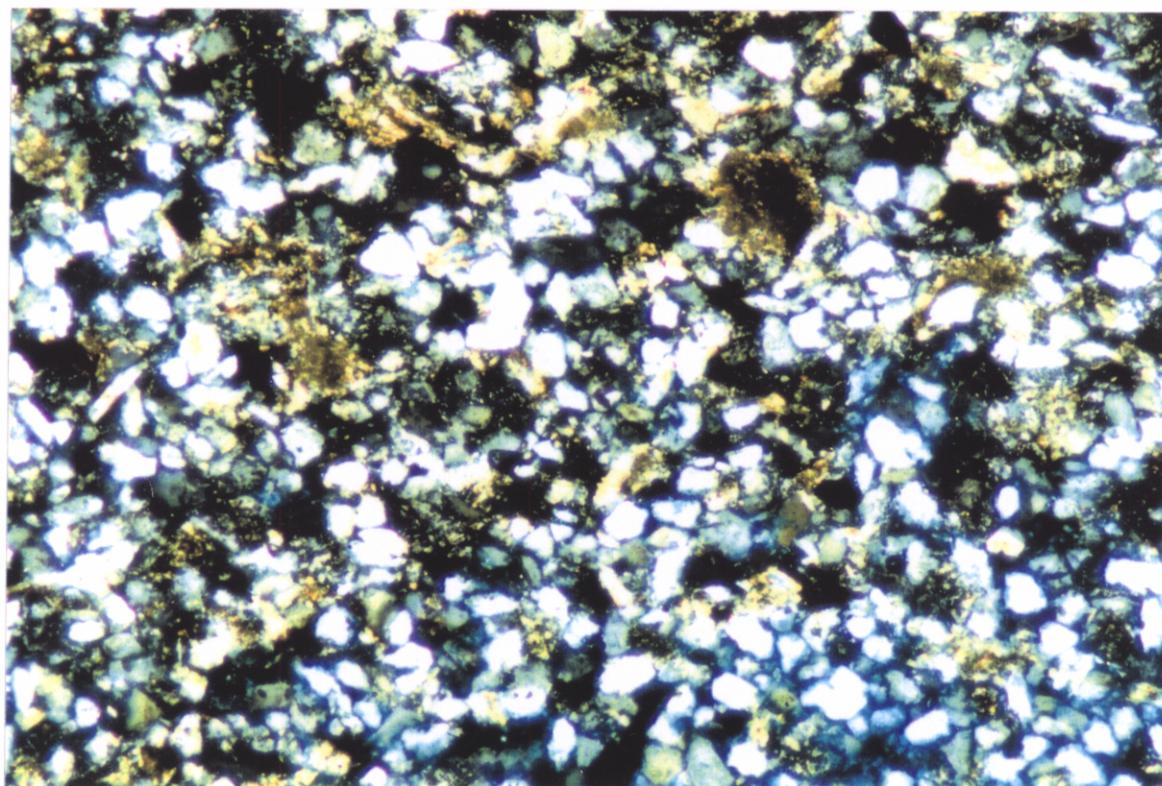
Figure 1b.

Same field of view as Figure 1a in crossed nicols illustrates the patchy distribution of micrite (yellow).
