**ENSCO 102 - TREFOIL SITE INVESTIGATION
BASS STRAIT, VICTORIA**

ORIGIN ENERGY RESOURCES LIMITED

This factual closeout report provides a summary of key project events, the geotechnical data that was recovered at each testing location, and other project information.

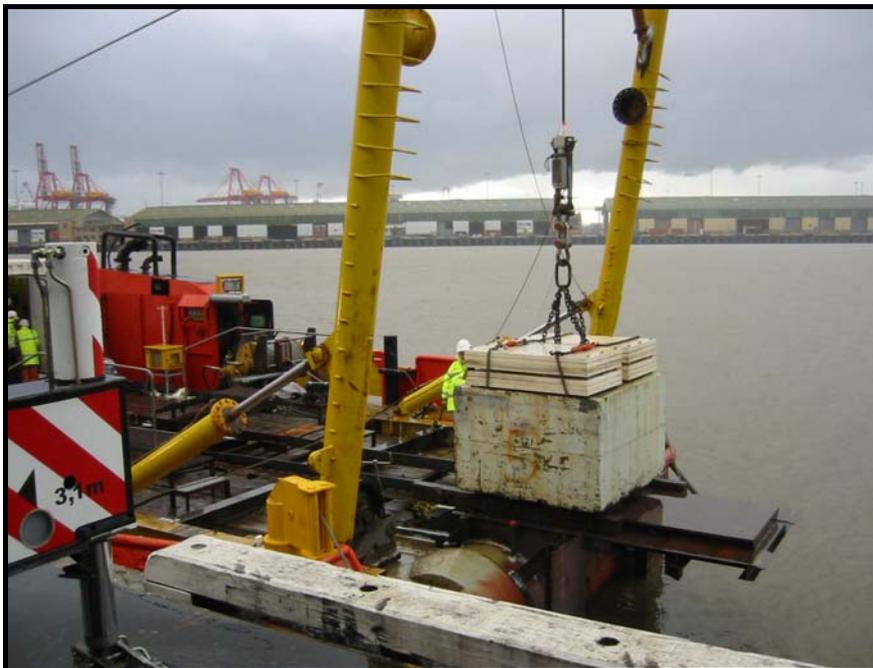
Plate 1 – Preparation for Proof Load Testing

Proof load testing was completed to 15.6 tonnes winch line load once Benthic Geotech's winch and main sheave block were installed on the vessel. Magnetic Particle Inspection testing was also complete to provide additional proof of structural adequacy.

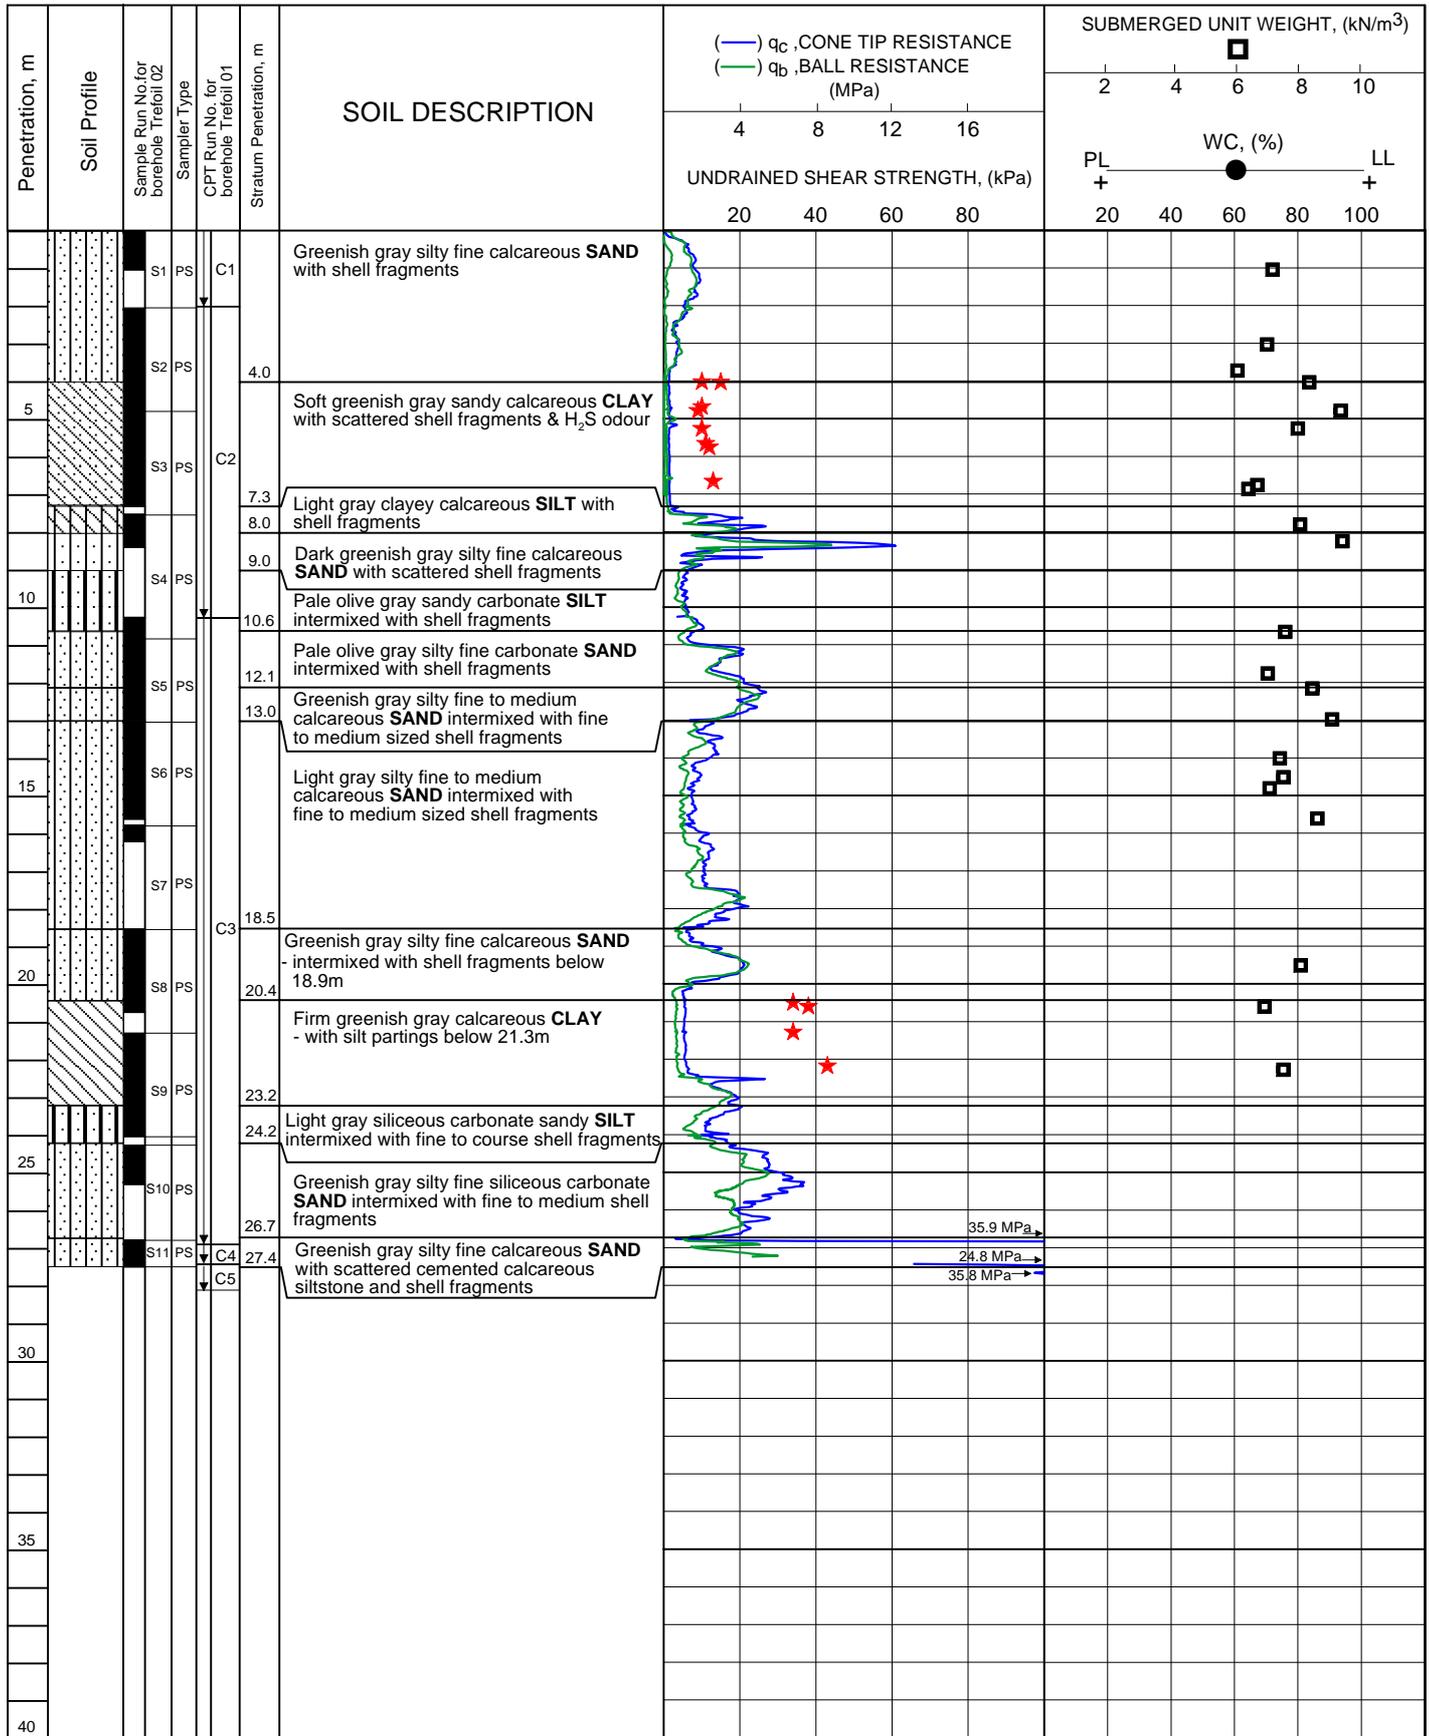
Material types, states and compositions have been based on visual logging techniques only – confirmation of these logs can only be completed via further detailed laboratory testing at an onshore testing laboratory.

Date: September 20, 2004
 Project: Trefoil Soil Investigation
 Client: Origin Energy
 Location: Bass Strait, Victoria
 Coordinates: 361 079m E, 5586 333m N (Boring, Trefoil 02)
 361 075m E, 5586 338m N (CPT, Trefoil 01)
 361 078m E, 5586 332m N (SBP, Trefoil 03)
 Water Depth: 70 m
 Drilling Equipment: PROD

The following pages contain a summary of the sampling intervals completed, borelogs for the recovered samples, and a sample inventory.

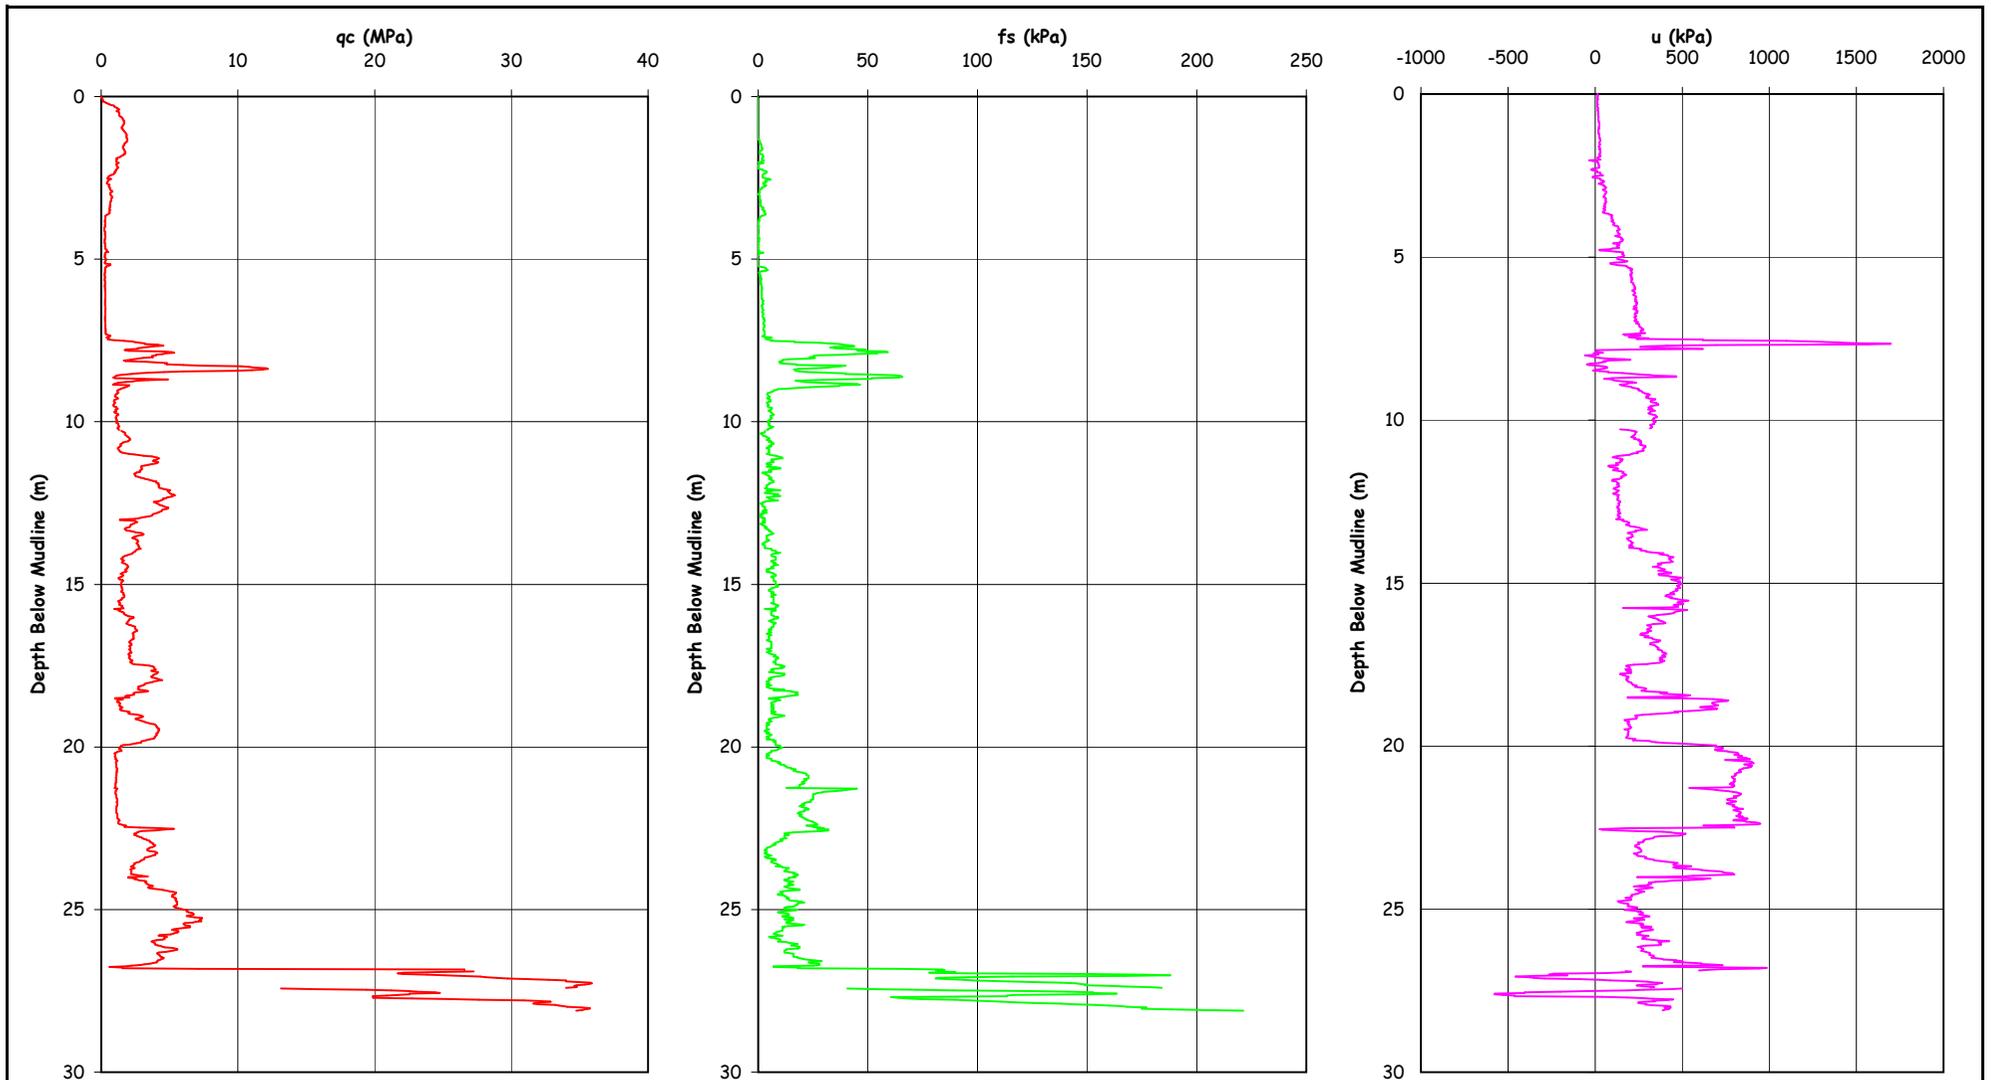
PROD CPT test

Borehole No. TRE1
 Eastings (mE) 361,075
 Northings (mN) 5,586,338
 Depth Datum Mudline

Continuous CPT profiles were generated for all CPT testing completed in virgin ground, and these data are presented in Appendix 3. For each test interval completed, a plot of both uncorrected and corrected CPT data (for pore pressure effects) is included. The uncorrected data comprises plots of cone tip resistance, q_c ; sleeve friction, f_s ; and combined hydrostatic and pore water pressure, u ; versus depth below mudline. The corrected CPT data comprises plots of net cone resistance, q_{net} , friction ratio, f_s/q_t , and pore pressure parameter ratio, B_q ; versus depth below mudline. For further discussion of these parameters and the corrections that have been applied, refer to Section (c) following.

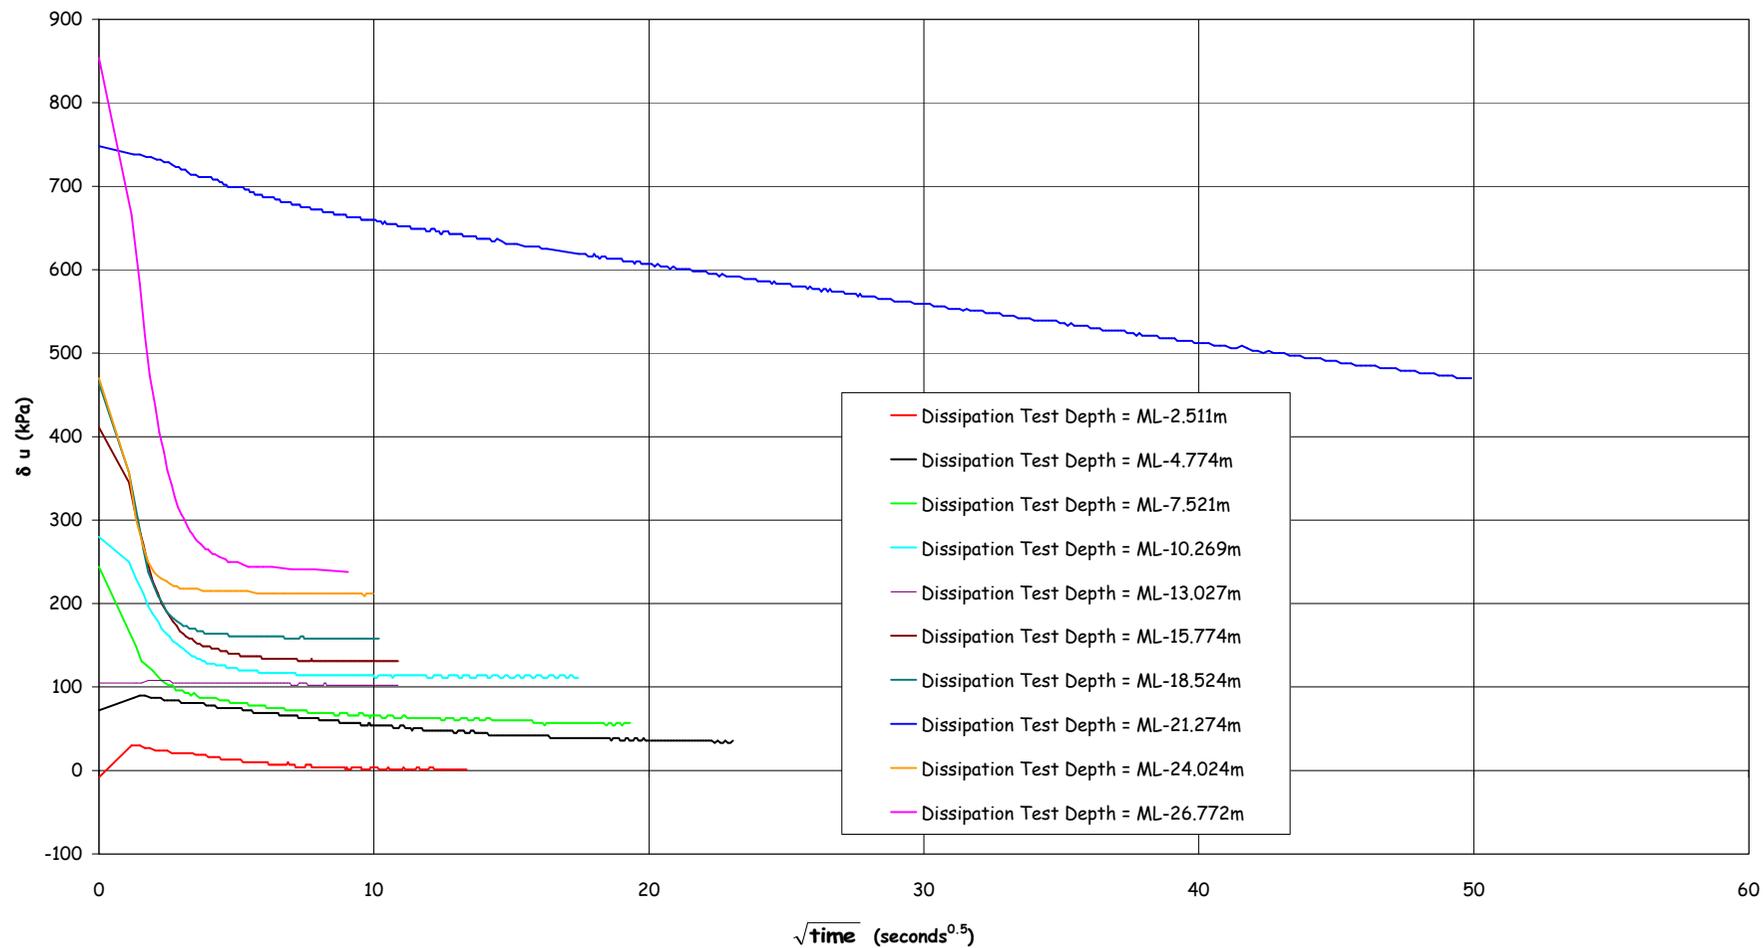
PROD CPT Dissipation Test

Borehole No. TRE1
 Eastings (mE) 361,075
 Northings (mN) 5,586,338
 Depth Datum Mudline

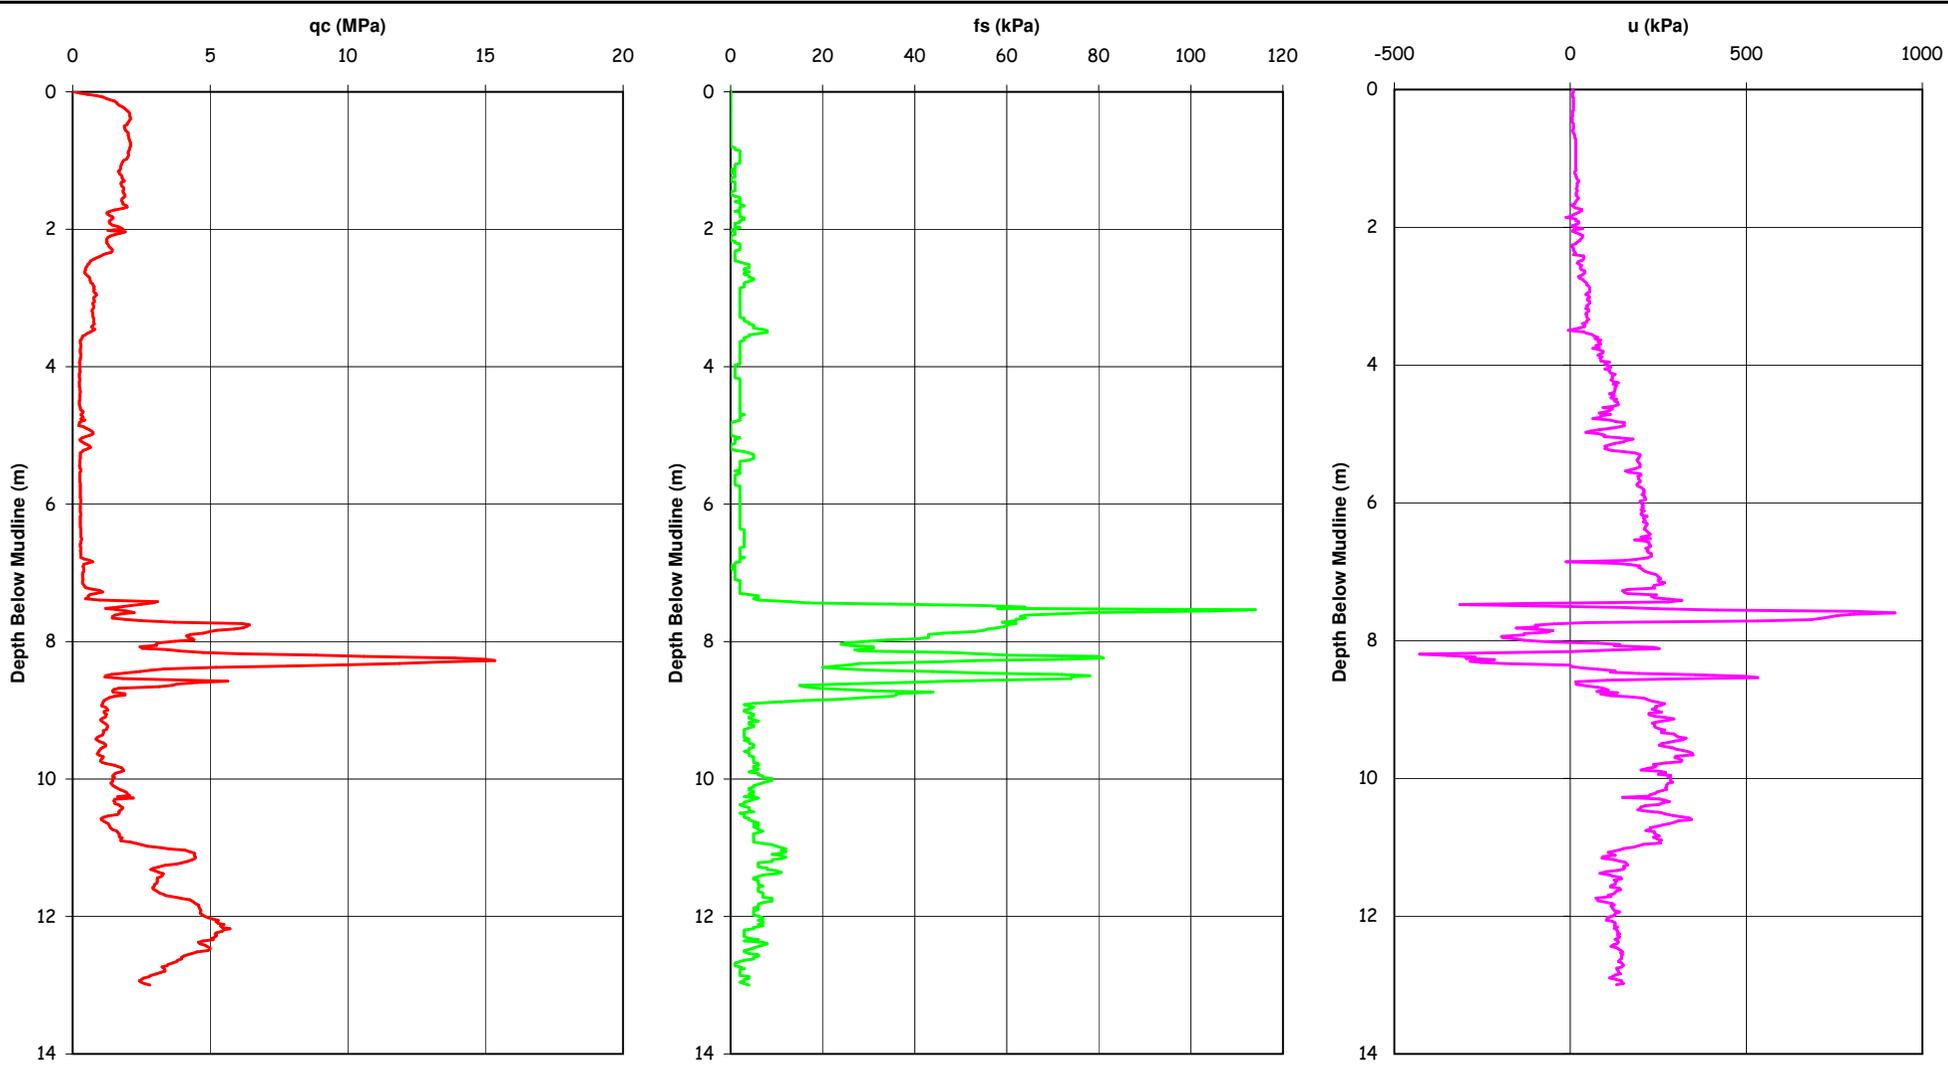
PROD CPT test

Borehole No. TRE4
 Eastings (mE) 361,093.0
 Northings (mN) 5,586,320.0
 Depth Datum Mudline

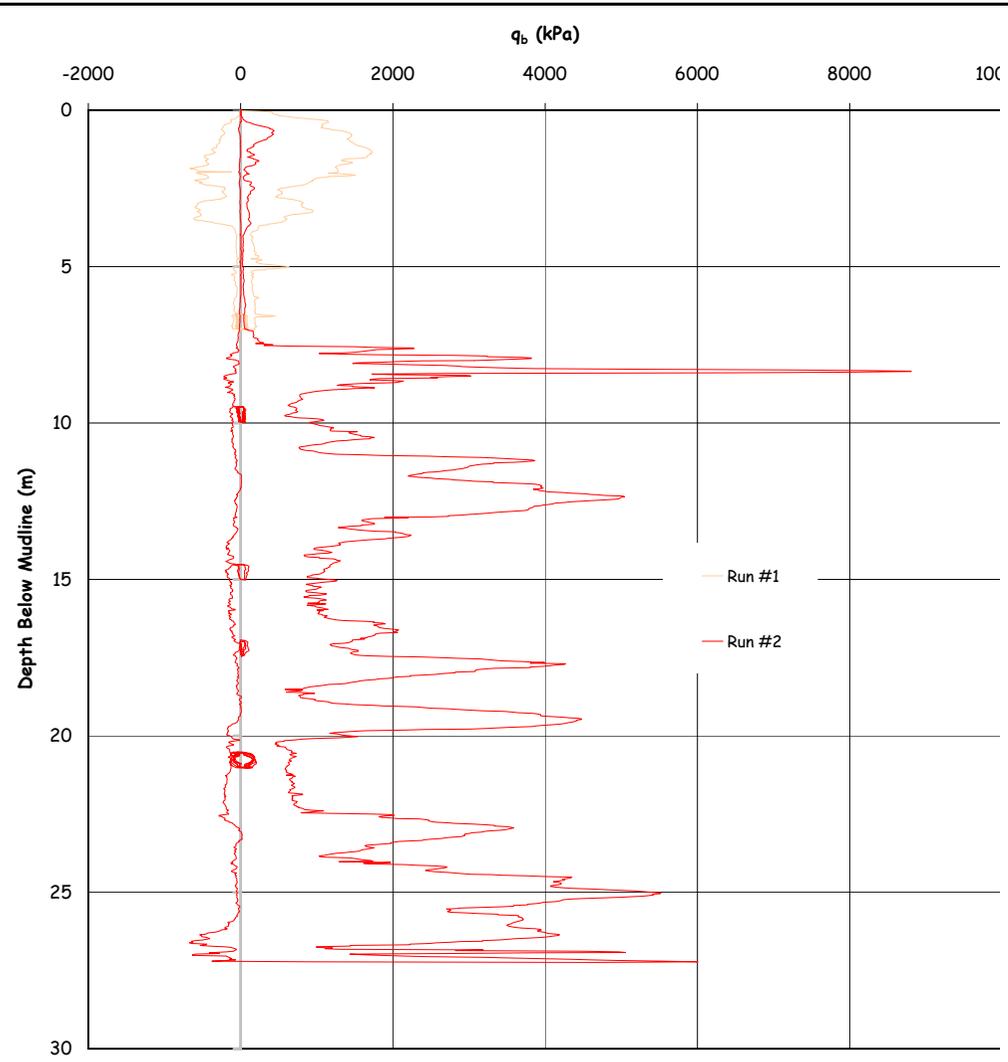
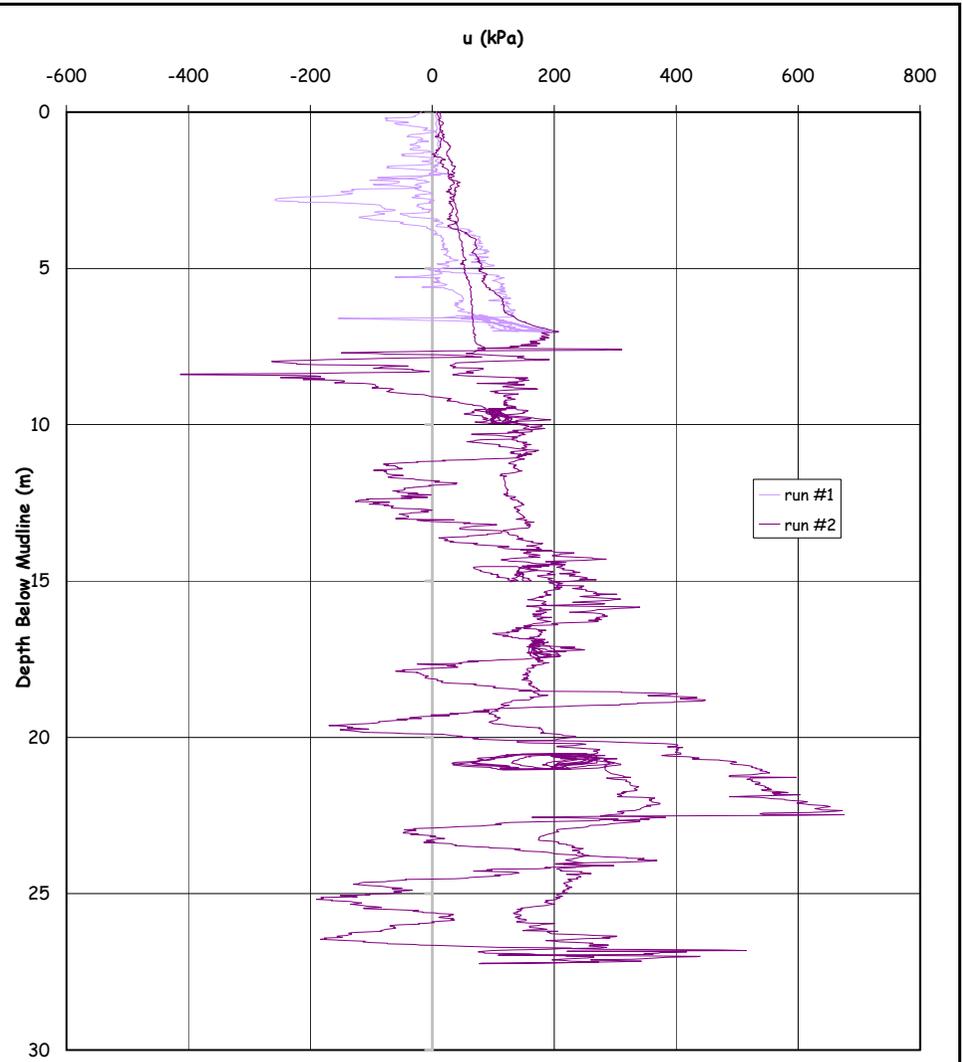
PROD Spherical Ball penetrometer test

Client Origin Energy
 Project Trefoil Site Investigation
 Test Date 20.09.2004
 Data Status Final
 Borehole No. TRE3

Eastings (mE) 361,078
 Northings (mN) 5,586,332
 Depth Datum Mudline
 Ball Diameter 60 mm

The SBP test results are provided in Appendix 4. The initial plot presents the entire depth range of probing. Subsequent plots illustrate the SBP response over the nominal depth intervals selected. It should be noted that 'positive' data generally represents 'downward' (penetration) of the SBP probe into the seabed, whilst 'negative' data represents 'upward' (extraction) of the SBP probe from the seabed. Also included on these plots are the data traces associated with the initial installation of the ball penetrometer through the soil profile prior to cycling, where appropriate. Some soil was noted both underneath and on top of the ball when the SBP tool was recovered from the borehole.

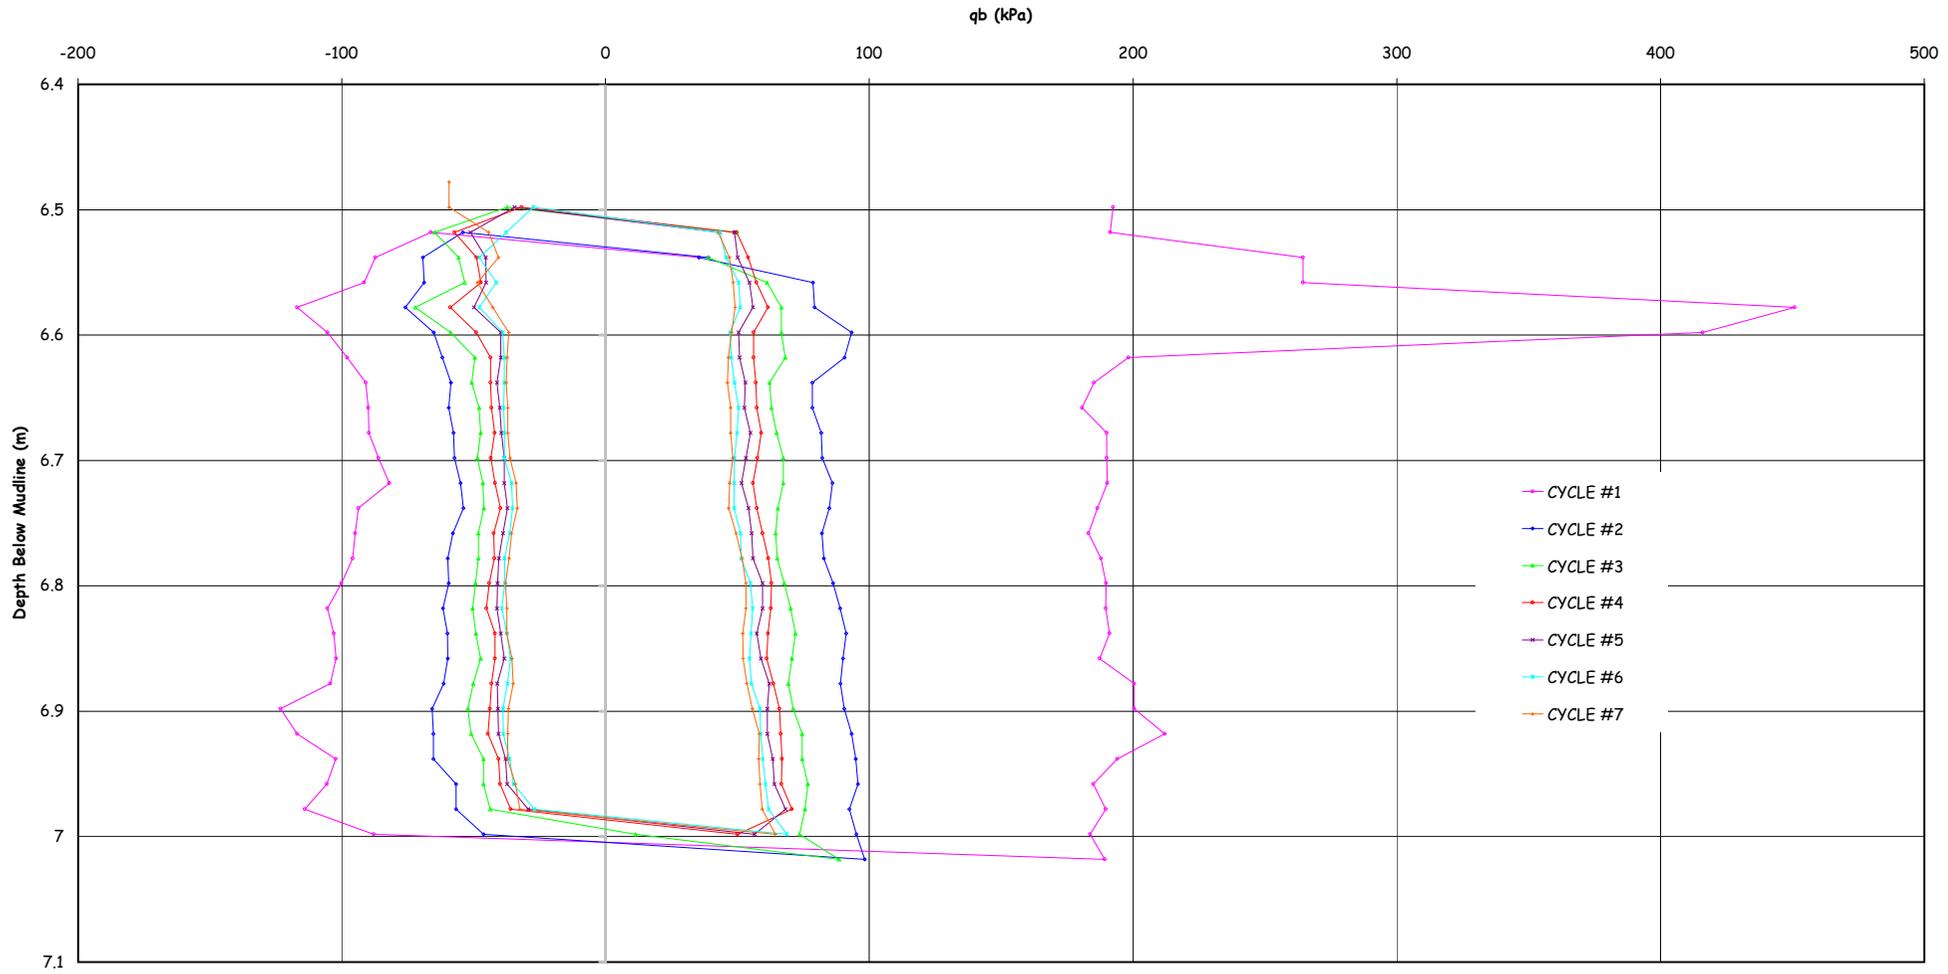
Cycle Set #1 - Cycling over depth interval 6.5m to 7.02m

PROD Spherical Ball penetrometer test

Client Origin Energy
Borehole No. TRE3
Test Date 20.09.2004
Depth Datum Mudline
Data Status Final
