# *FINAL SUPERVISION REPORT*

*PJ3D & PJ2D MARINE SEISMIC SURVEYS*

## *BENARIS PETROLEUM N.V.*

*BASS STRAIT, OFFSHORE TASMANIA*

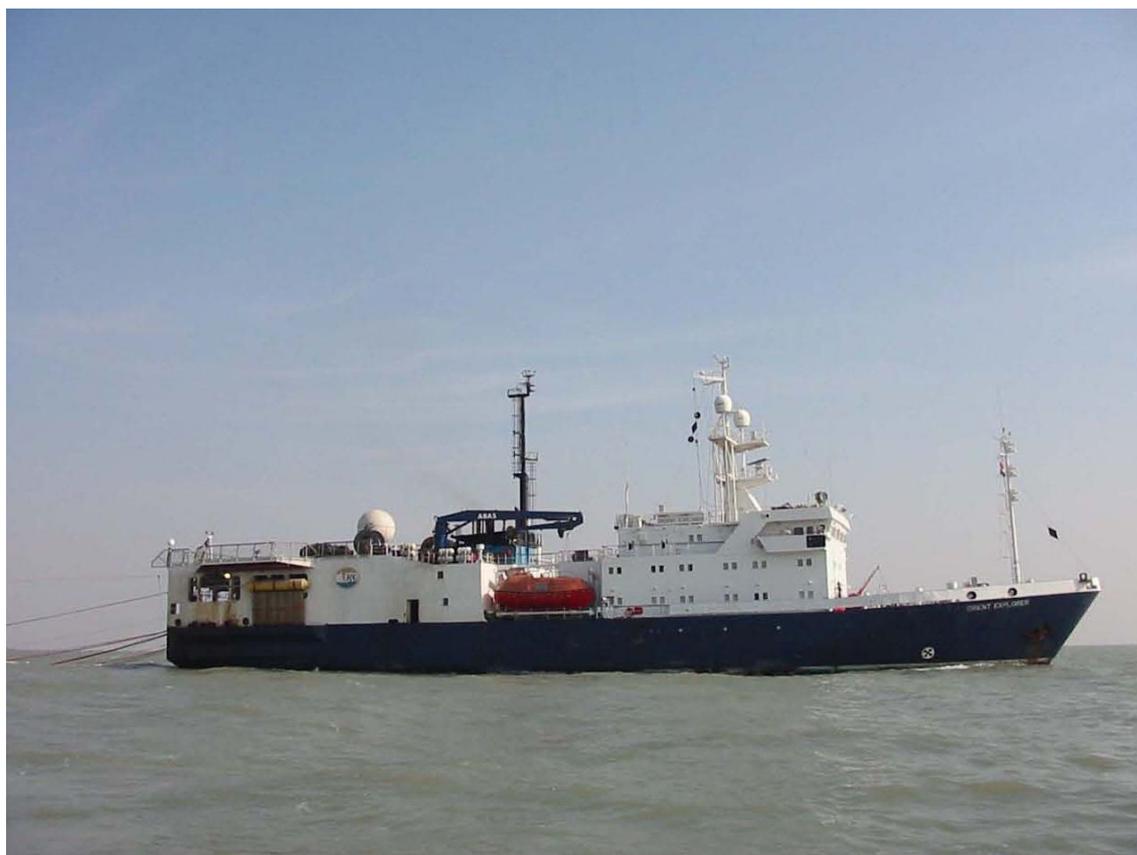
The vessel is set up as a 3D vessel, but her equipment, excluding the new recording suite, is old. The streamers are old and falling behind industry standards.

There are many signs, which would suggest that the vessel has been poorly maintained over the years and it will take a concentrated effort on the part of the contractor to return the vessel to a more acceptable condition. This was clearly flagged prior to the start of this survey, when the charge air cool started to leak and was found to be in such a deplorable condition that it had to be sent ashore for repair and a new unit placed on order. A number of routine maintenance items have been ticked as completed when they obviously haven't been touched. Again the charge air cooler is perfect evidence. The sewage system is in such a poor condition that nobody is willing to work on it, as are the two water makers. There are adequate numbers of showers and toilets available and the stewards worked hard to keep cabins and amenities clean. Dalmorneftegeofisika Trust own the vessel, Nordic Marine LTD are the Maritime operator and Total Marine in Australia supplied the marine crew. All seismic personnel were from various countries and contracted to PGS.

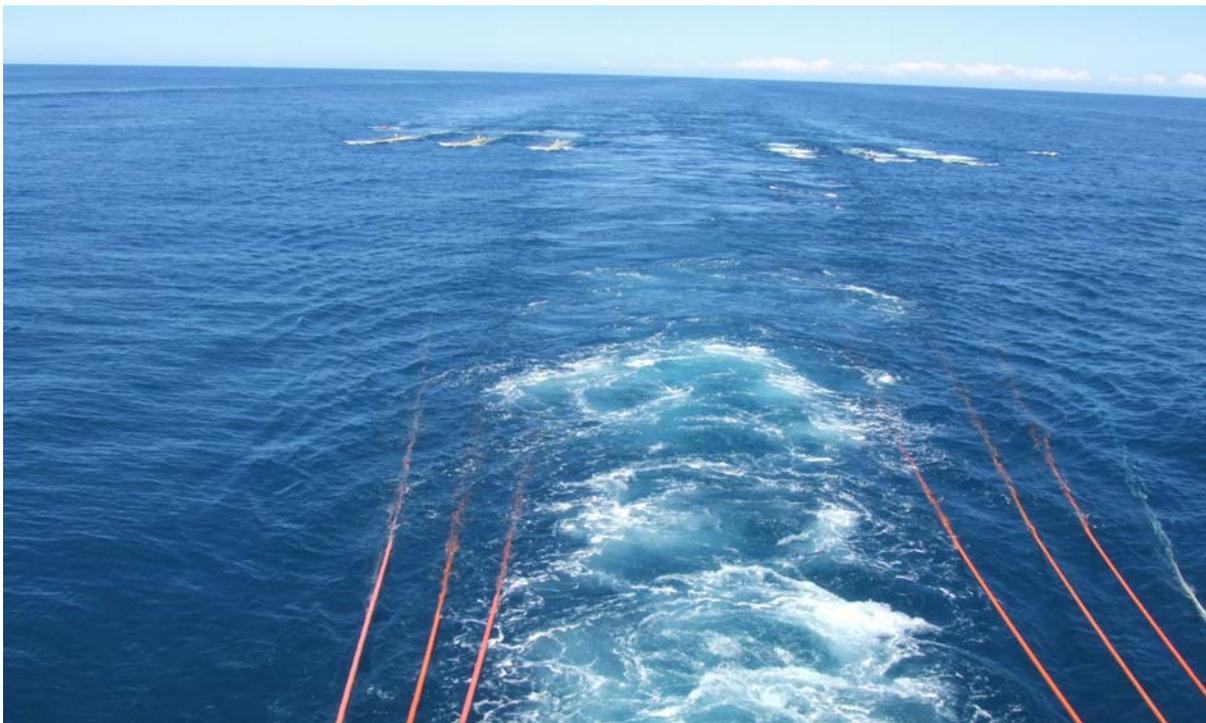
#### ***The Vessels Wash***

The wash of the vessel can be clearly seen in the below photograph, which was taken on one of the few days during the survey when a calm sea was experienced.
