Southern Margins Marine Seismic Survey Tasmania, Australia 2006

FINAL SURVEY REPORT

M/V Pacific Titan

31st May to 23rd June 2006

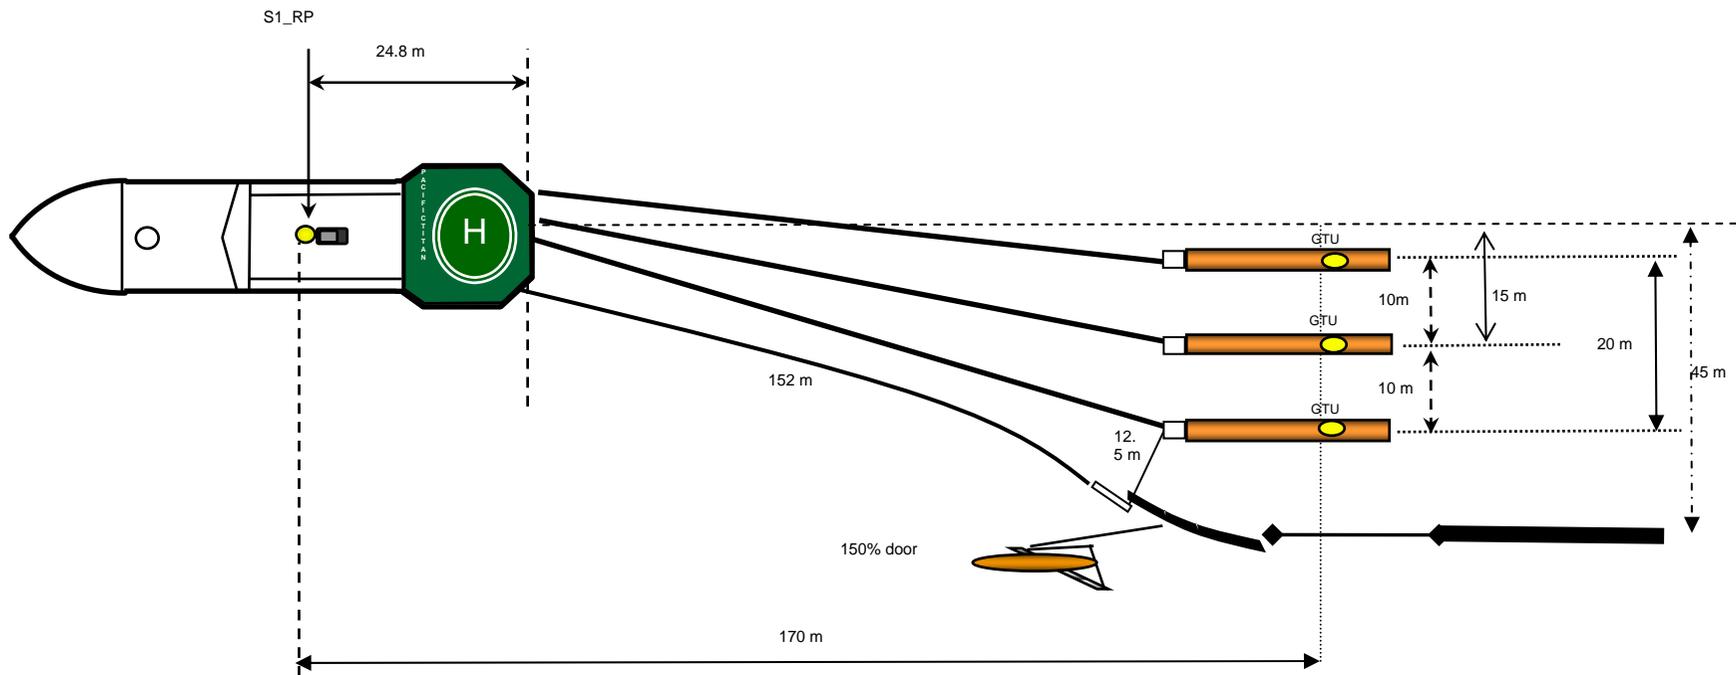
Offset for 2D Acquisition

DC Offset from Vessel Centreline to Centre of Source is 15m

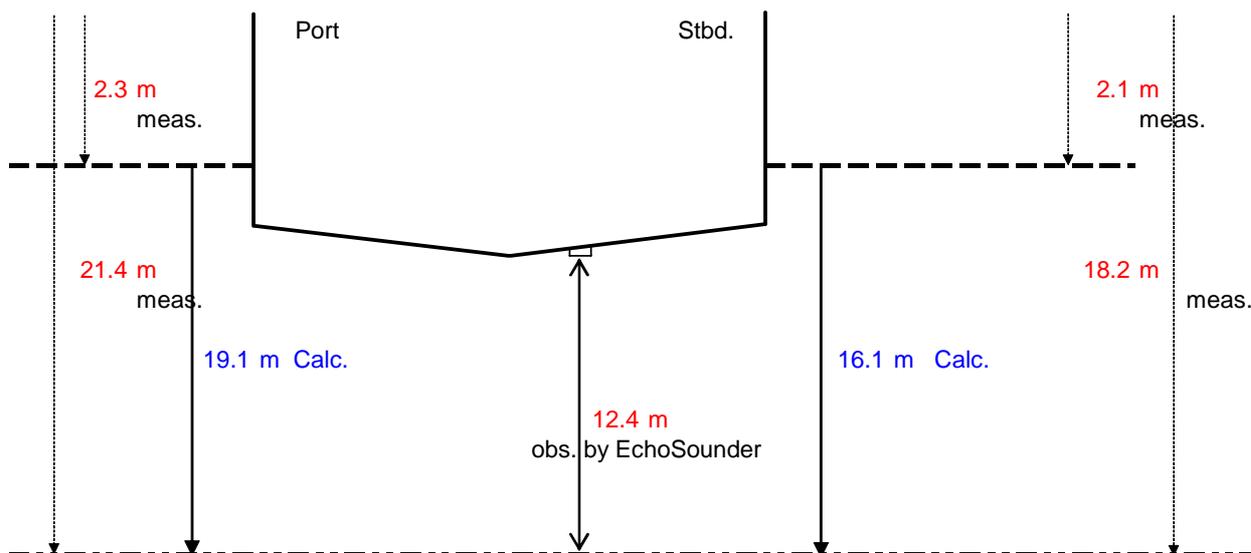
Measurements taken:-	metres		
Port Freeboard		2.3	Stbd Freeboard 2.1
Port Lead-Line		21.4	Stbd Lead-Line 18.2
EchoSounder Reading		12.4	Fwd Draught marks: 5.1
Time		20:15	Aft Draught marks: 5.5

Draught Marks:
 Aft : **5.5 m**
 Forward : **5.1 m** Theoretical Draught = **5.3 m**

Electronic Depth + Theoret. Draught = **17.7 m**
 True Measured Water depth = **17.6 m**

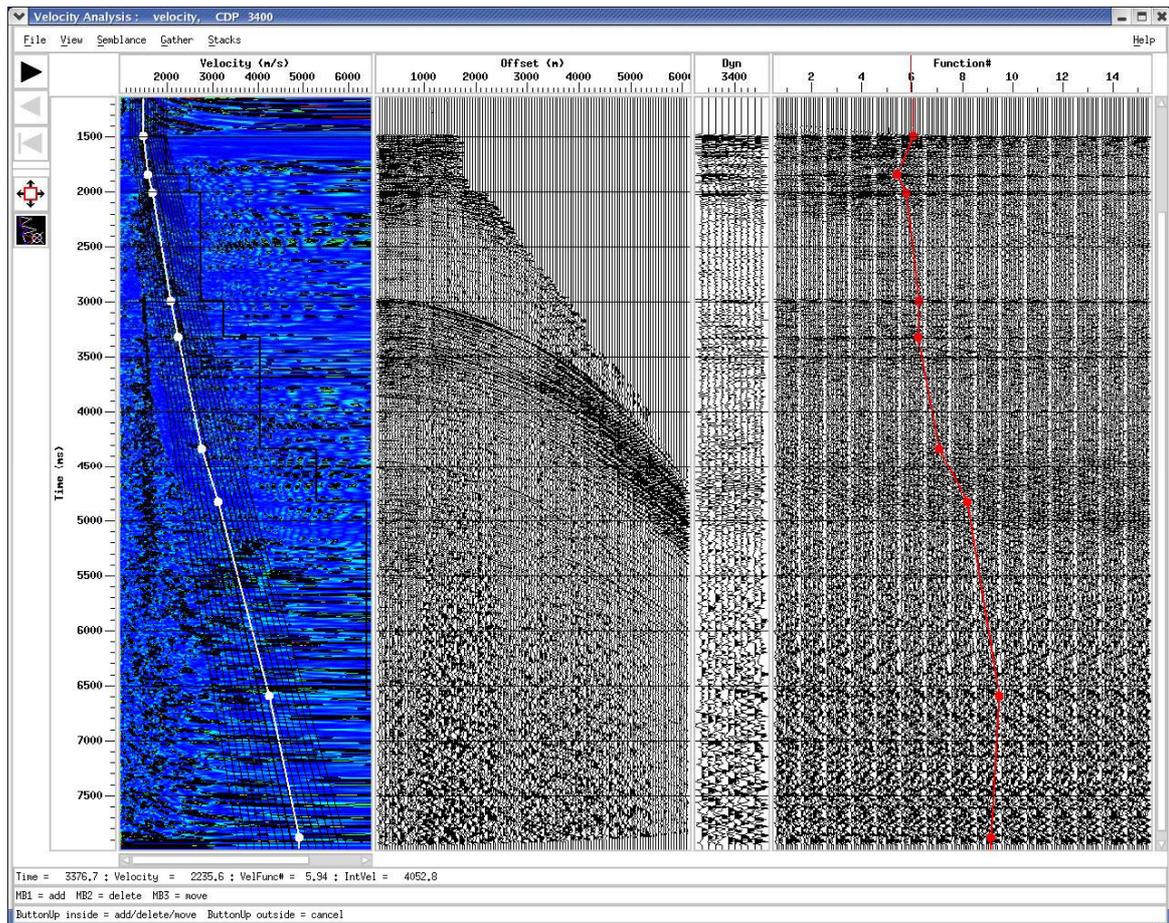
Figure 1. Velocity analysis interface with semblance, super-cdp gather and function stacks. Line SOSN06A-39-P024.

Velocities were picked for every line at a 2 km intervals using ProMAX's interactive velocity analysis package. This comprised of a semblance display with rms stacking velocity graph and interval velocity graph, CDP super gather panel and function stack panels. To improve the signal to noise ratio, super gathers were formed by combining fifteen adjacent CDP gathers. Stack panels were created from these 15 CDP's using 15 functions varying +/- 25% from the regional velocity function.

To speed up the on screen velocity picking procedure the velocity analysis displays were pre-computed. Normal move-out was applied to the gather to check that the events were lining up well.

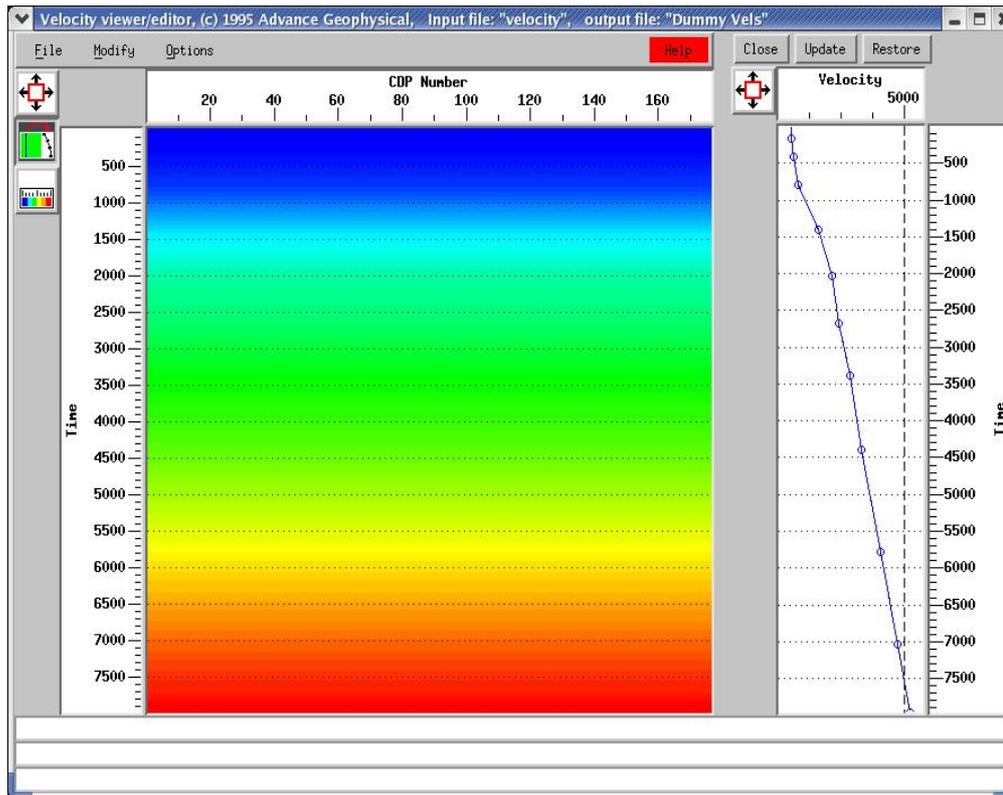
Figure 2. Iso-velocity display in ProMAX velocity viewer. Line SOSN06A-39-P024.

After velocity picking, velocities were viewed and QC'd on screen using the ProMAX velocity viewer module, which provided an iso-velocity display together with rms stacking velocities. This module was most useful for editing any stray velocity picks. NMO corrected gathers were also displayed on screen both at and between velocity locations for further verification.

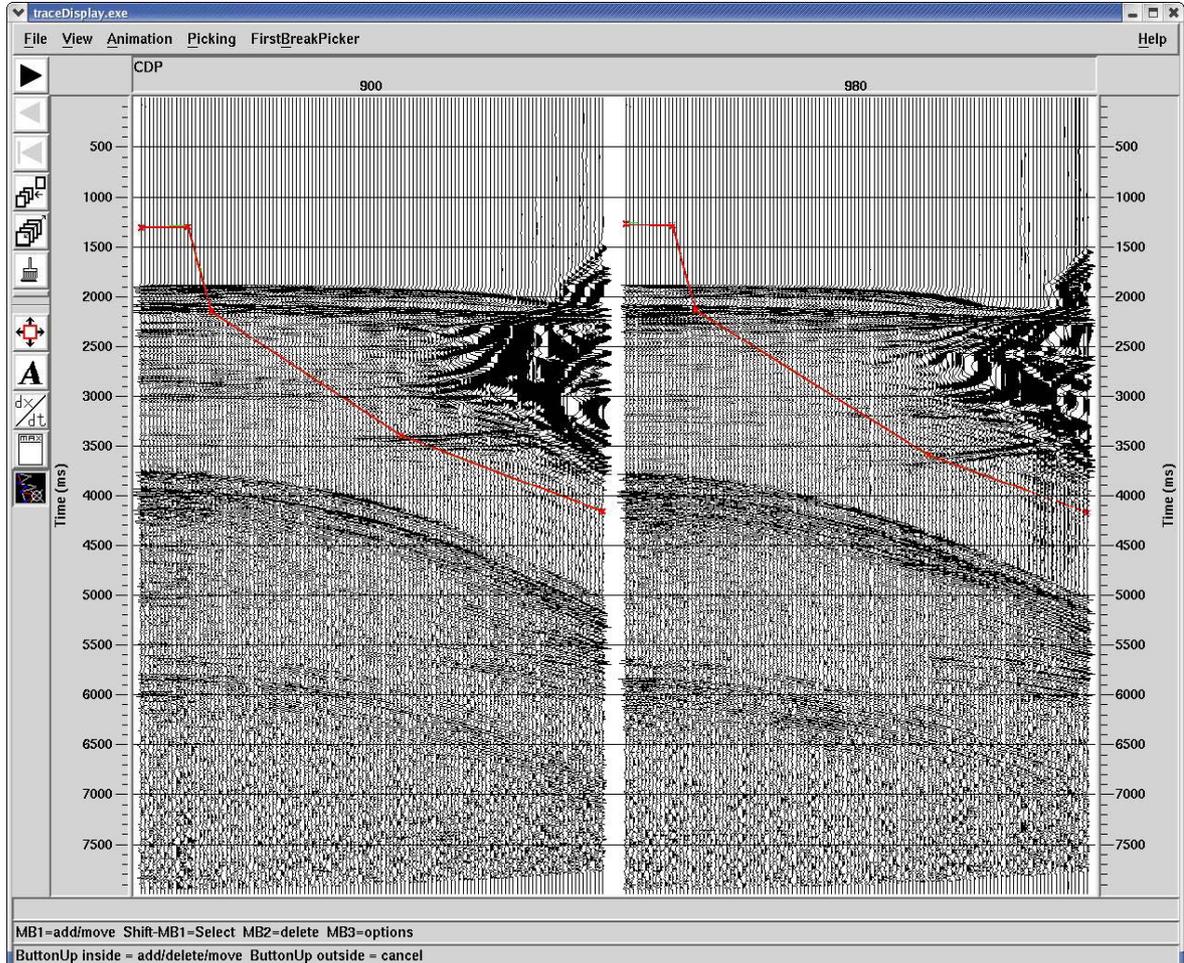
Figure 3. CDP gather to confirm the velocity picks. Note strong multiples present for most of the lines during this survey. Line SOSN06B-12-P26

CDP gathers were regularly displayed on screen to QC the velocities after NMO correction and ascertain the impact of swell noise and cable impacts on the pre-stack data. The CDP gathers were NMO corrected using the picked RMS stacking velocities.

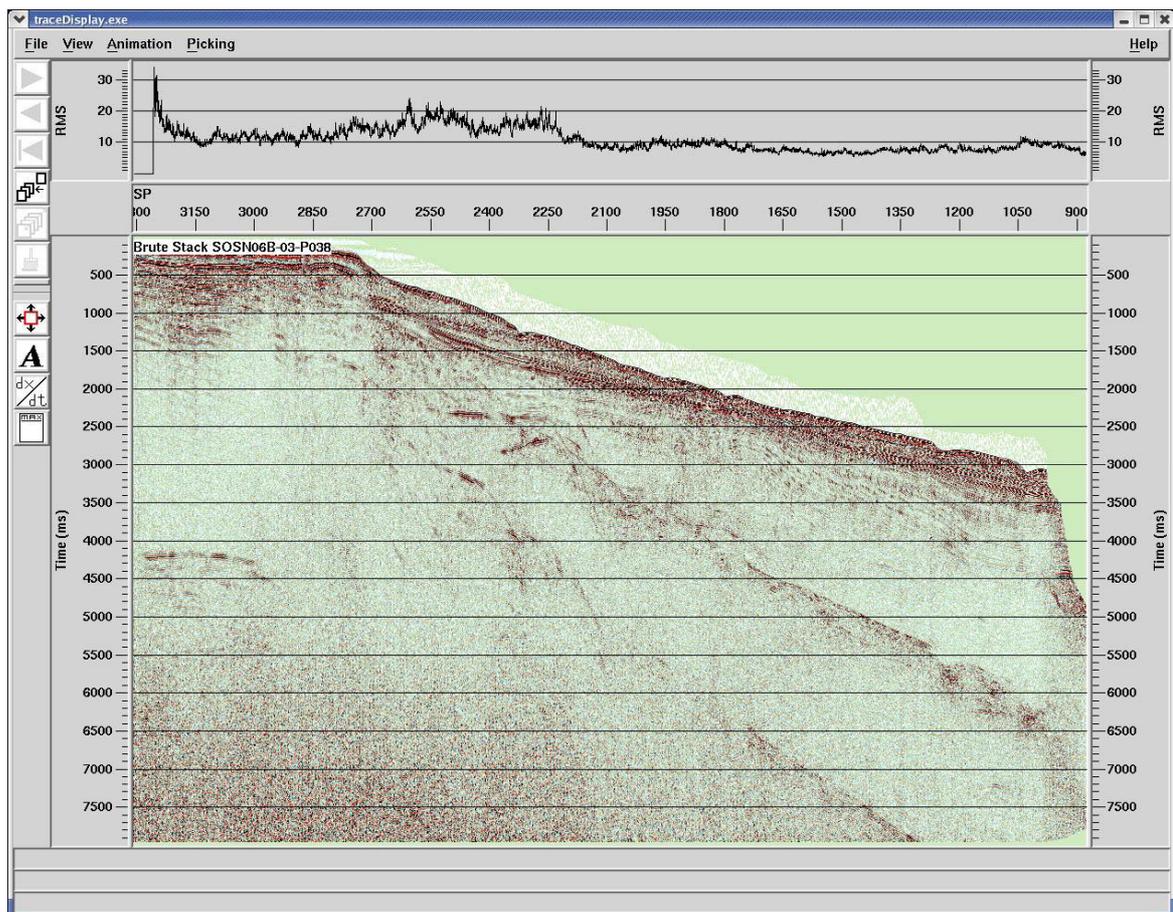
Figure 4. Brute stack. Line SOSN06b-03-P38. Strong water bottom multiples, diffractions and good structure where seen within the stacks. Swell noise stacked out well.

An average Shot RMS from a shallow time window was plotted along the top of the stack to monitor ambient and external noise levels. A 3Hz low cut filter was applied to the data prior to RMS computations.

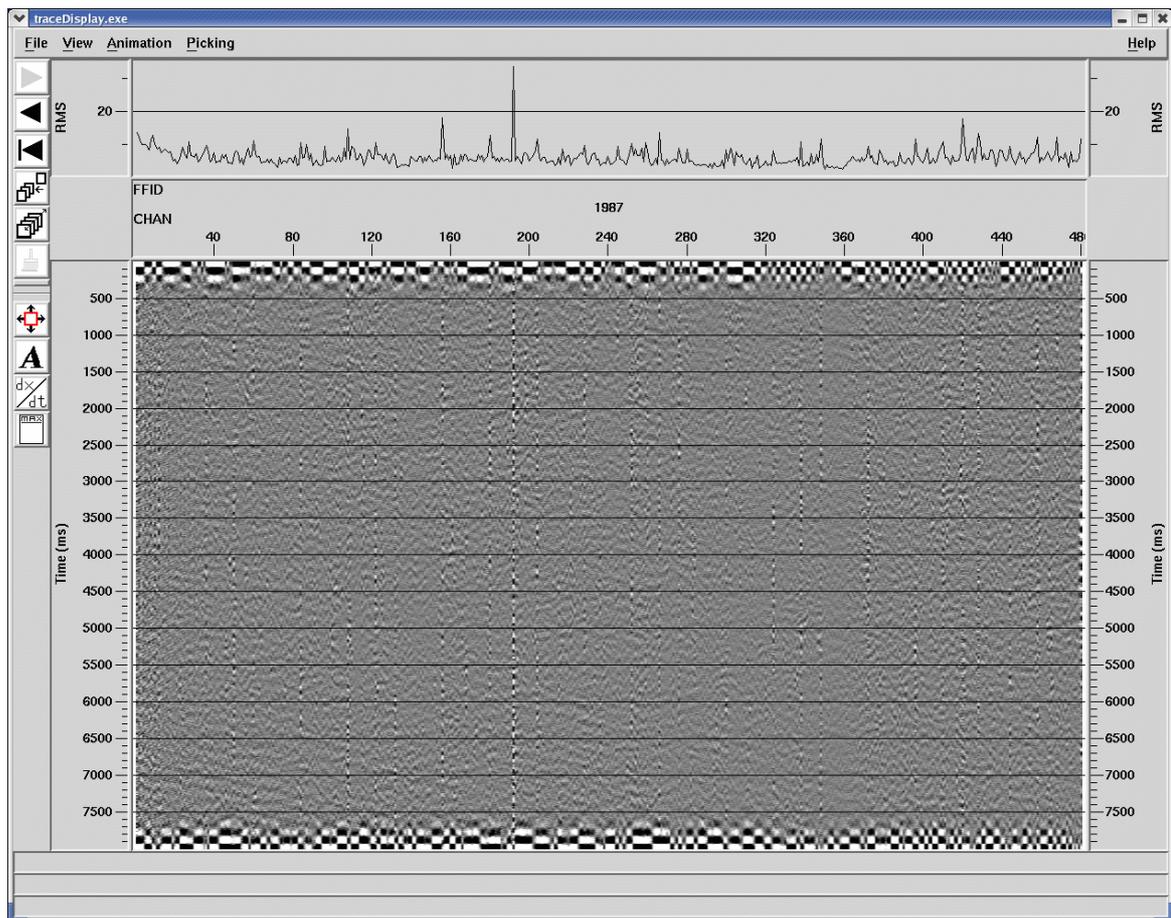
Figure 6. Noise Record and Channel RMS. Chan 192 noisy, possibly fishing gear caught. Line SOSN06A-05-P059.

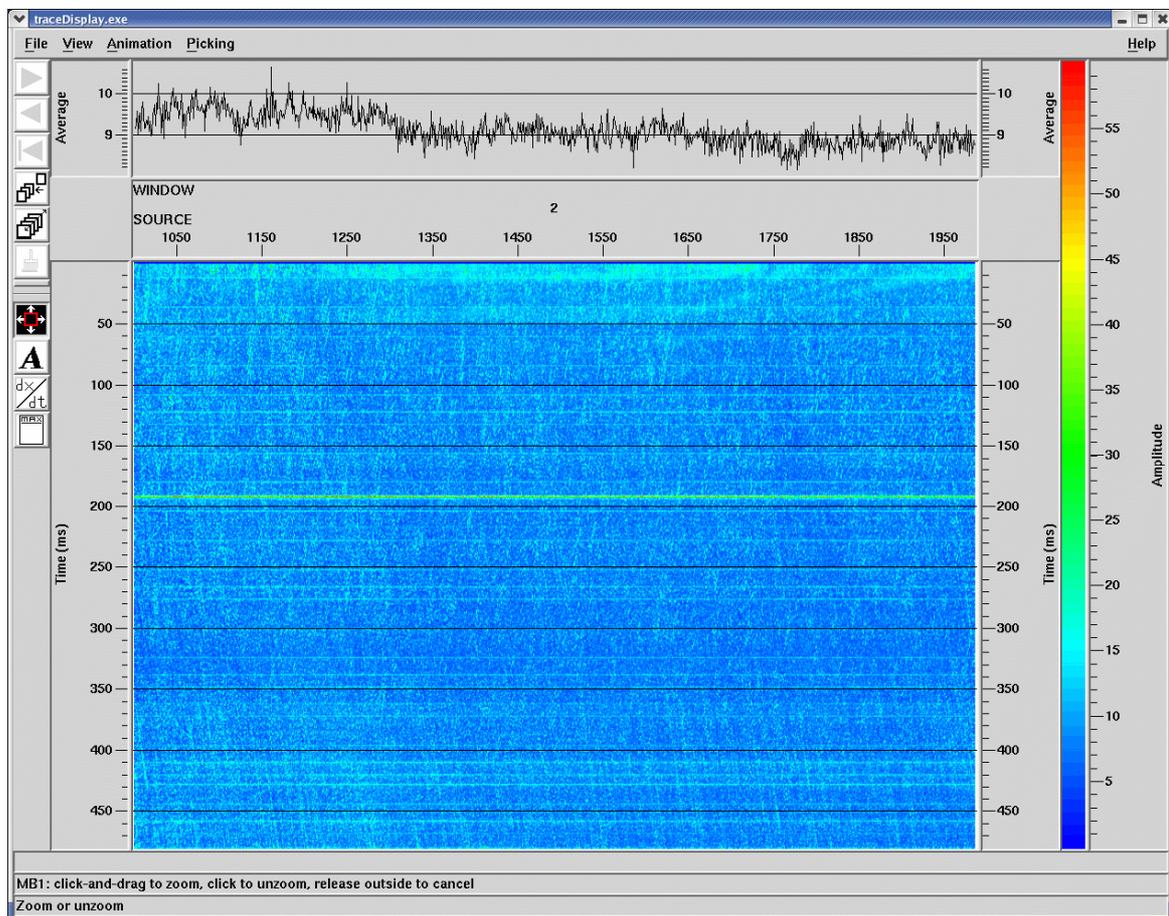
Figure 7. Example above of a quiet line containing swell noise. Ambient noise - shot vs. channel colour RMS Amplitude display, Deep Window, Line SOSN06A-09-P058.

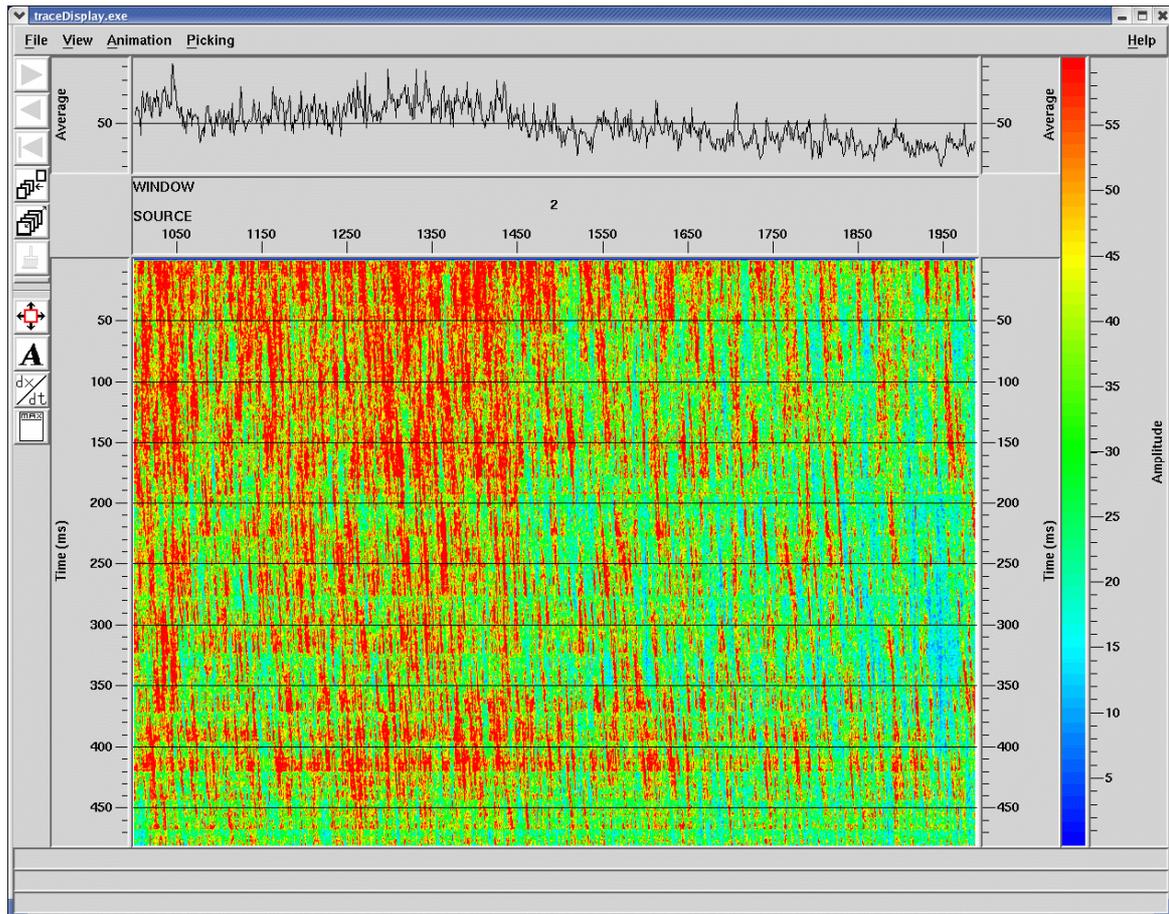
Figure 7a. Example of line containing the highest amount of swell noise. Ambient noise - shot vs. channel colour RMS Amplitude display, Deep Window, Line SOSN06A-11-P054.

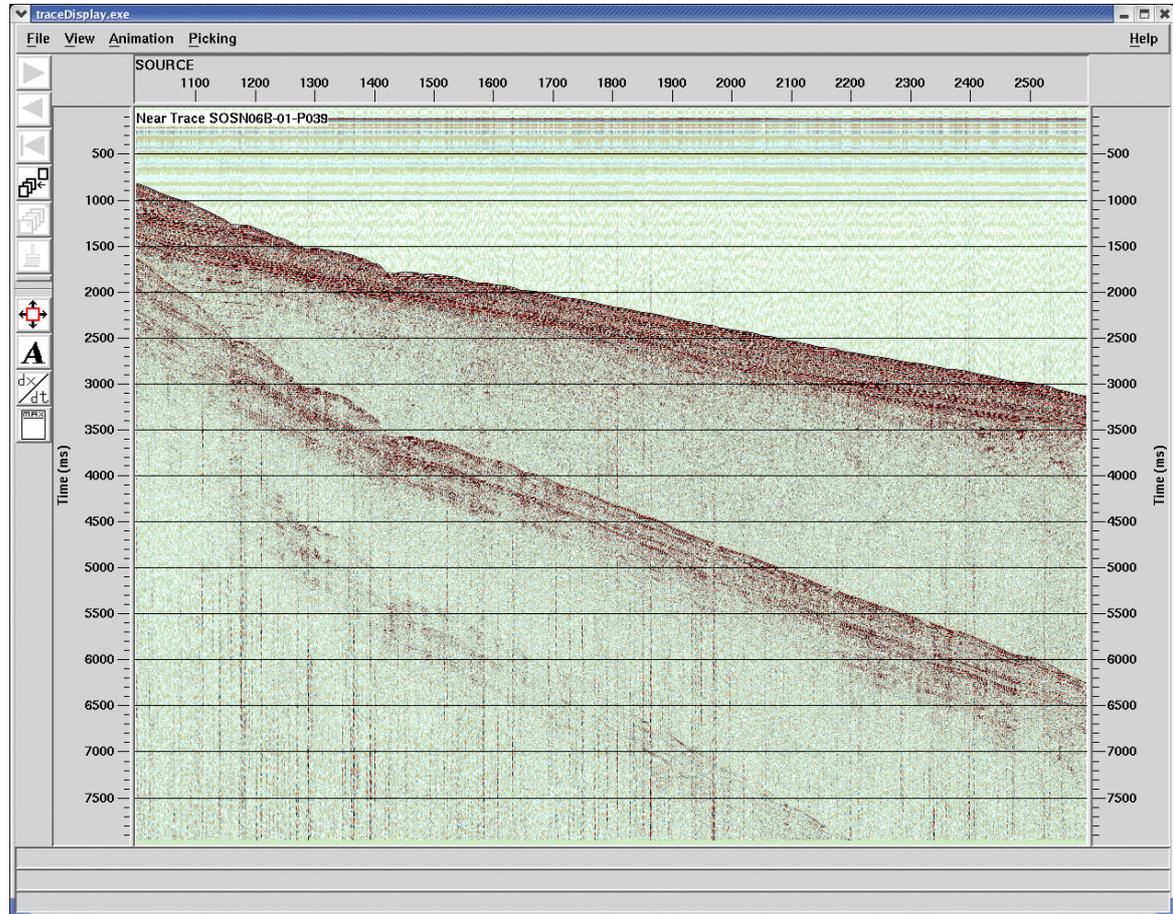
Figure 8. Near trace display. Line SOSN06B-01-P039.

Near traces were displayed on screen for every line in order to quickly determine any possible errors with acquisition, e.g. gun volume changes, bad records, time-break problems and any auto-fires not reported by the recording system. The near traces also provided a good indication of the geological conditions including strength of the water bottom multiples, residual seismic multiple energy, front end noise and swell noise contamination.

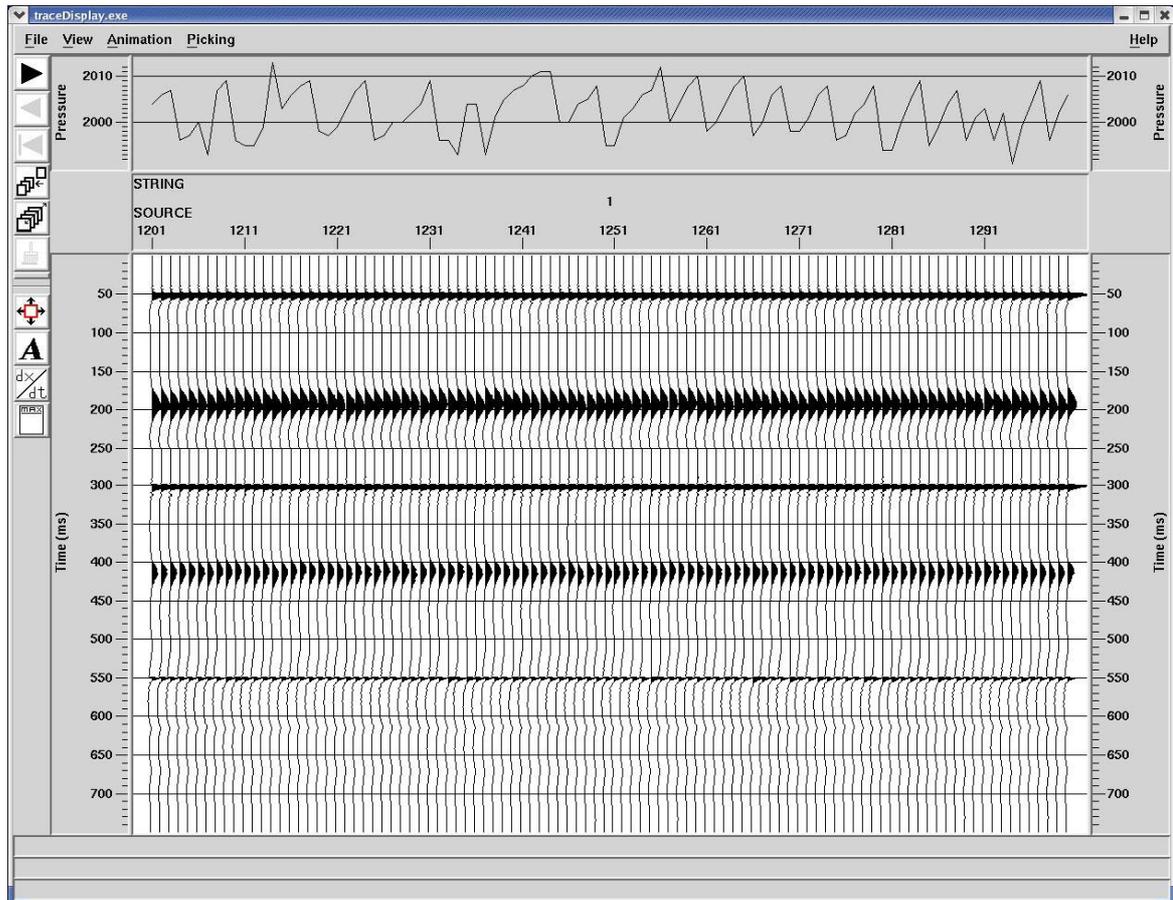
Figure 9. Near Field Hydrophones. Gun Array 1. Line SOSN06B-03-P038.

Each gun hydrophone was also displayed as a single trace display on screen. Additionally, the first 250ms of the 3 hydrophones from a single sub-array were stacked vertically and displayed. This proved useful in determining whether spurious signals were genuine gun timing problems or just electrical noise on the signal.

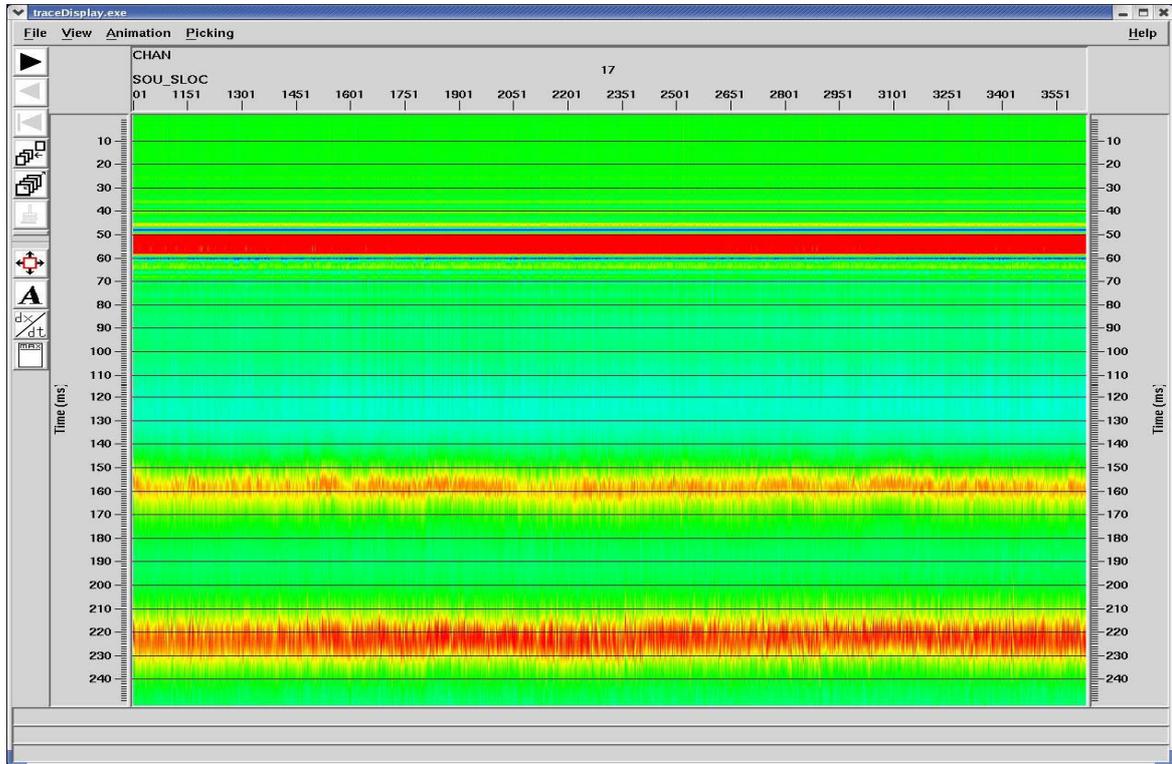
Figure 10. Near Field Hydrophones. Channel 17 = Gun Array 2 - Aft. Line SOSN06B-03-P038.

An additional colour amplitude display of the gun hydrophone channels was also found to be very useful in identifying gun problems. All anomalies were cross-checked against the Observers Logs and Gun QC Logs.

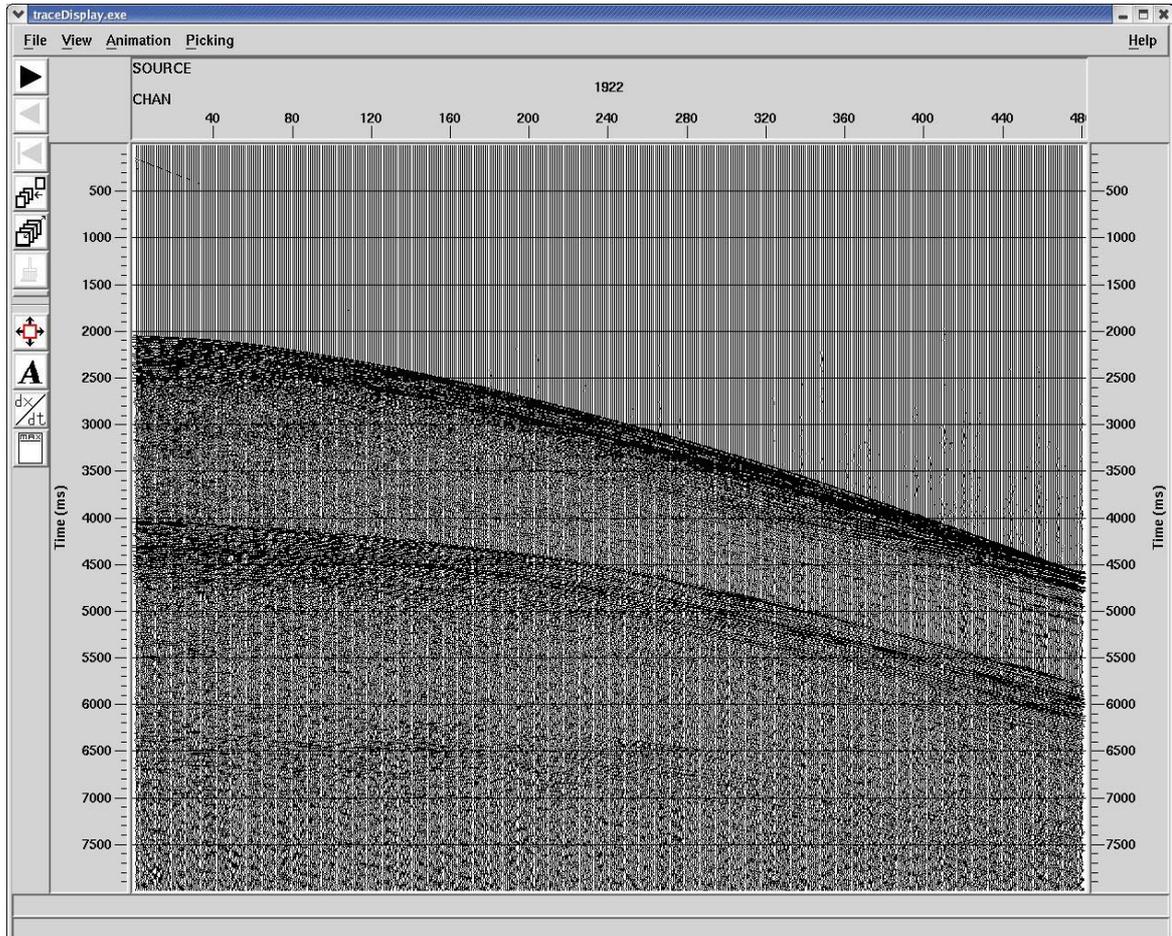
Figure 11. Shot gather. Line SOSN06B-12-P026 SP 1922.

Shot records were filtered to the signal bandwidth and balanced with a true amplitude gain recovery. They were displayed on screen at 4 km intervals for each line. Individual records were examined on screen if an issue with acquisition was suspected, such as noise, residual seismic energy or auto-fires. The colour RMS displays were used to pinpoint bad/suspicious shots, whose shot gathers were subsequently investigated on screen.

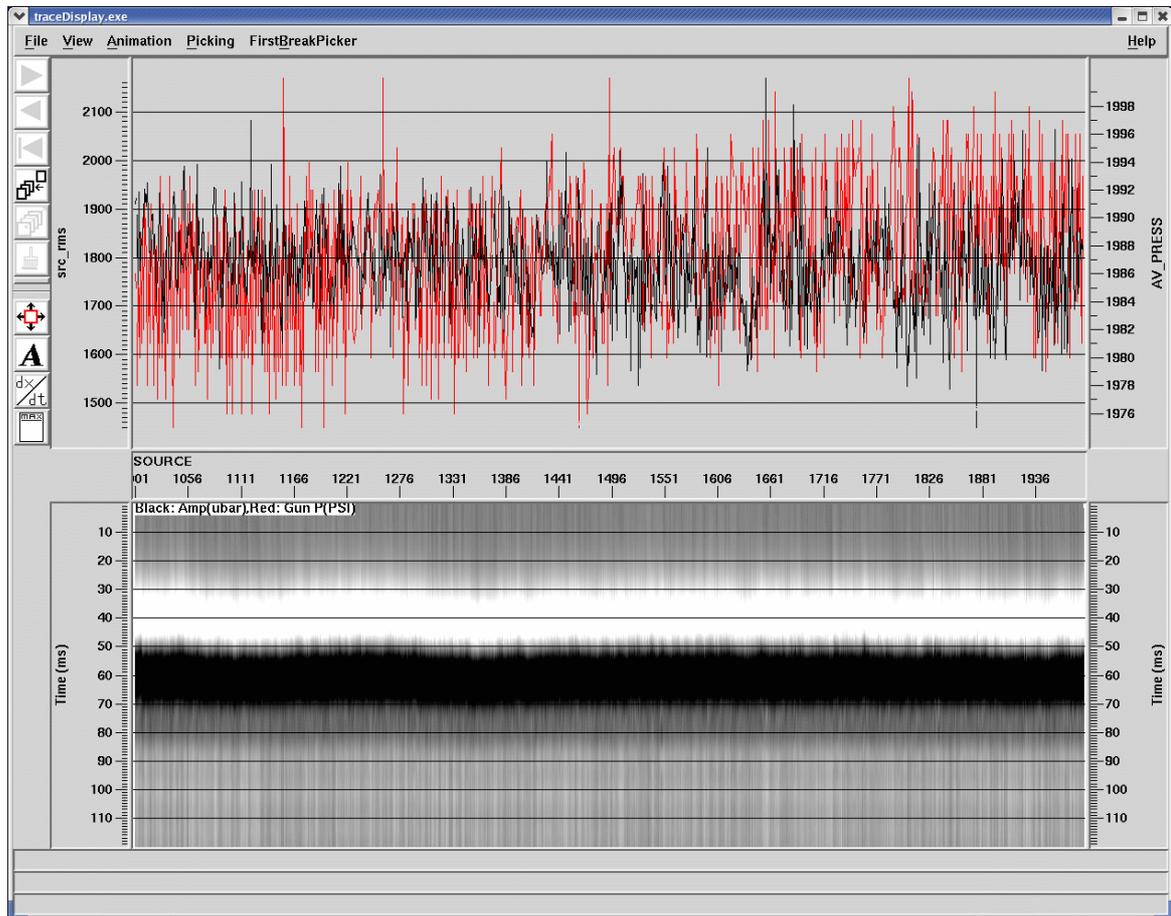
Figure 12. Direct Arrival RMS. Line SOSN06A-17-P055.

Normally these displays show little variance between each shot. However, due to the shallow water, the direct arrival and water bottom reflection were mixed creating far higher values than normal on some lines. Also, the amplitude varied according to water bottom geology.

Vessel speed is another factor which can cause fluctuations in direct arrival amplitude and pressure.

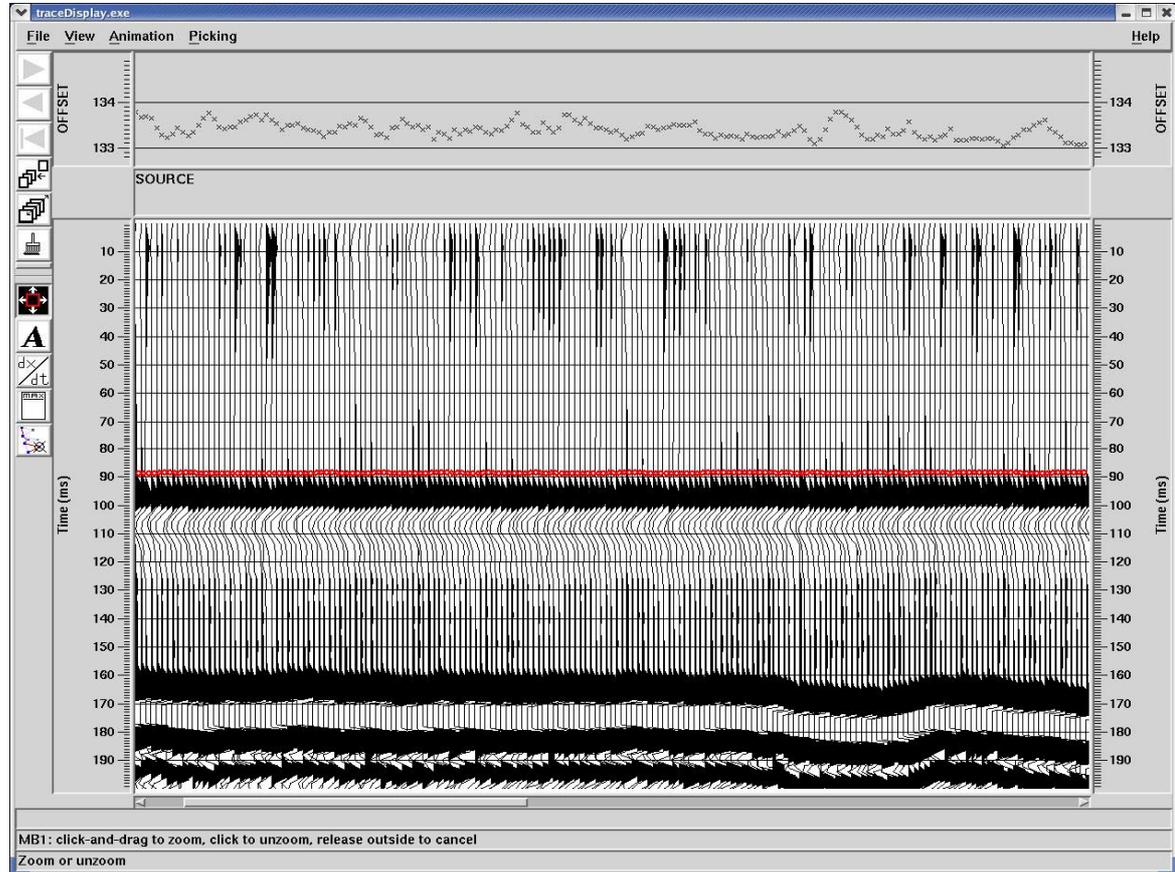
Figure 14. QC of consistency between first breaks and navigation derived first breaks (red). Line SOSN06A-17-P055.

In order to QC navigation data, the final processed P190 navigation files were merged with the near trace. The theoretical first break time was then computed using a water velocity of 1516m/s overlaid on the near trace as seen below.

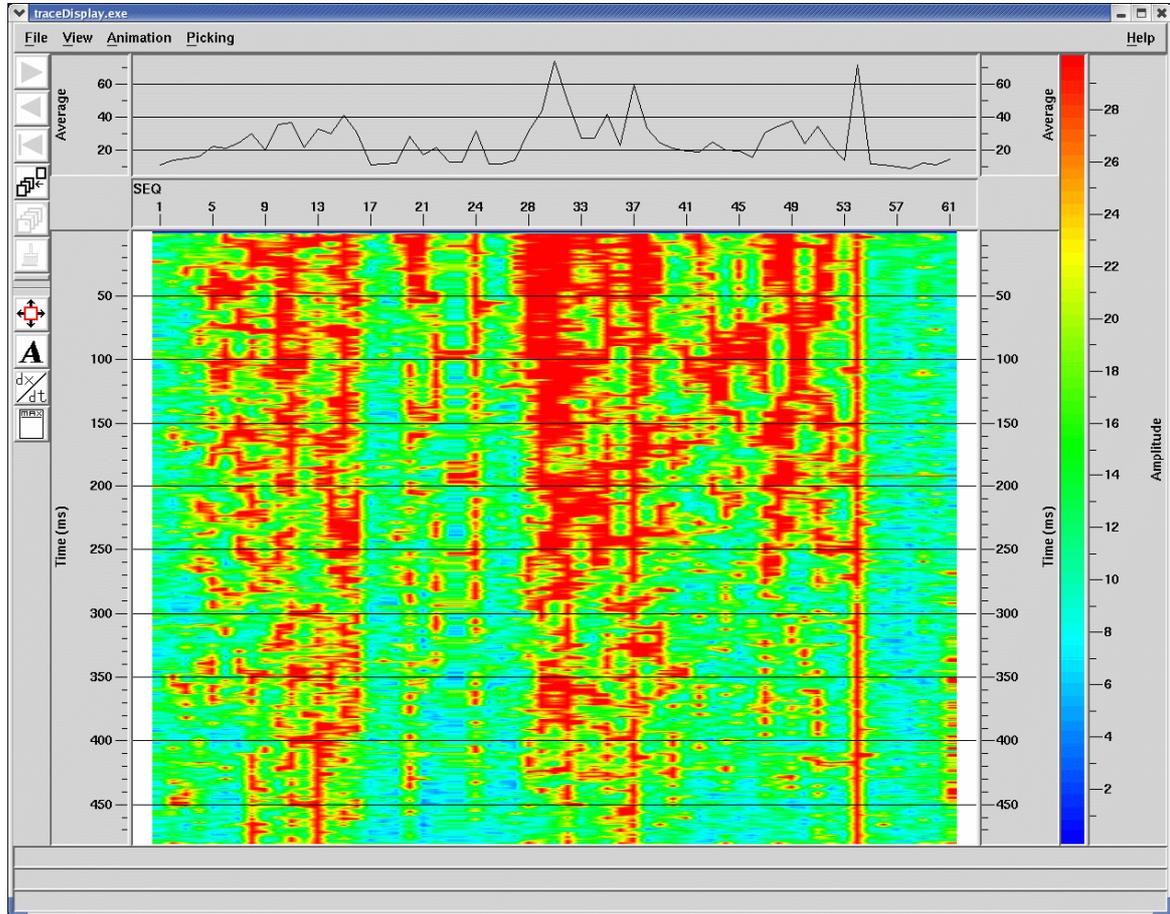
Figure 15. RMS Noise record history display. A good tool for comparing noise levels sequence-to-sequence and identifying faulty channels.

The following display shows the noise records collected during the survey compressed into a single display.

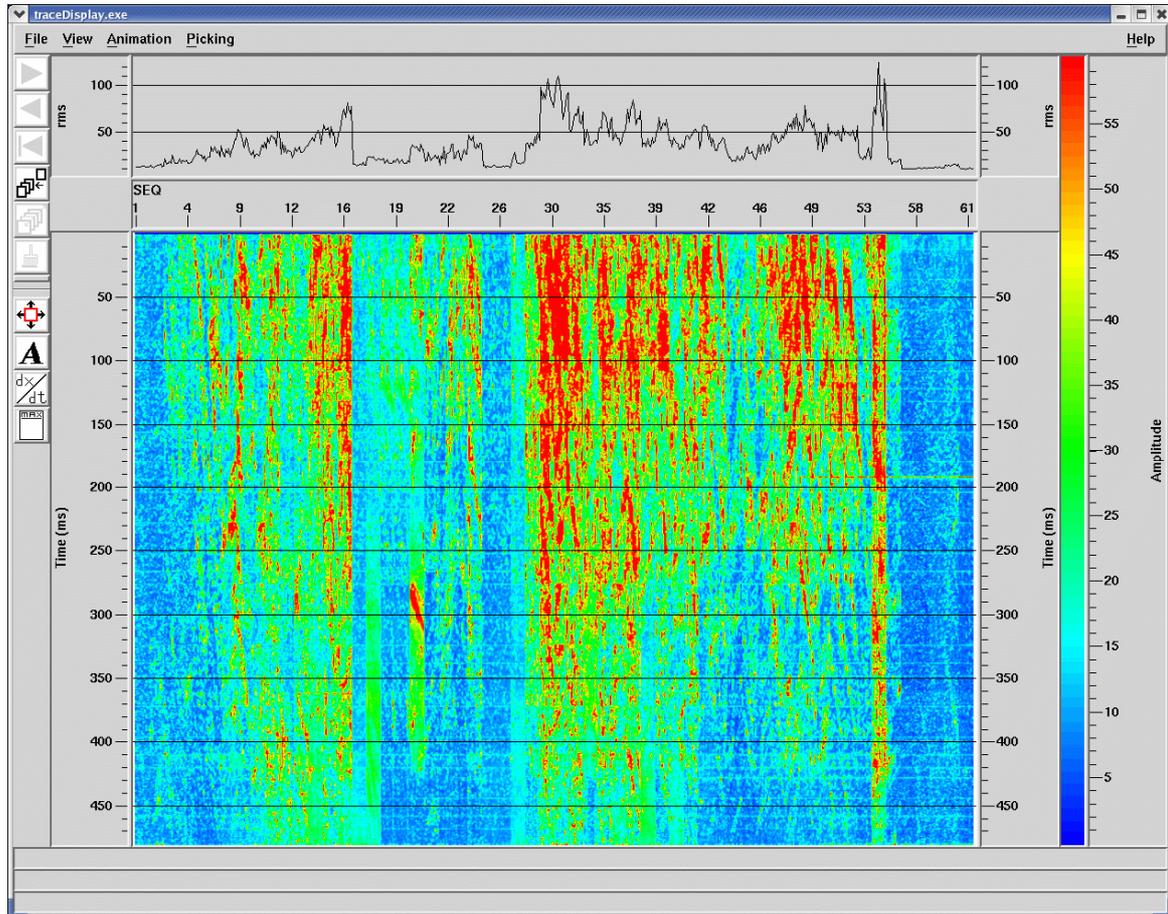
Figure 16. Shot Vs Channel RMS history display.

Another similar display to evaluate swell noise levels and noisy channels is shown below. This RMS analysis takes a representative sample of 10 shots from each sequence, and displays them side by side.
