FINAL SURVEY REPORT

VESSEL: M/V PACIFIC TITAN

- Marine 2D & High Resolution SEISMIC REFLECTION METHOD ACQUISITION -

Location	:	AUSTRALIA
Area	:	West of Tasmania - Australia
Survey	:	T/48P KING ISLAND 2D - SOSN08C MARINE
SEISMIC SURVEY		
Client	:	SANTOS OFFSHORE Pty Ltd
Duration	:	04th March 2008 - 12th March 2008
C.G.G.V. SURVEY N°	:	501 11 89 07 06 00 (Job N°: 6374)
CONTRACT N°	:	859832

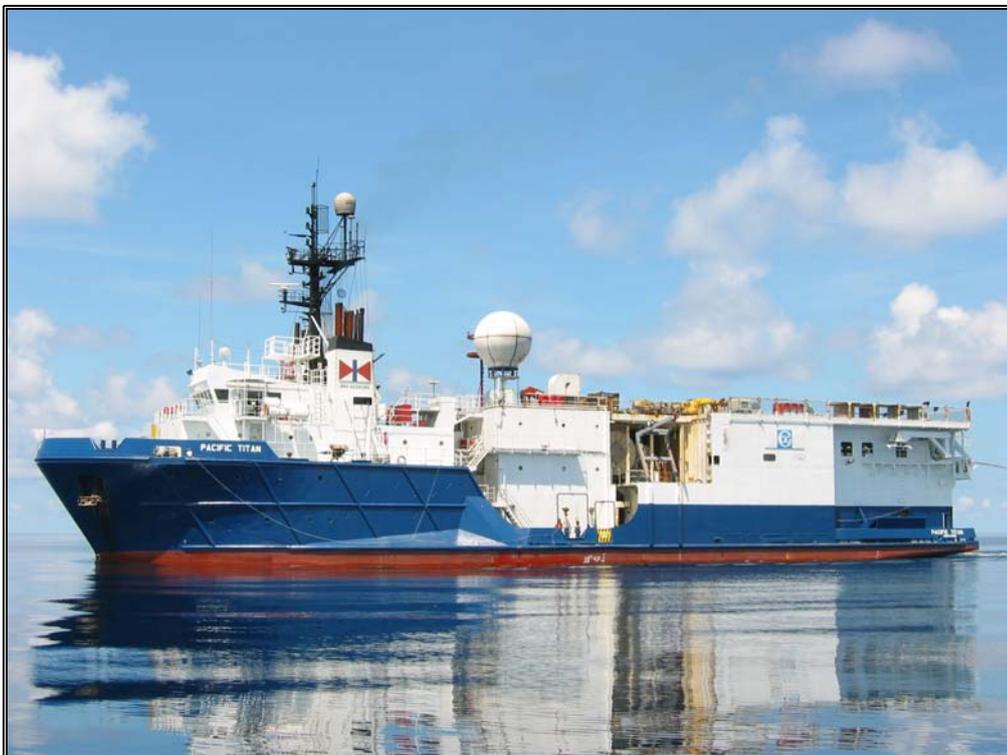
4.1. Vessel Specifications – Pacific Titan

M/V Pacific Titan is capable of doing both 2D and 3D seismic data acquisition work. For 2D work the vessel can tow 12 000 meters streamers. For 3D seismic work the vessel can do dual source/dual streamer (2X8000m) or dual source/three streamer (3X4000m) operation providing high quality 2D and 3D seismic data for the industry. Features include a SEAL-24 system configurable for multiple streamers. Options include real-time seismic processing, acoustic source positioning, and acoustic streamer positioning and onboard navigation. The following are general specifications for the vessel and seismic equipment on board.

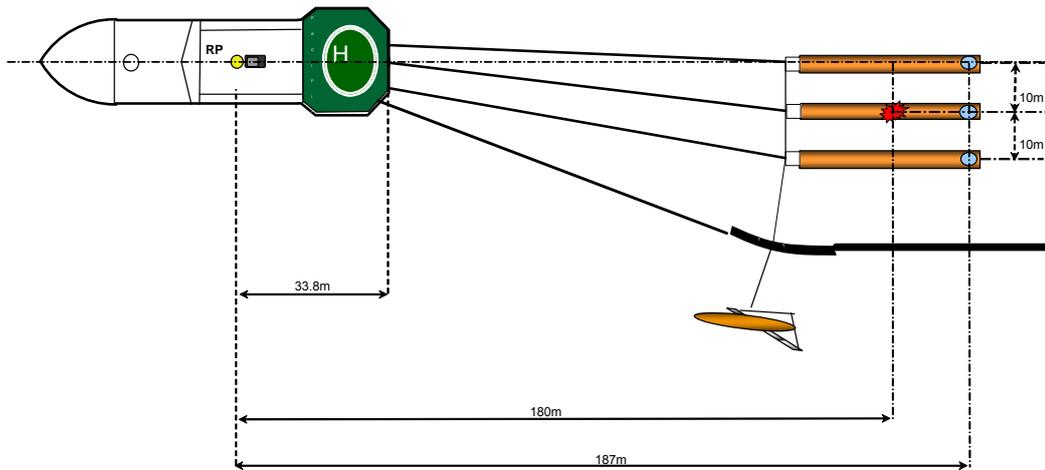
10.1. Towing Offset Diagram

Pacific Titan General Towing arrangement

- Centre of Source
- RGPS pod
- RP Reference Point
Vessel Centre Stern at sea level

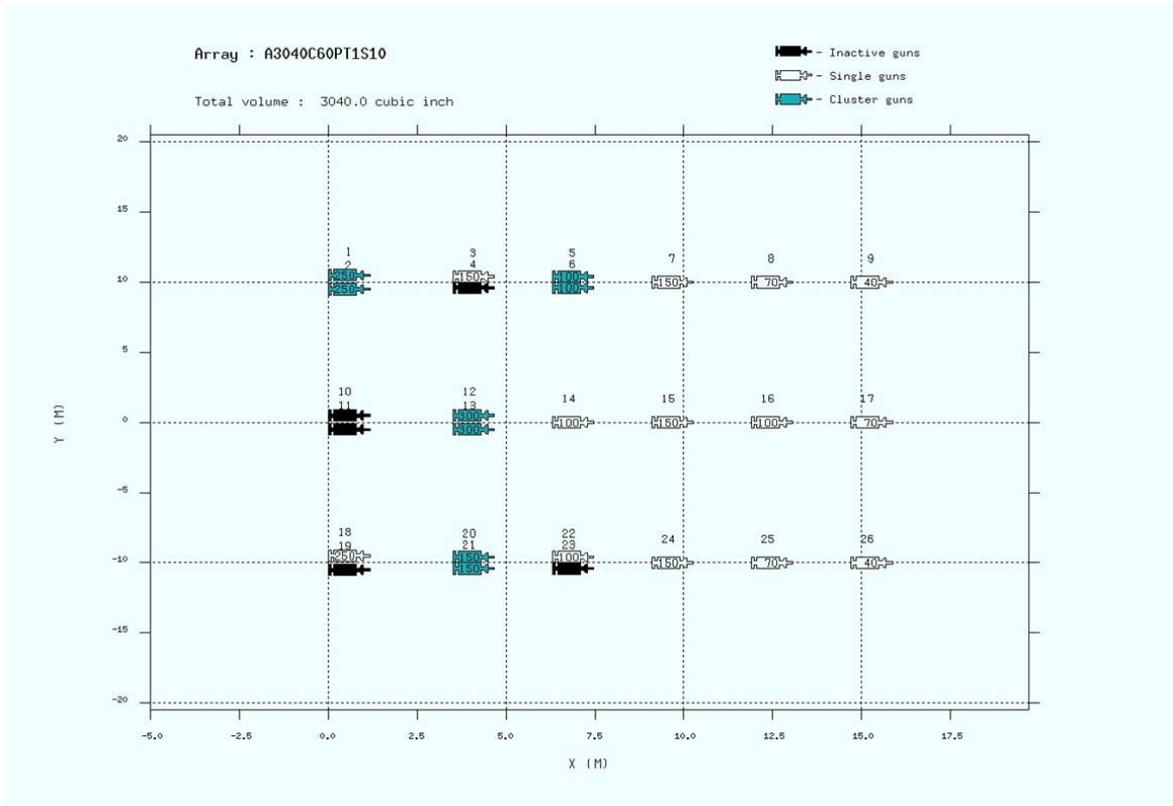
11.1.2. Source Layout

Total active volume: 3040 in³

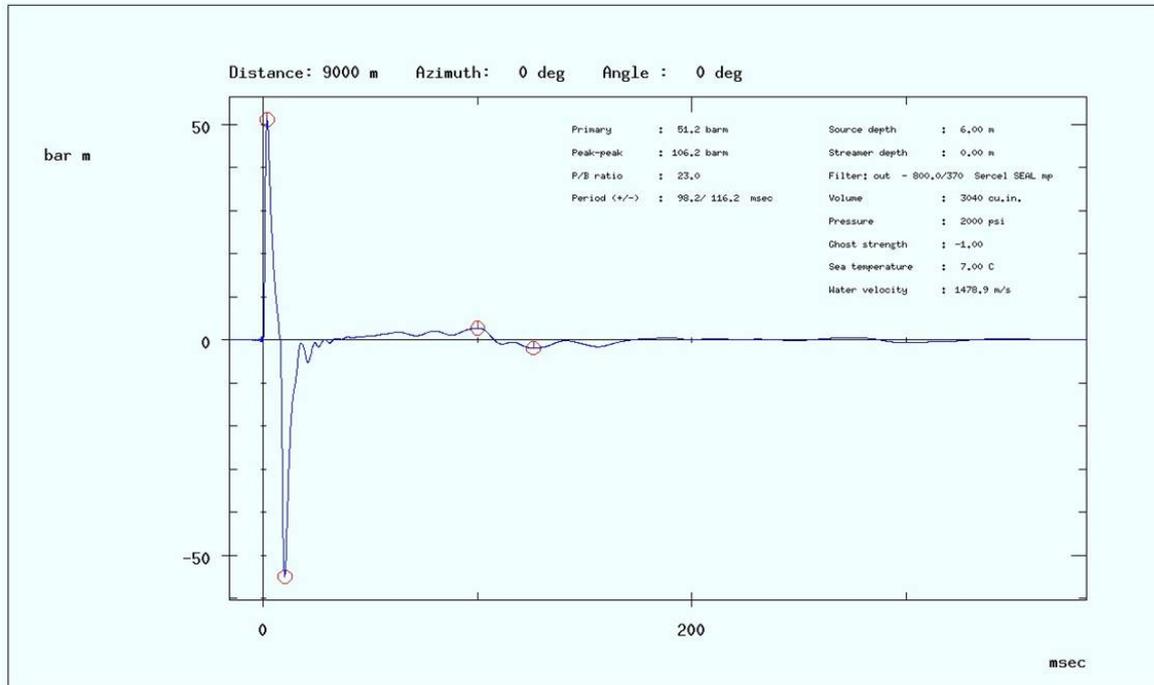
Far-field signature of array : A3040C60PT1S10

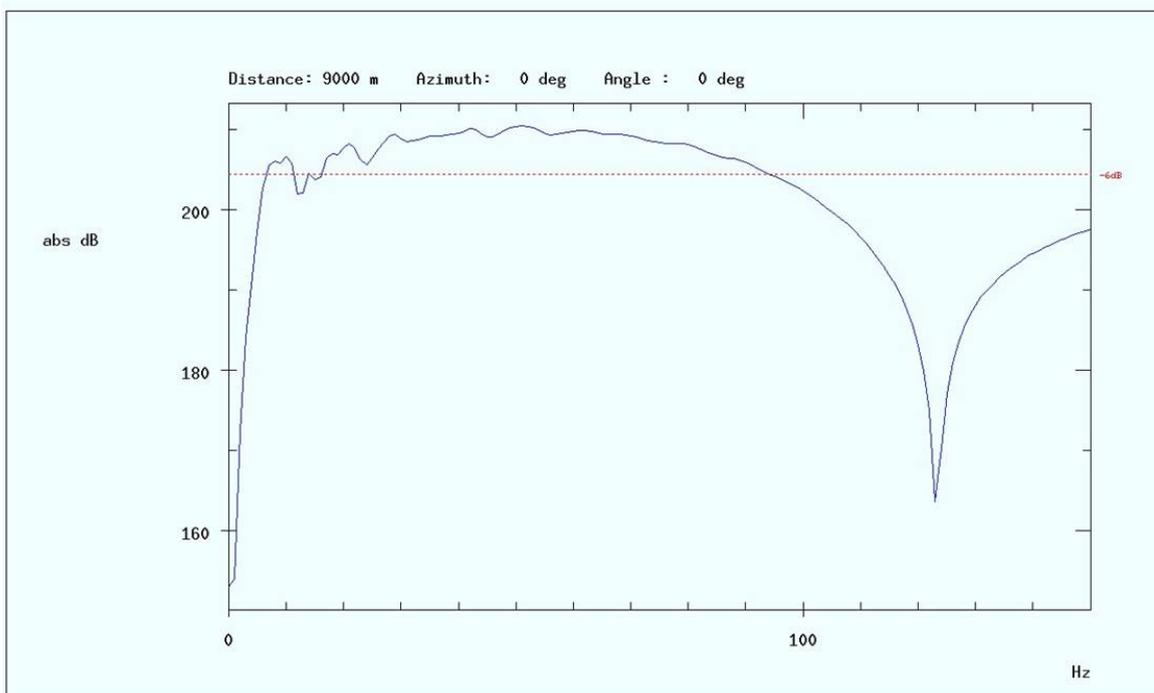
Amplitude spectrum of far-field signature of array : A3040C60PT1S10

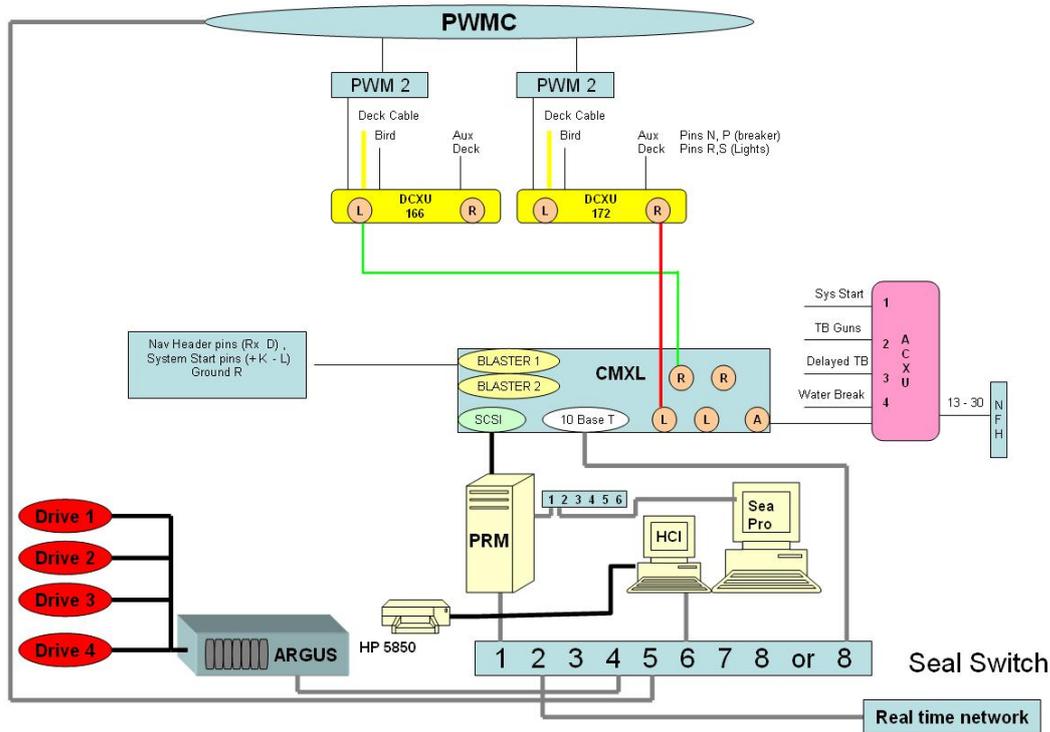
18. Instrumentation and QC System Description

Unit Type	Manufacturer	Software version
Recording	Sercel Seal	Version 5.1.14
Argus	Profocus: Raid disk and data management	Version 4.0
Tape drives	IBM 3590E	
Plotter	Versatech 24inch	
Onboard QC	Seal Seapro QC and ARGUS QC	Version 4.0
Source Controller	Seamap Gunlink 2000	Version 2.4.2
Auxiliary Systems	48 channel (Sercel AXCU)	
Bird Controller	Digicourse DMU + PC	Sys 3v01
Bird Type	Digicourse 5011E	Sys 3v01

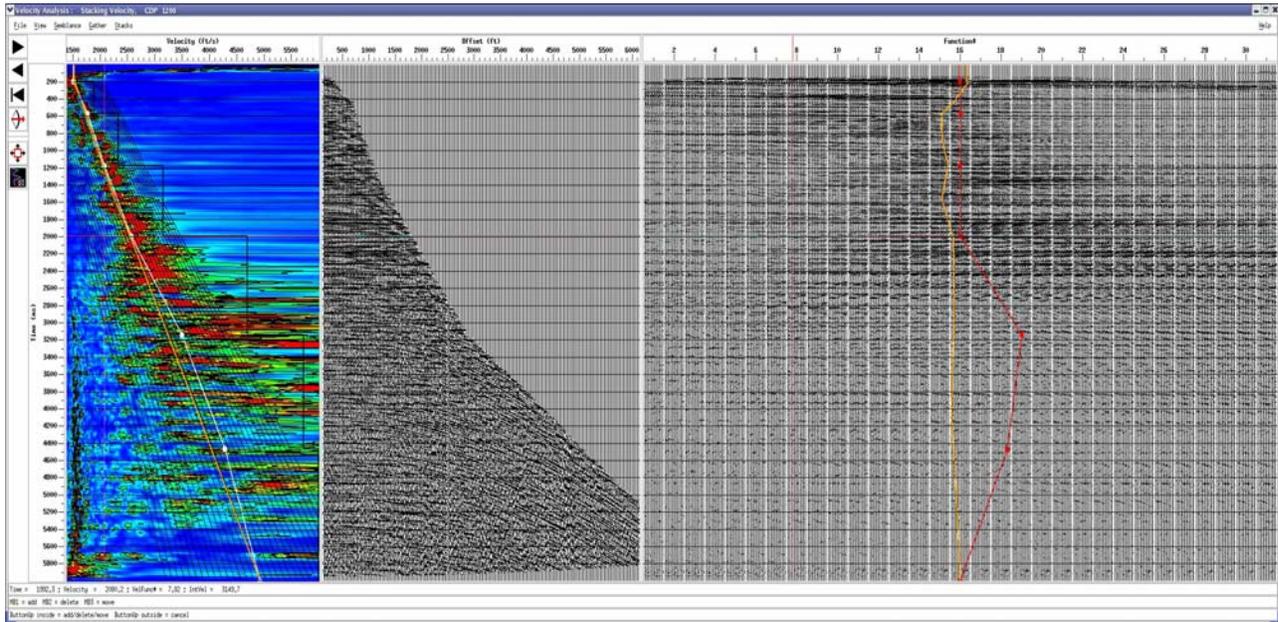
Brute velocities were picked for every line at a 2 km interval using ProMAX's interactive velocity analysis package. This comprised of a semblance display with RMS stacking velocity graph and interval velocity graph, CDP super gather panel and function stack panels.

To improve the signal to noise ratio, super gathers were formed by combining 15 adjacent CDP gathers. Stack panels were created from these 15 CDP's using 31 functions varying +/- 35% from the regional velocity function of the first two sequences. Thereafter, the velocity functions of the nearest adjacent line shot in the same direction, were used as a guide.

Figure 21-1: Velocity analysis for seq. 011. Graphical user interface with semblance, super-CDP gather and function stacks.

To speed up the on-screen velocity picking procedure, the velocity analysis displays were pre-computed. Normal move-out was applied to the gather to check that the events were lining up well.

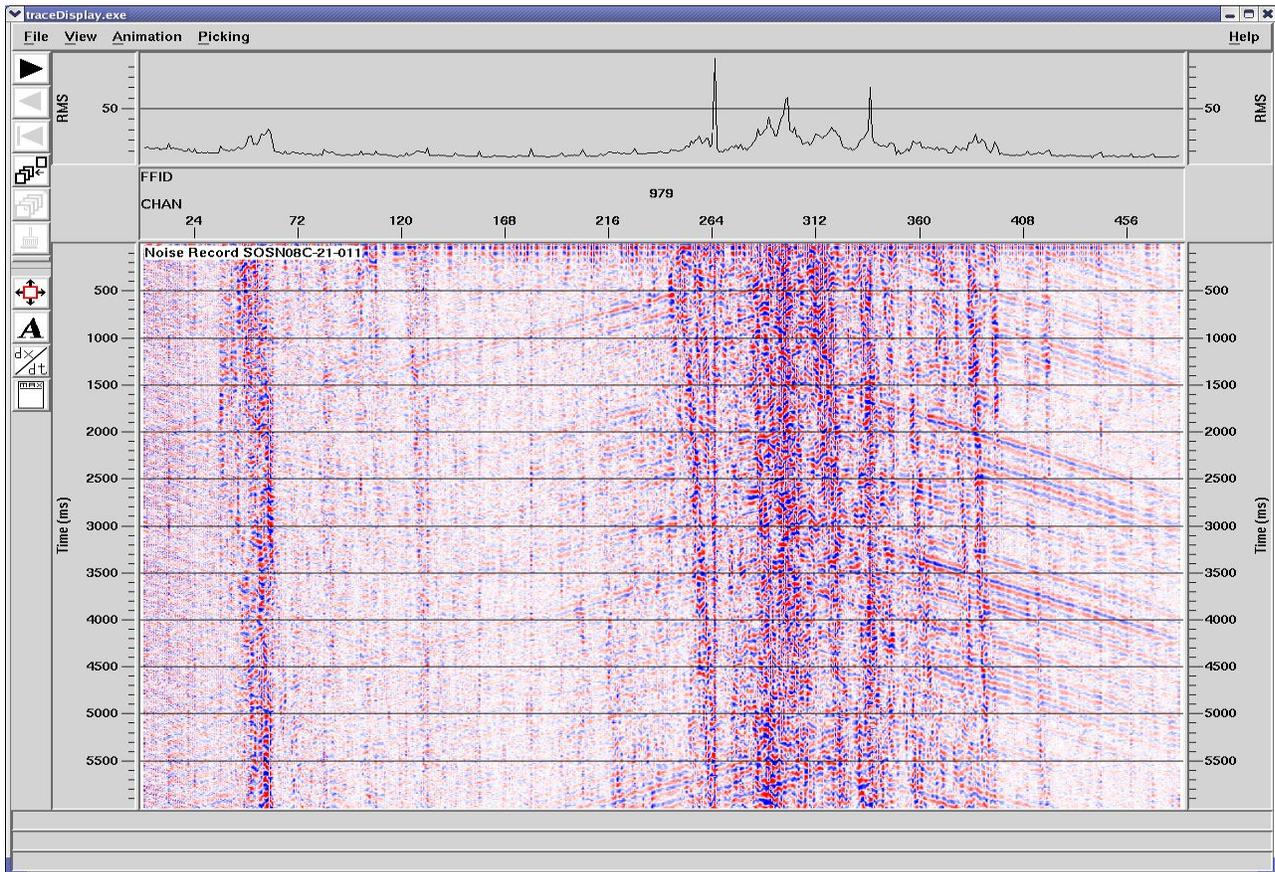
The noise records were recorded at the start and end of every line, and displayed for QC. Channel RMS values were computed for all 480 channels over the entire record for noise analysis, and graphed above the display. For every sequence the noise record at SOL and EOL was displayed on screen and archived to GIF format.

Figure 21-3: Example Noise Record with Channel RMS levels annotated, seq. 011. Note noisy channel 265, and bend noise in the middle of the streamer.

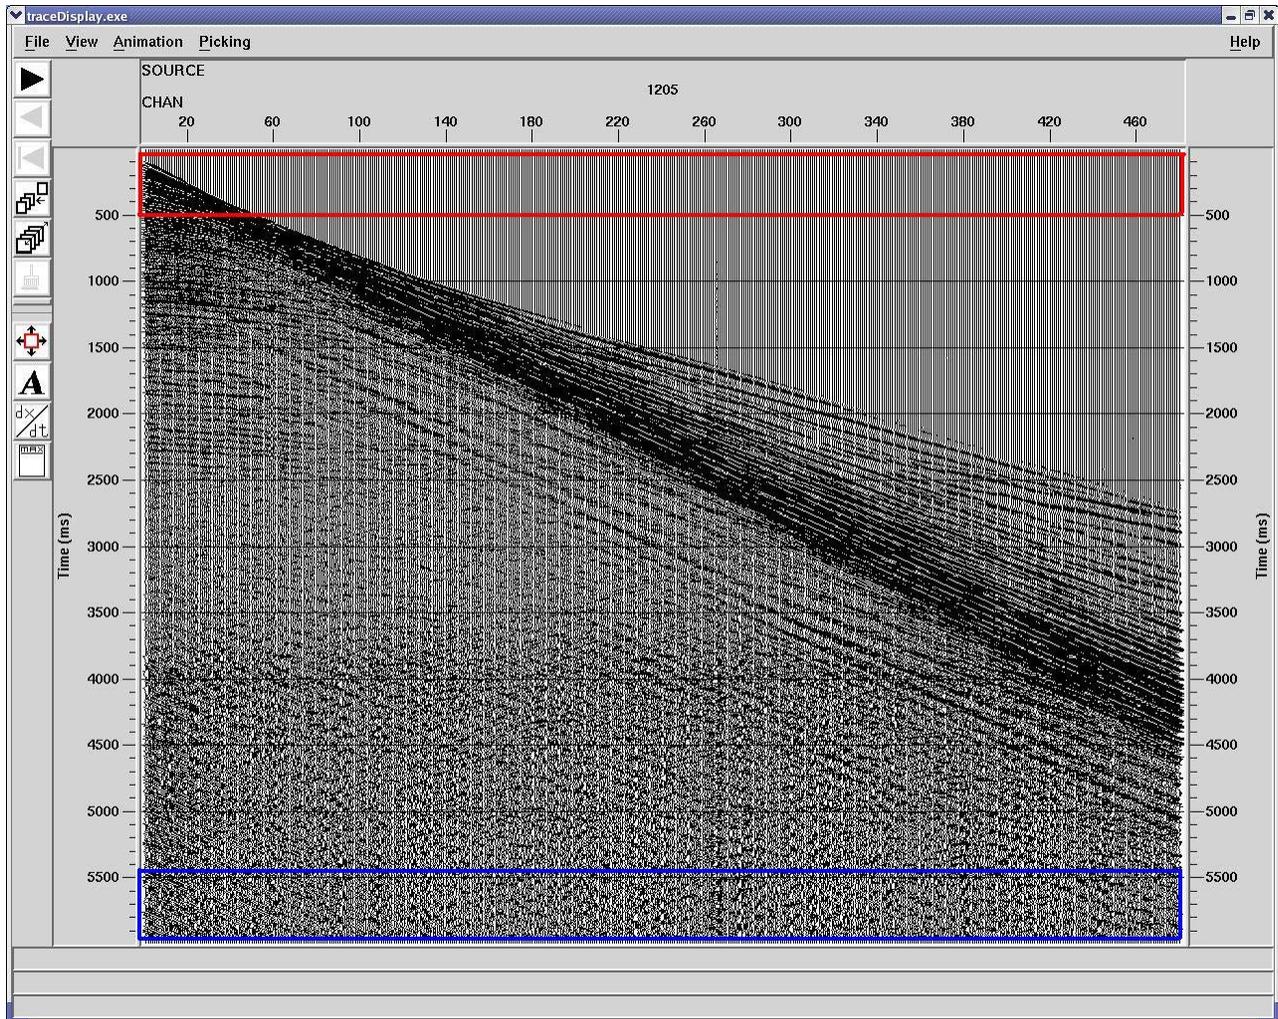
RMS values were calculated from two windows, a shallow window of 50-500ms at the start of the record, and a deep window of 5450-5950ms at the end of the record. RMS values from all channels were averaged for each shot. They were displayed on the graph.

Figure 21-5: Shot gather with shallow and deep RMS analysis windows annotated.

For all RMS computations a scaling factor of 46.5 was used to convert from millivolts to microbars, the instrument sensitivity being 21.5 Volts/Bar.

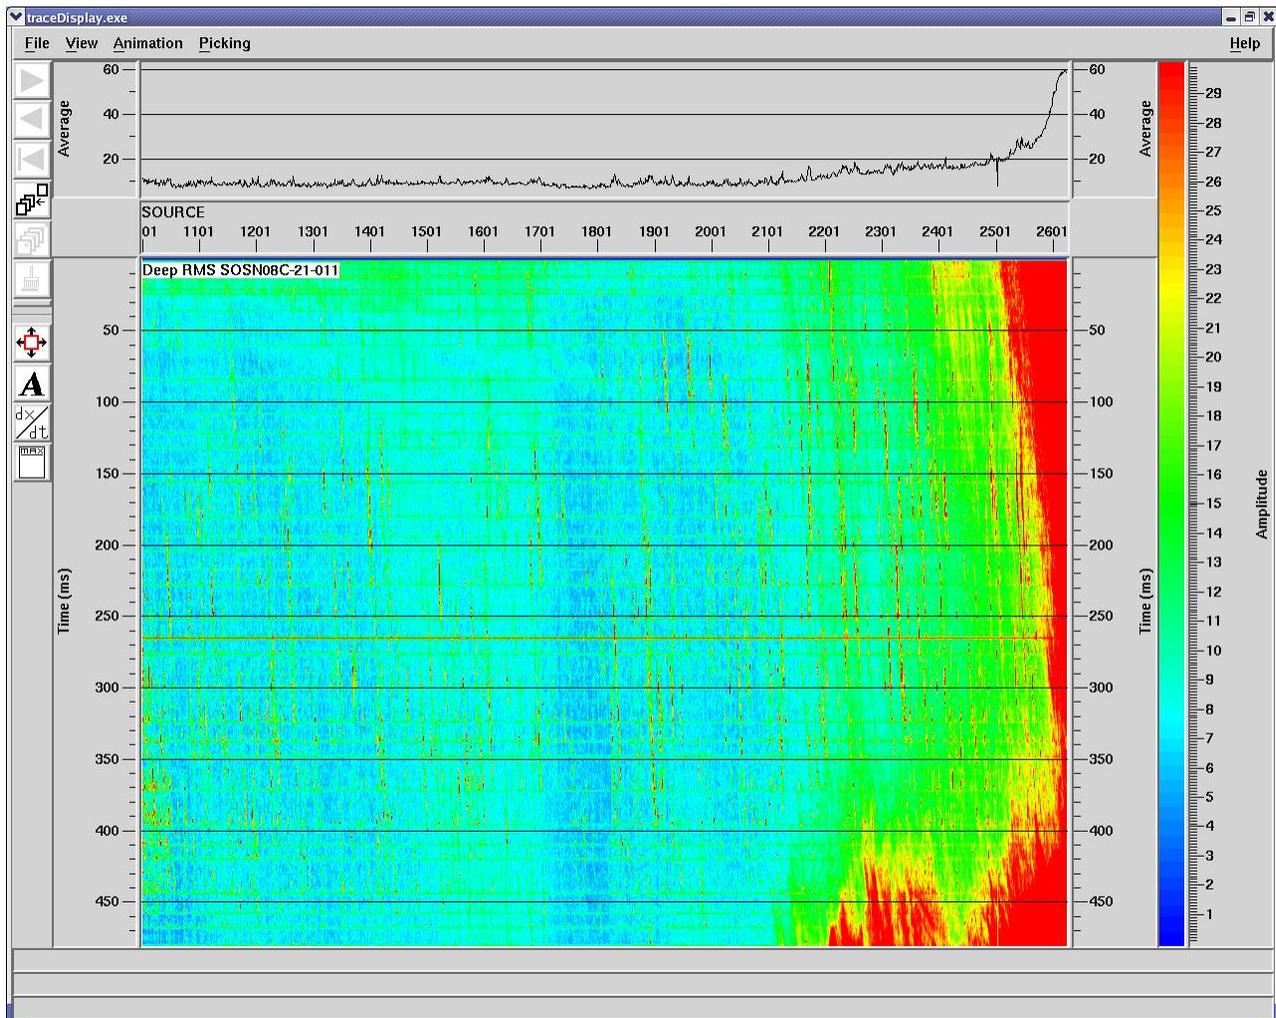
Figure 21-6: Deep RMS window for seq. 011. Note increased residual energy towards deeper end of prospect at

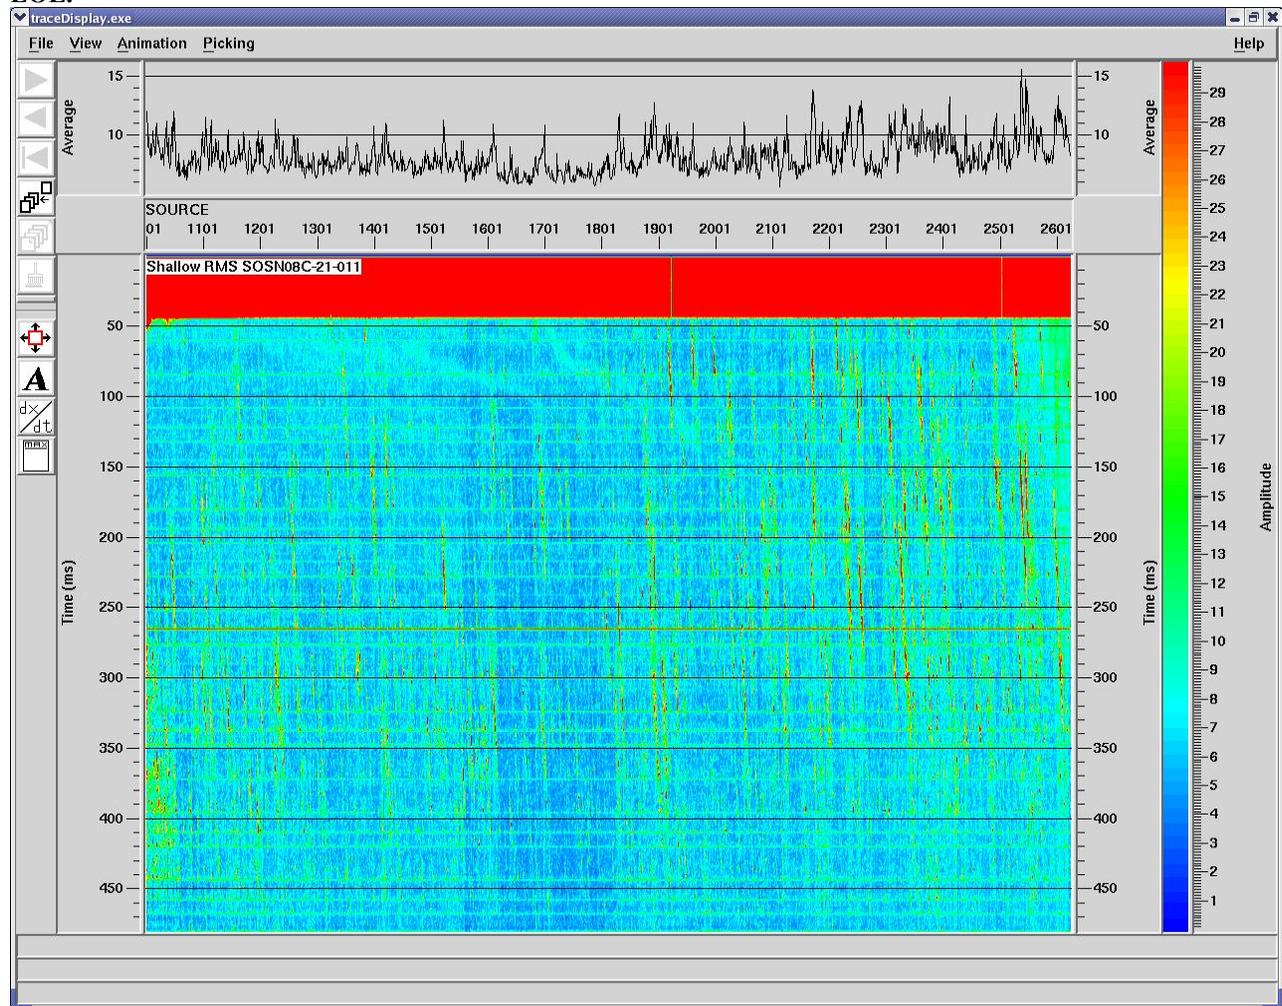
Figure 21-7: Examples of Shallow rms window QC from seq. 011. The first 50 channels are dominated by direct arrival energy. Noise on trace 265 and swell noise are evident.

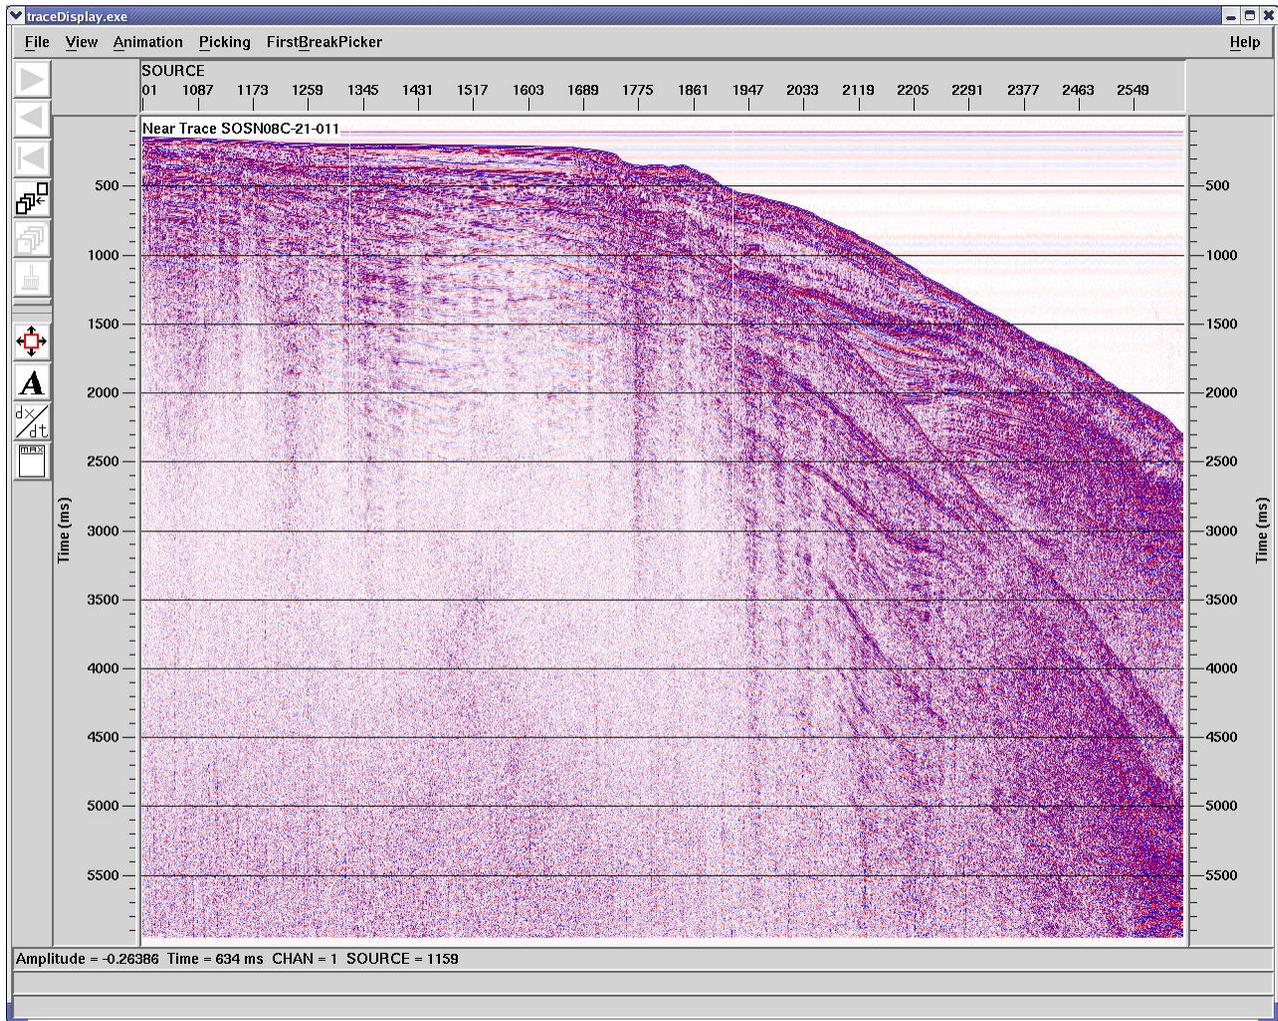
The near traces were displayed on screen for every line in order to quickly determine any possible errors with acquisition, e.g. gun volume changes, bad records, time-break problems and any auto-fires not reported by the recording system. The near traces also provided a good indication of the geological conditions, including strength of the water bottom multiples, residual seismic multiple energy and swell noise contamination.

Figure 21-8: Near trace display, seq. 011.

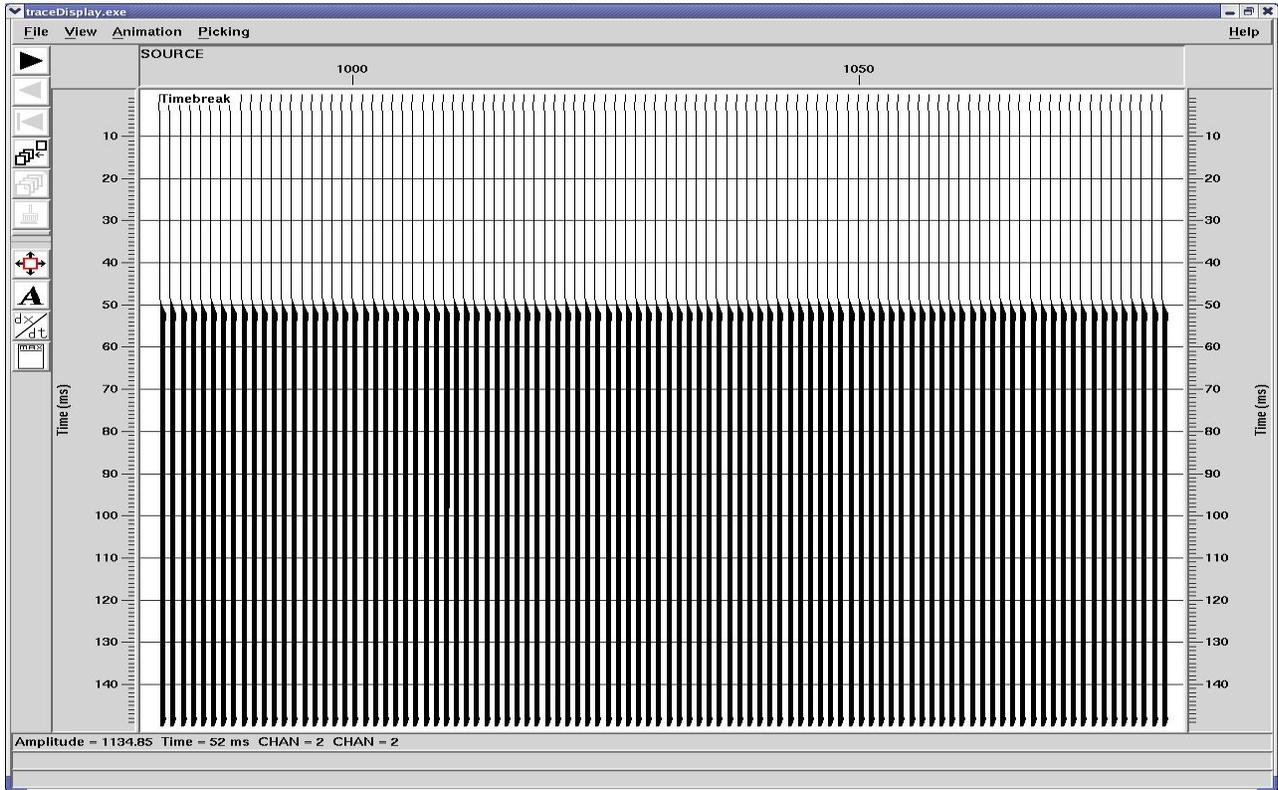
Time break and water break channels were displayed as a single trace display on screen. The first 500ms from all 6 hydrophones within each sub-array were stacked vertically and displayed in order to evaluate the performance of the guns. This proved useful in distinguishing genuine gun problems from noise on the trace. The auxiliary channel displays were used to locate air leaks and autofires.

Figure 21-9: Timebreak QC (Auxiliary channel 1).

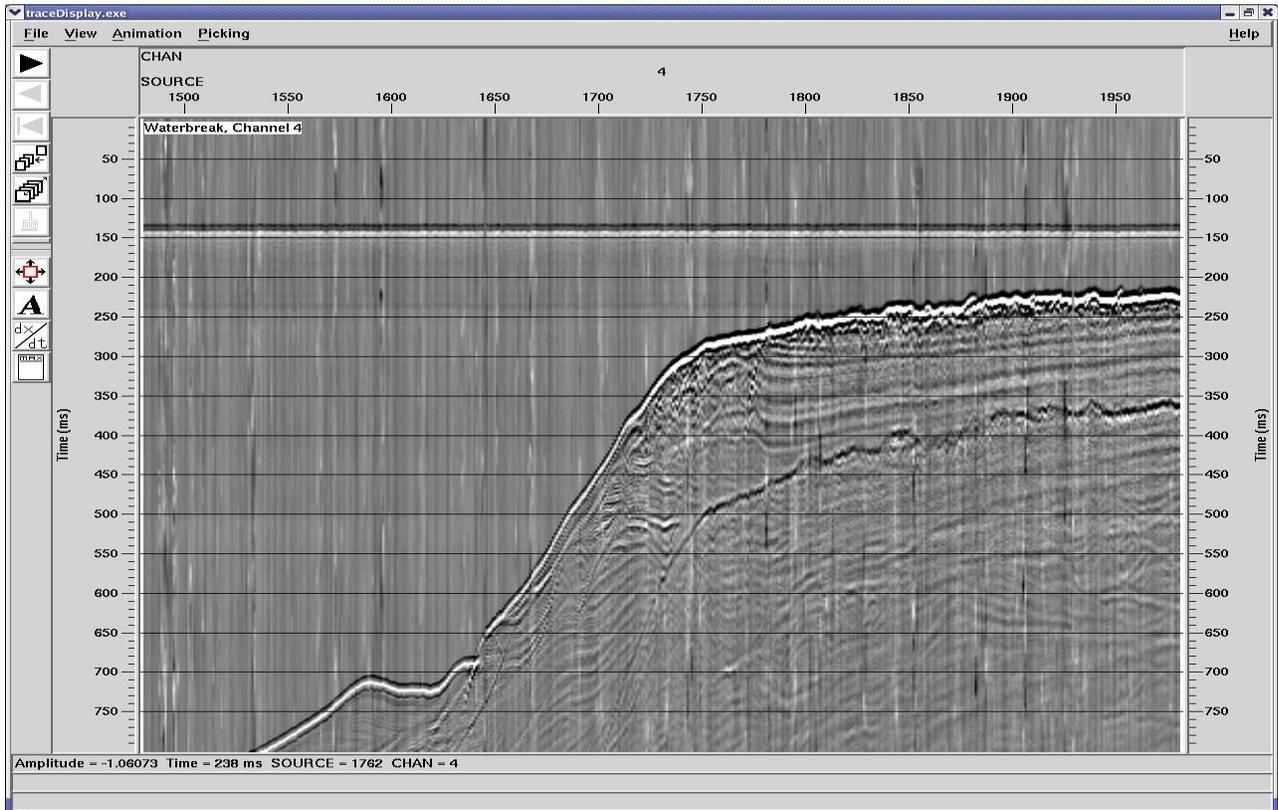
Figure 21-10: Waterbreak hydrophone QC (Auxiliary channel 4).

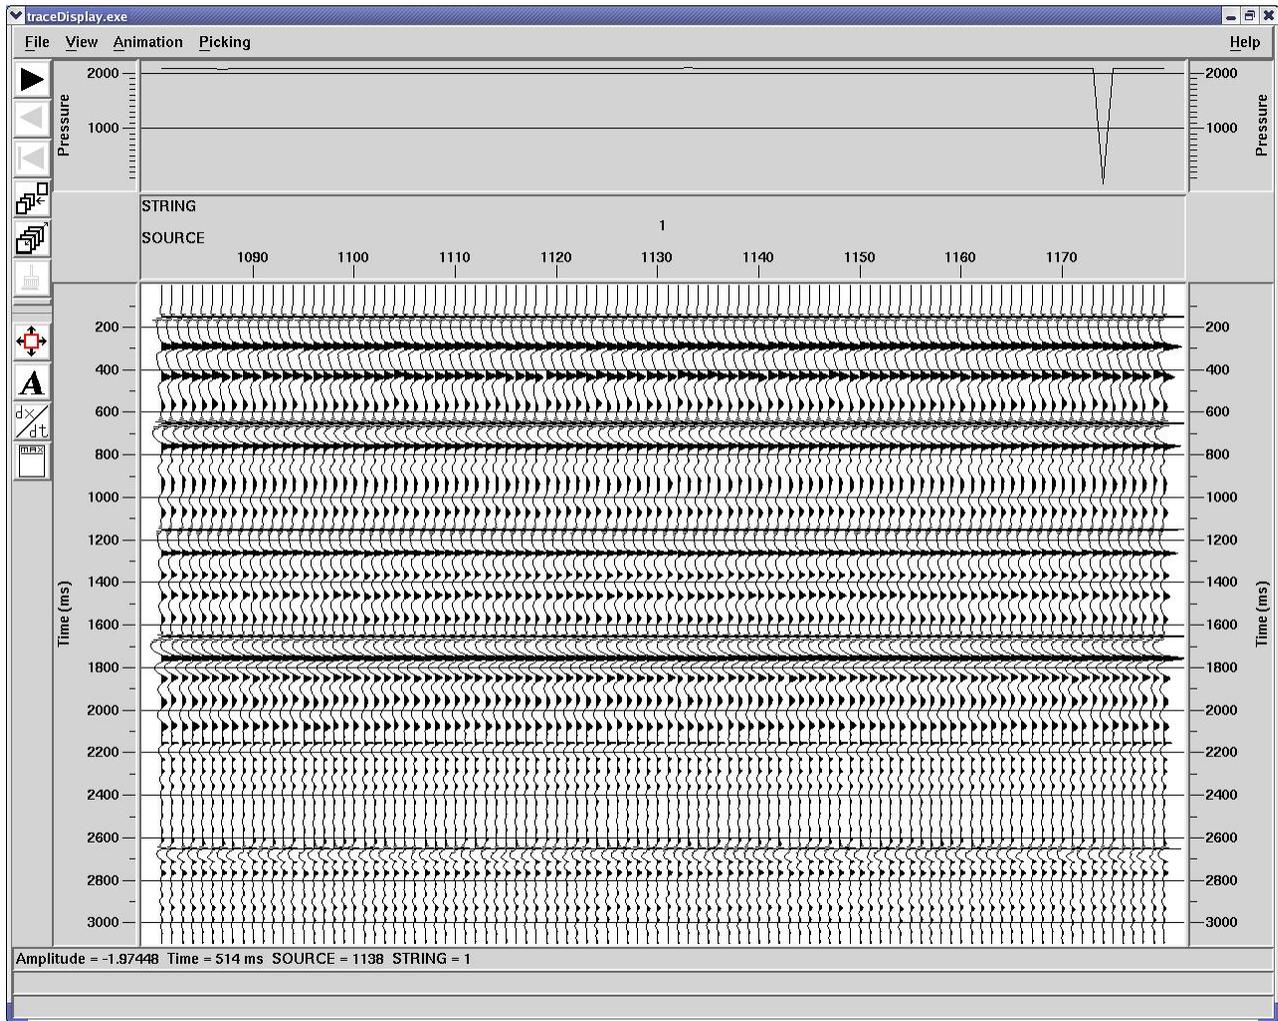
Figure 21-11: QC of vertically stacked near field hydrophones 1 to 6 on gunstring 1 (Auxiliary channels 13 to 18). Note annotation of gun pressures, missing header for SP 1174.

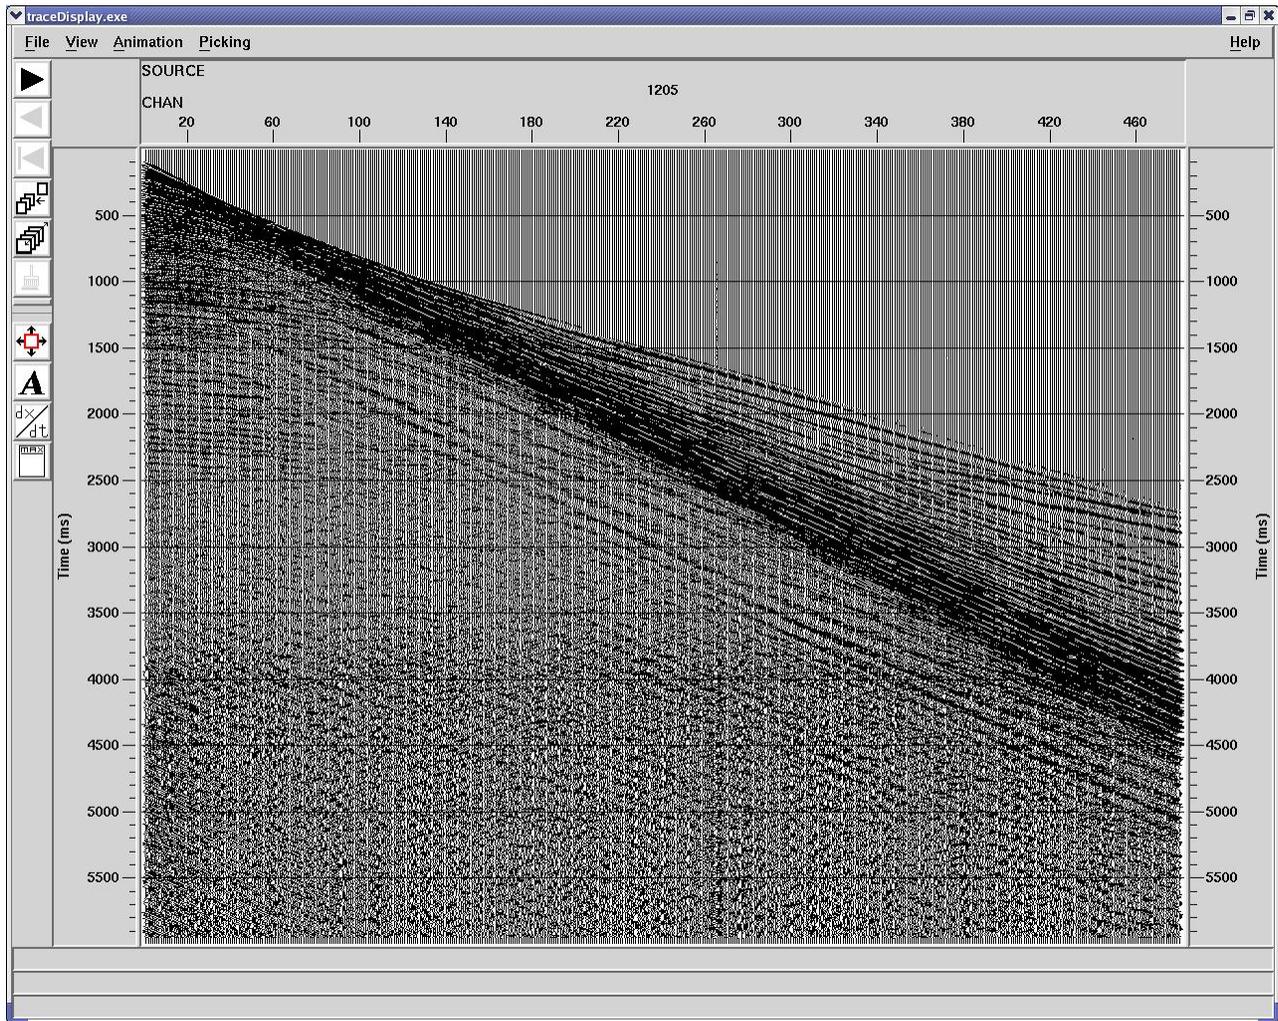
Consistently noisy channels were also identified on the raw shot displays, and cross checked against the Observer Logs, which were modified if necessary.

Figure 21-12: Raw shots display, SP 1205, seq. 002. Note strong refraction multiples from the seabed on the longer offsets and noise on channel 265.

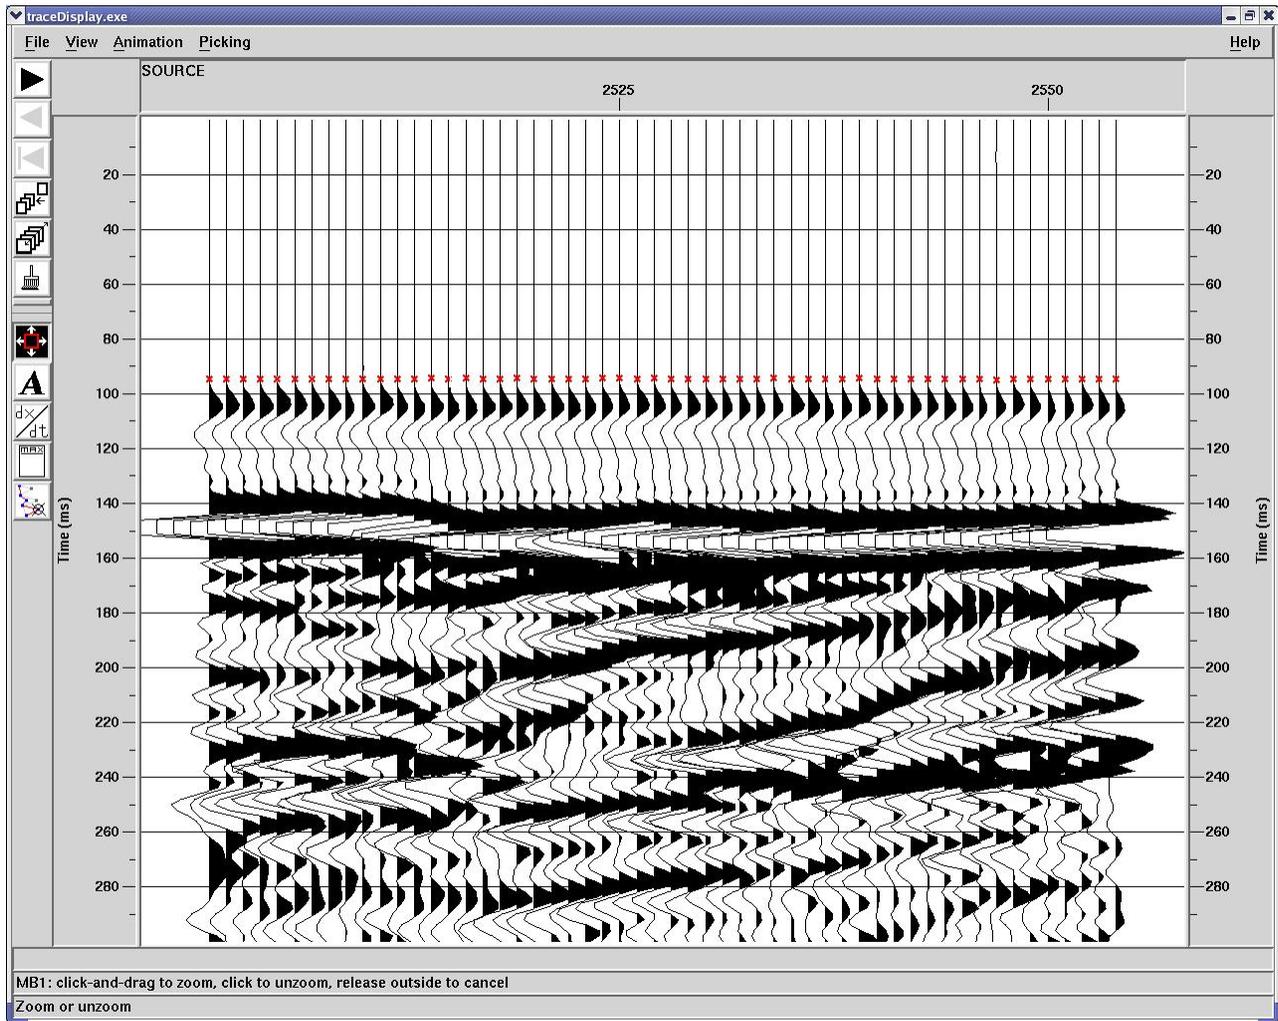
In order to QC the navigation data, the final processed P190 navigation files were merged with the near traces for each line. The predicted first break time was computed using the water velocity. This was displayed overlaid on the near trace as seen below (in red), to enable QC of the consistency between the predicted and the recorded first breaks.

Figure 21-13: Navigation QC display.

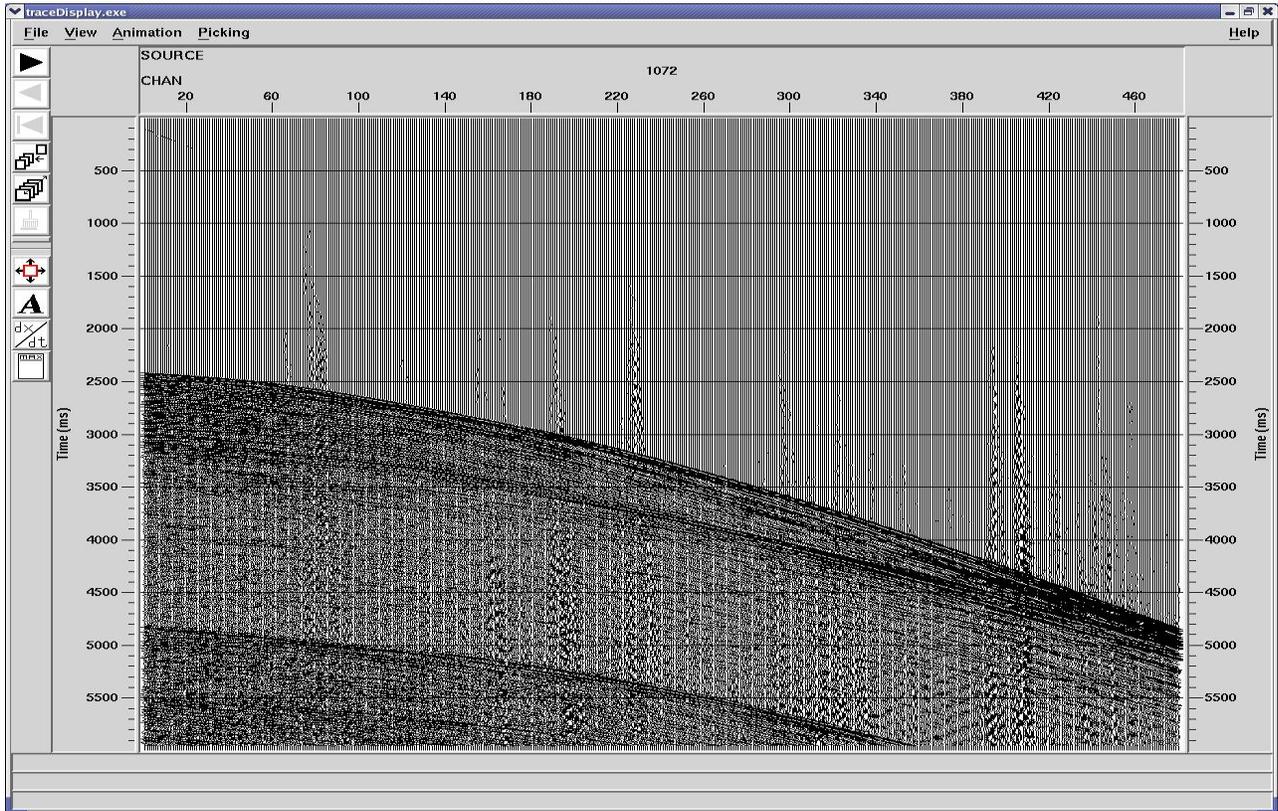
Swell bursts were seen on the raw shot records, typically affecting less than 10% of the traces, usually at a level below 25ub. Because of the high fold of coverage, this noise invariably stacked out, even with no noise attenuation processes applied to the data.

Figure 22-1: Shot gather of SP 1072 for seq. 019. Swell noise affecting approx 10% of traces is evident.

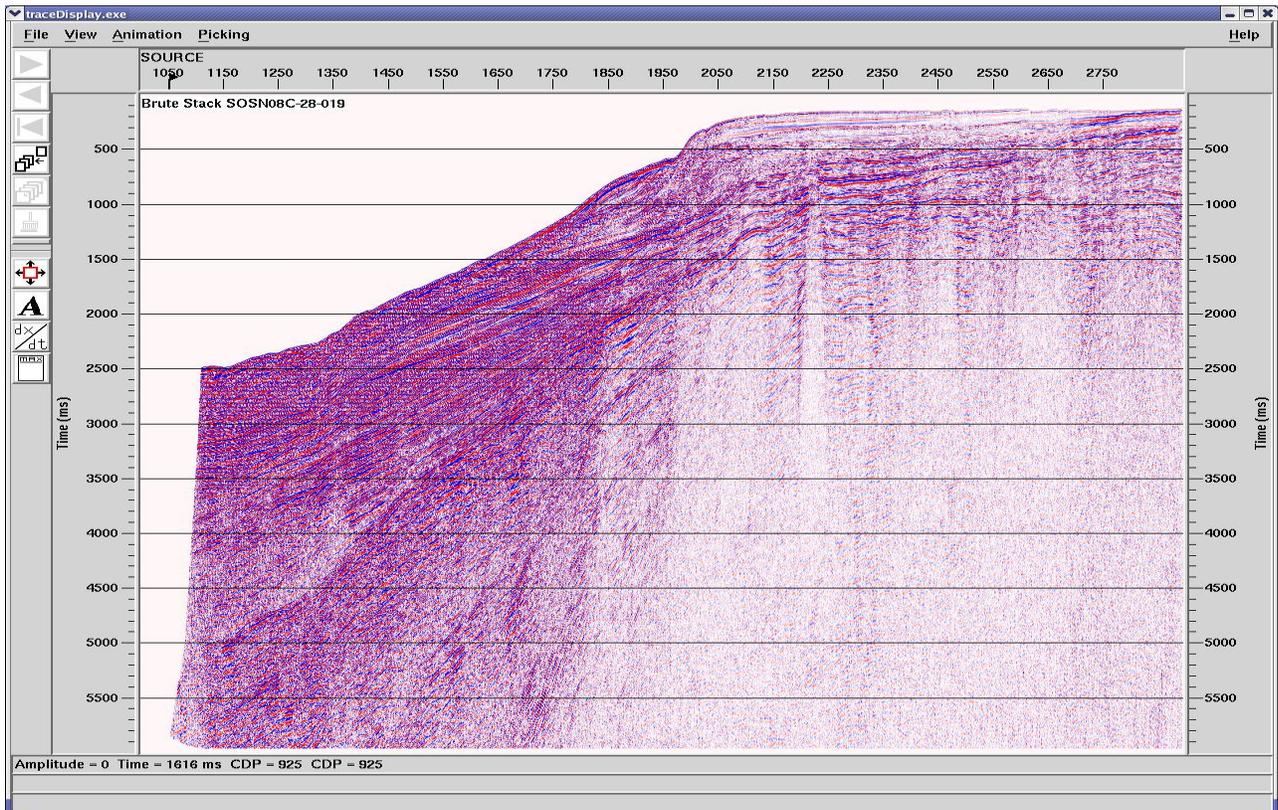
Figure 22-2: Brute stack for seq 019. Not noticeably affected by swell.

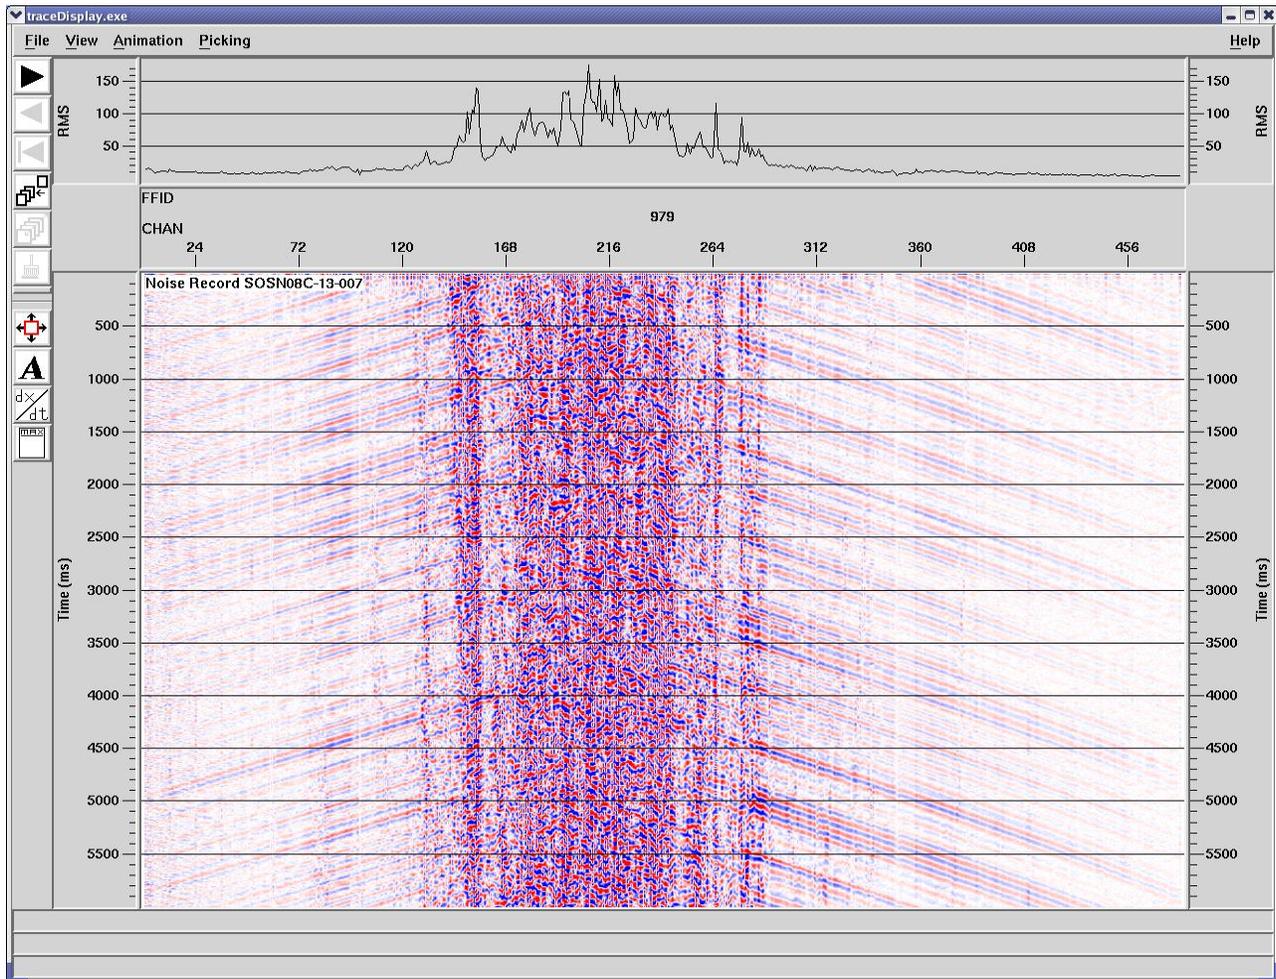
On occasion the streamer was still in turn when the SOL noise files were recorded, due to the line run-in being constrained by safe navigation areas, with associated noise up to 150ub. Notes regarding the sequences affected can be found in the QC logs.

Figure 22-4: SOL noise display of sequence 007. Streamer still in turn while SOL noise records were taken.
