FINAL SURVEY REPORT

VESSEL: M/V PACIFIC TITAN

- Marine 2D & High Resolution SEISMIC REFLECTION METHOD ACQUISITION -

Location	:	AUSTRALIA
Area	:	West of Tasmania - Australia
Survey	:	T/48P KING ISLAND 2D - SOSN08C MARINE
SEISMIC SURVEY		
Client	:	SANTOS OFFSHORE Pty Ltd
Duration	:	04th March 2008 - 12th March 2008
C.G.G.V. SURVEY N°	:	501 11 89 07 06 00 (Job N°: 6374)
CONTRACT N°	:	859832

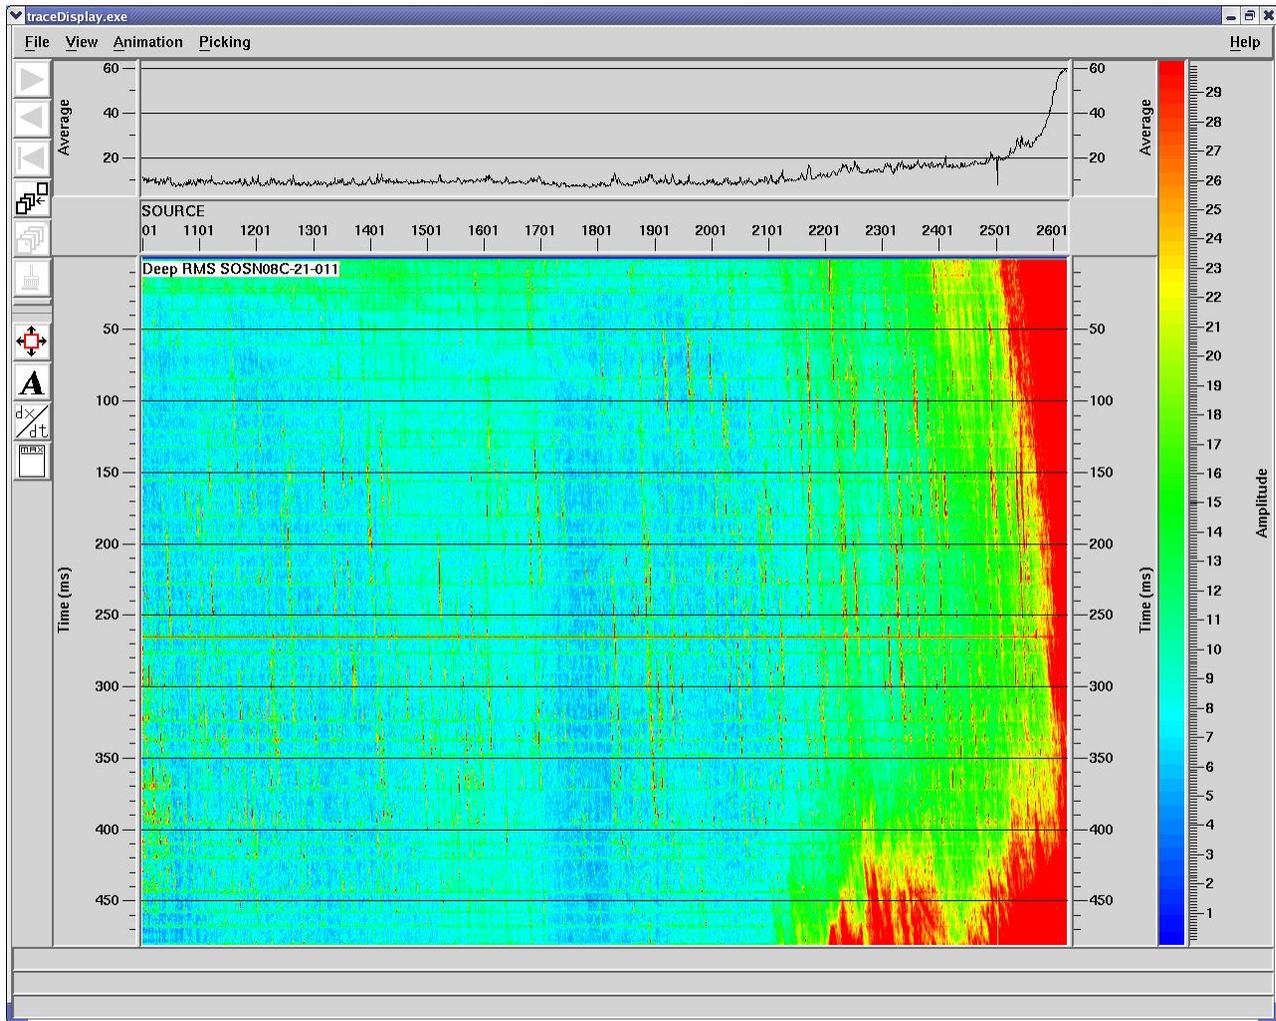
In the prospect area residual energy extending into the next shot was occasionally observed. This resulted in increased RMS.

Figure 22-5: Residual reflection's energy on deep RMS shot vs. channel screen display of sequence 011.

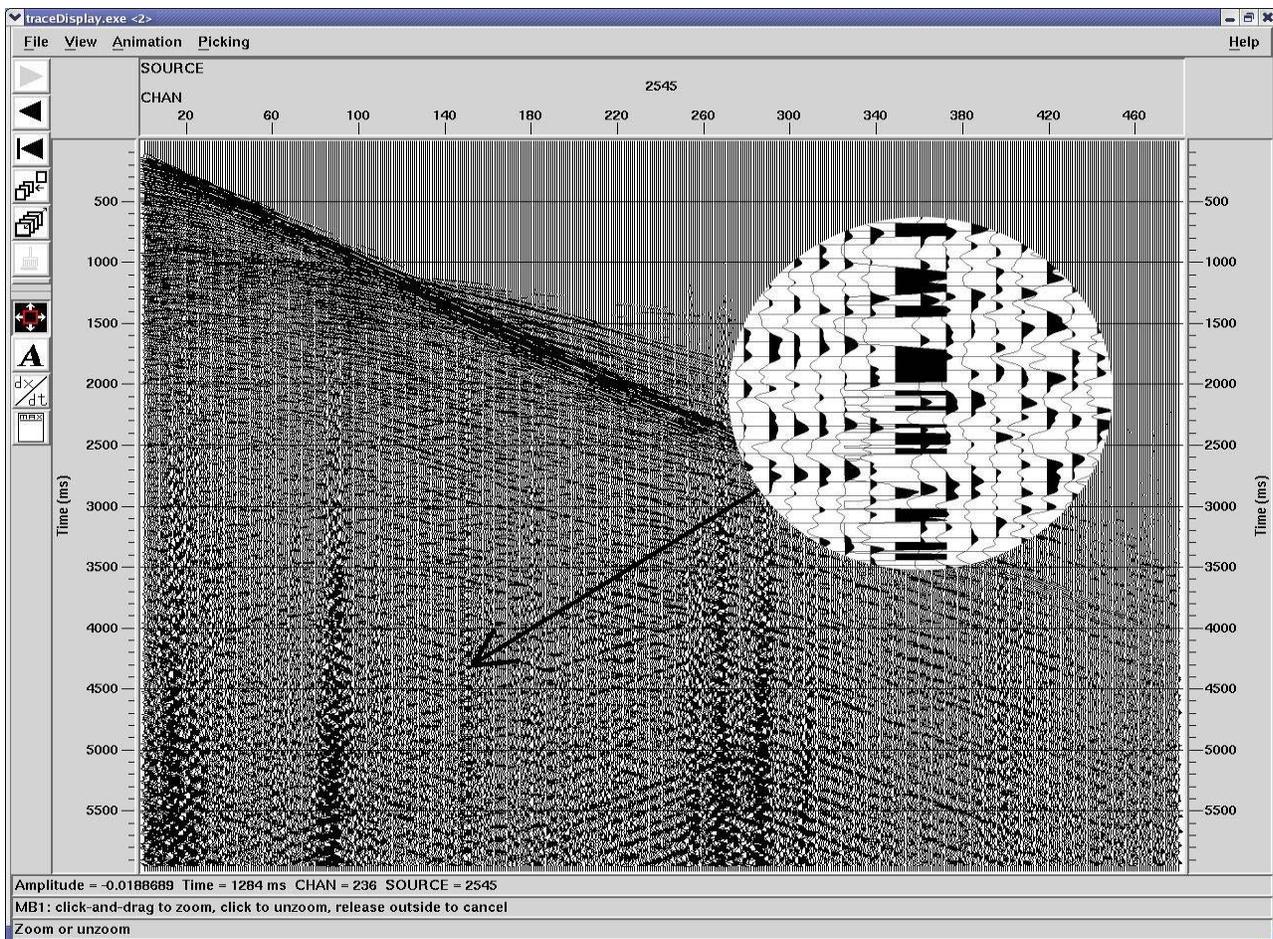
Figure 22-7: Shot gather of SP 2545 for seq. 017. Note spiky channel 150.

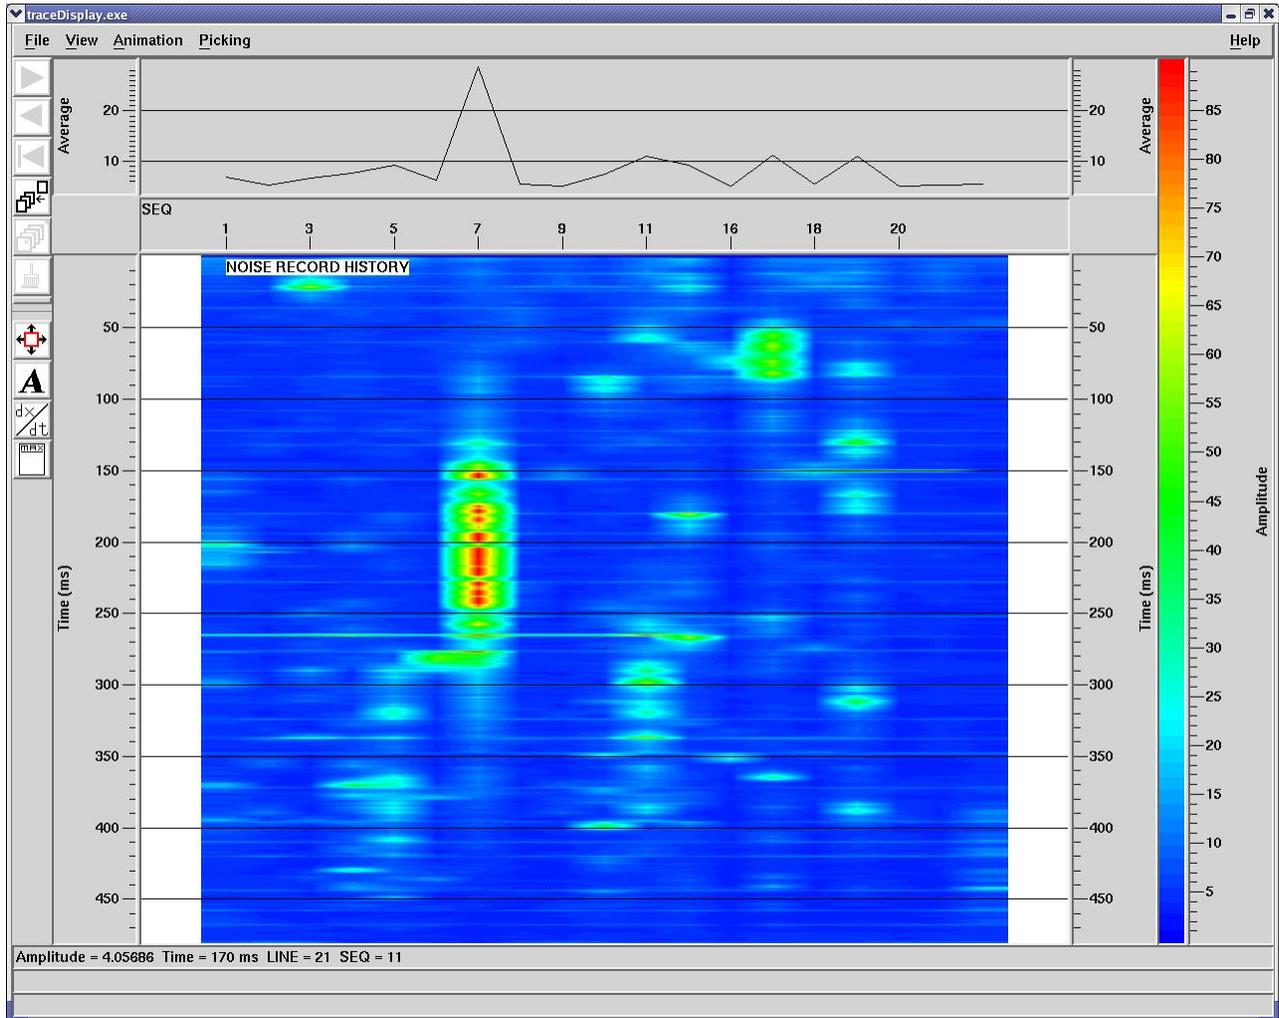
All channels for each noise record have been stacked together to a single trace, and these average channel values are annotated above the display.

Figure 22-8 : Noise history display for Sequences 001 to 022.

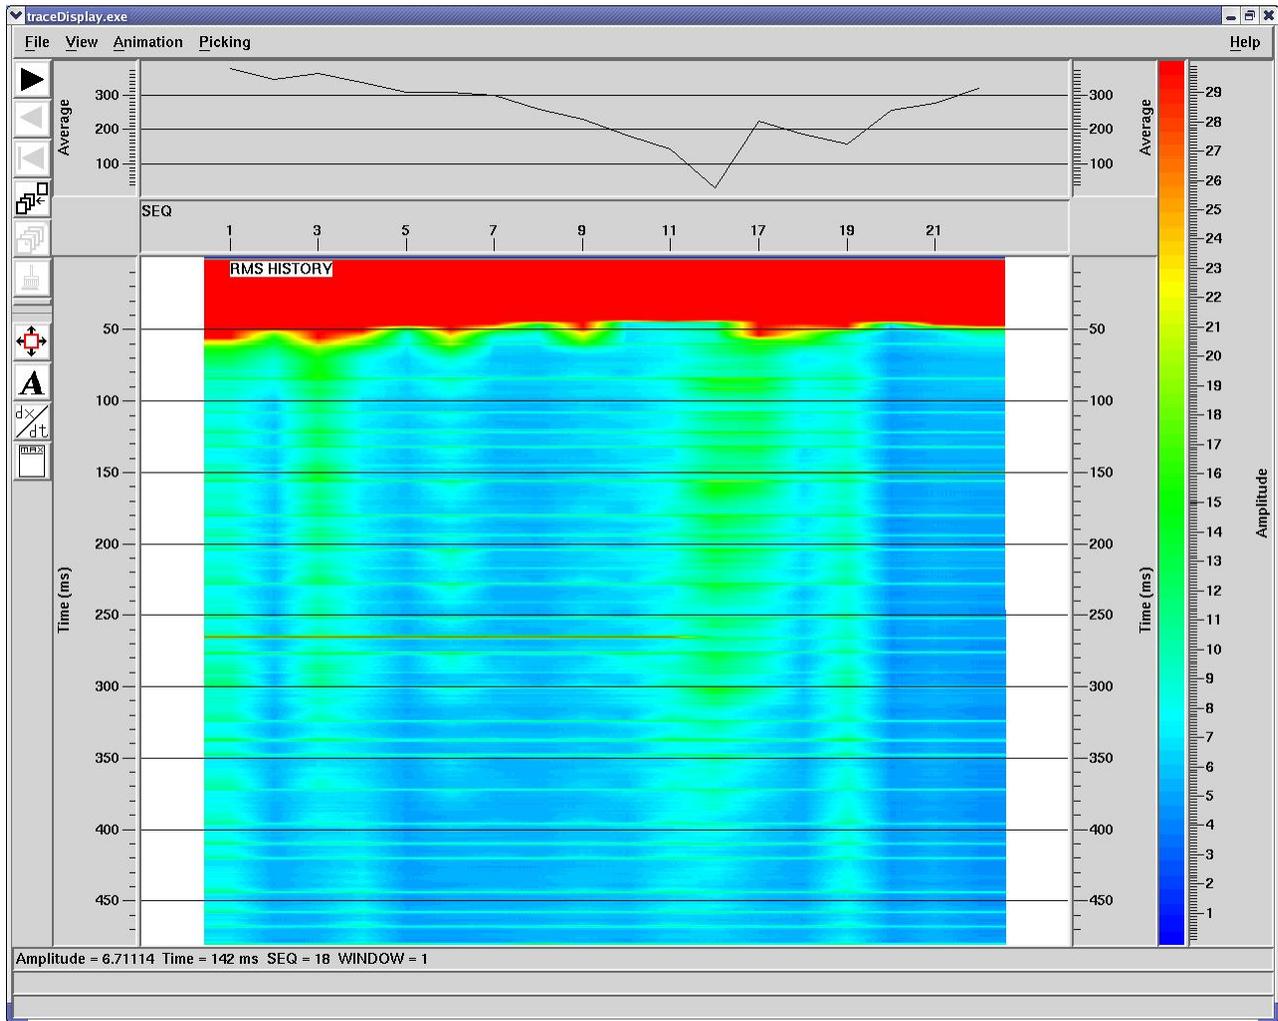
The following display shows the line average RMS for each individual channel on the streamer for Sequences 001 to 022, calculated from the shallow RMS window at 50 to 500 ms.

Figure 22-9: Shallow RMS history display for sequences 001 to 022. Showing some sequences affected by low amplitude swell noise and the first 50 channels dominated by direct arrival energy.

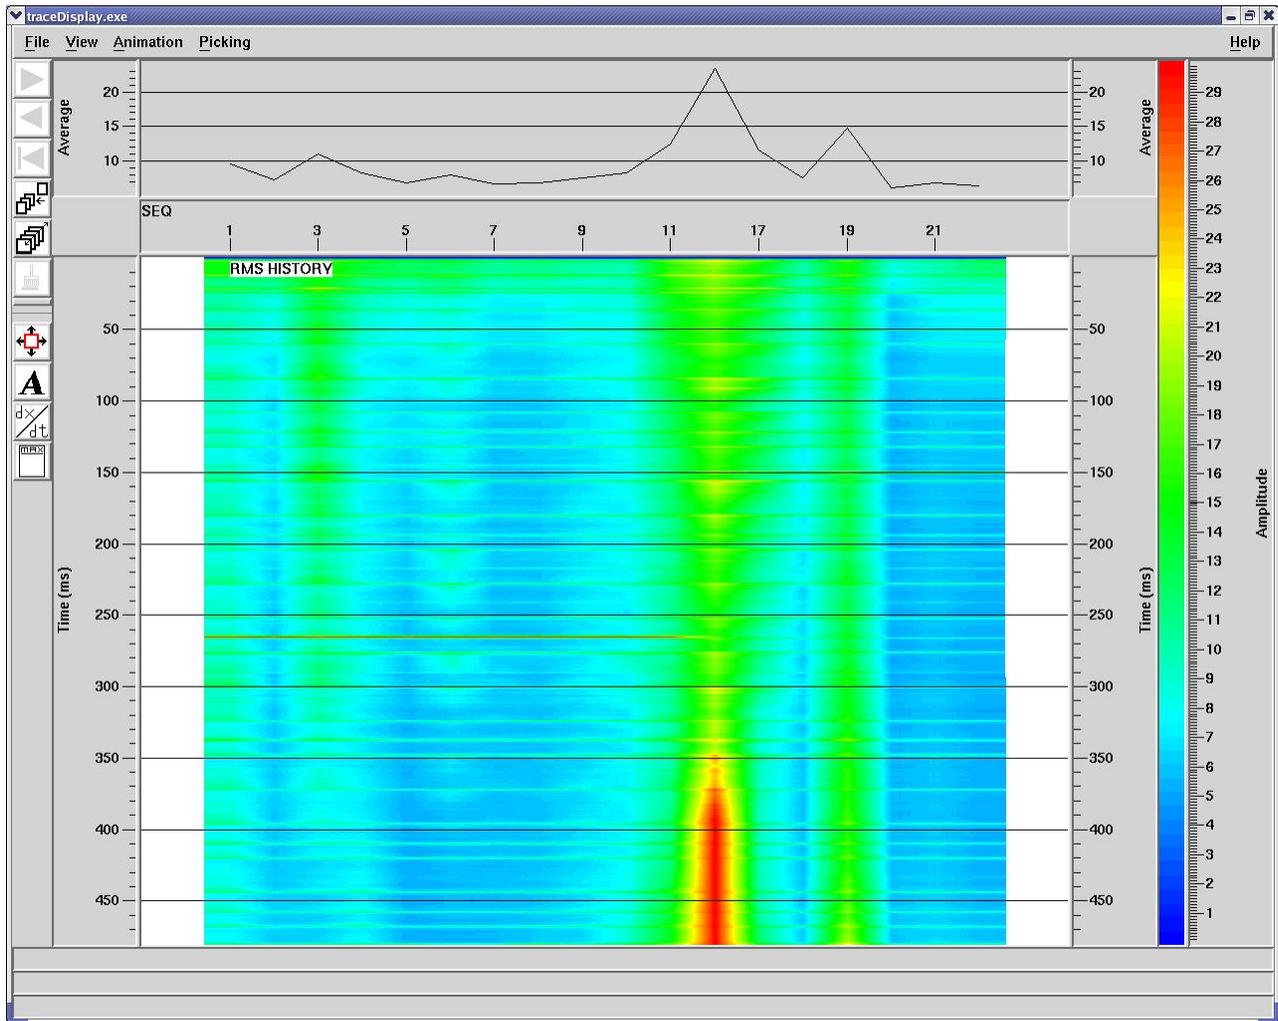
The following display shows the line average RMS for each individual channel on the streamer for Sequences 001 to 022, calculated from the deep RMS window at 5450 to 5950 ms

Figure 22-10 History of deep RMS window. Showing some sequences affected by low amplitude swell noise and residual energy.

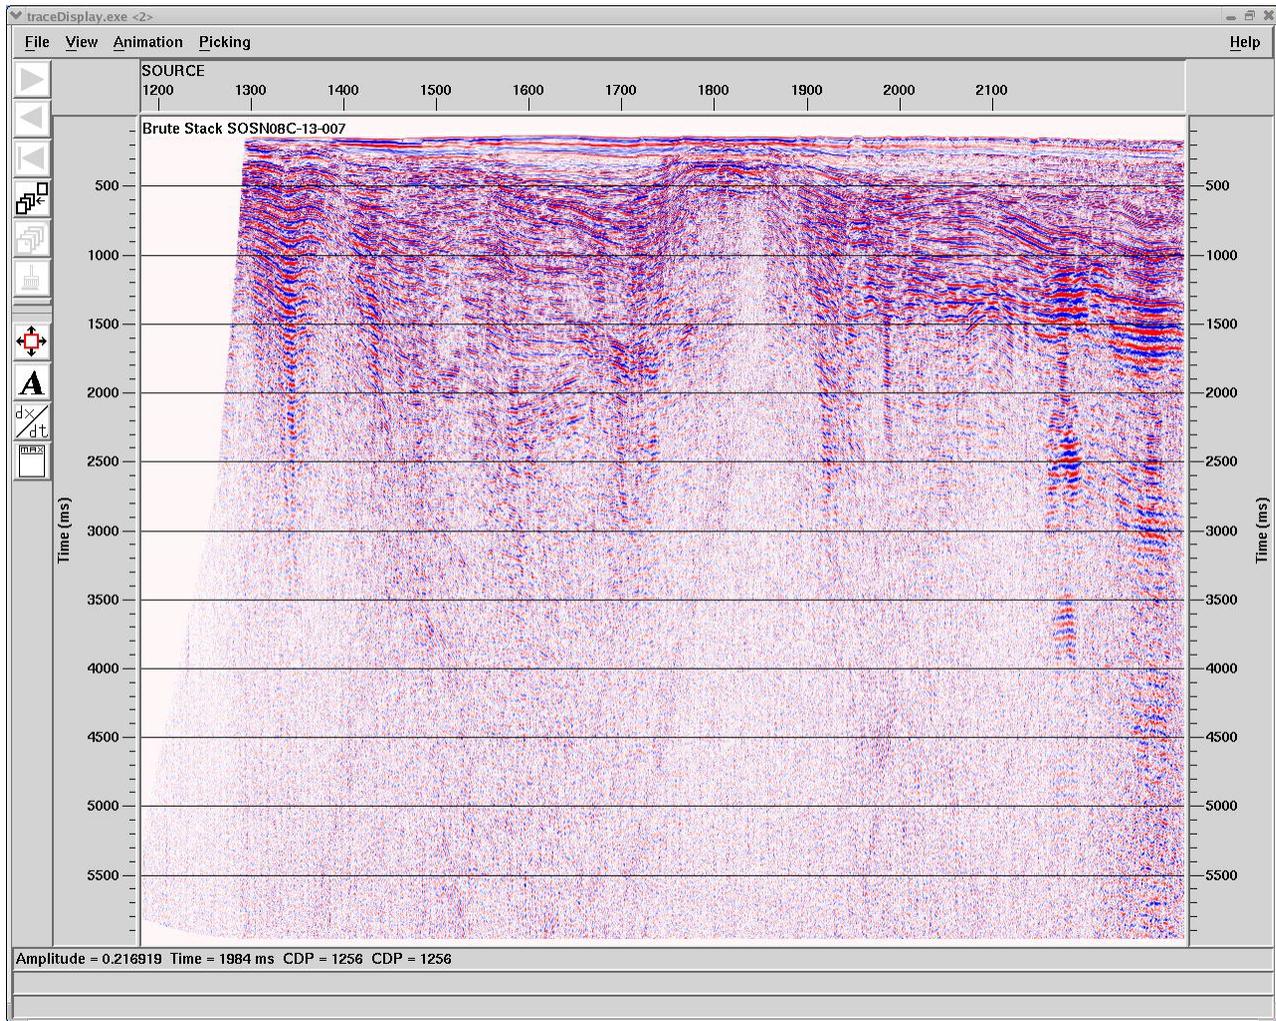
Signal penetration was good for the top half of the record, but poor beyond this, probably as a result of the high reflectivity of the intermediate layers. Strong multiples were observed.

Figure 23-1: Brute stack of sequence 007.

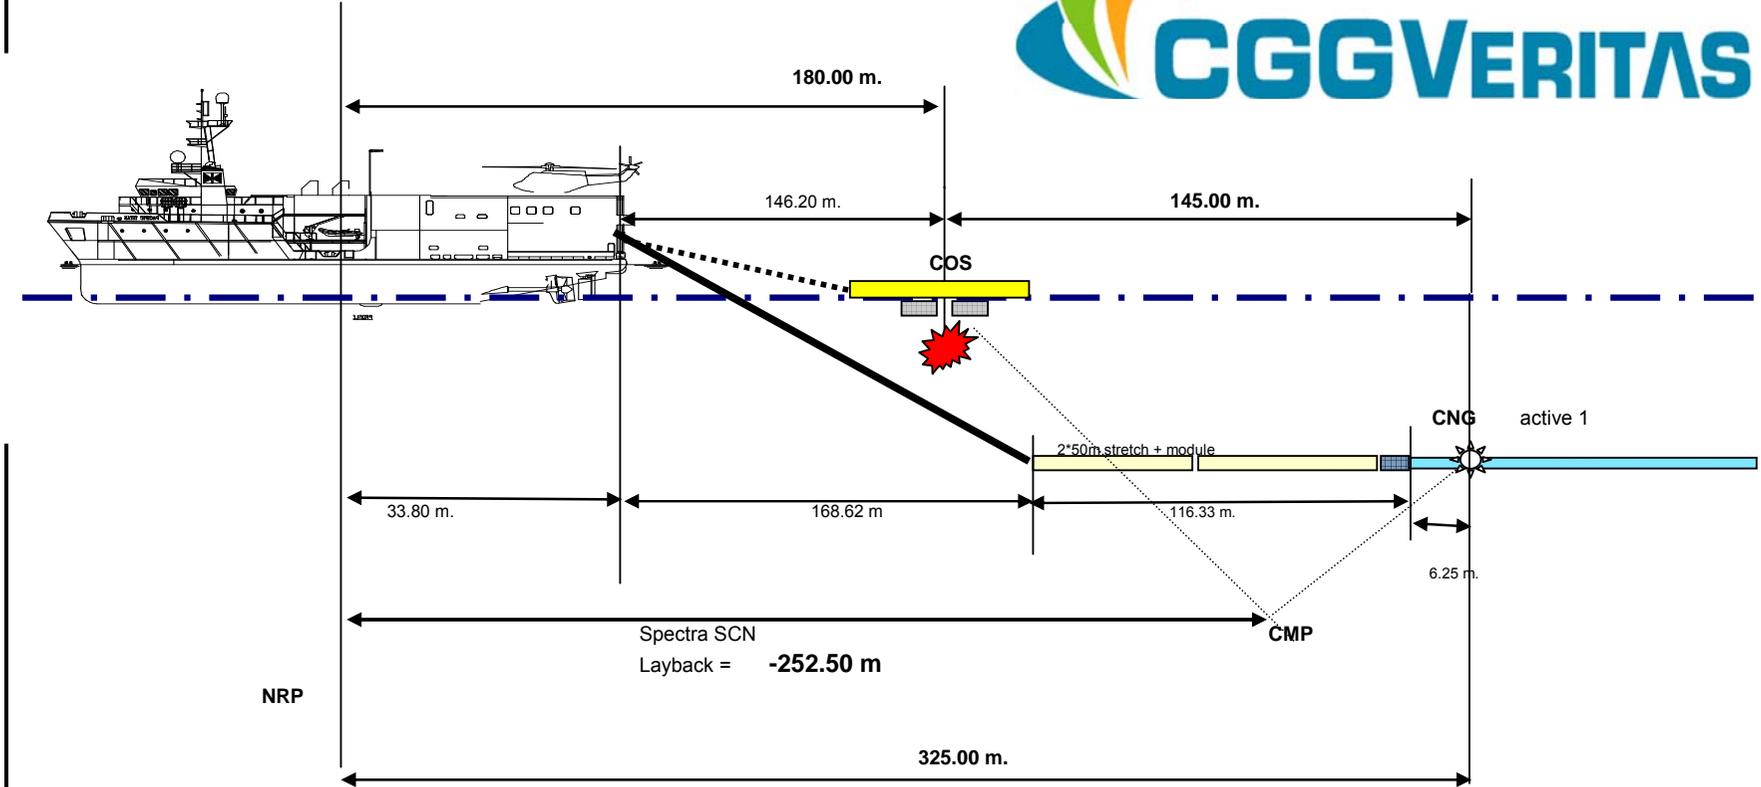
M/V Pacific Titan Towing Dimensions/Offset Diagram

Principal Distances:		Principal Offsets:		Used as:
NRP-Stern	33.80 m.	COS-CNG	145.00 m.	
Stern-COS	146.20 m.	NRP-CMP	-252.50 m	Spectra SCN Layback
Stern-CNG	291.20 m.			
NRP-COS	180.00 m.	NRP-CNG	325.00 m.	Offset from NRP

Centre near group derived from Seal manuals = 6.25m from coupling

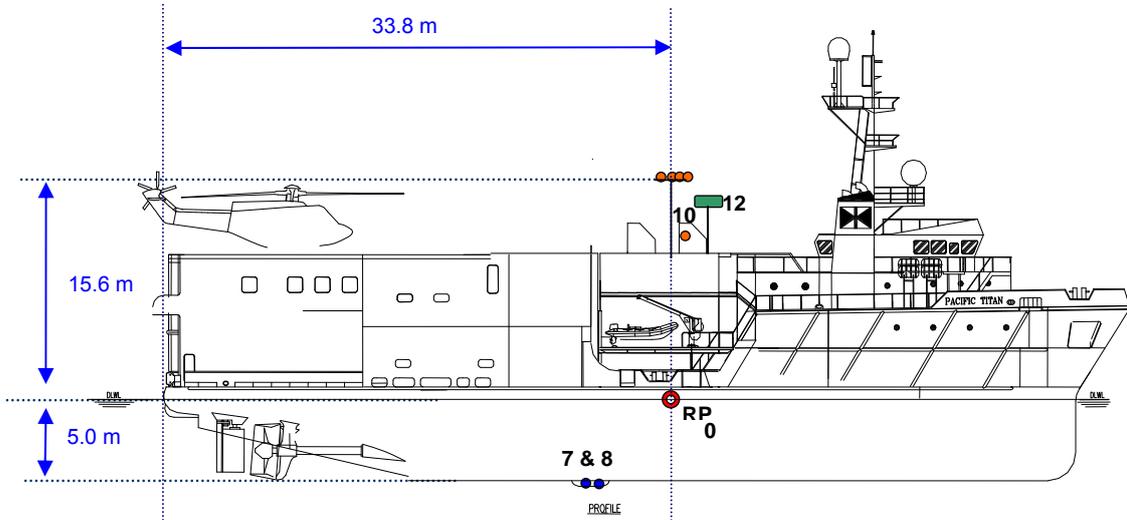
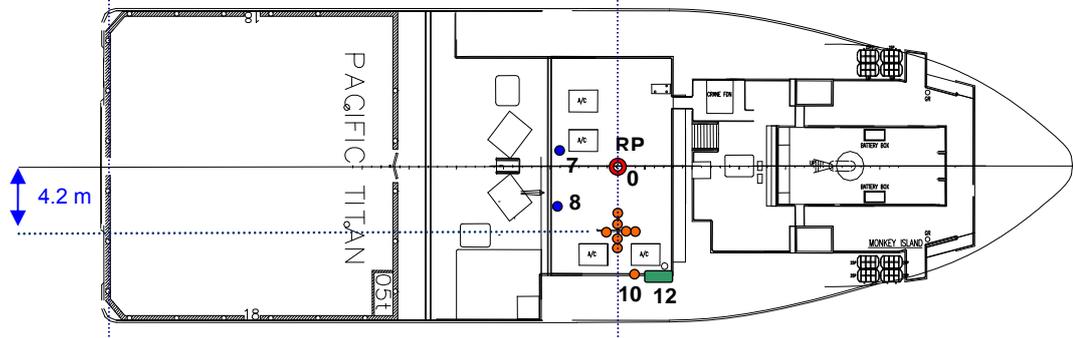
Antenna Offsets

No	Spectra ID	X	Y	Z	Description	Cable Id
0	V1	0	0	0	Vessel ref point	
		0	-33.8	0	Vessel centre Stern from ref point	
1	V1G1,V1G5	5.25	0	15.6	SPM1 XP,HP. Alison 940D	2 Red Rings
2		3.15	0	15.6	Alison 940D	5 Red Rings
3					motorola UHF Radio antenna	
4	V1G2, V1G3, V1G4	4.2	1.05	15.6	SPM2 XP,HP Multifix. Alison 940D	3 Red Rings
5					Seatex Yagi VCU, UHF antenna	4 Red Rings
6					Seatex Omni VCU, UHF antenna	1 Red Ring
7	V1E1	-1.3	-5.8	-5	Simrad EA 600, 200kHz tranceducer	
8	V1E2	1.5	-6.1	-5	Simrad EA 600, 12kHz tranceducer	
9	Speedlan					
10	Runt 1				Trimble Bullet	
11					sailor VHF Antenna	2 Green Rings
12	V1GY1				Simrad GPS Gyro
