Tap Oil T/47P 3D PSTM

XRLIN TEST REVISED 3
SAIL LINE 1078p1028

Summary

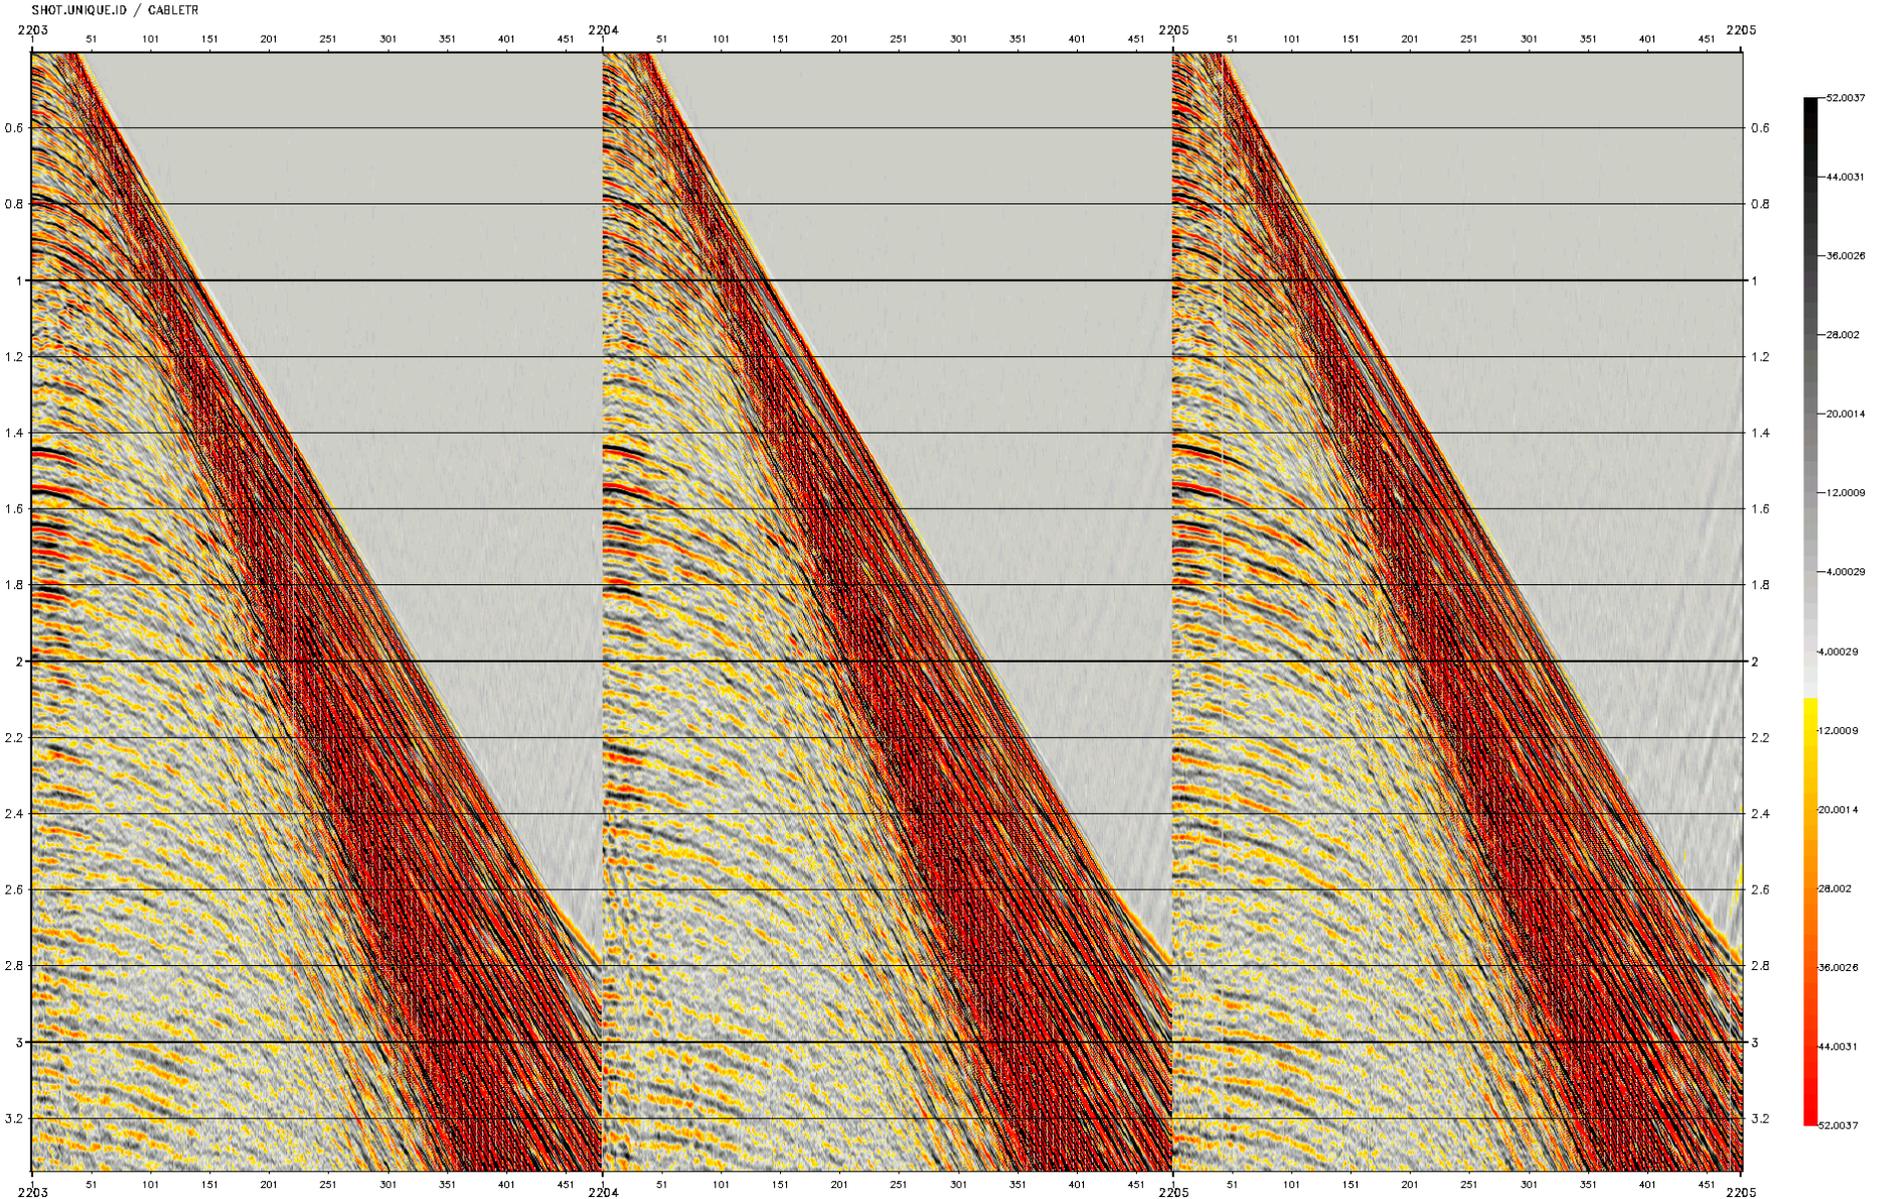
Tango:vegas:spr224ws:s563top:1078 noxrlin.1

Shots before XRLIN – Top view

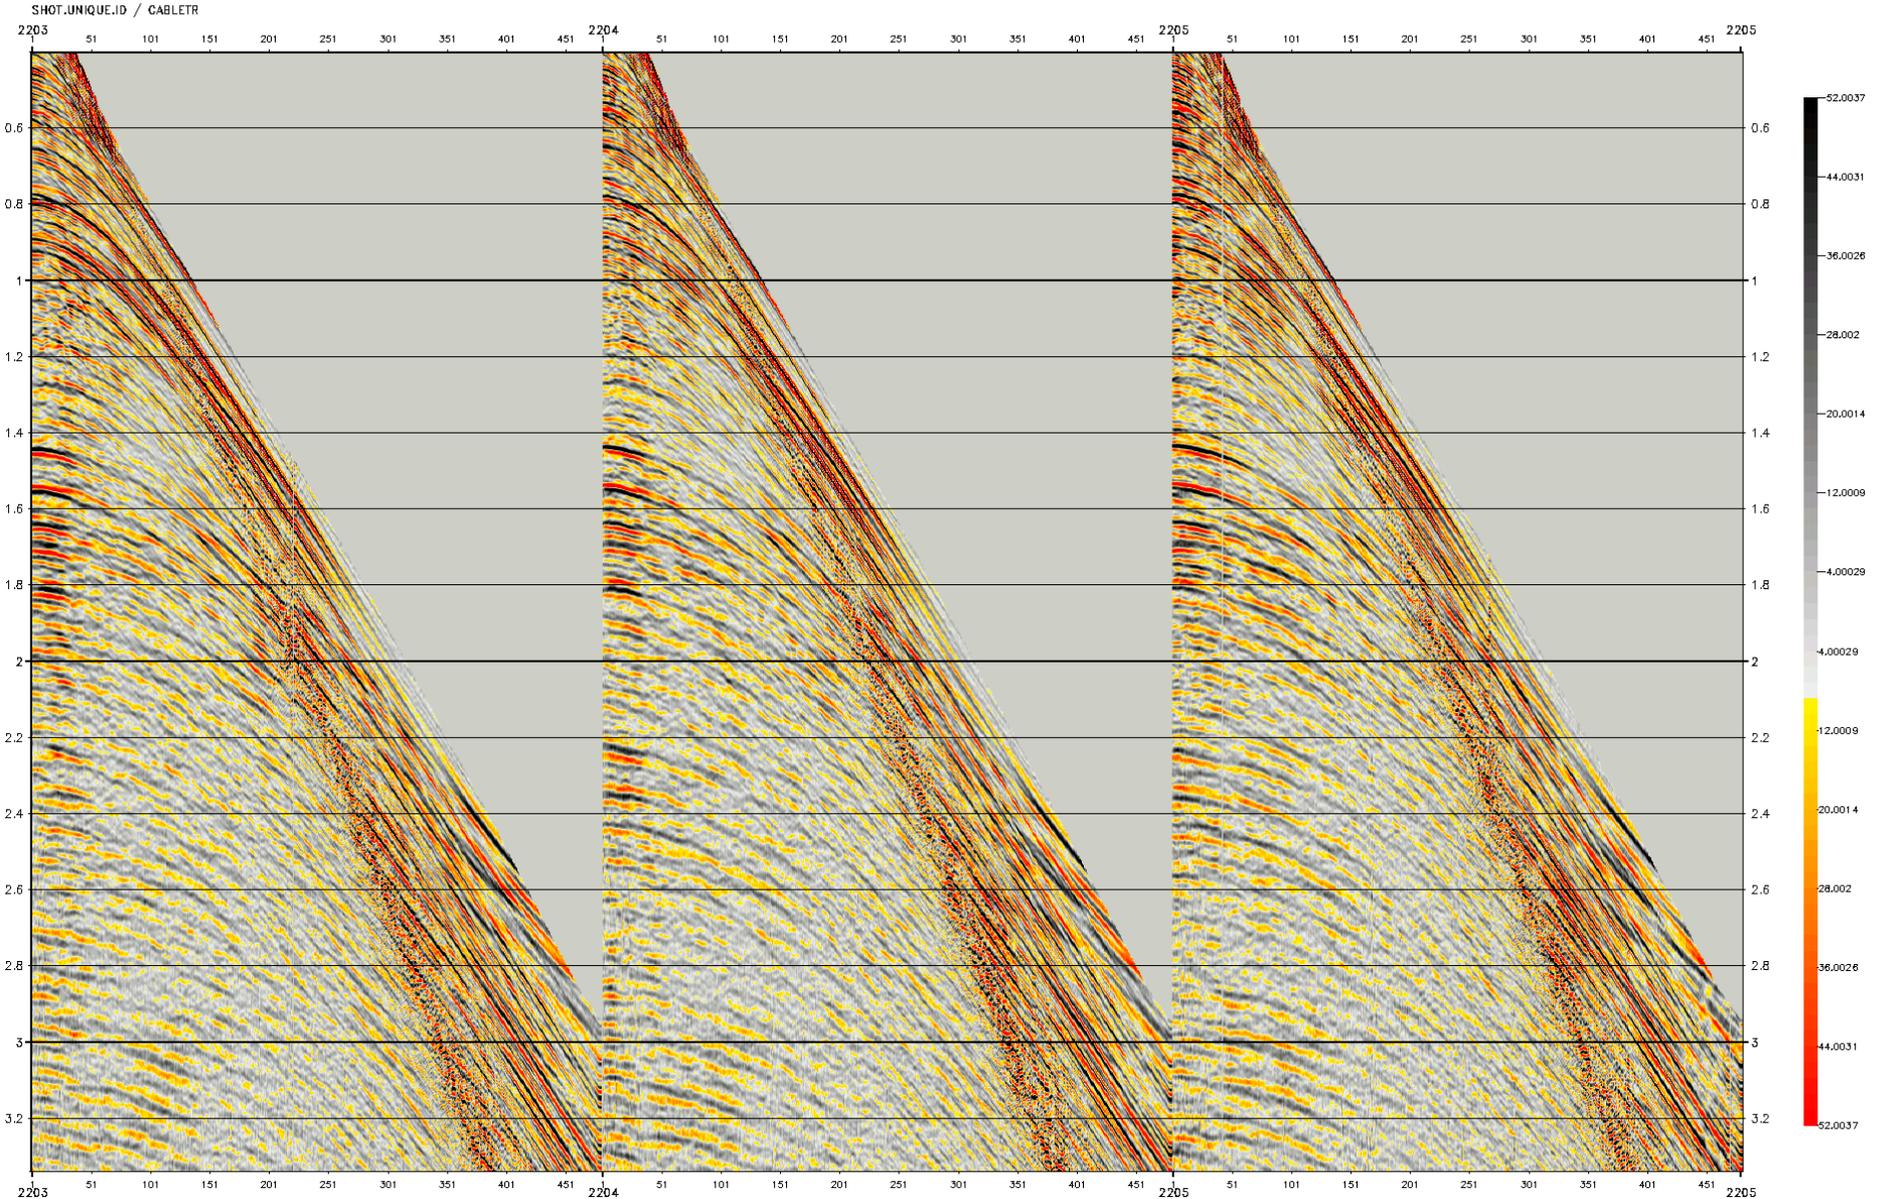
Tango:vegas:spr224ws:s563fap:qc1078 Isf11.1

Shots after XRLIN Test 3 – Top view

- As test 3 was not taking care of the negative dip, another test is done in transform range (test 4)
 - Transform range -1600 to 800 **Test 3**
 - Transform range - 1100 to 800 **Test 4**
 - Rest of the parameters are same as test 3

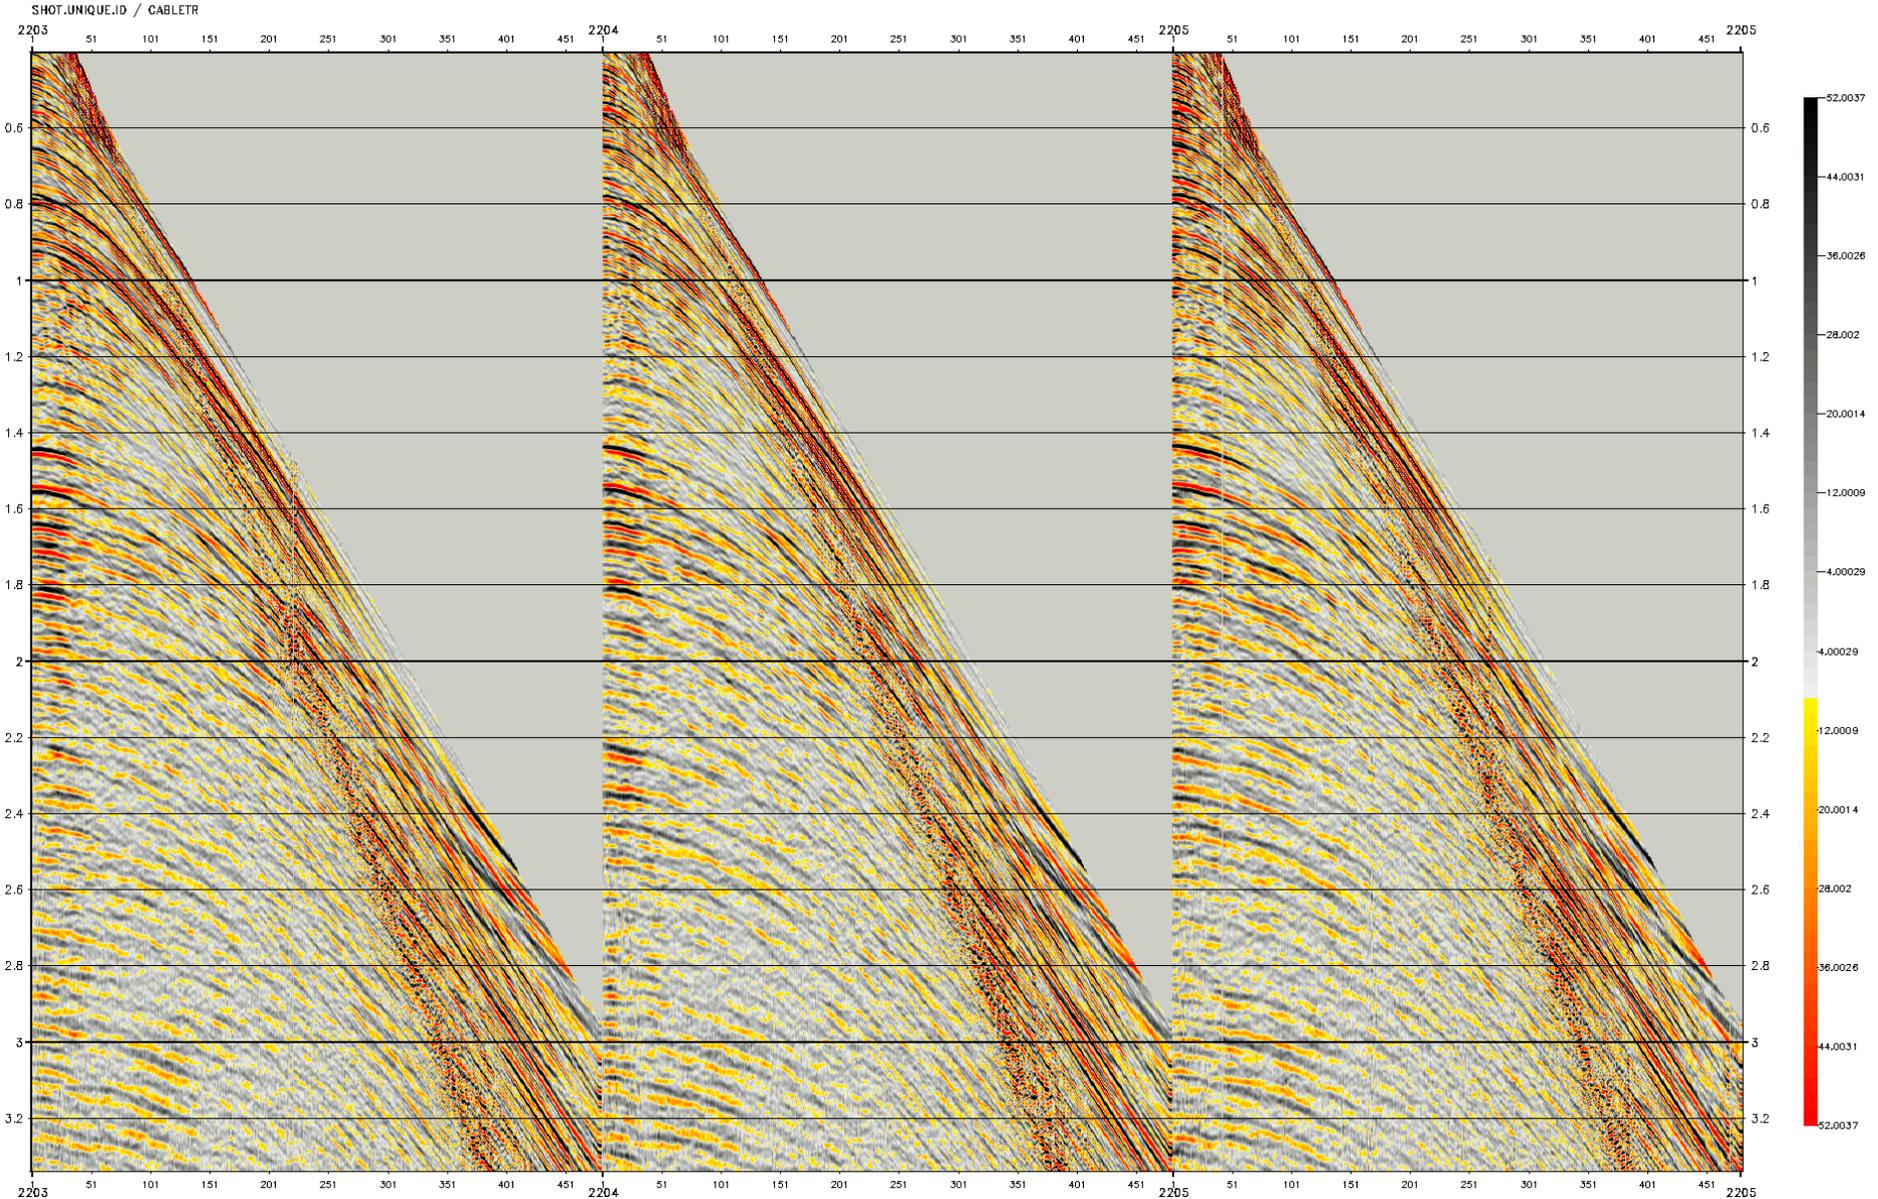
Tango:vegas:spr224ws:s563tap:qc1078 Ist22.1

Shots after XRLIN Test 4 – Top view

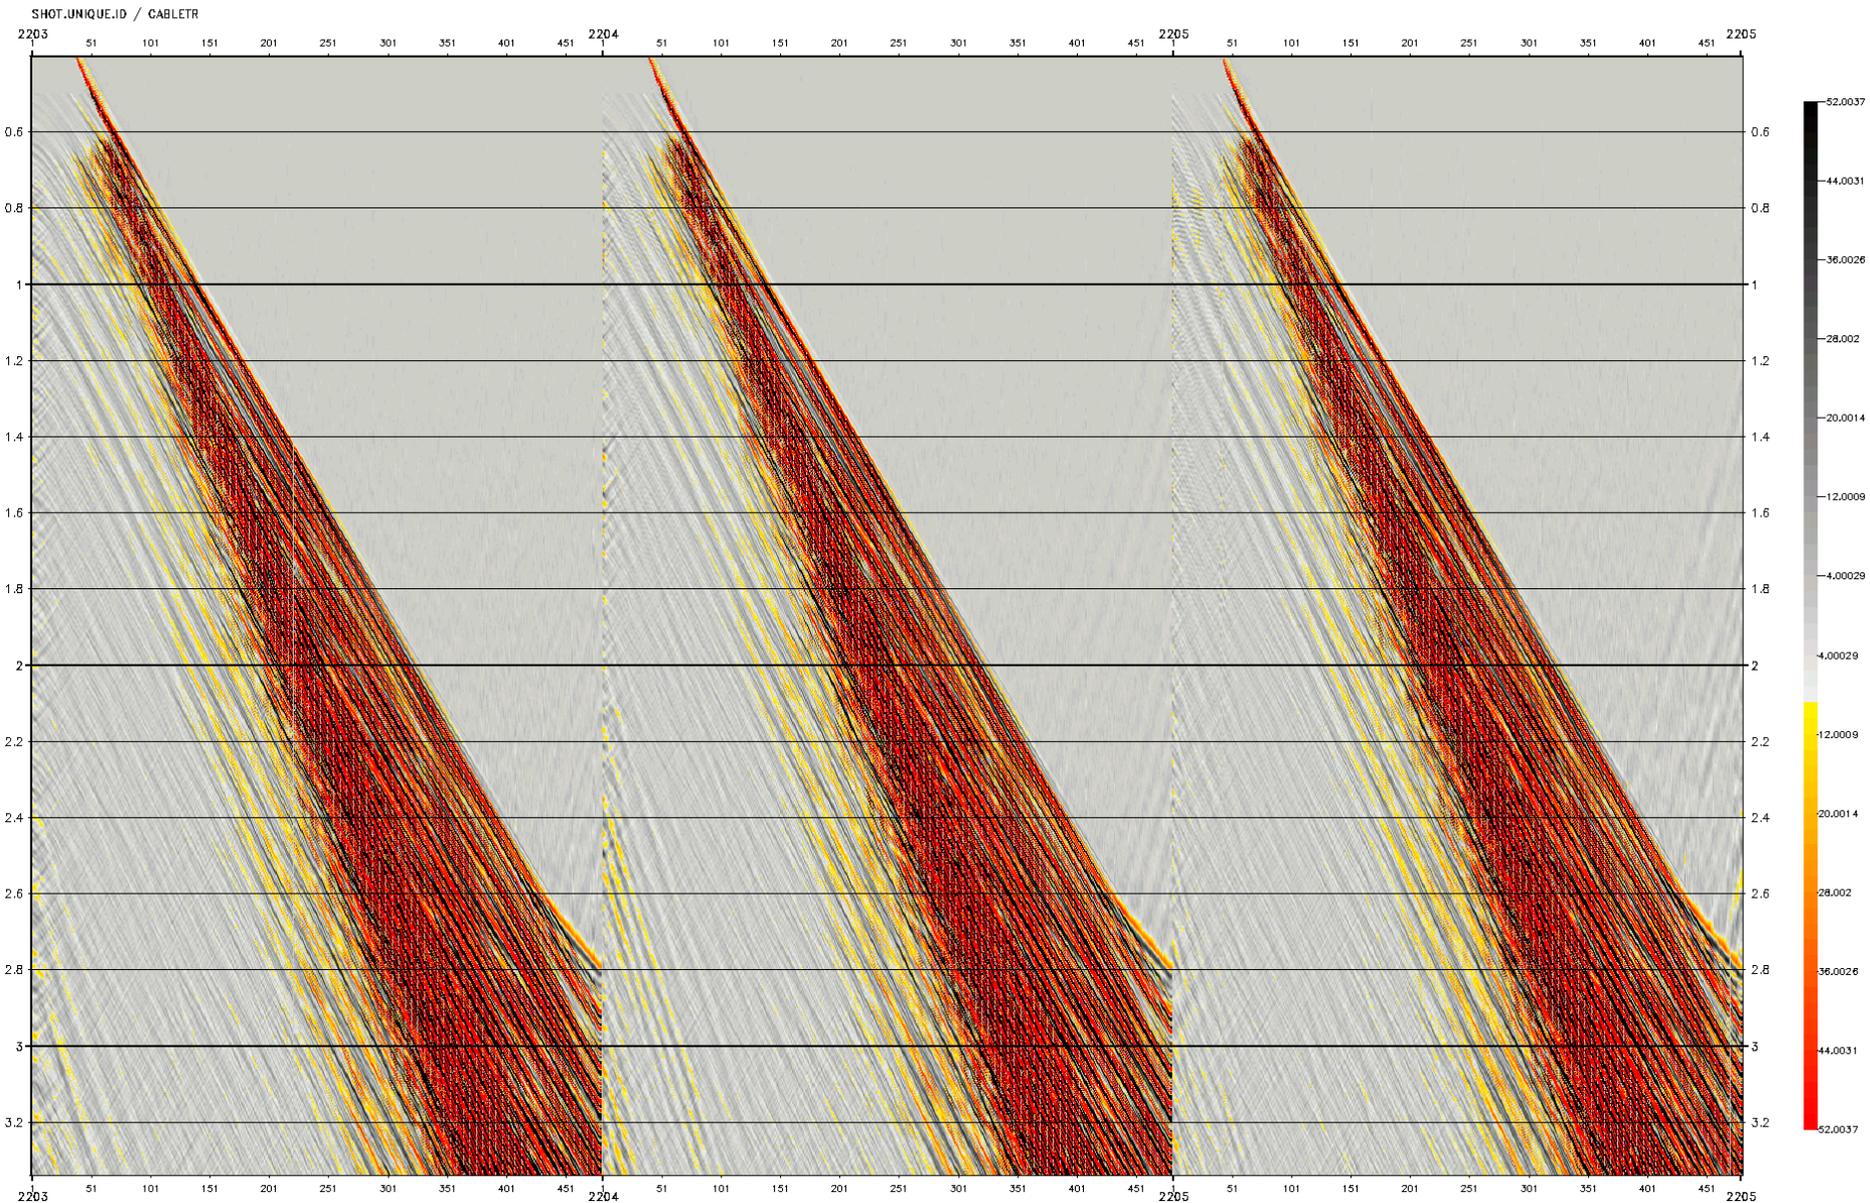
1078 noxrlin-qc1078 ts111

Difference display Test 3 – Top View

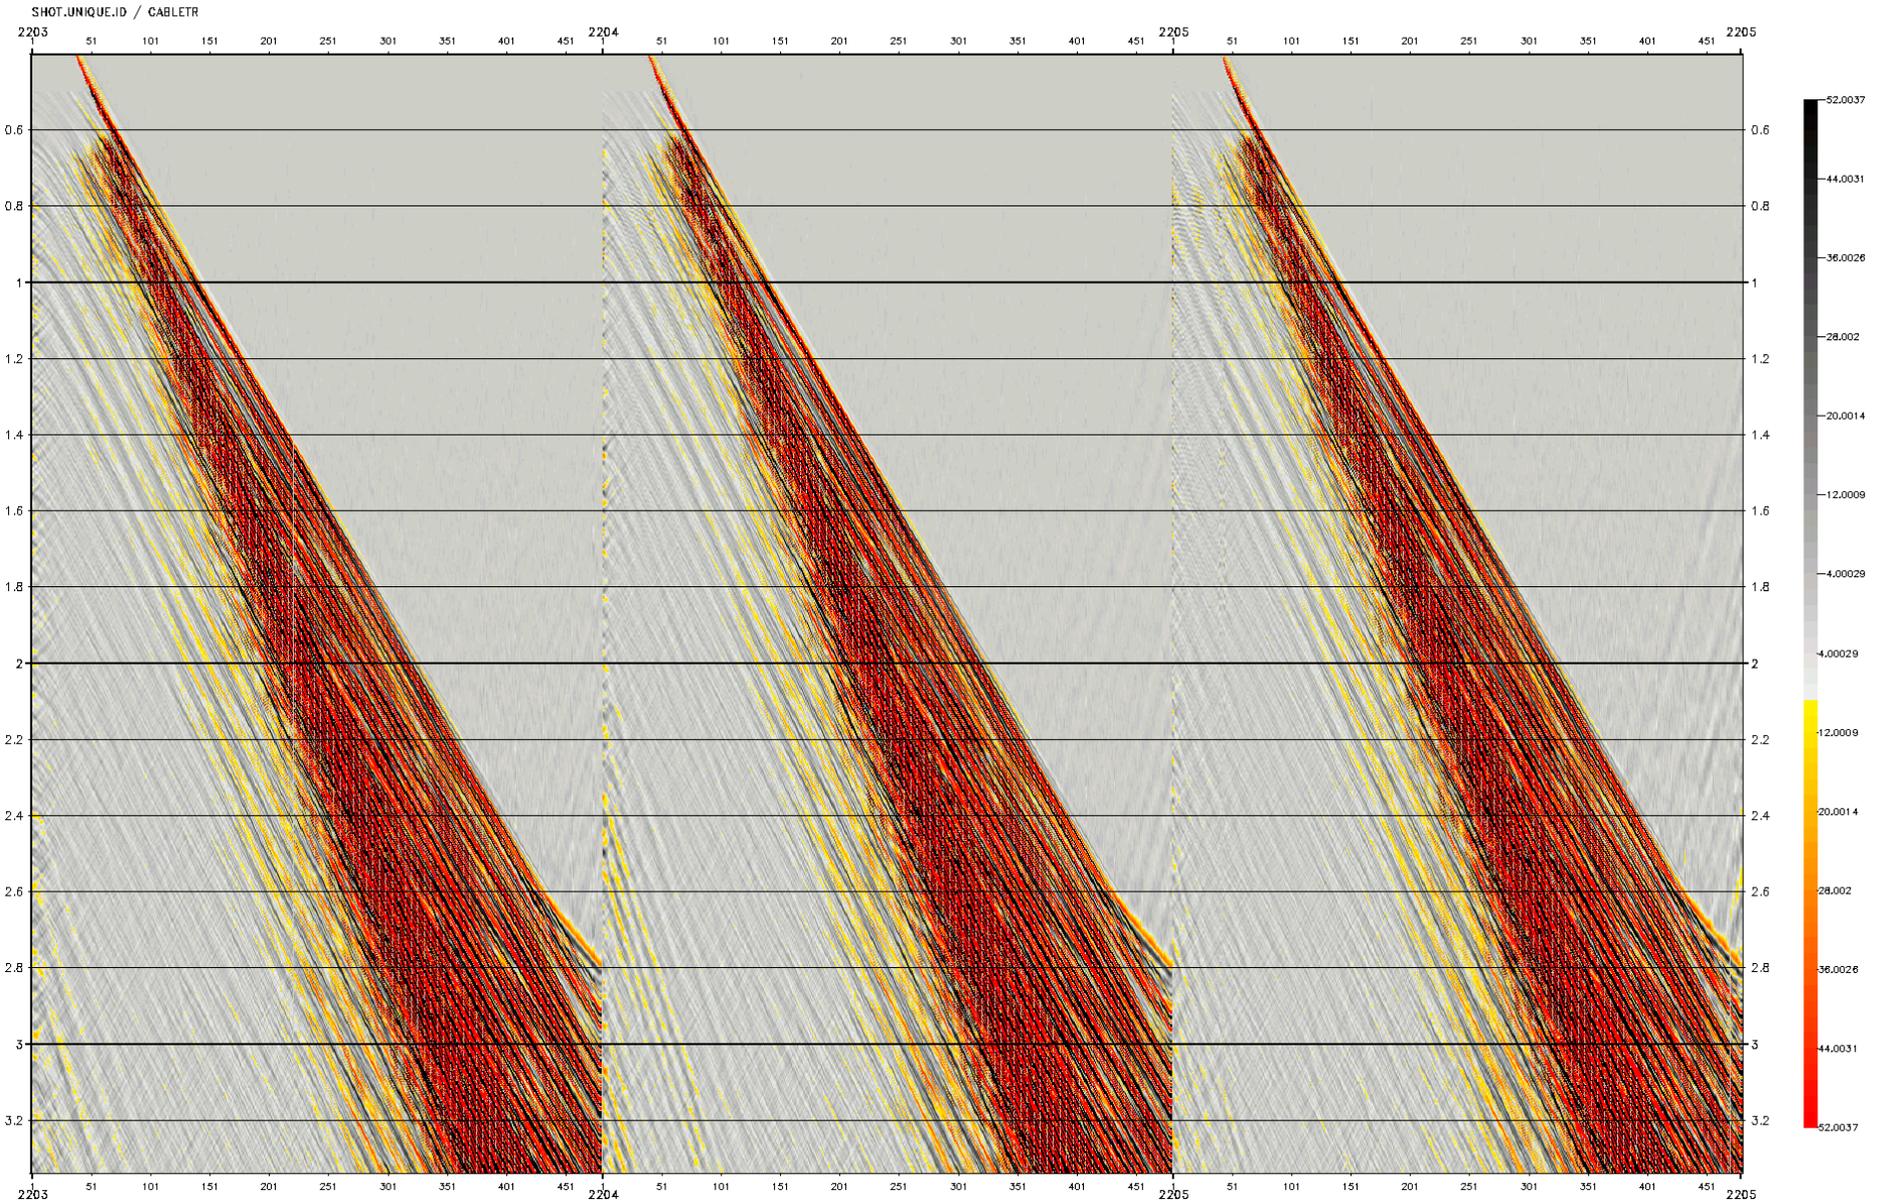
1078 noxrlin-qc1078 tst22

Difference display Test 4 – Top View

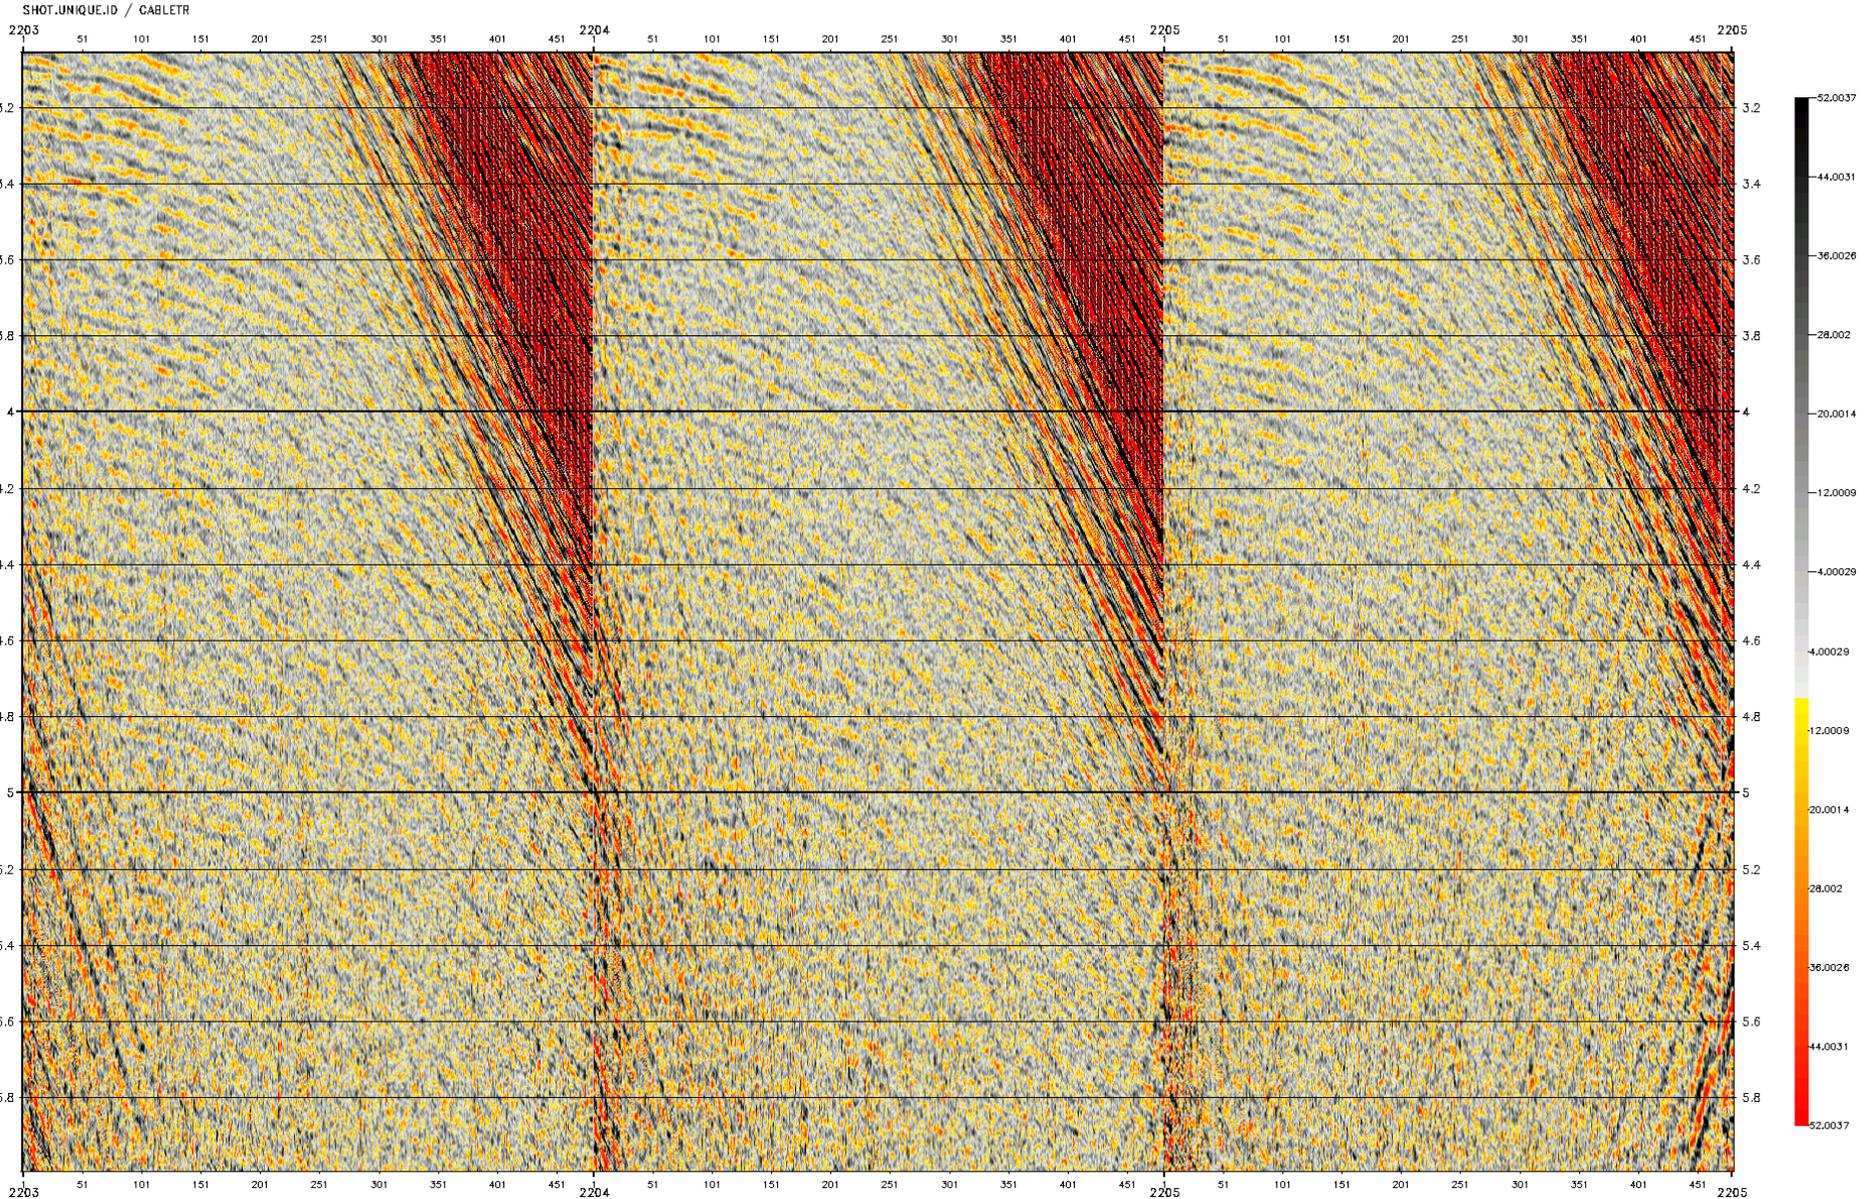
Tango:vegas:spr224ws:s563tap:1078 noxrlin.1

Shots **before** XRLIN – Bottom view

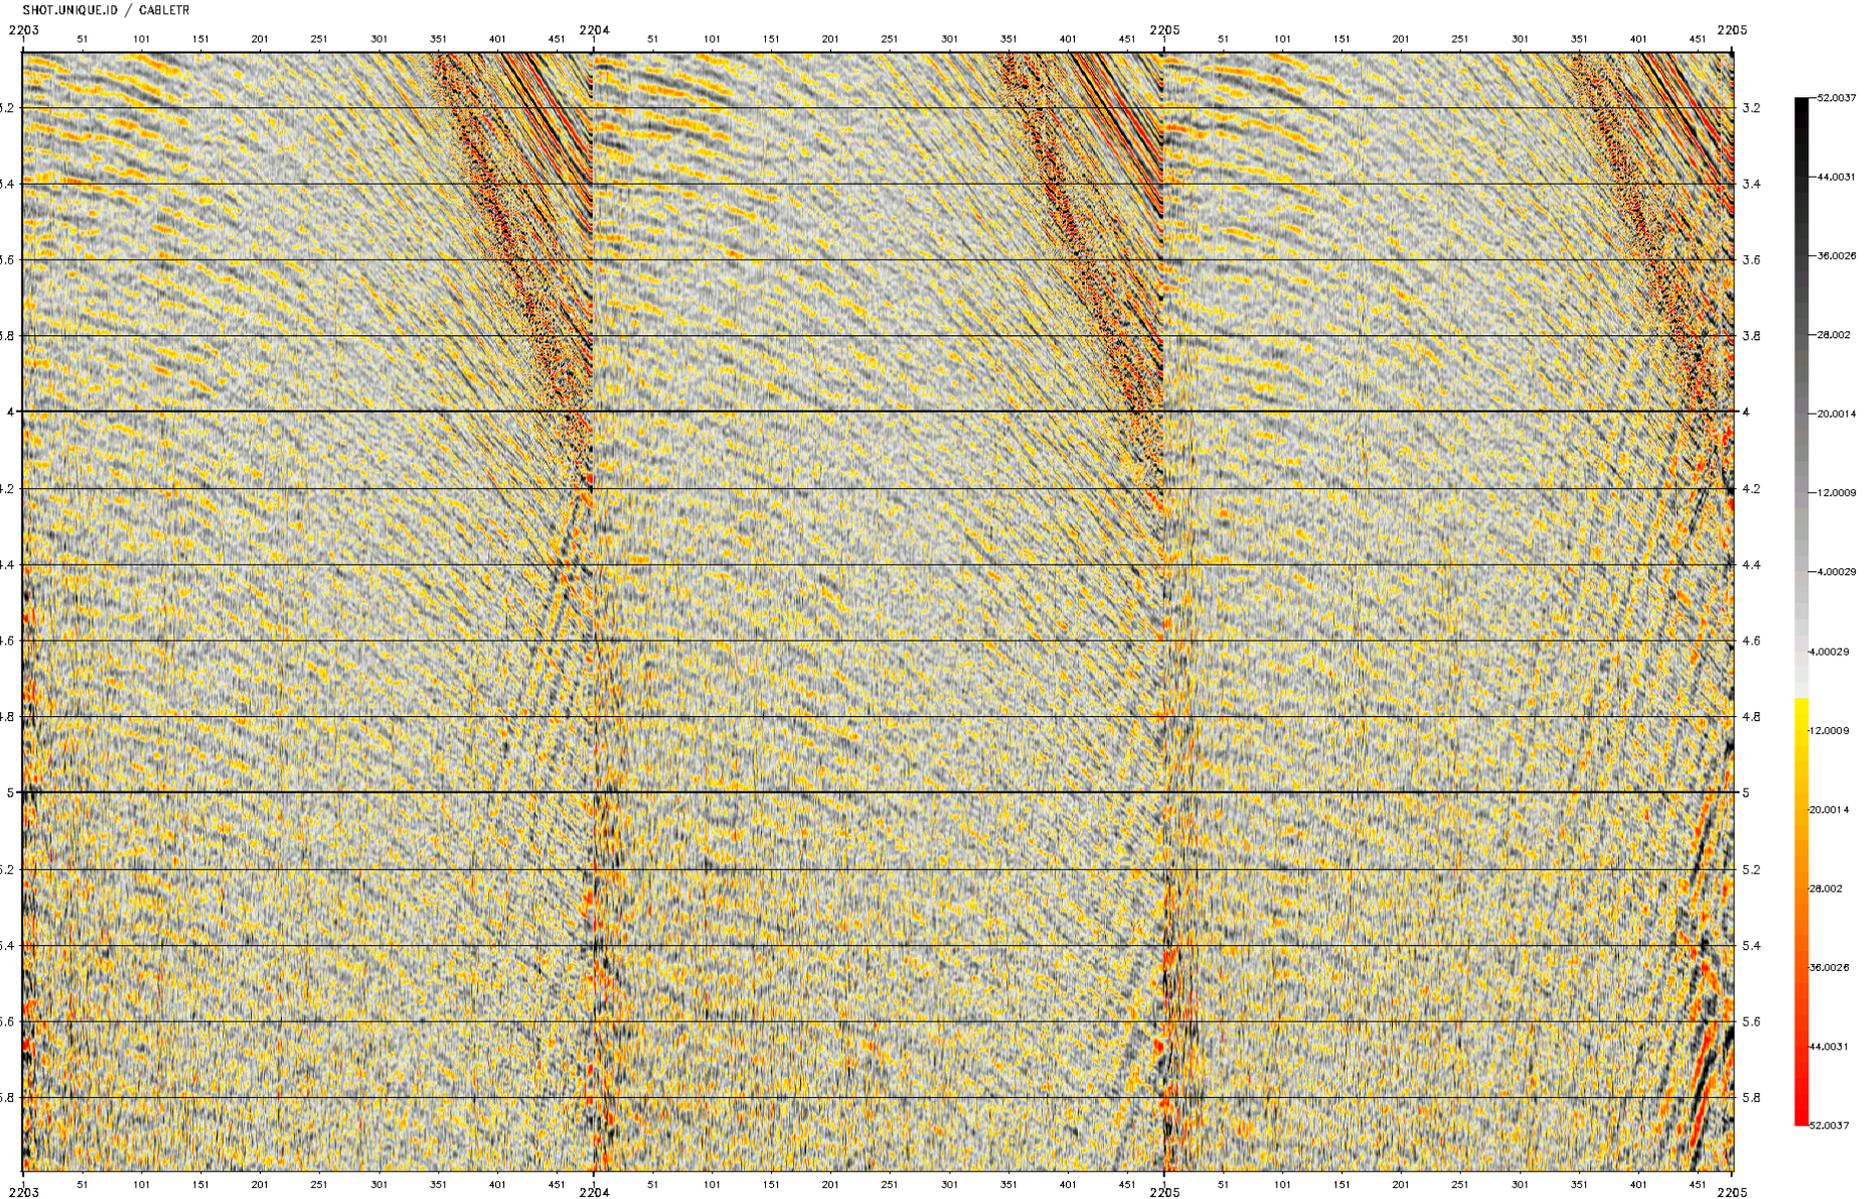
Tango:vegas:spr224ws:s563lap:qc1078 tsf11.1

Shots after XRLIN Test 3 – Bottom view

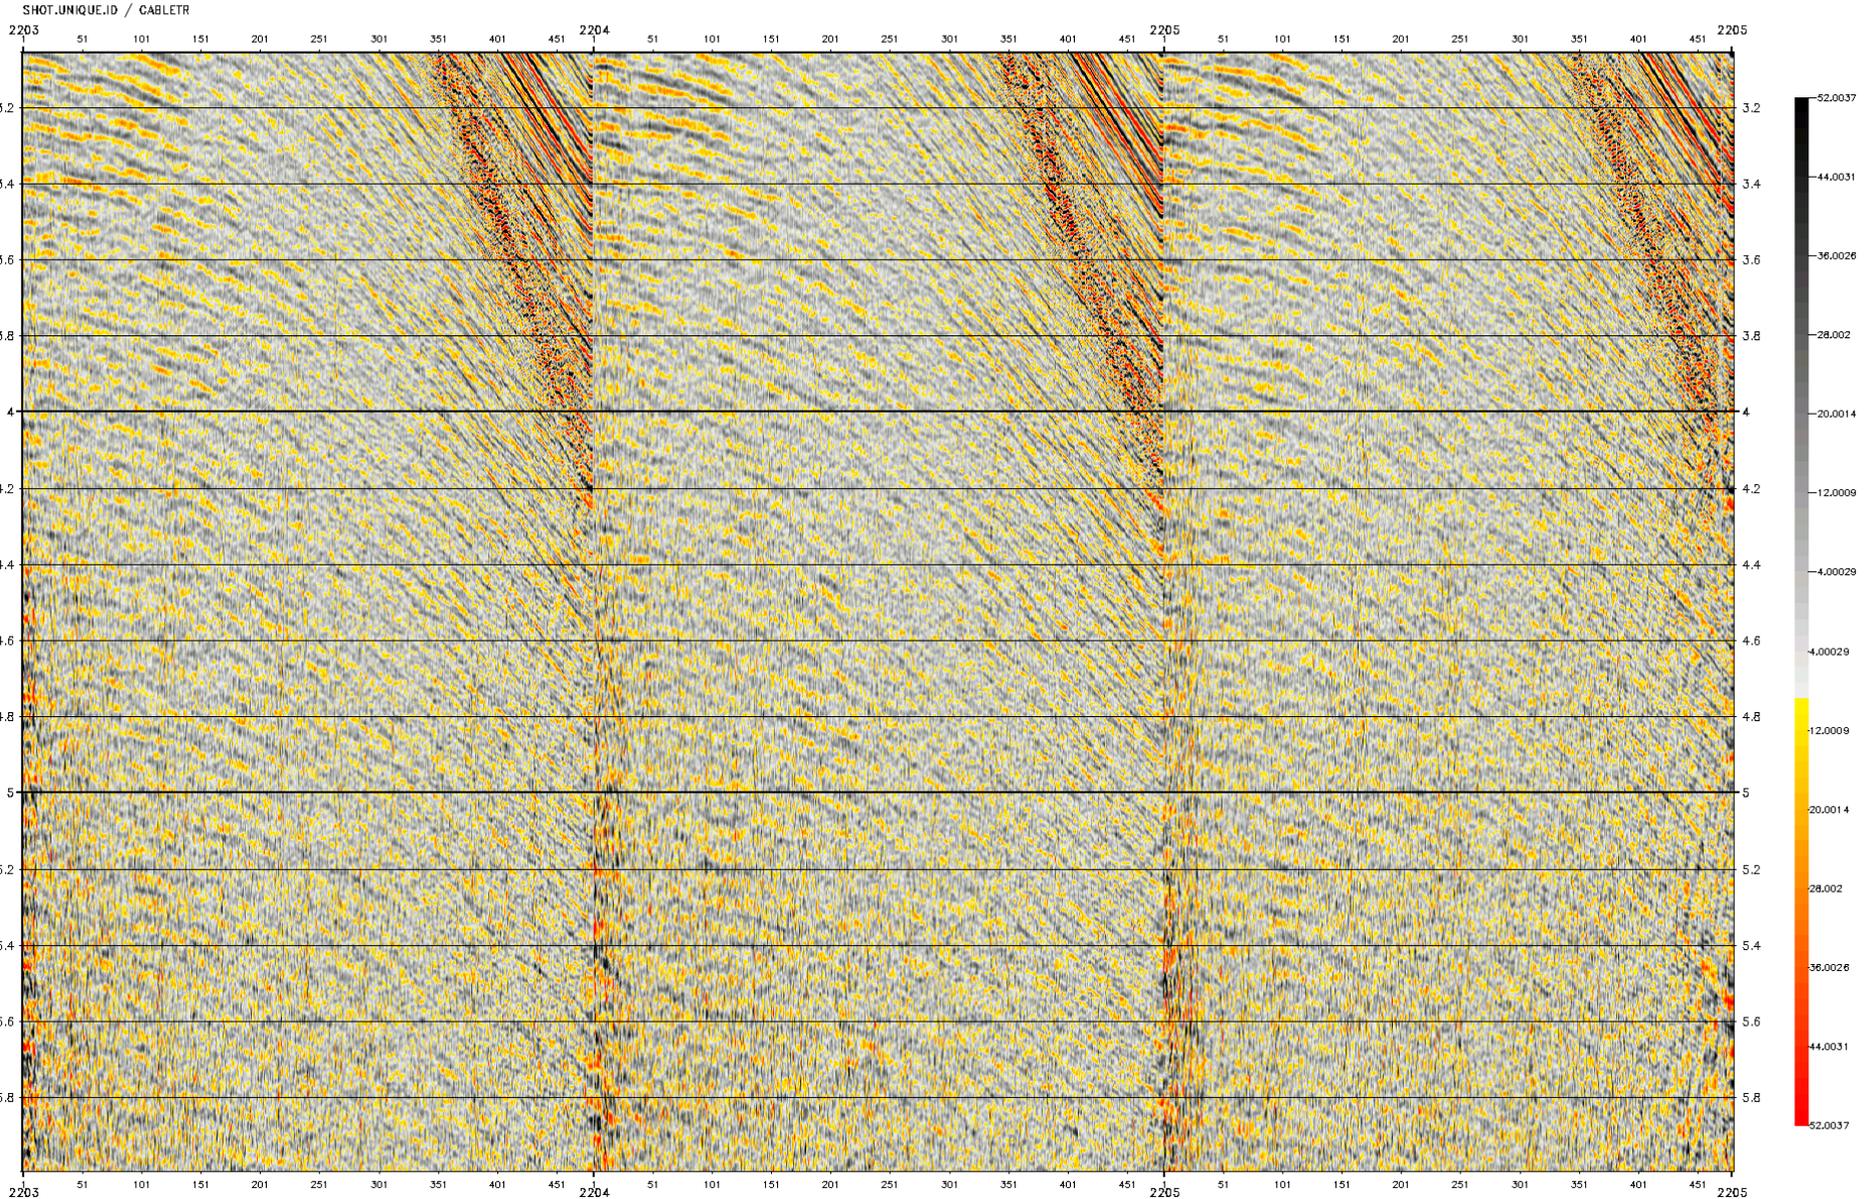
Tango:vegas:spr224ws:s563fap:qc1078 Ist22.1

Shots after XRLIN Test 4 – Bottom view

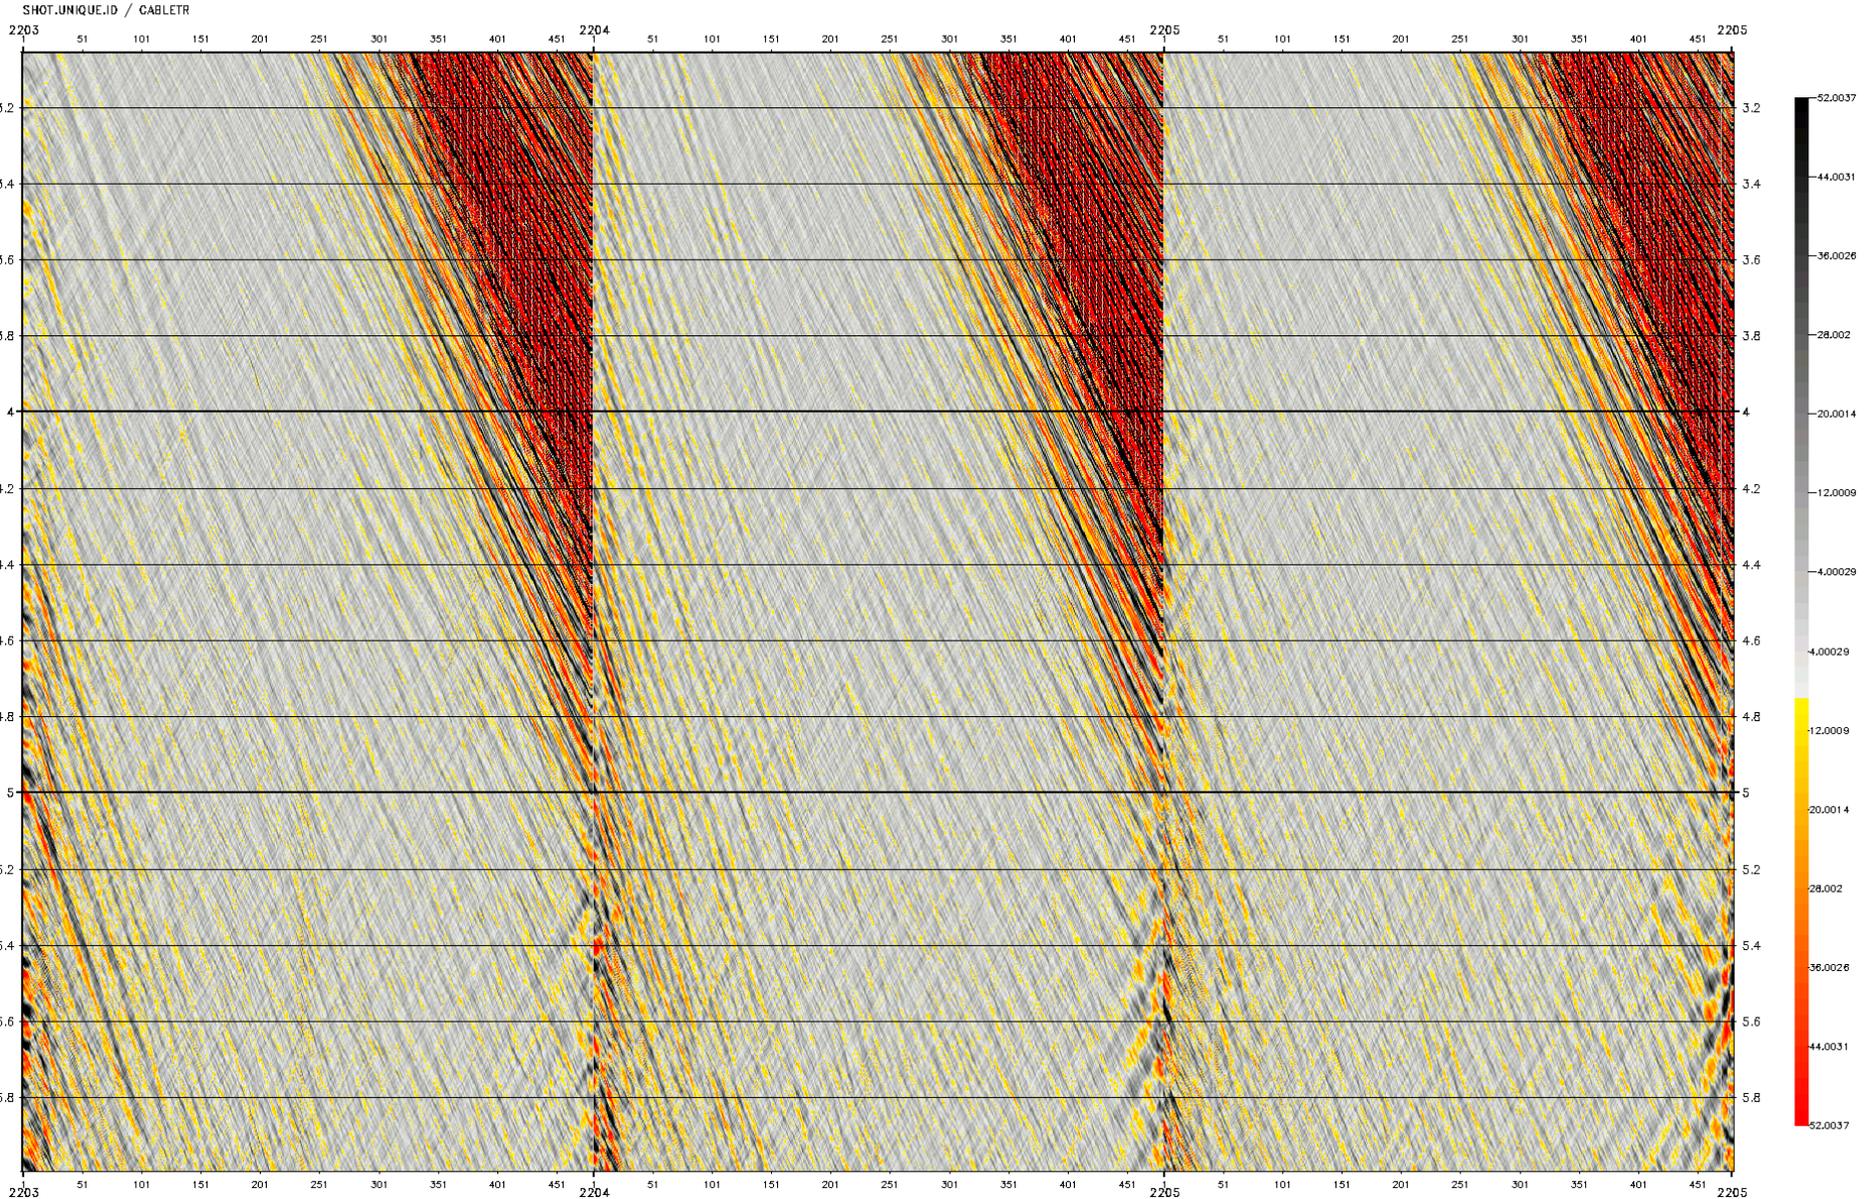
1078 noxrlin-qc1078 Ist11

Difference display Test 3 – Bottom View

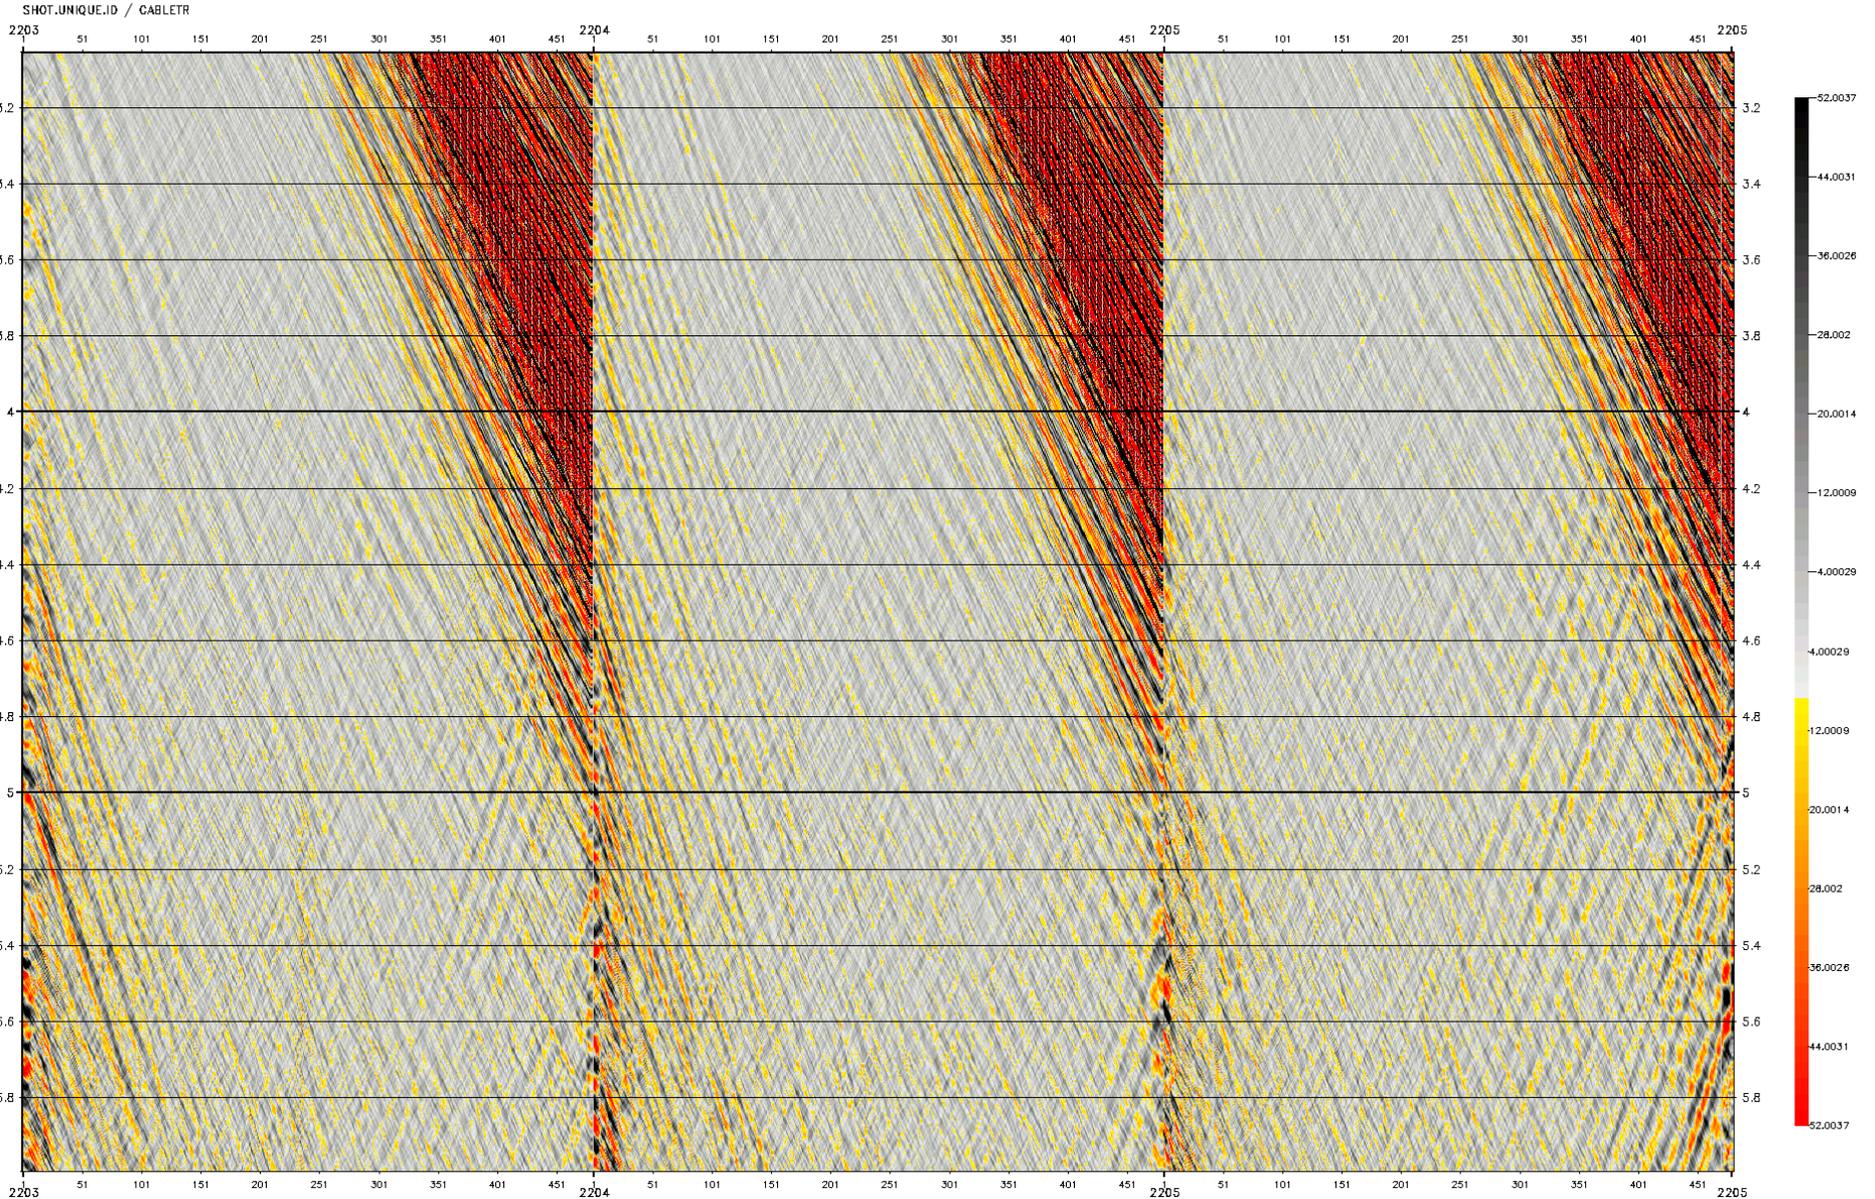
1078 noxrlin-qc1078 Ist22

Difference display Test 4 – Bottom View
