DATA ACQUISITION SUPERVISION REPORT

2D MARINE SEISMIC SURVEY

3D OIL LIMITED

BLOCK T/41P OFFSHORE TASMANIA

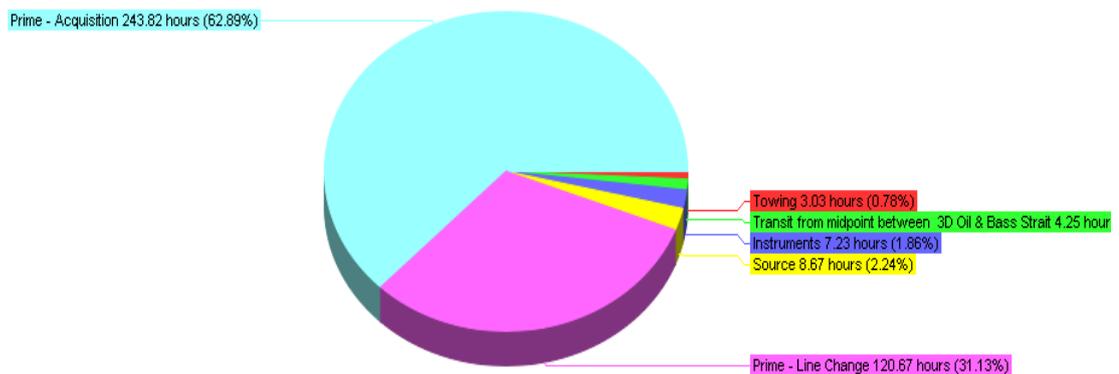
3D Oil T41P 2D - Timing Breakdown

Code	Description	Duration
01	Prime - Acquisition	243.82
02	Prime - Line Change	120.67
19	Transit from midpoint between 3D Oil & Bass Strait	4.25
30	Source	8.67
35	Instruments	7.23
38	Towing	3.03

Total Time = 387.670 Hours

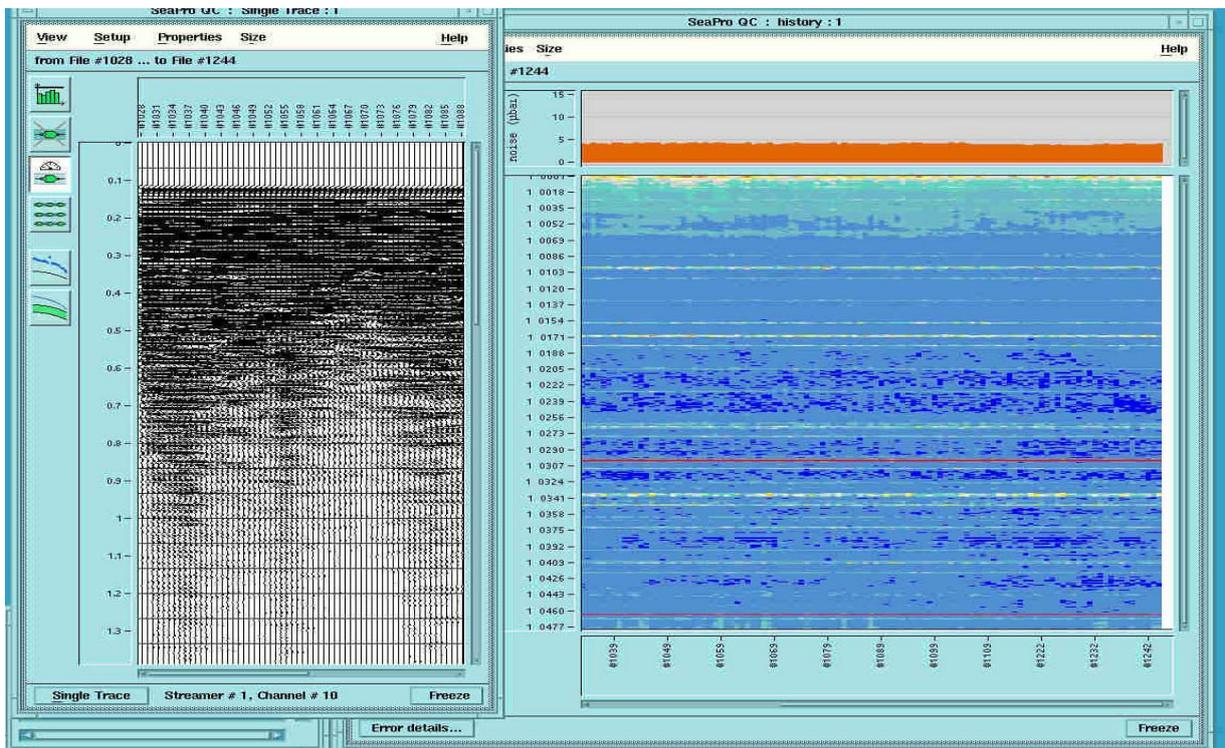
The Pacific Titan is fitted with a Sercel 24 bit SEAL system. This was a brand new system for the Pacific Titan and relatively new to the market. It has been used extensively in China on land crews, proving to be robust and operator friendly. The Sercel system provided a comprehensive array of real time on screen displays, showing auxiliary channels, Streamer channel display and single trace display. The last 20 records could be accessed and displayed for QC evaluation. A shot display similar to the old oscilloscope display but greatly expanded and colour coded to indicate noise strength was also available. All displays could be manipulated to improve data quality control. The figure below shows a sample screen shot from the Seal recording system.

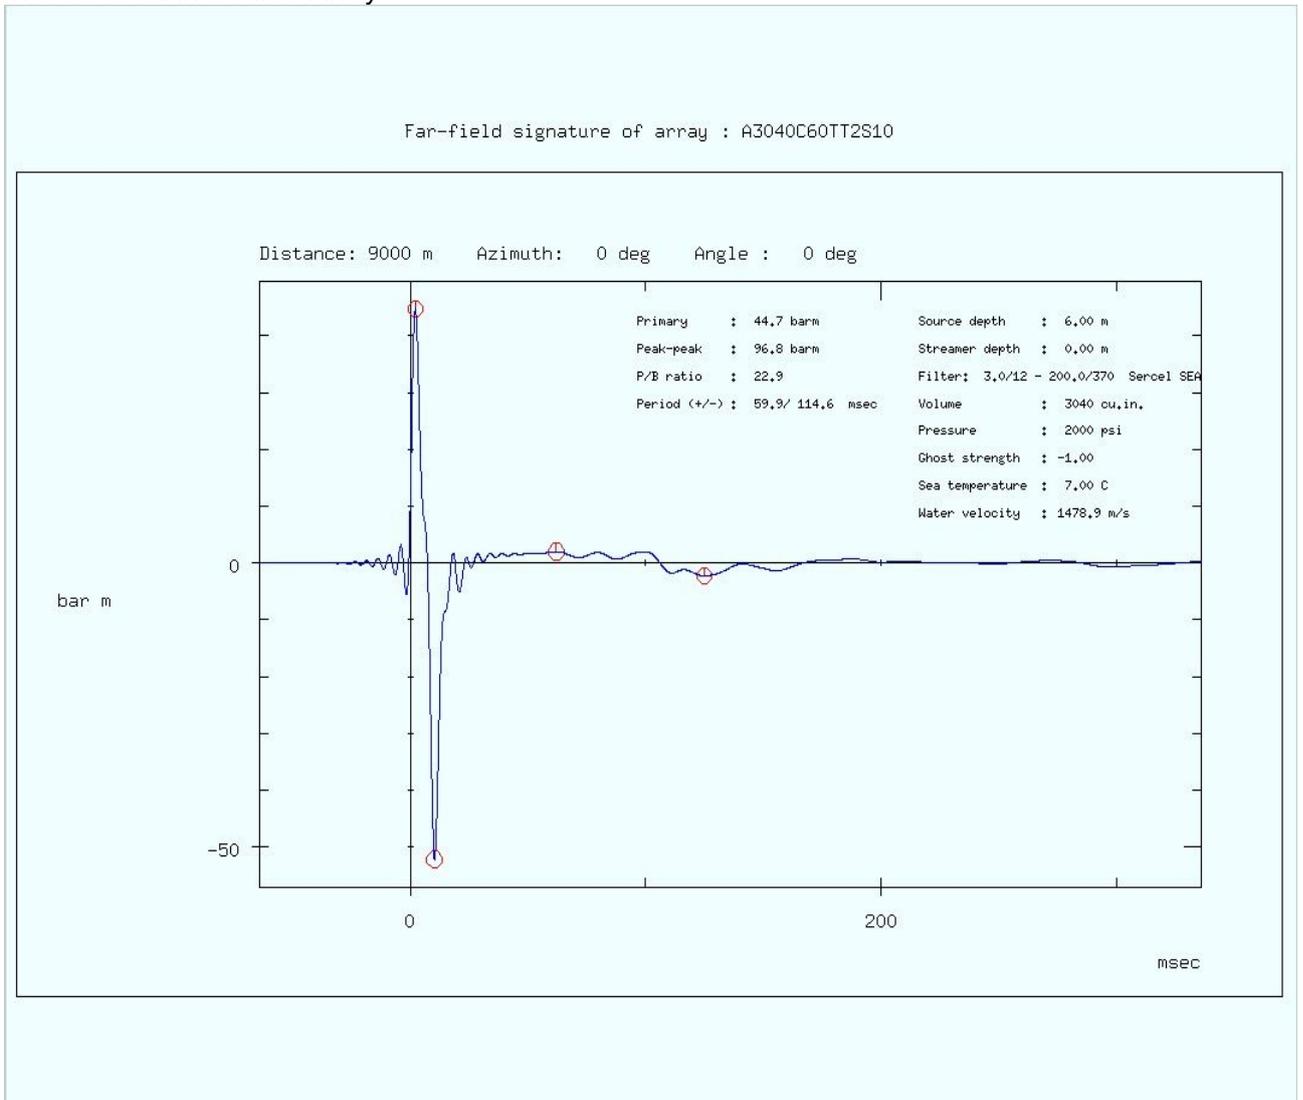
The 3040 cu in Source Array

The three sub arrays were equipped with a total of 26 array elements. The drop out spec was generated by CGGVeritas. A total of 8.67 Hrs were lost to the source arrays. A 3040 cu³ inch array was used through out the survey.

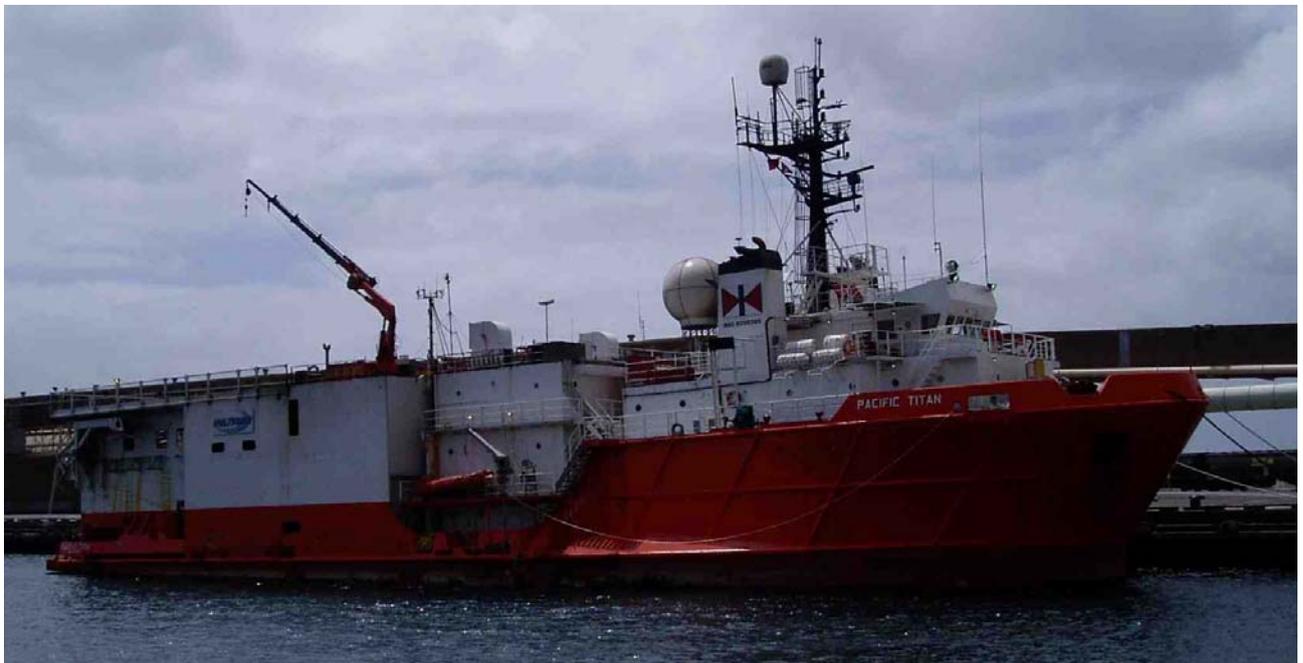
The vessel has been poorly maintained over the years and needs to have a general tidy up to be comfortable. For the size of the vessel the cabins for both seismic and marine crews are small and cramped. Conditions are reminiscent of 20 years ago. Extended surveys on this vessel could

become a serious OHS issue. There are adequate numbers of showers and toilets available and although the steward worked hard to keep them clean, they are in a poor state and need to be completely refitted to a standard fitting the current OHS standards expected of crews and vessels. The same argument could be applied to the quarters for the seismic crew.

- Showers and toilets need renewing, they are in a very poor state and unhygienic
- The overall appearance of the vessel is poor, this reflects on both the contractor and the Company.
- With the overall OH&S performance expected of and delivered by both the Marine Crew and the Seismic Crew. The acceptance of a vessel in the Pacific Titans condition is a let down the hard work done by the crew in maintaining a safe and comfortable work environment.

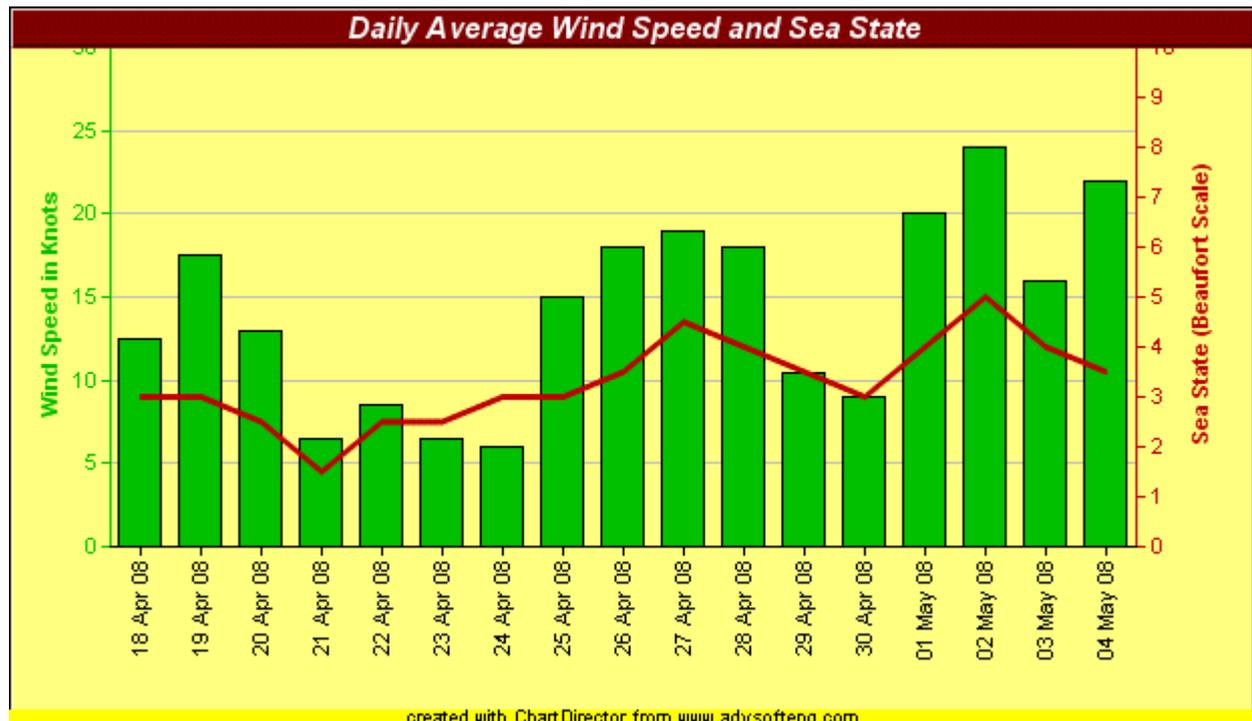
The diagram shown below gives the average wind speed and sea state for the survey period.

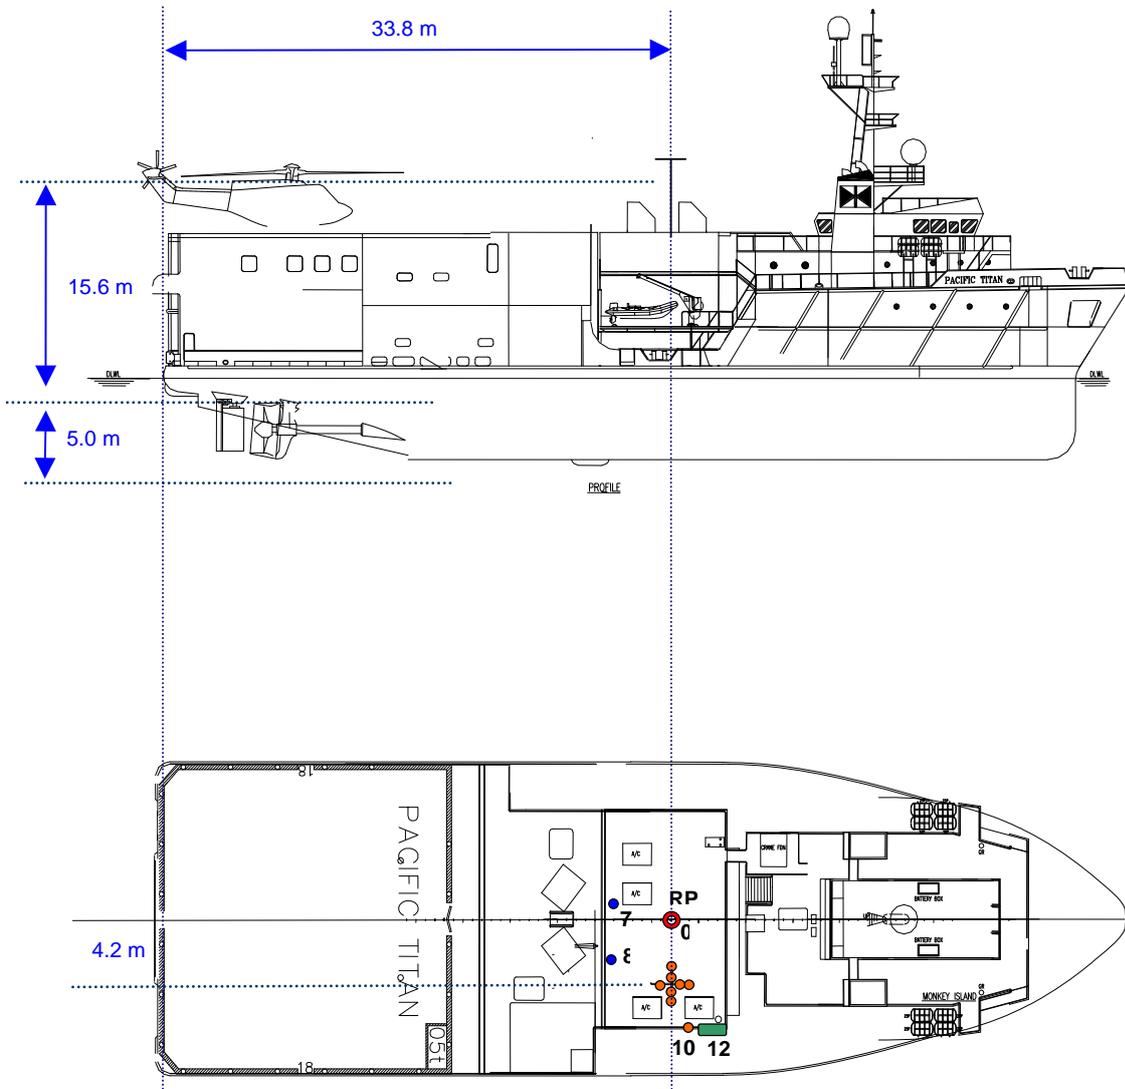
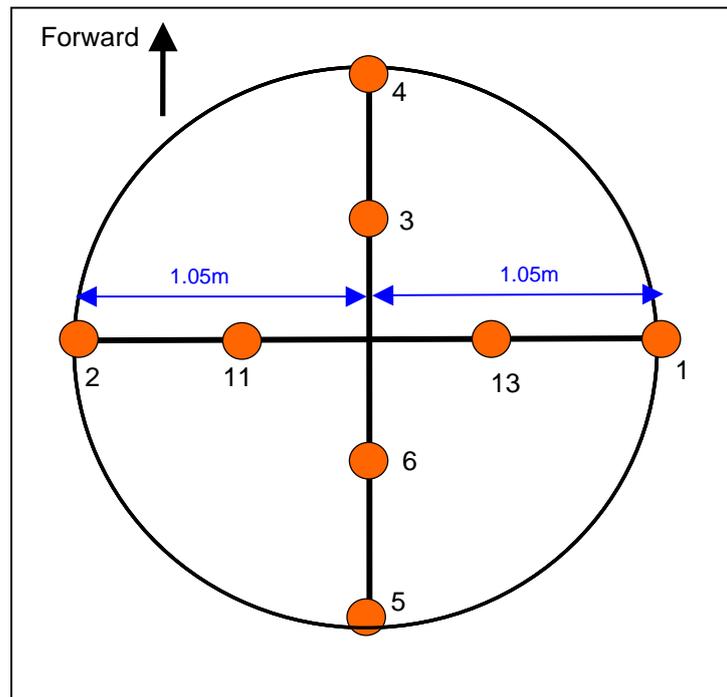
7.1 GPS ANTENNA POSITION

No	Spectra ID	X	Y	Z	Description	Cable Id
0	V1	0.00	0.00	0.00	Vessel ref point	
		0.00	-33.80	0.00	Vessel centre Stern from ref point	
1	V1G1,V1G5	5.25	0.00	15.60	SPM1 XP,HP. Alison 940D	2 Red Rings
2		3.15	0.00	15.60	Alison 940D	5 Red Rings
3					motorola UHF Radio antenna	
4	V1G2, V1G3, V1G4	4.20	1.05	15.60	SPM2 XP,HP Multifix. Alison 940D	3 Red Rings
5					Seatex Yagi VCU, UHF antenna	4 Red Rings
6					Seatex Omni VCU, UHF antenna	1 Red Ring
7	V1E1	-1.30	-5.80	-5.00	Simrad EA 600, 200kHz tranceducer	
8	V1E2	1.50	-6.10	-5.00	Simrad EA 600, 12kHz tranceducer	
9	Speedlan					
10	Runt 1				Trimble Bullet	
11					Sailor VHF Antenna	2 Green Rings
12	V1GY1				Simrad GPS Gyro	
13	Gun deck re-rad				Gun deck re-rad

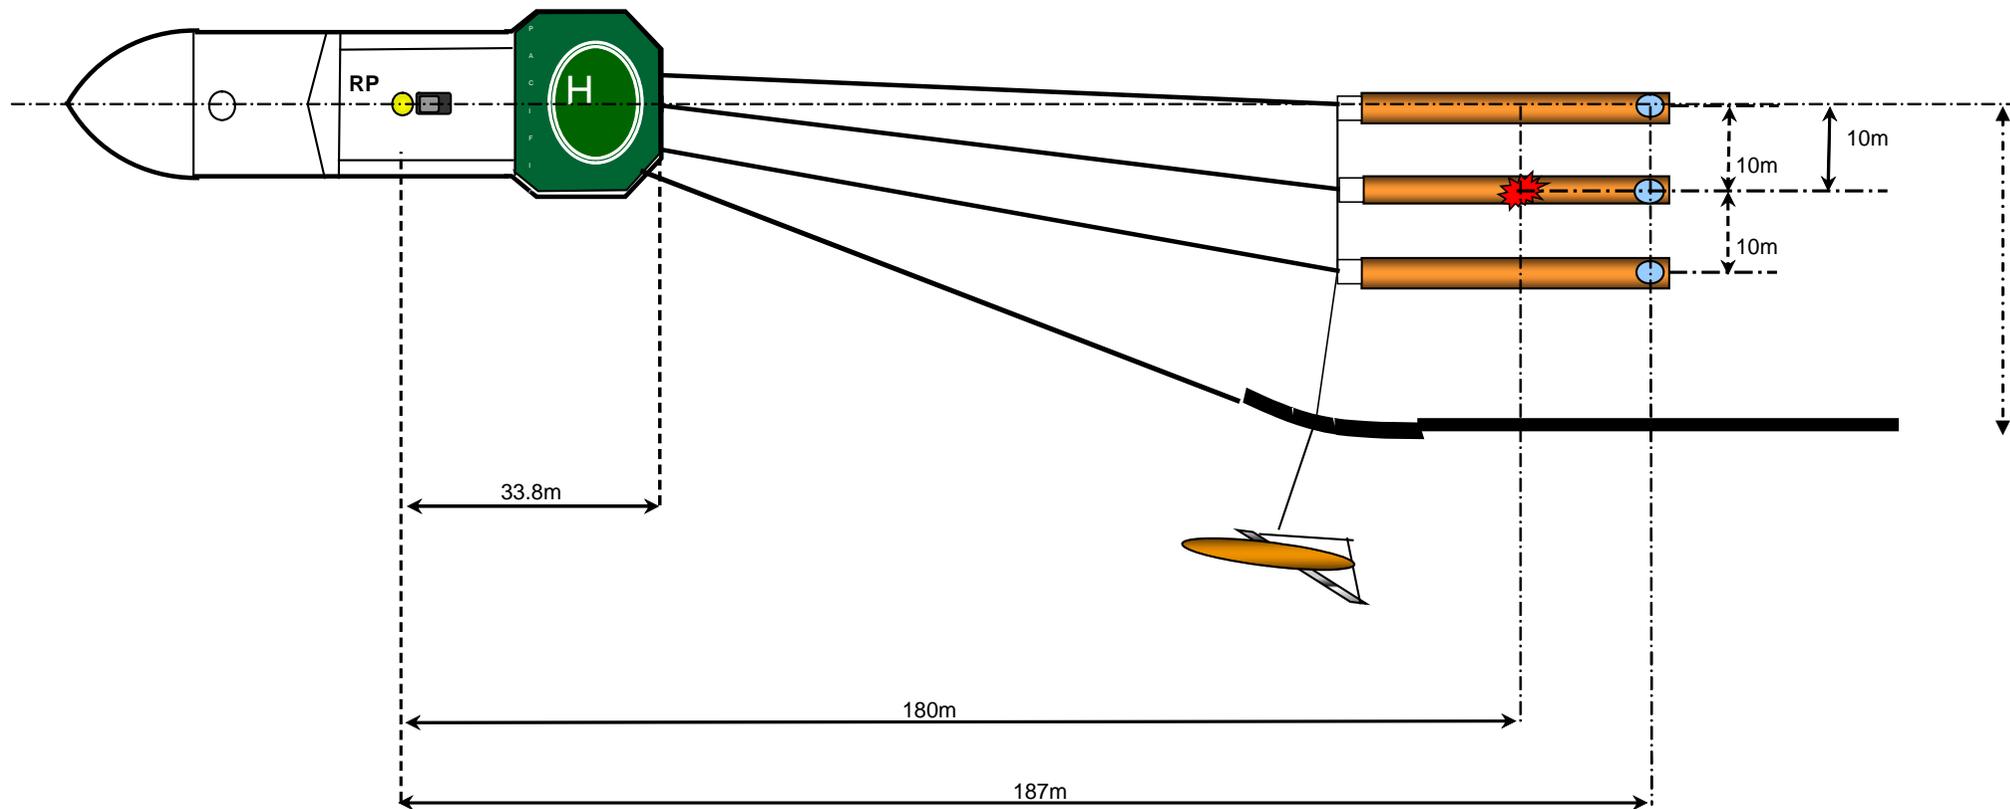
RP Reference Point
Vessel Centre Stern at sea level

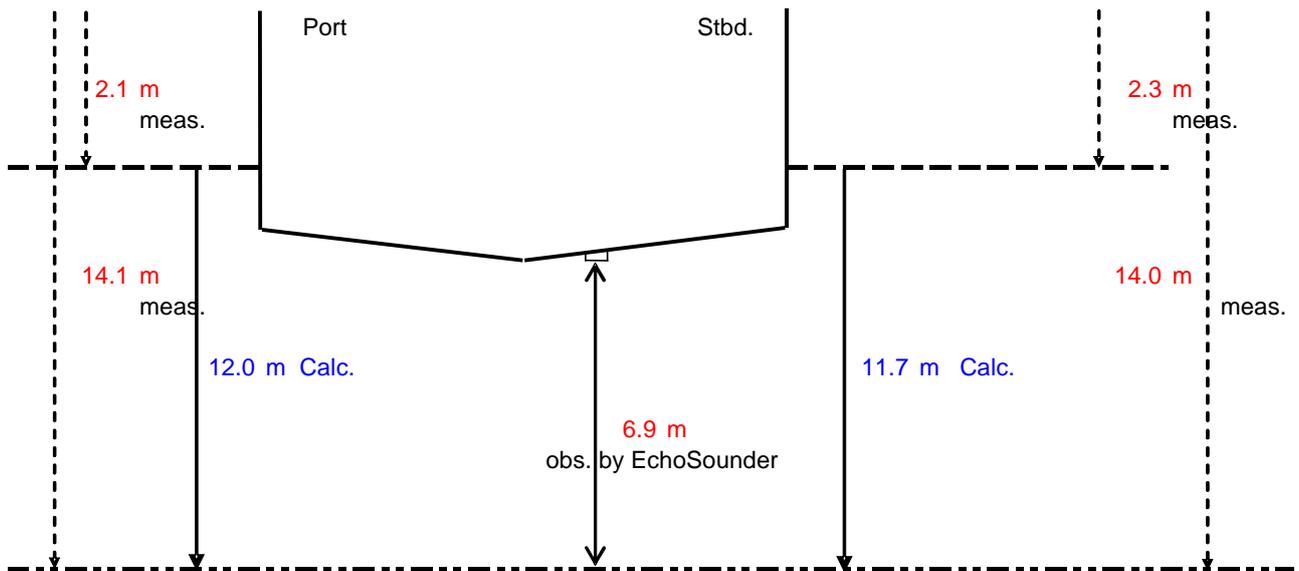
Measurements taken:-	metres		
Port Freeboard		2.1	Stbd Freeboard
Port Lead-Line		14.1	Stbd Lead-Line
EchoSunder Reading		6.9	Fwd Draught marks:
Time		2:55	Aft Draught marks:

Draught Marks:
 Aft : 5.2 m
 Forward : 4.6 m
 Theoretical Draught = 4.9 m

Electronic Depth + Theoret. Draught = 11.8 m
 True Measured Water depth = 11.9 m
