FINAL ACQUISITION REPORT

BELLERIVE 3D MARINE SEISMIC SURVEY

ORIGIN ENERGY RESOURCES LTD

T/34P
OTWAY BASIN
TASMANIA

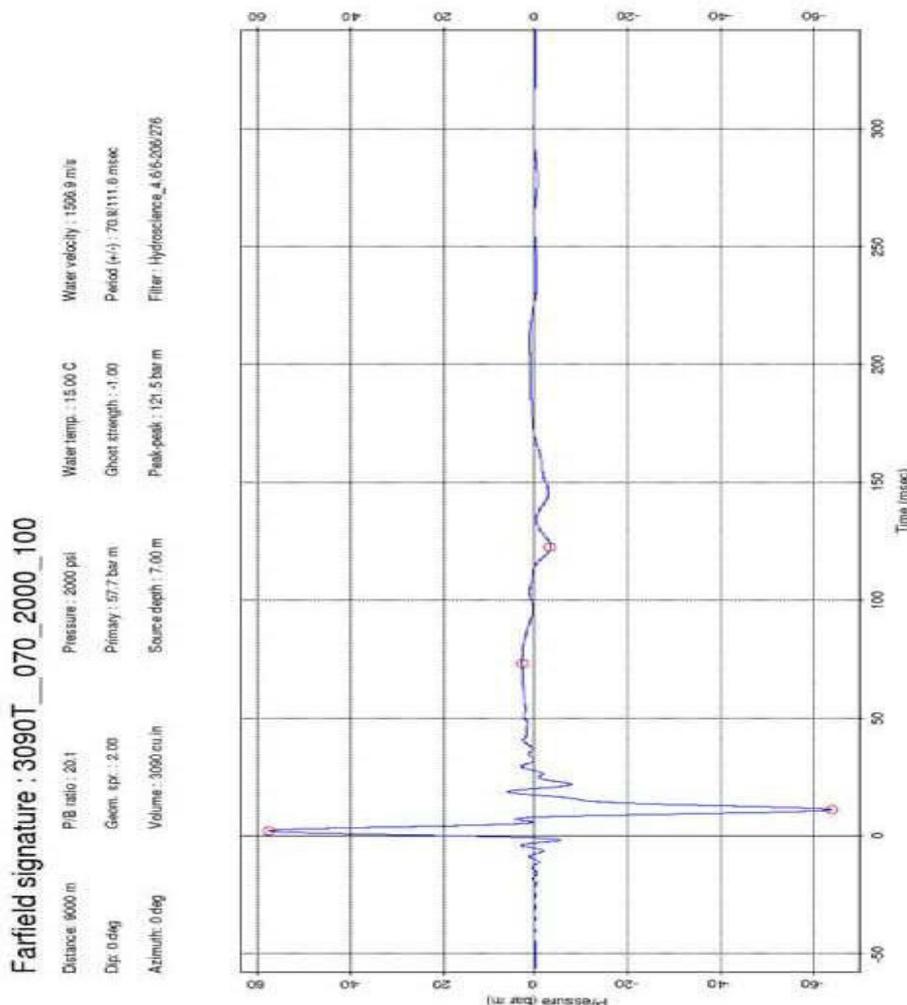
Figure 1 3090 in³ Gun Array Far Field Signature

The drop out spec was generated by PGS. The 3090 in³ array was used throughout the survey. A rigorous maintenance schedule was maintained on the array strings and individual elements were replaced at the specified time regardless of their performance. A total of 7.37 hours were lost due to a single electronic failure in the array control system that took longer than anticipated to fault find. Other than that one incident the arrays performed faultlessly.

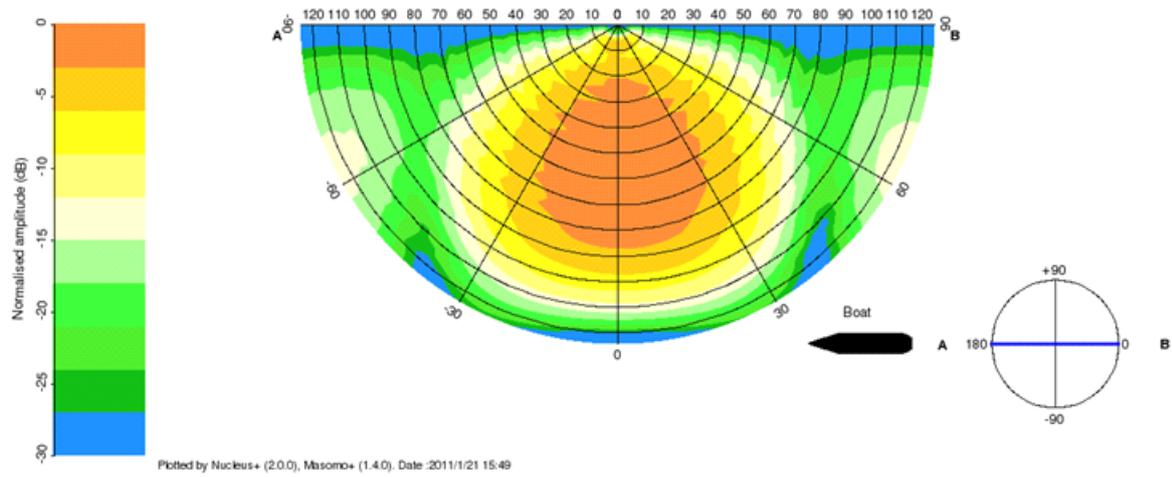
Figure 3 Source Directivity Plots

Source directivity : 3090T__060_2000_100

Azimuth : 0 deg

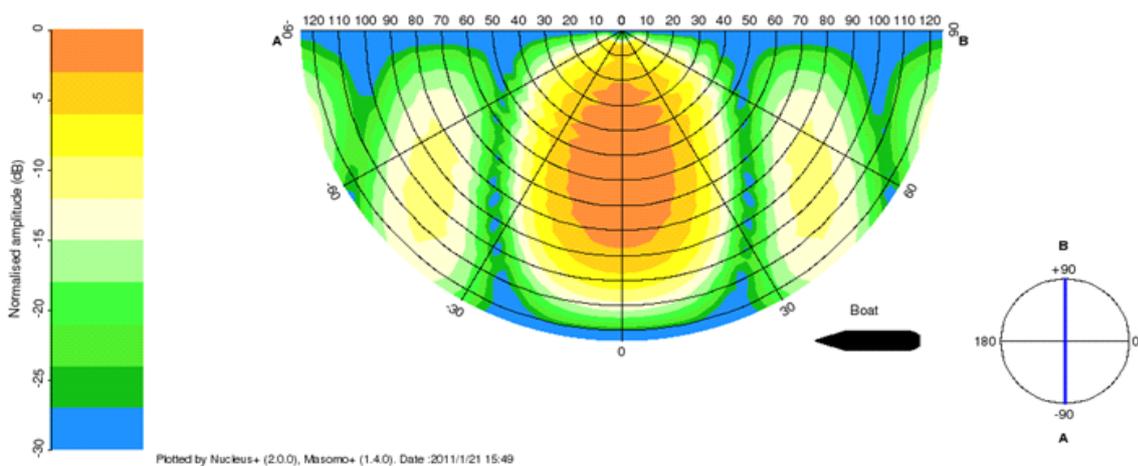
Source directivity : 3090T__060_2000_100

Azimuth : 90 deg

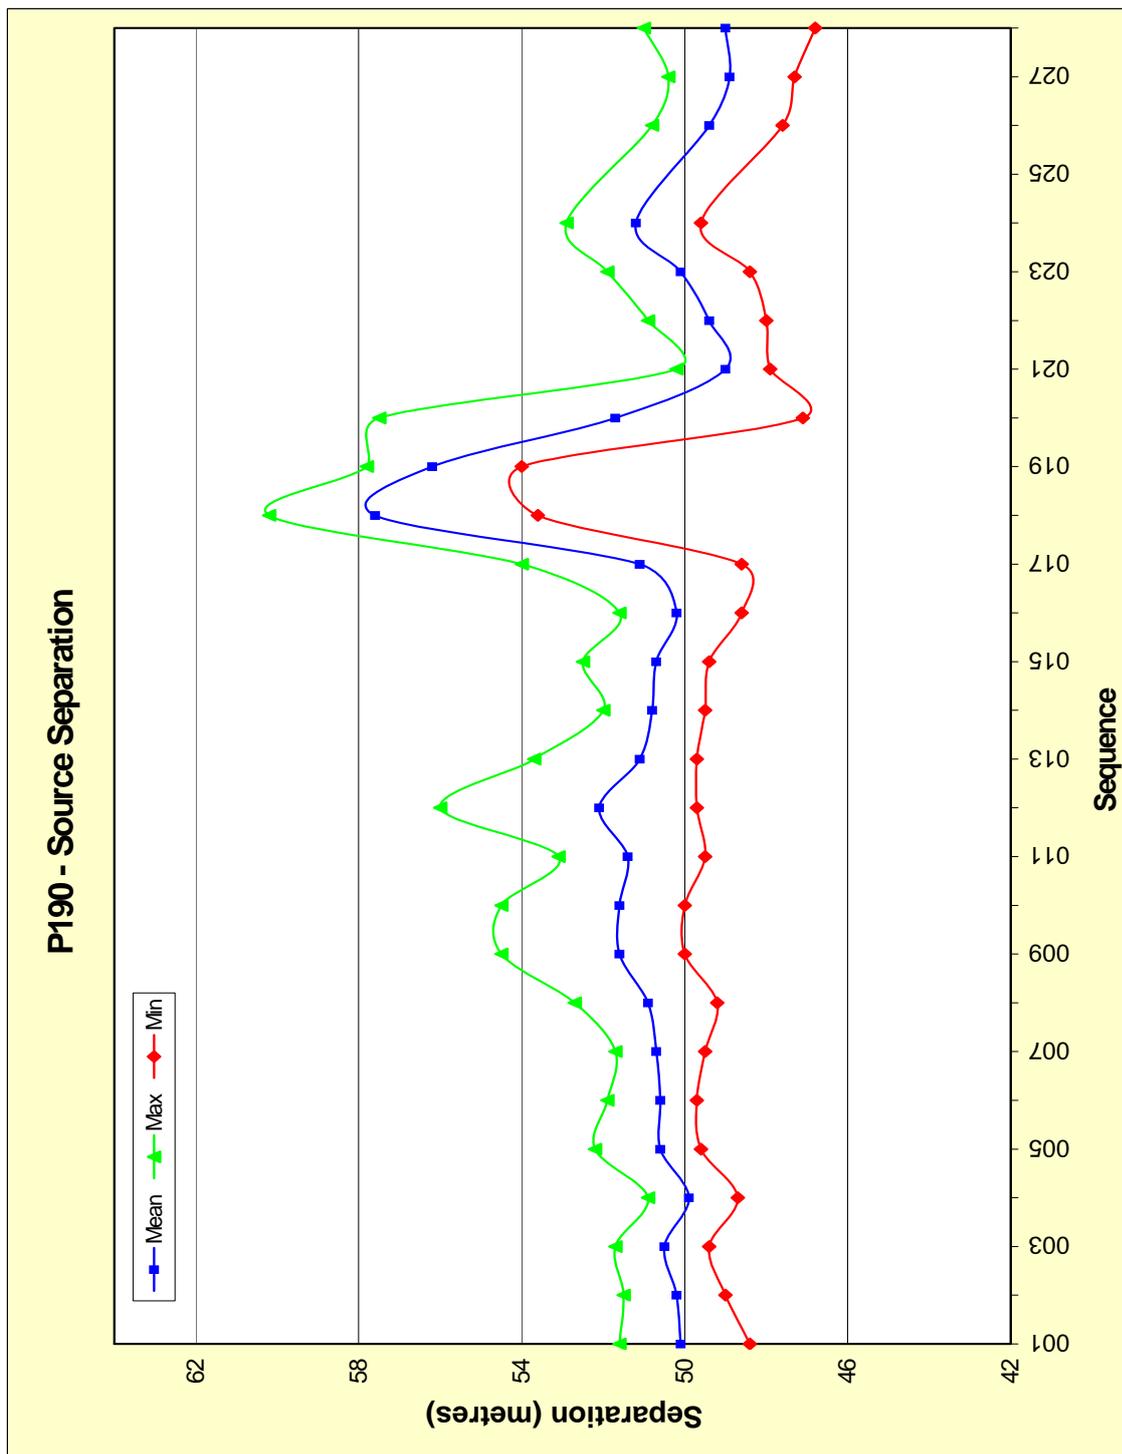
Figure 01 Source Separation

The industry tolerance for the source mean separation of 10% either side of 50m was not kept on two lines. The survey mean source separation was observed as 51.0 metres.

The gun string separation tolerance of 10% around 10 metres was not kept as can be seen from Table 1. The sea state, and the faulty Actuator, jammed open on array strings 2, and 5 for a number of lines were the main causes.

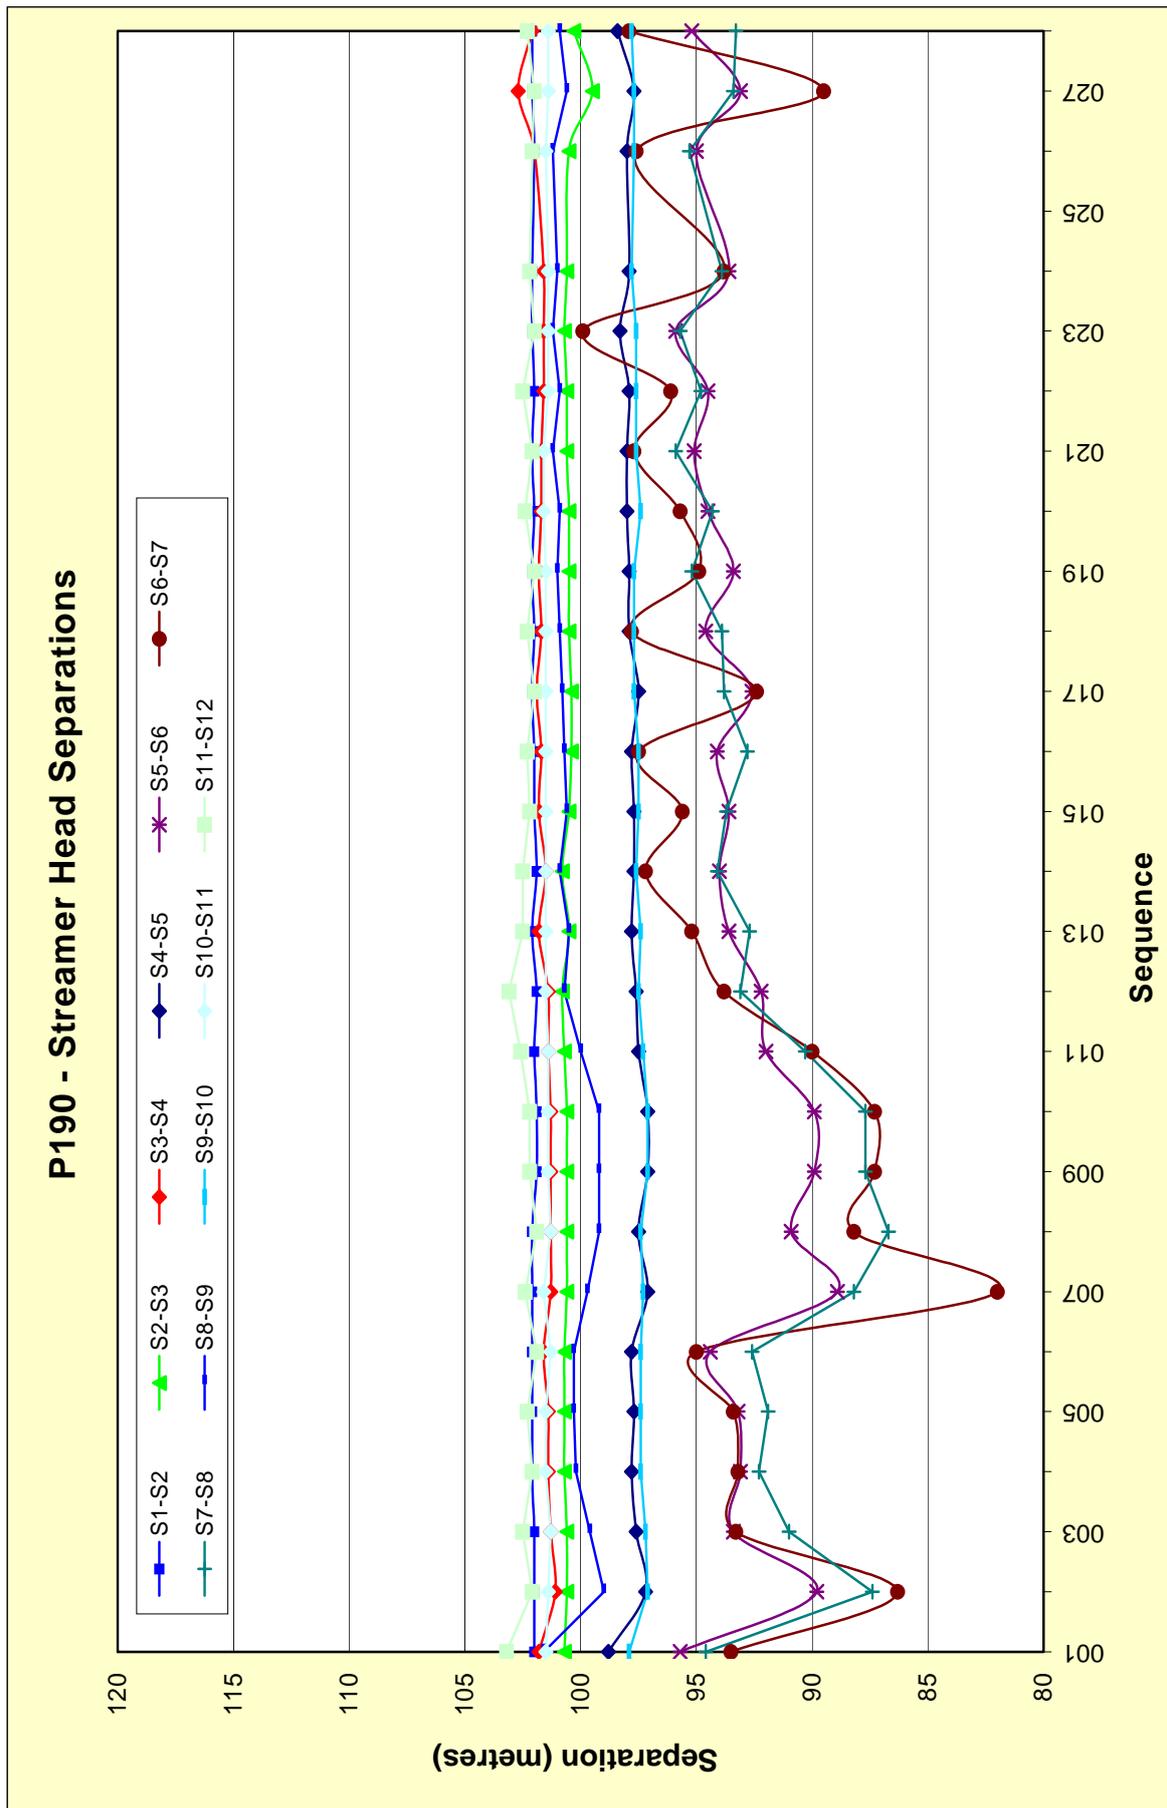
Figure 02 Streamer Front End Separation

Except for streamers 6 to 7, and 7 to 8 the front end mean streamer separations were within 10% of 100 metres for the period of the survey.

The DigiFin *Fan Mode* was employed from 900 metres along the streamers. The *Fan Mode* was set at 1.2. The effect on the streamer separations commenced at approximately 1100 metres.

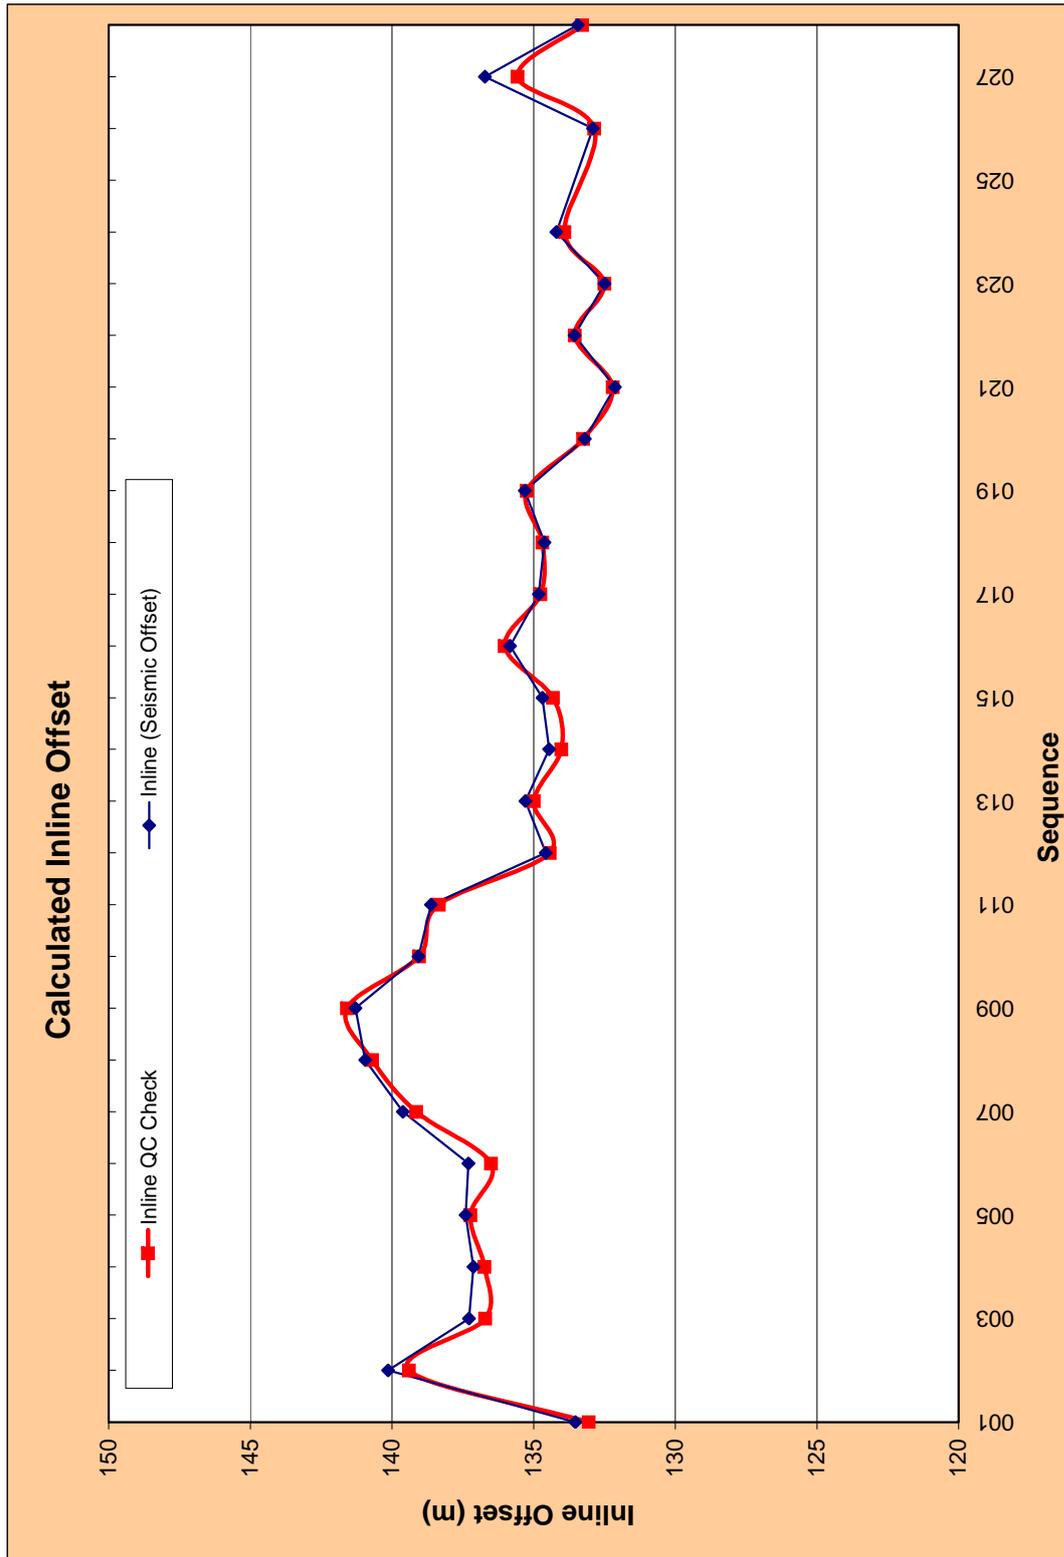
Figure 03 Inline Offset

The mean inline offset from the source to the streamers was 135.7 metres.

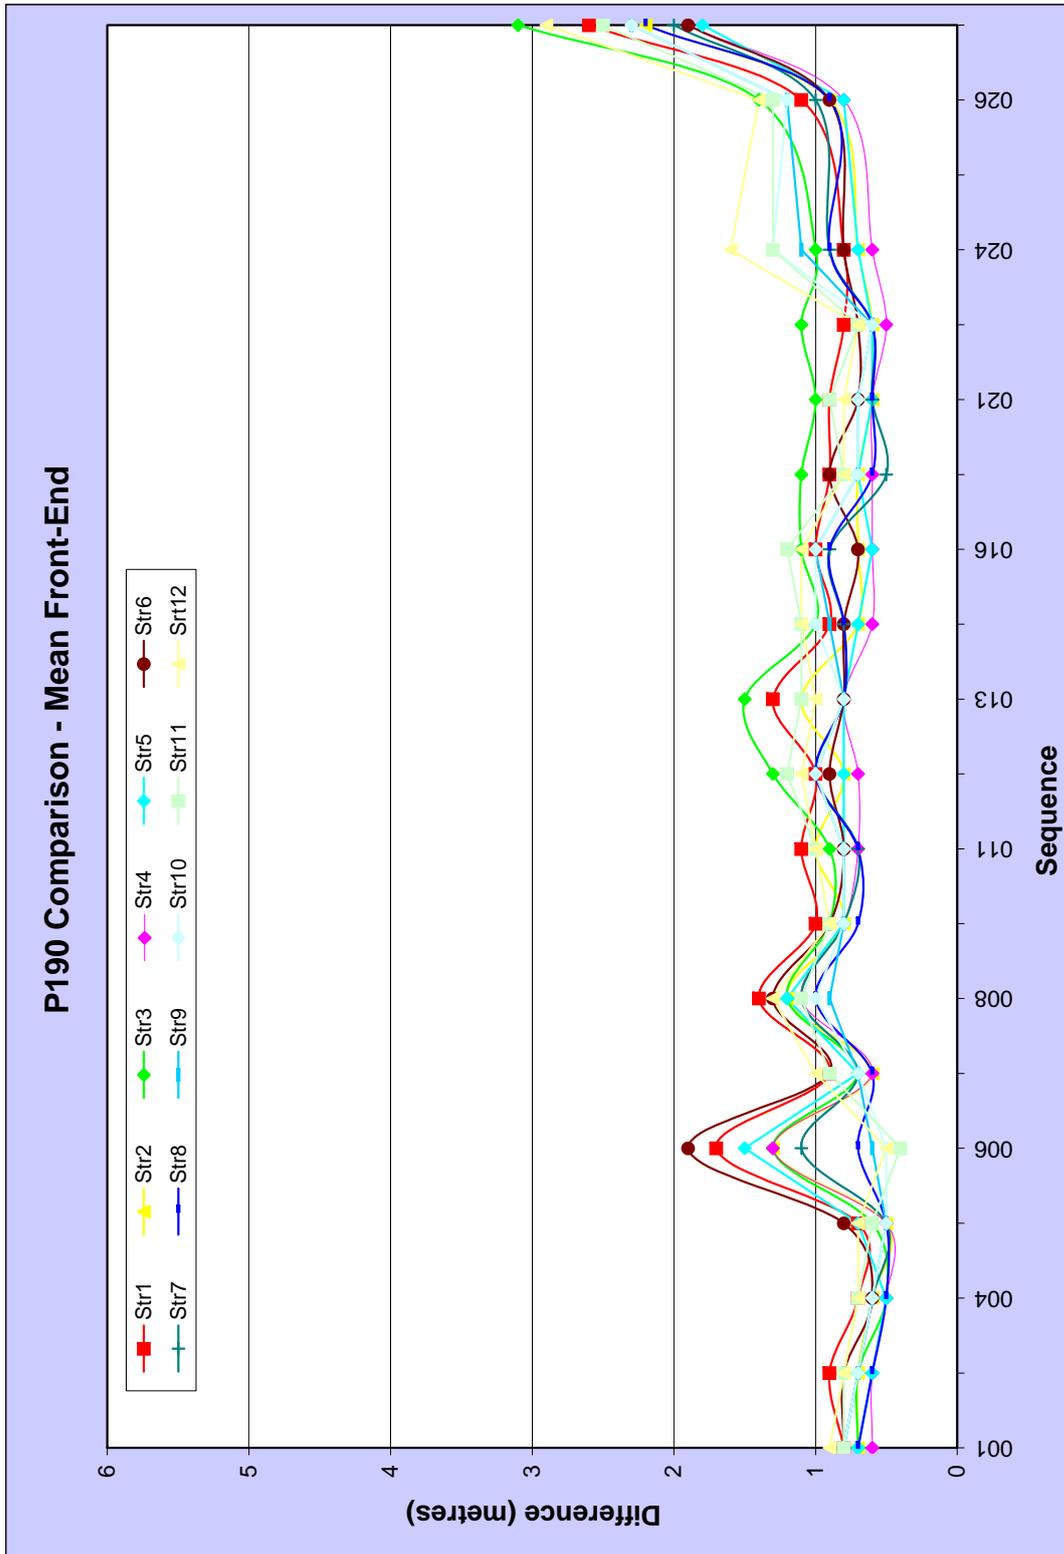
Figure 4 Front End P190 Comparison Results

The use of independent processing enabled an independent appraisal of the raw data quality, and the accuracy and precision of the final positions.

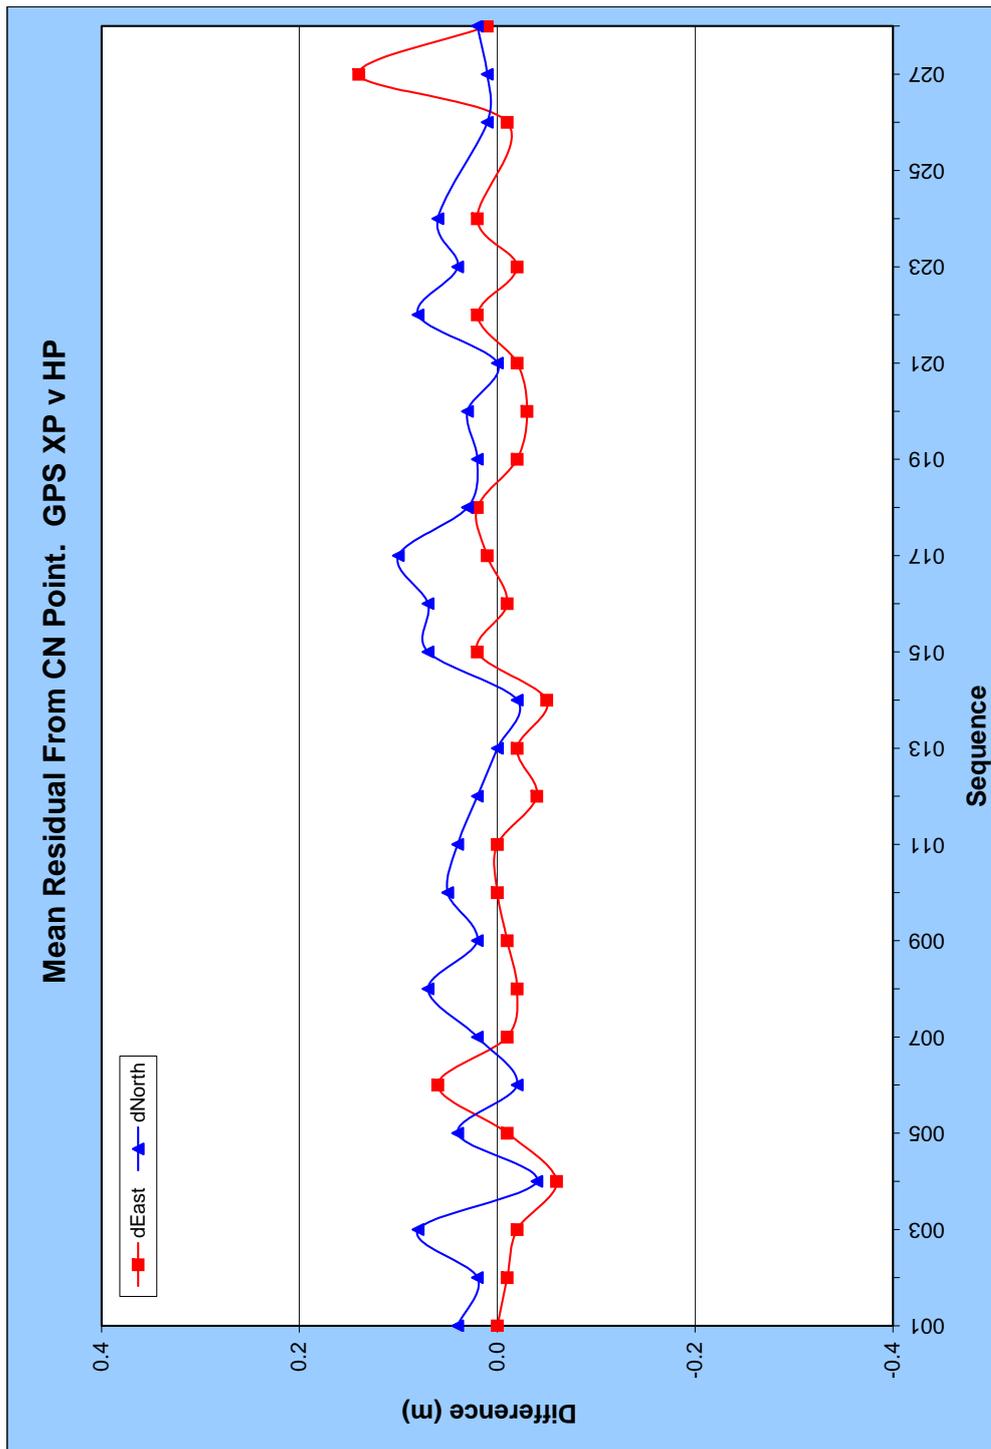
Figure 07 GPS XP HP Mean Position Comparison

Sequence 022, 023 corrections were only available via the internet. HP corrections were not available for a short period sequence 020.

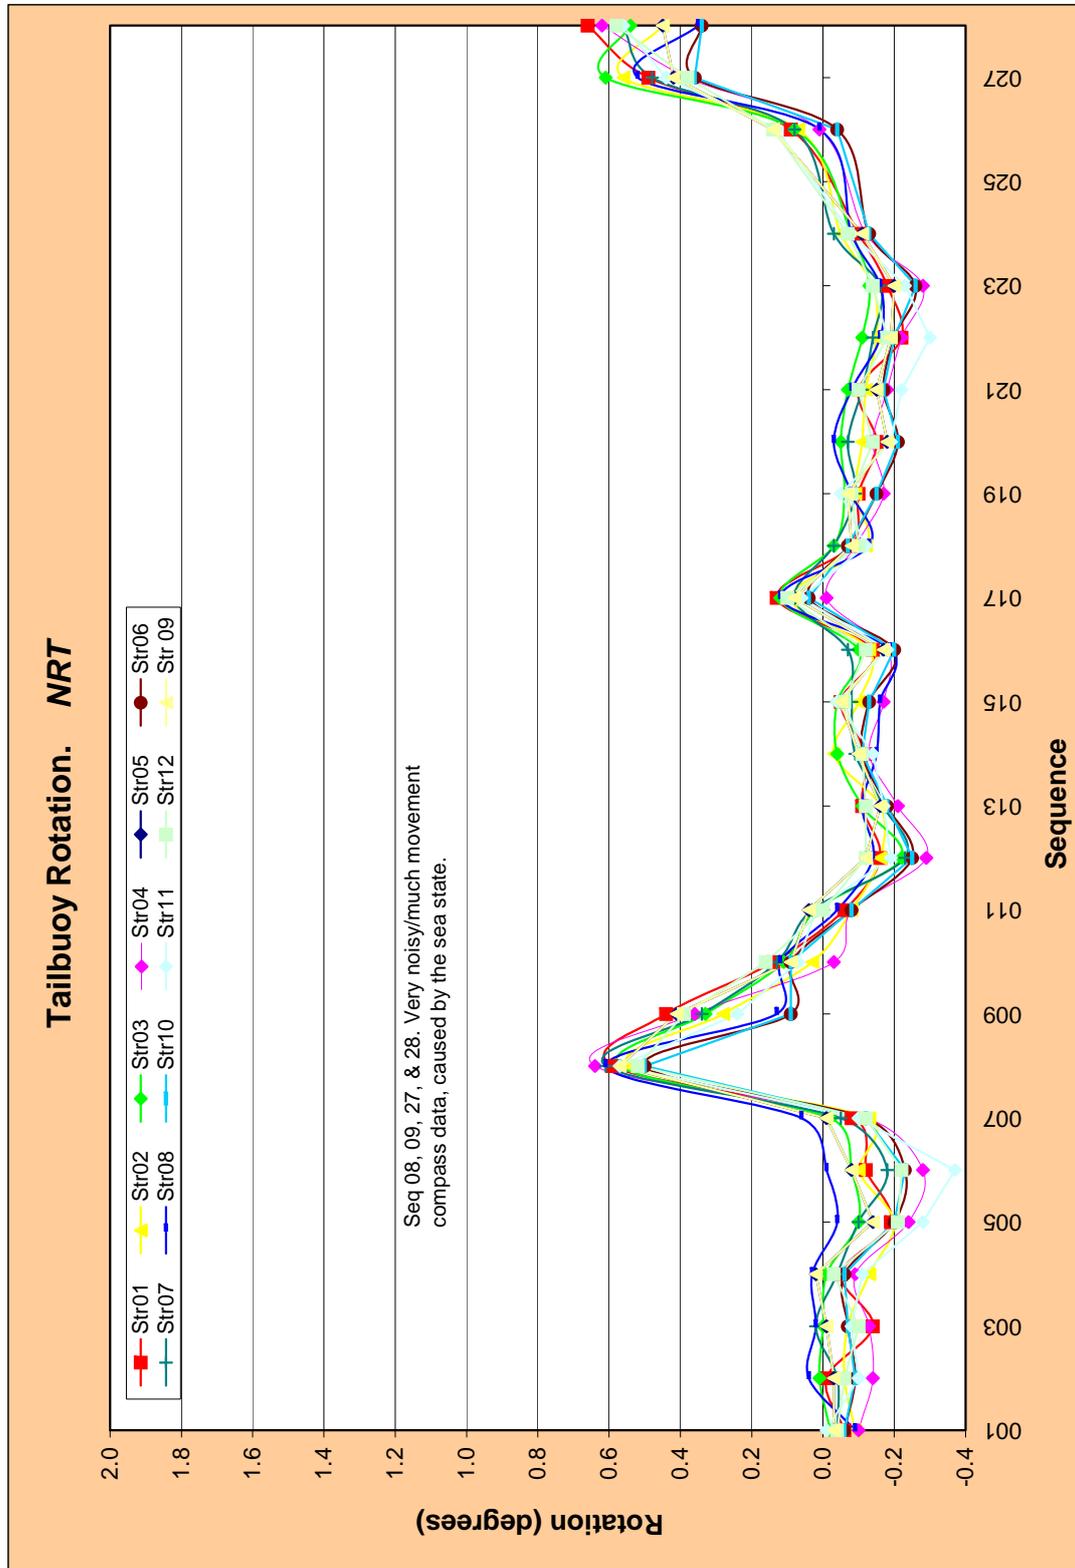
Figure 09 Mean Tailbuoy Rotation.

Sequence 008, 026, and 027 a mean rise of between 0.4, and 0.6 degrees, with 009 around 0.35 degrees was recorded. No other explanation for the cause could be given except the very rough sea conditions that prevailed resulted in extremely noisy, erratic compass data.

It is thought the use of DigiFins to fan the end of the streamers resulted in generally higher bias levels, therefore a less rigid regime was in place for replacement based on the compass bias reports.

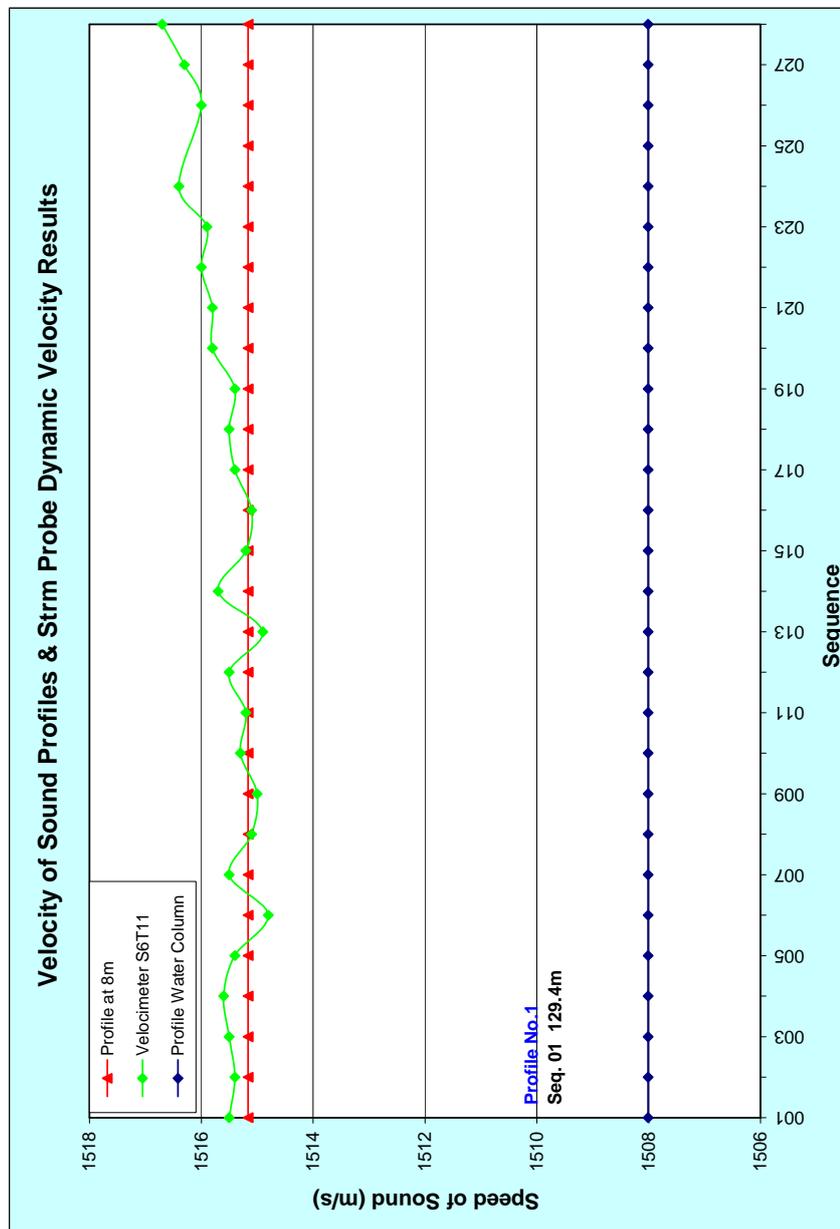
Figure 10 Velocity of Sound Comparisons

Two instruments were used for velocity of sound observations. One Sippican drop from the Ramform Sterling at the start, and end of the survey. A velocimeter installed on streamer six.

No problems were seen, or reported with the Instruments. The velocity profile results, and the mean velocity of sound for each line produced by the velocimeters can be viewed in file R.Sterling.Origin_BELLERIVE_NAV Stats

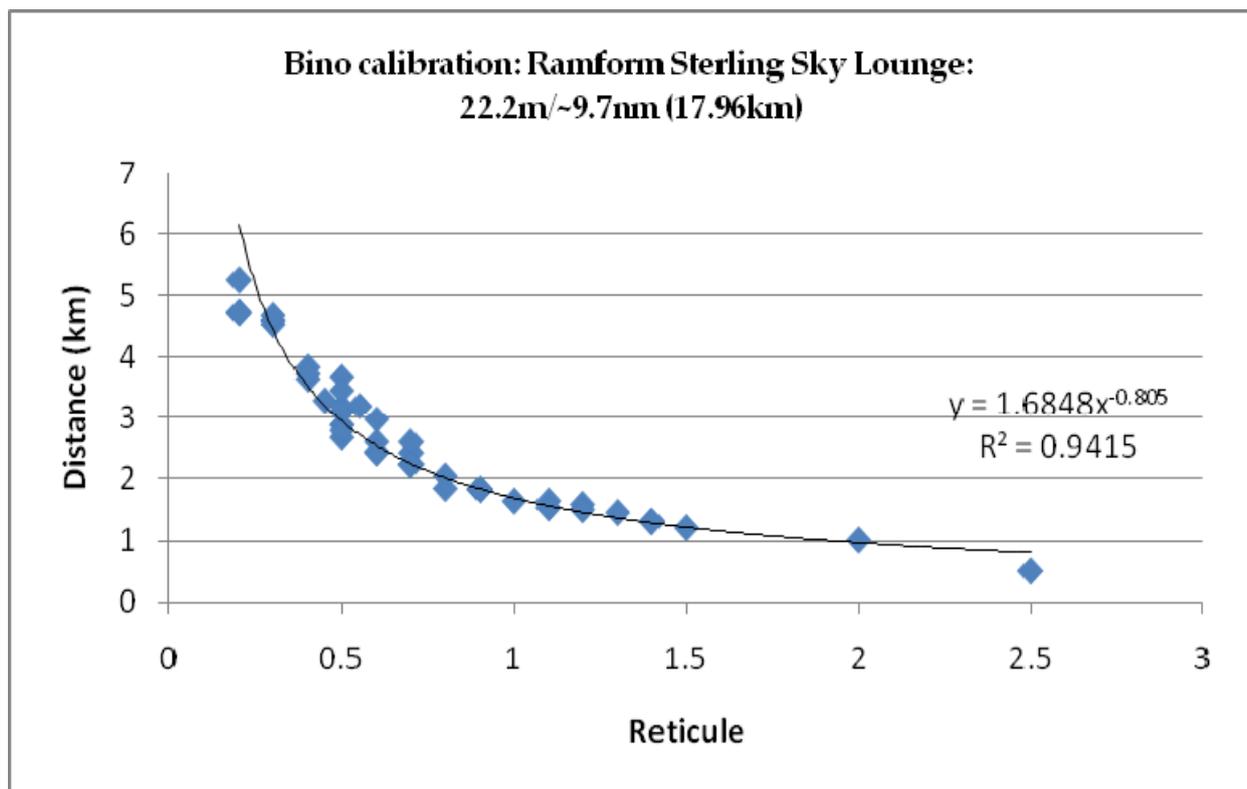
Calibration of the range finding binoculars was undertaken to enable the distance marine mammals were sighted from the vessel to be accurately estimated. A series of measurements were made to nearby vessels using the ships radar to obtain accurate distance measurements whilst recording the number of reticules below the horizon through the binoculars. These were then plotted and a regression equation fitted to obtain an accurate measure of distance across a range of reticules

Graph and regression curve for binocular calibration.
