Storys Creek,  
23rd. Mar. 2002

REPORT ON PROSPECTING BY THE HAHL BROS. ON THE STRICKLAND MINE  
EL 1/92 CUTTACK MINING AND EXPLORATION

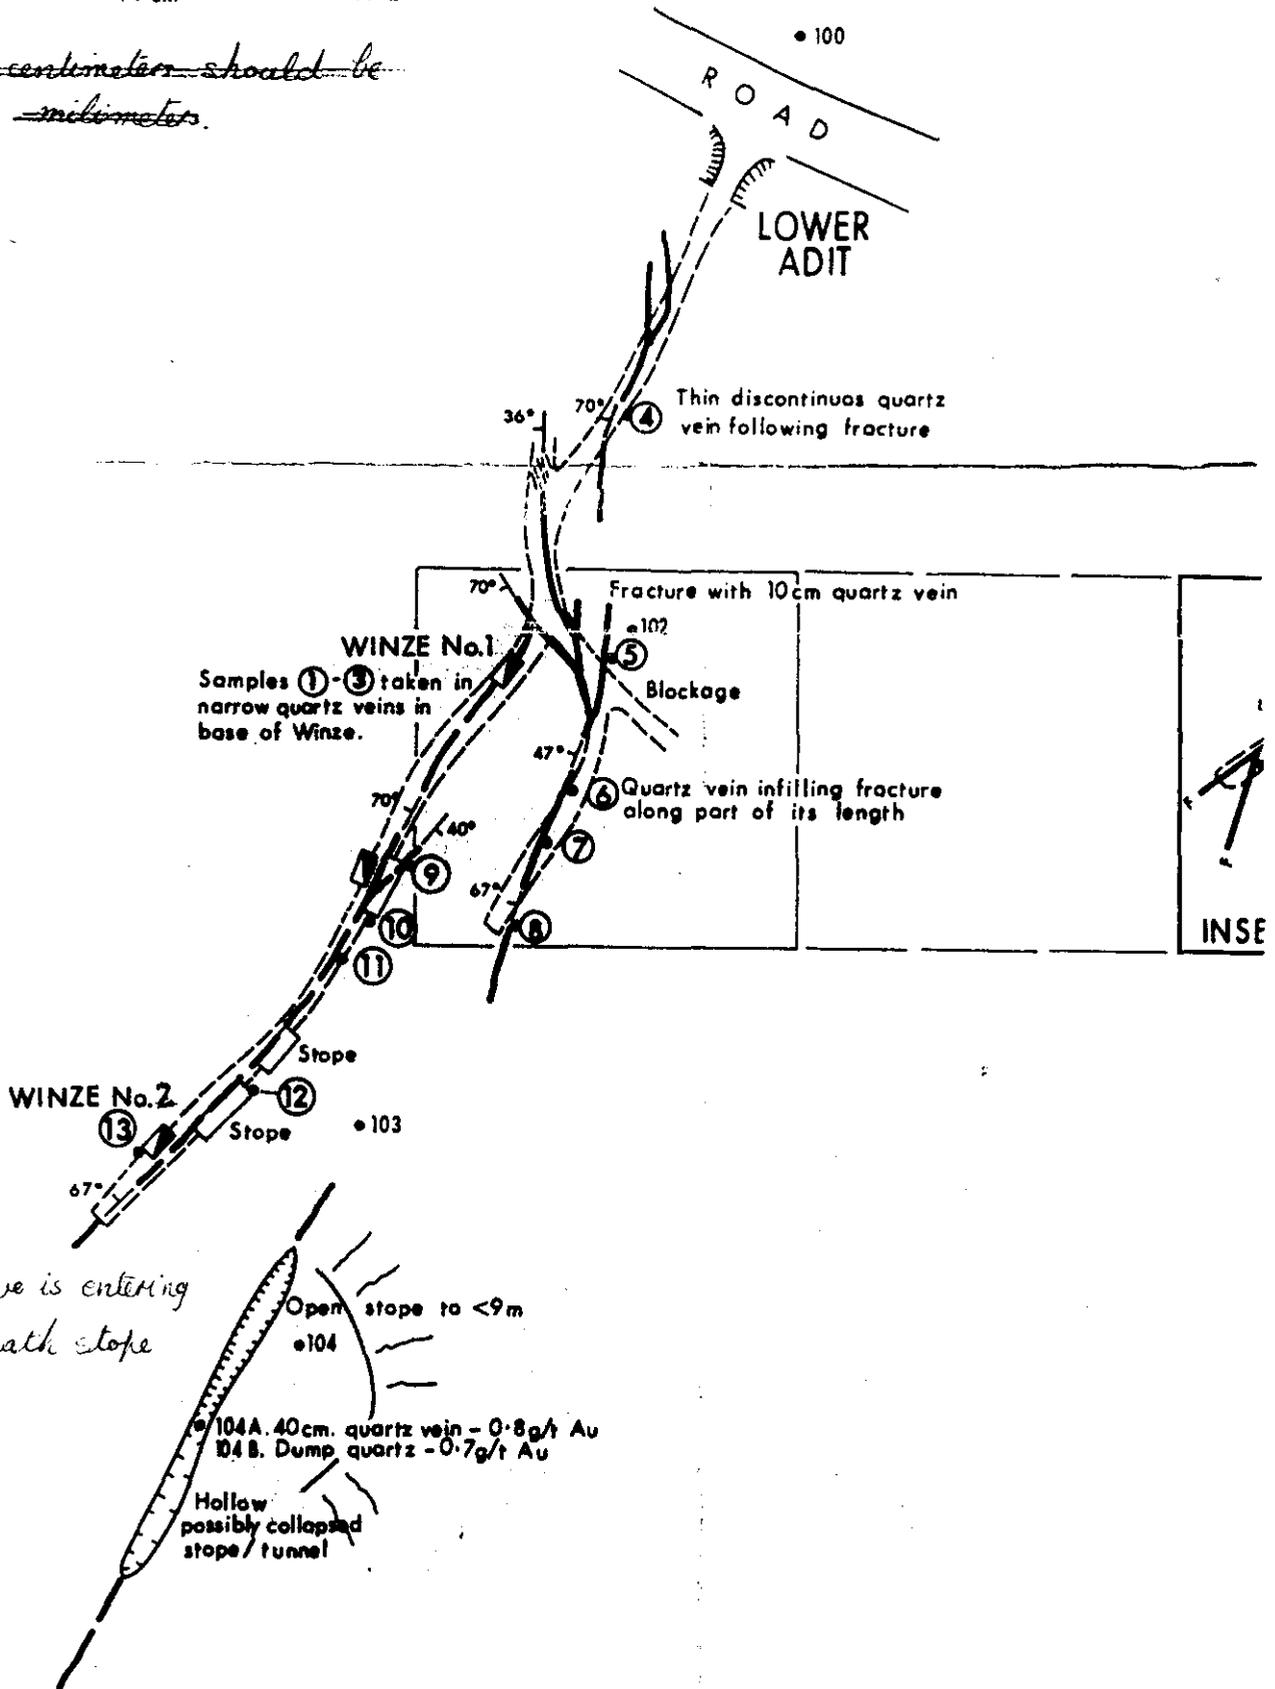
Fig. 1  
 STRICKLAND.

note that drive is entering  
 area underneath stope

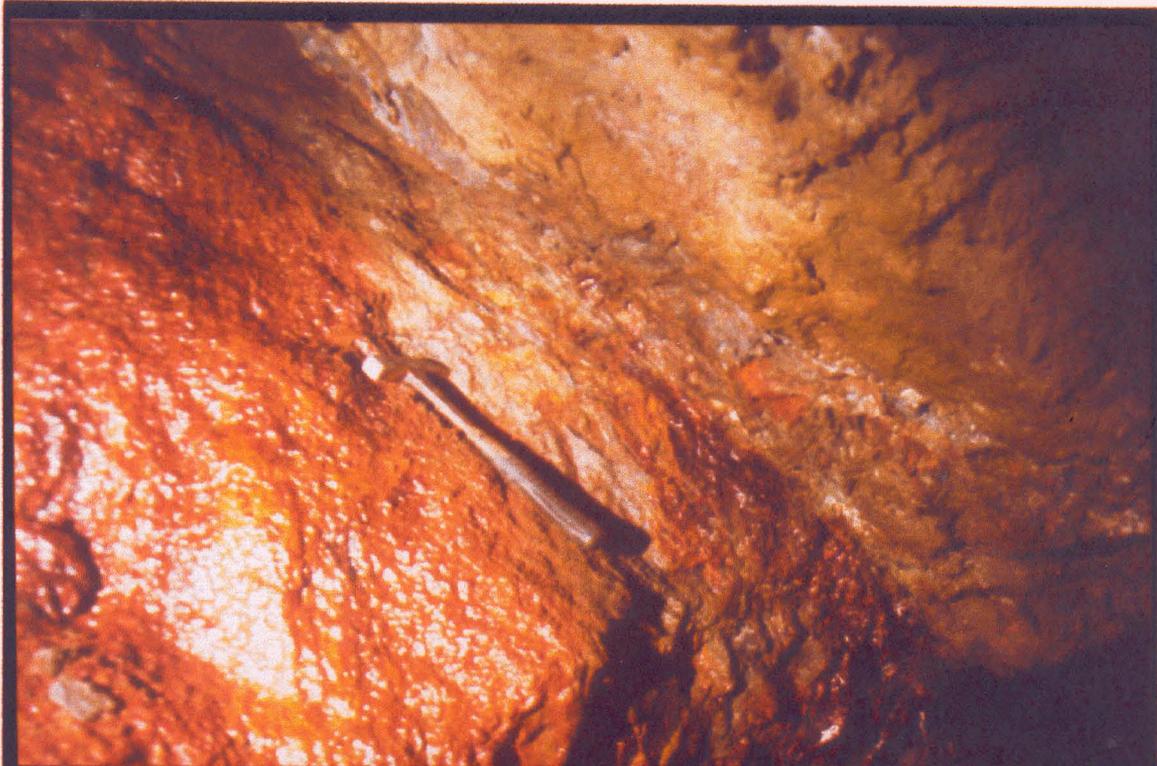
Photo 1 Edge of Stope above winze

Work moved to the area of the second winze. Just before the winze is a small stope approx. 4m. x 4m. going 50 to 60 degrees up dip over the level. The dip here is shallower than the vein in the winze below and the surface stope above and may be the same feature as the change of dip in Nr.1 winze. The faces in the stope are stained and the quartz is not readily seen but where visible is about 10cm. with the widest part about 20cm. near the top left hand corner. At the bottom right hand end of the stope just above the winze the vein has petered out to a stringer. The winze was then attacked. Although directly above the winze the vein is only a stringer, immediately below the floor of the drive on

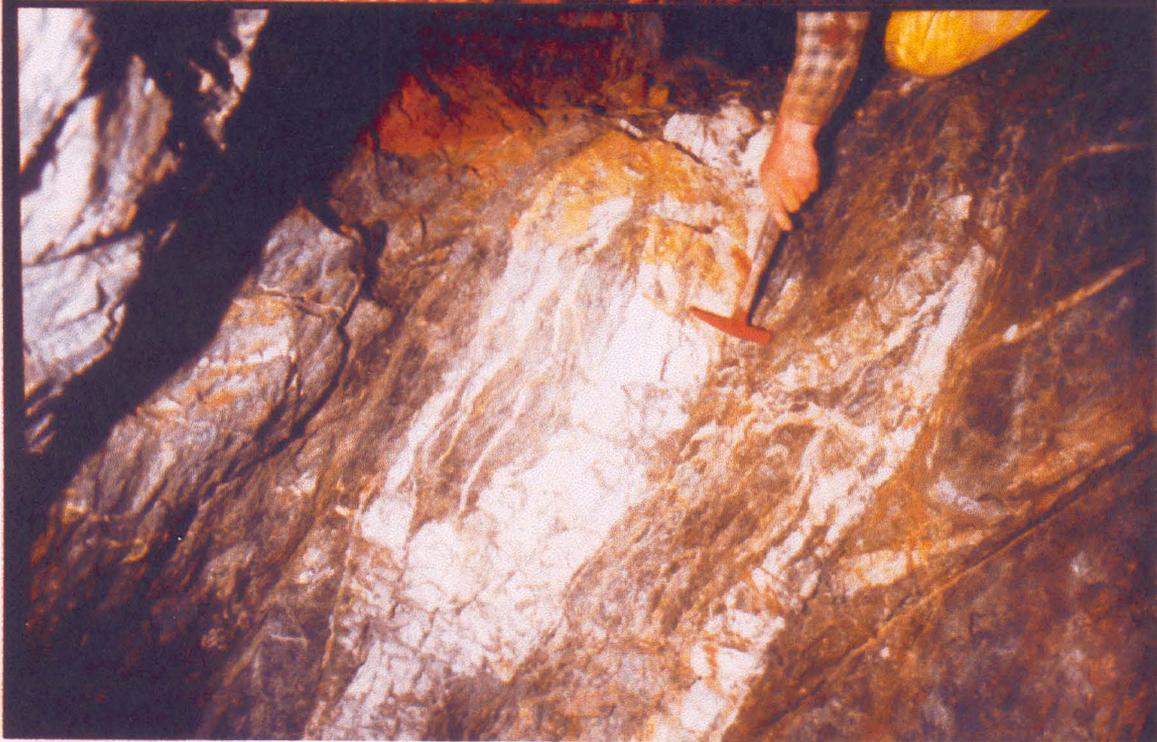
Photo 2 N<sup>th</sup> face of winze

the south side it is a good solid body of stone 30 cm. wide. It is of milky quartz with some laminations between two good walls. Photo 3 shows the vein at the lowest part exposed but it maintains this character the whole way. On the north side of the winze the vein is more broken up and mixed with country rock. See photo 2. Bailing had progressed for less than half a meter when it was found that the winze was full of broken rock. It is unlikely that the ore taken from the winze was put back there so it seems likely that the rock came from the stope above the level. The reason for putting it down the winze is not clear. The broken rock was then shovelled out to a depth down dip of 2.6m. amounting to about 8 tonnes of material. When nearing this point a tom was removed from the broken ore, this tom went straight down and indicated that the winze is at least a further 2m. deeper than the 2.6m. reached. Unfortunately the EL was relinquished and work had to cease at this point. The 'orebody' starts in the stope and continues where traced in the winze. The vein as a whole dips to the N.W. and the 'orebody' pitches steeply to the S.W.

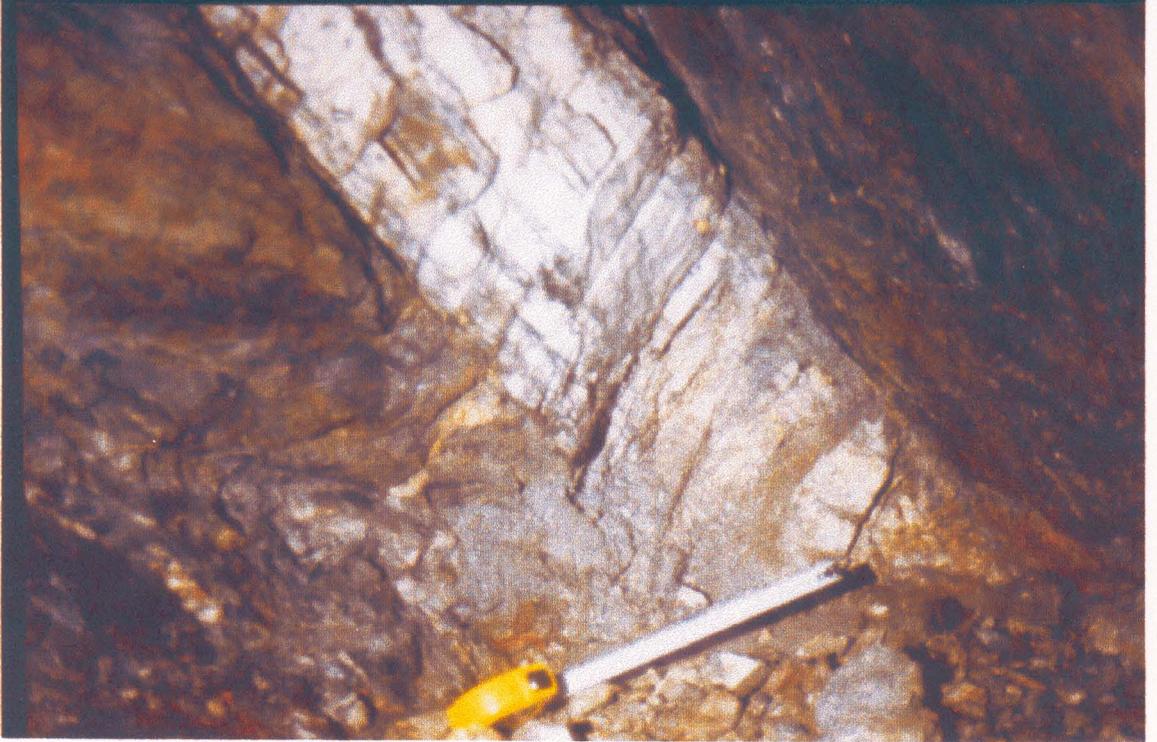
Photo 3 S<sup>H</sup> Side Winze Tape 30cm

Four samples were taken for assay. Two samples were taken from the broken rock supposed to have come from the stope. It was intended to take a piece of white quartz and a piece with substantial laminations for comparison. On the brief last visit time did not allow for a long search and no suitably laminated piece was found from this material. Two samples of vein quartz were taken from the bottom of the winze (as far as we had cleaned it out), one from each side. On the south side, see photo 3, the quartz broke out in small blocky lumps with partings of clay and arsenopyrite? On the north side, Photo 4, the stone was more homogenous and was chipped away with difficulty from just above water level. The four samples were forwarded to Mr. Lethborg of Westbury, who had them assayed at the Beaconsfield mine. Due to lack of attention by the assayer who fail to note the identification tags the results were returned unidentified and their usefulness is much reduced. The results were disappointing, ranging from near zero to 17g/t. (see attached sheet). Going on some feedback from Mr. Lethborg it now seems likely that the 17g/t sample came from the south side of the winze, Photo 3. This area also appeared to contain the most sulphides.
