# Comstock Mine Environmental Monitoring Report First Quarterly 2001

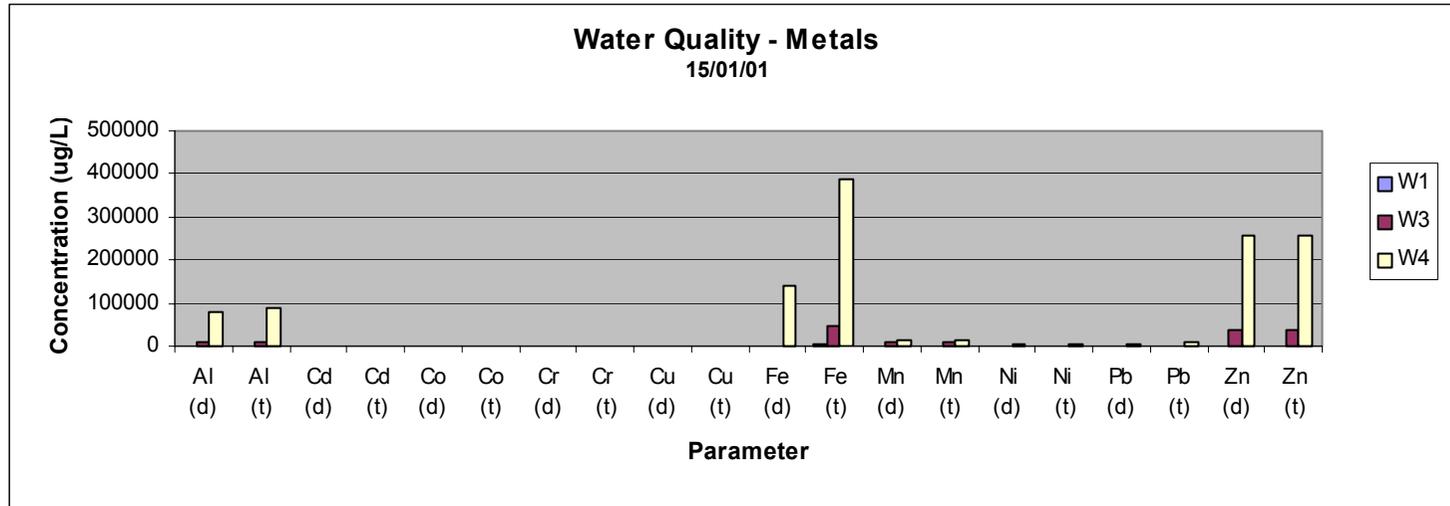
**Figure 1.** Water sampling results for metals on 15/01/01.

Samples were taken on January 15, 2001 and analysed at 'Analytical Services Tasmania' on January 23, 2001 for all of the required parameters (Figures 1, 3 and 4). Laboratory results are located in Appendix A.

The results of this sampling event are quite comparable to a 'low flow' period. The pH remained between 4.5 – 5.0, and the dissolved metals Fe, Mn, and Zn were of similar quality as well.

The results of this sampling event have shown no direct correlation between 'high flow' and 'low flow' events of the past. The pH has increased in acidity from 4.97 during a 'low flow' event to 3.1. The dissolved metals Al, Cd, Co, Cu, Mn, Ni and Zn have all increased in concentration, while the dissolved metals Cr, Fe, and Pb have all decreased in concentration, some quite dramatically. A lack of sampling and baseline concentrations in the past hinder any accurate interpretation of these results. A more detailed sampling program may be required for this location in the future.

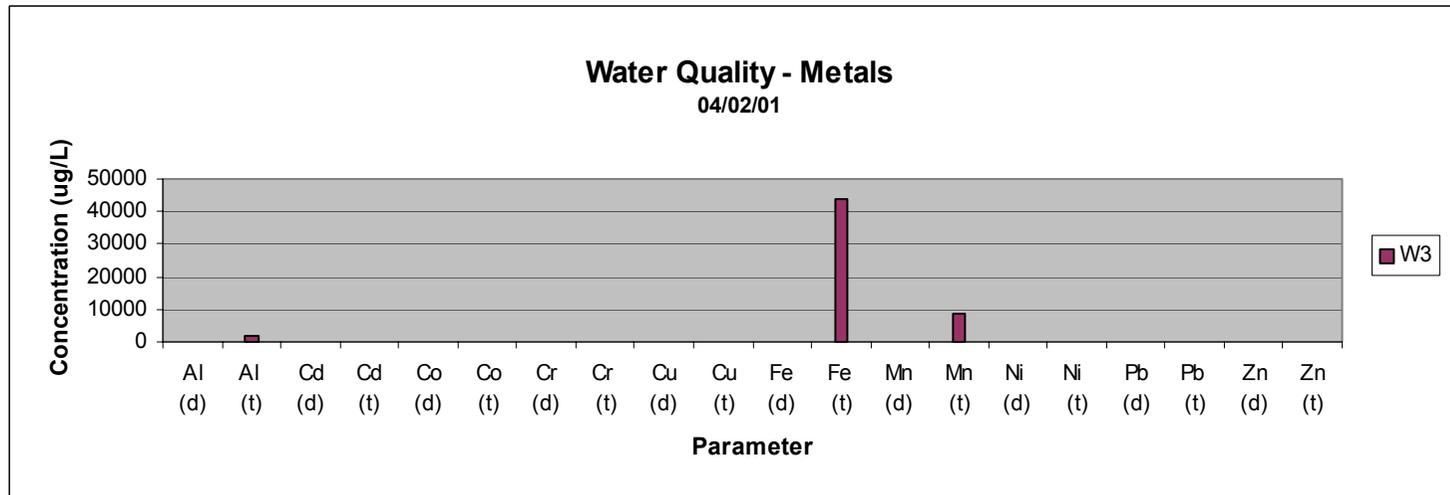
**Figure 2.** Water sampling results for metals on 04/02/01.

Another set of samples were taken at this location on February 4, 2001 and analysed at 'Analytical Services Tasmania' on February 7, 2001 for all of the required parameters (Figures 2, 3 and 4). Laboratory results are located in Appendix A.

The results of this sampling event have shown no direct correlation with any sampling event of this location in the past. While pH and all of the total metals are comparable to a 'low flow' event (even better in most cases), the dissolved metals are barely detectable. These kind of results indicate an inconsistency in water sampling techniques from 'cradle to grave'. A more detailed examination of sampling procedures will occur in the near future to avoid these inconsistencies.

- 
- To avoid assumptions and inaccurate interpretations of data, the flow ( $\text{m}^3/\text{s}$ ) at every sampling point will be appropriately estimated during sampling periods.
  - To avoid inconsistencies with sampling results (as was the case with W3 on February 4, 2001), sampling personnel will be trained with the appropriate sampling procedures. This will include recognised surface water sampling techniques and laboratory consultation on sample handling and timing.
  - To achieve a higher understanding and interpretation of the influence of mining activities on surface water, all metals analysis will include testing for 'dissolved' and 'total' characteristics.
  - As a convenient reference and comparison to the past sampling results, all quarterly reports shall include a chart in the Appendix, which summarises all of the sampling results of the past. (See Appendix B)

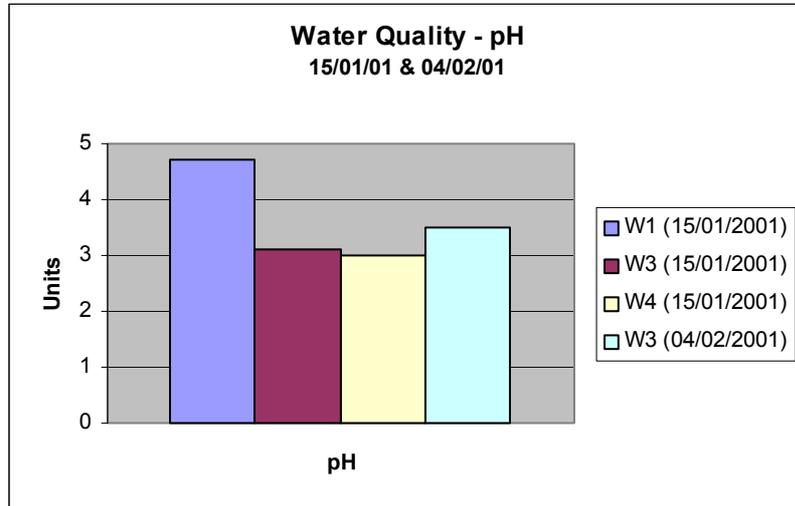
**Figure 3.** Water sampling results for pH on 15/01/01 and 04/02/01.

The settling pond at the base of the new Swansea Tramway Waste Rock Dump is a fairly recent addition to the mine works area. The pH and TSS at this location is comparable to the results at the W3 location, although the metals are significantly more concentrated. At the time of sampling, no surface water mitigation implements were present. Since this time, drainage patterns and ponds (Plate 1) have been constructed with silt dams and limestone buffers. The next sampling event should show a substantial decrease in all concentrations.

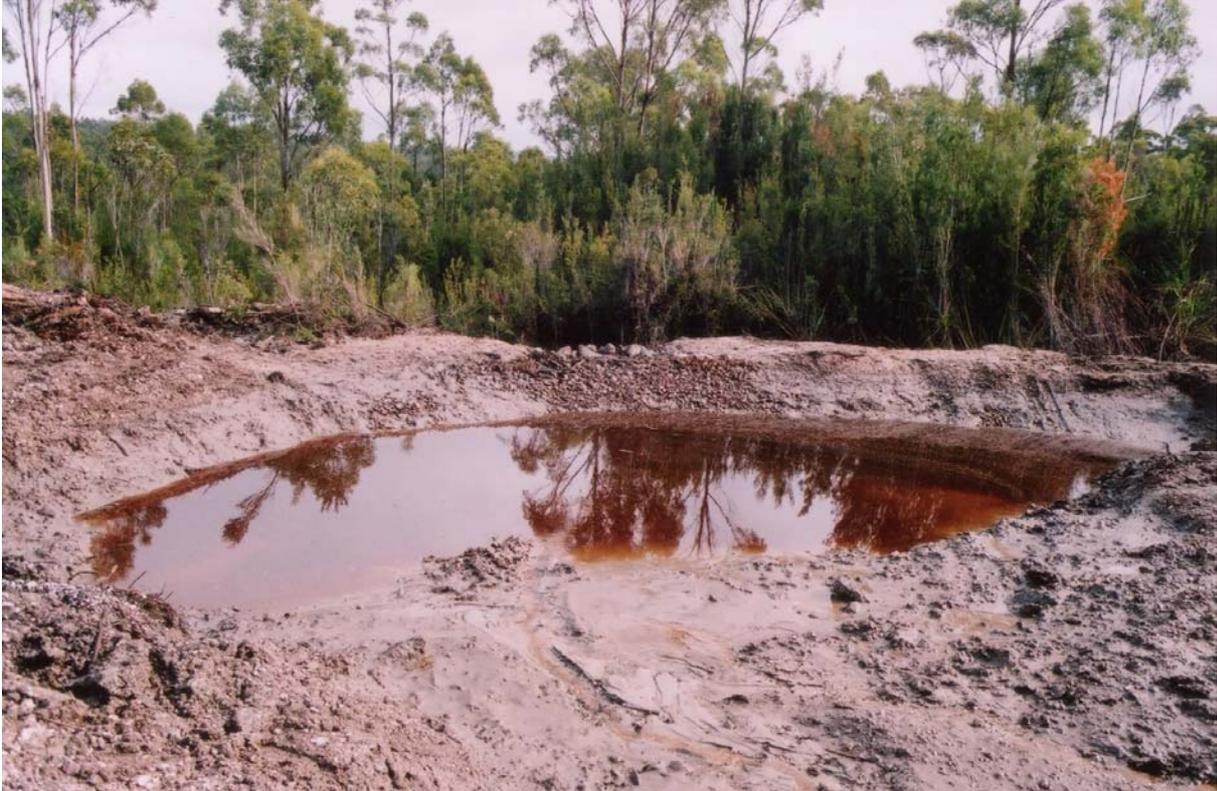
**Plate 1.** Swansea Tramway Waste Rock Dump collection pond.

Sampling location W4 is situated in a small pool at the base of the Swansea Tramway Waste Rock Dump.

In accordance with the requirements of Mineral Resources of Tasmania, the Department of Primary Industry, Water and Environment, and all related environmental legislation, the Swansea Tramway Waste Rock Dump during the period between January 2001 and March 2001 had progressively been structured to store segregated waste rock from the mining activities. Drainage patterns and holding ponds have been constructed to collect and treat wastewater run off. Additional control implements pertaining to wastewater and erosion control for the Swansea dump are planned for the following months.

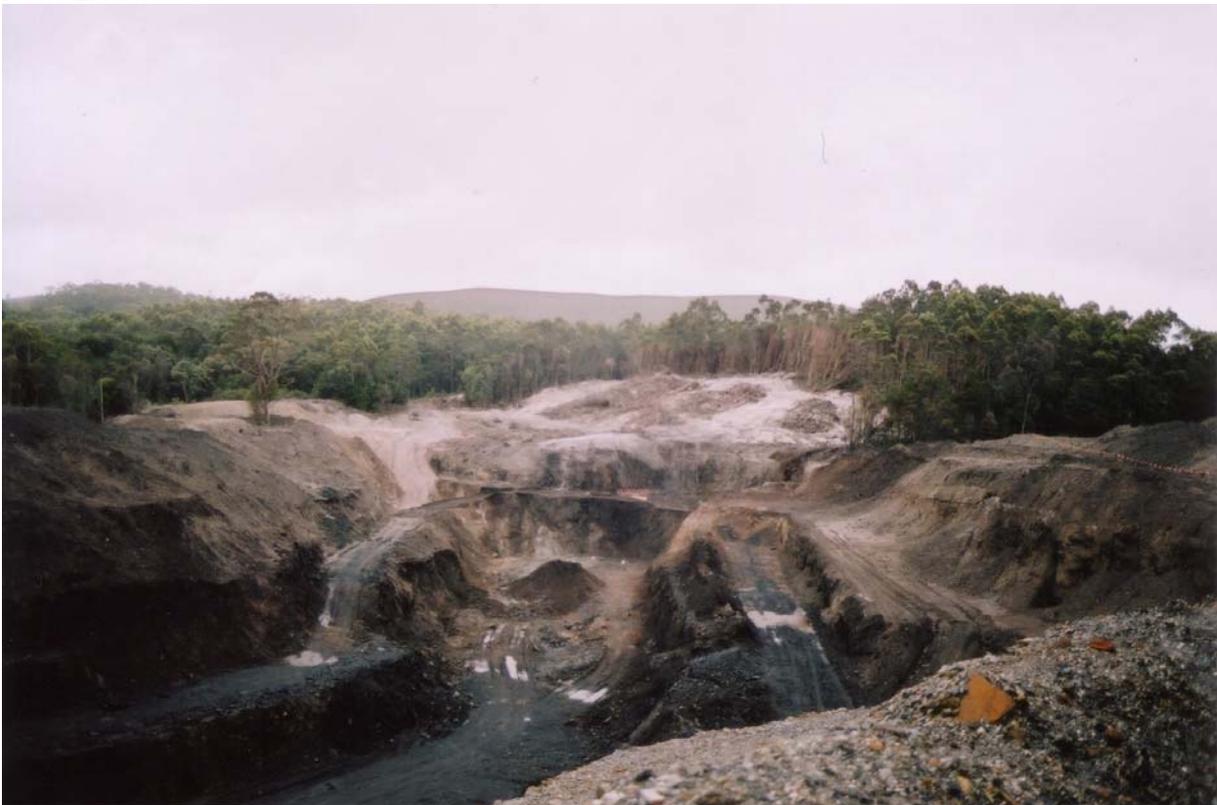
**Plate 2.** Allison's decline.

This site represents the east wall of Allison's decline.

The walls constructed around Allison's decline are quite stable. With the lack of activity since September, there has been little to no erosion in this area (Plate 2).

Continued site inspections by the mining staff ensure that this will not become an issue in the future.

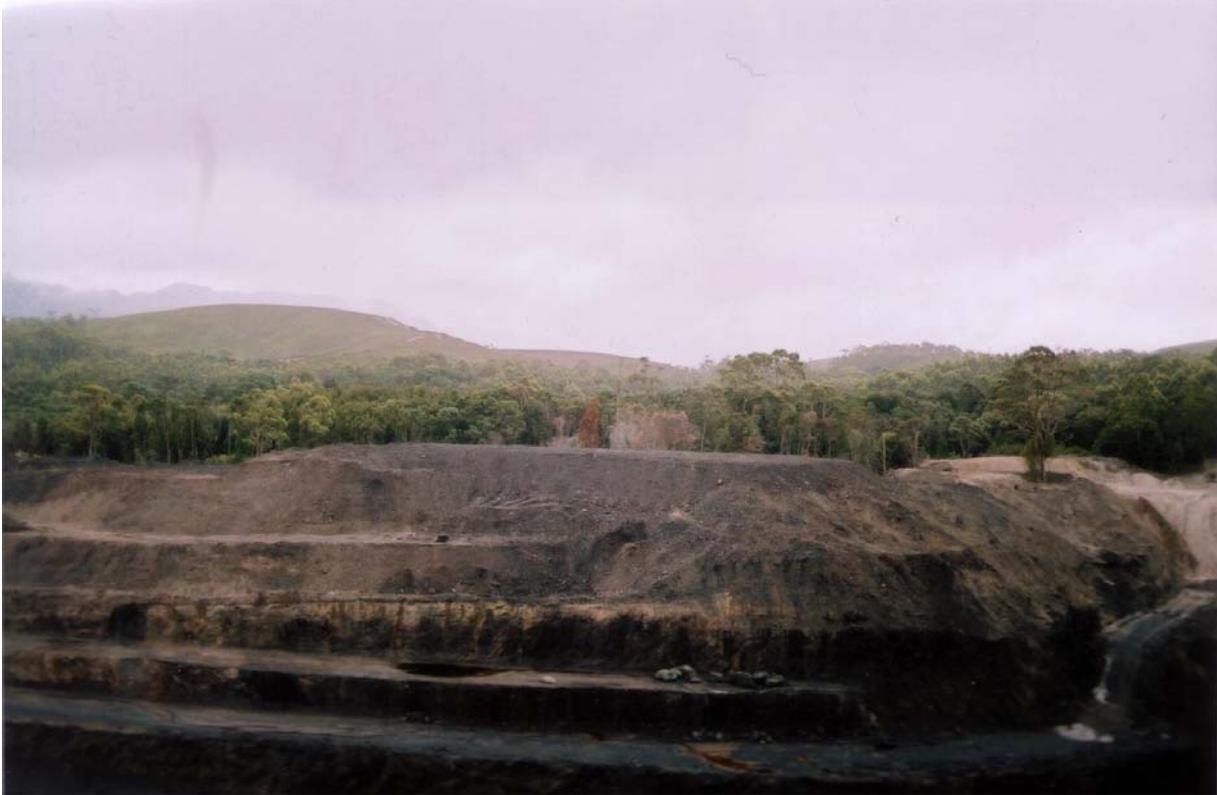
**Plate 3.** Central Mine Waste Rock Dump.

This site represents the southwestern batter of the Central Mine Waste Rock Dump.

During this three-month period, the Central Mine Waste Rock Dump had been periodically rehabilitated as the weather permitted. By the end of March, the dump was near to full rehabilitation, expecting to be completed within the following few weeks (Plate 3). Slope stability is a large part of this rehabilitation plan. Further issues in this area are not expected.

In accordance with the requirements of Mineral Resources of Tasmania, the Department of Primary Industry, Water and Environment, and all related environmental legislation, the Central Mine Waste Rock Dump during the period between January 2001 and March 2001 had progressively been rehabilitated as the weather permitted. The dump structuring will be completed during the month of April, and revegetated at an optimal time.
