Comstock Mine Environmental Monitoring Report Third Quarterly 2001

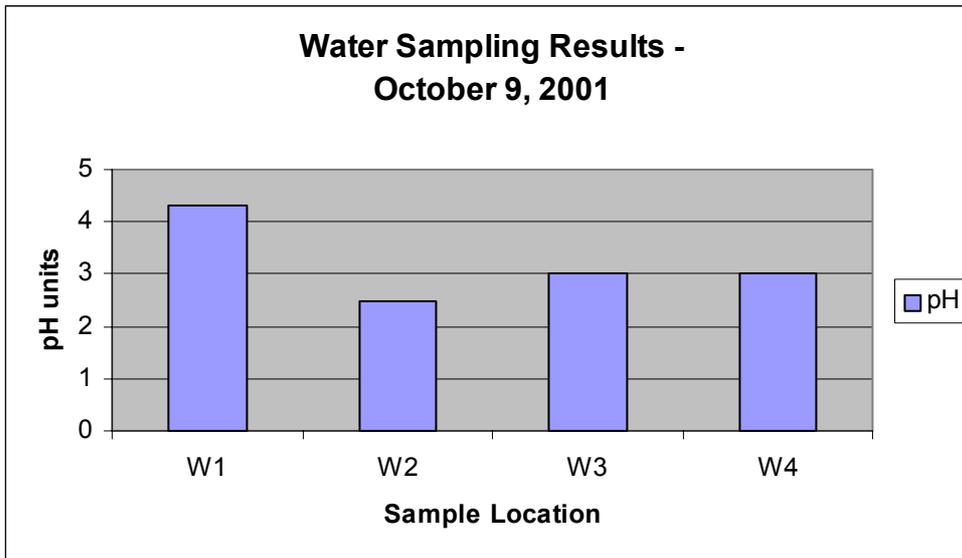
Figure 1. Water sampling results for pH on 09/10/01.

The pH of this area is around 2.5, with high acidity, aluminium, iron, and zinc. By maintaining the limestone and silt screens around the inlet, the quality of water entering the adit will improve. However, due to the shock of metal concentrations and a low pH during a storm event, these procedures will likely not be of great assistance.
